# Final Reclamation Inspection

Operator: RITCHIE EXPLORATION INC

Location ID: 313860

Inspection Document #: 720300150

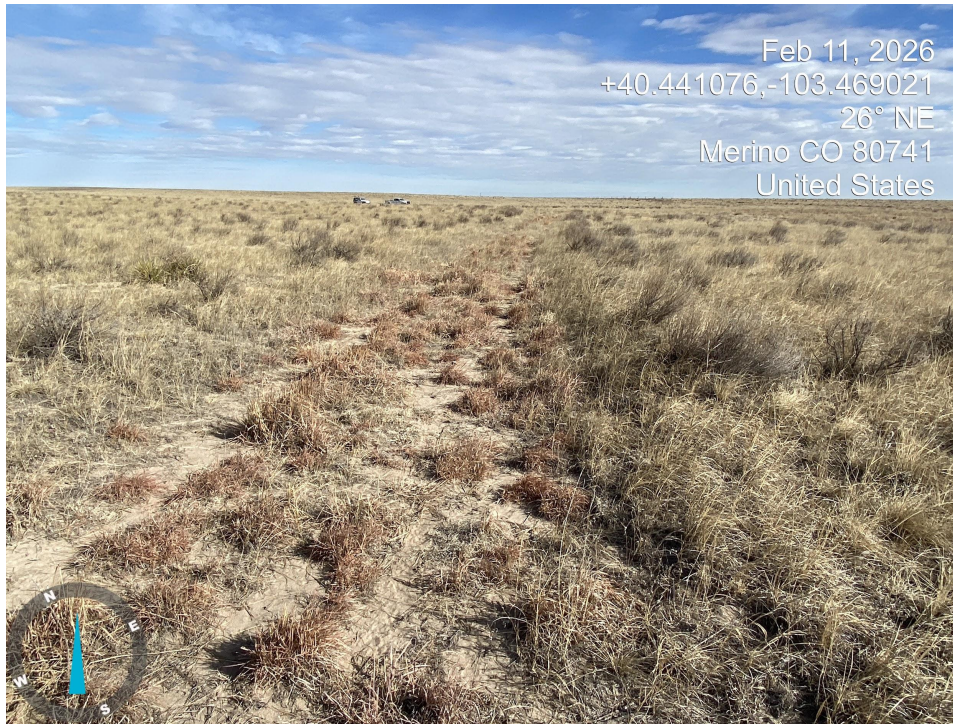
**Photo 1.** Photo taken from access road facing East of location facing North. showing evidence of road and bare soil with some desirable bunch grass growing. Acces road goes from the tank battery location through Merino-State 1 (API 087-06775) to Merino State 3 (API 087-07205)

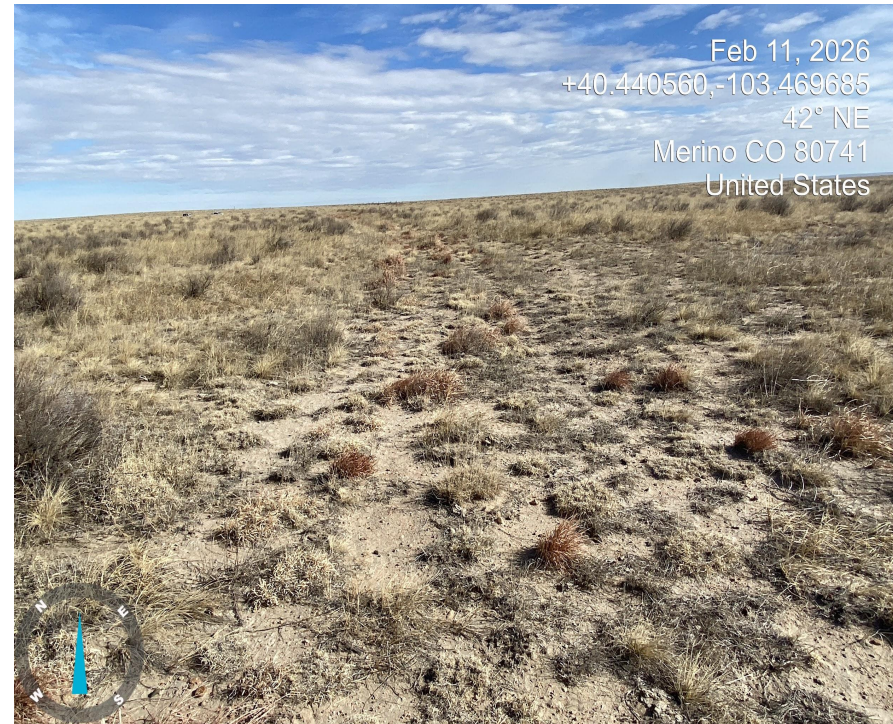
**Photo 2.** Photo taken from access road east of location facing Northeast. See comment under photo 1.

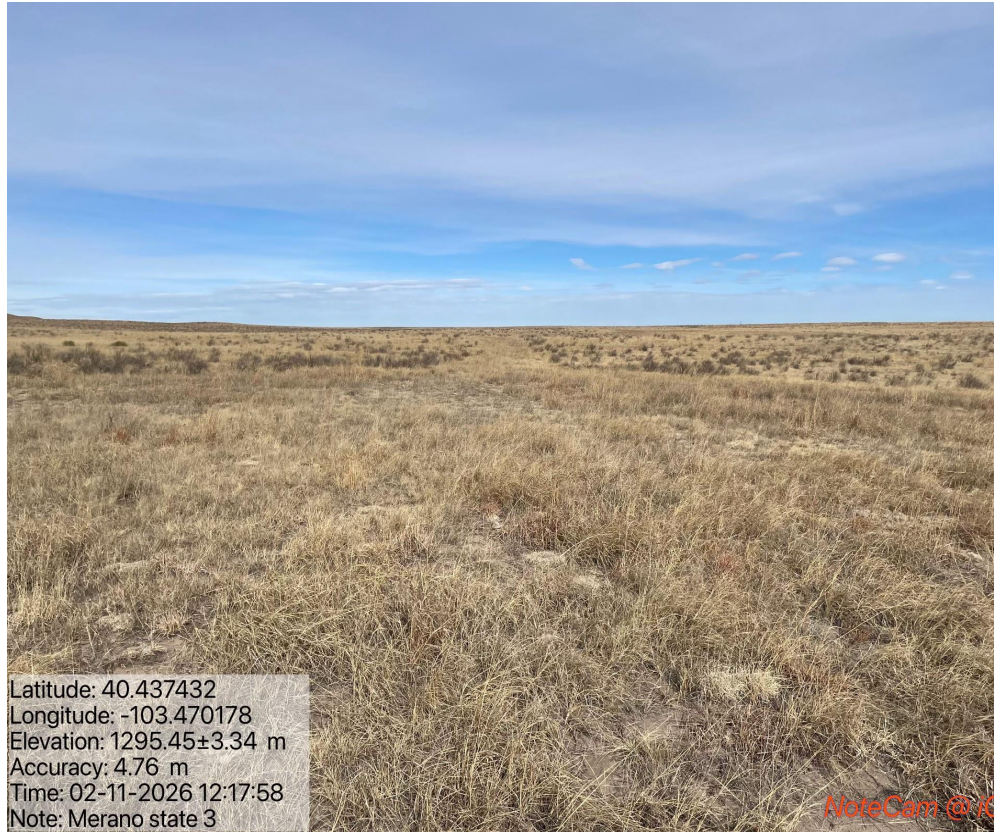
**Photo 3.** Photo taken from the location facing north. Showing an overview of location with growth of desirable native grass growth.

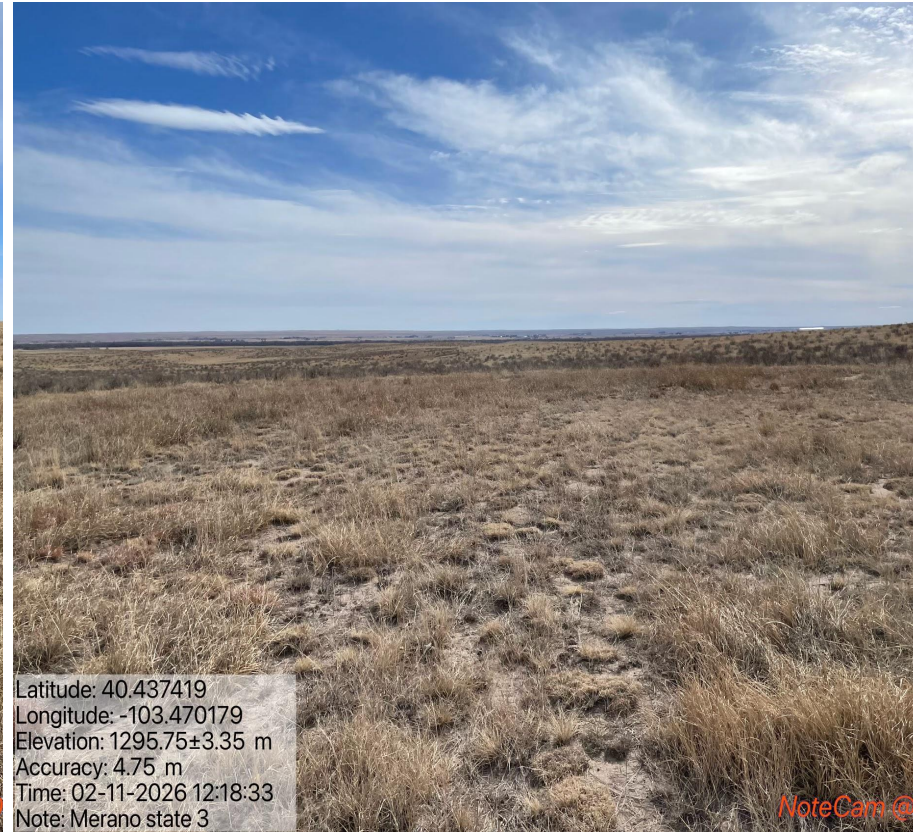
**Photo 4.** Photo taken from the location facing east. Showing an overview of location showing some bare areas and growth of desirable native grass growth.

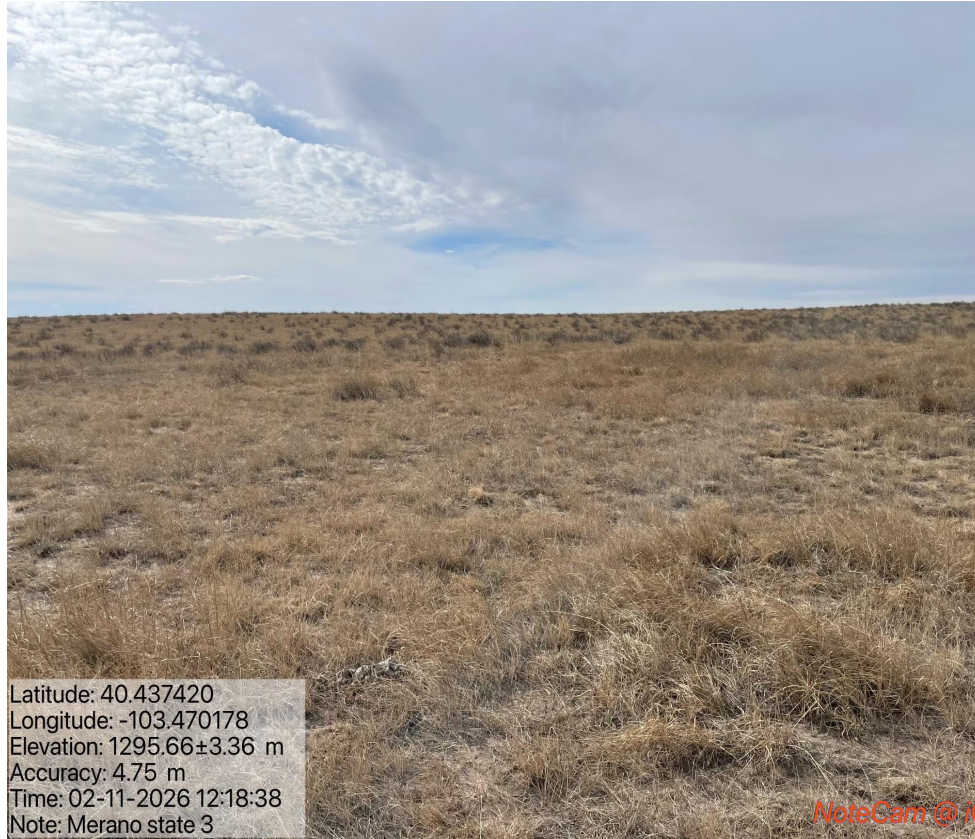
**Photo 5.** Photo taken from the center of the location facing north. See comment under Photo 1.

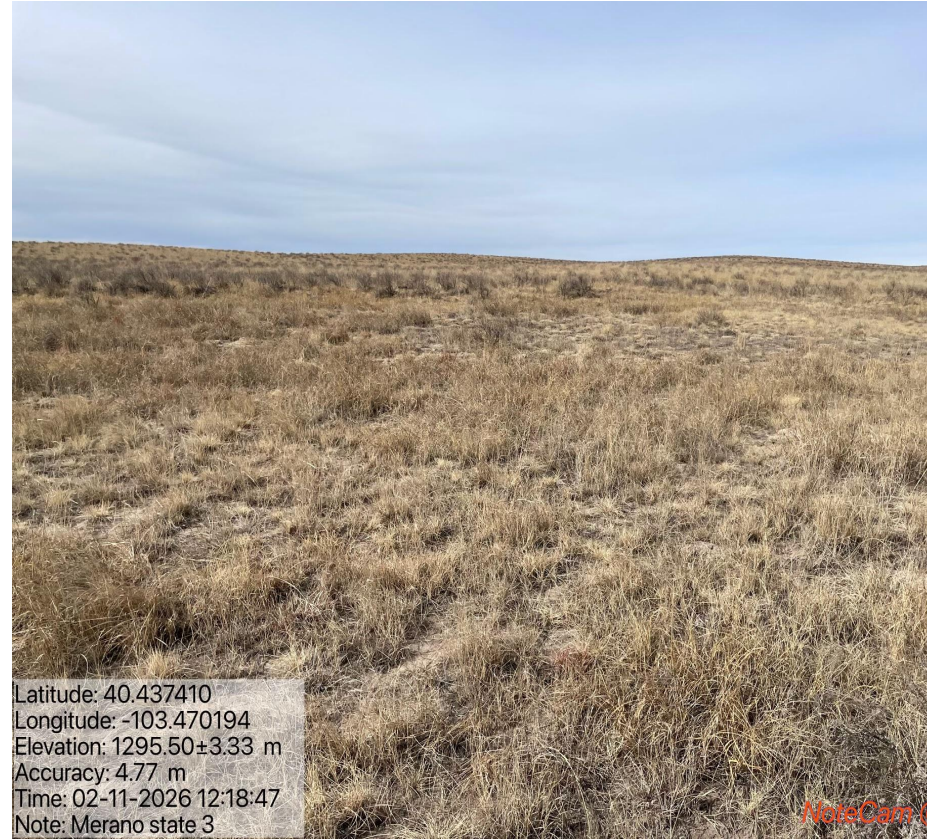
**Photo 6.** Photo taken from center of location facing east. See comment under Photo 2.

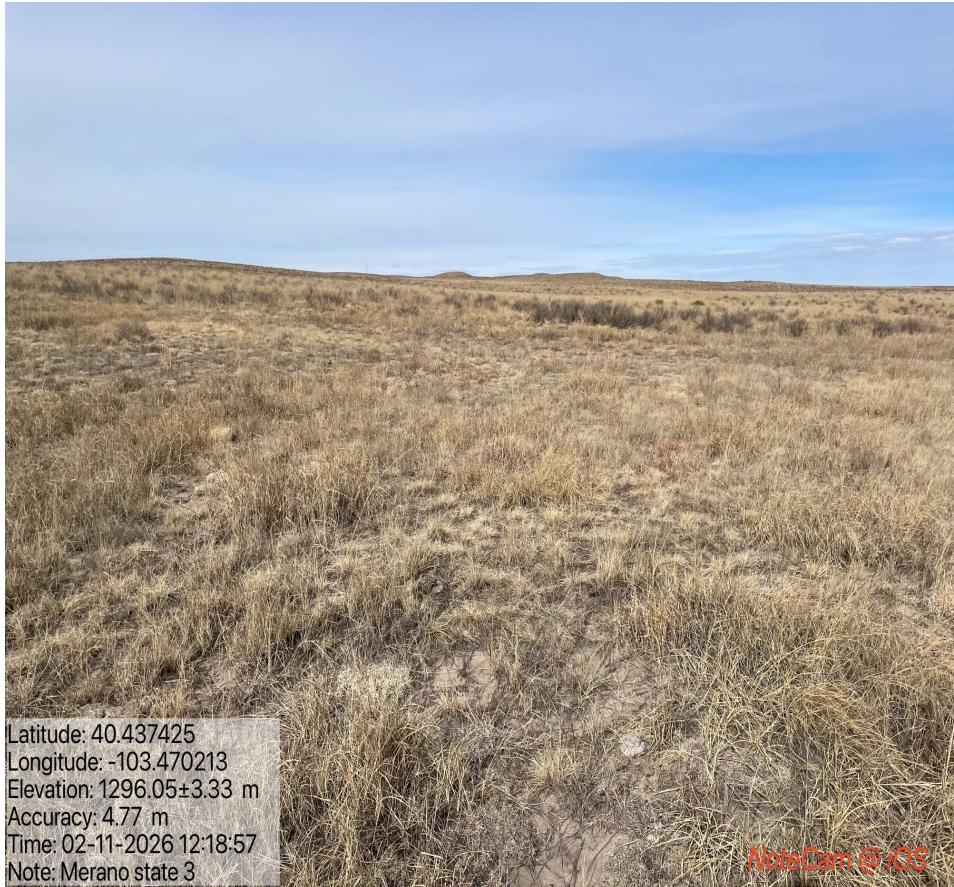
**Photo 7.** Photo taken from of the location. See comment in photo 1.

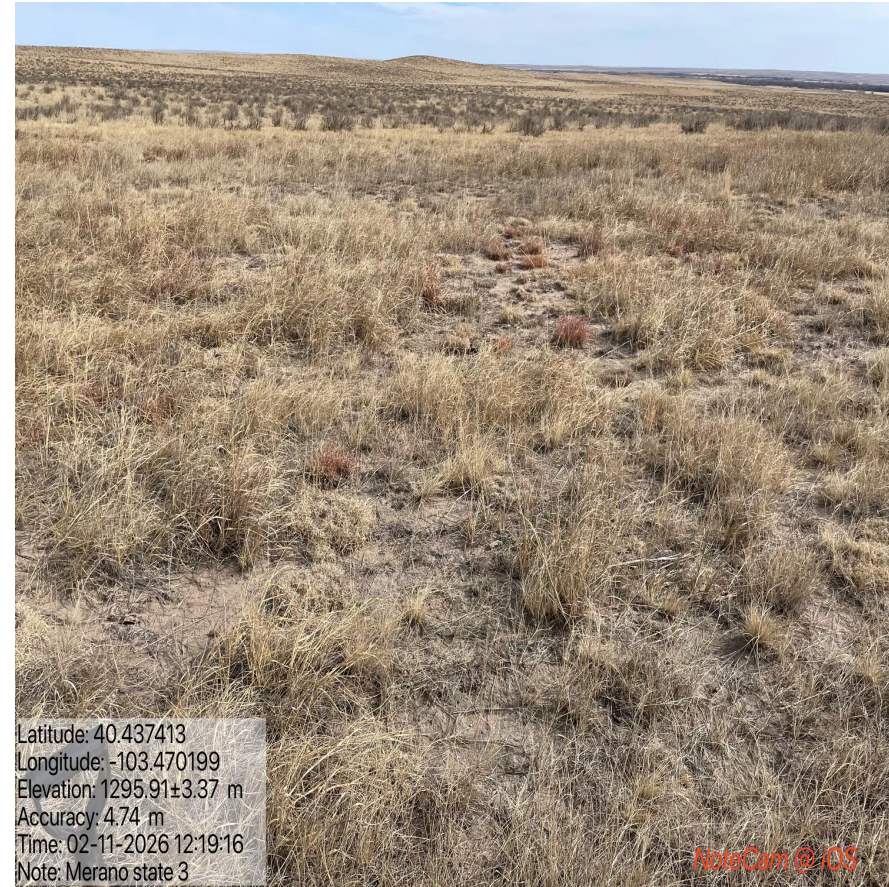
**Photo 8.** Photo taken from of the center of location showing growth of native grass species and presents of bare soil.

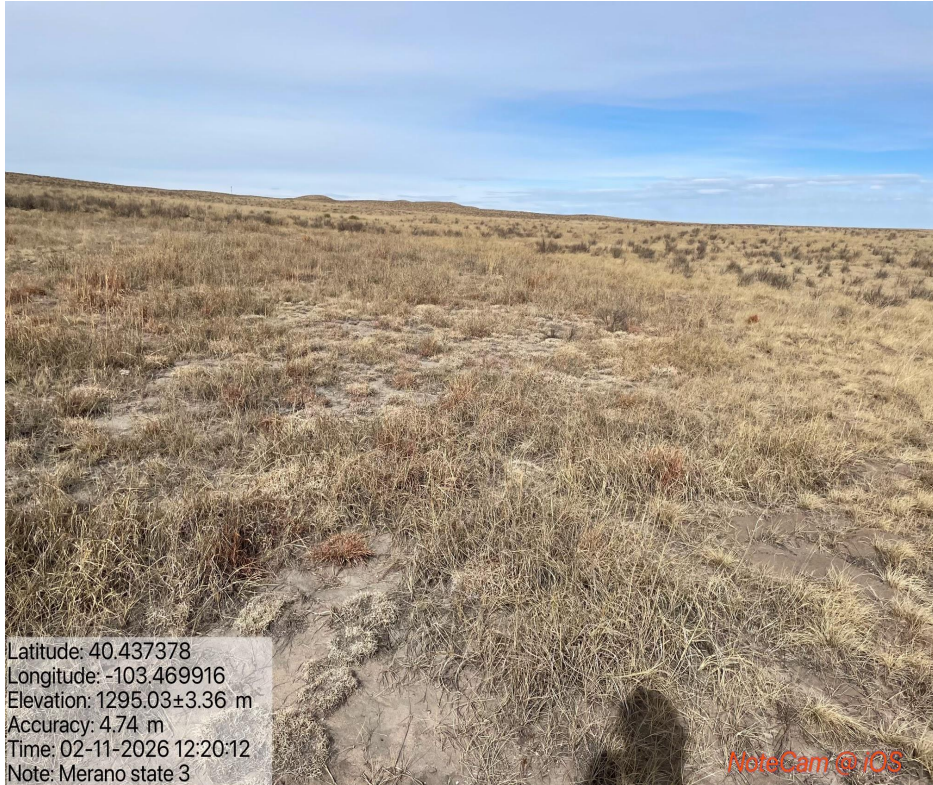
**Photo 9.** Photo taken from east side of location facing north east. Showing desirable vegetation growth as well as areas of bare soil and some evidence of erosion.

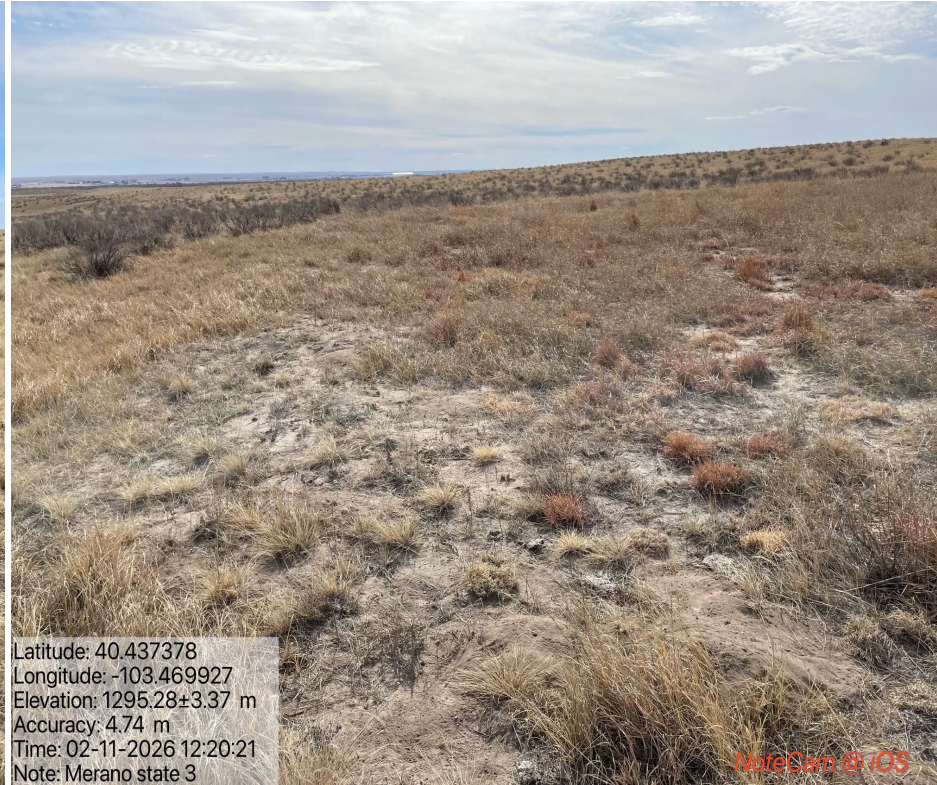
**Photo 10.** Photo taken from east side of location facing east. Showing evidence of erosion and bare soil and erosion.

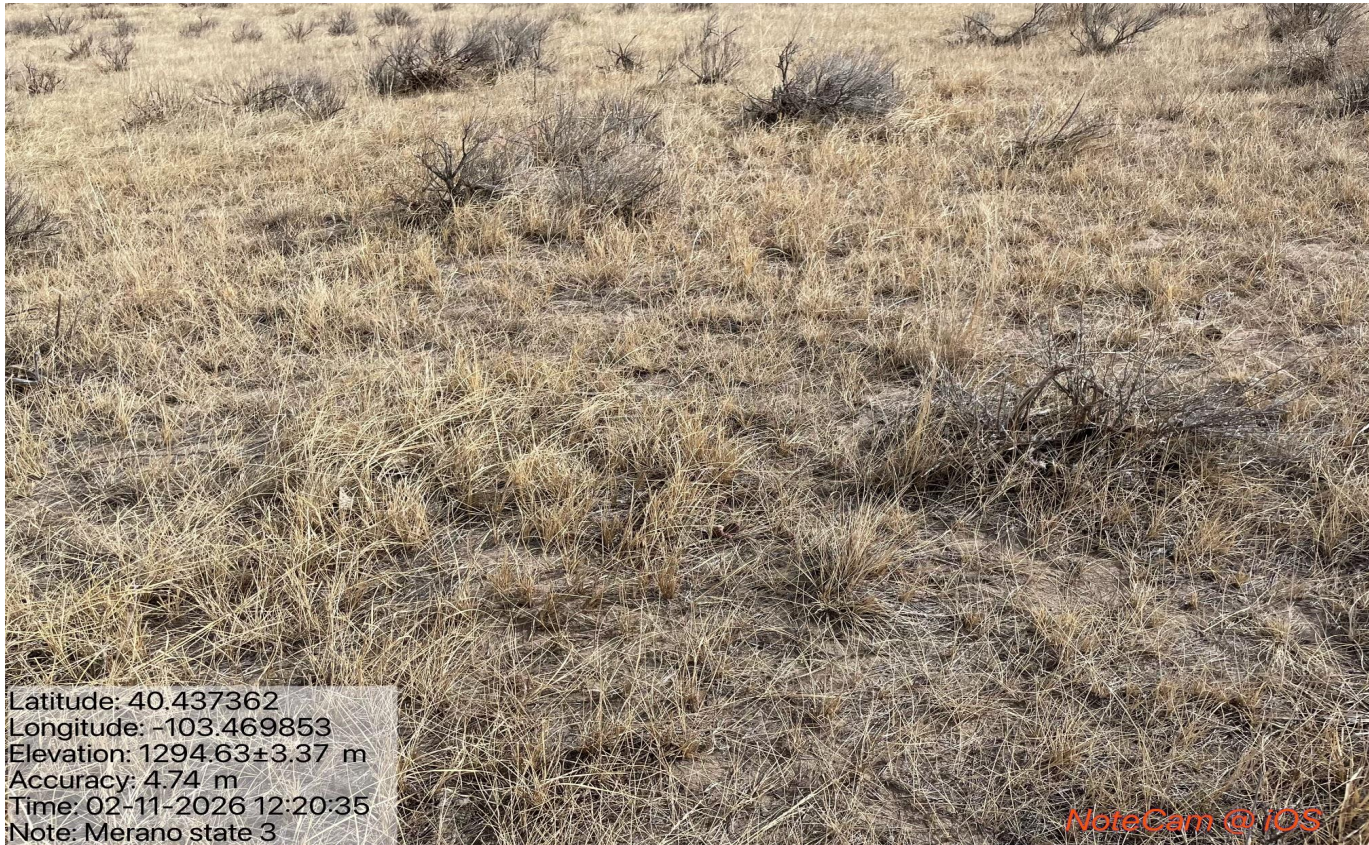
**Photo 11.** Photo taken from south side of location. Showing reference area with desirable native grass and shrub species.

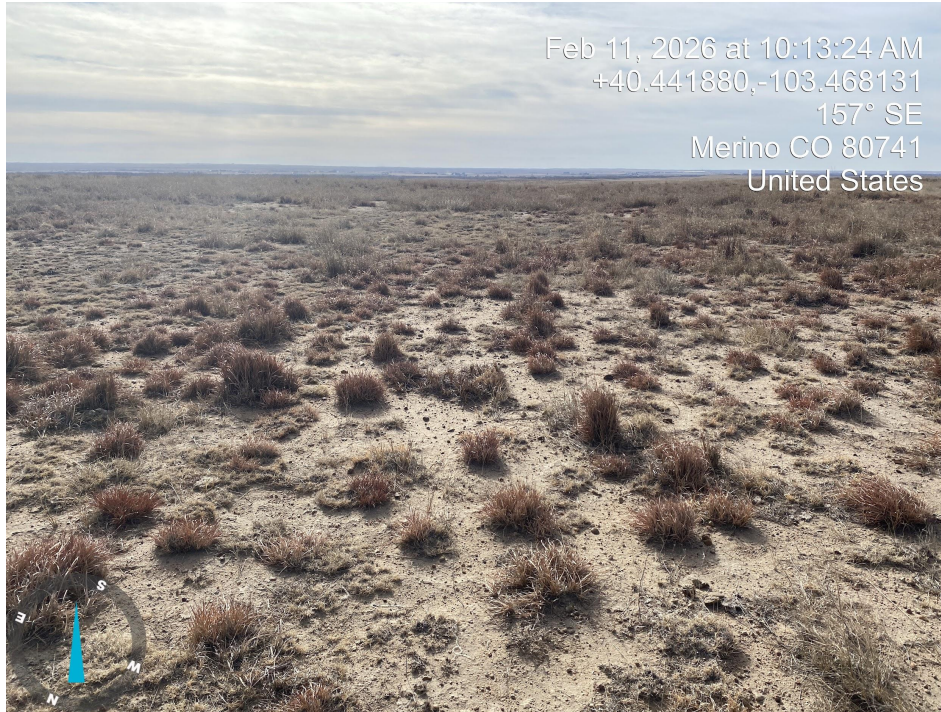
**Photo 13.** Photo taken from top of pit and facility location on the north edge of location facing south. Area where photo was taken is where the historical tank battery was for the location. Location showing bare areas between bunchgrass and stunted vegetation. A compaction test was performed and indicates that area was not decompacted properly and is contributing to the bare areas present.

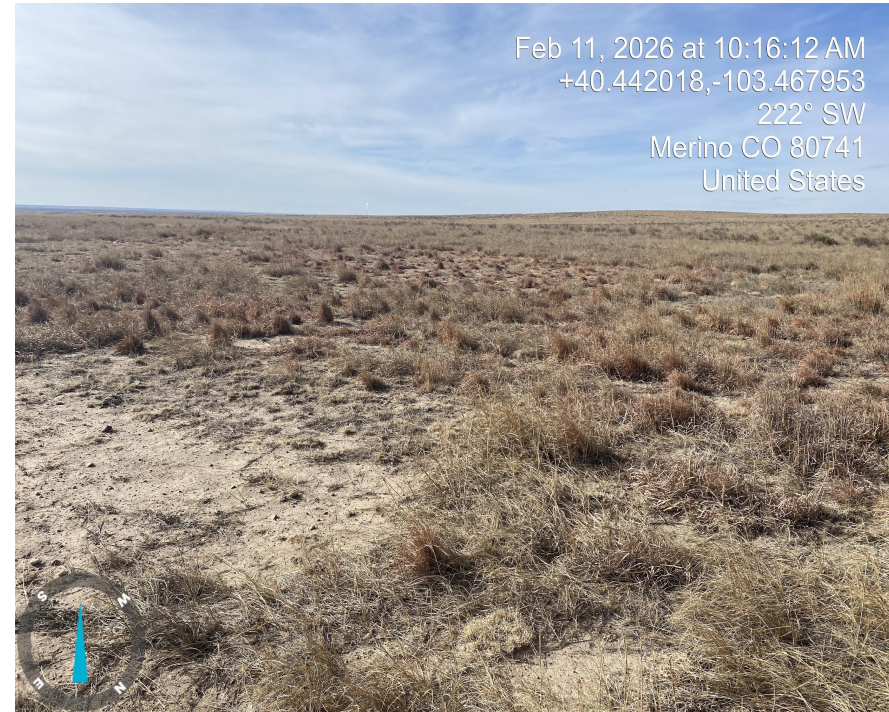
**Photo 14.** Photo taken from the north edge of pit location facing southwest, showing bare areas and stunted vegetation.

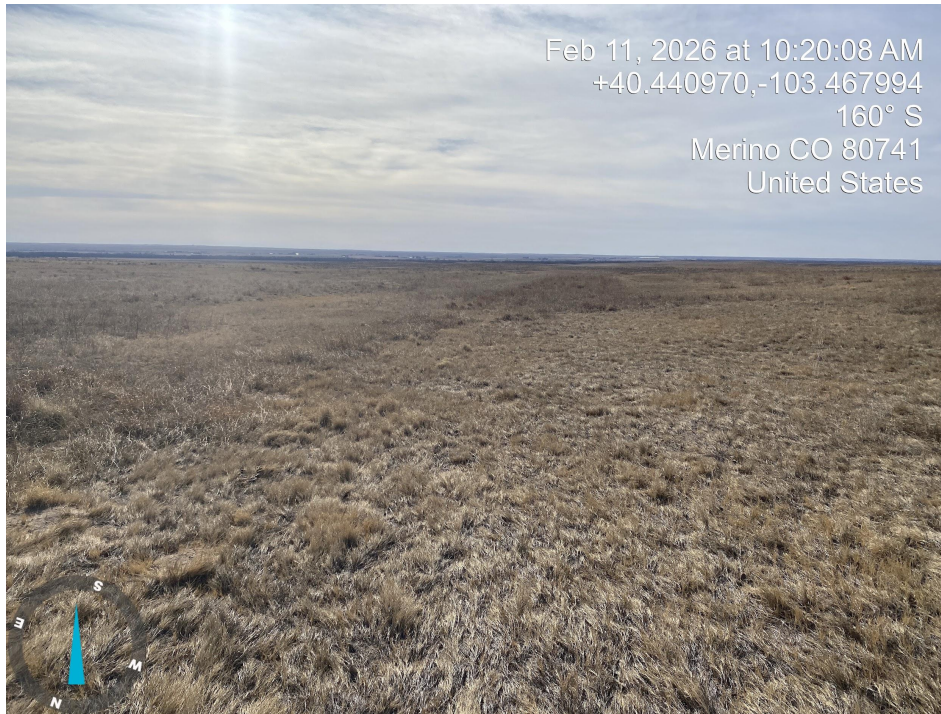
**Photo 15.** Photo taken from east edge of pit location between the first and second pit location. There were four pits at this location. Vegetation is matted down indicating sheet flow of water has run down area and off the location to the east. Area to the southeast was previously identified as a potential salt kill area but looks to have good vegetation establishment.

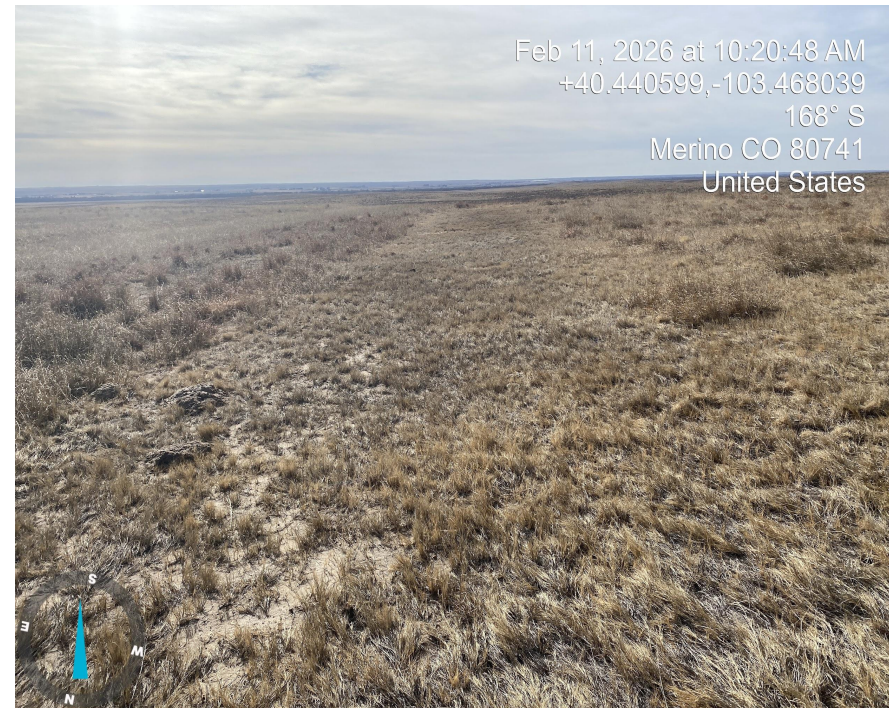
**Photo 16.** Photo taken from the eastern edge of pit location, between second and third pit facing south showing matted vegetation

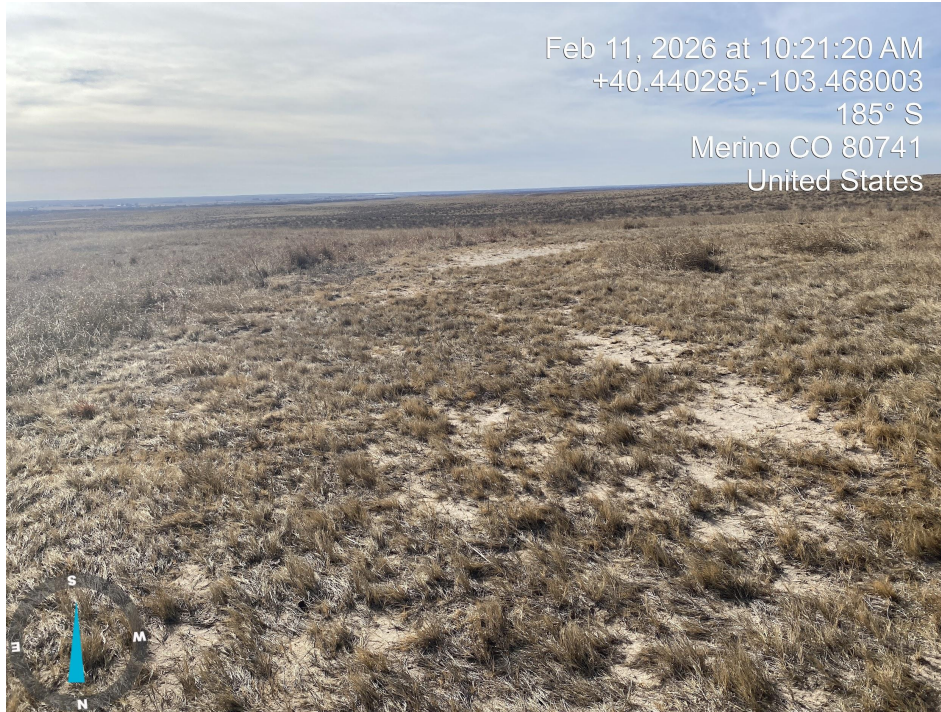
**Photo 17.** Photo taken from area were pits where located and are associated with this location showing bare areas and stunted vegetation growth.

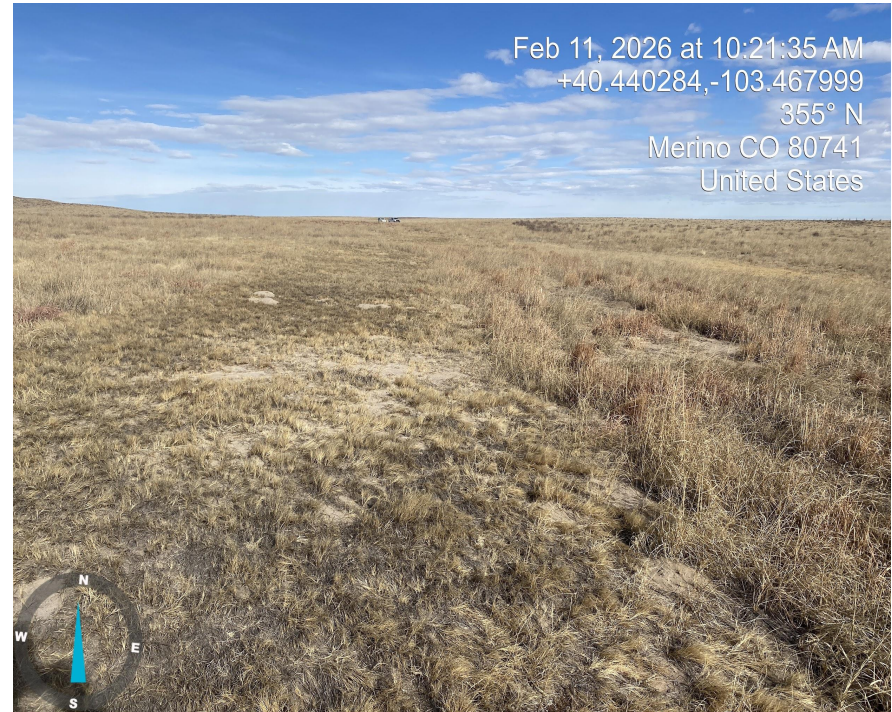
**Photo 18.** Photo taken from the edge of were pits where located looking back at area where pits were located that where associated with this location. Showing bare areas and stunted vegetation.

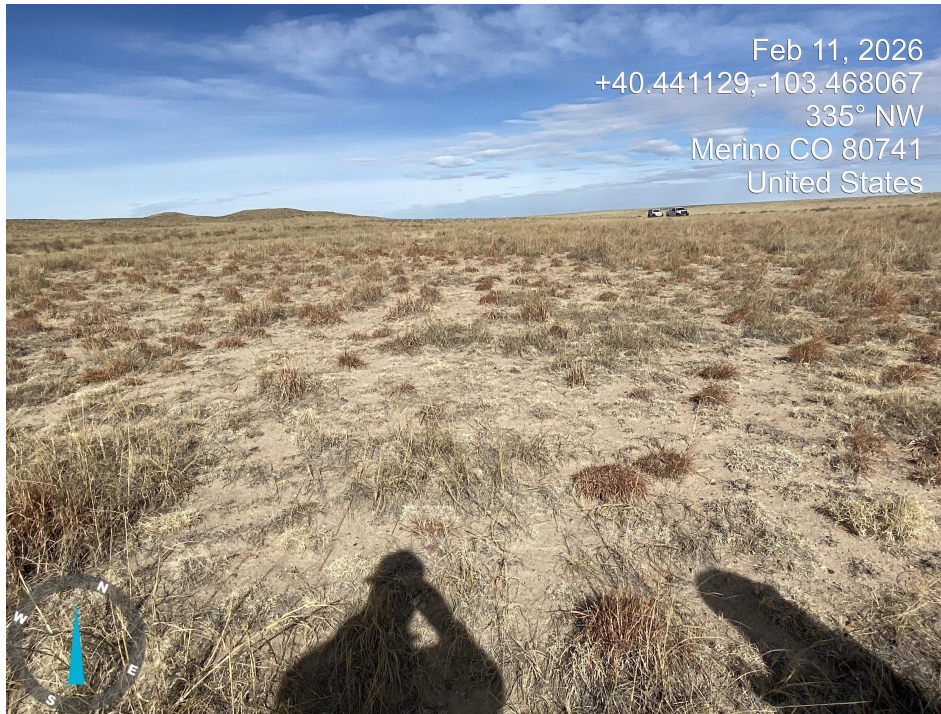
**Photo 19.** Photo taken from where tank battery showing bare areas and growth of some desirable grasses. Compaction test was performed and area has compaction issues between bunchgrass.

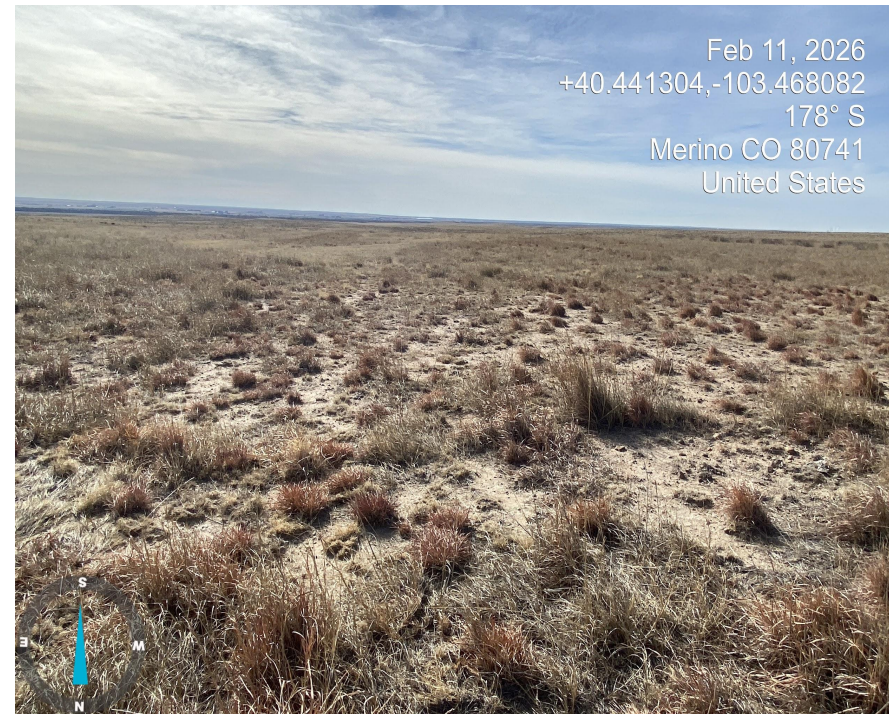
**Photo 20.** Photo taken from the northern edge of were pits and production facility was located facing south at area where pits were located that where associated with this location. Showing bare areas and stunted vegetation. Vegetation is desirable however the bare areas between vegetation has compaction issues.

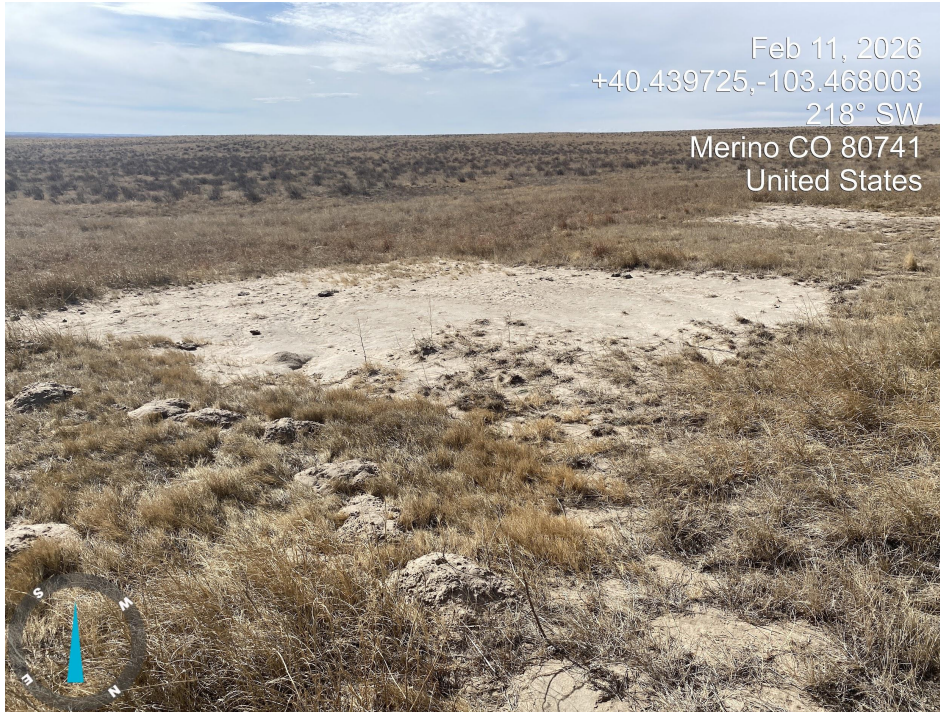
**Photo 21.** Photo taken from the southern end of were pits where located showing a potential salt kill area with no vegetation present.

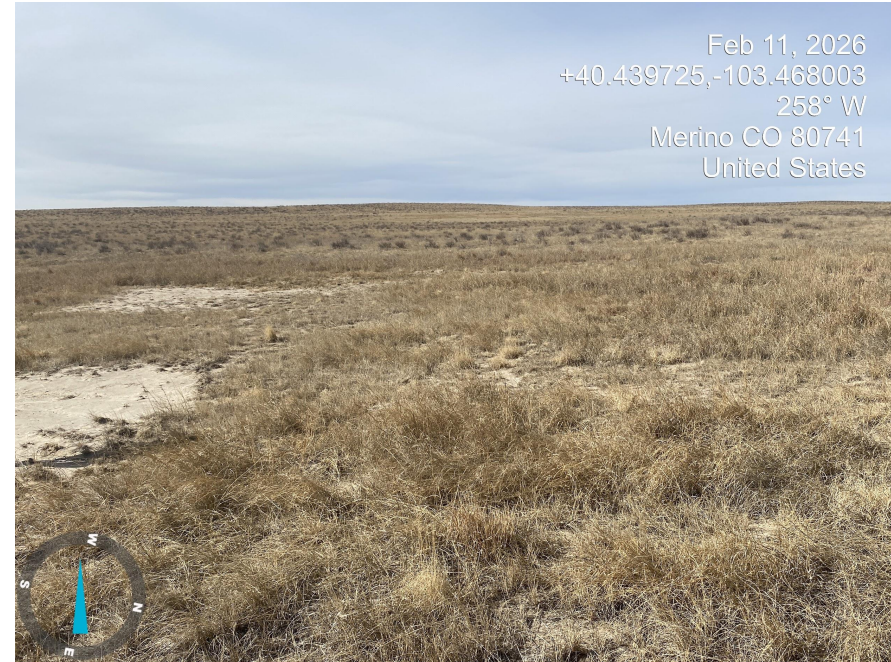
**Photo 22.** Photo taken from the edge of were pits where located. Showing bare areas and stunted vegetation.

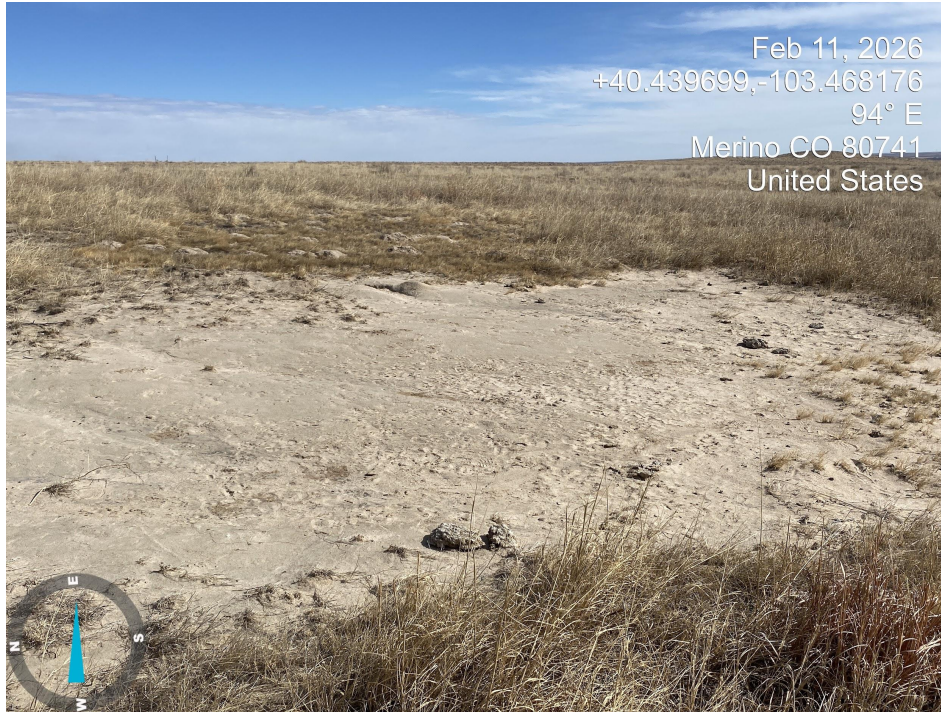
**Photo 23.** Photo taken from area were pits where located and are associated with this location showing potential salt kill area.

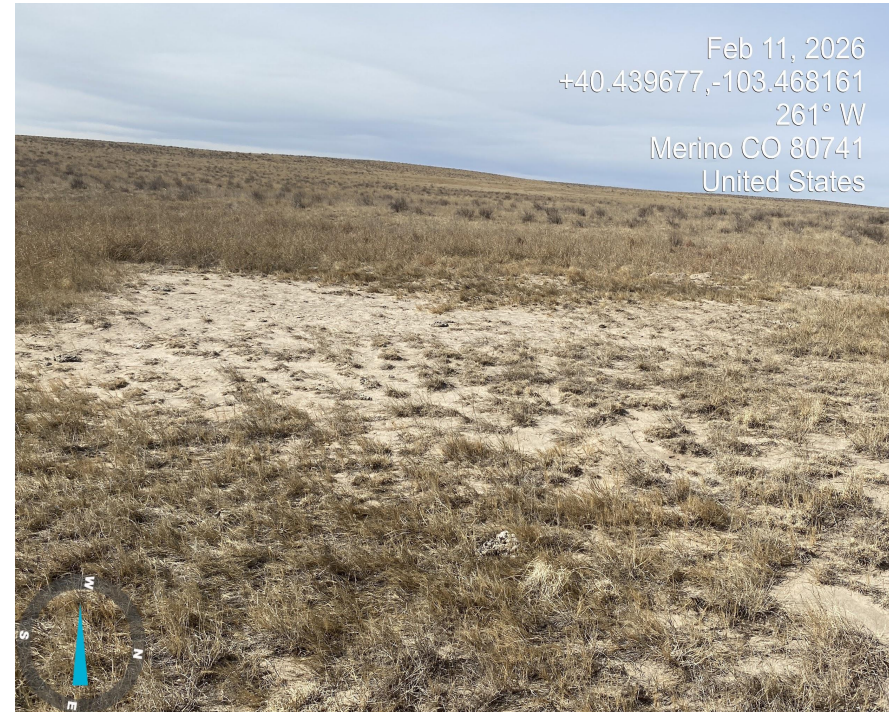
**Photo 24.** Photo taken from the southern edge of were pits where located. Showing potential salt kill areas and stunted vegetation.

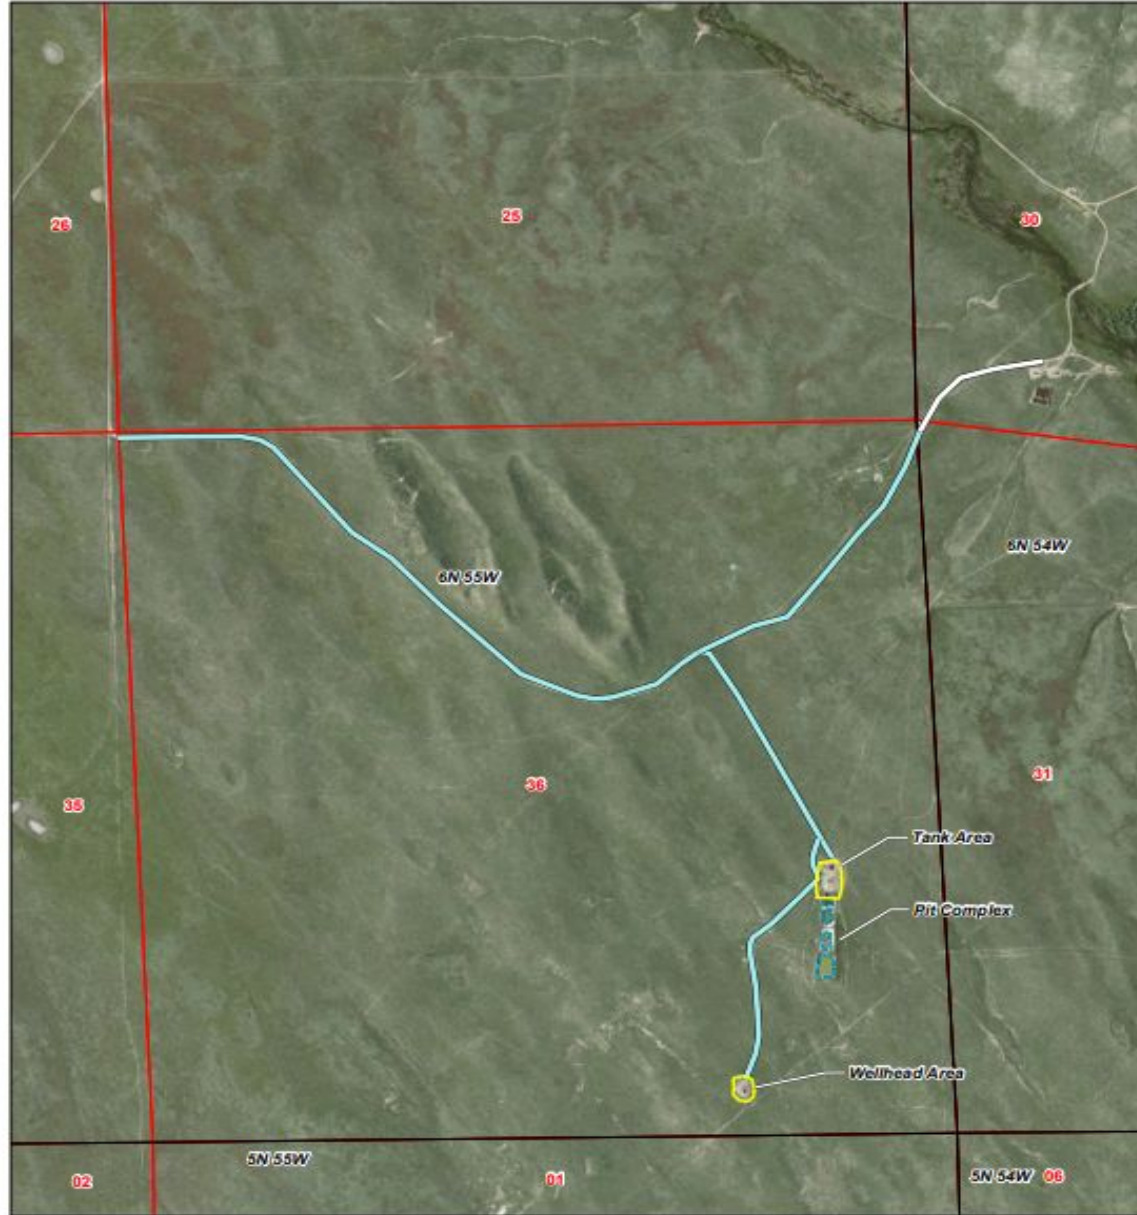
**Photo 26.** Documenting from “Final Site Reclamation Report for the Merino State No. 3 Lease Site” Document #2313913 showing access roads that need to be reclaimed.

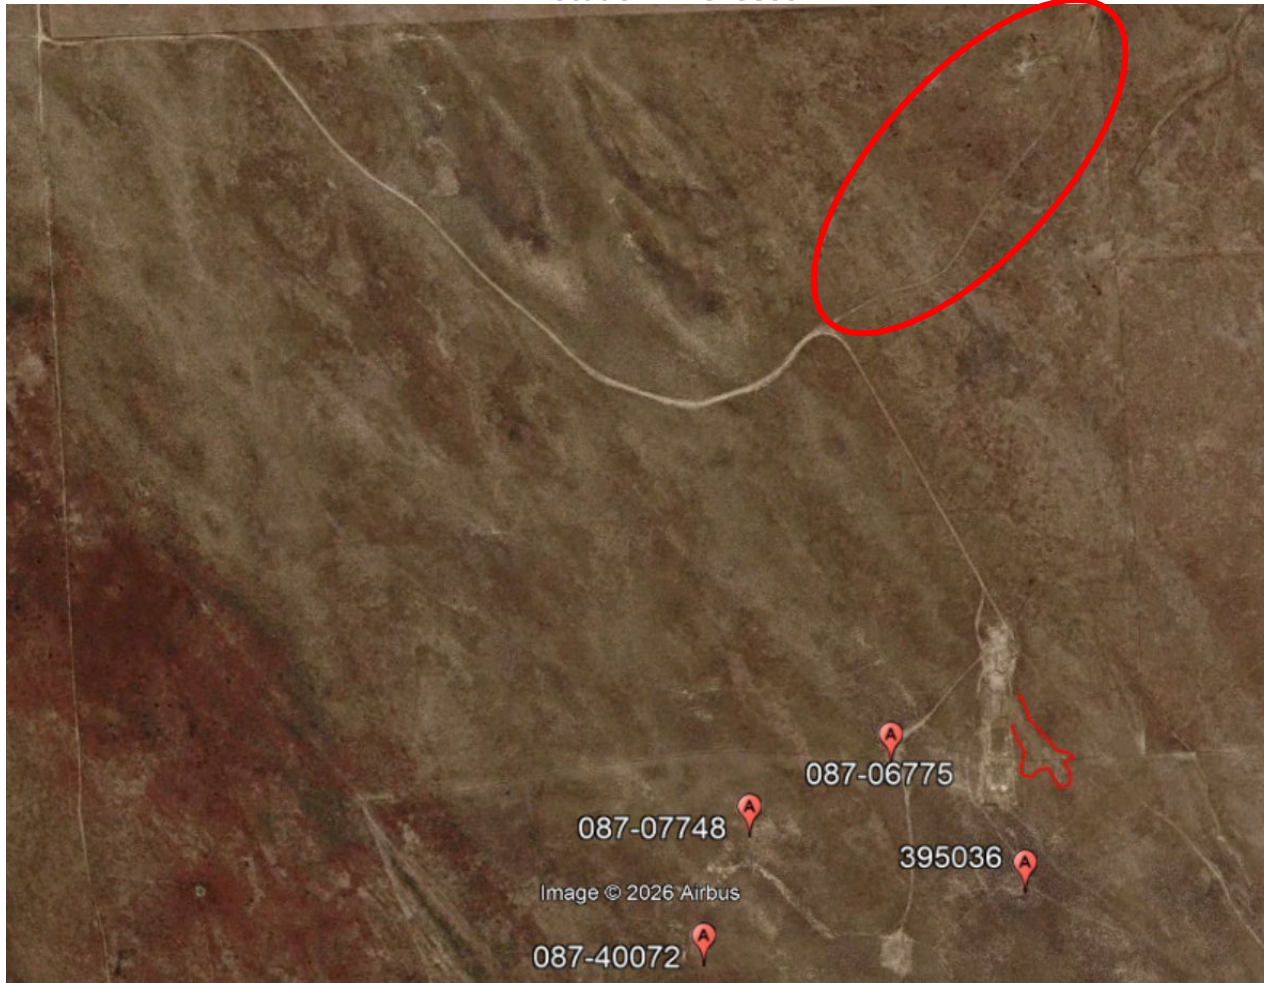
**Photo 27.** Google Earth satellite imagery showing the main lease road leading to the tank battery and Merino State 3 is still visible. The Northeastern section of the access road, circled in red, is progressing to final reclamation; however, the other section of the main lease road to the tank battery pits and well head is not and needs to be reclaimed. The site visit on February 11 confirmed that the main lease road was still visible and that reclamation had stalled.
