Inspection/Audit Photos

Location: KT RESOURCES LLC ANT HILL UNIT #30-42 PAD

Location ID: 316154

Date: 03/23/2026

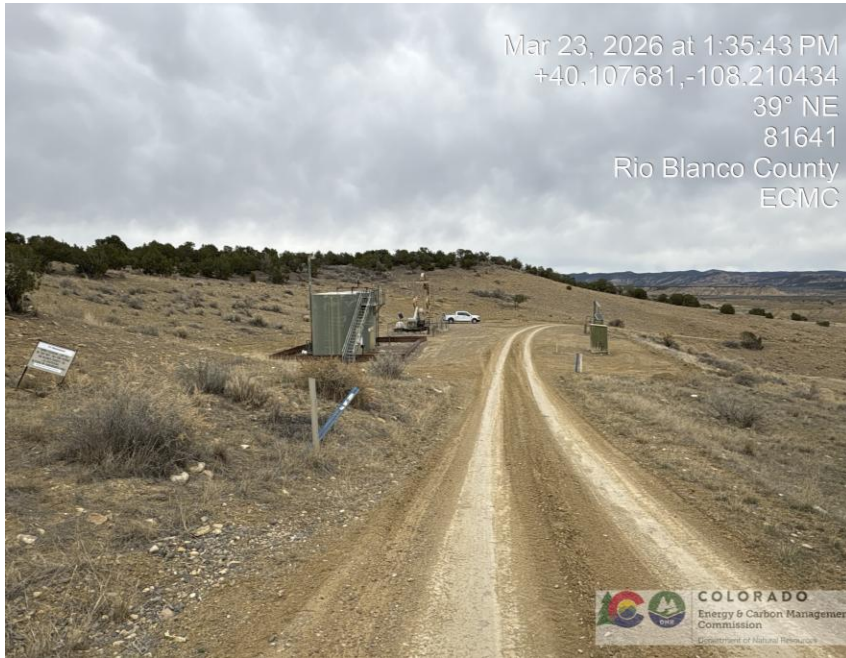
Photo # 3626 Entrance to location

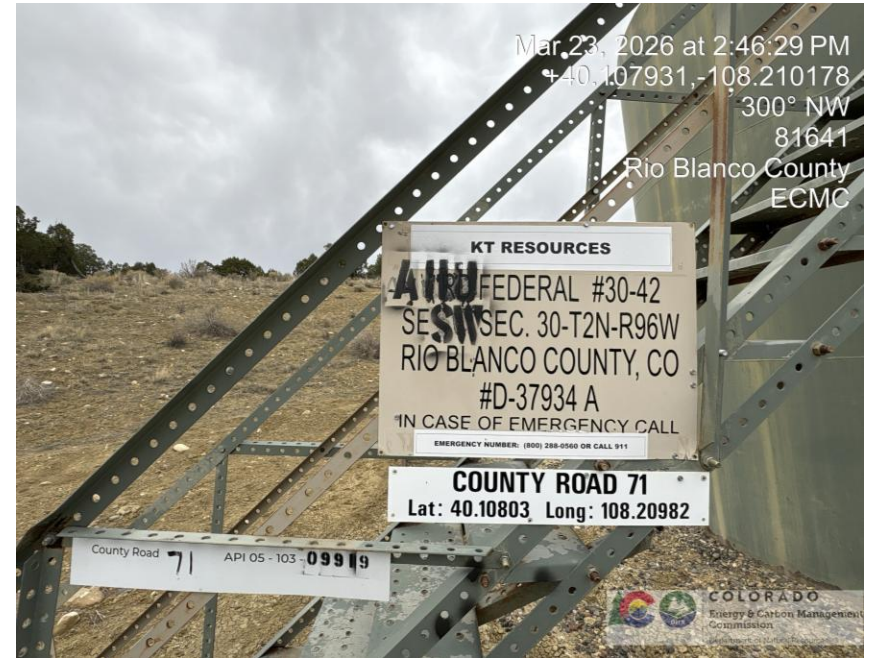
Photo # 3680 Location

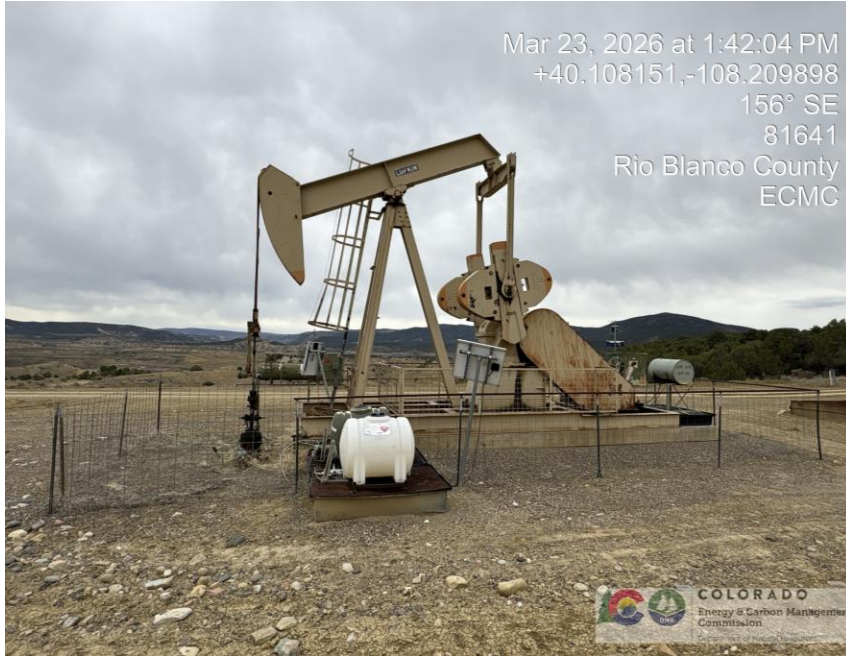
Photo # 3630 Location

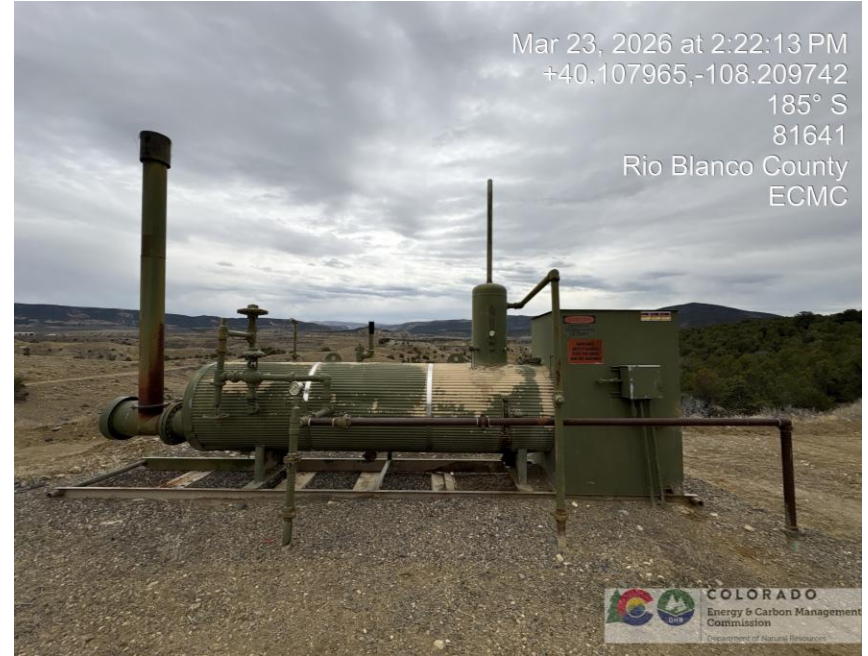
Photo # 3661 Location

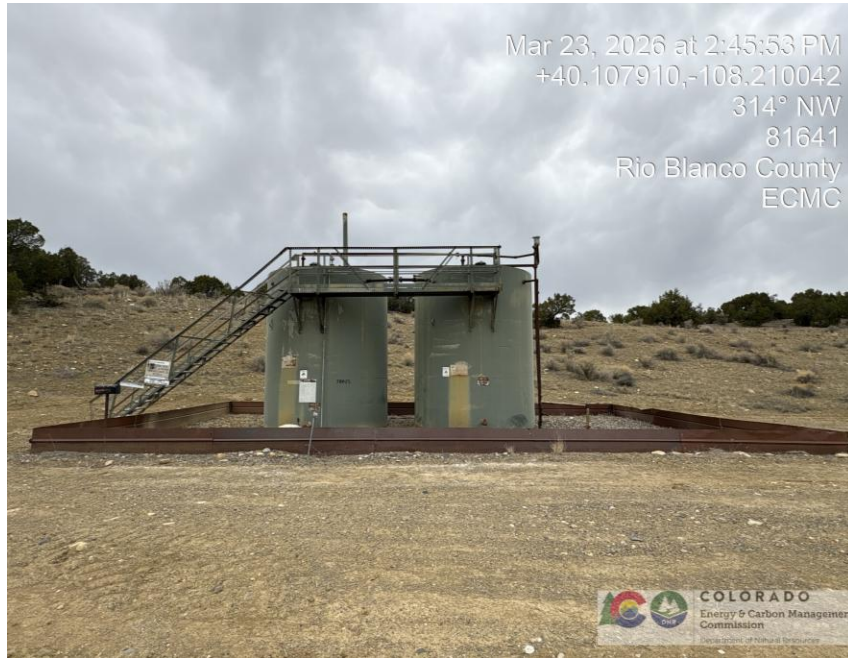
Photo # 3679 Location

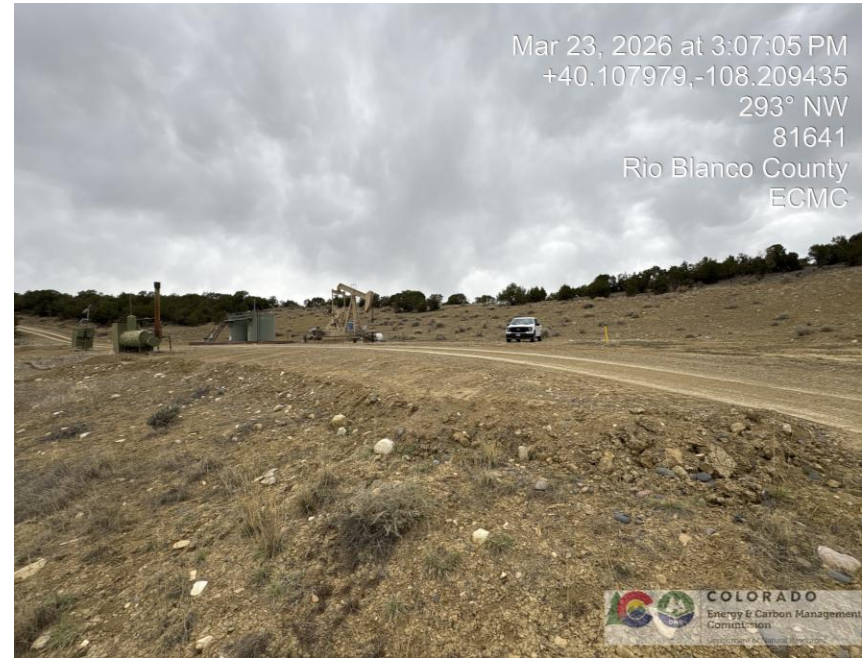
Photo # 3702 SE corner of location

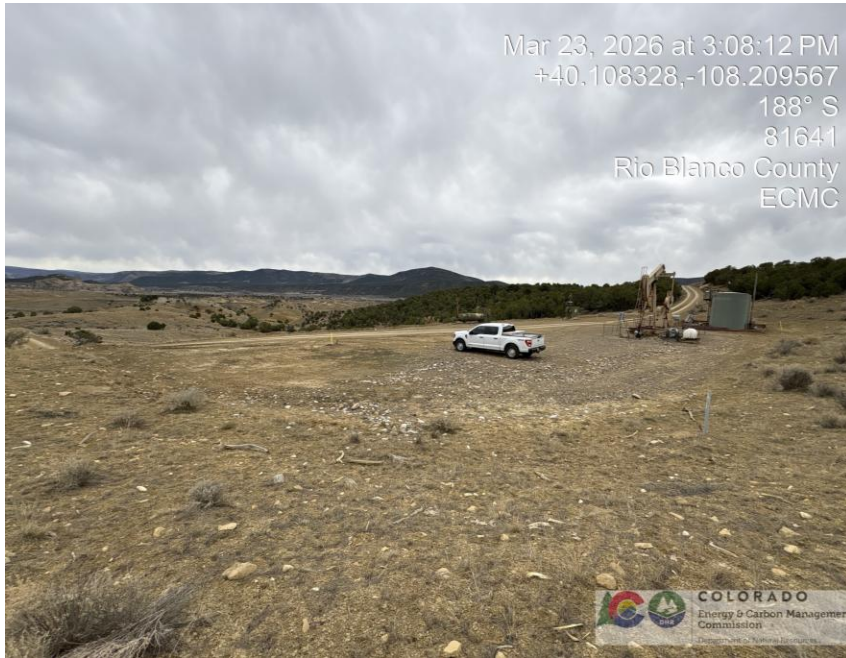
Photo # 3703 NE corner of location

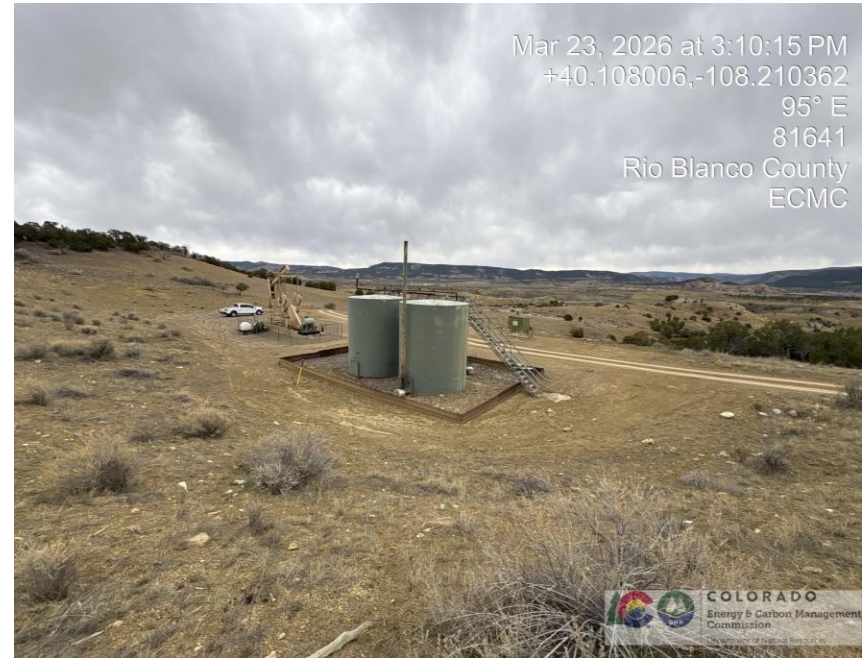
Photo # 3704 NW corner of location

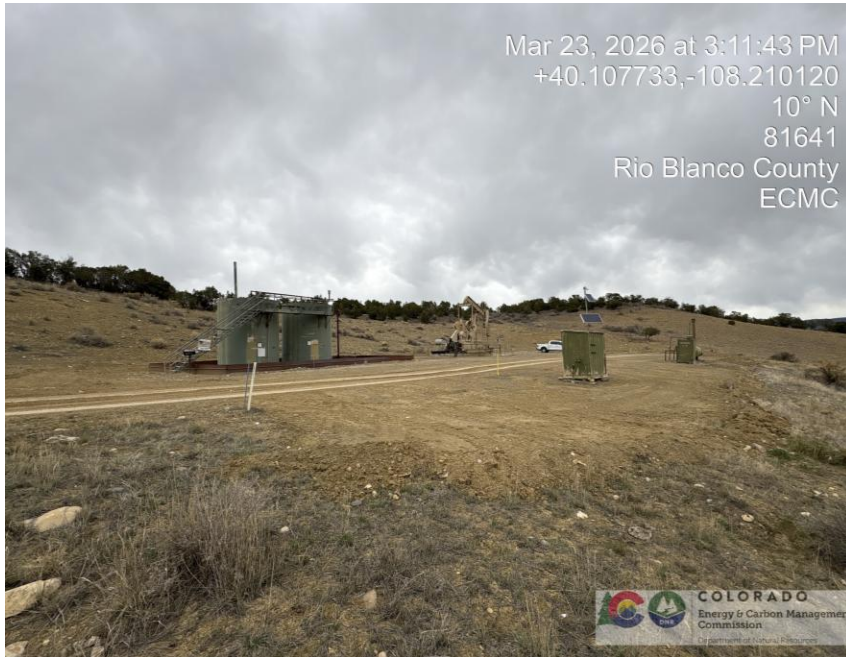
Photo # 3705 SW corner of location

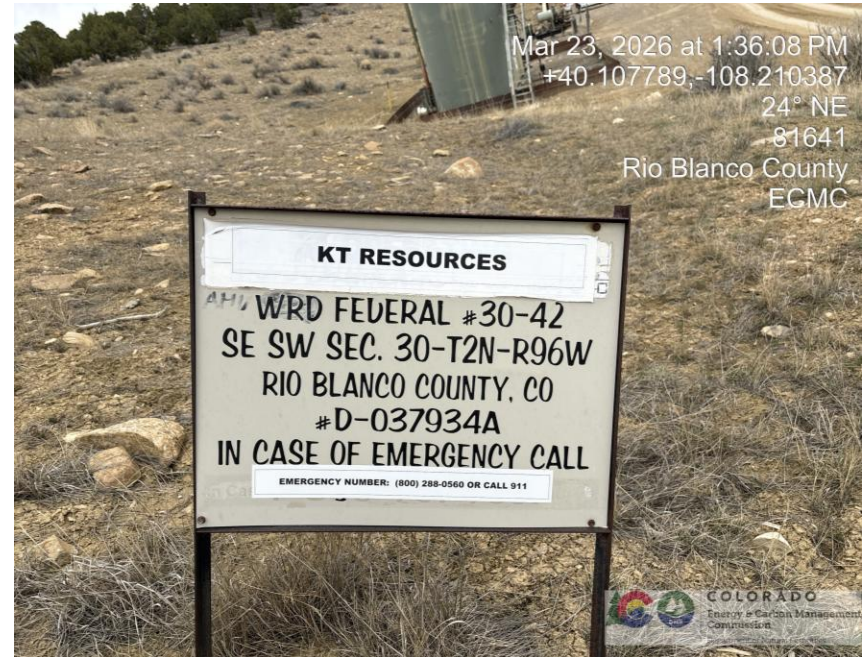
Photo # 3627 Well name on sign at entrance to location does not match database or wellhead sign

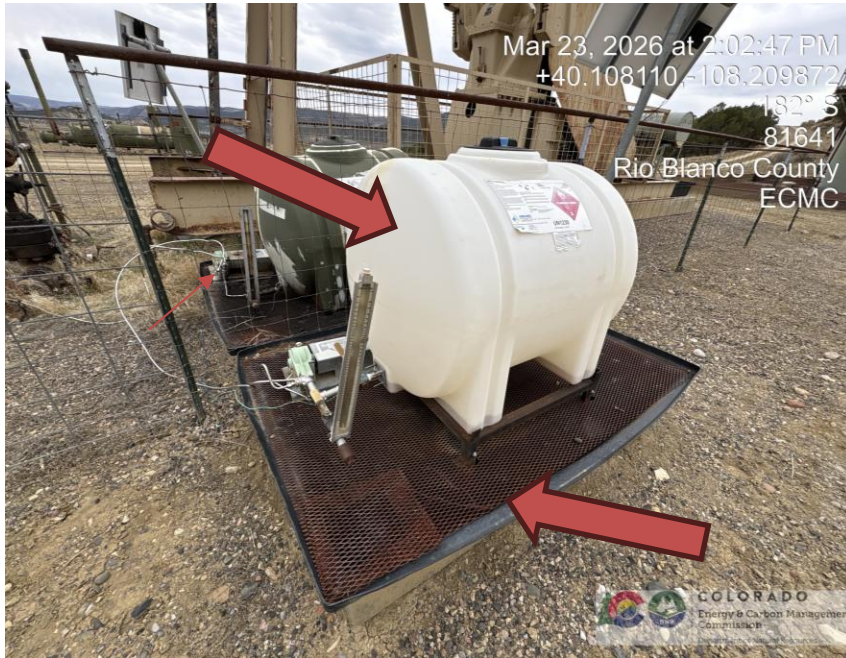
Photo # 3644 Unused chemical tank and containment on location/not in service and disconnected

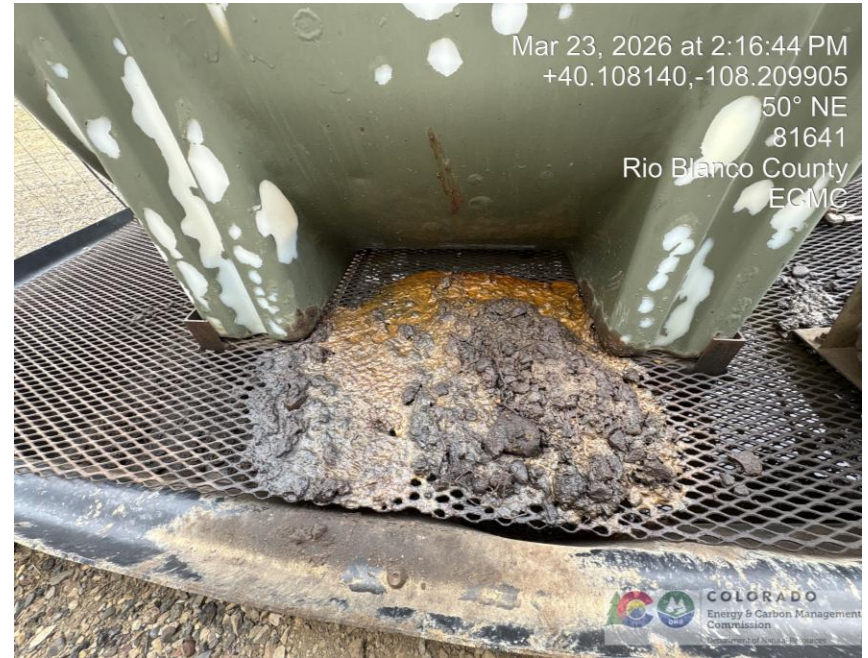
Photo # 3654 Oily waste placed on top of chemical containment grate

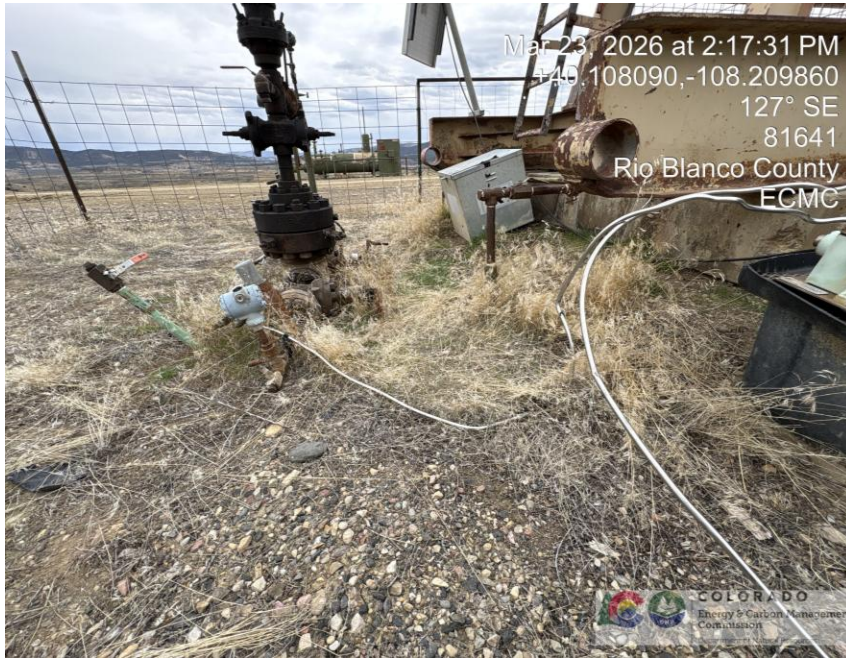
Photo # 3655 Dead weeds/debris

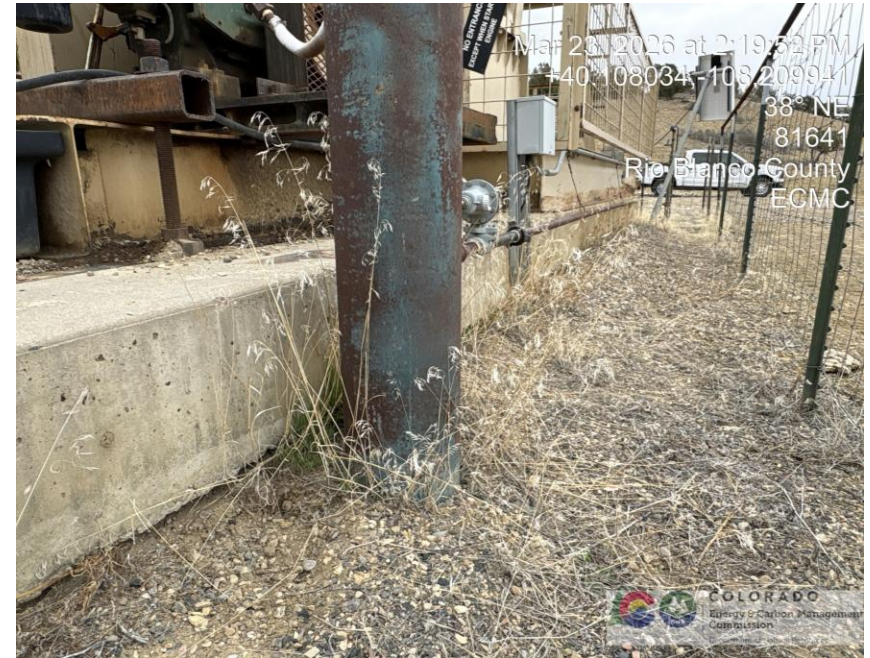
Photo # 3658 Dead weeds/debris

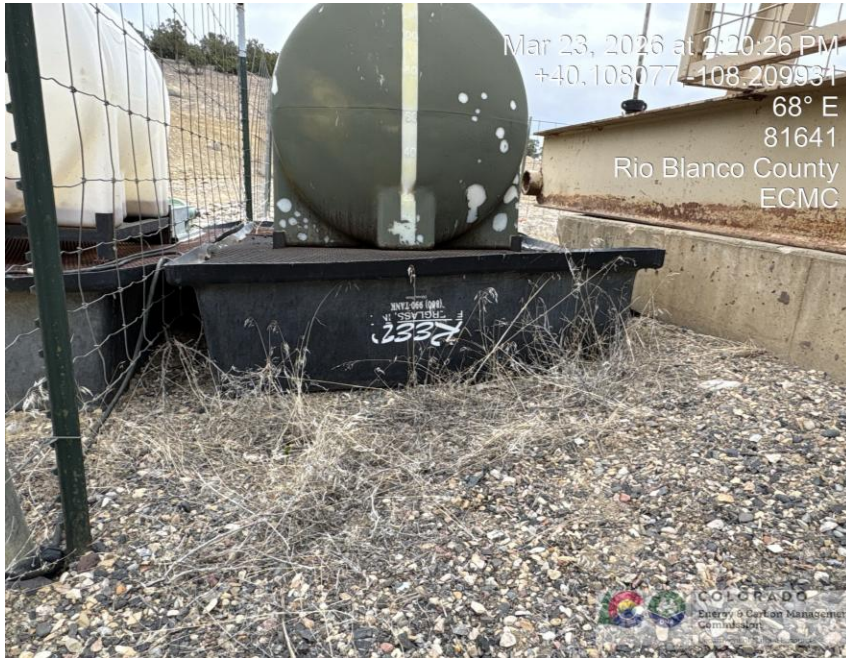
Photo # 3659 Dead weeds/debris

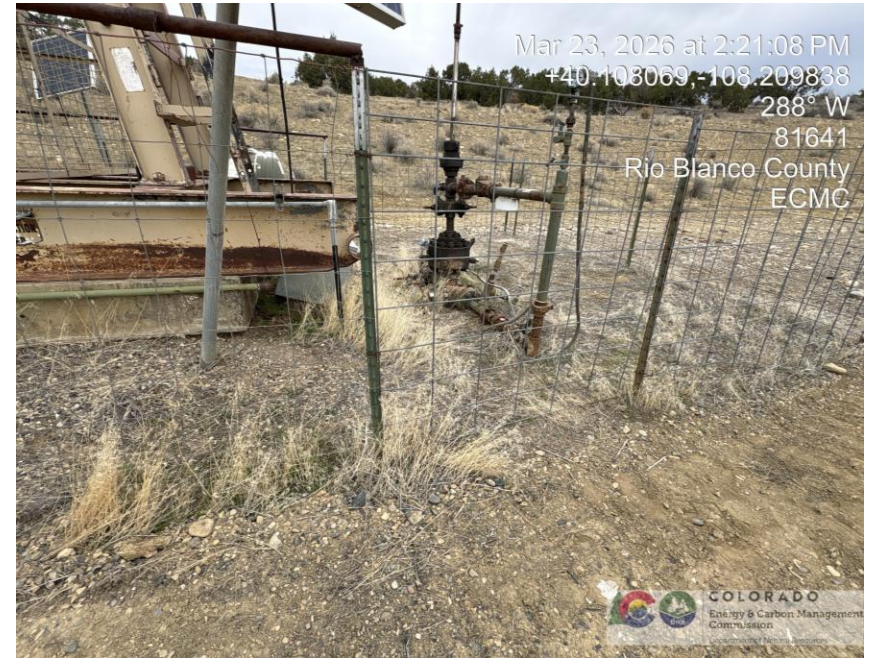
Photo # 3660 Dead weeds/debris

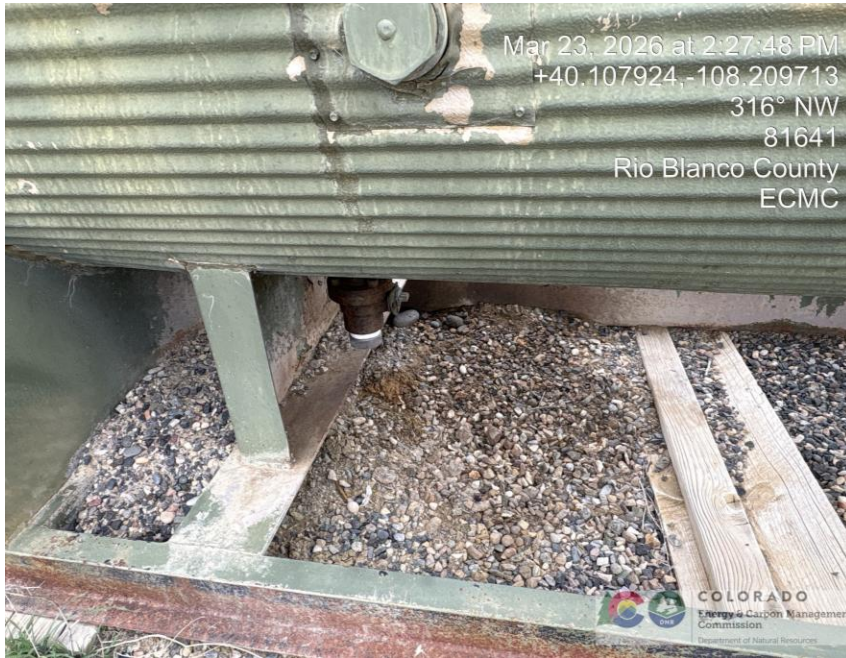
Photo # 3665 Stained soil

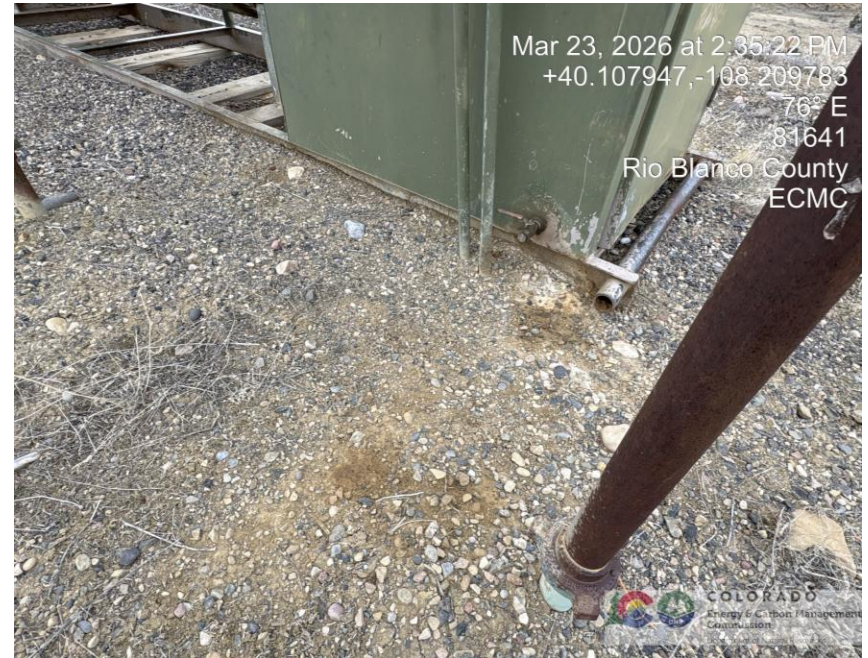
Photo # 3670 Stained soil

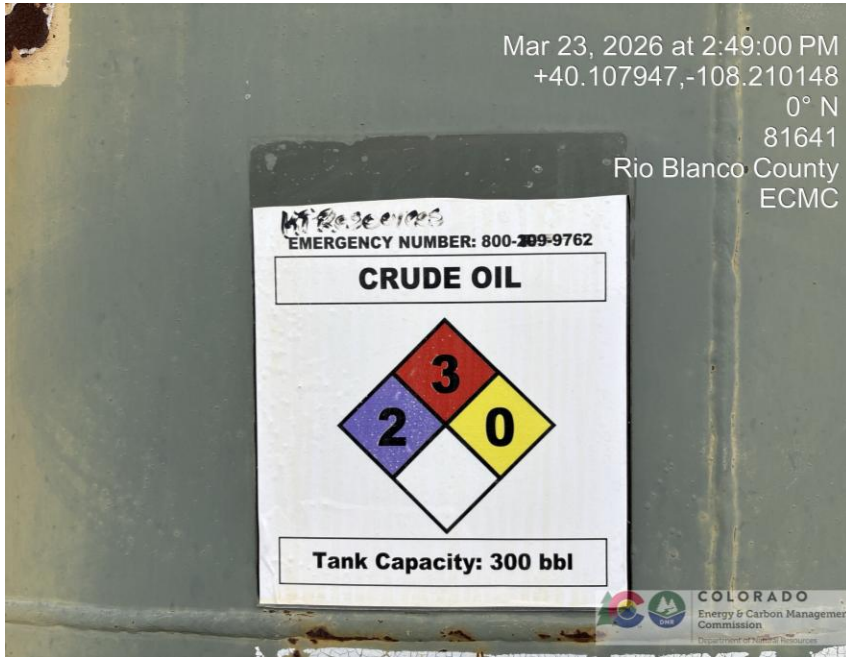
Photo # 3682 Illegible tank label/Operator name is illegible and contact number is disconnected

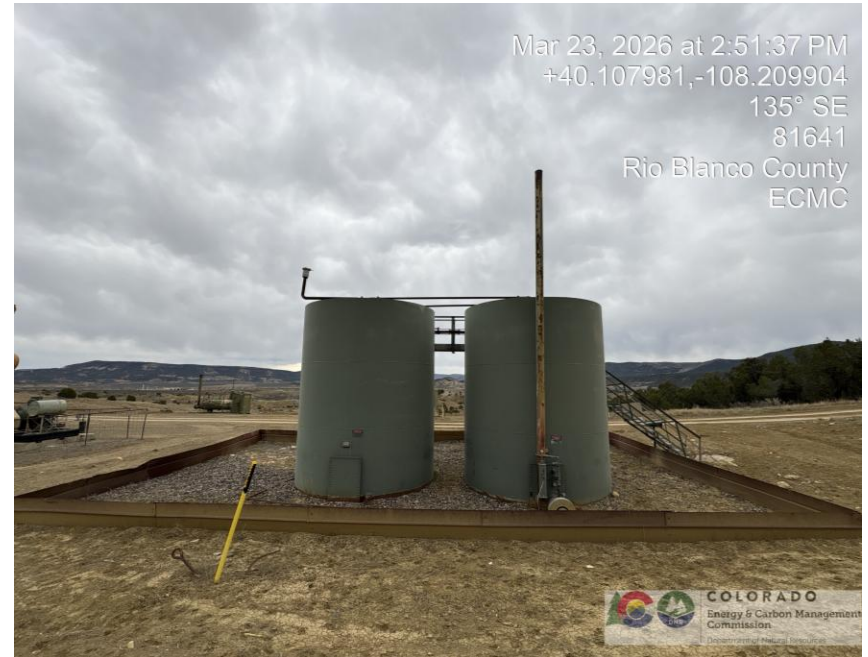
Photo # 3685 Secondary containment is not sufficiently impervious to contain spilled or released materials (No liner installed)
