**Inspection Photos**  
**Location Name: Enduring Resources**  
**Location ID: Koshak # B-4A. API 05-067-08763**

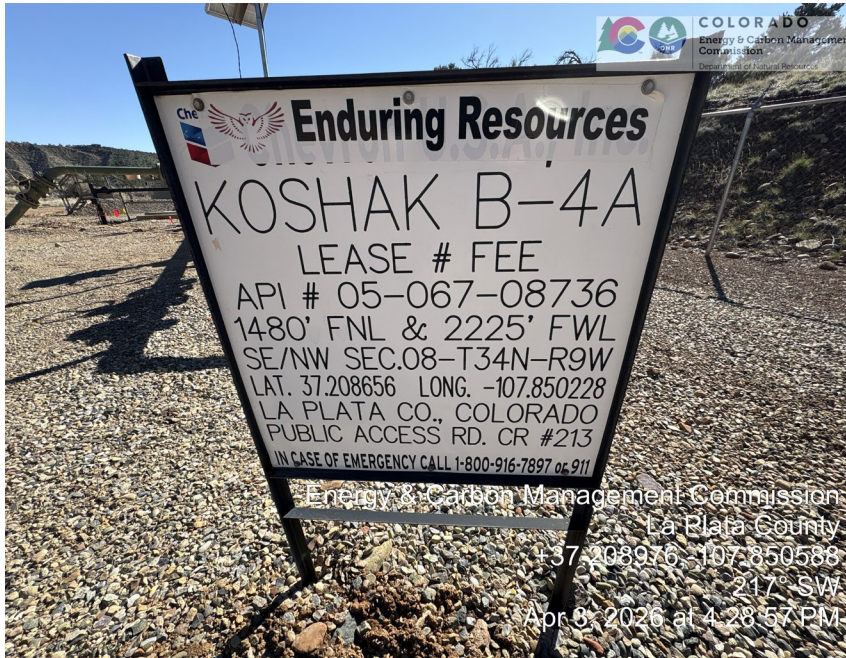
**1. Well location sign.**

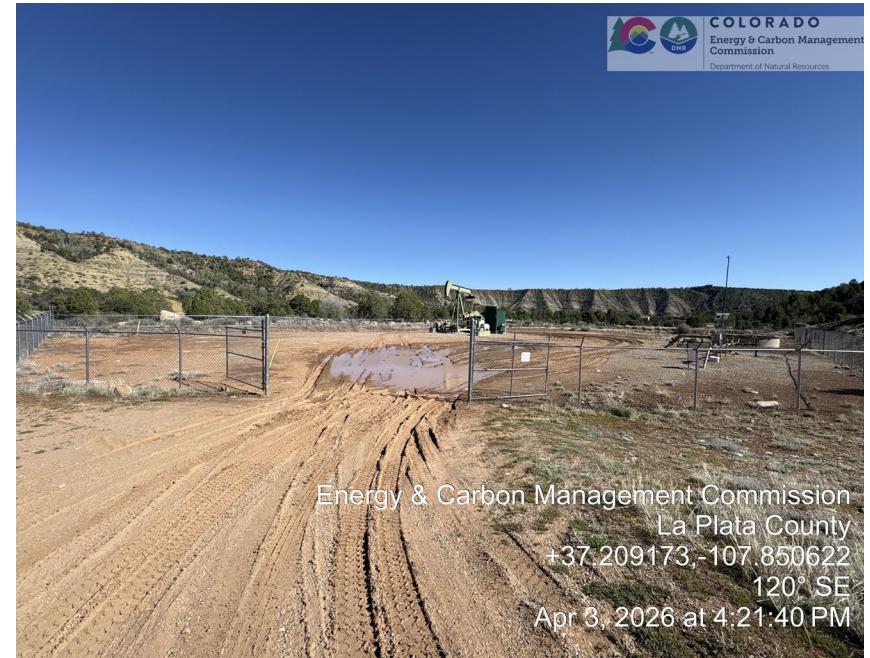
**2. Well location entrance. Large puddle inside gate. Gate was open at time of inspection.**

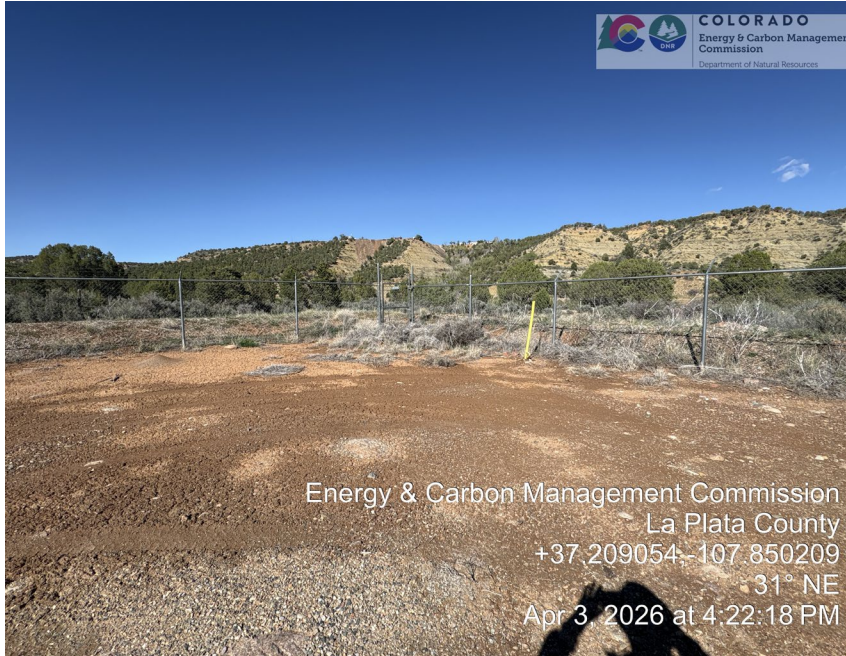
**3. Pile of vegetative debris in NE corner of well pad piled against corner of fence.**

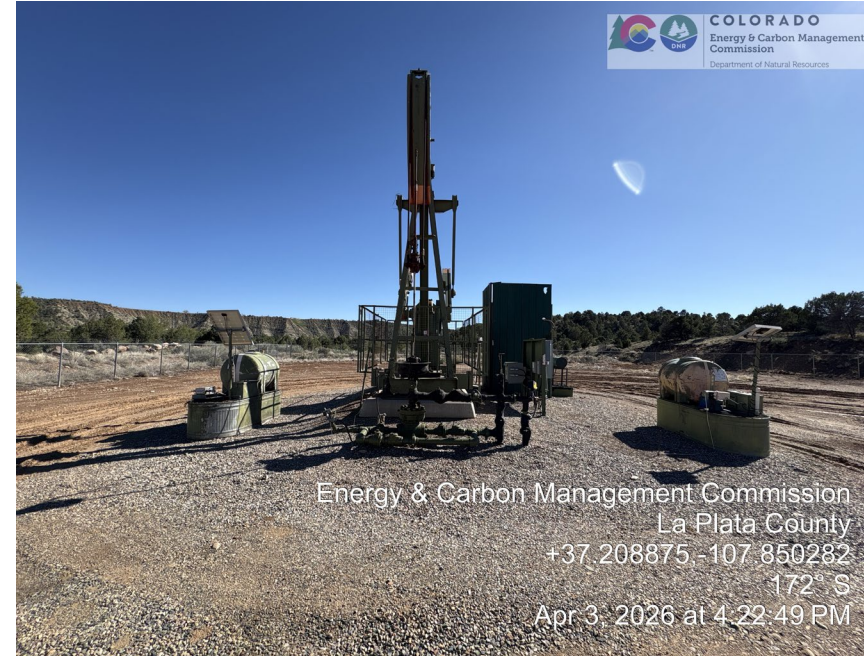
**4. Pump jack, wellhead, chemical treatment tanks over secondary containment.**

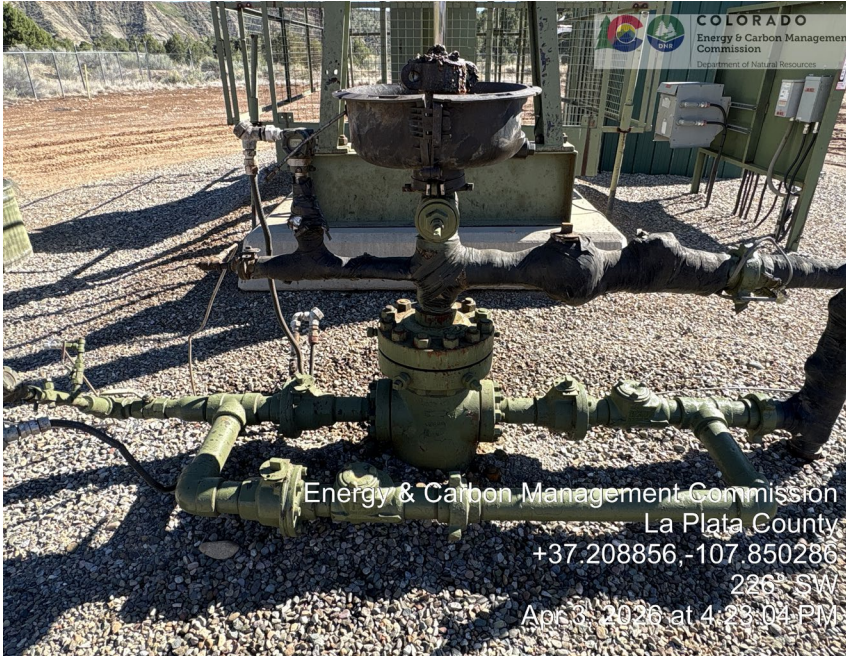
**5. Wellhead.**

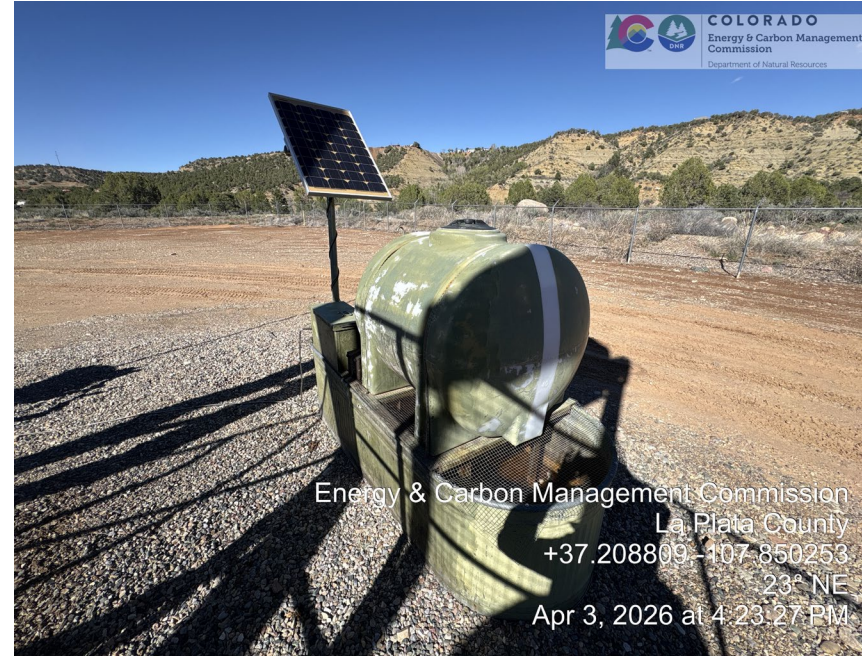
**6. Chemical treatment container.**

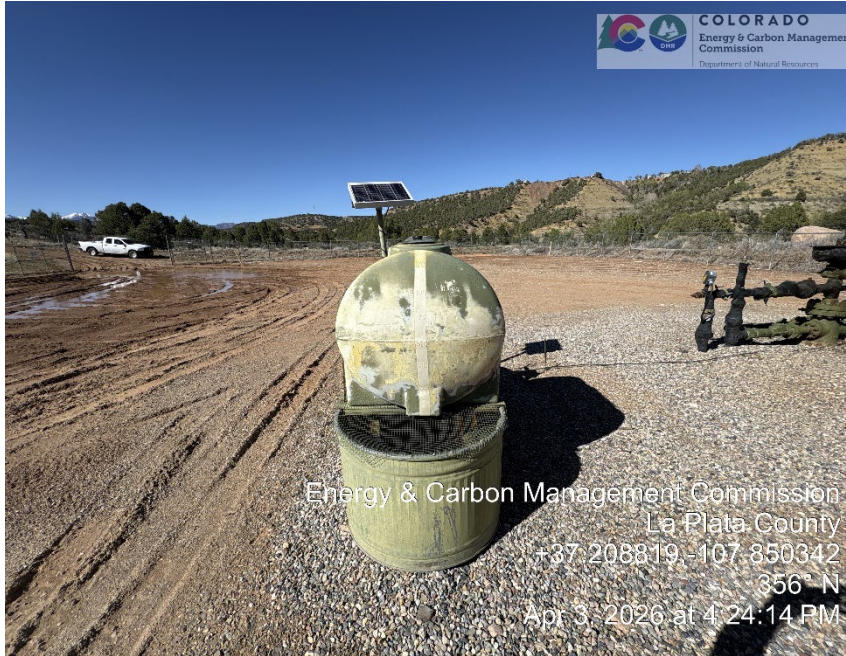
**7. Chemical treatment container. Lacks labels indicating contents and volume. Has an MSDS-like label that is peeling and difficult to read with some indication of flammability but no NFPA Diamond.**

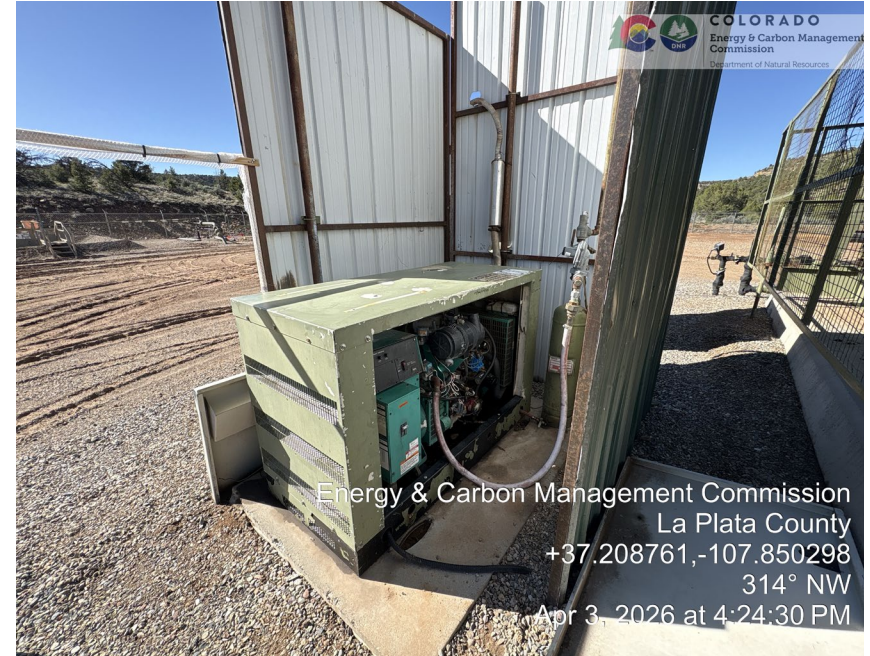
**8. Generator power for electric prime mover inside sound barrier structure. Was operating at time of inspection.**

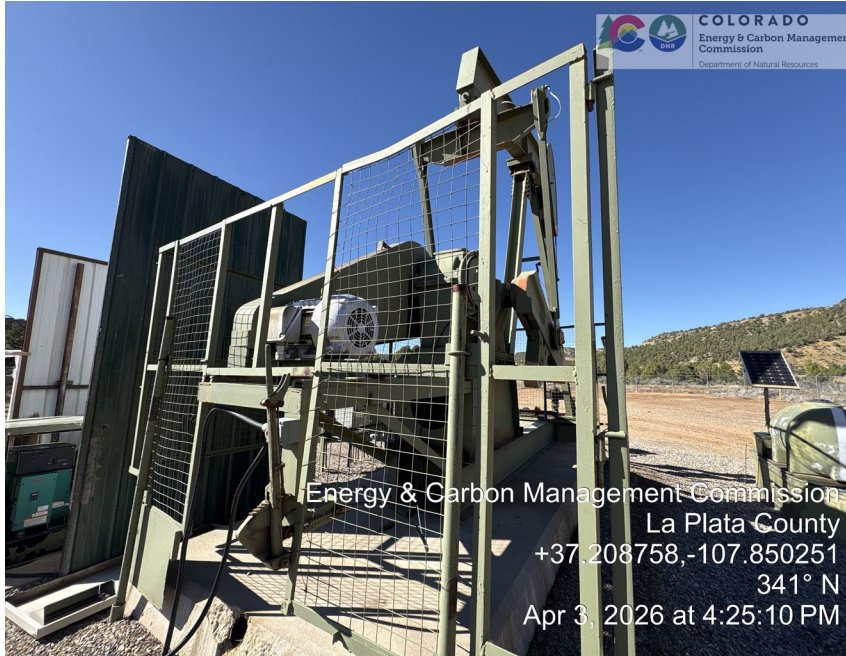
9. Pumpjack and electric prime mover.

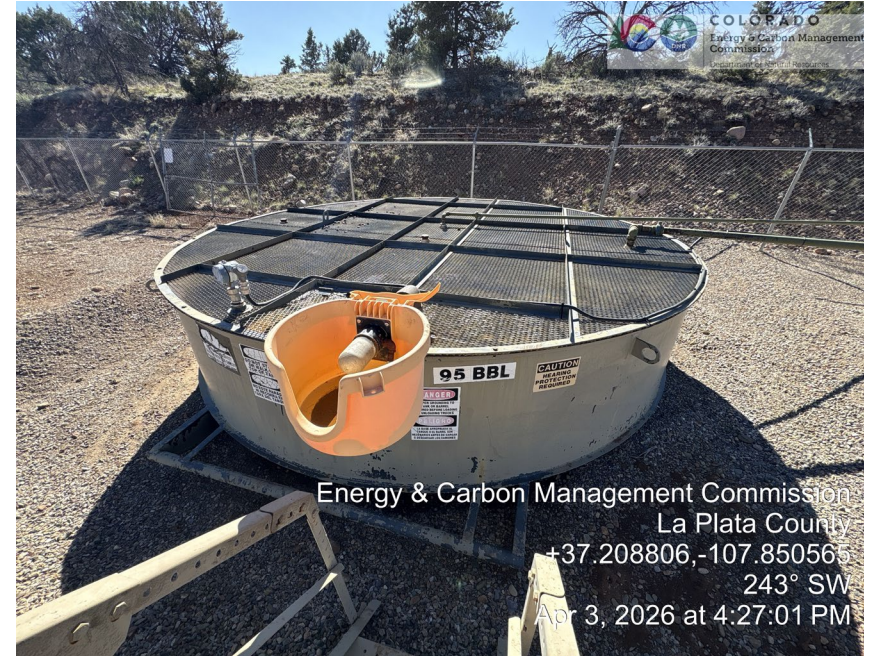
10. Open-topped 95 BBL steel produced water tank inside berm. Berm is adequate. Tank has necessary labels.

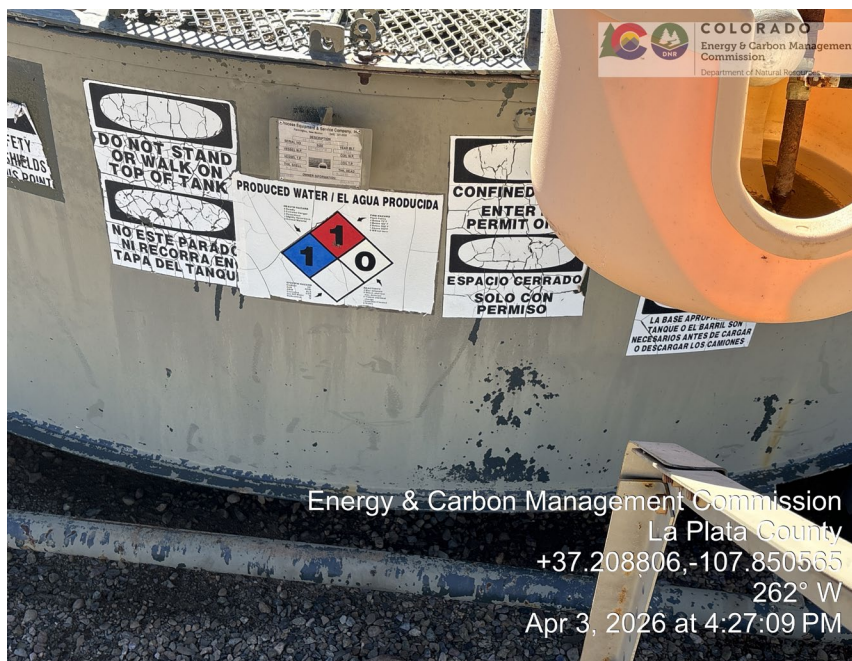
11. Additional tank labels and NFPA diamond.

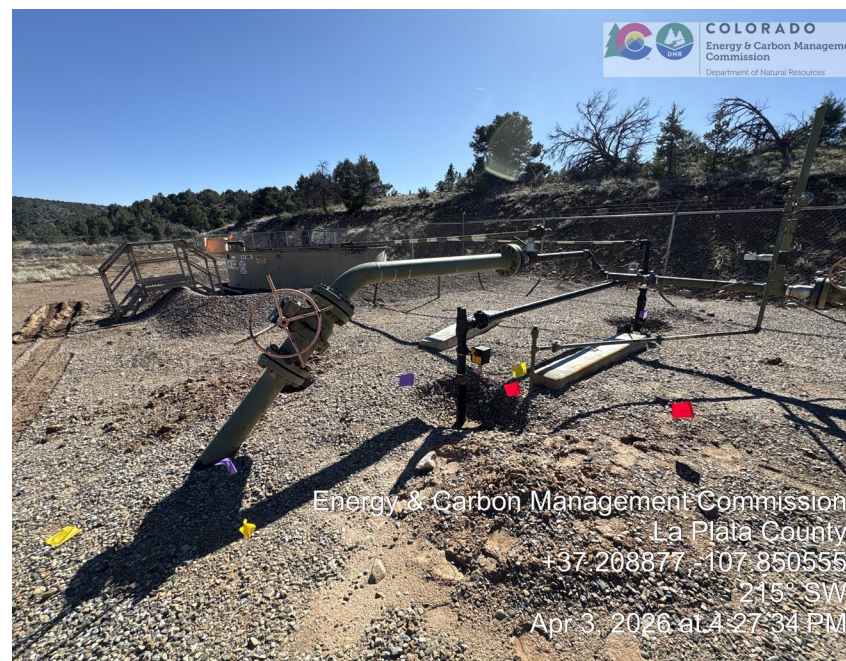
12. Flow lines with valves. Pin flags should be removed when no longer needed.

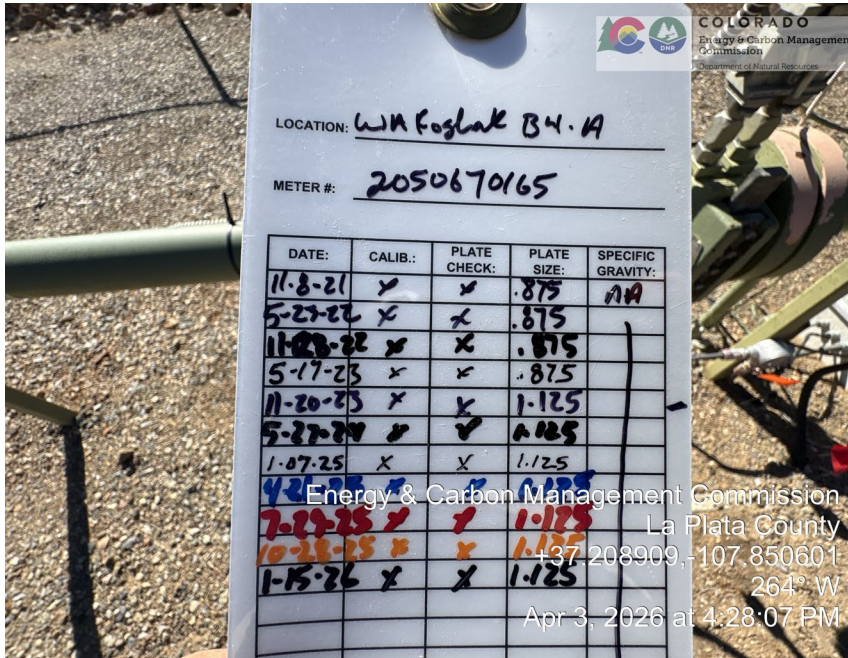
**13. Meter calibration card dated 1/15/2026.**

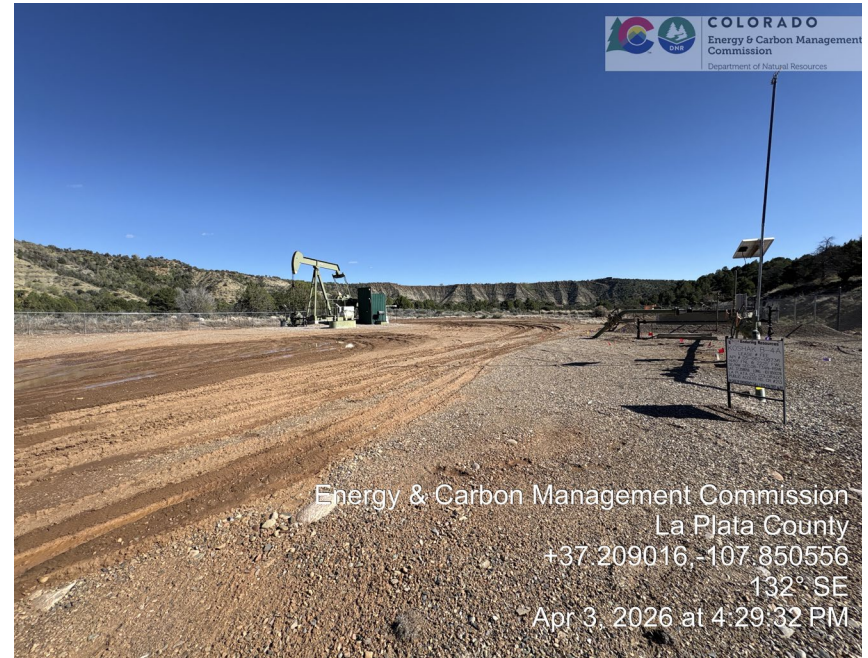
**14. Well location overview looking SE.**

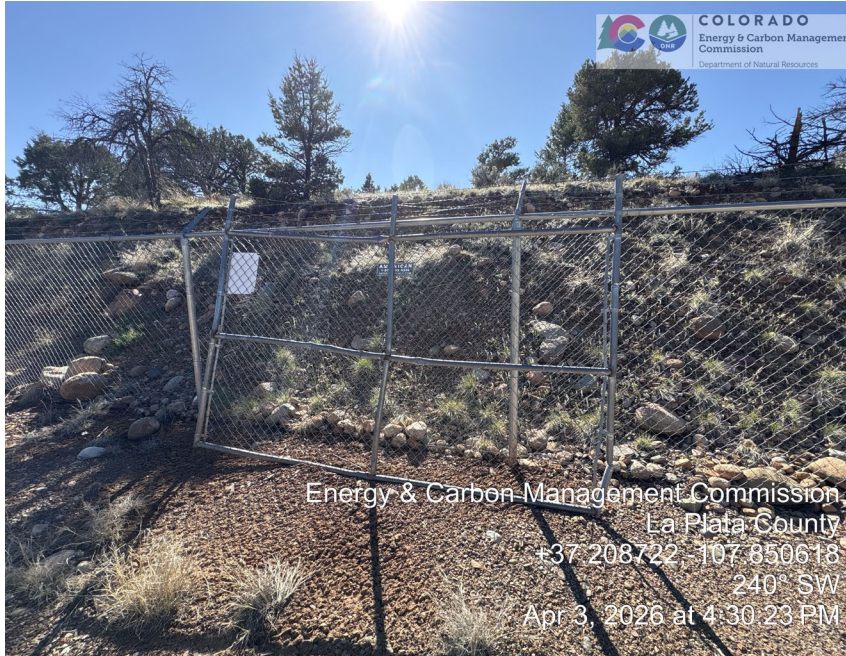
**15. Chain link fence on west edge of pad. Unused fence gate segment.**

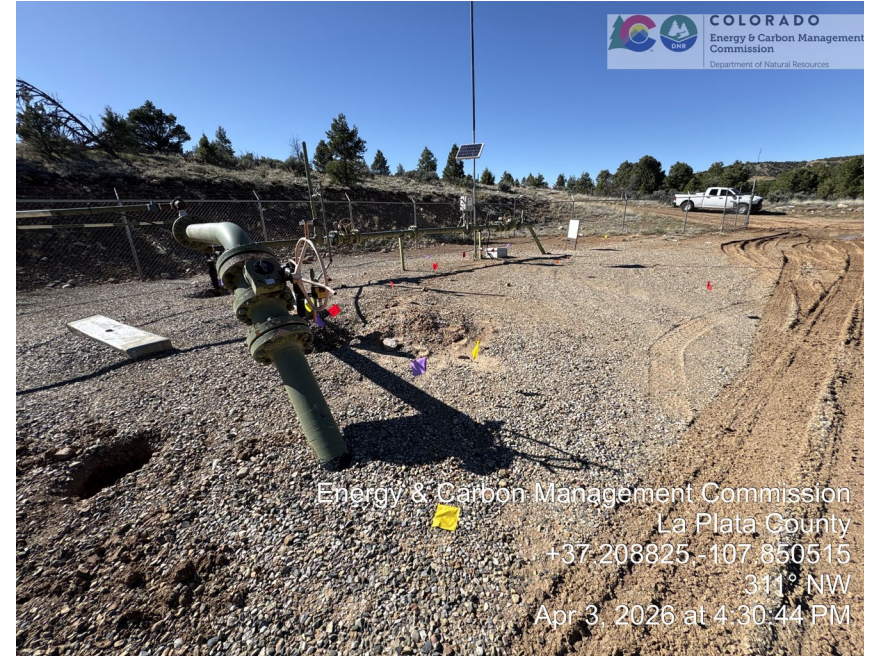
**16. Flow lines, meter run, and telemetry. Note pin flags.**

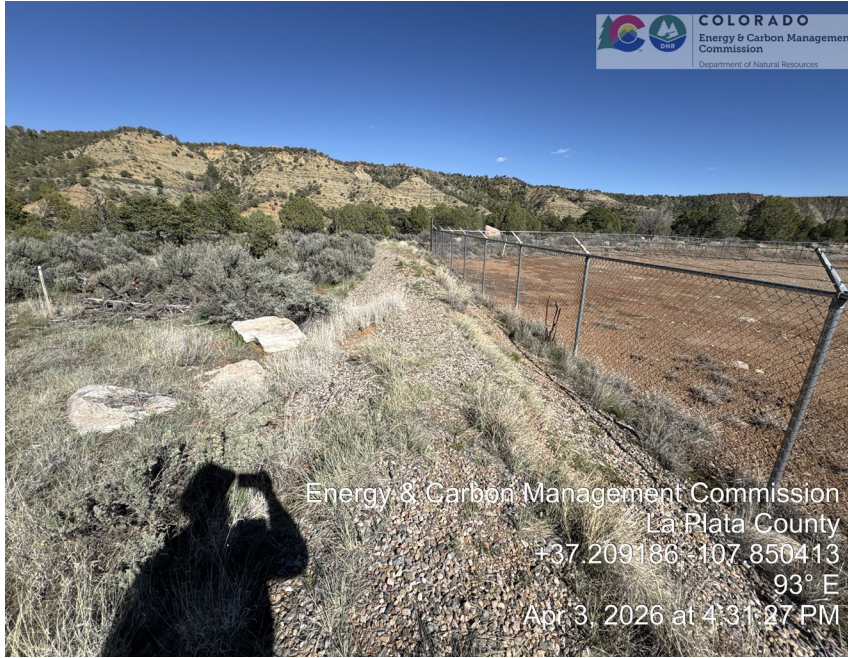
**17. Location perimeter berm.**

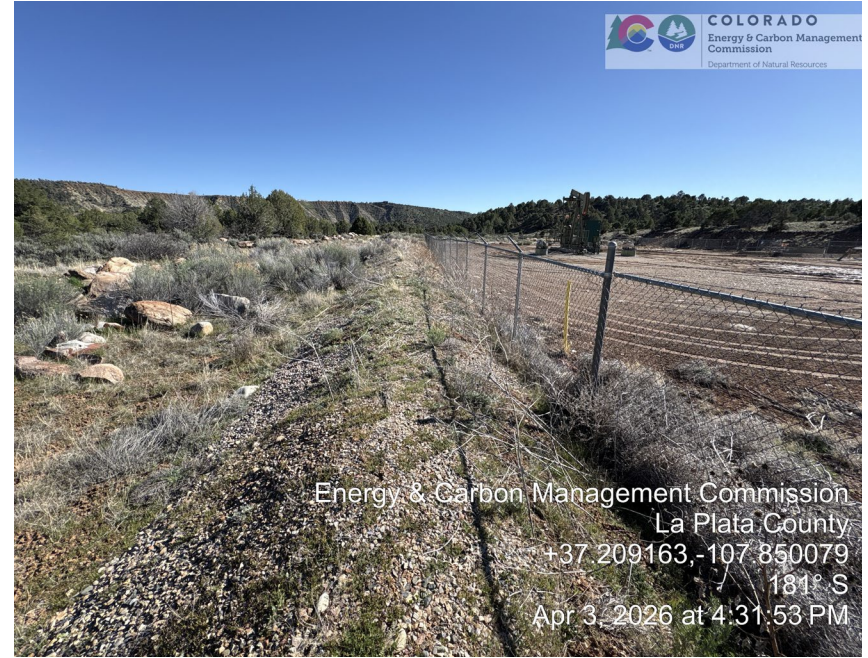
**18. Location Perimeter berm.**

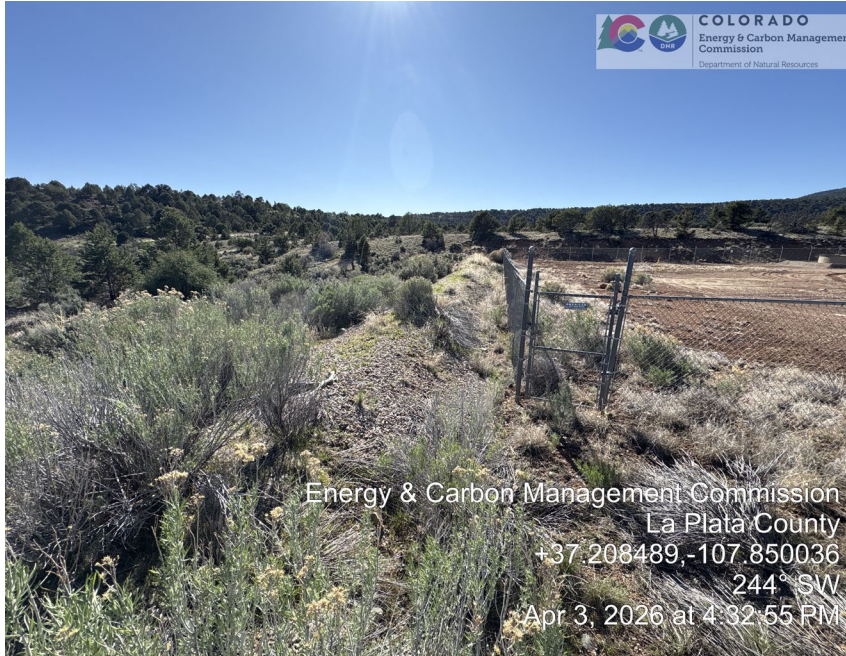
**19. Location perimeter berm.**

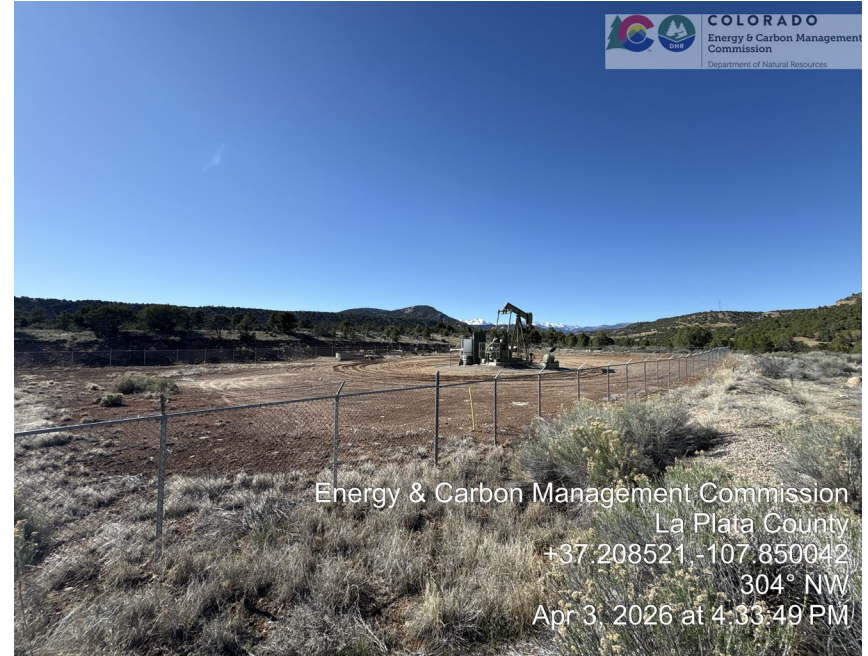
**20. Overview looking northwest from perimeter berm in southwest corner.**
