Final Reclamation Inspection

Operator: KERR MCGEE OIL & GAS ONSHORE LP - 47120

Location ID: 336577

Location Name: BOHLENDER JACOB T. UNIT

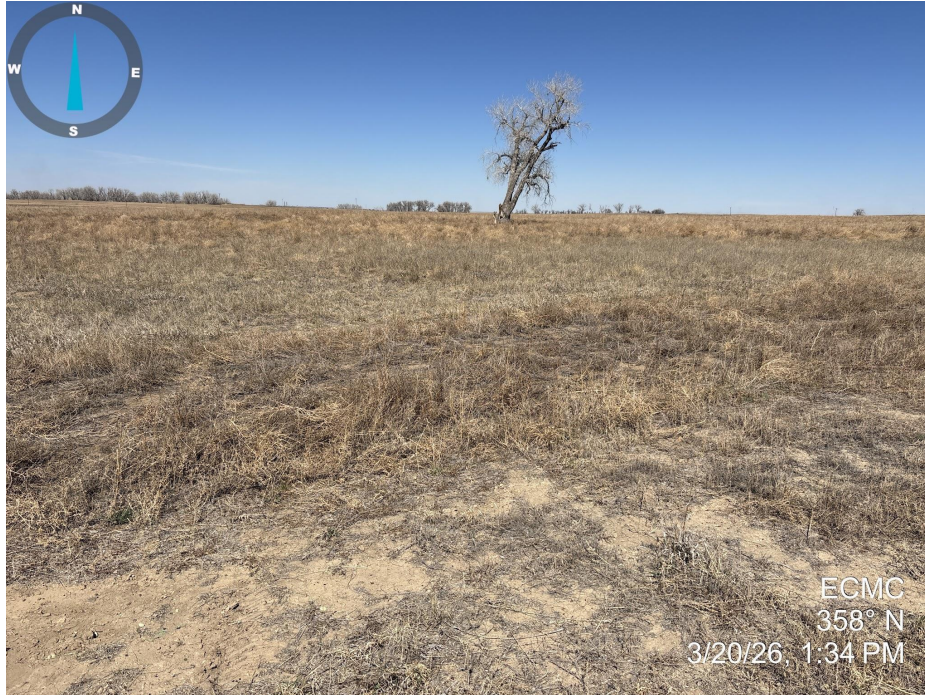
Photo 1. Photo taken of the multi-well location, facing north. Photo illustrates that final reclamation activities appear to have taken place at the location, but vegetation establishment does not meet Rule 1004 standards. Weedy annual vegetation including russian thistle (*Salsola tragus*) was observed at the location.

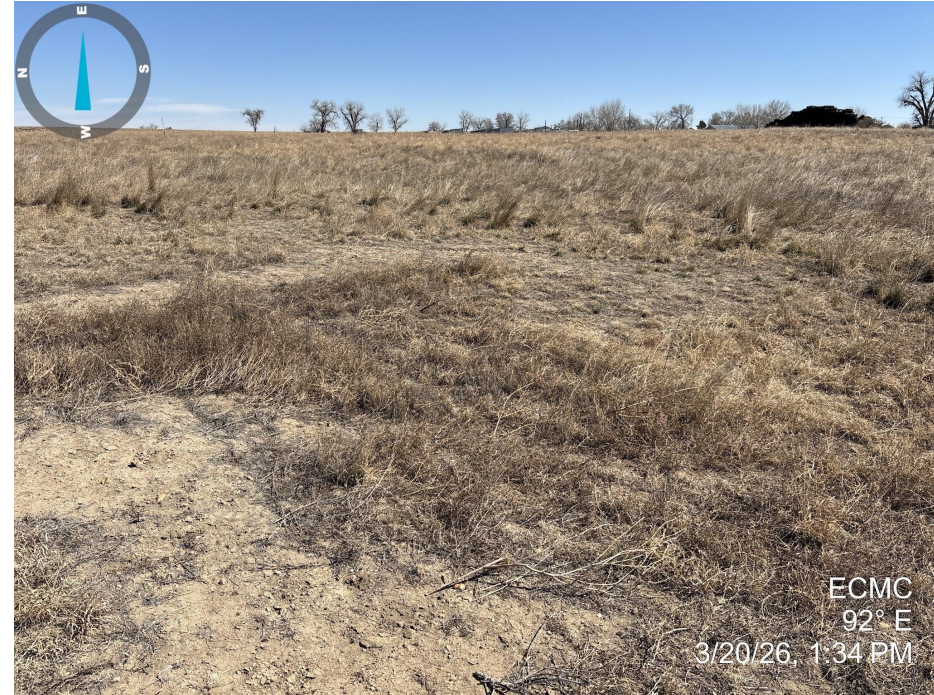
Photo 2. Photo taken of the multi-well location, facing east. See comments under Photo 1.

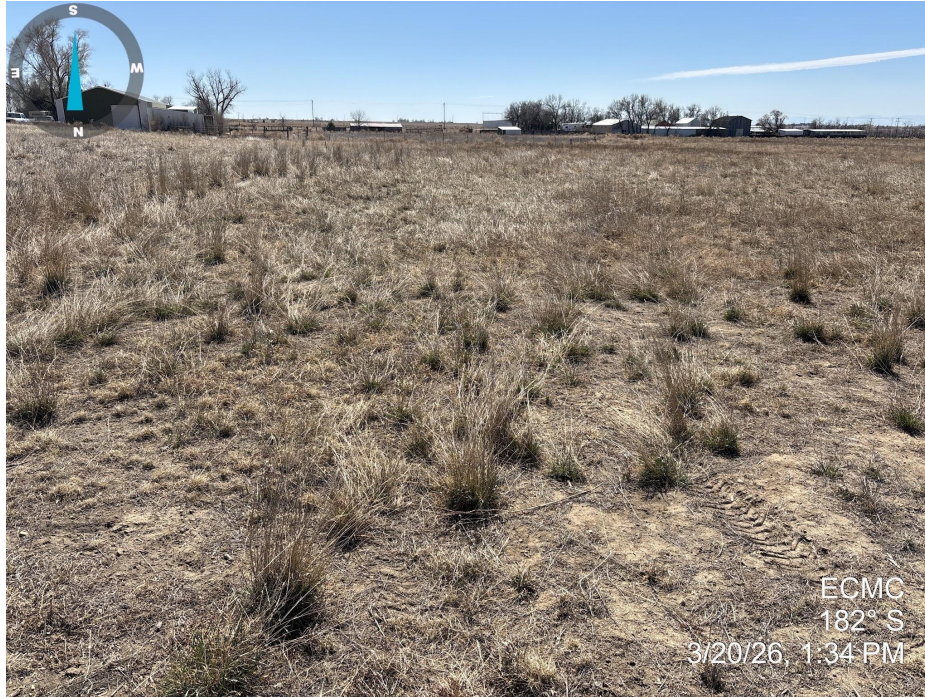
Photo 3. Photo taken of the multi-well location, facing south. See comments under Photo 1.

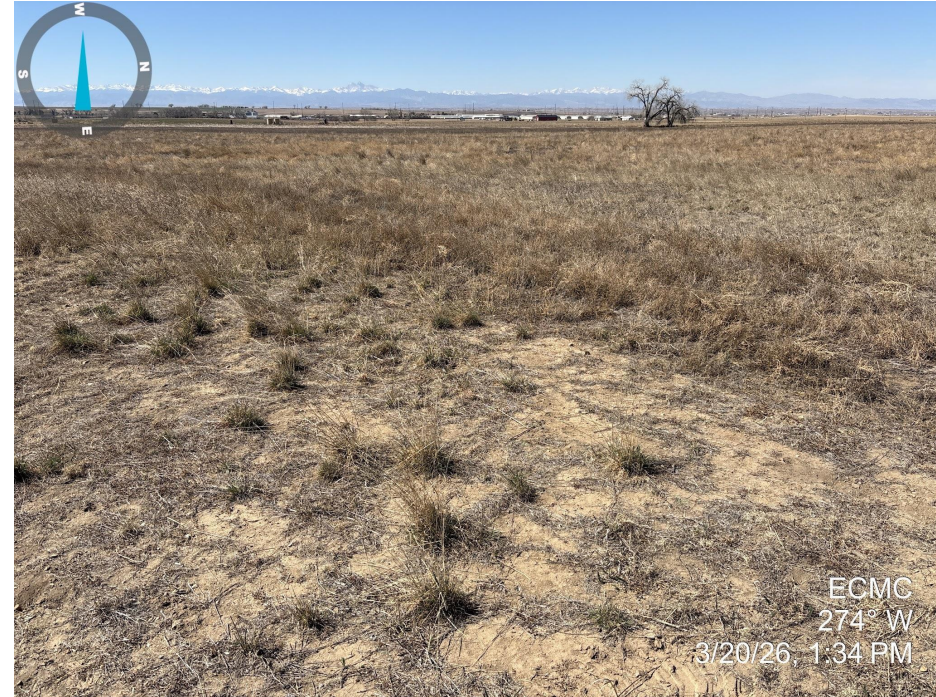
Photo 4. Photo taken of the multi-well location, facing west. See comments under Photo 1.

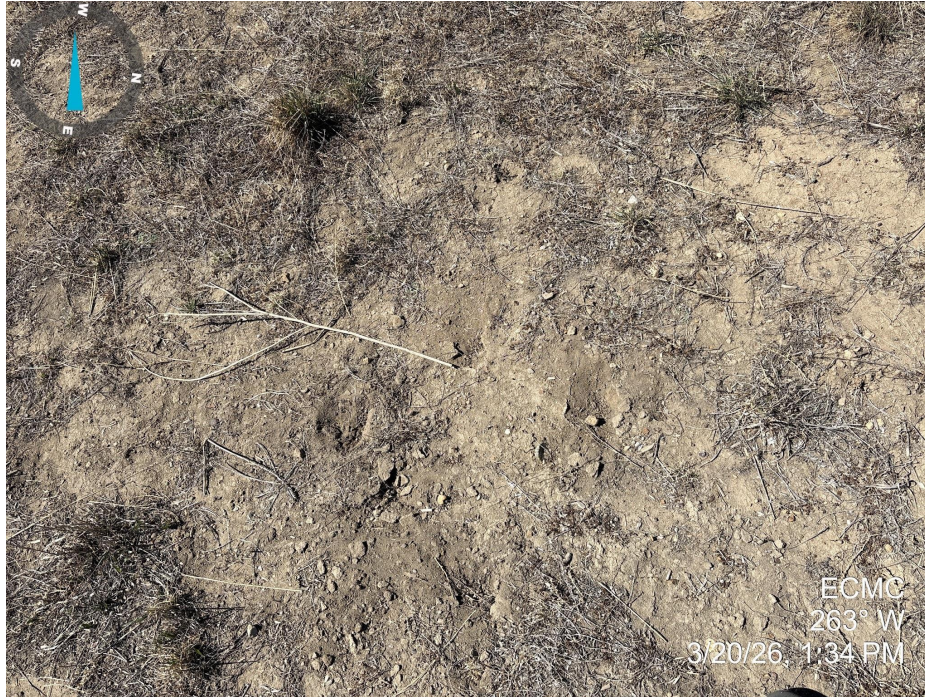
Photo 5. Photo taken of ground cover at the well location. Photo illustrates perennial grass and bare ground.

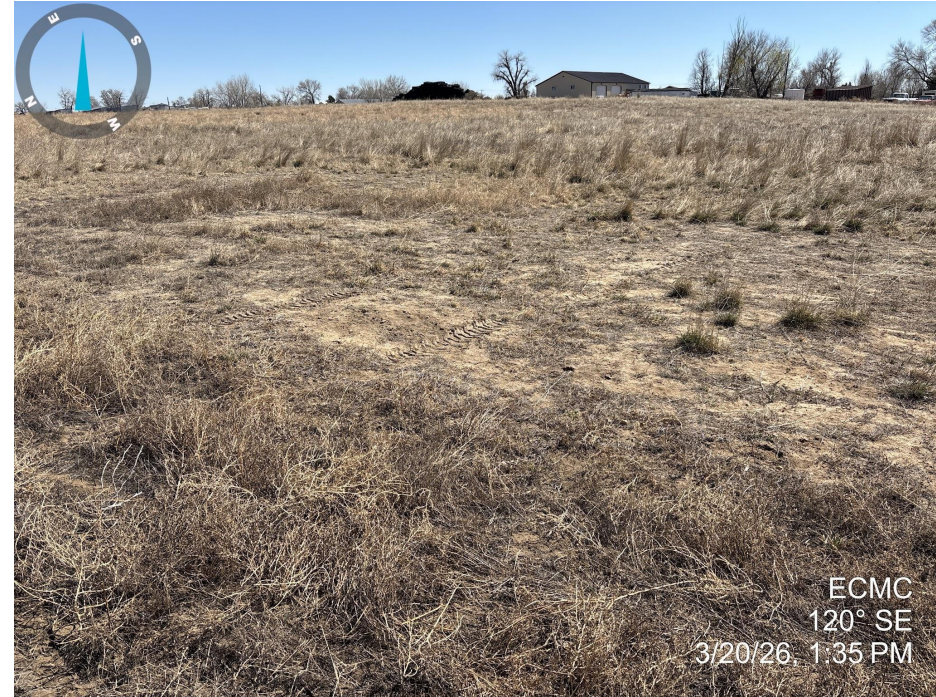
Photo 6. Photo taken of the multi-well location, facing southeast. See comments under Photo 1.

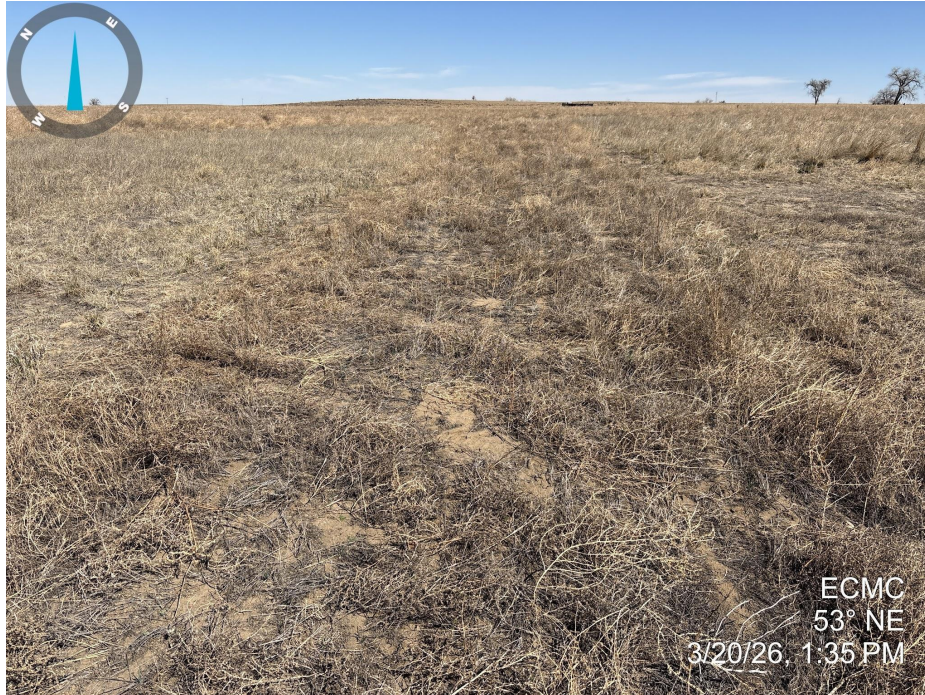
Photo 7. Photo taken of the access road to the location, facing northeast. Photo illustrates that reclamation activities appear to have taken place along the road, with evidence of drill row seeding, but vegetation has not established to Rule 1004 standards. Weedy annual vegetation including russian thistle (*Salsola tragus*) was observed.

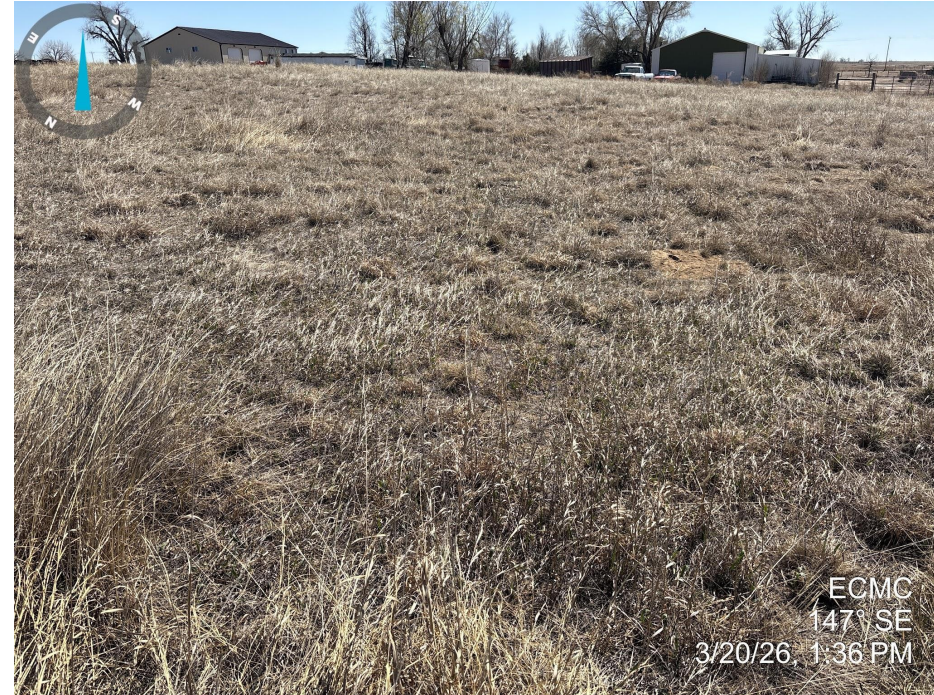
Photo 8. Photo taken of the reference area to the location, south of the location, facing southeast. Photo illustrates perennial grass and weedy annual vegetation.
