Inspection Photos

API: 071-09374

Operator: EVERGREEN NATURAL RESOURCES

Inspection Date: 4/7/2026

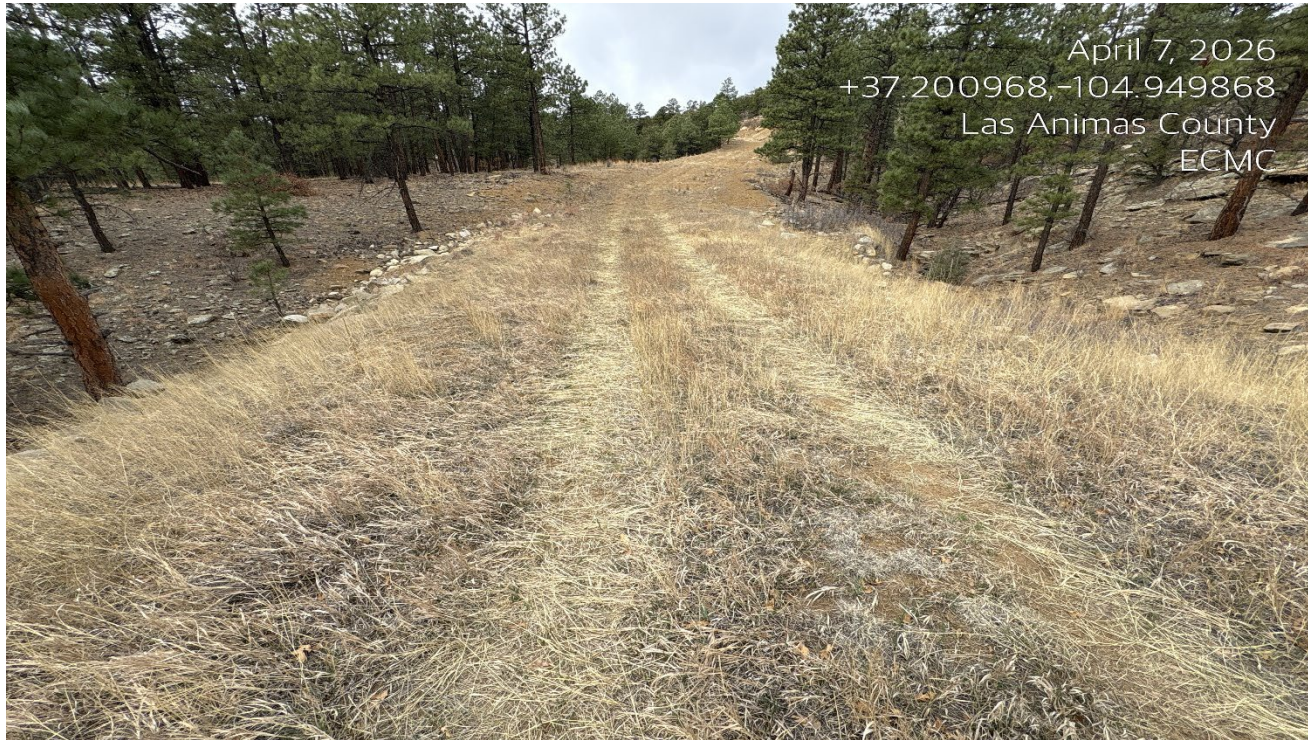
Photo 1. Facing west along the access road that remains per approved variance.

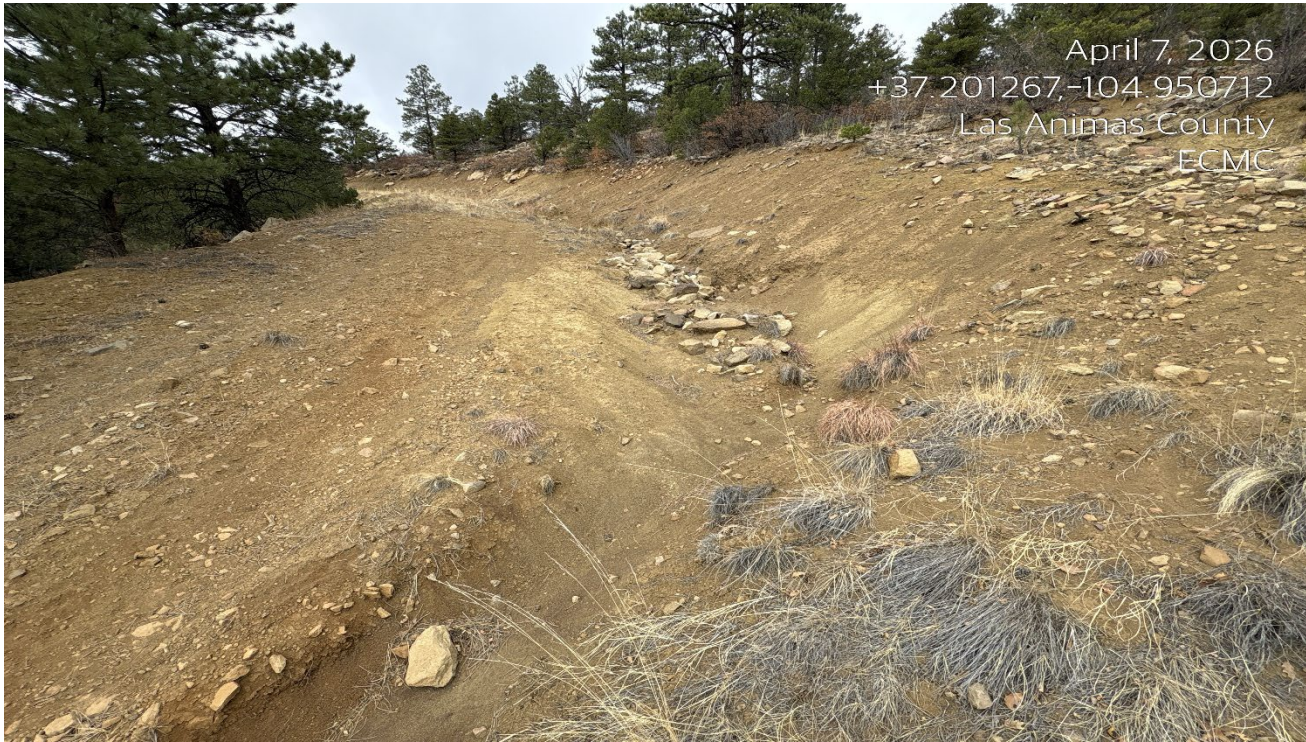
Photo 2. Facing west climbing up the road. This area has eroded and needs to be repaired and stabilized.

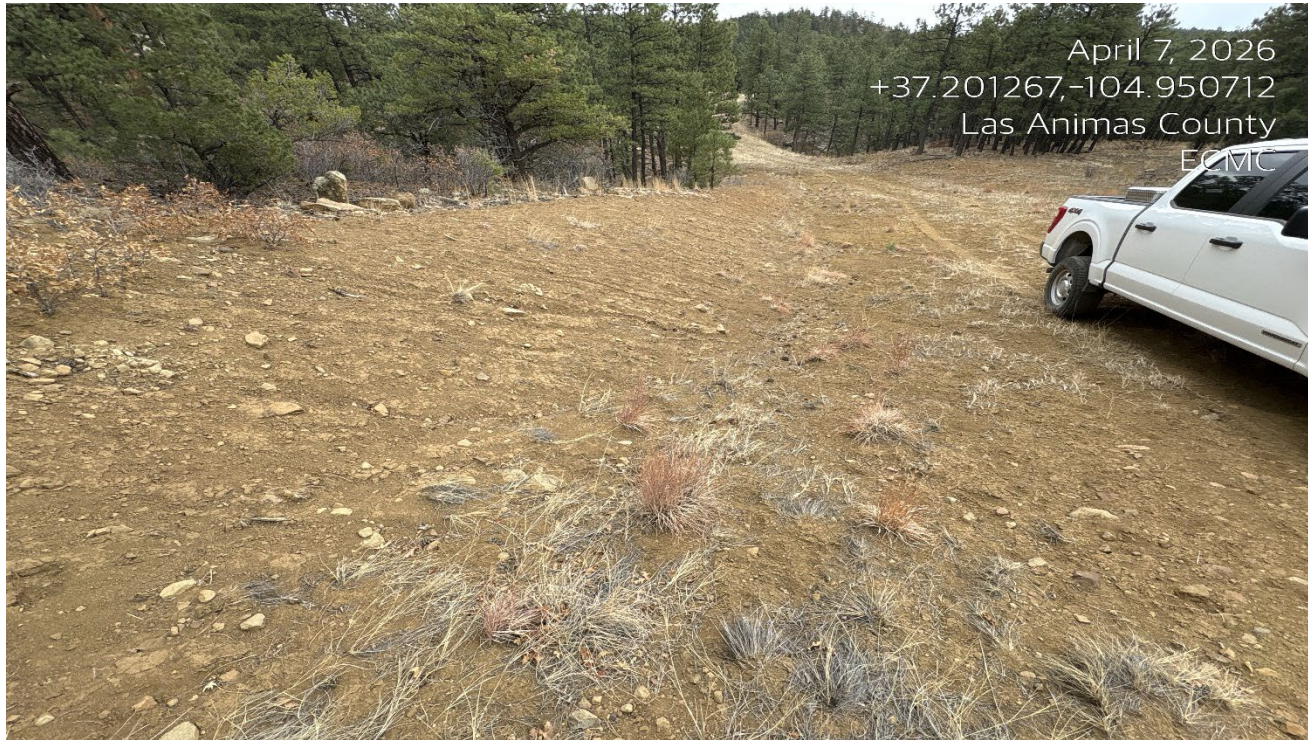
Photo 3. Facing east back down the road side. This area could use additional reseeding to establish vegetation.

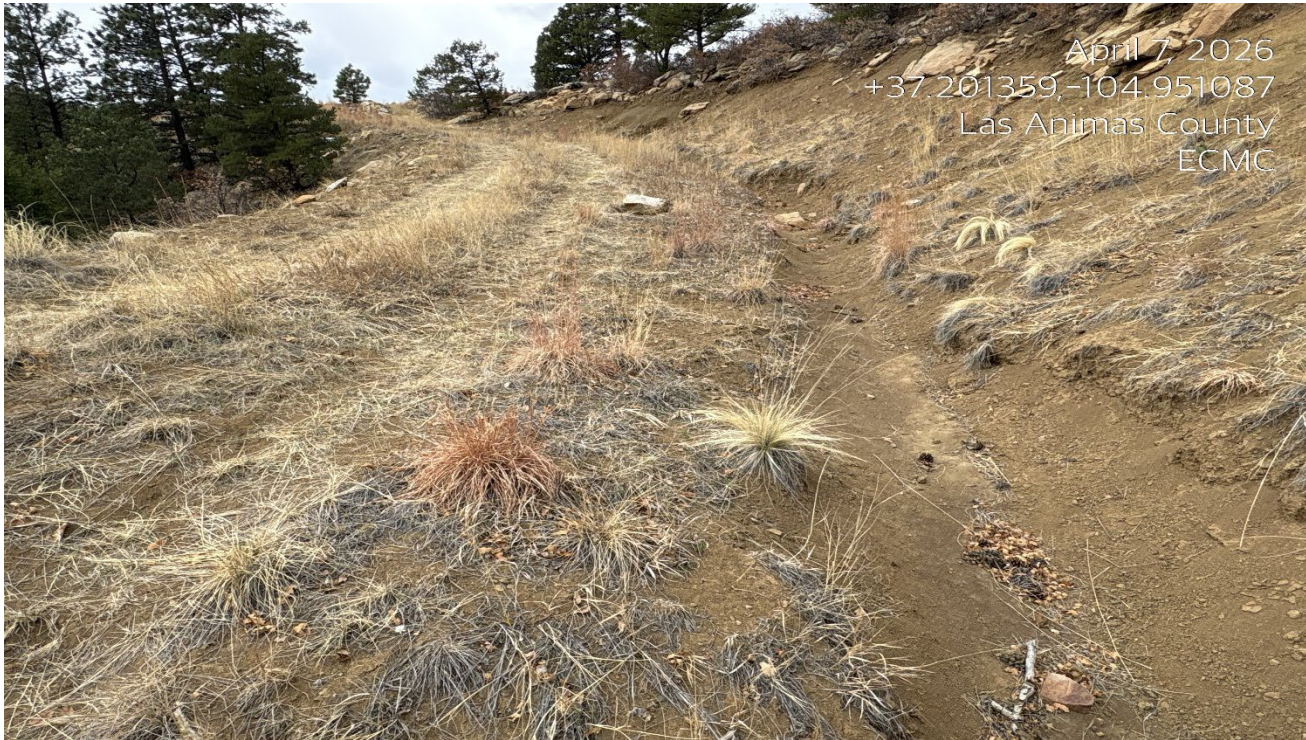
Photo 4. Facing west along the access road. Stormwater is directed down the length of the road side causing the erosion in the previous photo.

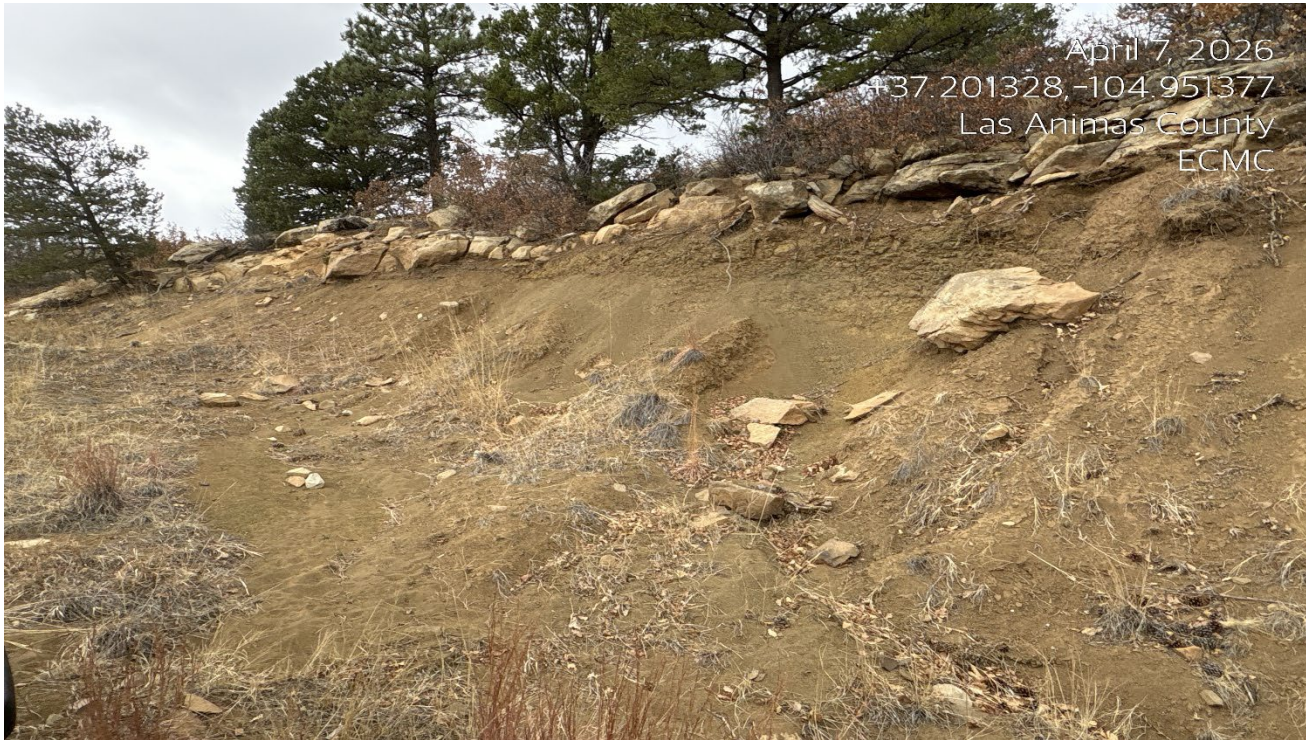
Photo 5. There is stormwater runoff causing erosion at this point which is directed down the road.

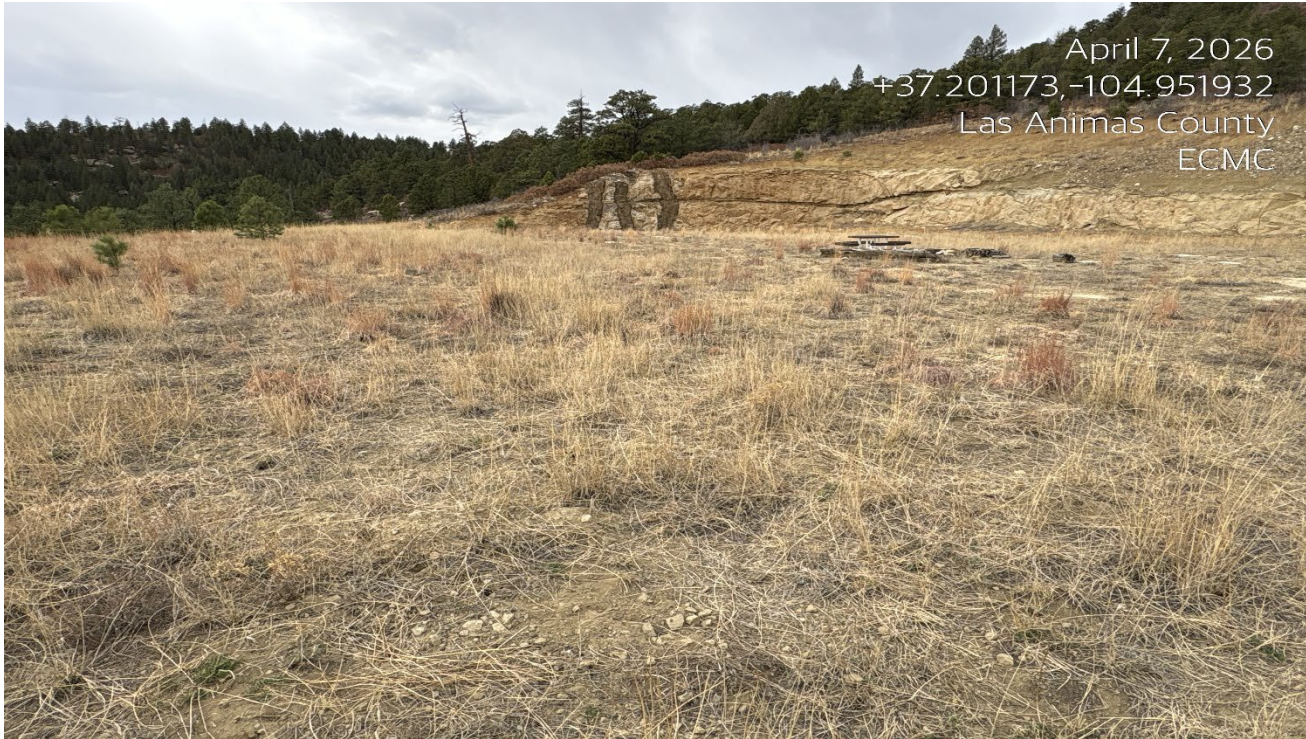
Photo 6. Facing northwest at the location that remains per approved variance.

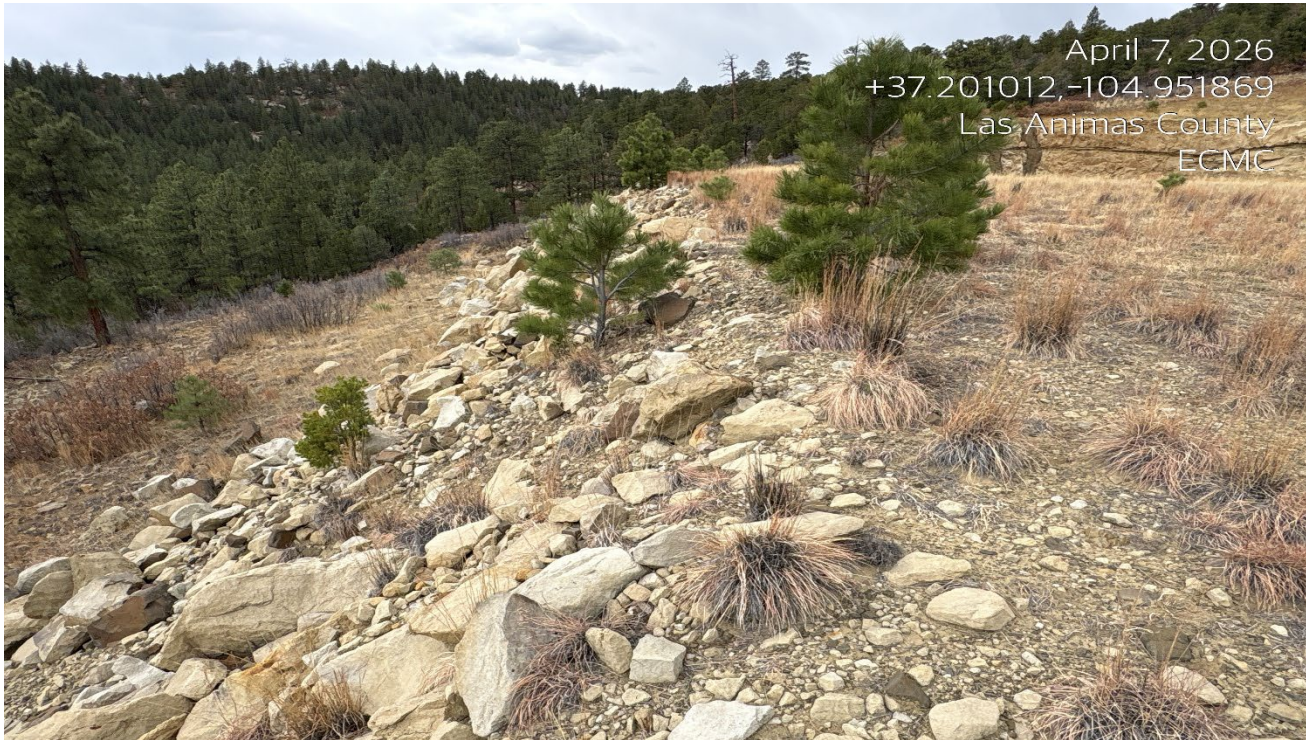
Photo 7. Facing west along the fill slope.
