Inspection/Audit Photos

Location Name: QB ENERGY OPERATING LLC PUCKETT 32D-25D (Mesa 22)

Location #: 335506

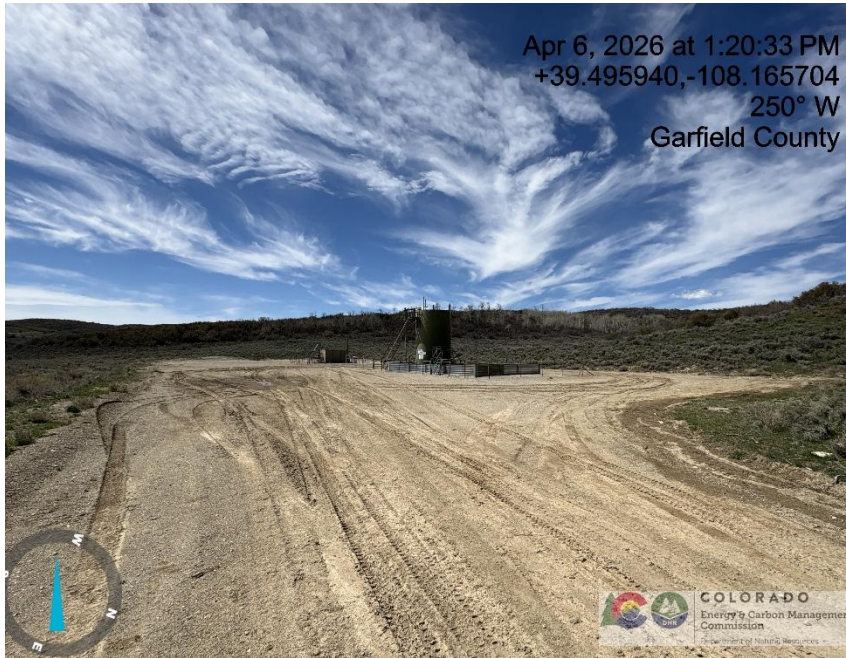
Photo # 5228 From entrance to location

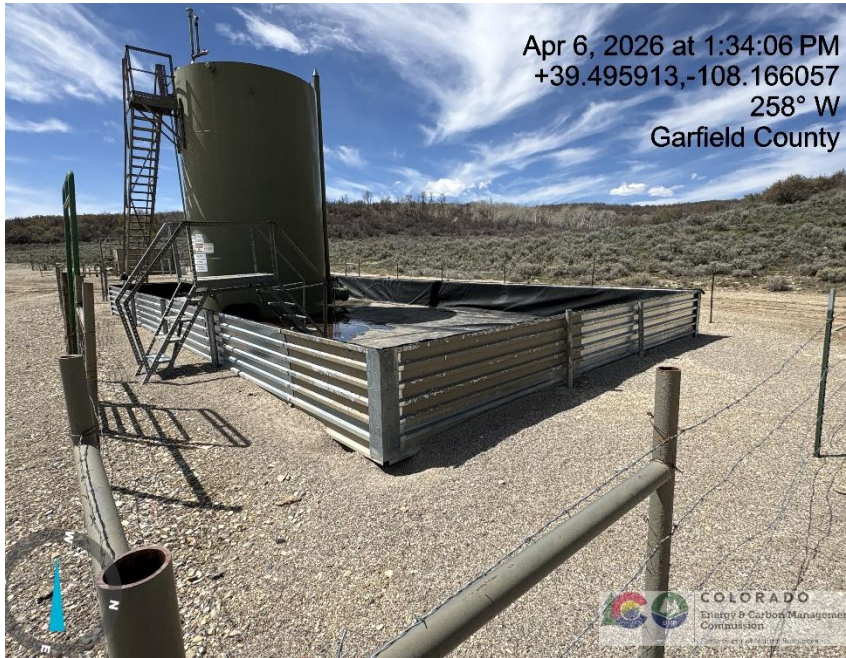
Photo # 5234 Tank battery lacks required signage

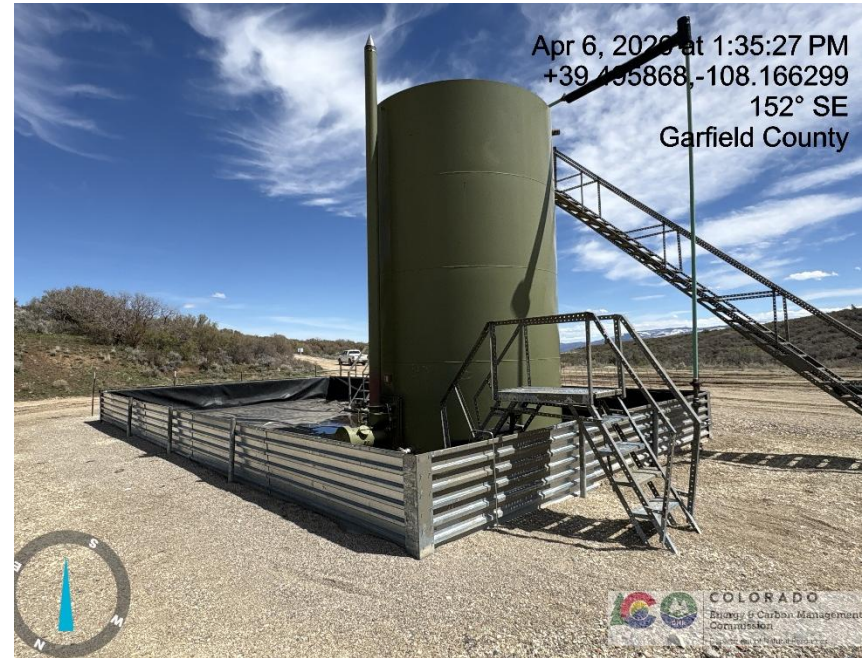
Photo # 5235 Tank battery lacks required signage

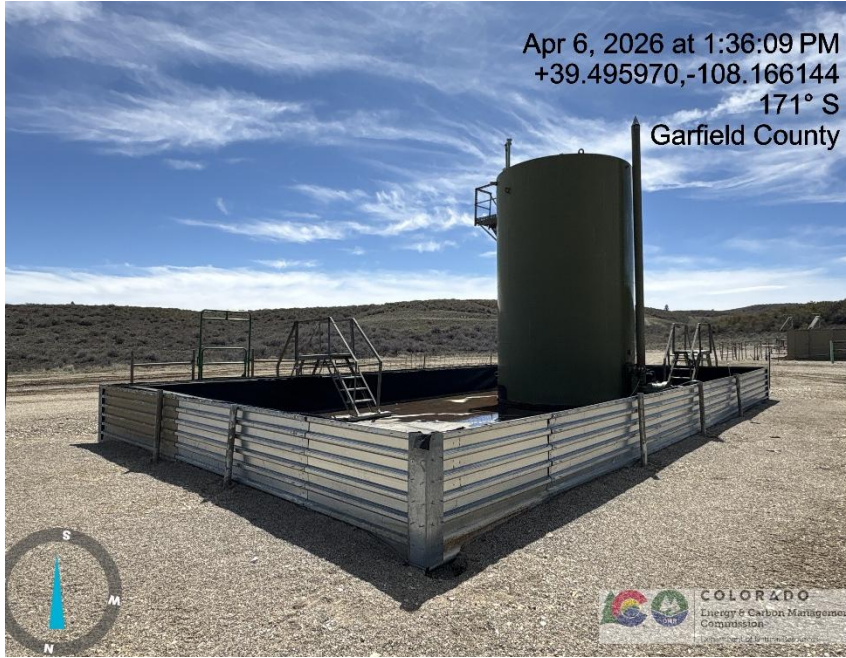
Photo # 5236 Tank battery lacks required signage

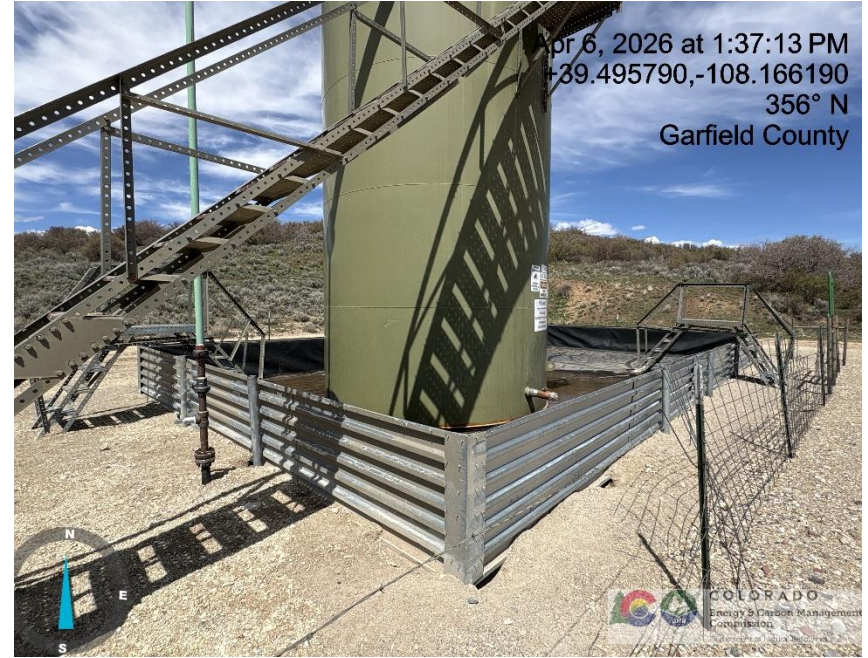
Photo # 5237 Tank battery lacks required signage

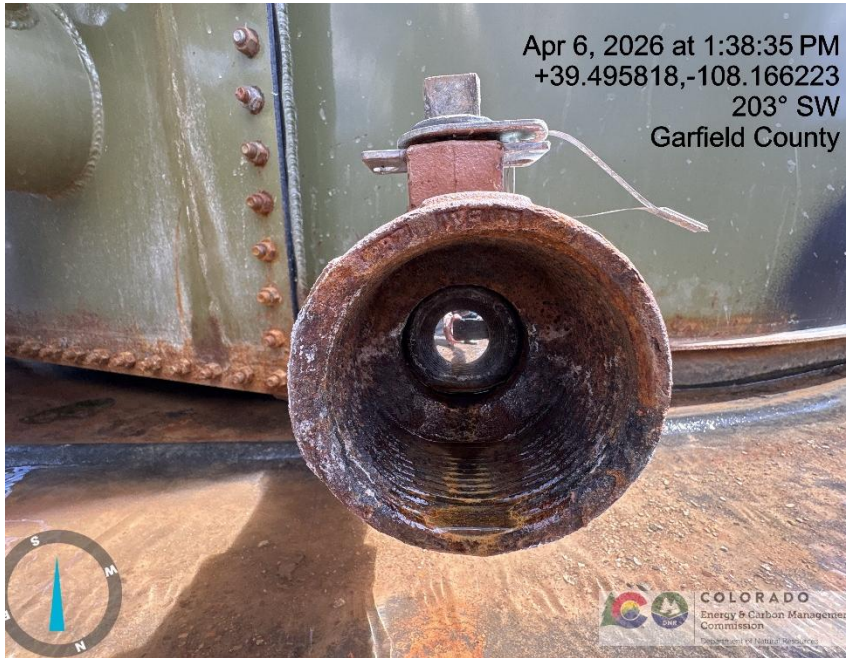
Photo # 5238 Open ended load line
