Inspection Photos

API: 009-06440

Operator: MURFIN DRILLING COMPANY

Inspection Date: 4/9/2026

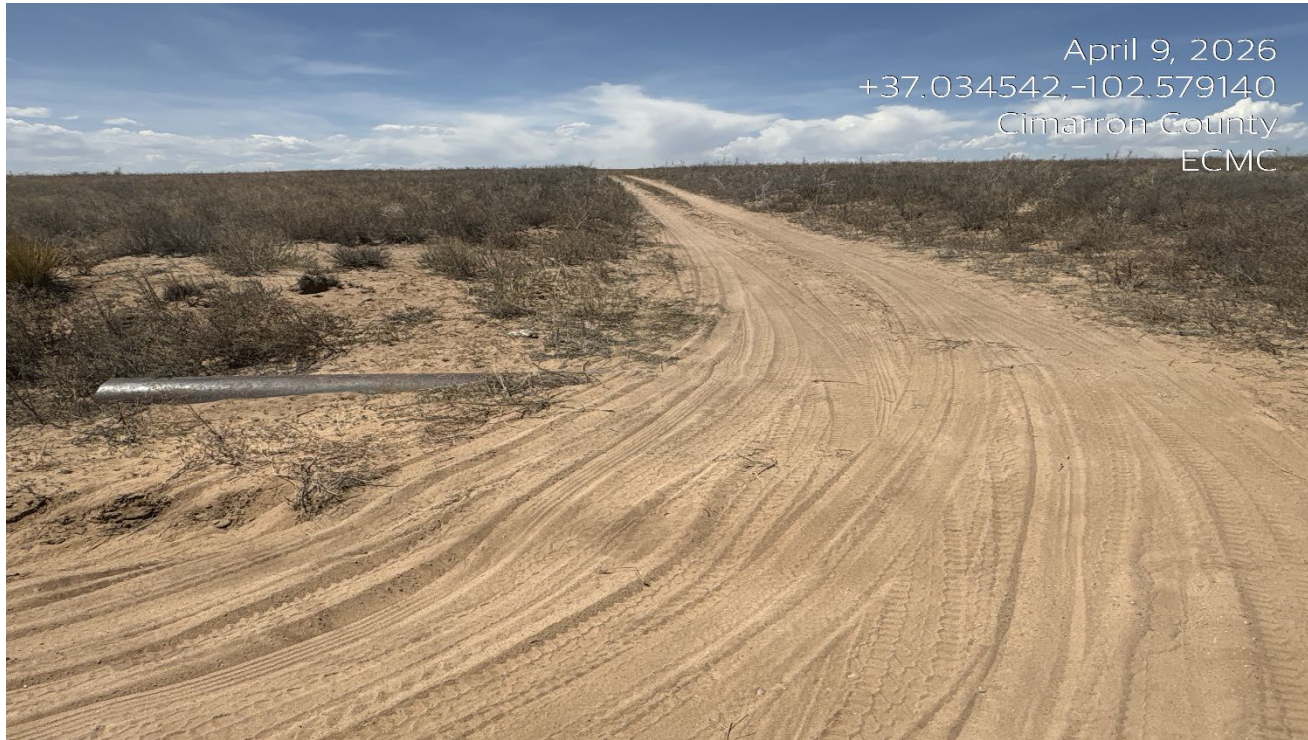
Photo 1. Facing west at the beginning of the access road.

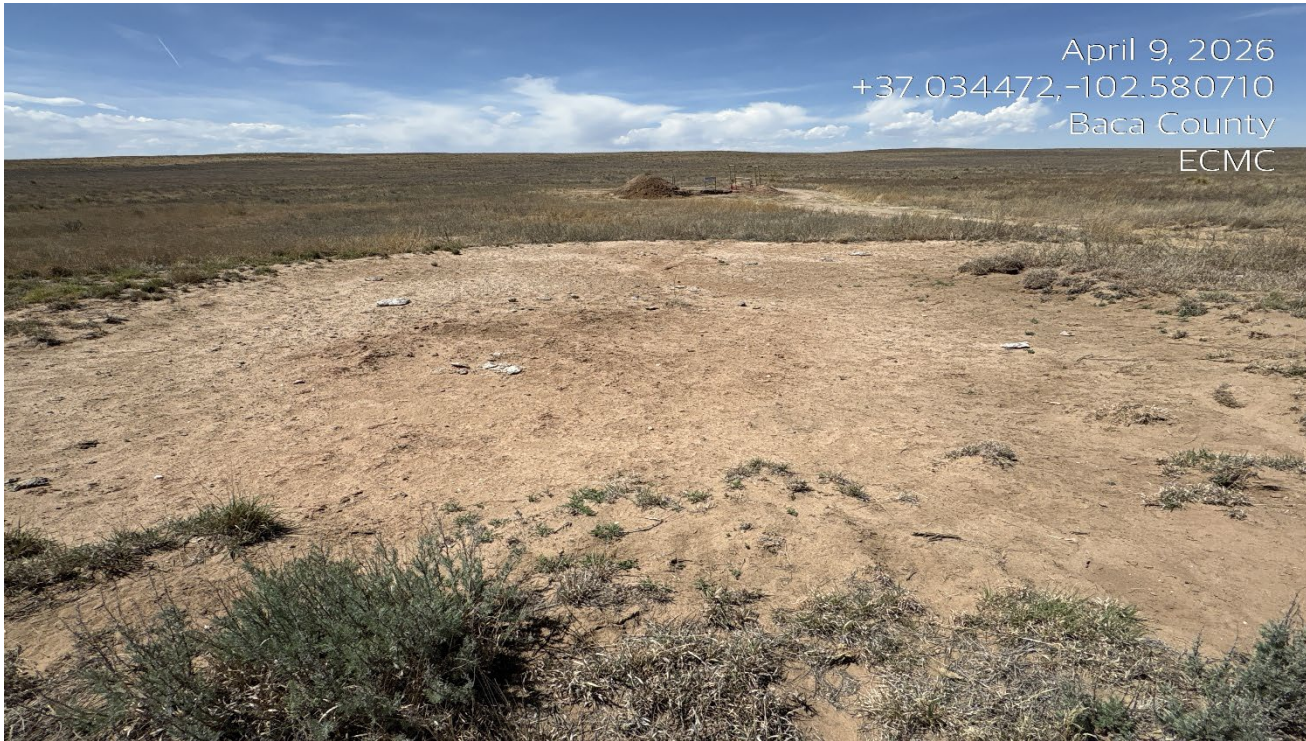
Photo 2. Facing west about 140 feet from the wellsite. This area appear to be where flowline risers were removed.

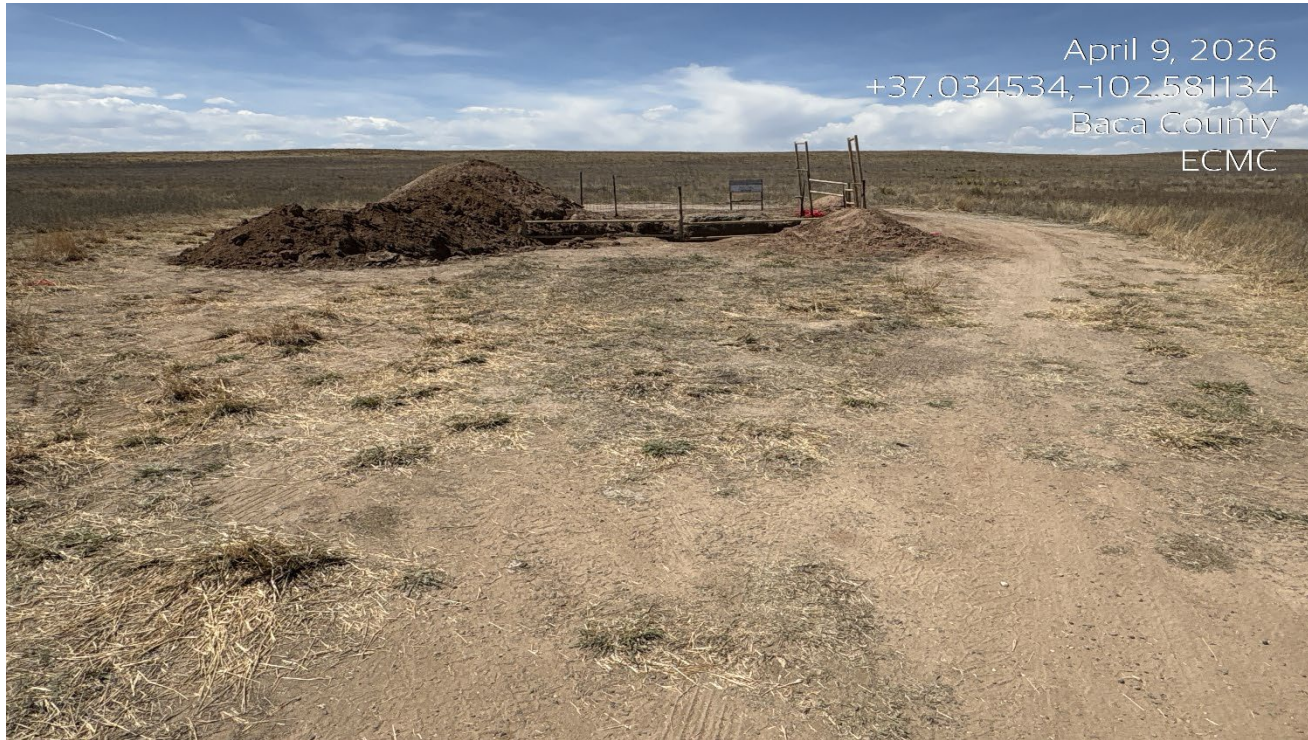
Photo 3. Facing west toward the location.

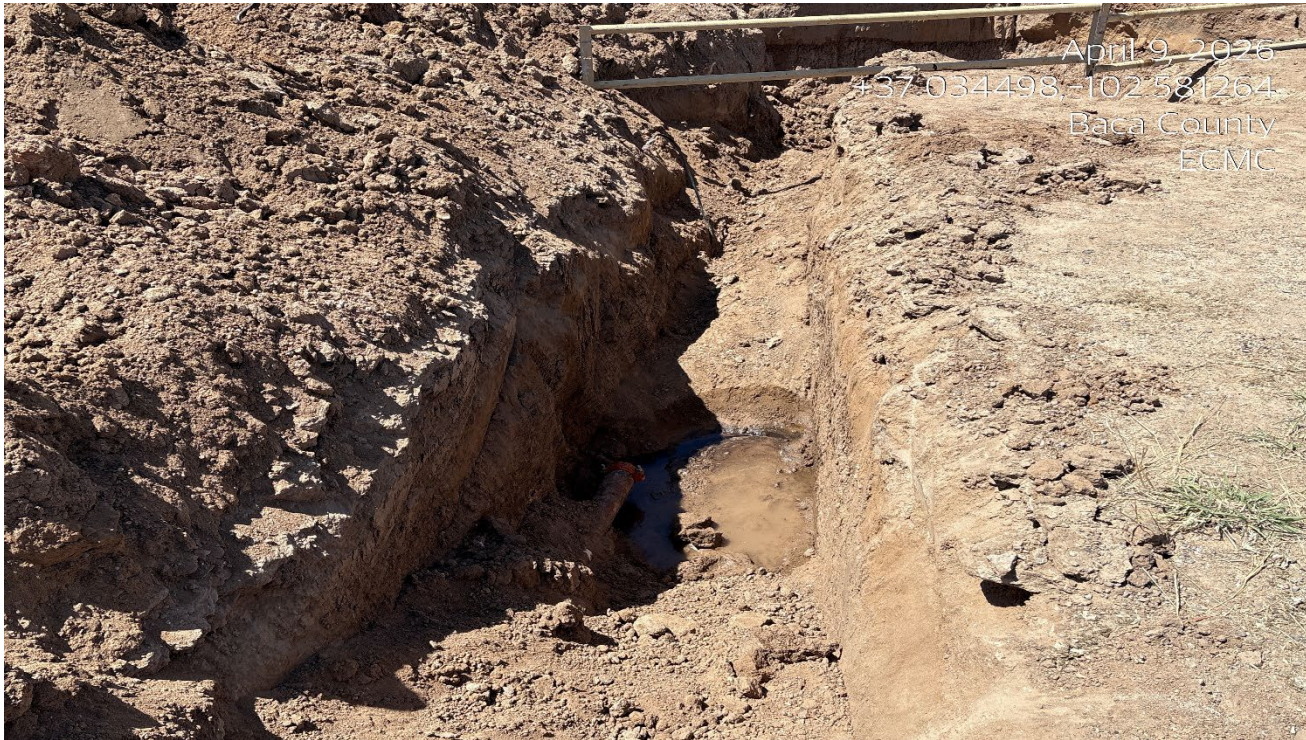
Photo 4. Near the abandoned well is a capped flowline. There is standing water at this area from a possible leak of the flowline.

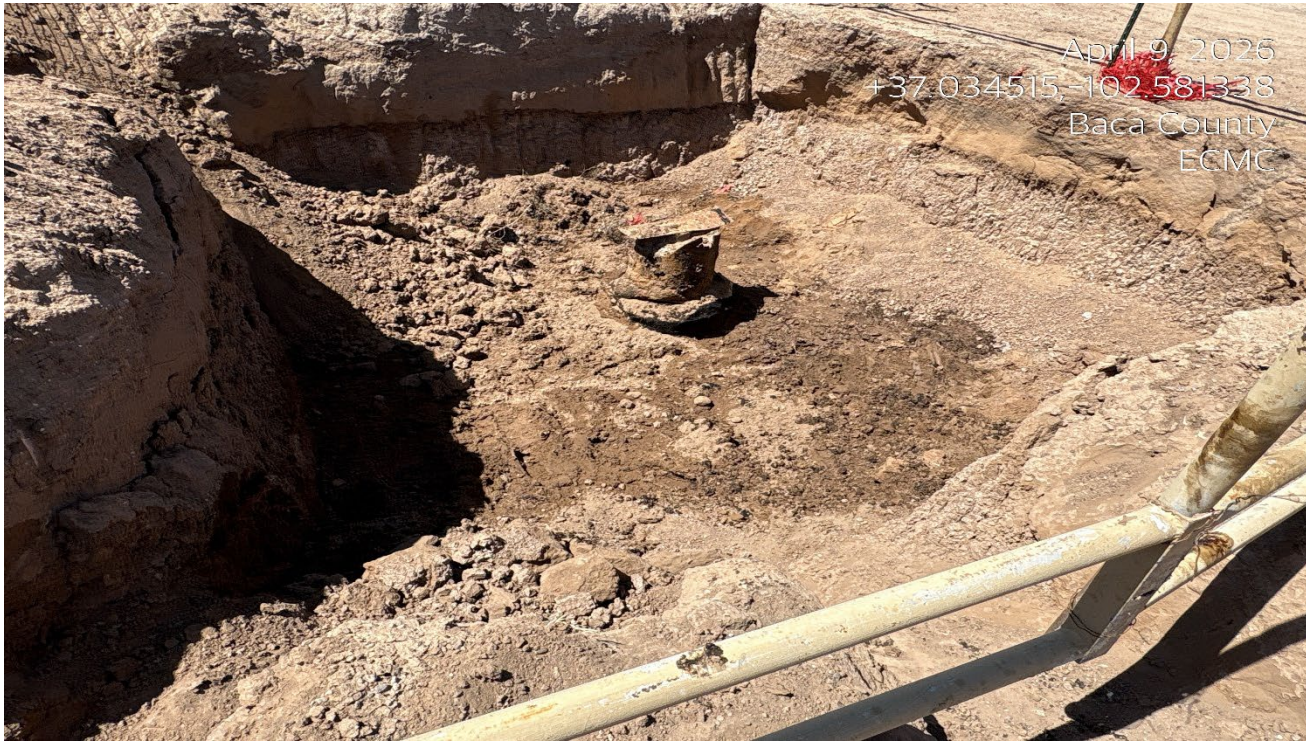
Photo 5. Facing toward the cut and capped well. There appears to be wet impacted soils around the abandoned well.

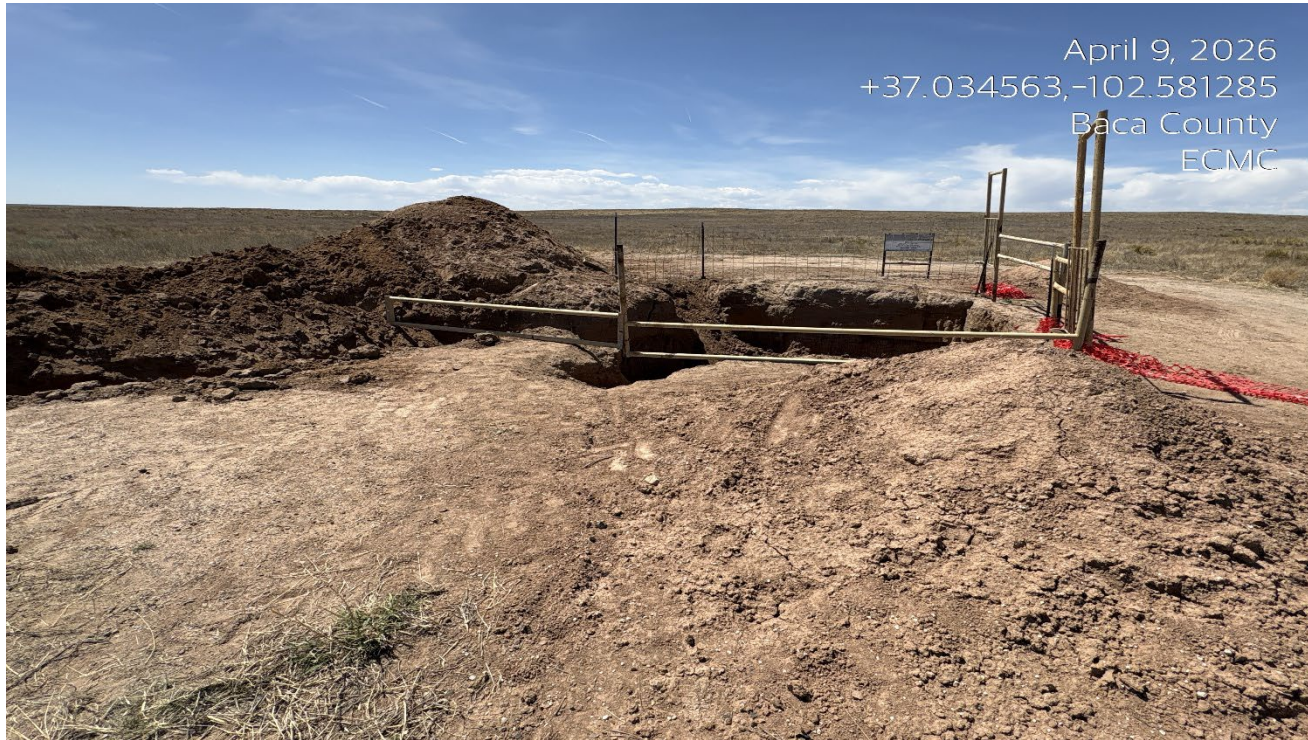
Photo 6. Facing west toward the excavated abandoned well site.
