Inspection Photos

API: 009-06637

Operator: INVESTMENT EQUIPMENT LLC

Inspection Date: 4/9/2026

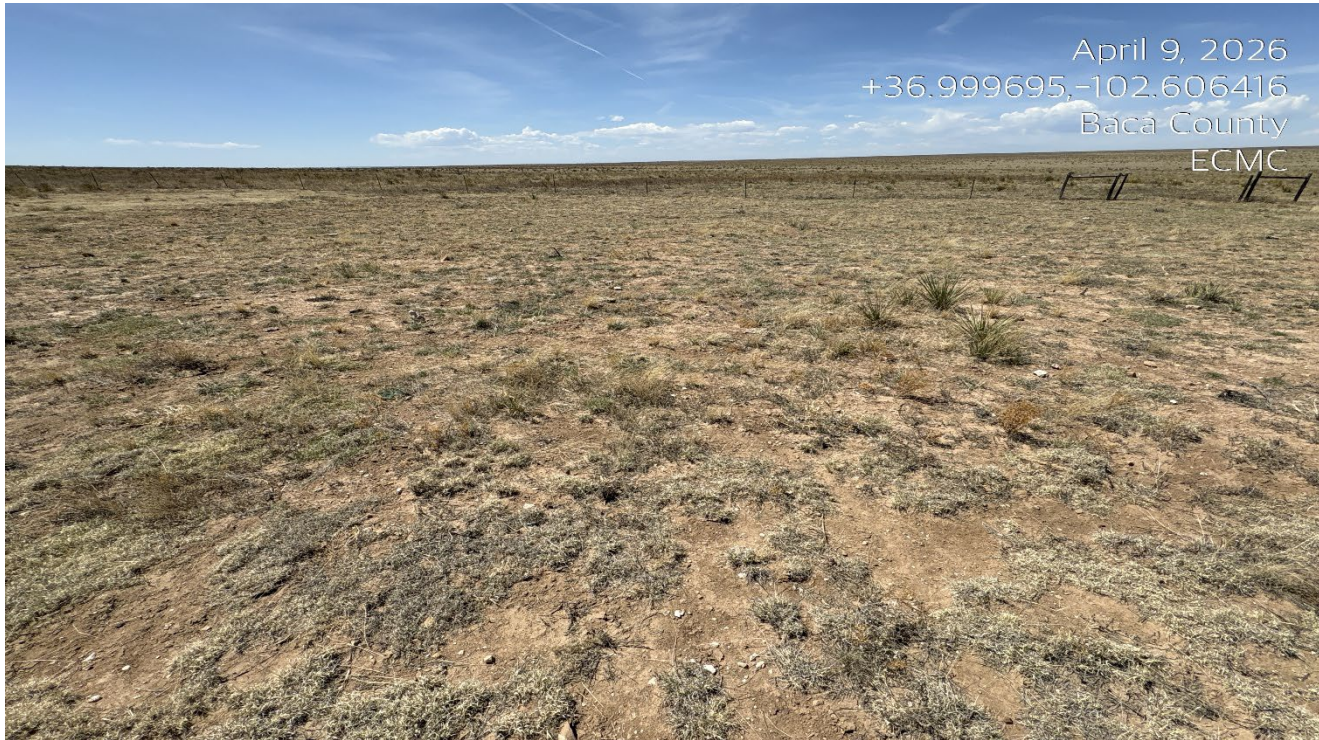
Photo 1. Facing west toward the location. This area of the location is revegetating very well.

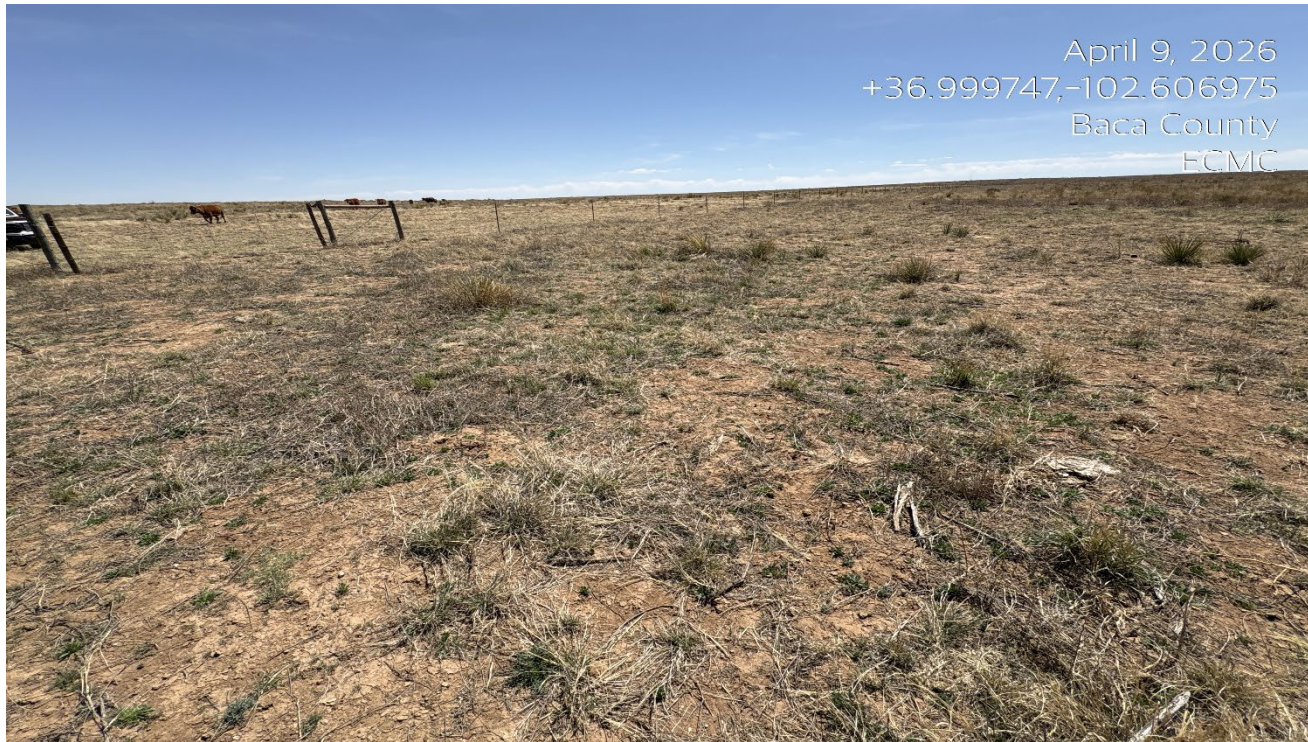
Photo 2. Center of the location facing south.

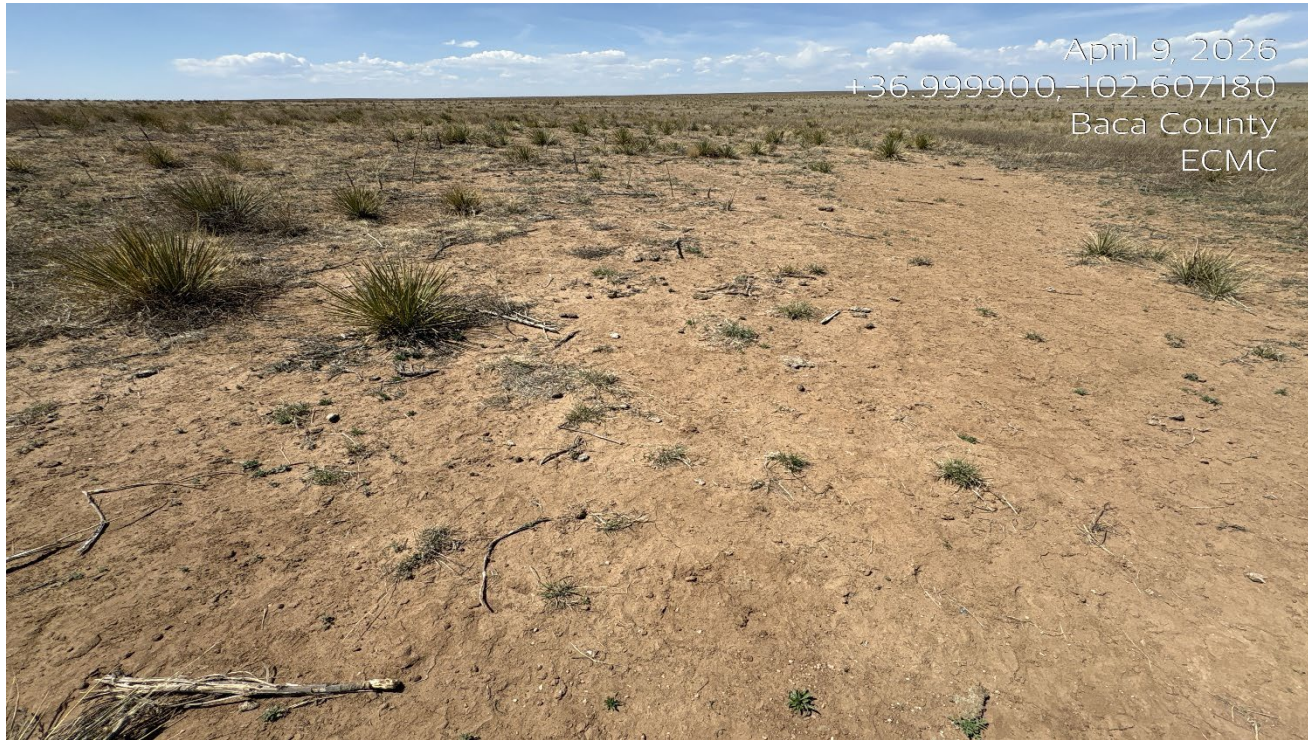
Photo 3. Facing toward the northwest side of the location. This area is slowly revegetating but could benefit from additional reseeding.

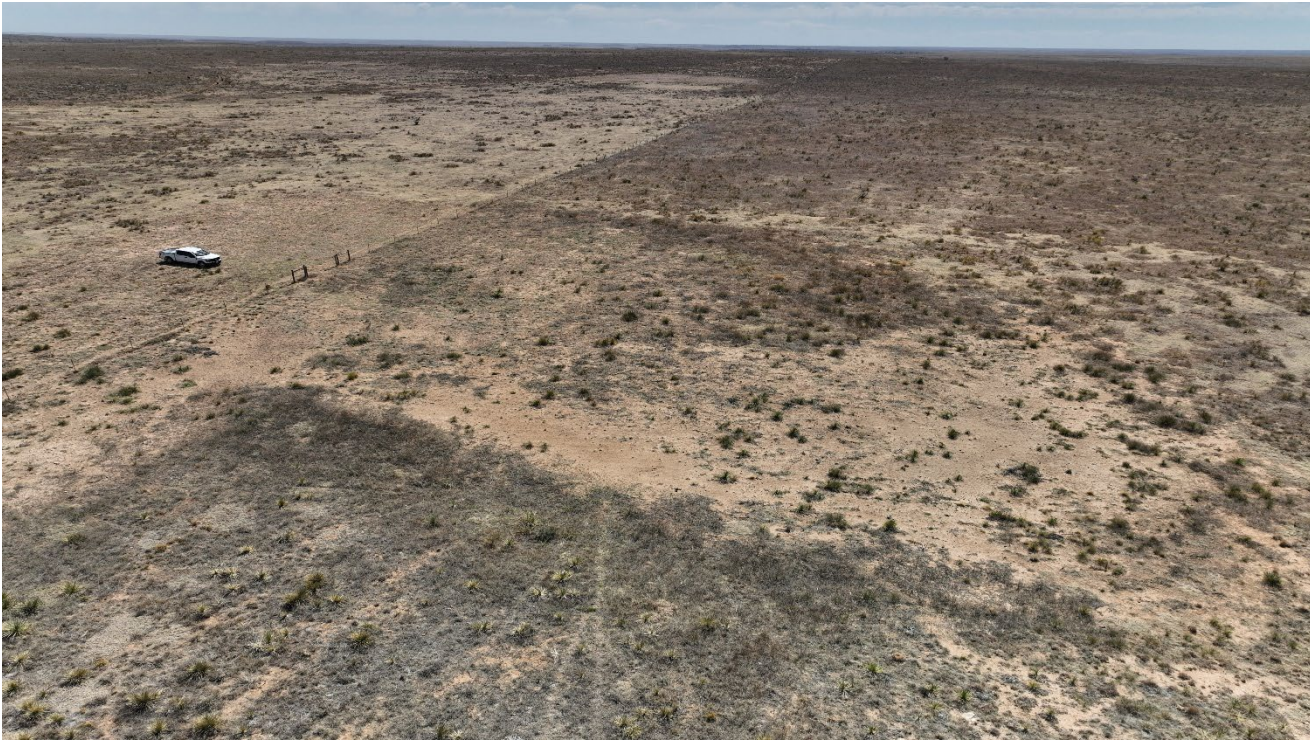
Photo 4. Drone aerial photo facing south toward the location.

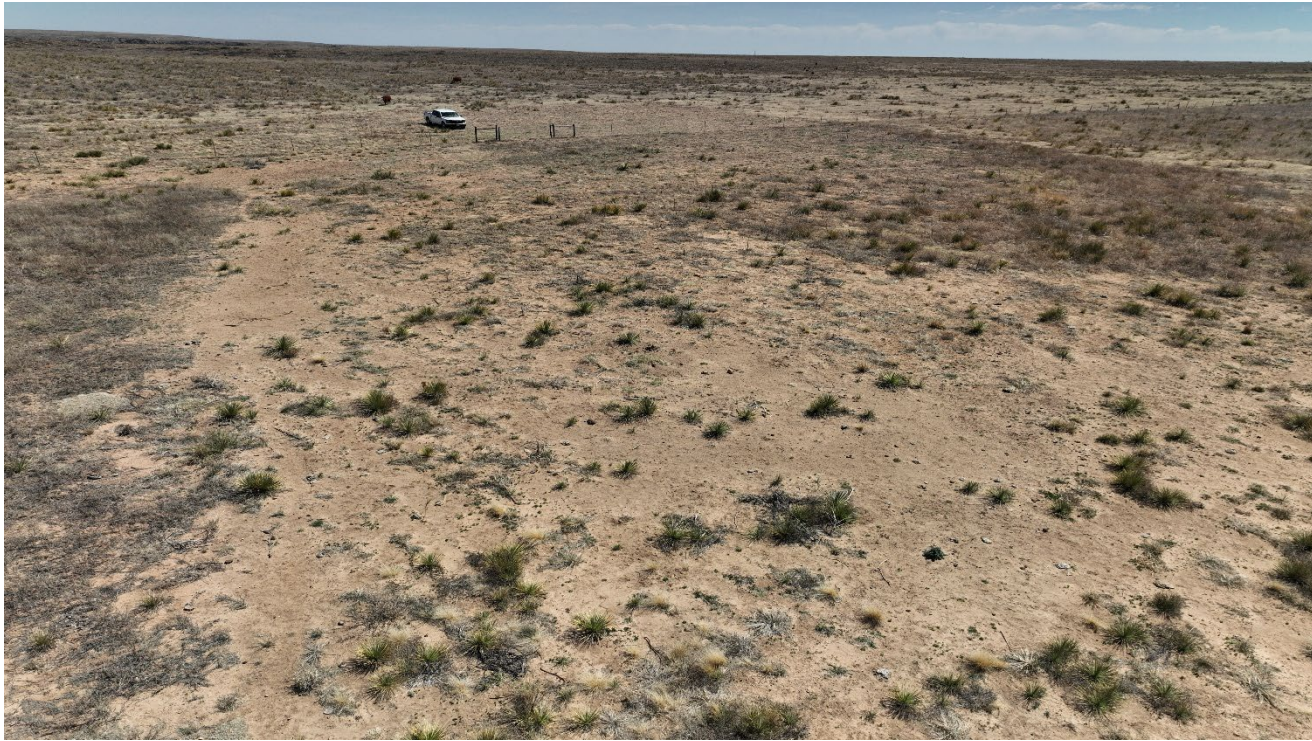
Photo 5. Drone aerial photo facing southeast at the location. This area is slowly revegetating but could benefit from additional reseeding.

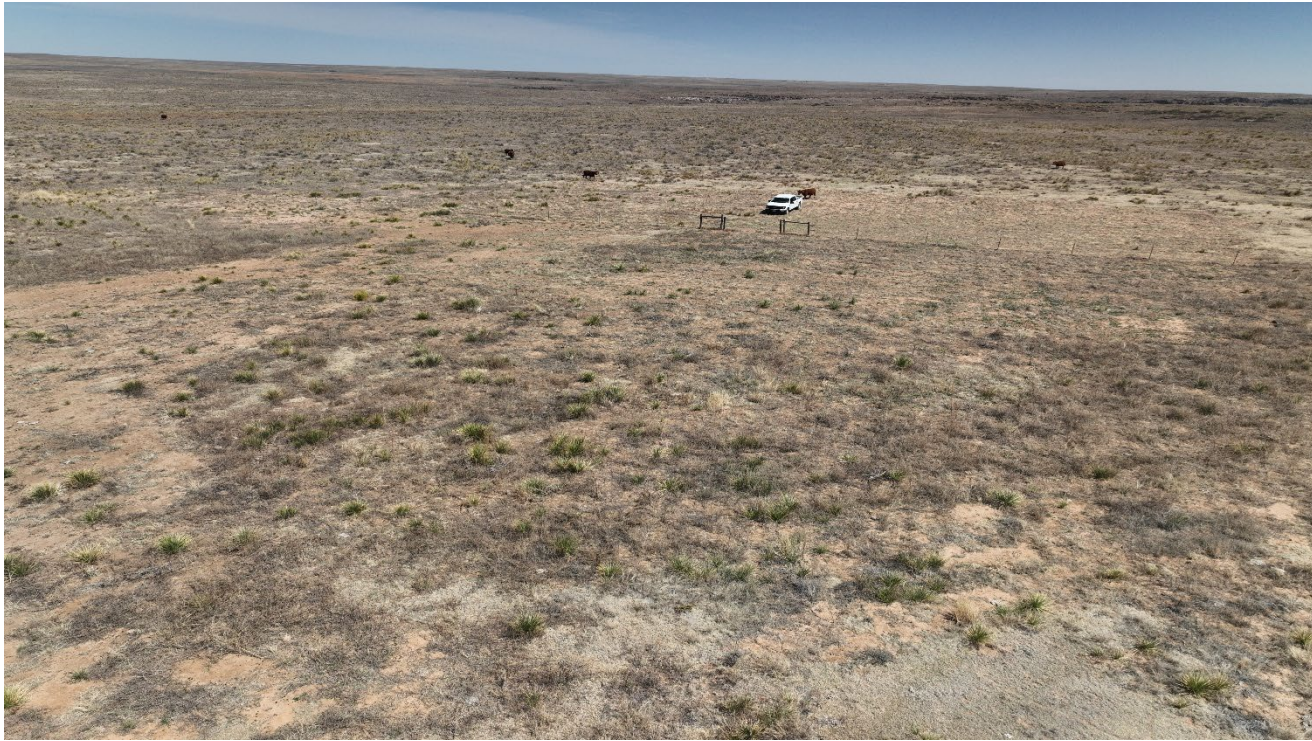
Photo 5. Drone aerial photo facing east at the location.
