Inspection Photos

API: 009-06668

Operator: JETTA OPERATING COMPANY INC

Inspection Date: 4/9/2026

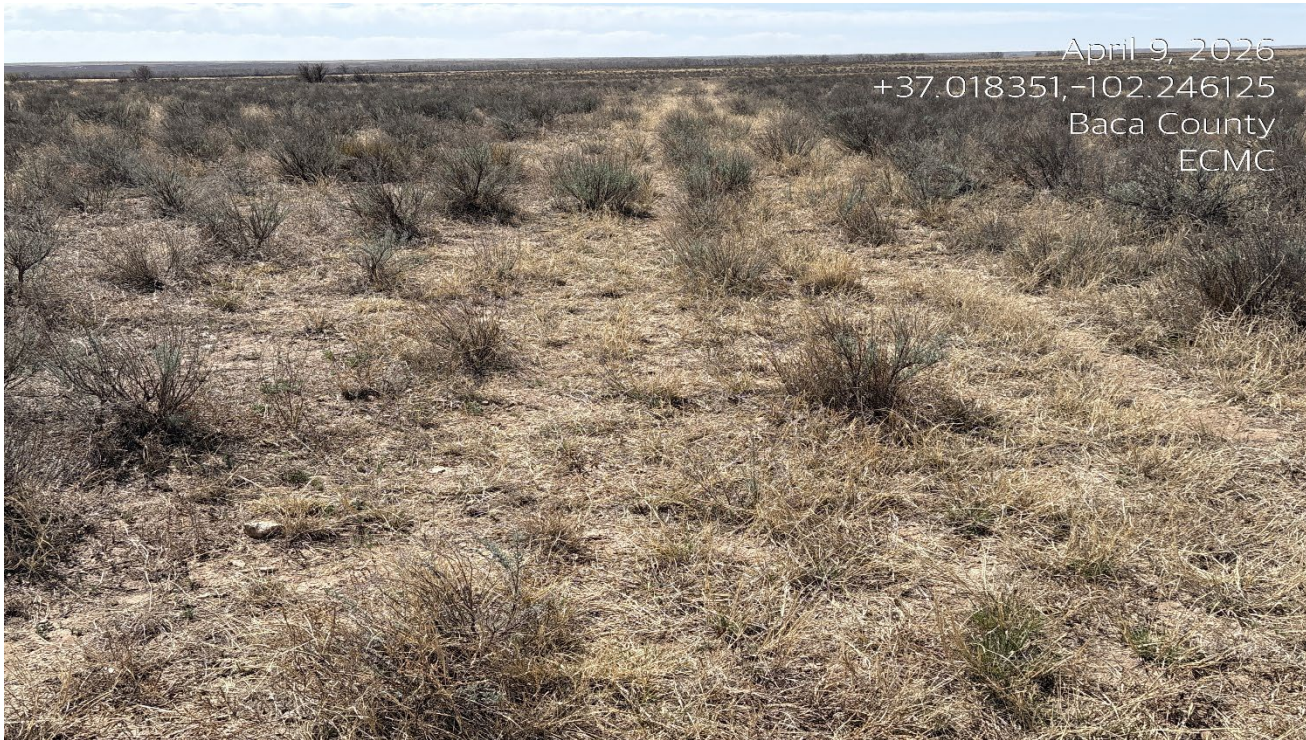
Photo 1. Facing south toward the former access road. The native vegetation has re-established along the road.

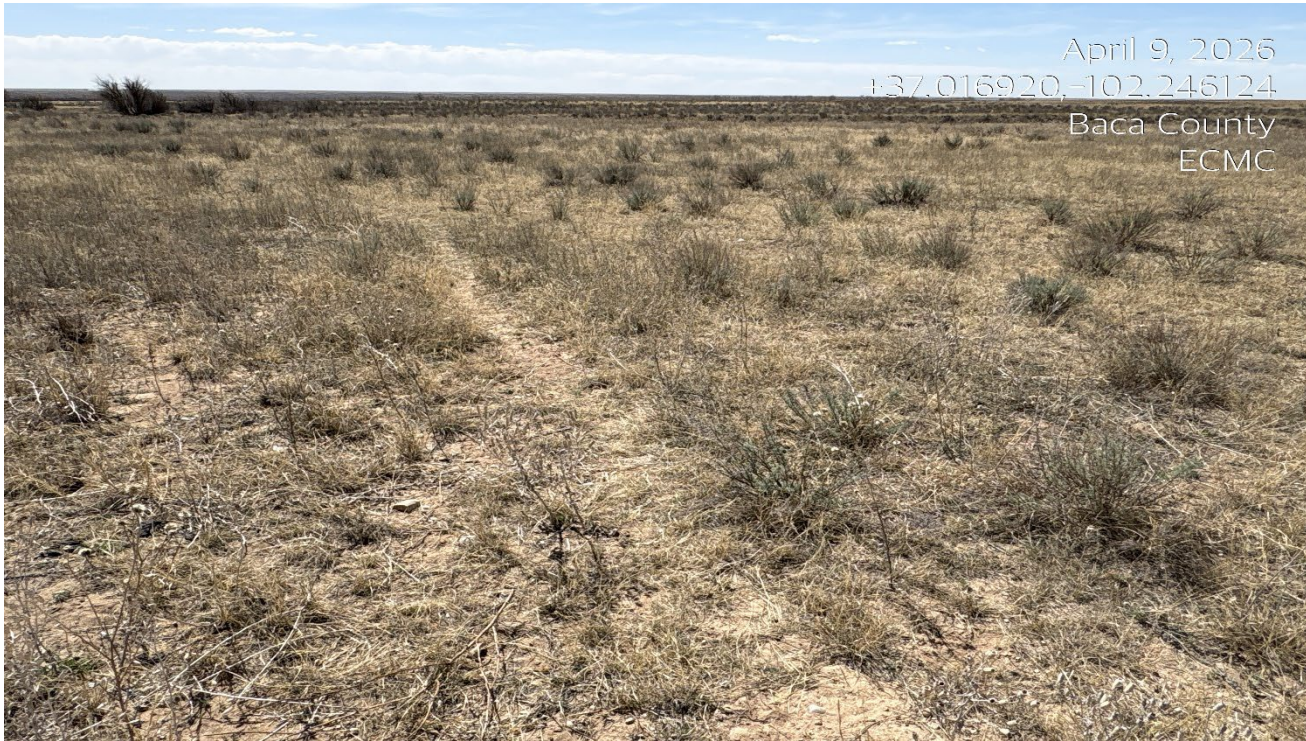
Photo 2. Facing south toward the location. The native vegetation has re-established throughout the location.

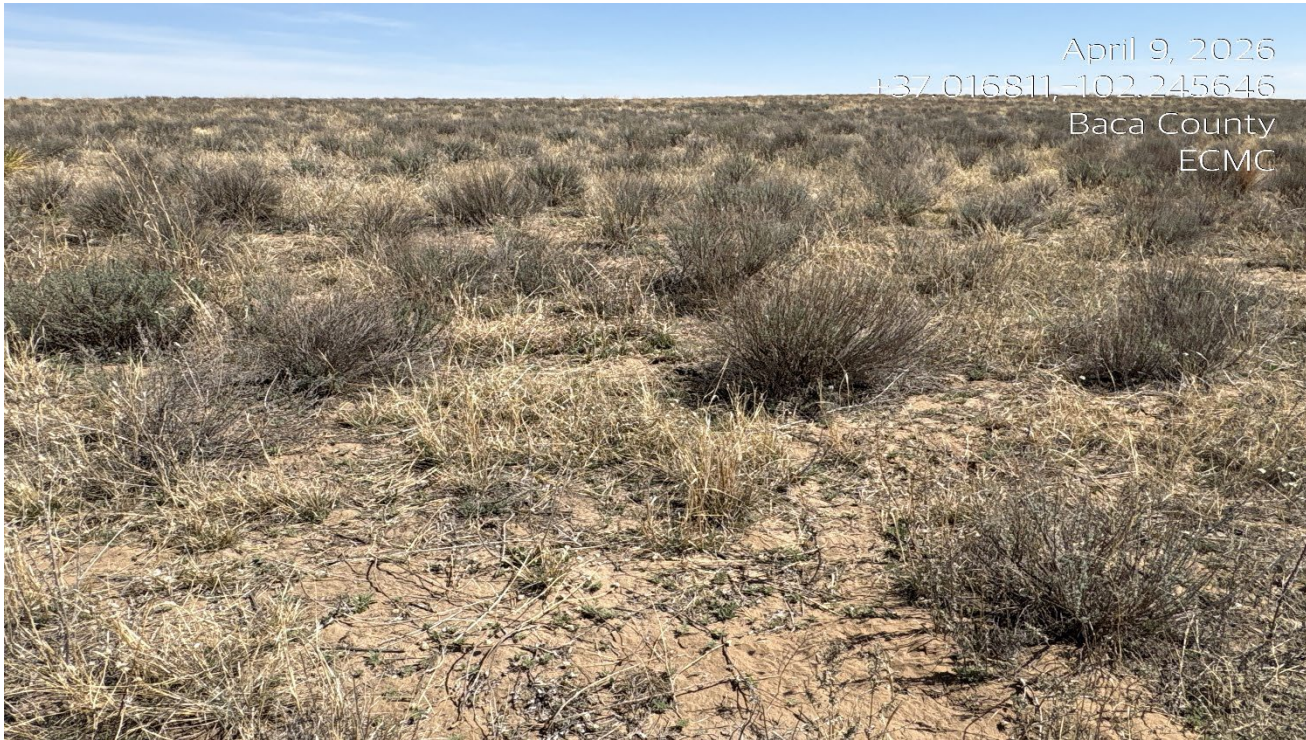
Photo 7. Facing north toward the surrounding reference area which consists of native Sand dropseed, Sand sage, Prairie sandreed, ect.
