Inspection Photos

API: 009-06669

Operator: JETTA OPERATING COMPANY INC

Inspection Date: 4/9/2026

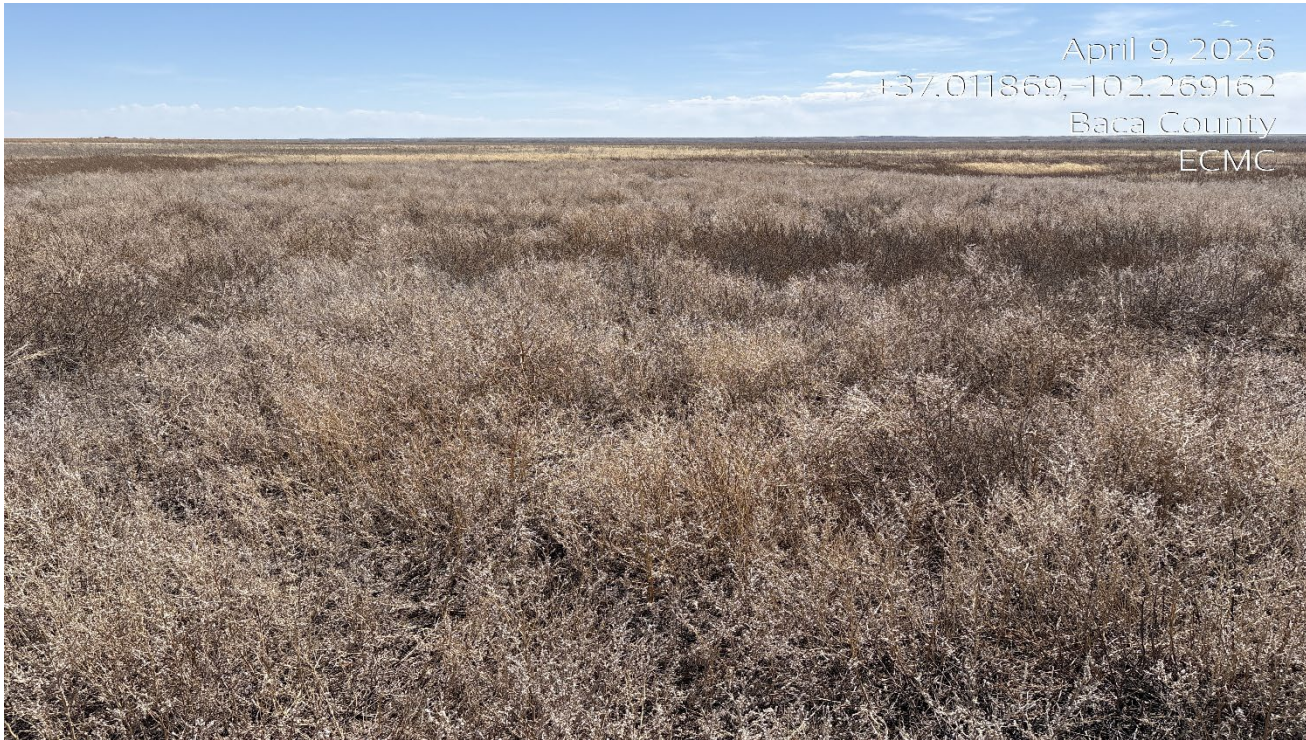
Photo 1. Center of the location facing east. The location consists of tall undesirable weeds (Kochia, Russian thistle).

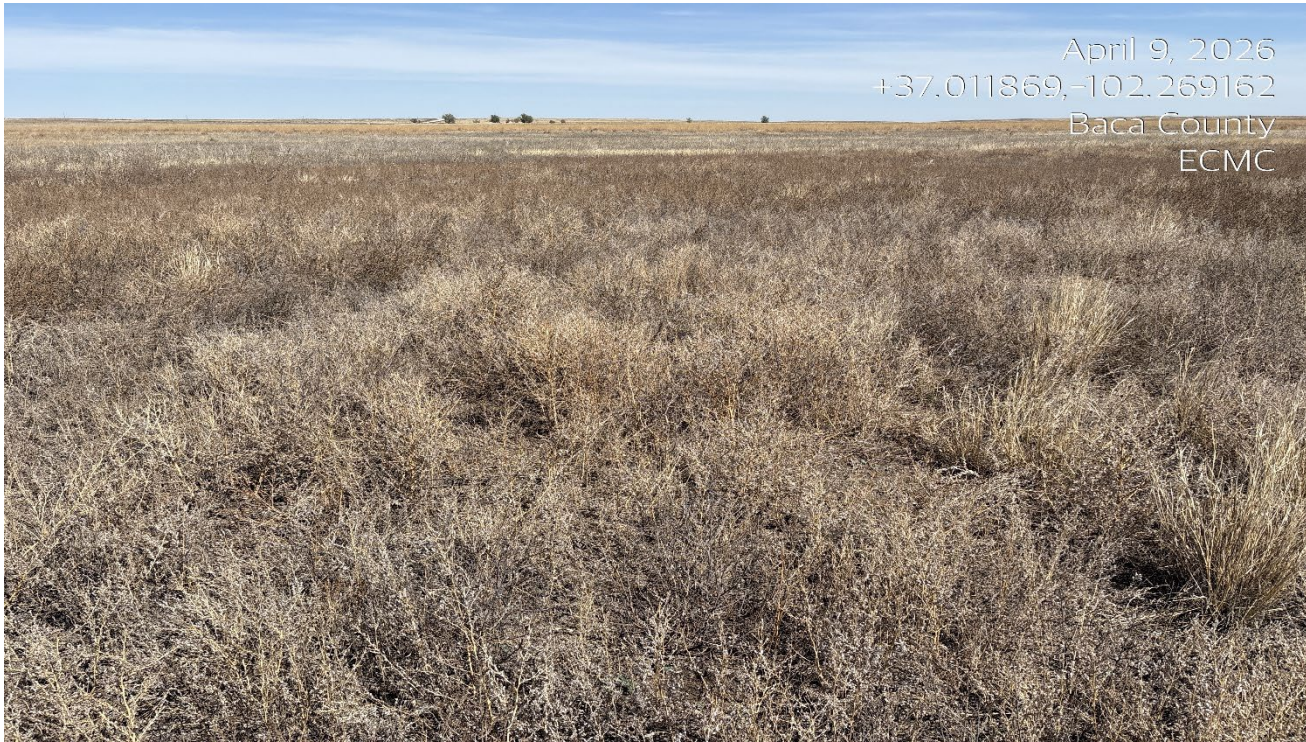
Photo 2. Center of the location facing north. The location consists of tall undesirable weeds (Kochia, Russian thistle).

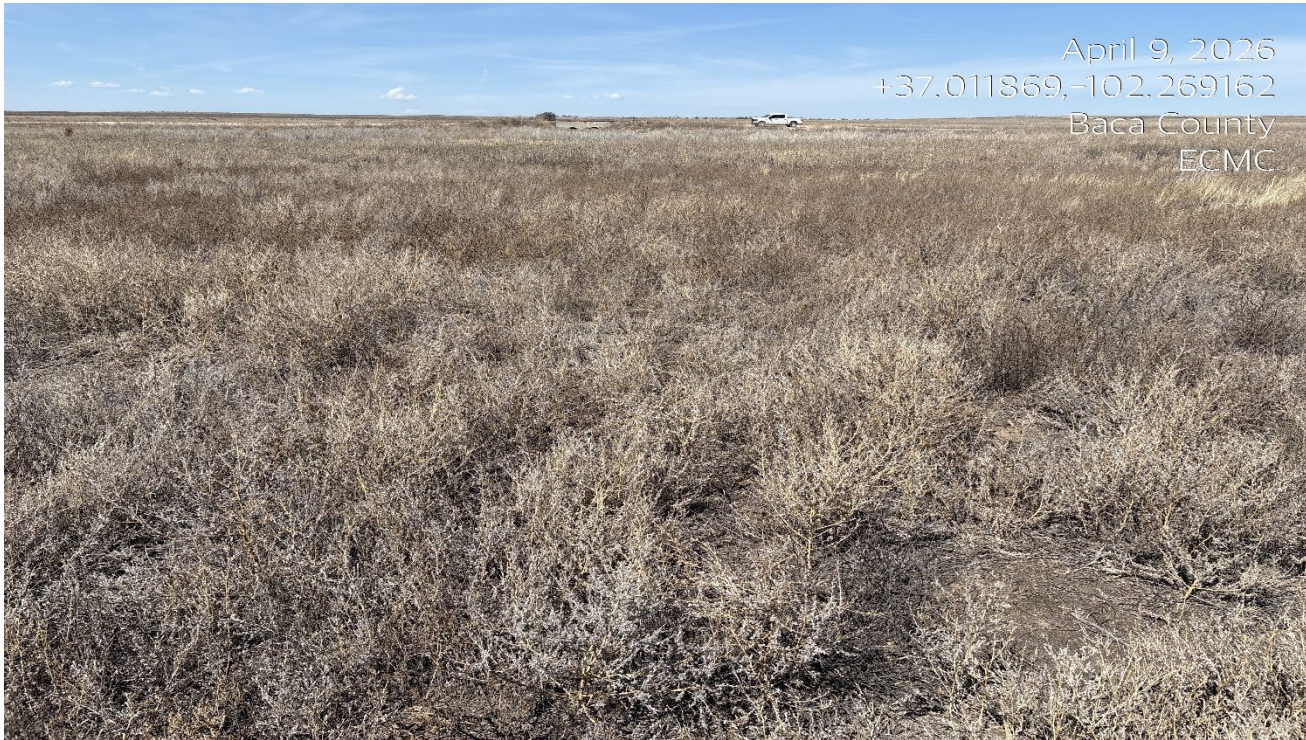
Photo 3. Center of the location facing west. The location consists of tall undesirable weeds (Kochia, Russian thistle).

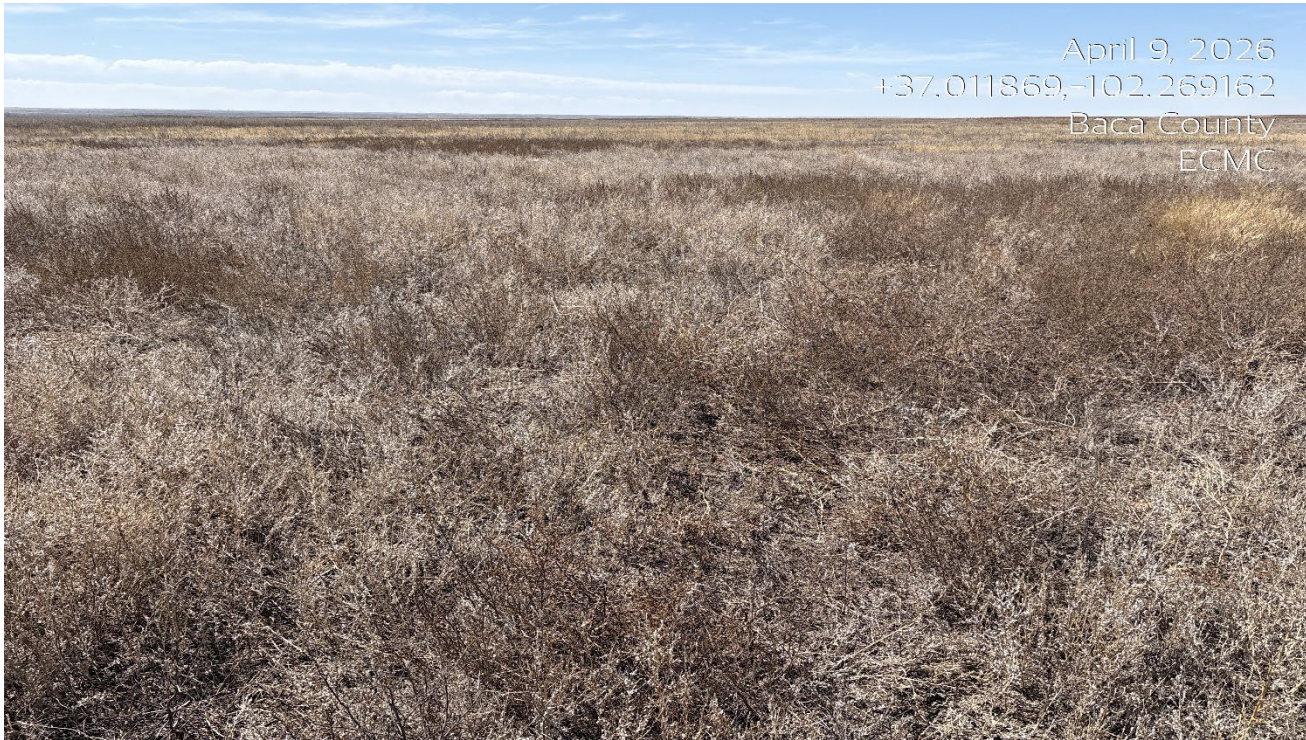
Photo 4. Center of the location facing south. The location consists of tall undesirable weeds (Kochia, Russian thistle).

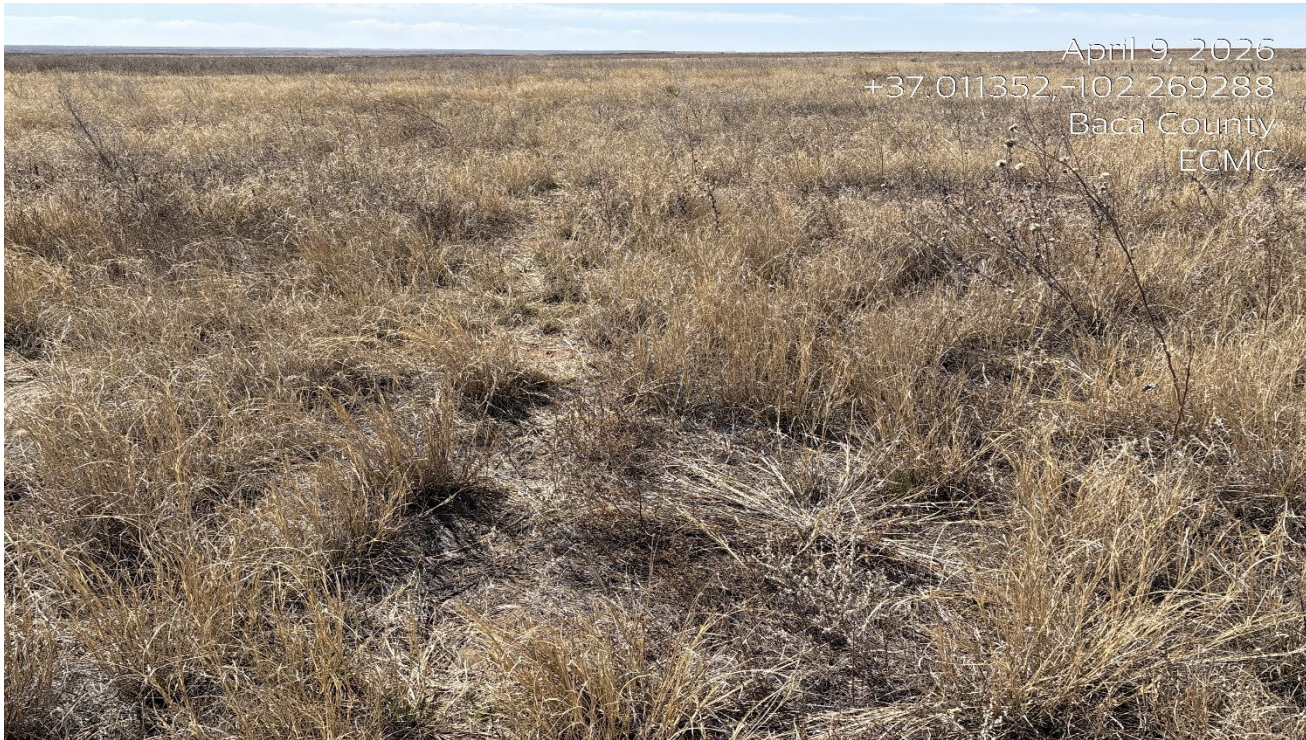
Photo 5. Facing south outside of the location toward the surrounding CRP pasture which consists of native Sand drop seed, Blue grama, Big bluestem grasses.

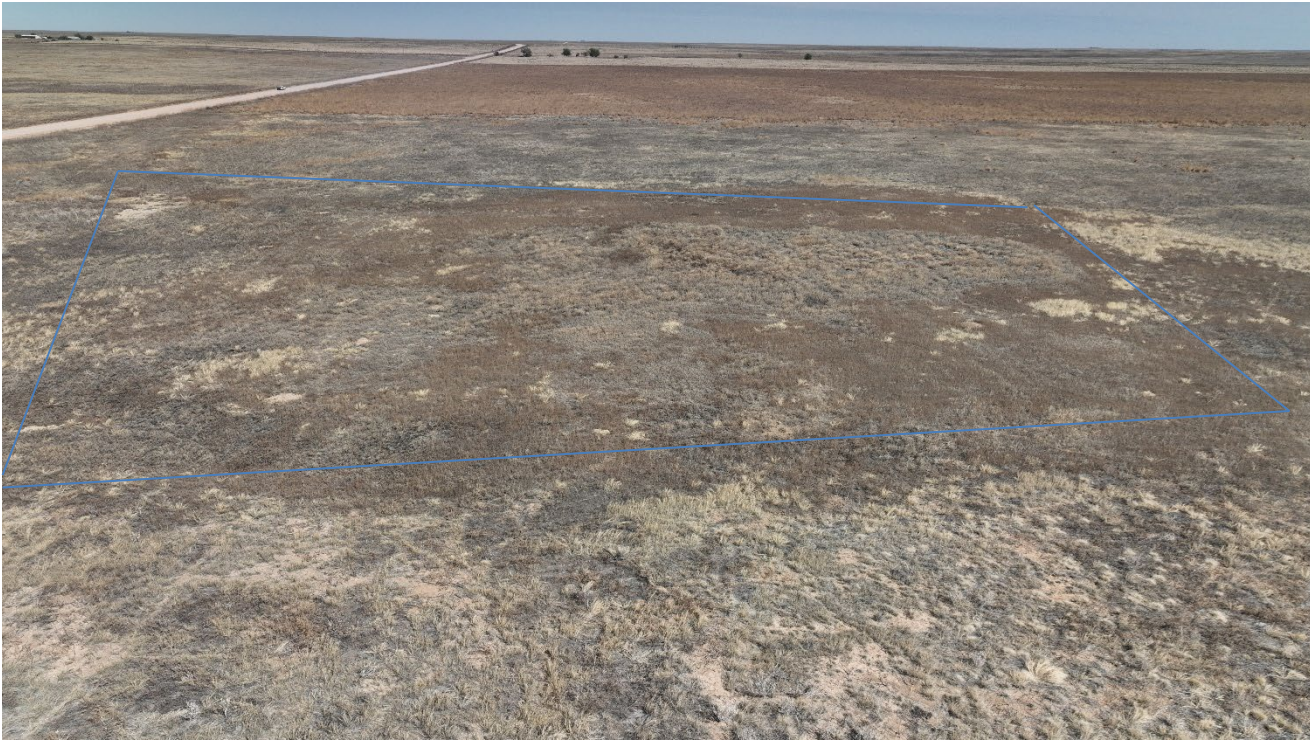
Photo 6. Drone aerial photo facing north toward the location. The darker shaded vegetation inside the blue square is undesirable weeds throughout the location. Outside of the location (blue square) is native CRP grassland.

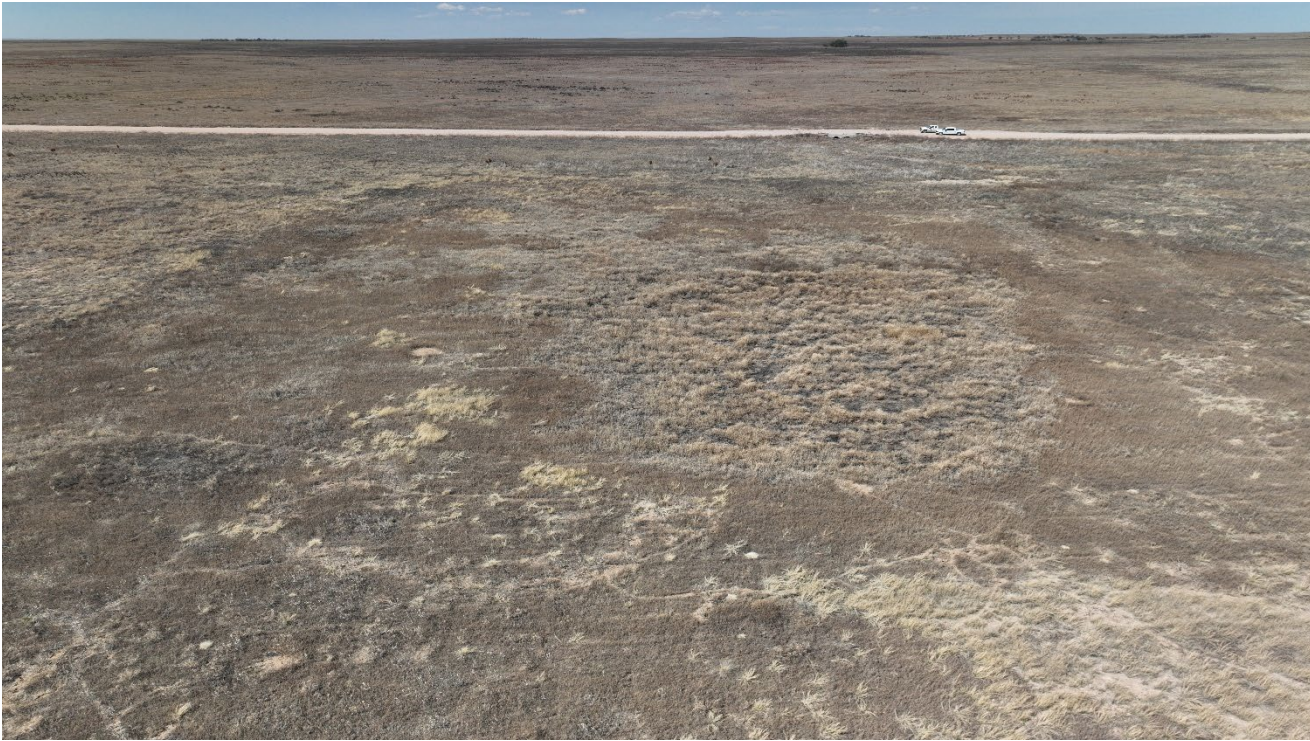
Photo 7. Drone aerial photo facing west toward the location. The darker shaded vegetation inside is undesirable weeds throughout the location.

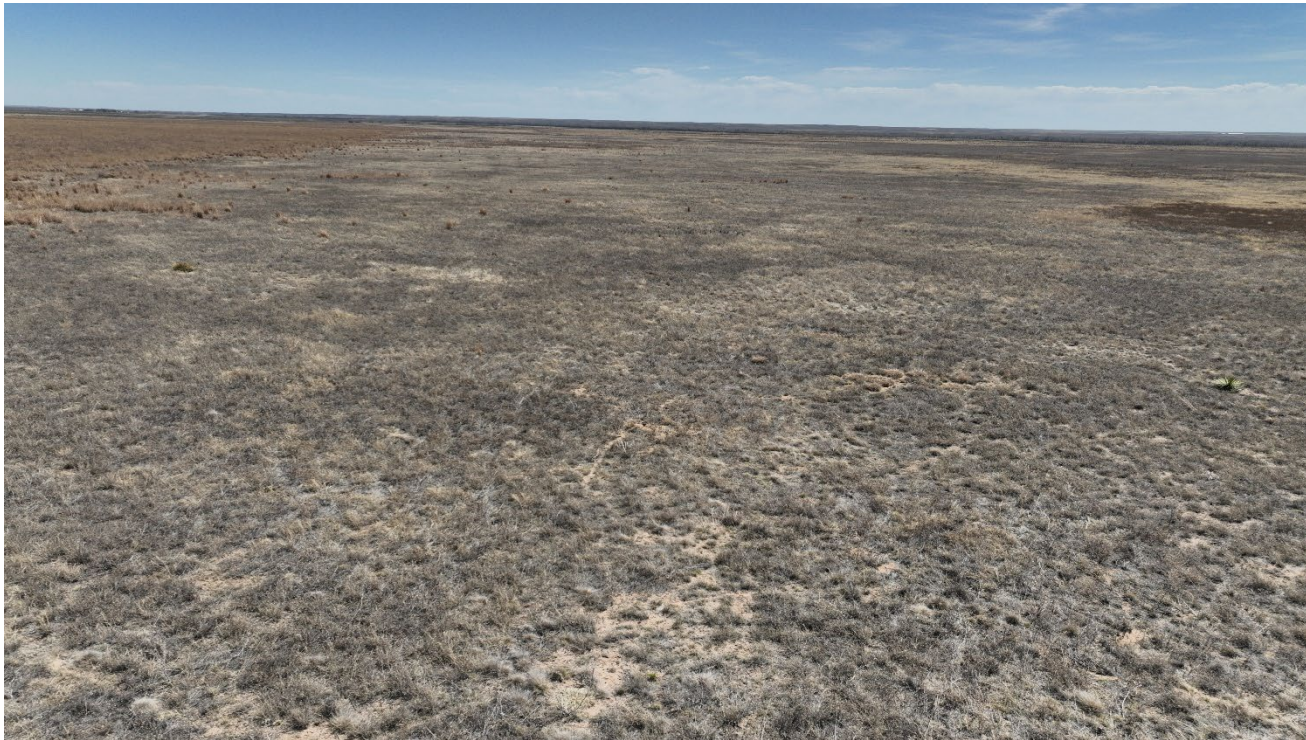
Photo 8. Drone aerial photo facing east outside of the location toward the surrounding CRP pasture which consists of native Sand drop seed, Blue grama, Big bluestem grasses.
