Final Reclamation Inspection

Operator: PDC ENERGY INC

Location ID: 330514

Inspection Photos
Location Name: SKURICH ROTHE-65N63W 6NENW
Location ID: 330514

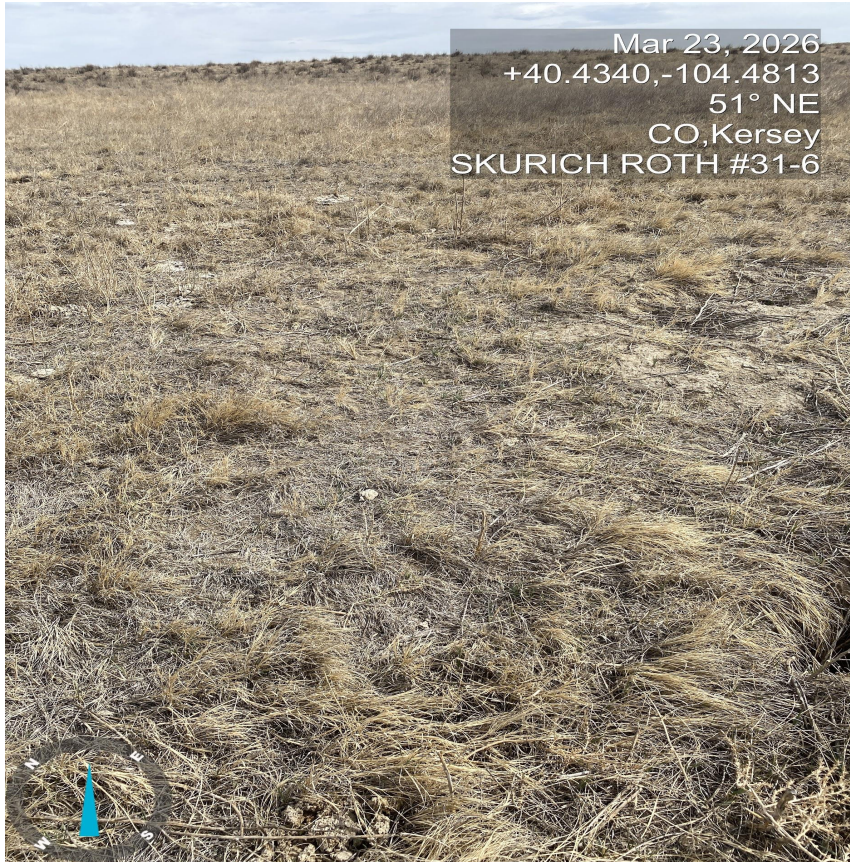
Photo 3. Photo taken north of main lease road facing northeast, Showing reference are for road.

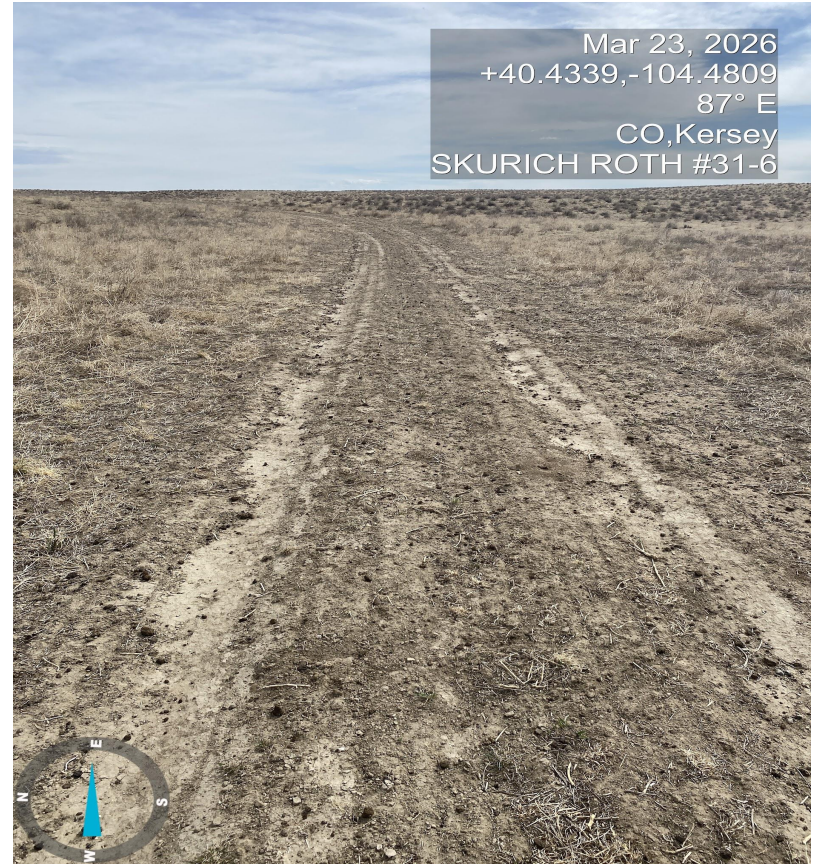
Photo 4. Photo taken from the main lease going west to east, facing northeast, showing bare soil. Some drill seeding was performed, and manure was spread on the main lease road. The majority of the road is comprised of bare soil, and more work is needed to meet final reclamation standards.

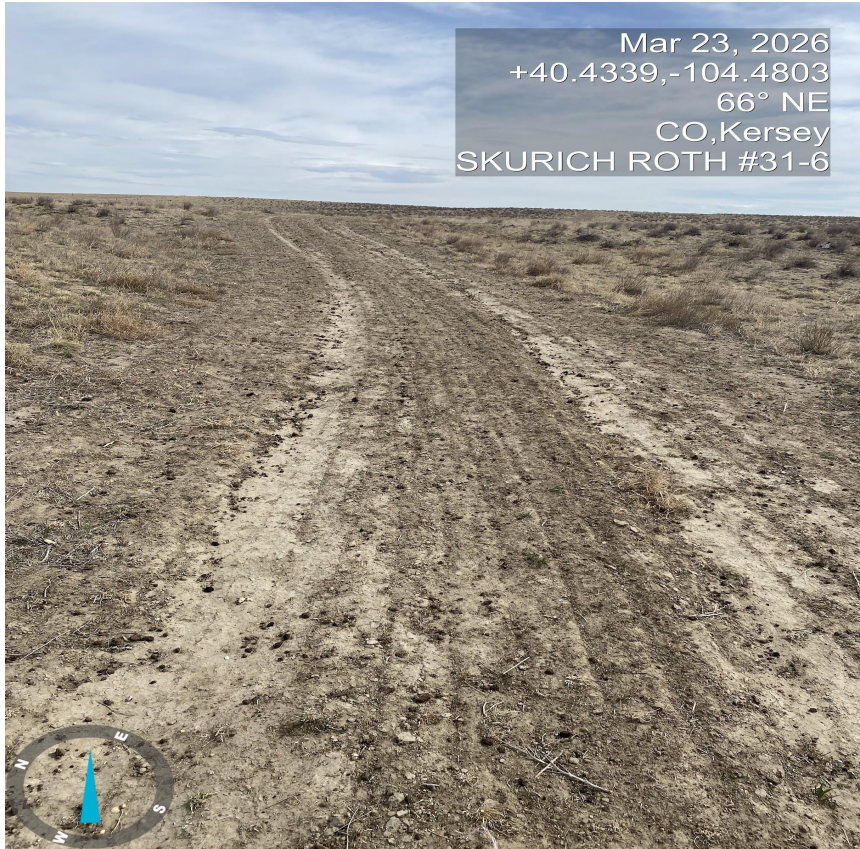
Photo 5. Photo taken from the main lease going west to east, facing northeast. See comment under photo 4.

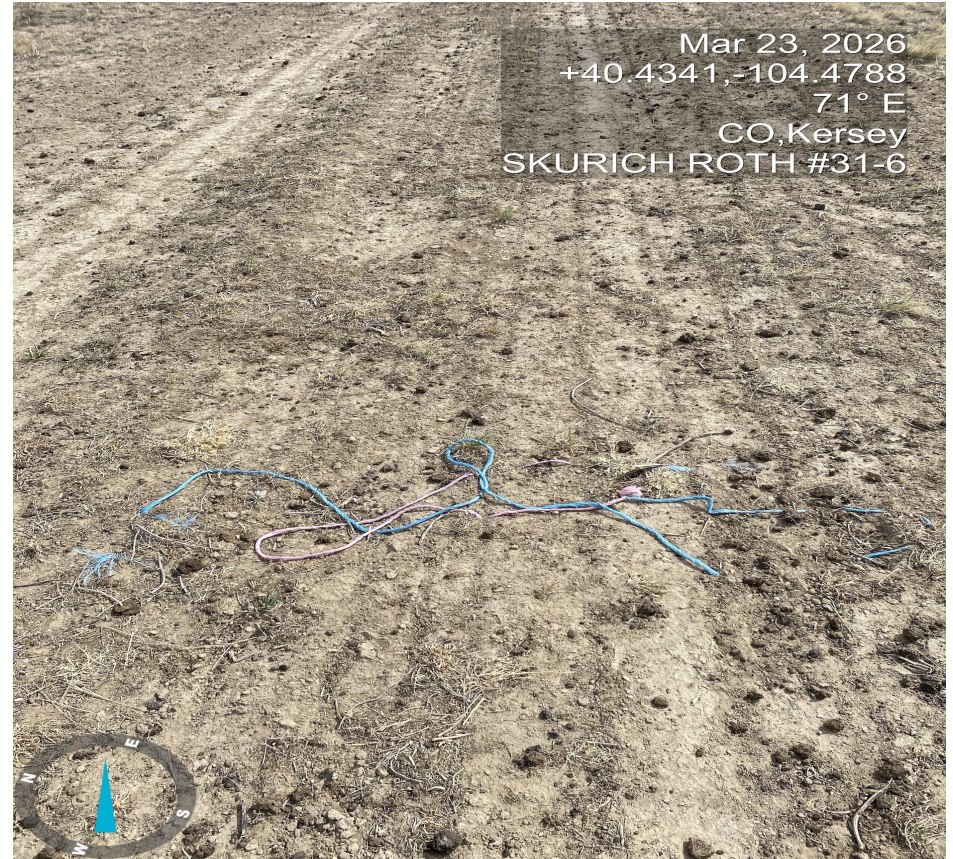
Photo 6. Photo taken from the main lease going west to east. See comment under photo 4. Baling twine from reclamation activities was found throughout the access road.

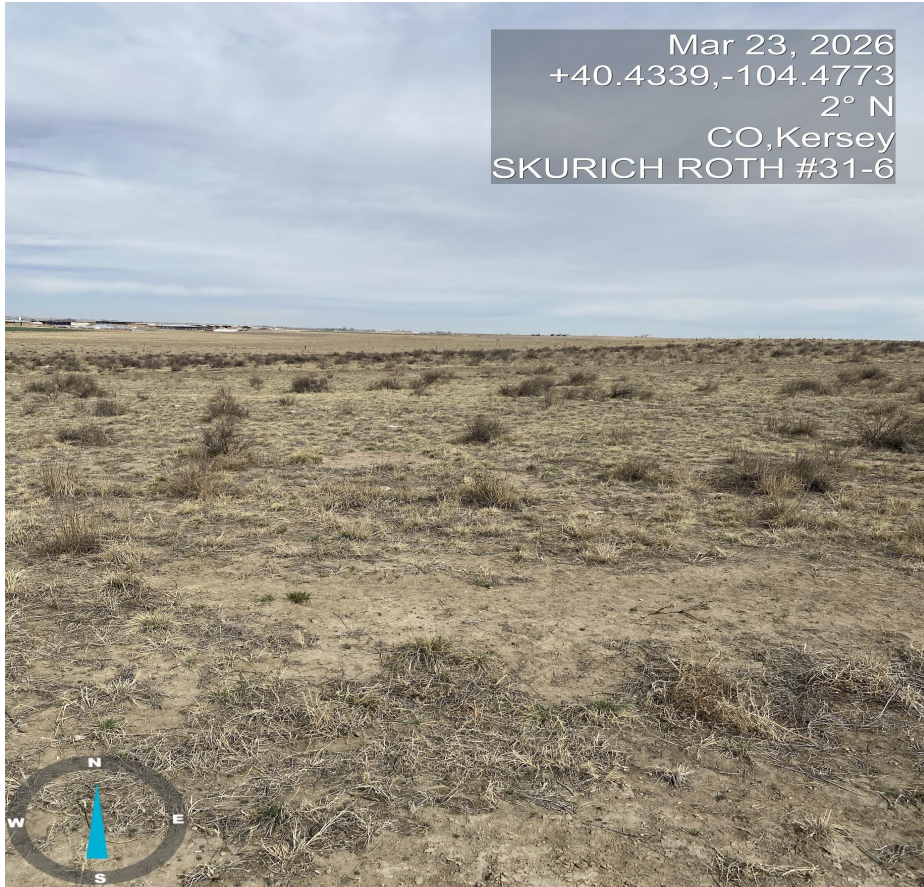
Photo 7. Photo taken from location facing north, showing growth of some desirable grass species as well as bare soil present on disturbance area.

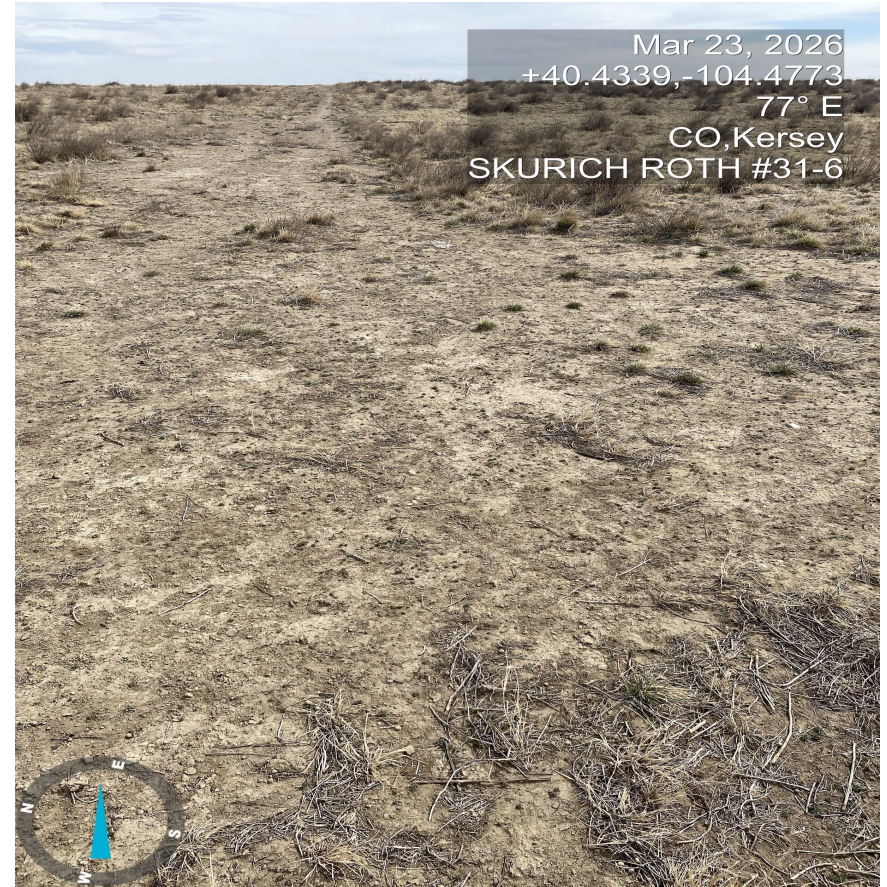
Photo 8. Photo taken from the location facing east showing bare soil on the location and the location access road.

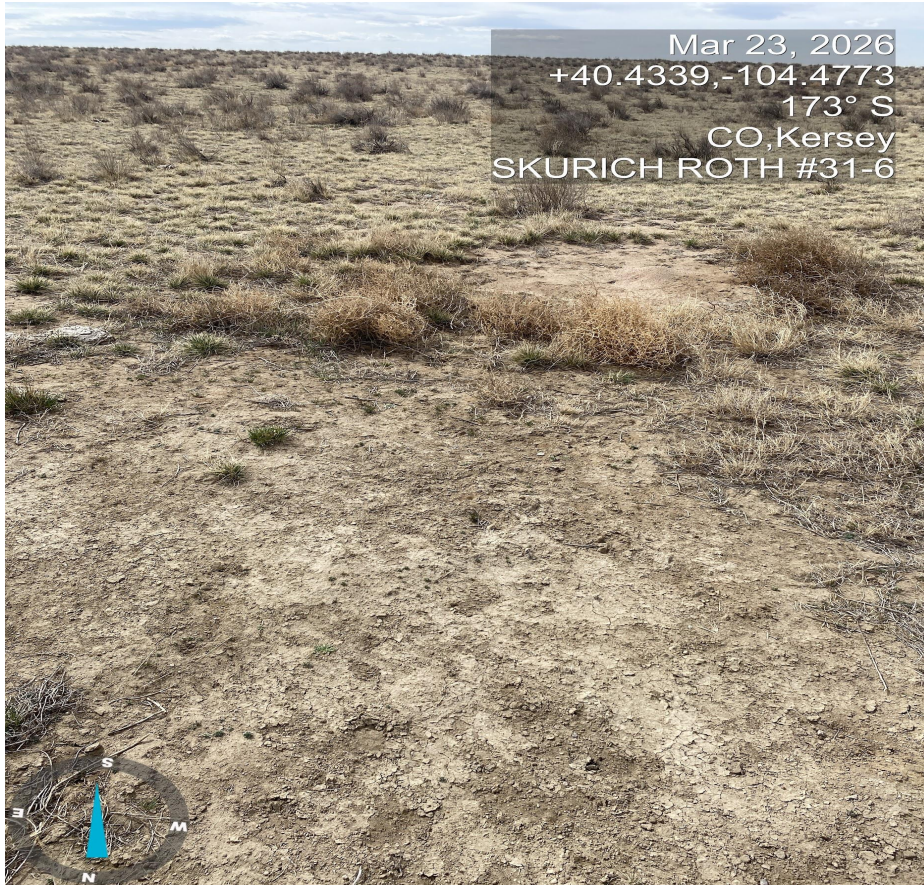
Photo 9. Photo taken from the location, facing south, showing bare soil in the foreground; in the mid-ground, a small number of undesirable weed species; and in the background, desirable vegetation growth.

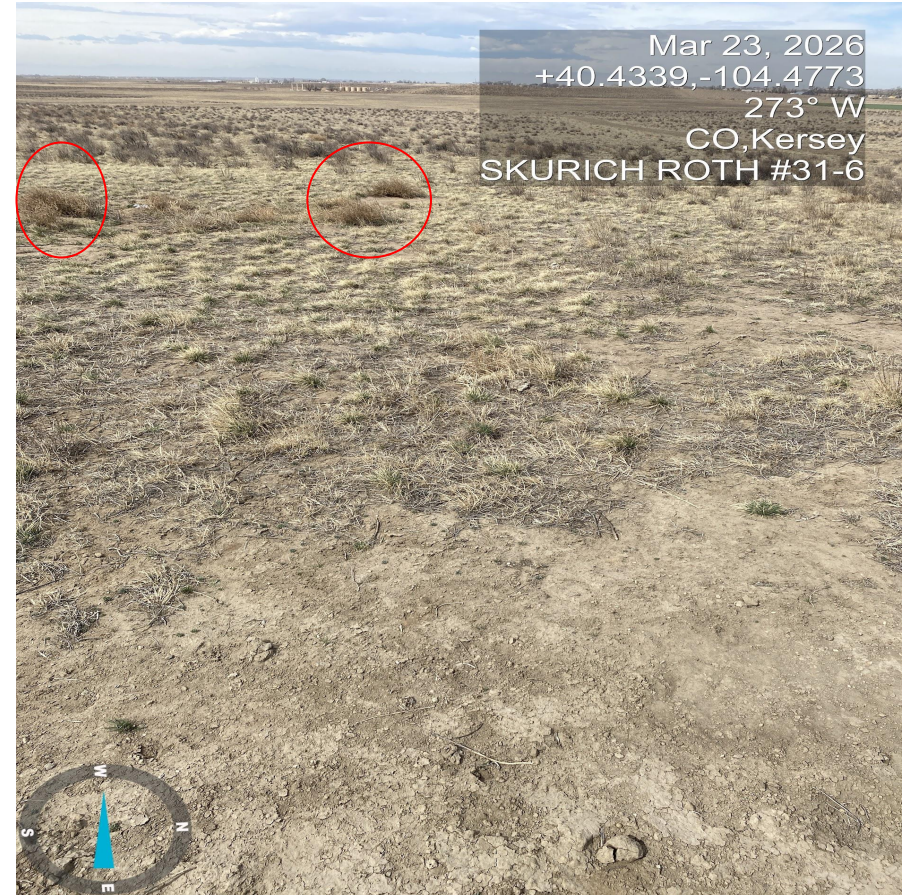
Photo 10. Photo taken from the location facing west shows bare soil as well as some desirable grass species growing. Some undesirable weeds are present, highlighted in the red circle.

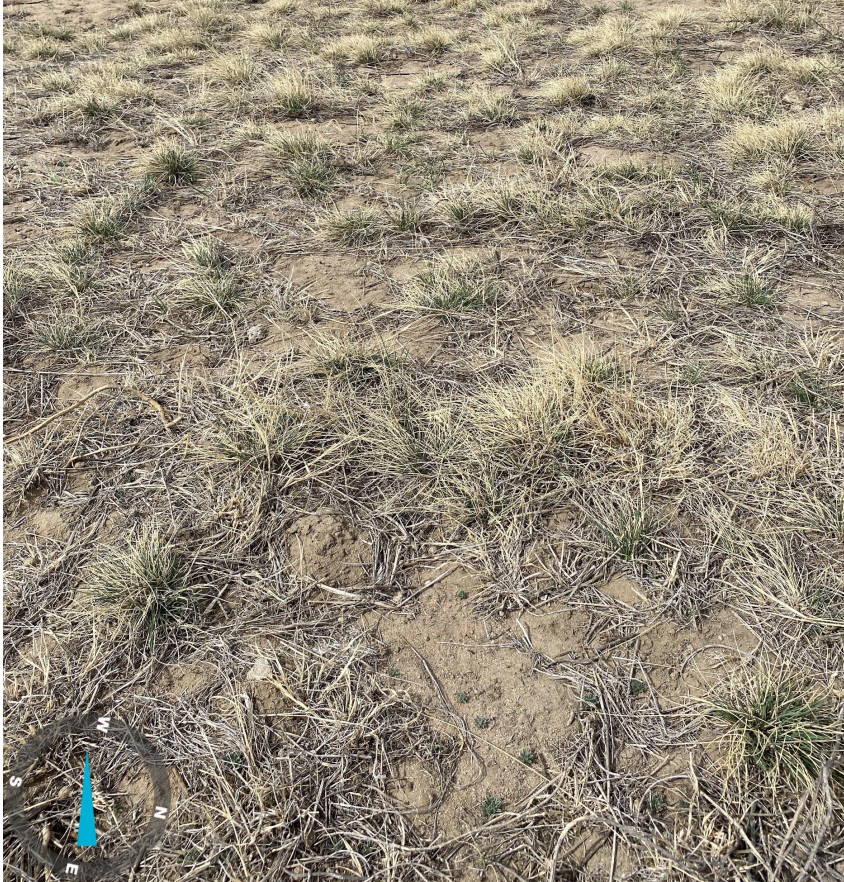
Photo 11. Photo taken from the western edge of the disturbance area facing west, showing the reference area with desirable grass species growing.

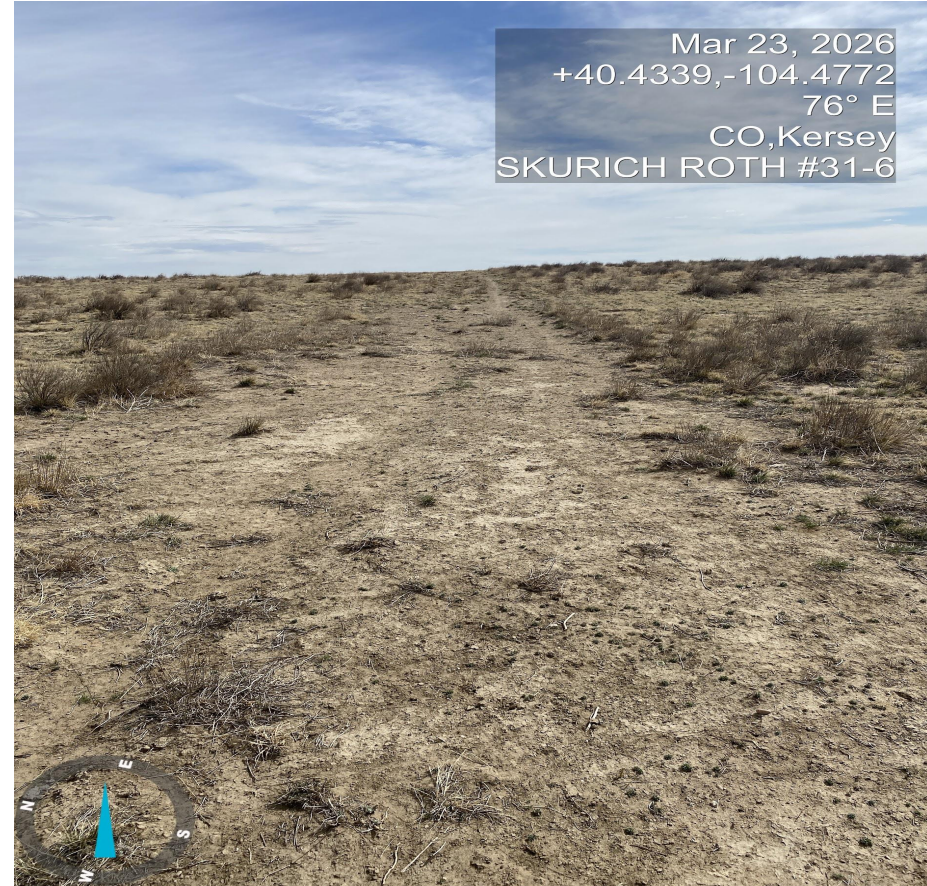
Photo 12. Photo taken from the location access road, facing east, showing that most of the road is bare soil.

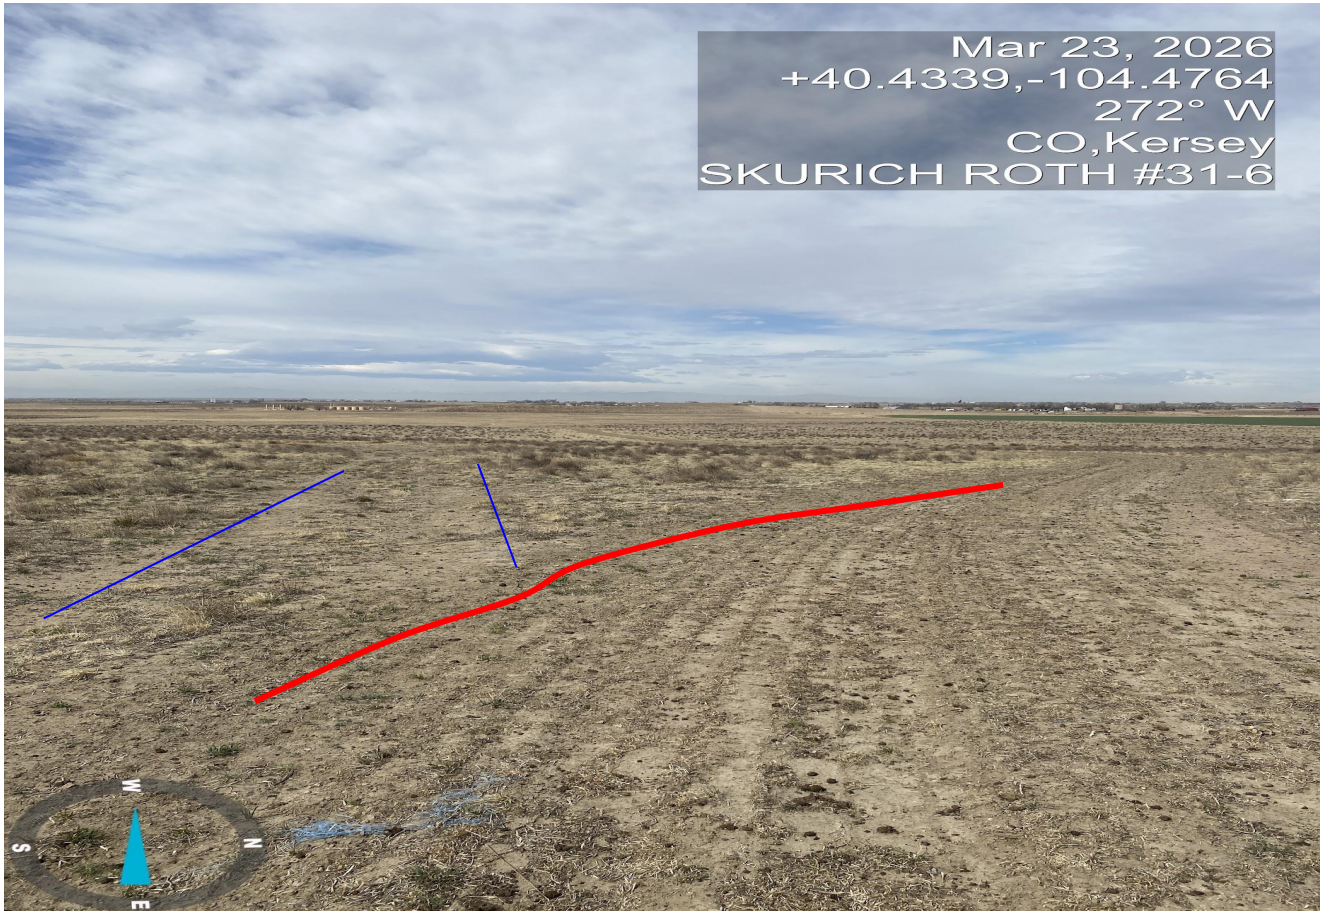
Photo 13. Photo taken at the point where the secondary access road intersects the main lease road. To the right of the red line is the main lease road and the location access road is outlined by the two blue lines. Both roads have significant bare soil, and more work is needed to meet final reclamation standards. Work was recently completed on the main lease road but not on access road to well location.
