# Final Reclamation Inspection

March 23, 2026

Operator: PDC ENERGY INC

Location ID: 323520

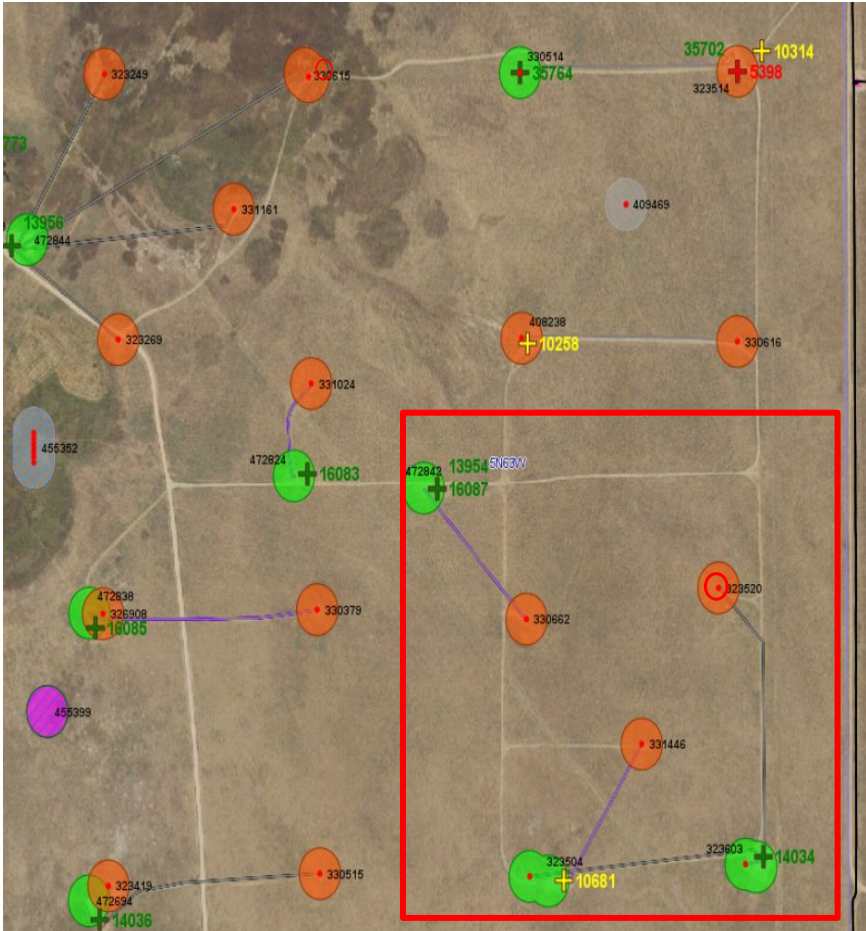
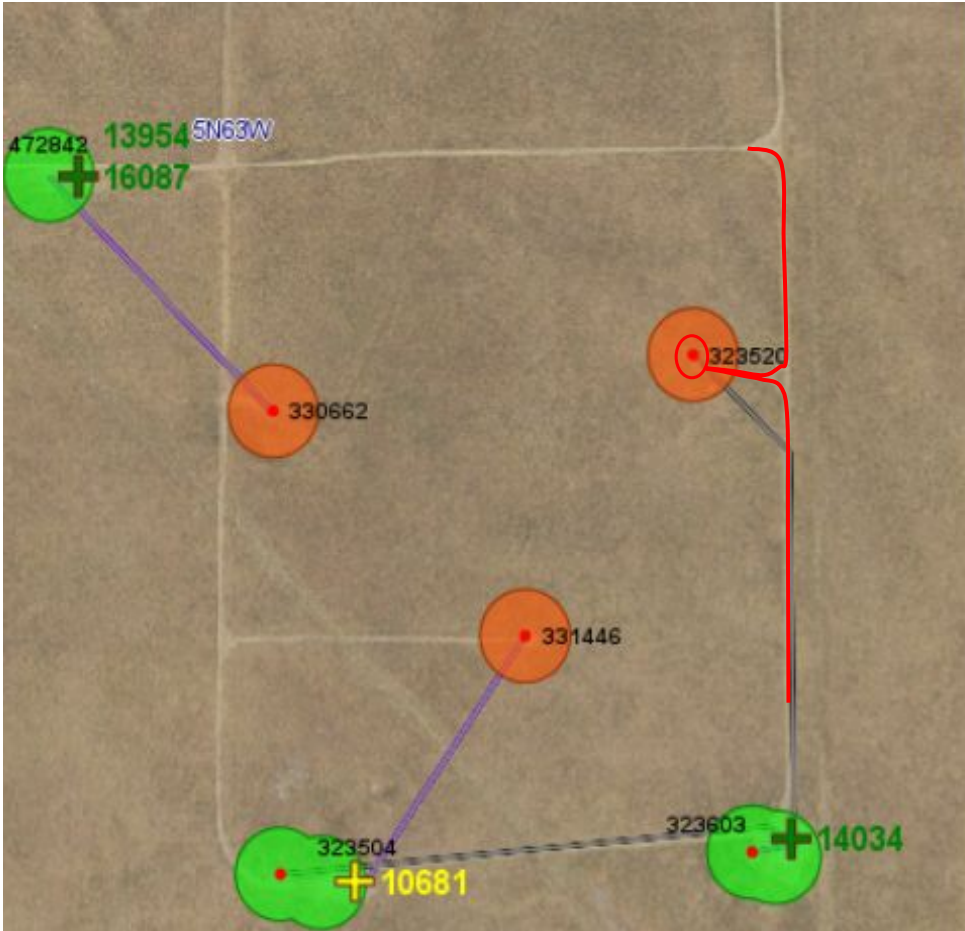
**Photo 1 & 2:** Satellite image of the location showing an overview of the area; the access road and well location are highlighted with a red circle and line.

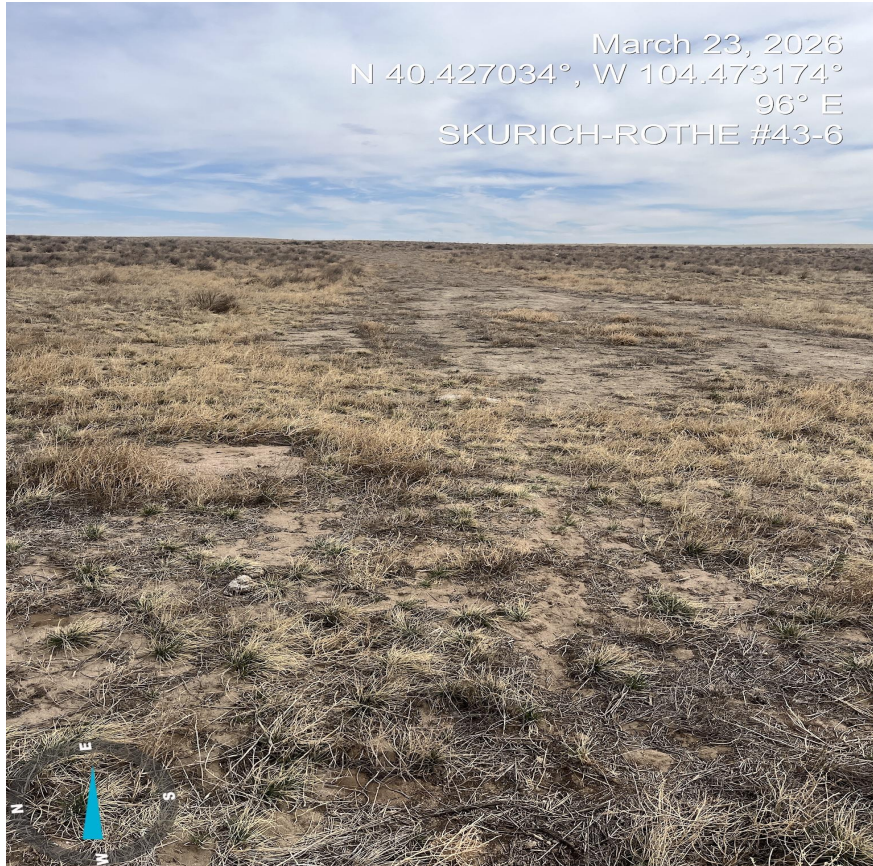
**Photo 3.** Photo taken from the disturbance area facing east showing the establishment of desirable vegetation in the disturbance area. Bare soil is present where the well was previously located and on the access road.

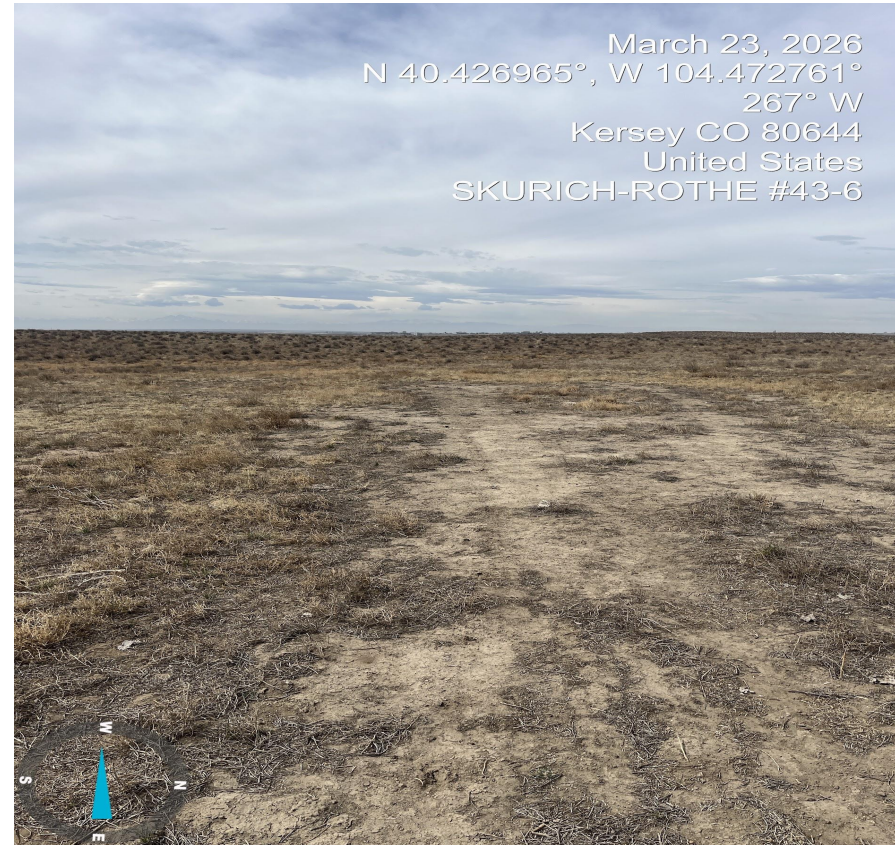
**Photo 4.** Photo taken from the disturbance area facing west, see comment under photo 3.

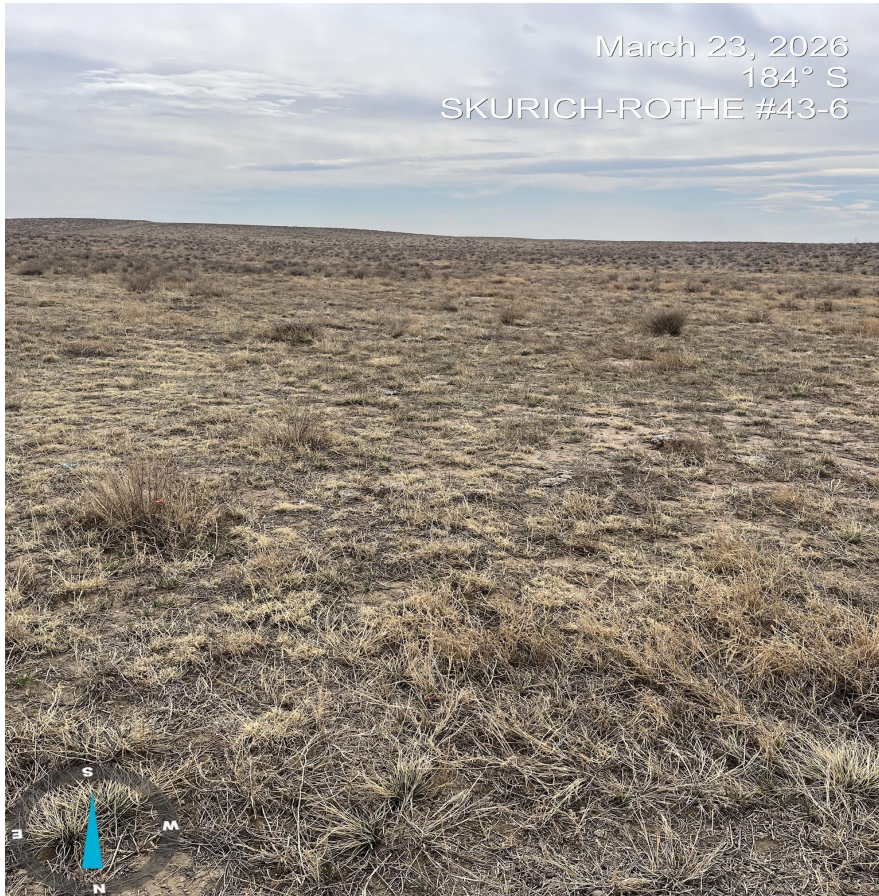
**Photo 5.** Photo taken from the disturbance area facing south showing the establishment of desirable vegetation.

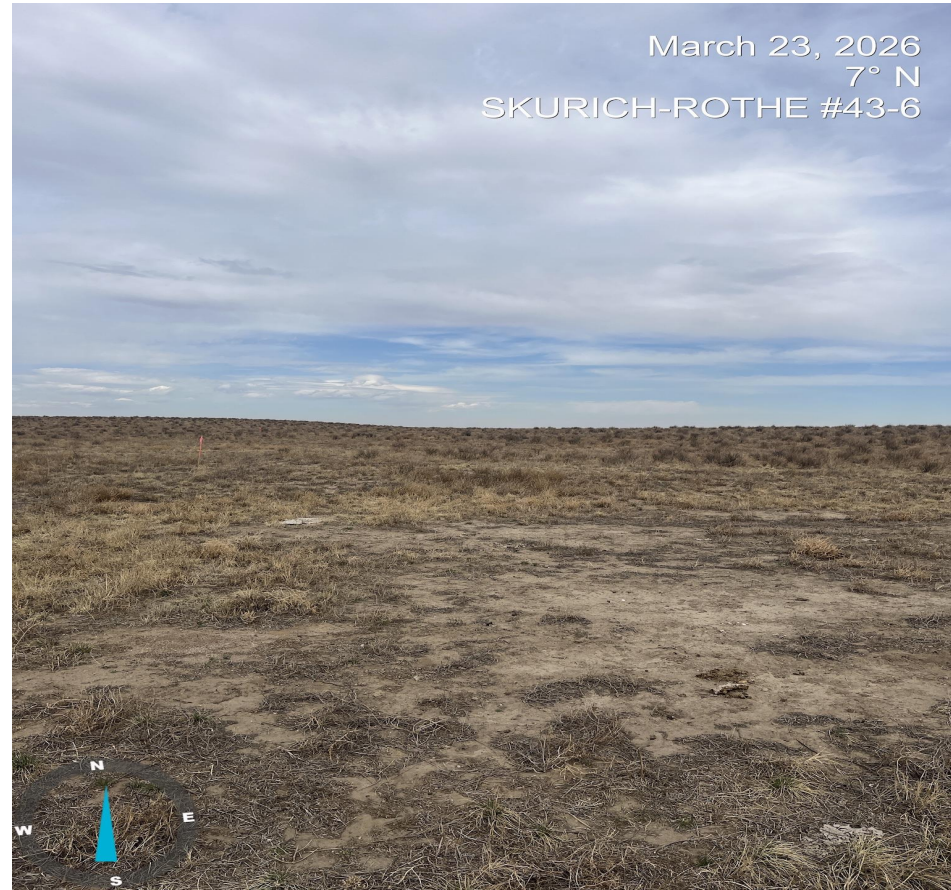
**Photo 6.** Photo taken from the disturbance area facing north, showing the establishment of some desirable vegetation and bare soil where the well was located.

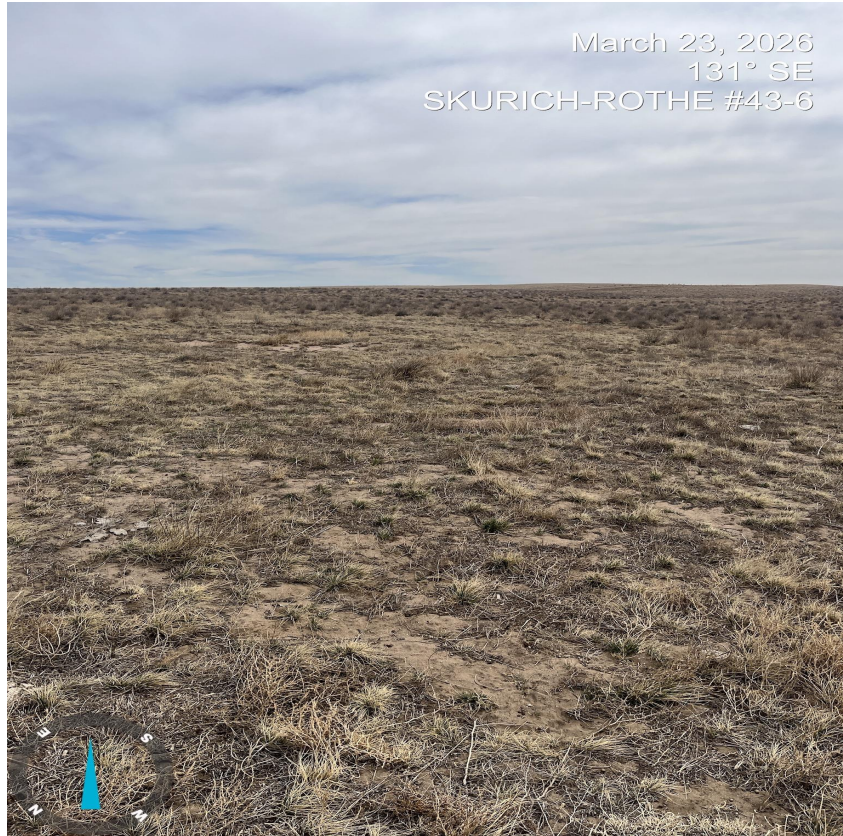
**Photo 7.** Photo taken from the disturbance area facing southeast, showing establishment of desirable vegetation.

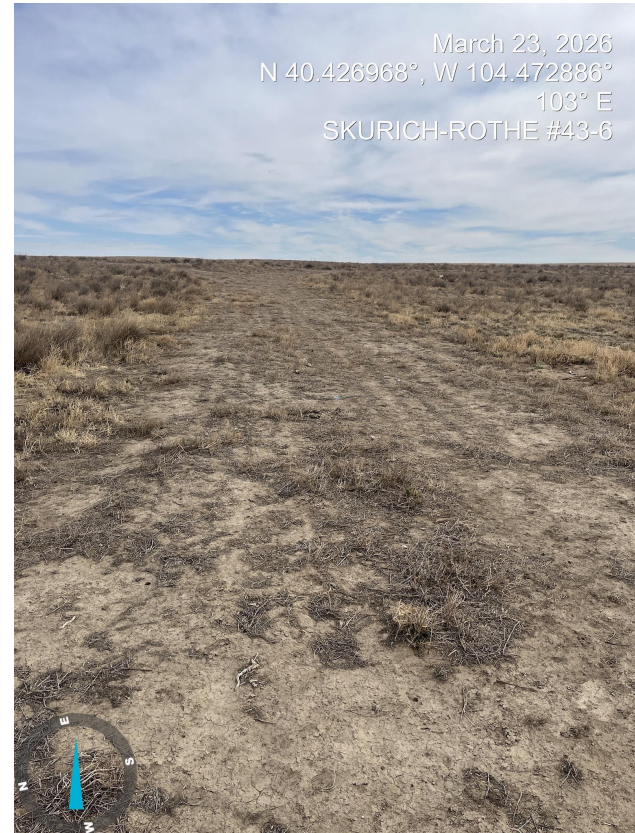
**Photo 8.** From the access road, facing east, the well location is approximately 30 feet west of the photo location. Road has a small amount of desirable vegetation establishment, but is mostly bare soil.

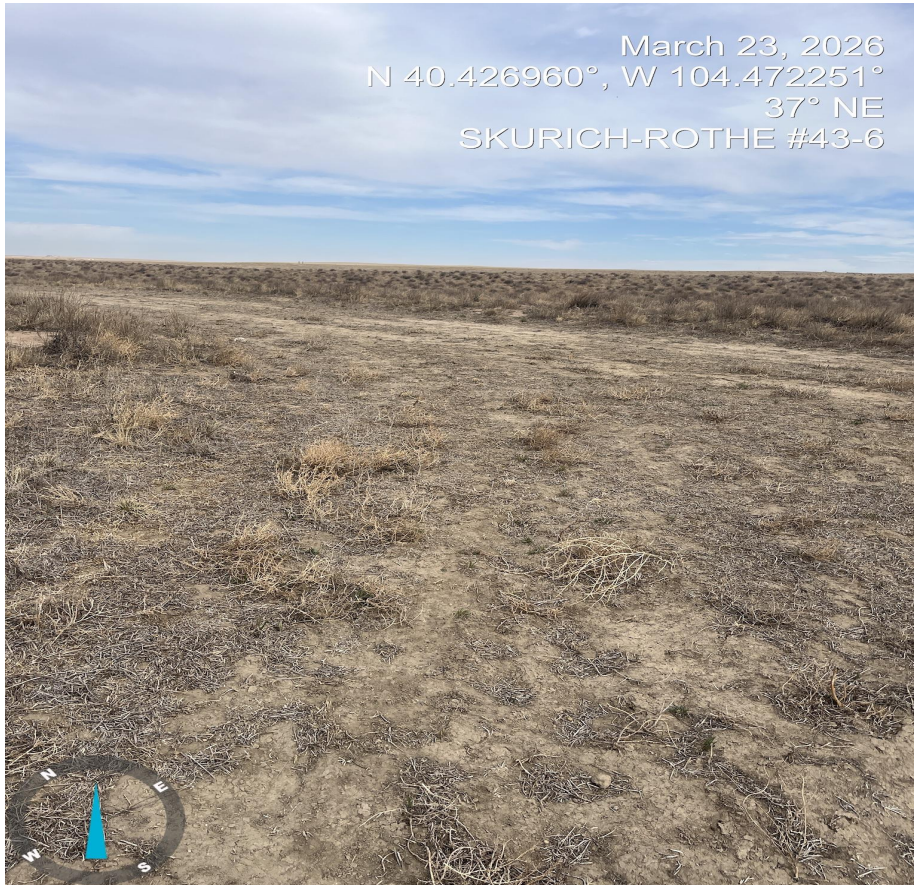
**Photo 9.** Photo taken from the east side of the well access road at its intersection with the lease road, showing bare soil and the establishment of undesirable vegetation.

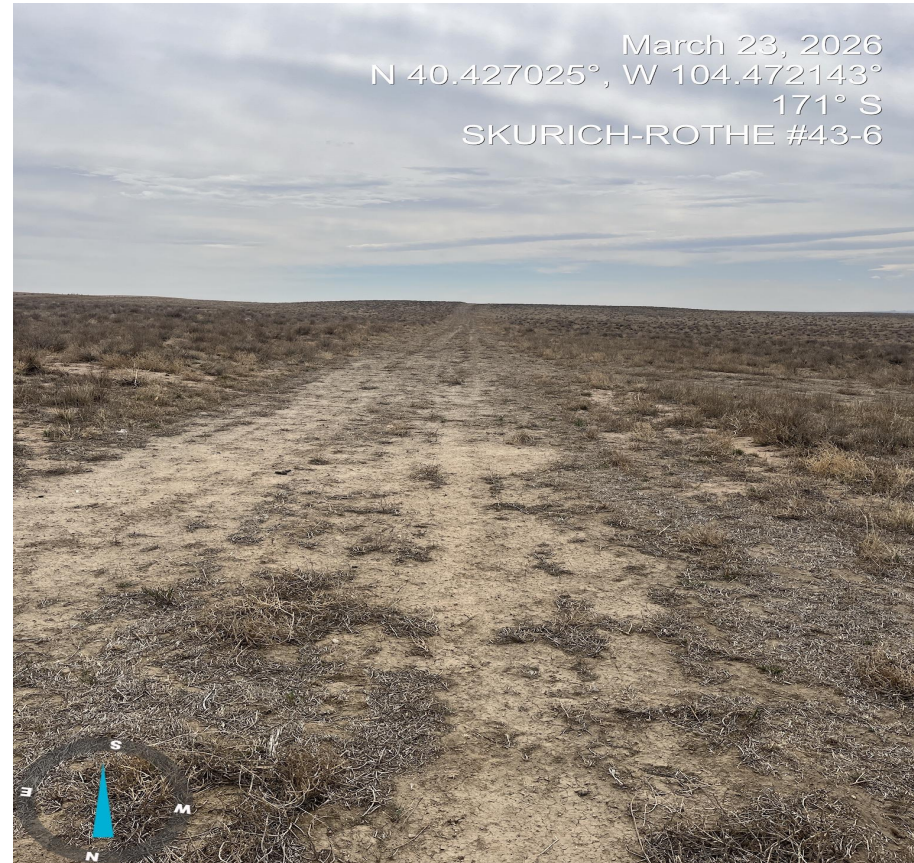
**Photo 10.** Photo taken from the lease road facing south showing bare soil and the establishment of undesirable vegetation.

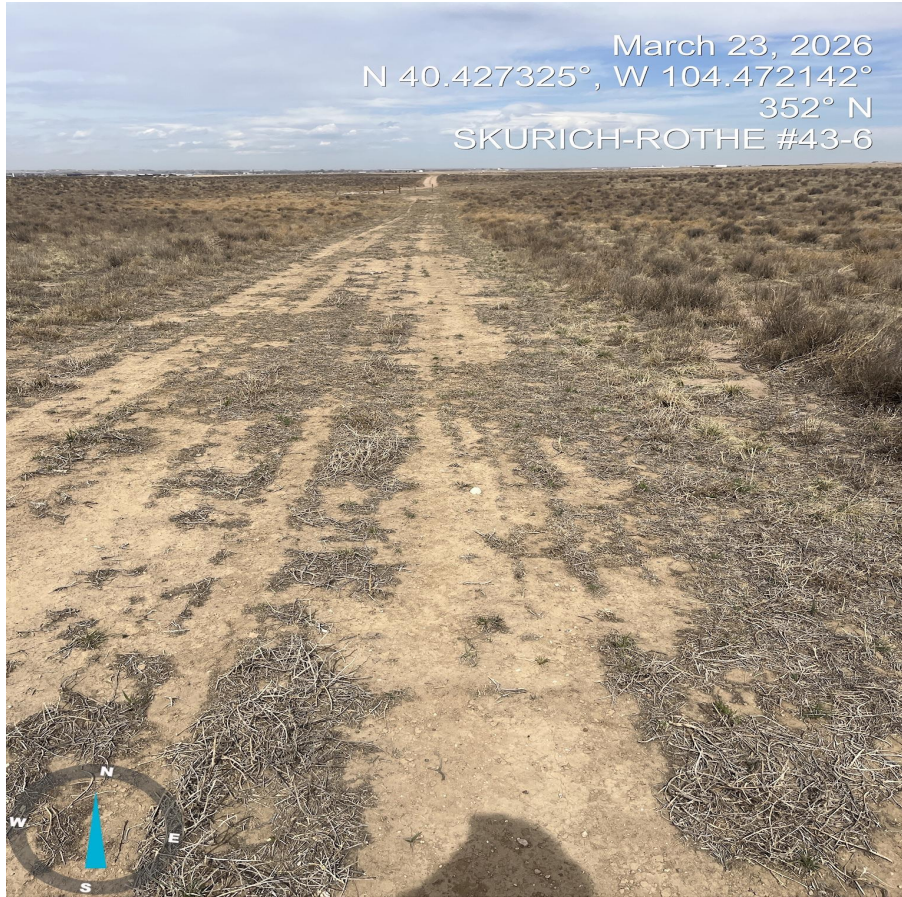
**Photo 11.** Photo taken from the lease road north of the well location, showing bare soil and some establishment of desirable vegetation on the east side of the road.

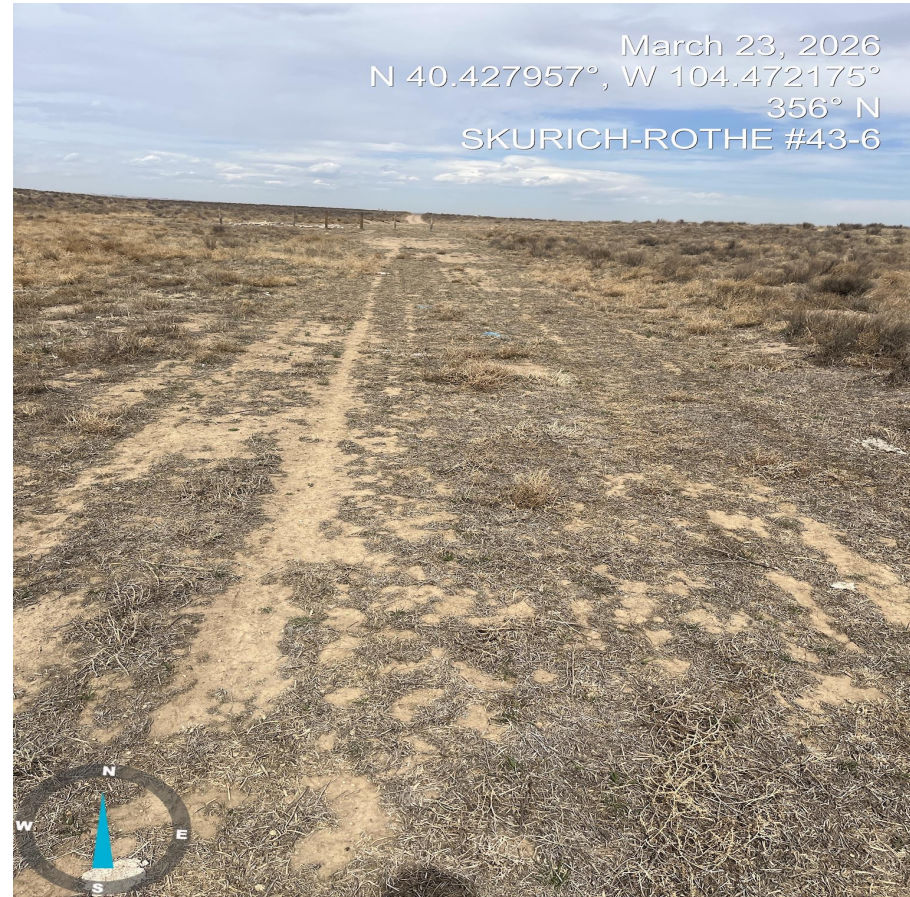
**Photo 12.** Photo taken from access road north of well location, showing bare soil and some establishment of desirable vegetation on the east side of access road.
