Final Reclamation and Stormwater Inspection

Operator: EXTRACTION OIL & GAS INC - 10459

Location ID: 463225

Well Name: Hippen UU 32-2,13; Pezoldt UU 32-4J/

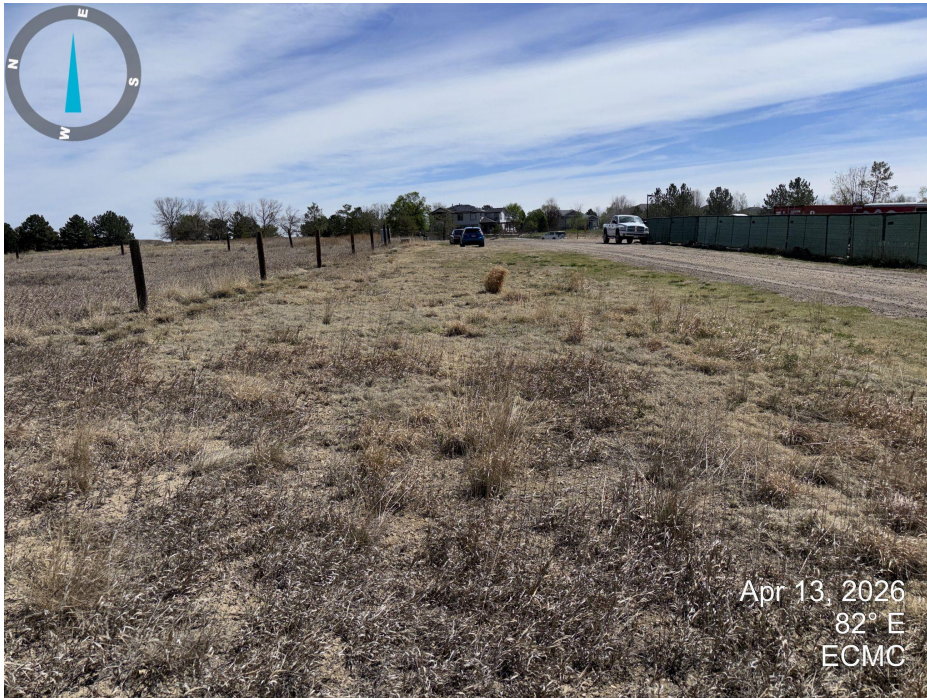
Photo 1. Looking east across the location from the west side. All equipment has been removed. Weeds appear to be controlled on the tank battery at the time of inspection.

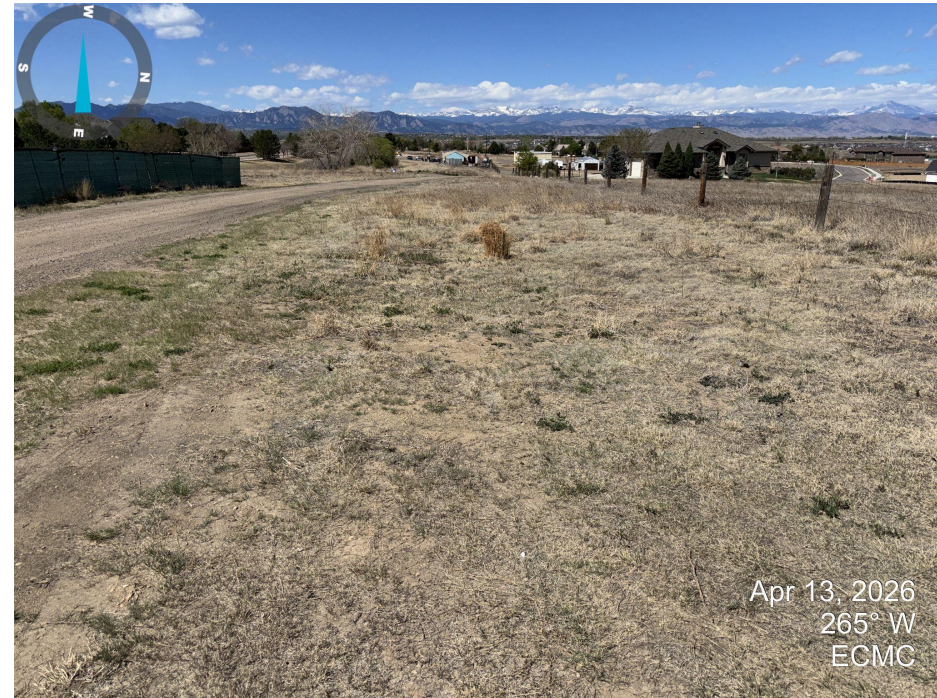
Photo 2. Looking west across the west side of the tank battery from the center of the location. Desirable perennial vegetation is present on this side of the location including saltgrass and blue gramma.

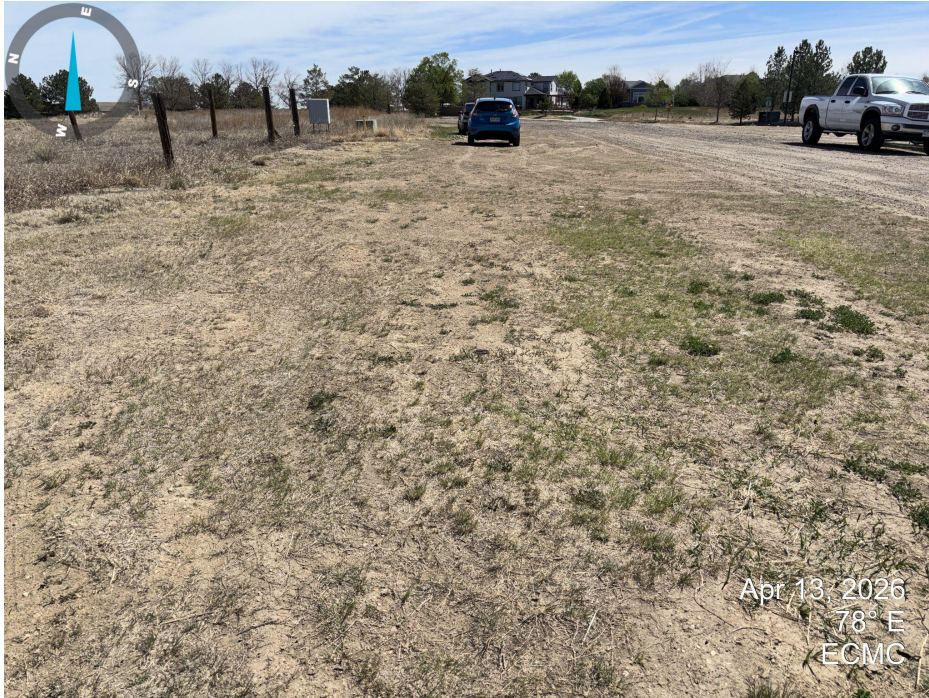
Photo 3. Looking east from the center of the location. Desirable perennial vegetation is present on the east side in areas that are not being driven on.

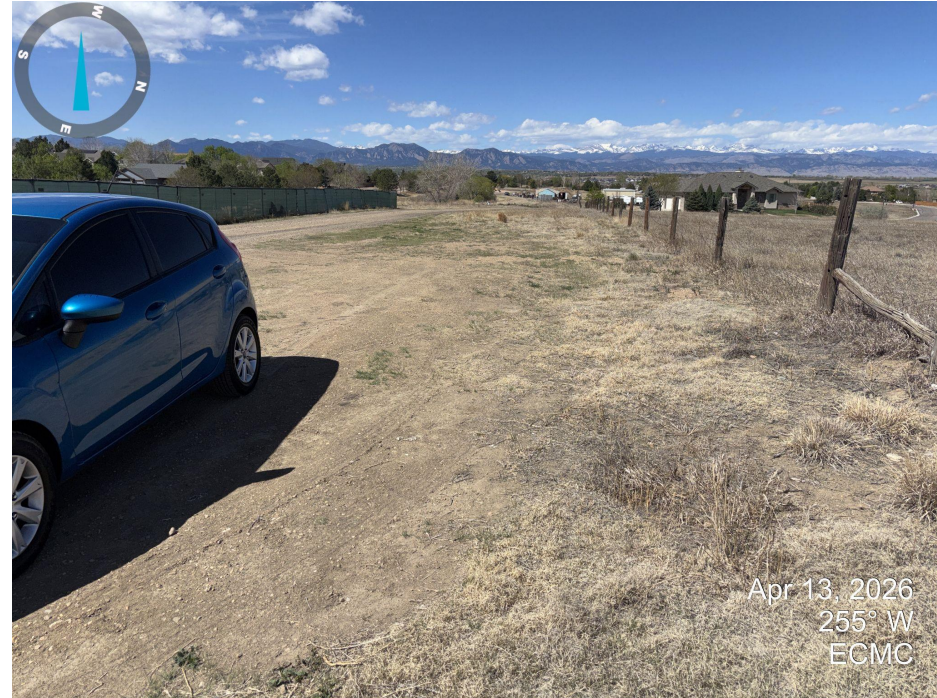
Photo 4. Looking west from the east side of the location. It appears that a portion of the tank battery is being used for parking for a nearby equipment depot.

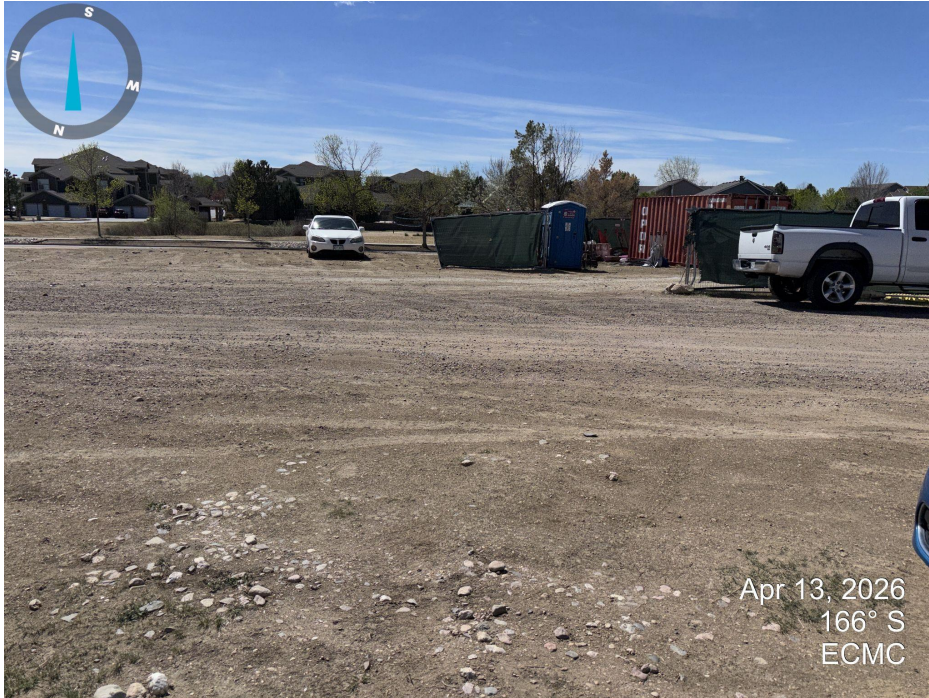
Photo 5. Cars are parking in this area because of this equipment/ materials depot nearby.

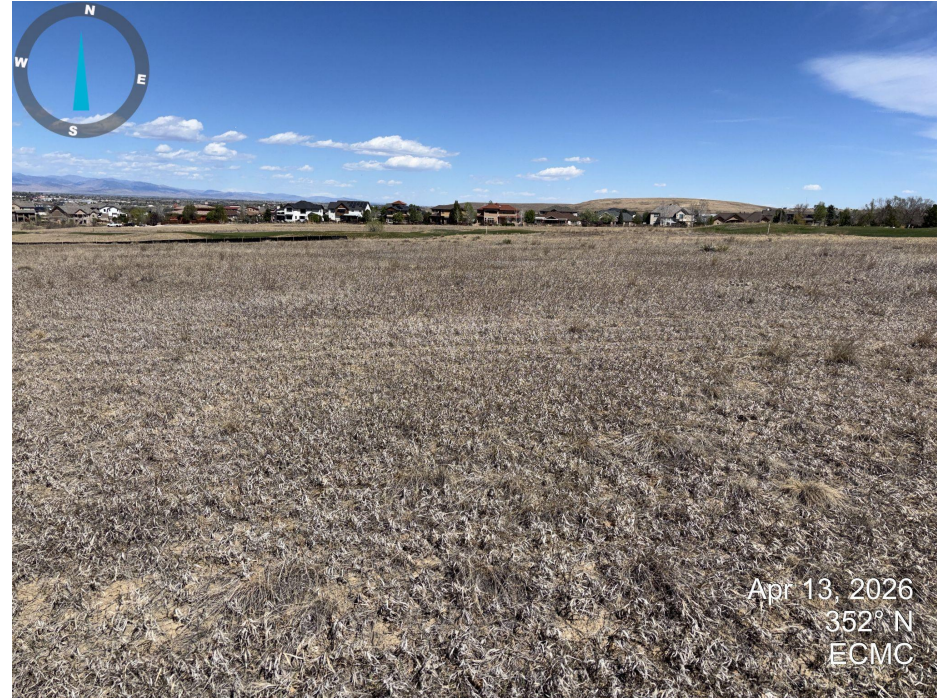
Photo 6. Reference vegetation to the west of the tank battery location. Vegetation is primarily smooth brome.
