Inspection Photos
Location Name: Simcoe State 01-36; 35-08 #3
Location ID: API 05-067-08323

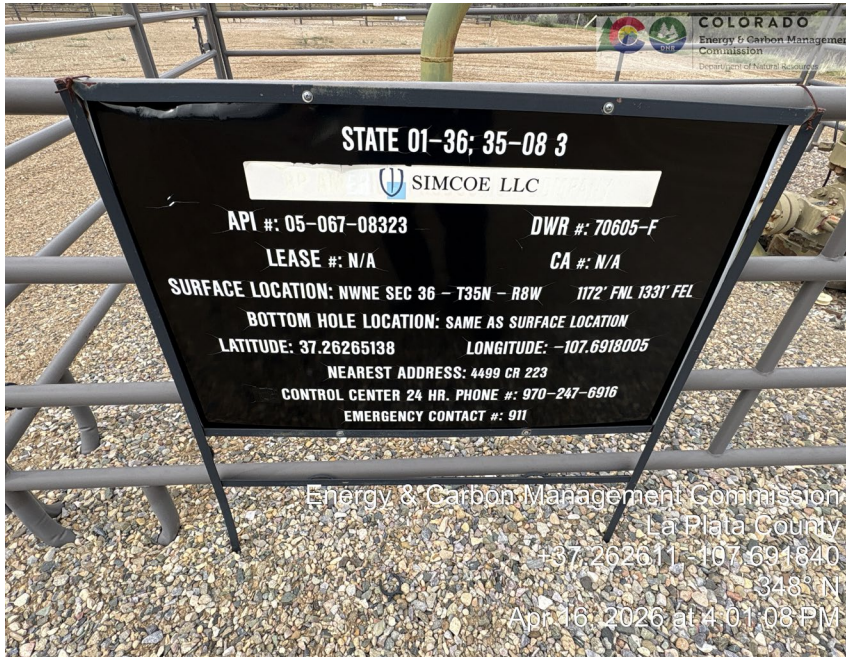
1. Well sign

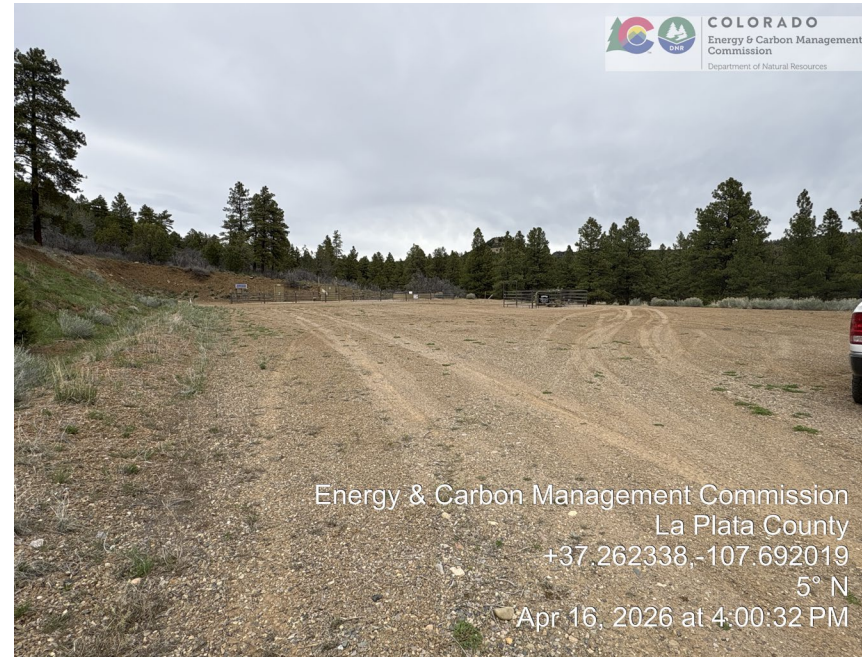
2. Well location overview.

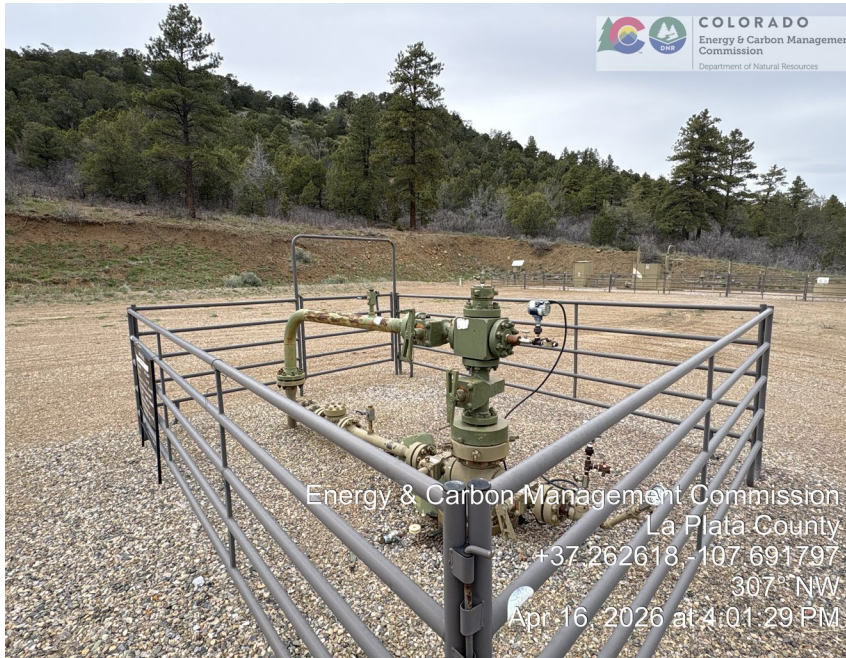
3. Wellhead behind cattle panel fence.

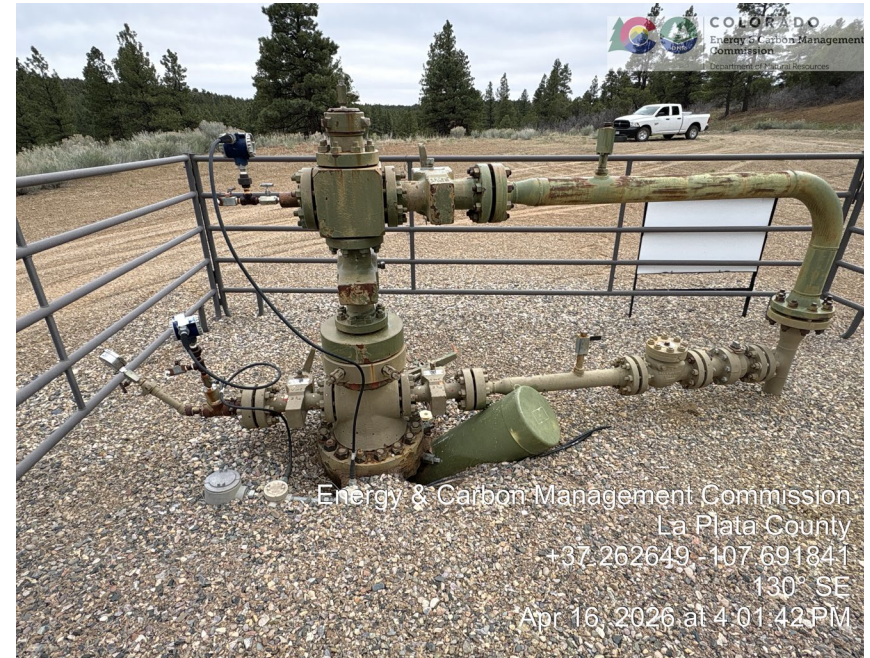
4. Wellhead.

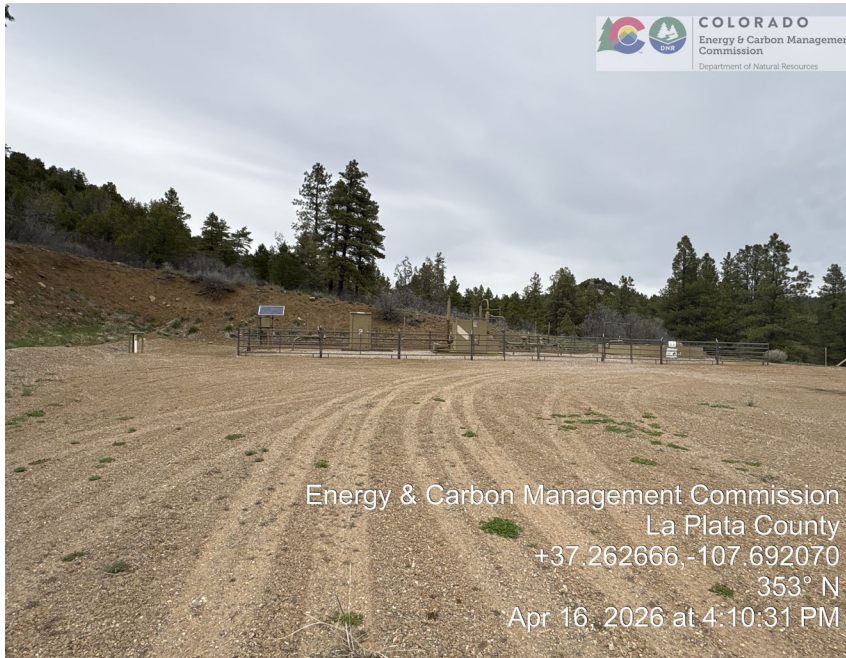
5. Production equipment.

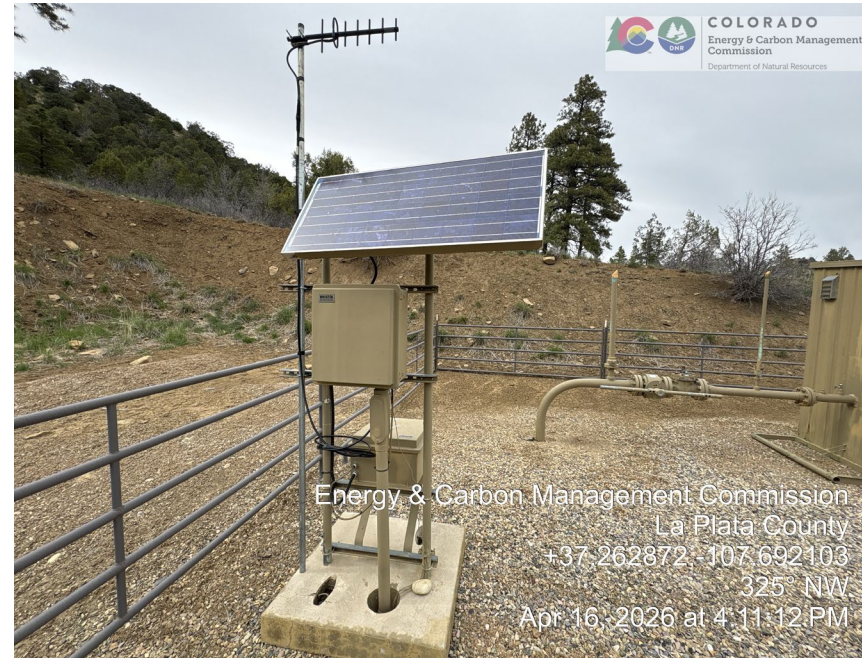
6. Solar telemetry.

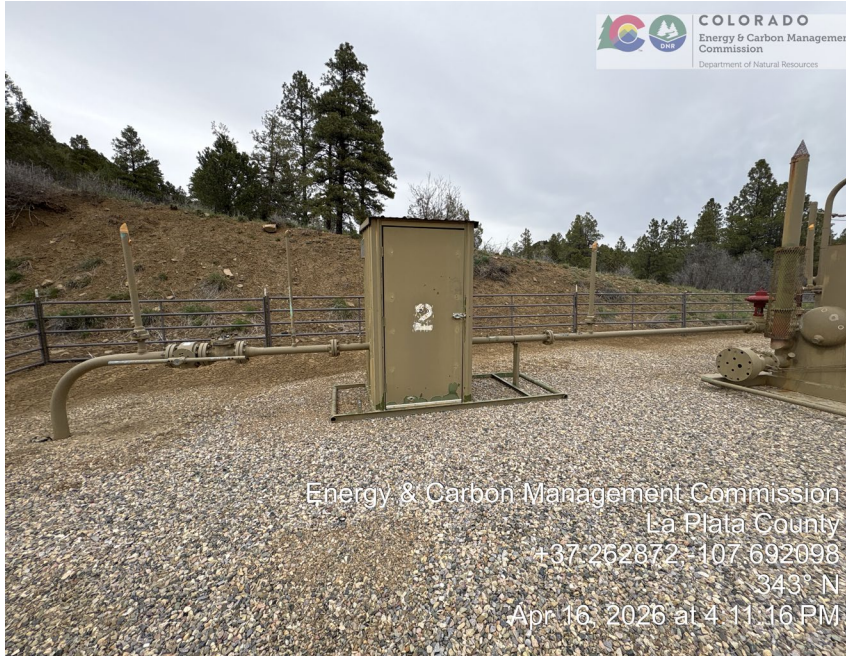
7. Meter run shed.

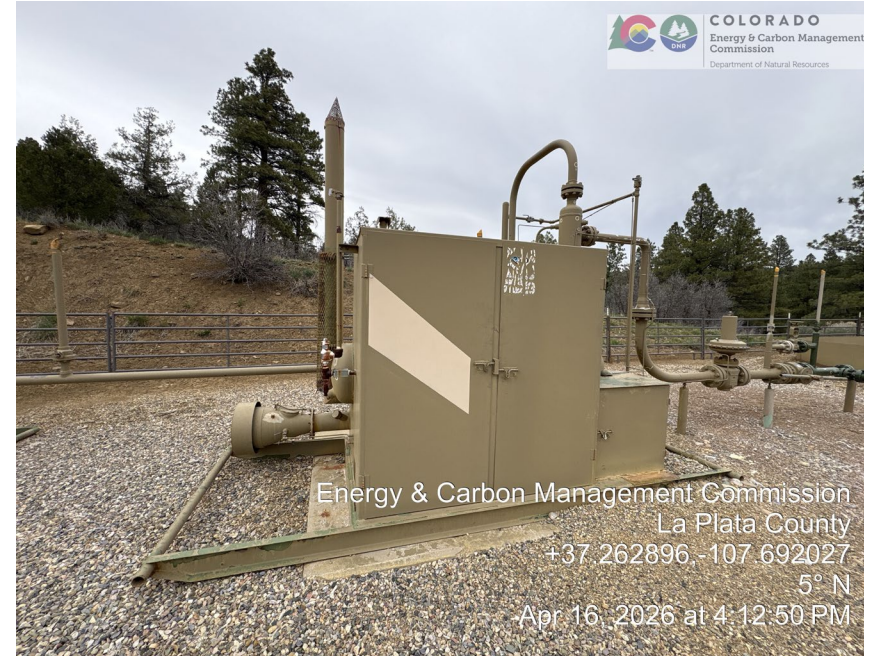
8. Horizontal heated separator.

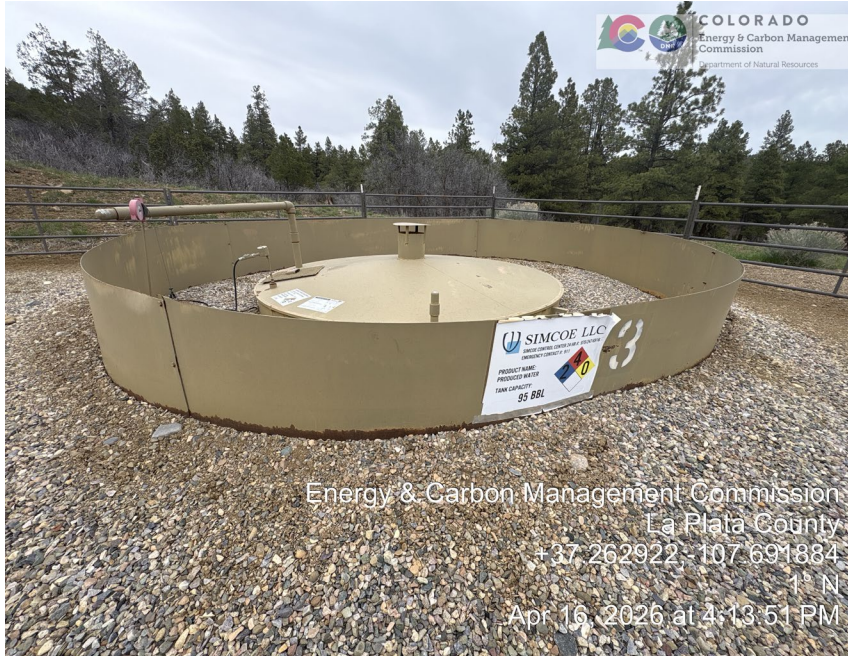
9. 95 BBL PBV steel tank with secondary containment.

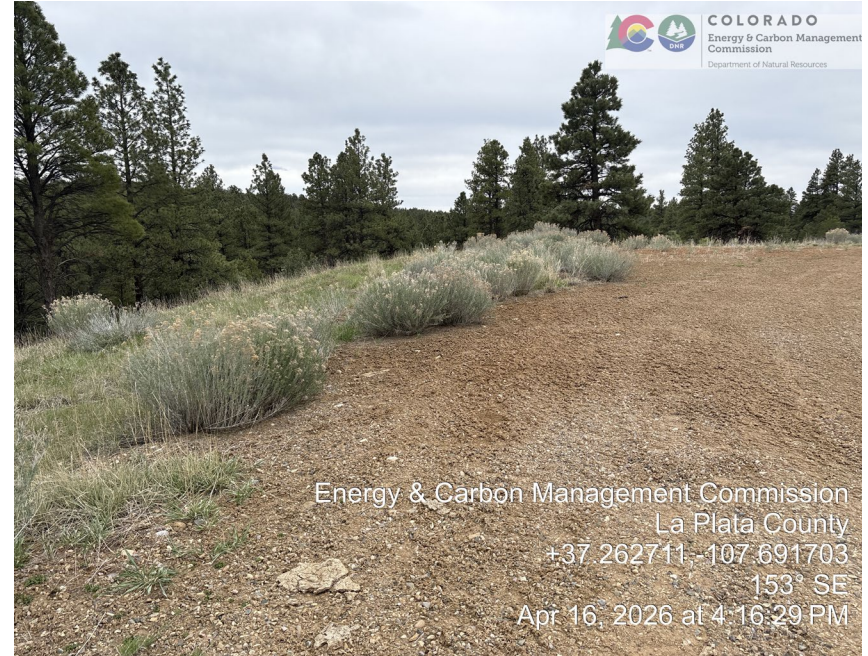
10. Reclamation vegetation.

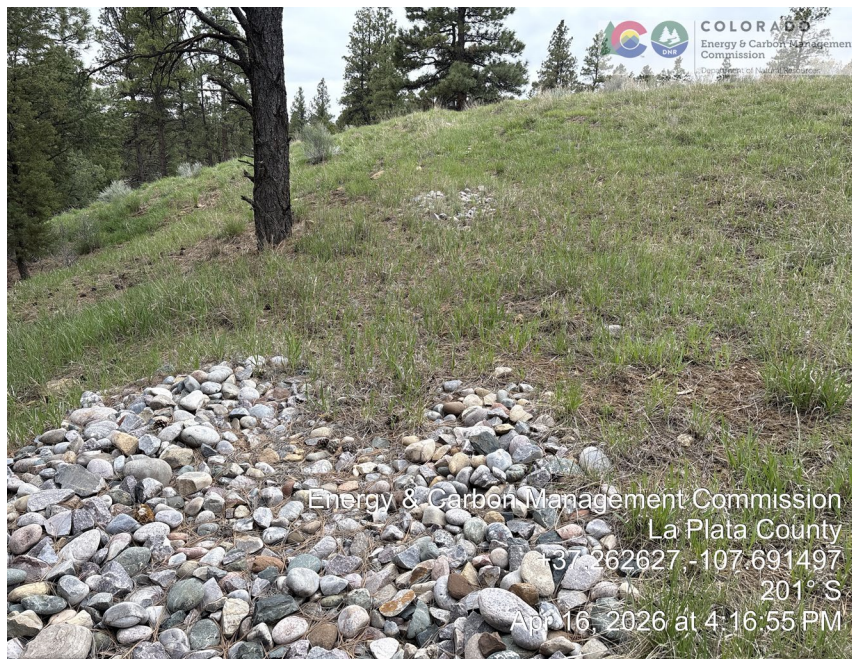
11. Sediment trap and ditch on east side of pad.

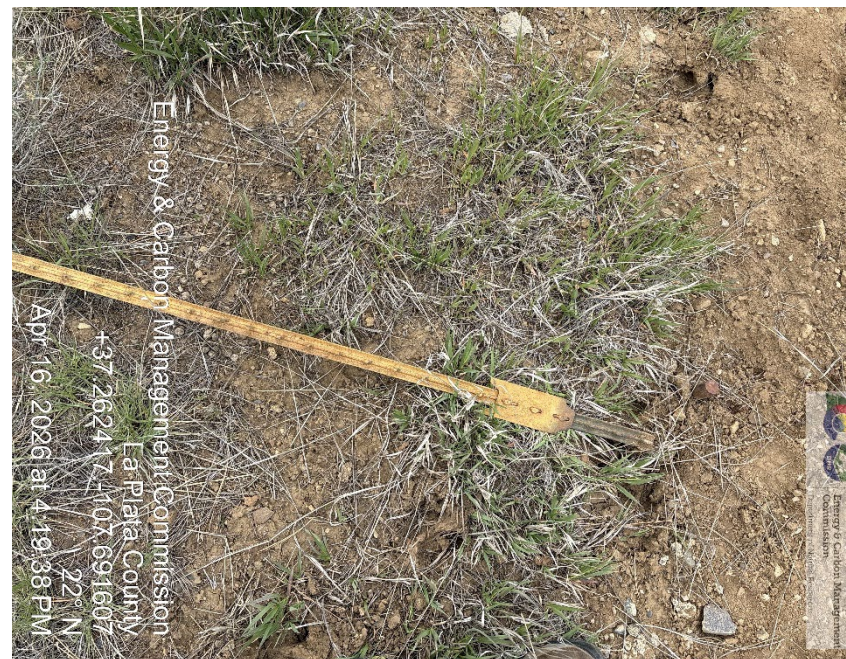
12. Down rig anchor marker in SE corner in reclamation vegetation.

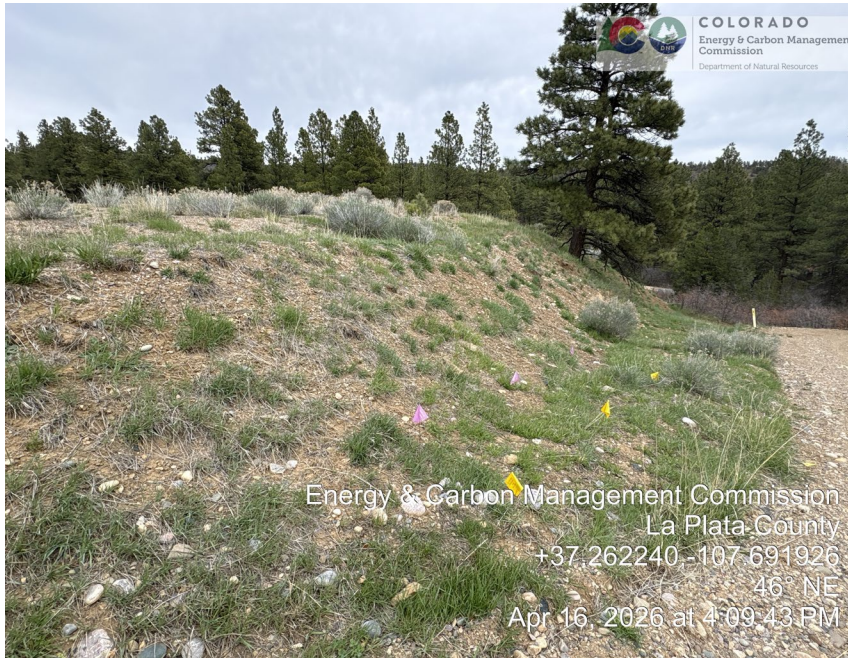
13. Cut slope next to location access road near entrance.

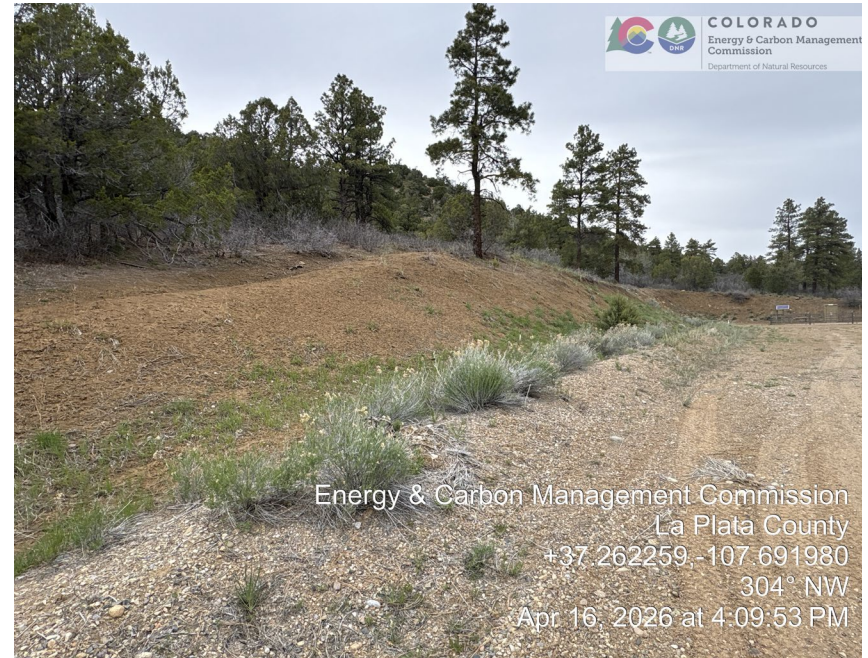
14. Ditch and berm on west side of pad.
