Inspection/Audit Photos

Location: SCOUT ENERGY MANAGEMENT LLC HEFLEY, M E #8X

Location ID: 315552

Date: 04/7/2026

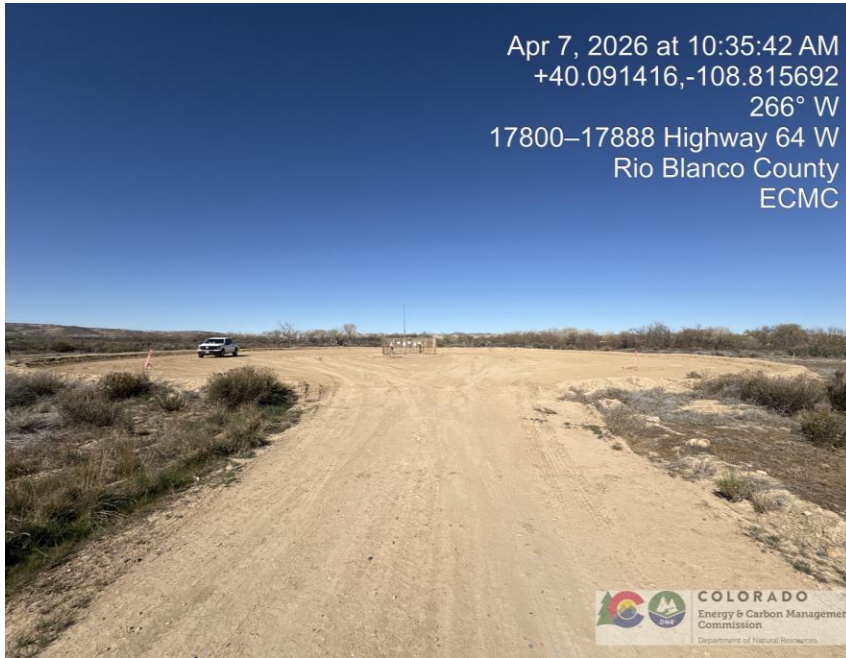
Photo # 4186 Entrance to location

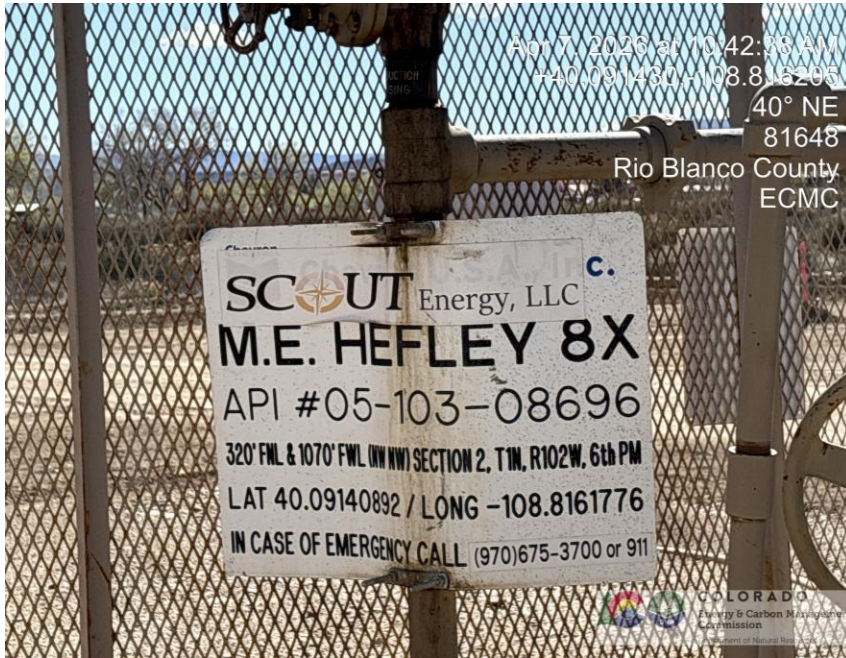
Photo # 4192 Sign lacks public road used to access the well

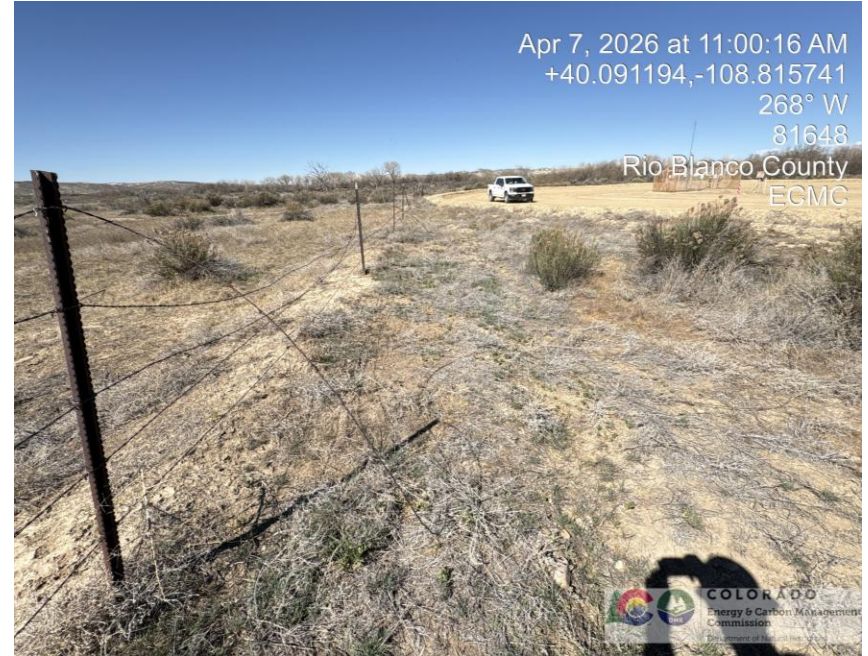
Photo # 4202 Loose barbed wire fencing on location/wildlife hazard

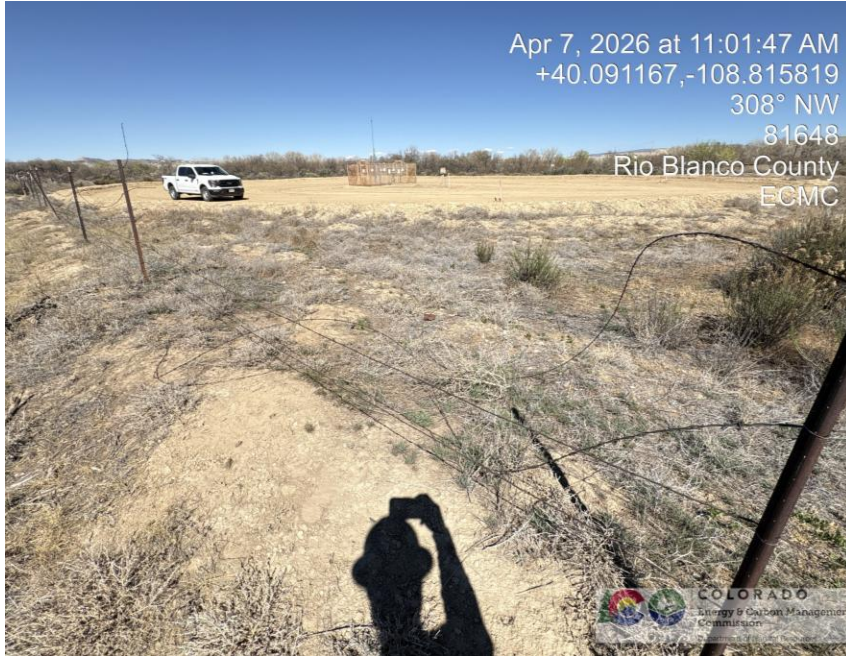
Photo # 4204 Loose barbed wire fencing on location/wildlife hazard

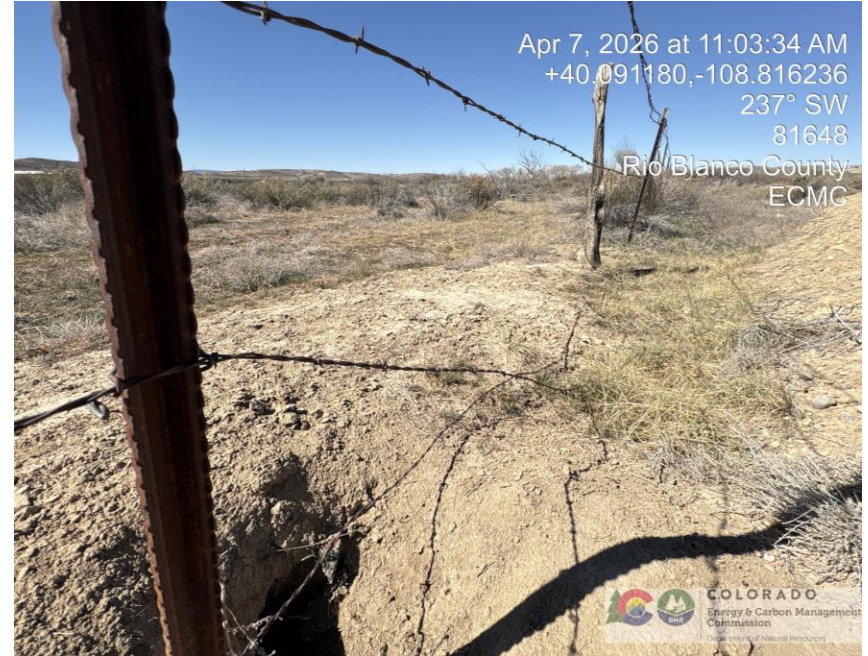
Photo # 4205 Loose barbed wire fencing on location/wildlife hazard

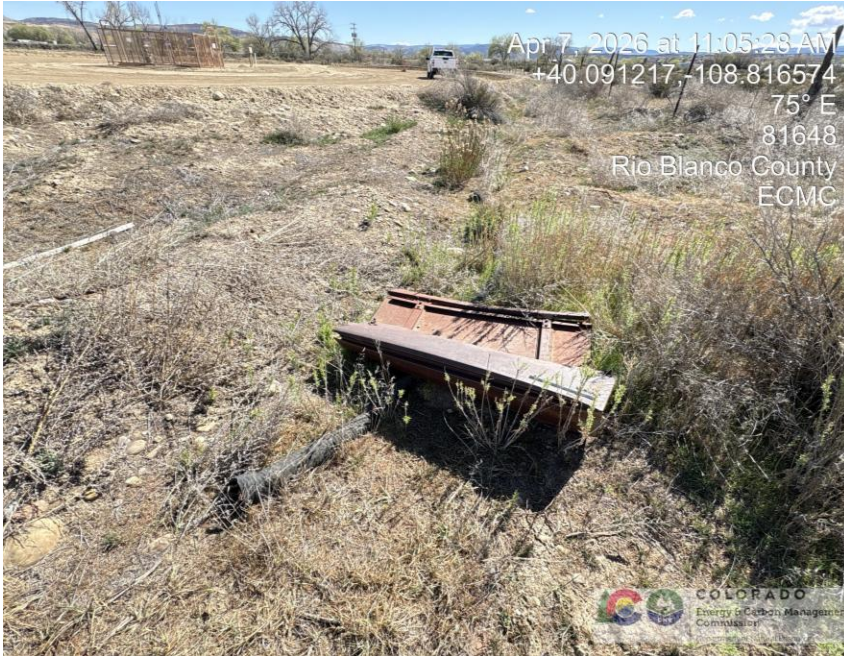
Photo # 4206 Debris

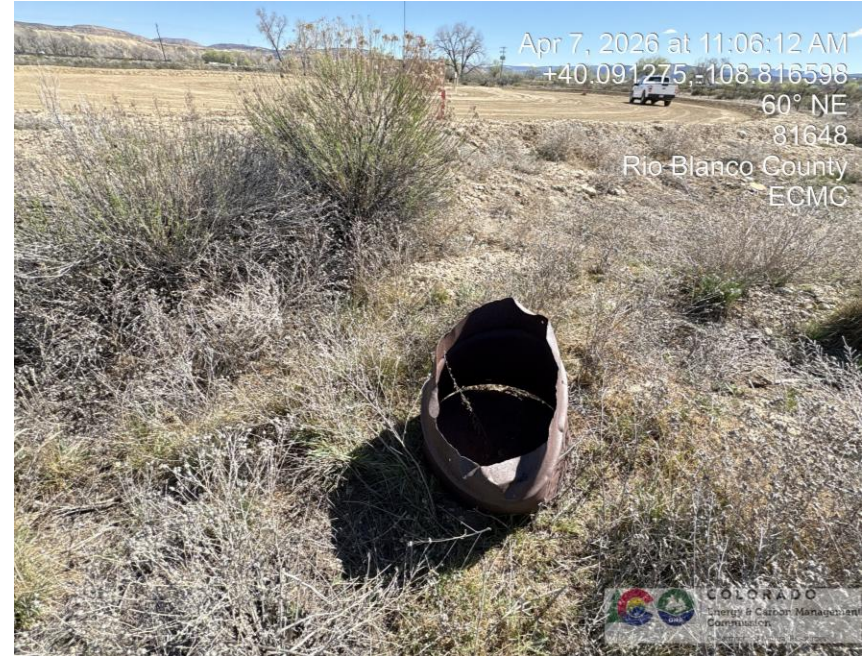
Photo # 4207 Debris
