# Inspection Photos

API: 061-06847

Operator: MULL DRILLING COMPANY

Inspection Date: 4/15/2026

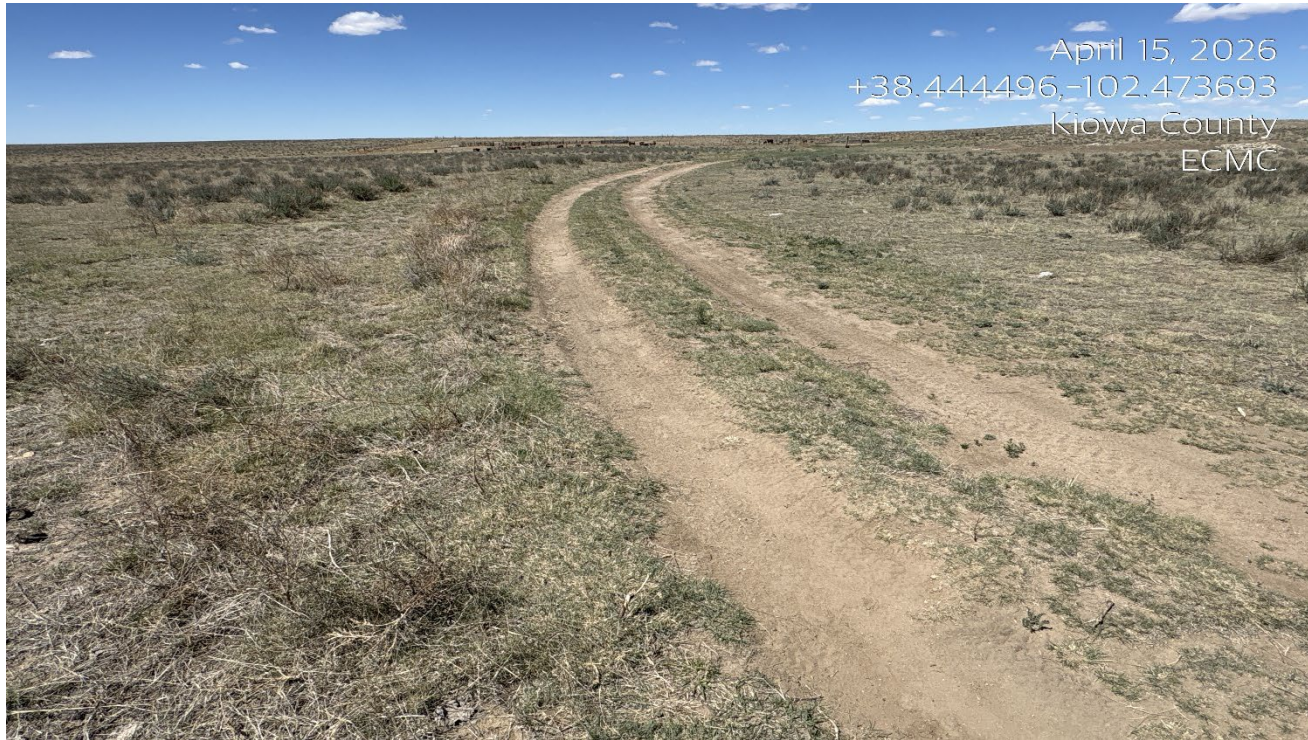
**Photo 1.** Center of the location facing north.

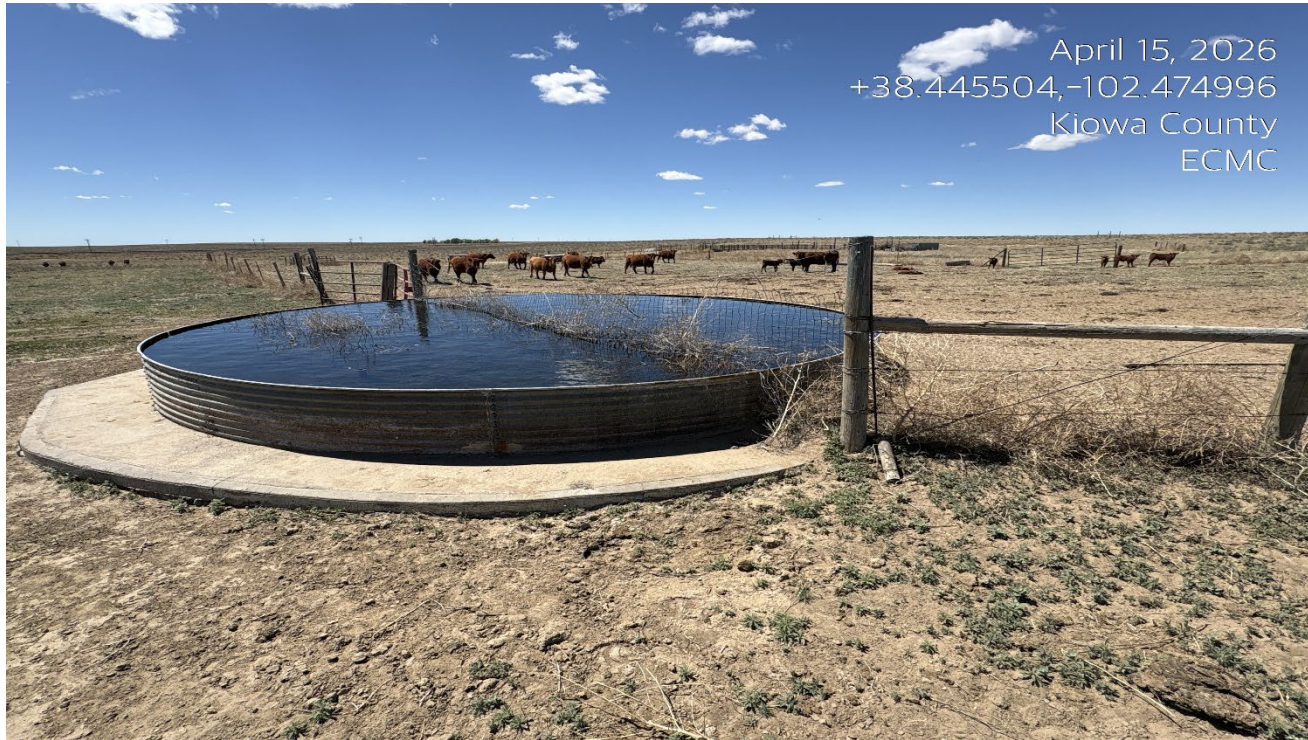
**Photo 2.** Facing west. There is a livestock tank located approx. 375' east of the abandoned well site..

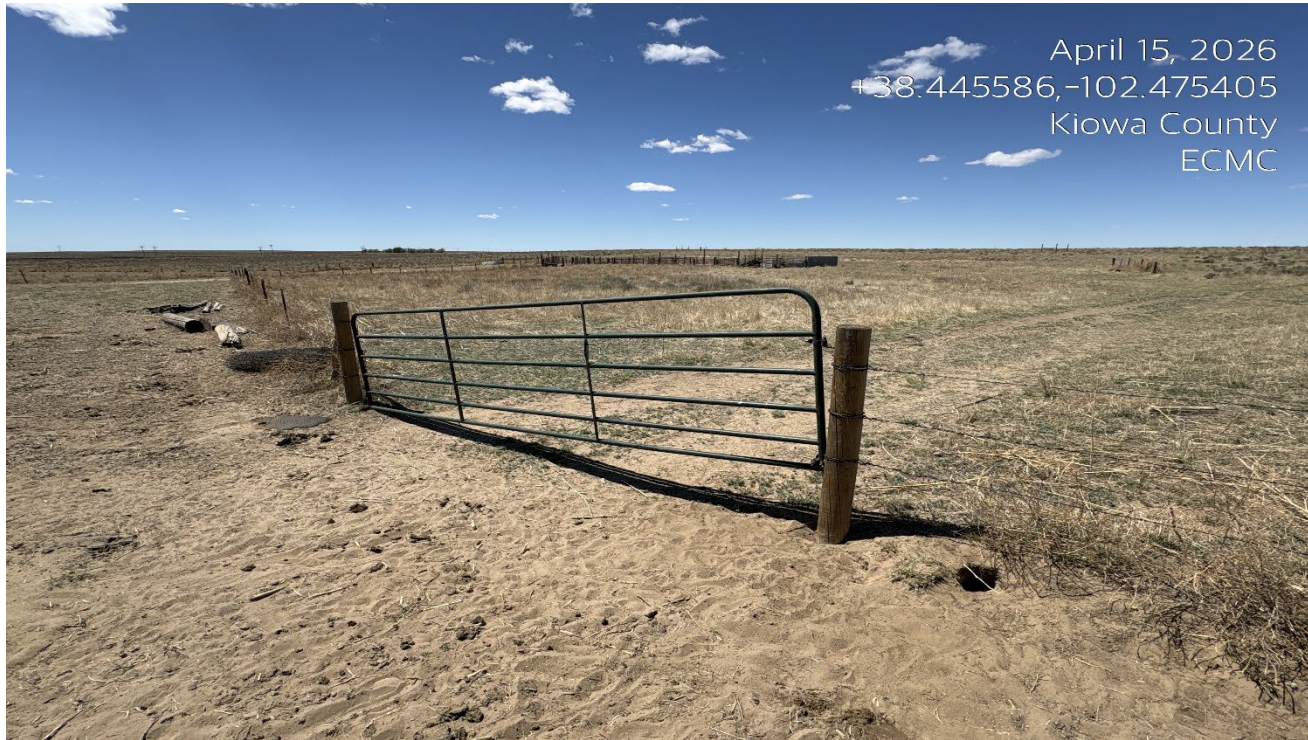
**Photo 3.** Facing west toward the location.

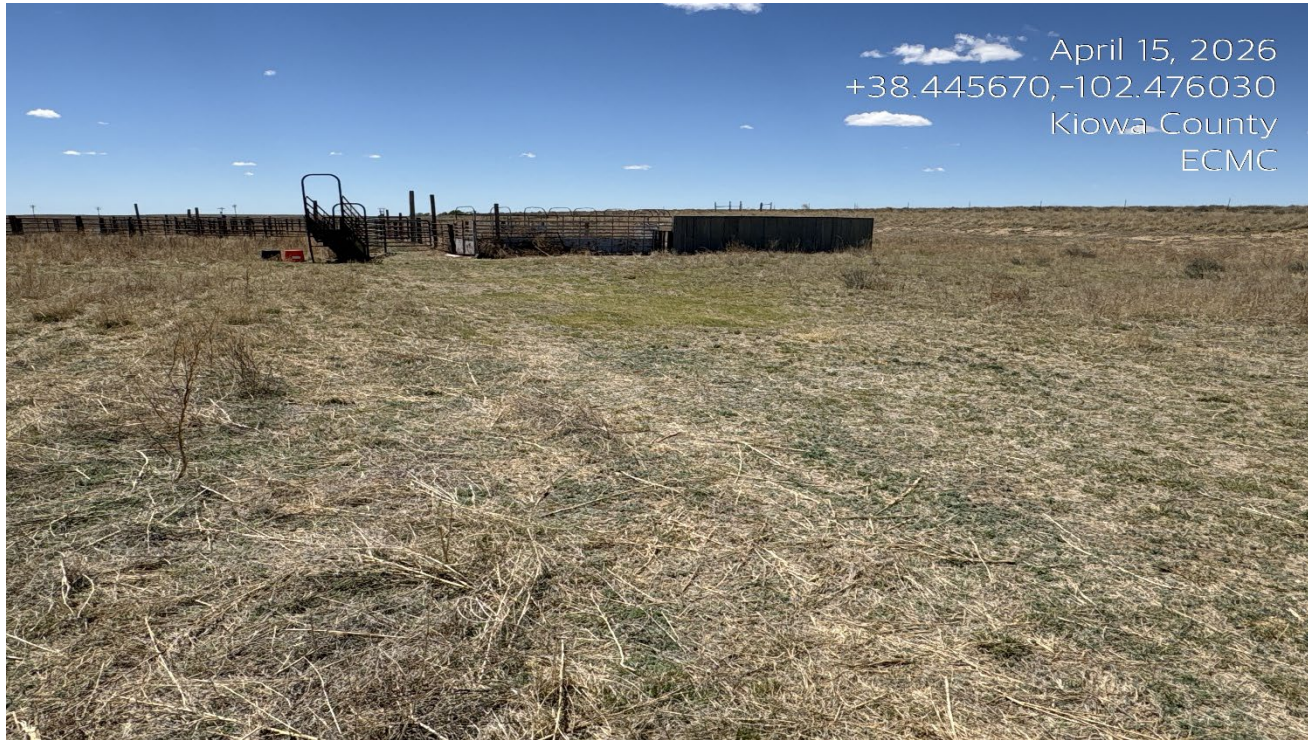
**Photo 4.** Facing southwest at the location. The plugged and abandoned well is located within the constructed corral area.

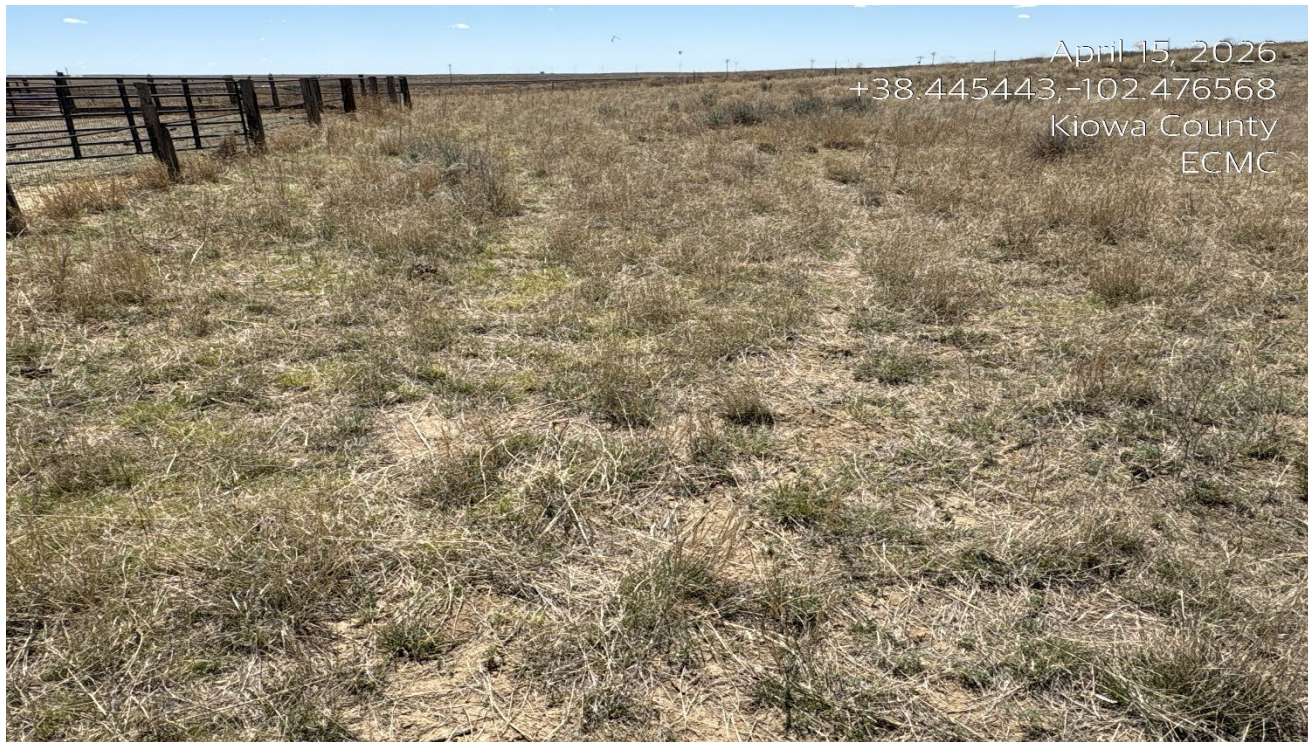
**Photo 5.** Facing south at the west side of the location adjacent to the corrals. There are perennial grasses in this area.

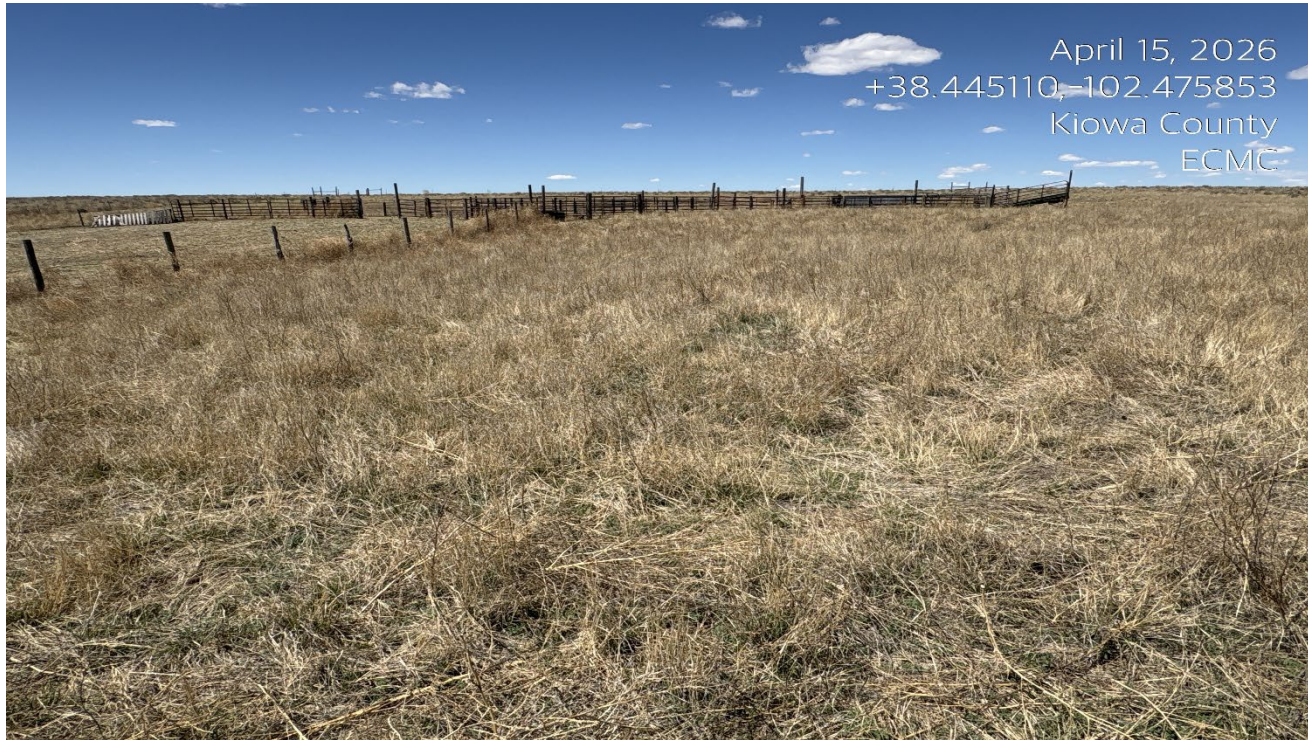
**Photo 6.** Southeast corner facing northwest toward the location. There are perennial grasses in this area. The plugged and abandoned well is located within the constructed corral area.
