Inspection Photos

Location Name: LARAMIE ENERGY LLC Logan Wash 797-23-45AX Pad

Location ID: 383305

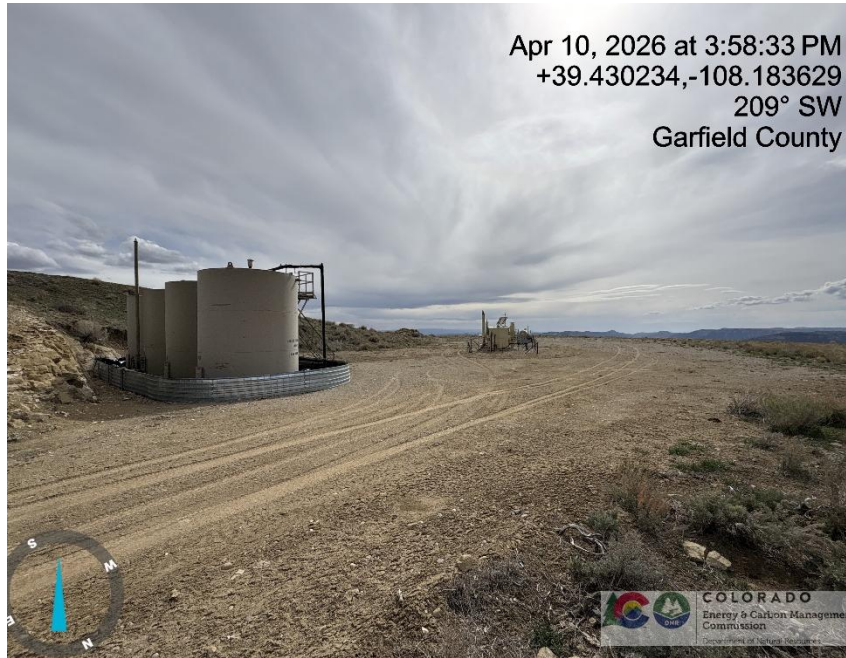
Photo # 8432 From entrance to location

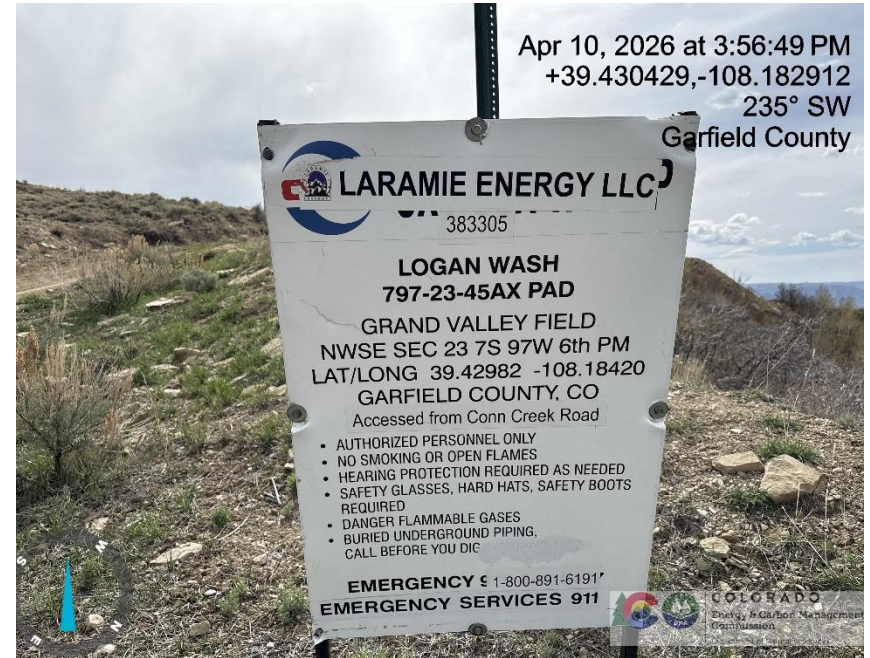
Photo # 8433 Sign at start of spur road to location

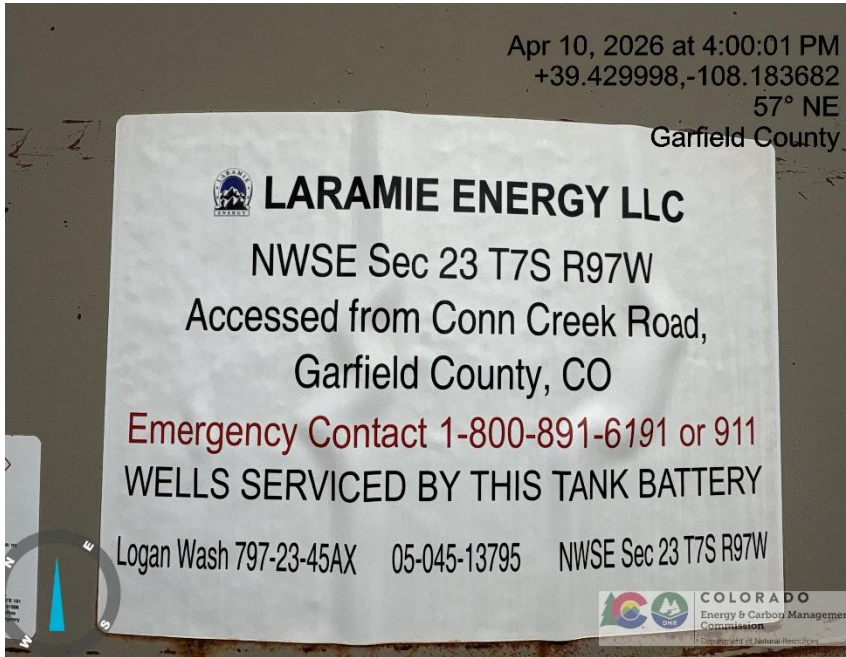
Photo # 8434 Battery signage

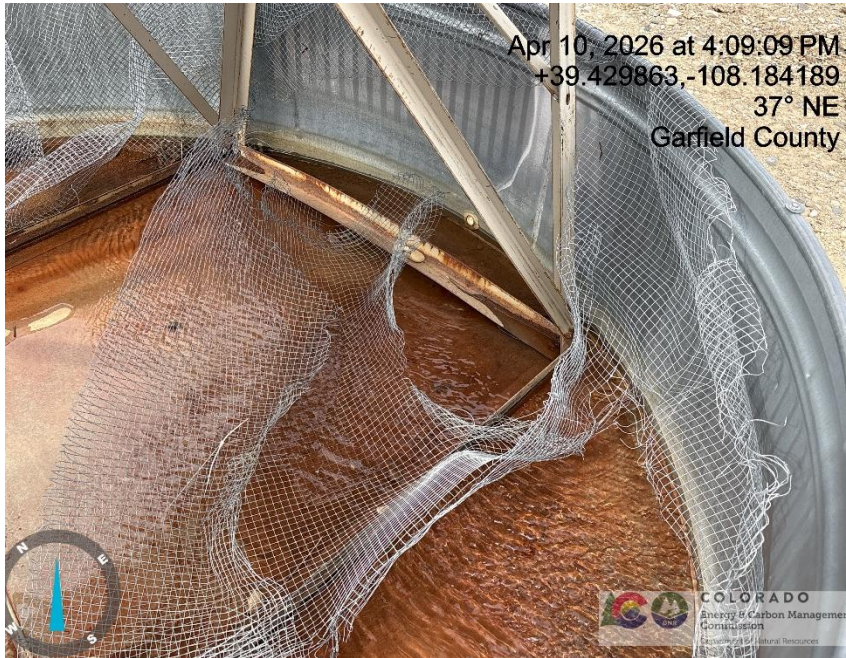
Photo # 8440 Wildlife protection for methanol tank containment needs maintenance

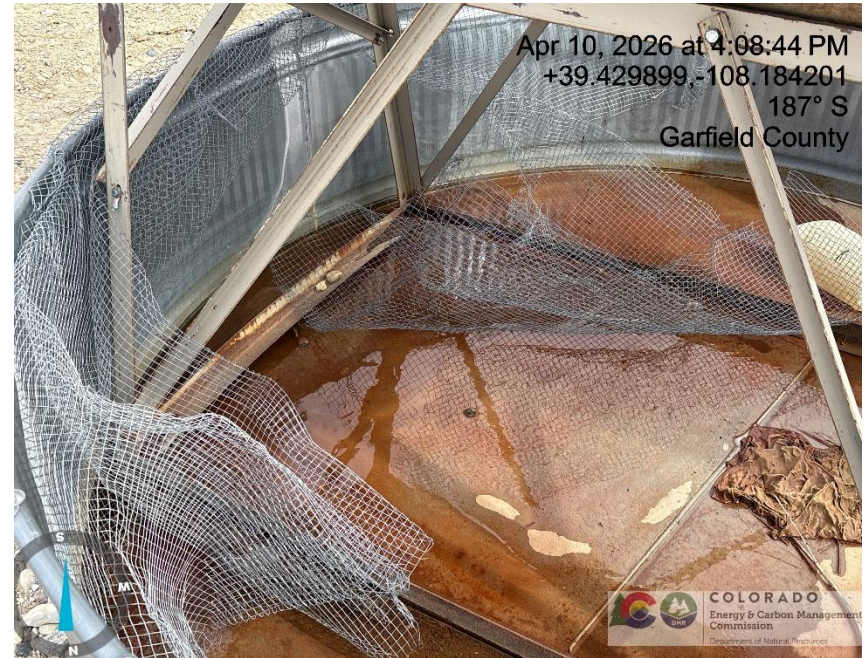
Photo # 8441 Wildlife protection for methanol tank containment needs maintenance

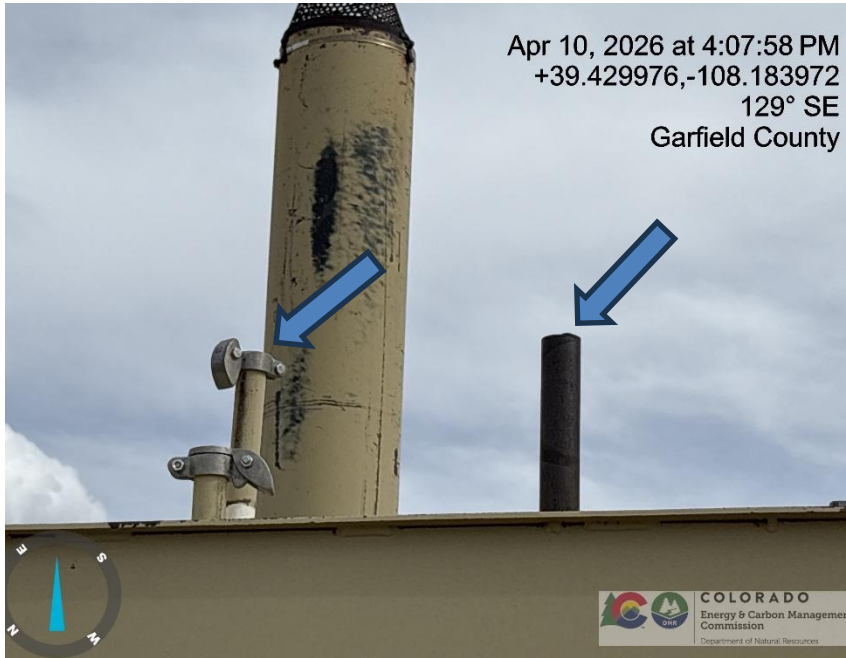
Photo # 8442 PRV vent lines on separator do not comply with CECMC pressure safety device rules

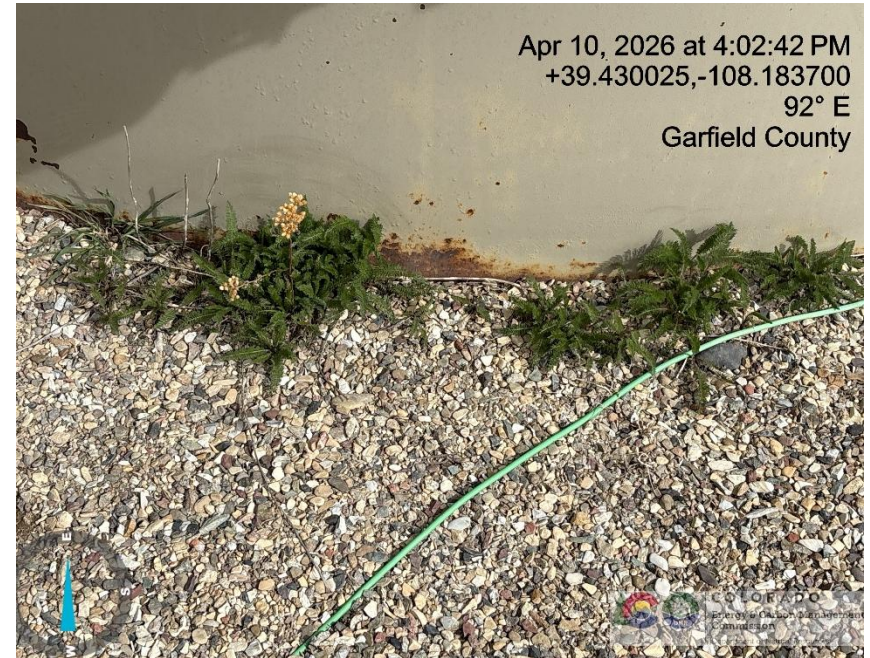
Photo # 8443 Weeds in secondary containment

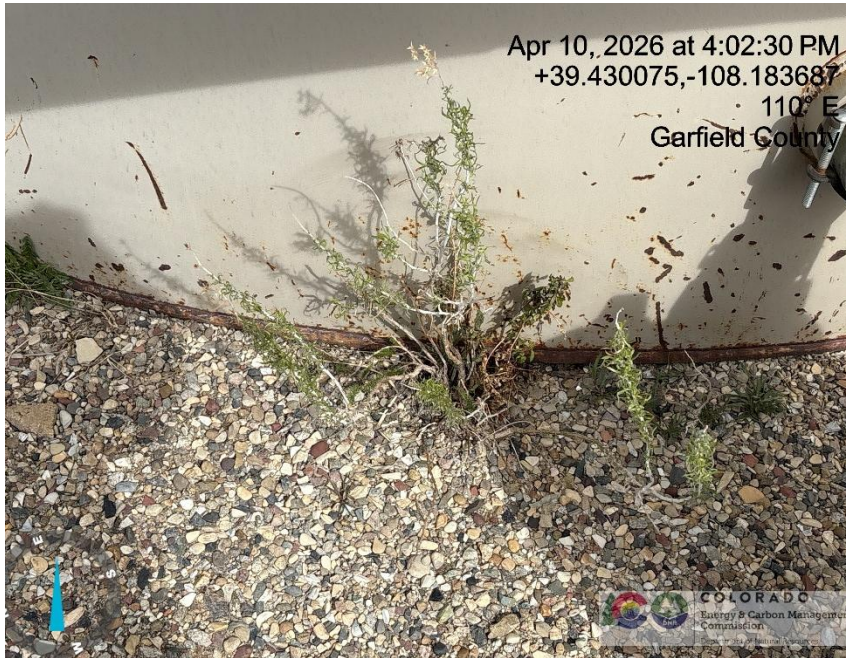
Photo # 8444 Weeds in secondary containment

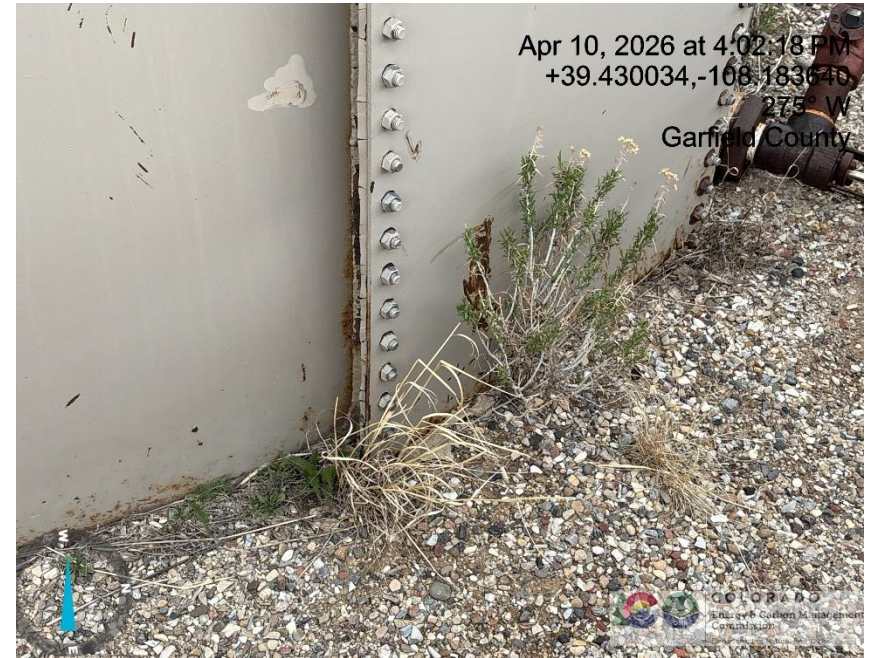
Photo # 8445 Weeds in secondary containment

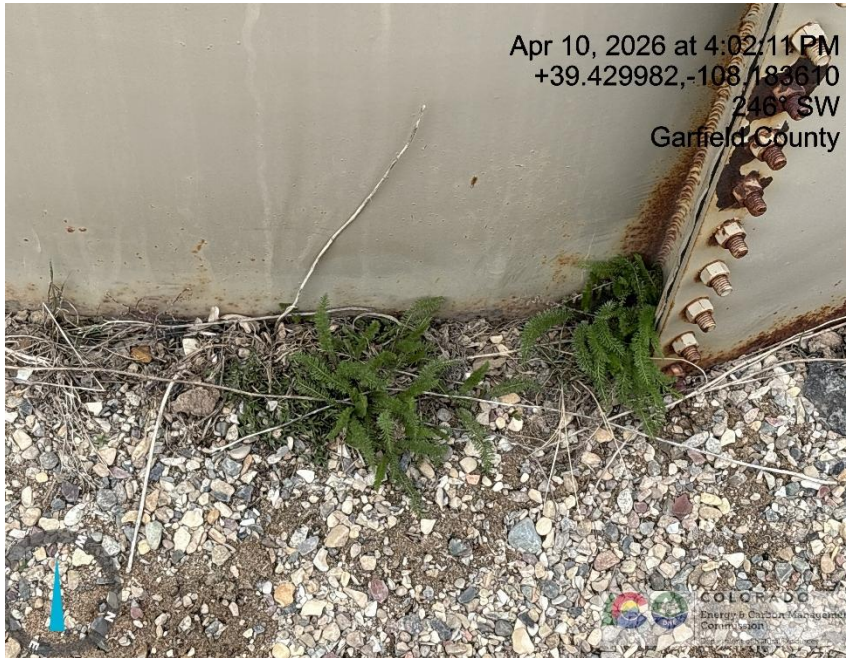
Photo # 8446 Weeds in secondary containment

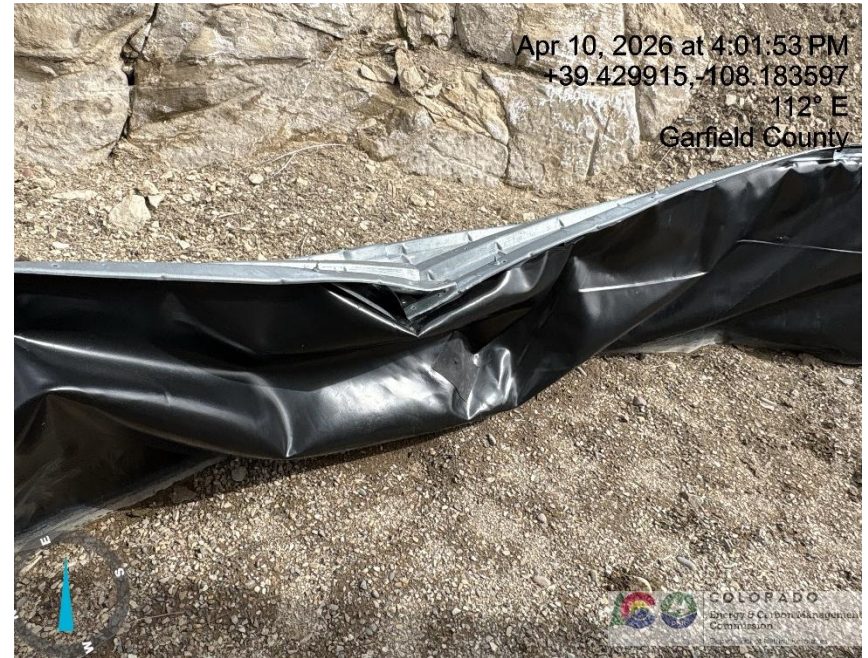
Photo # 8447 Damage to secondary containment

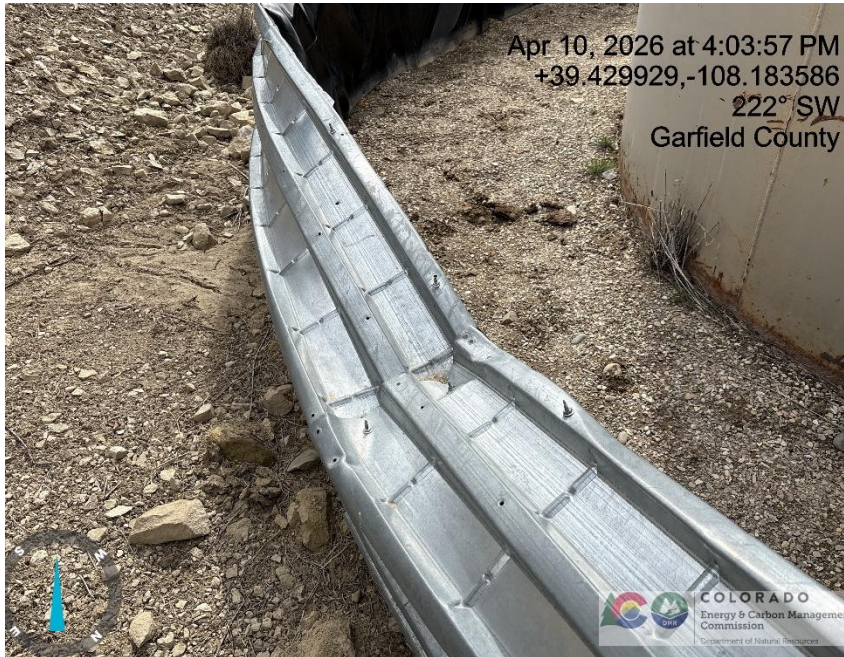
Photo # 8448 Damage to secondary containment
