QB ENERGY OPERATING LLC ROLES-67S93W 13NESE (J13W) Facility # 334558

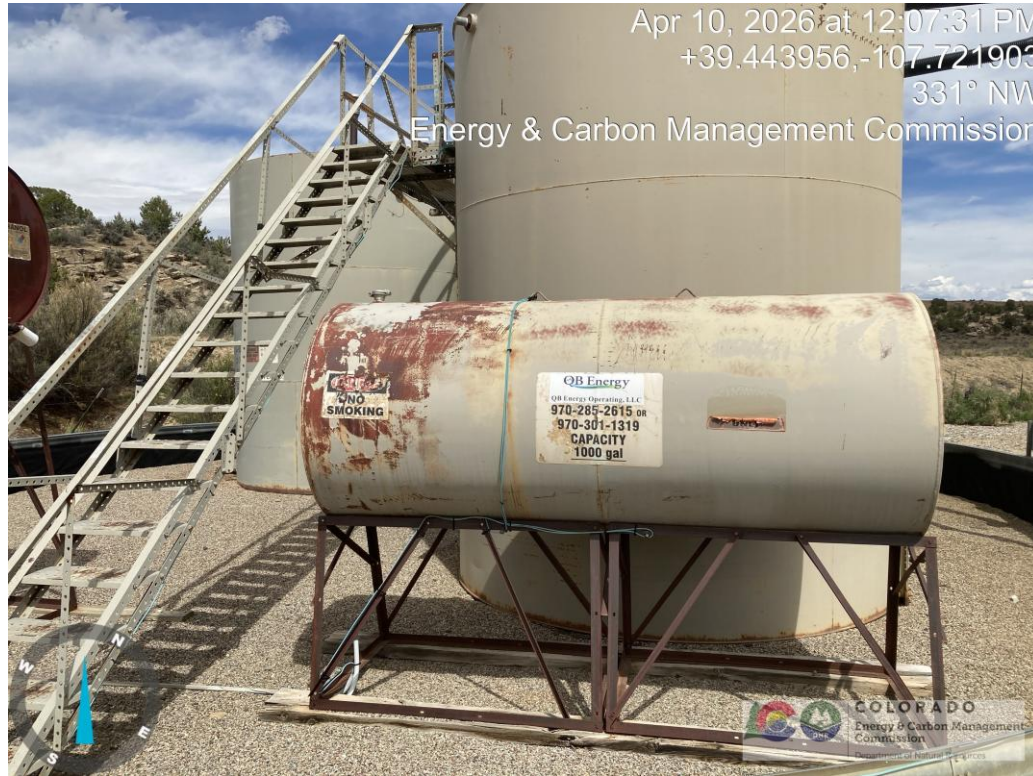
Methanol tank paint is in poor condition, and no smoking sign is in poor condition.

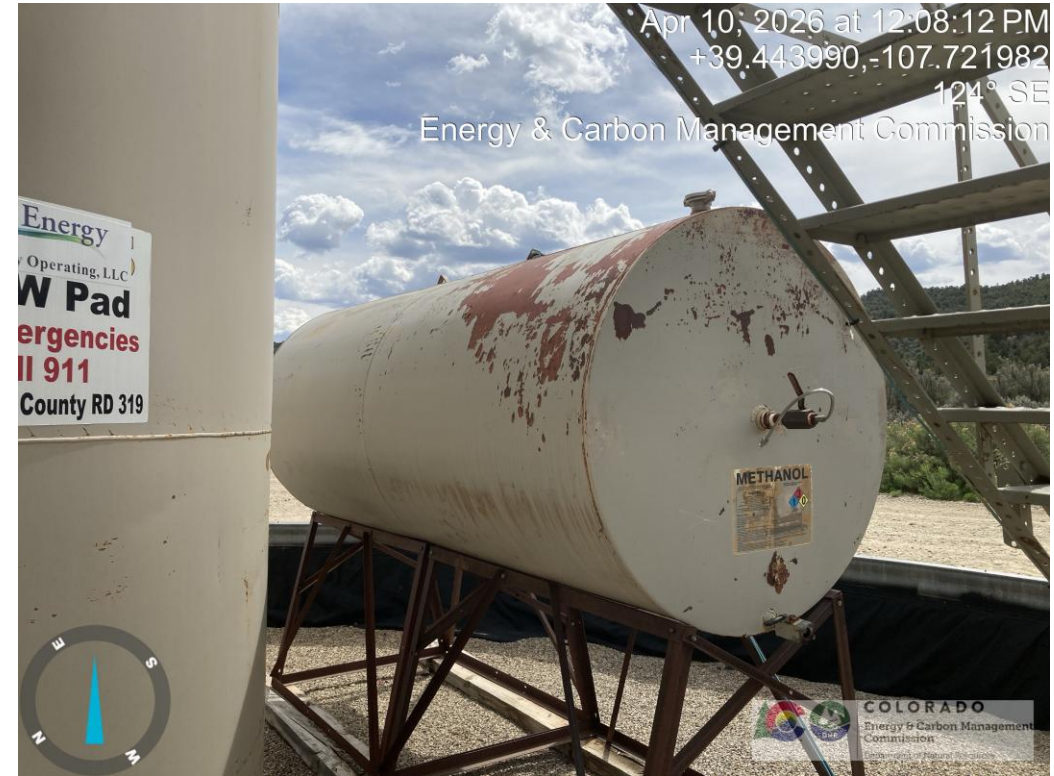
Methanol tank paint is in poor condition.

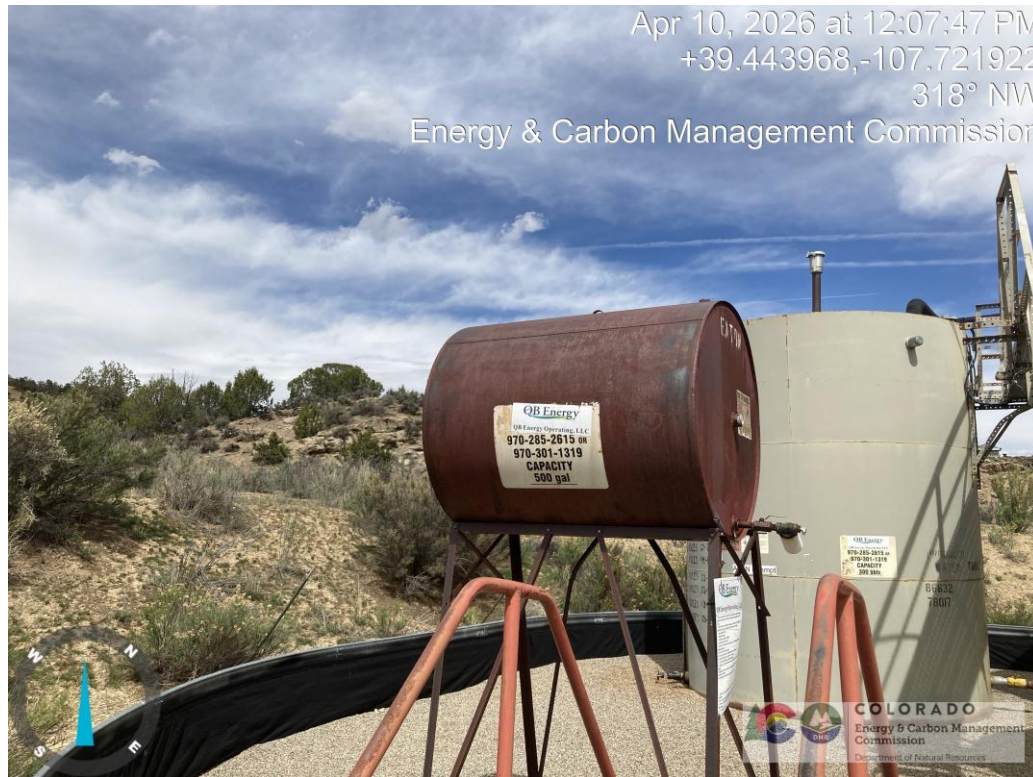
Methanol tank paint is in poor condition or lacks paint.

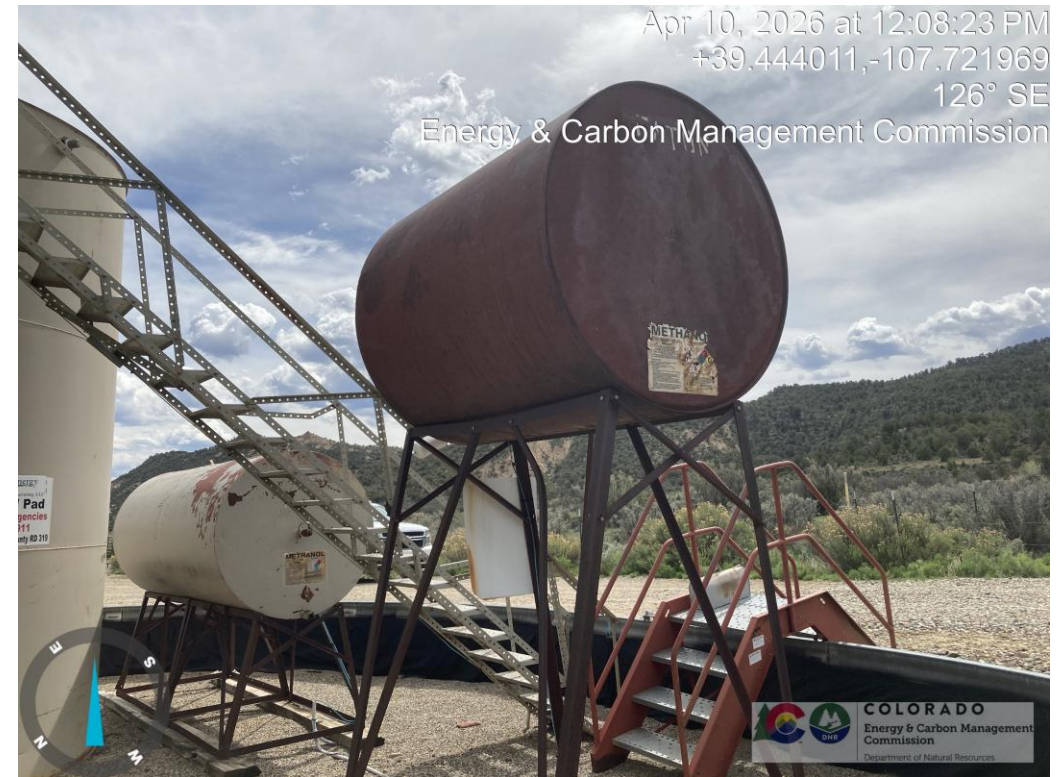
**Methanol tank paint is in poor condition or lacks paint.
Label is in poor condition.**

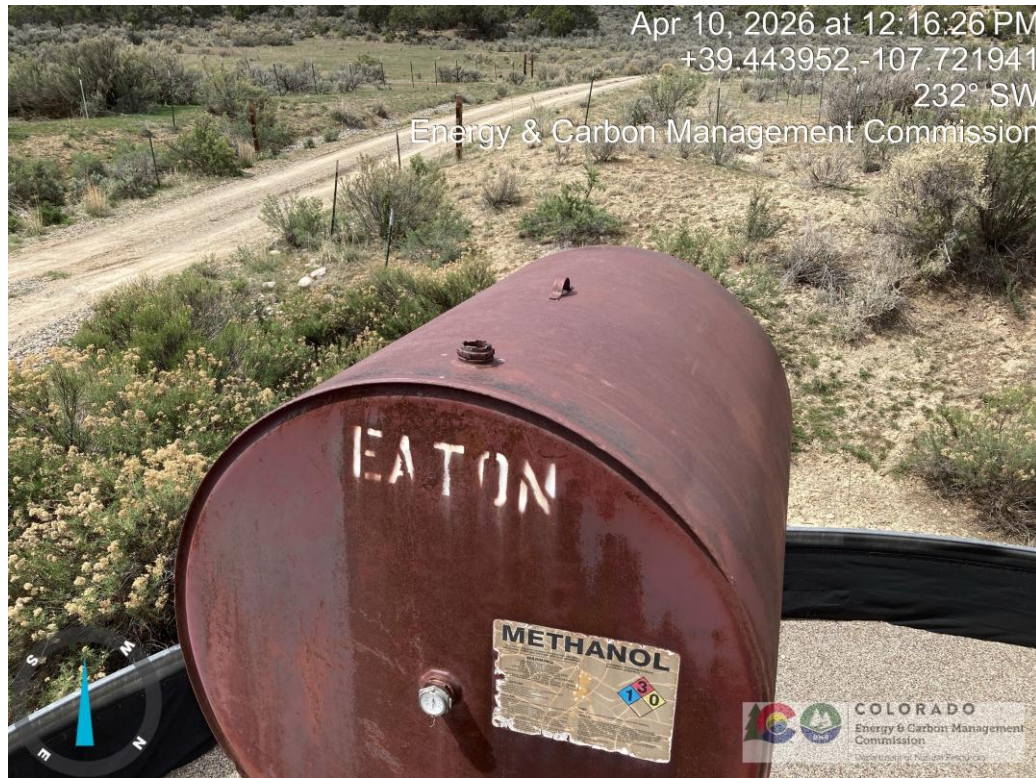
No lid on top of methanol tank.

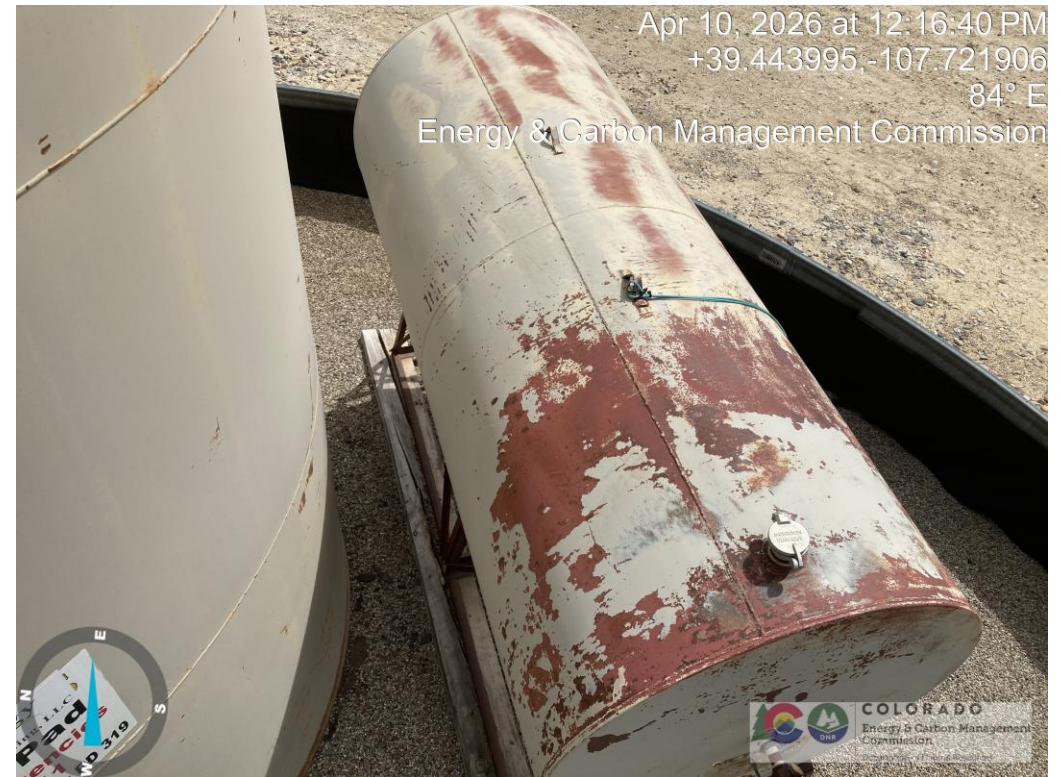
Paint is in poor condition.

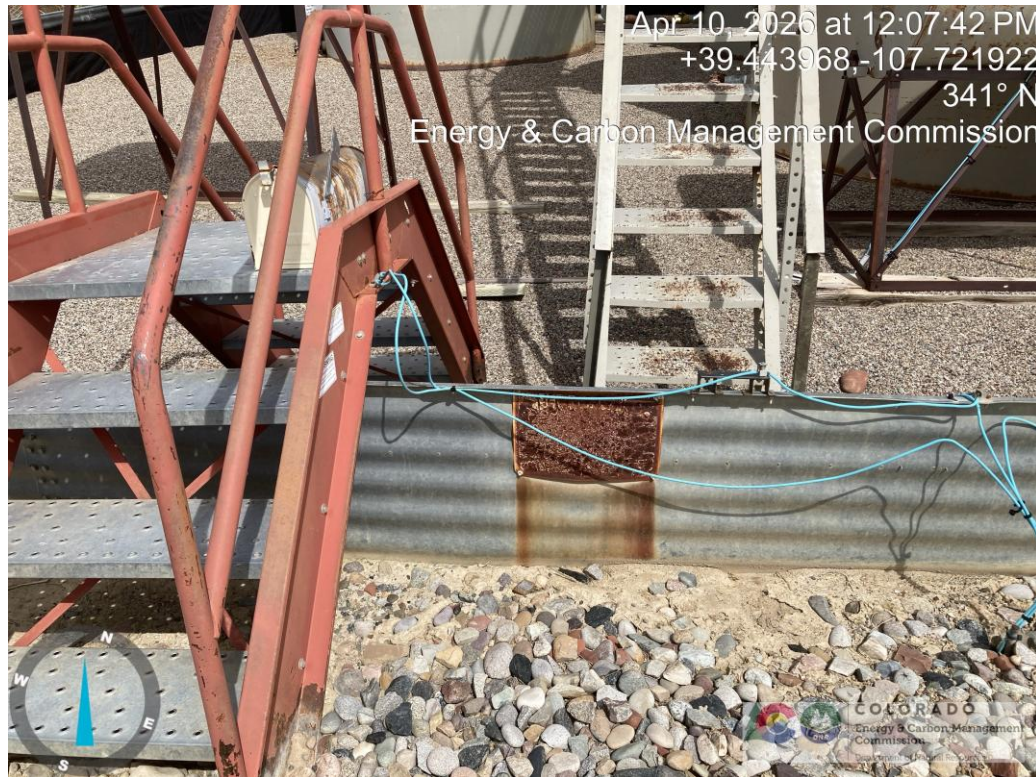
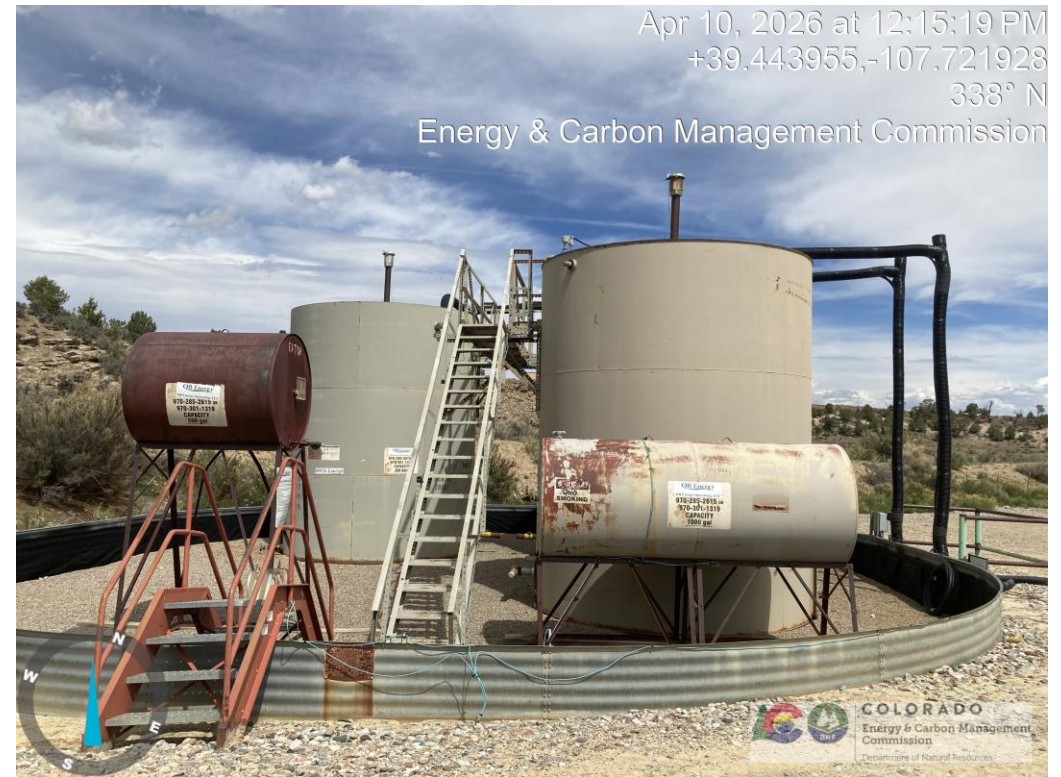
Rusted old sign on metal tank battery berm.

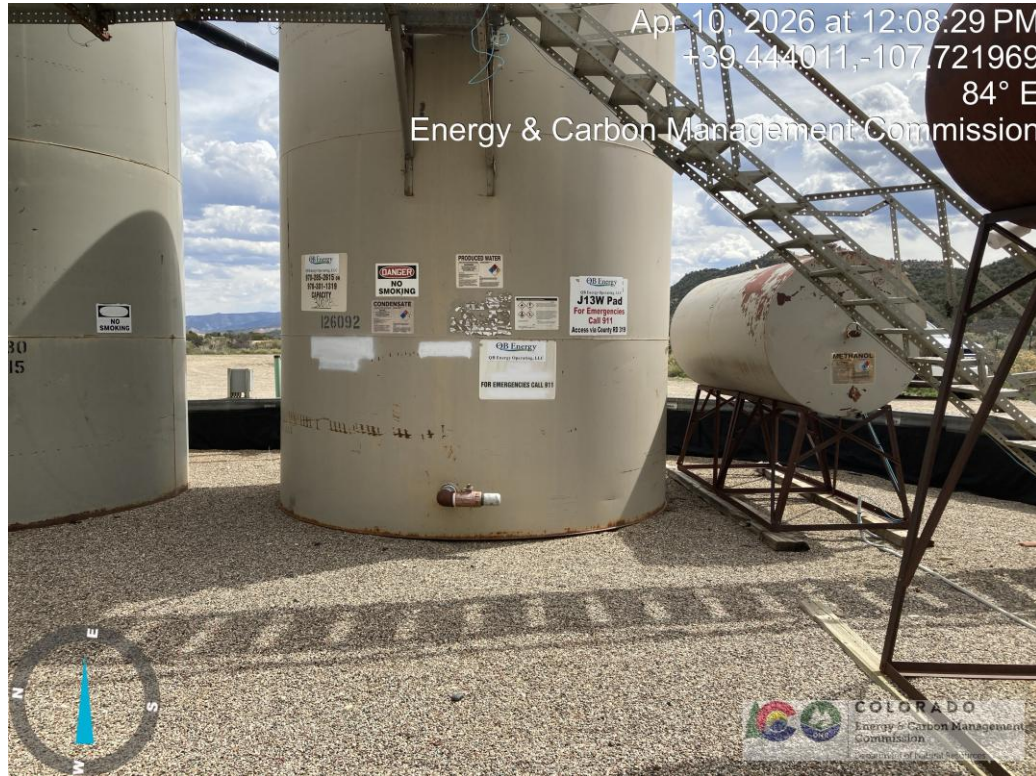
Rust around tank bottoms.

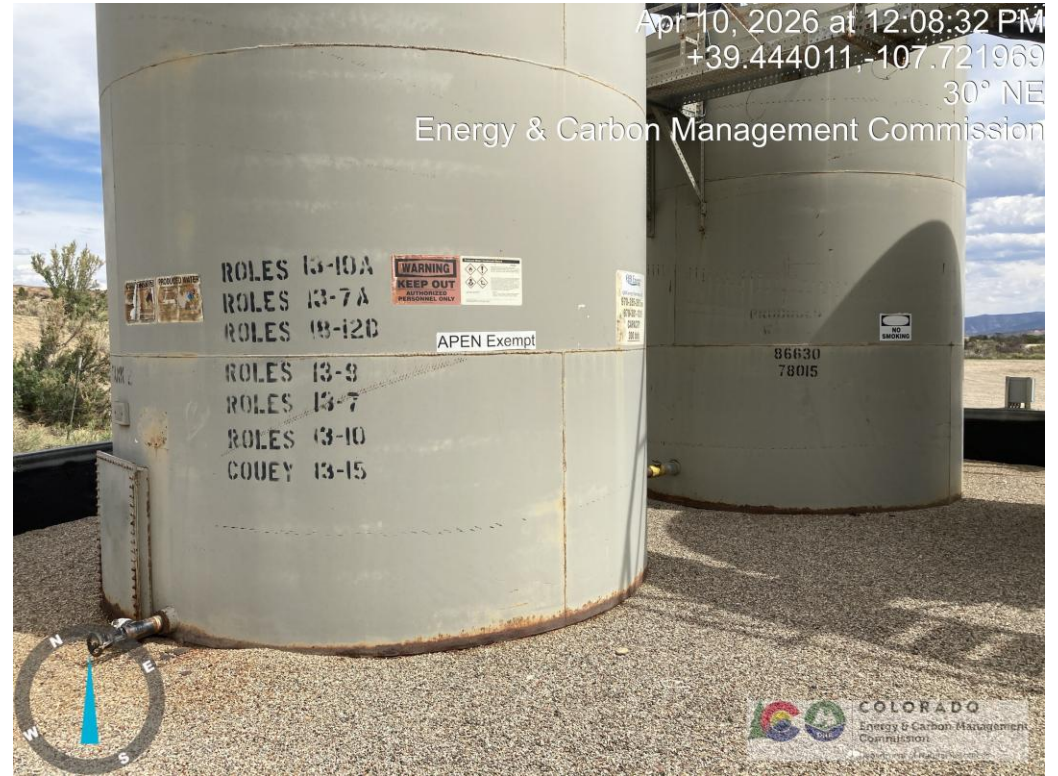
Rust around tank bottoms.

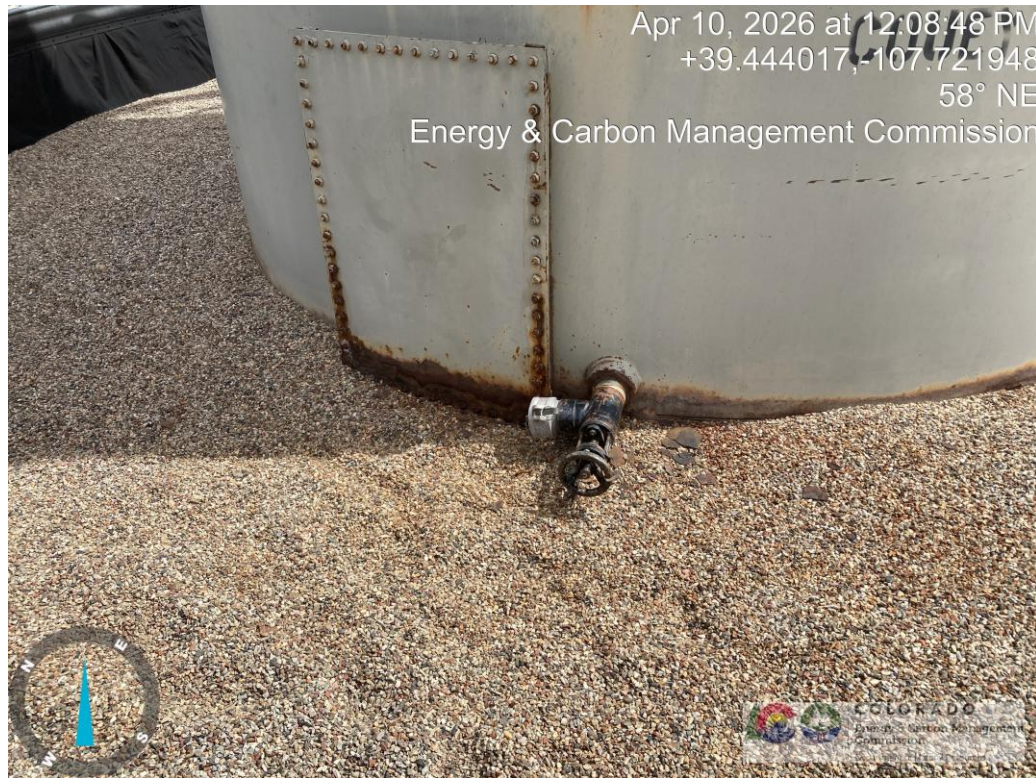
Rust around tank bottoms.

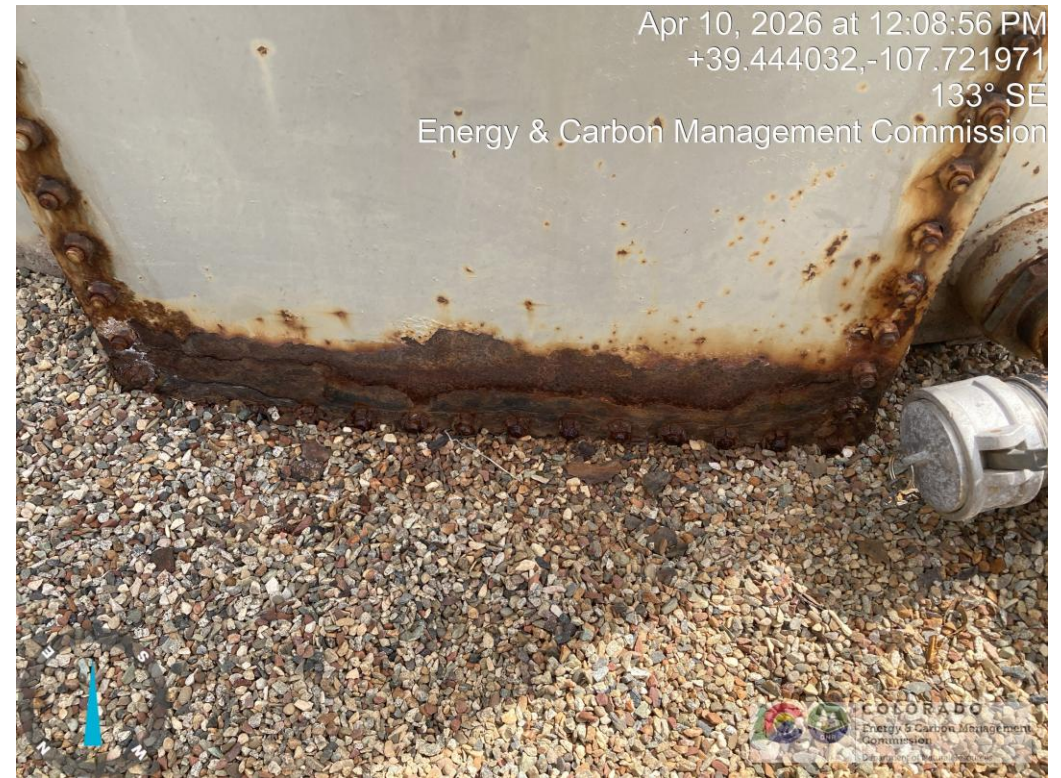
Rusted and flaking tank man hatch.

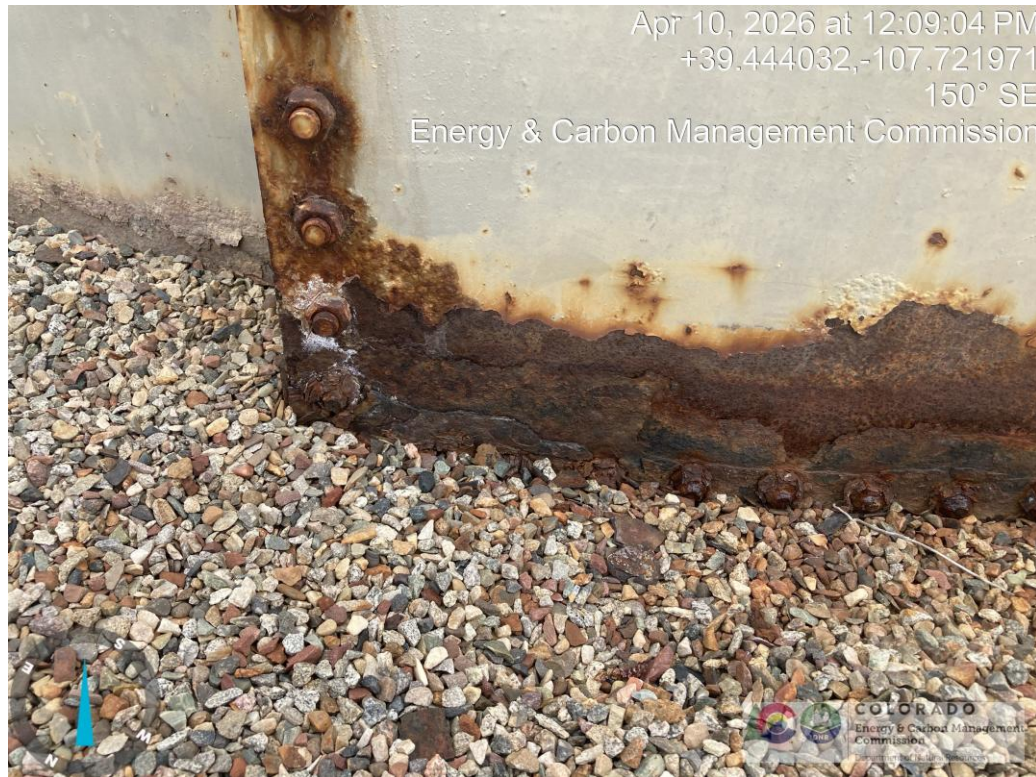
Rusted and flaking tank man hatch and bolts.

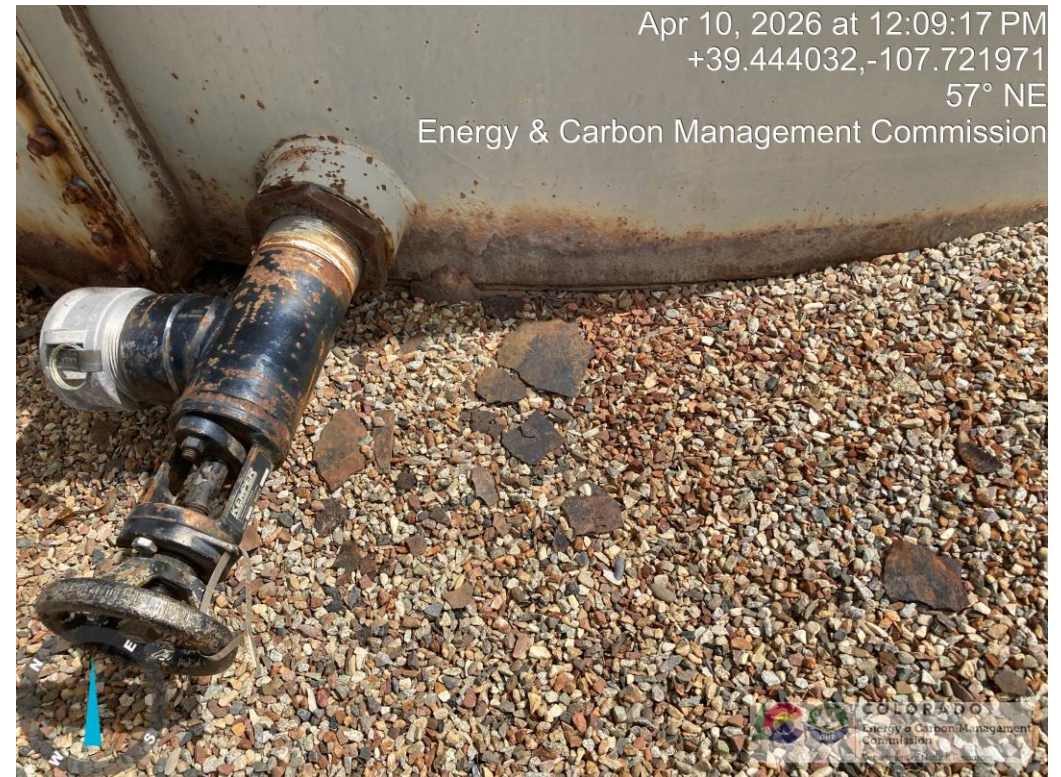
Paint deterioration and areas of rust.

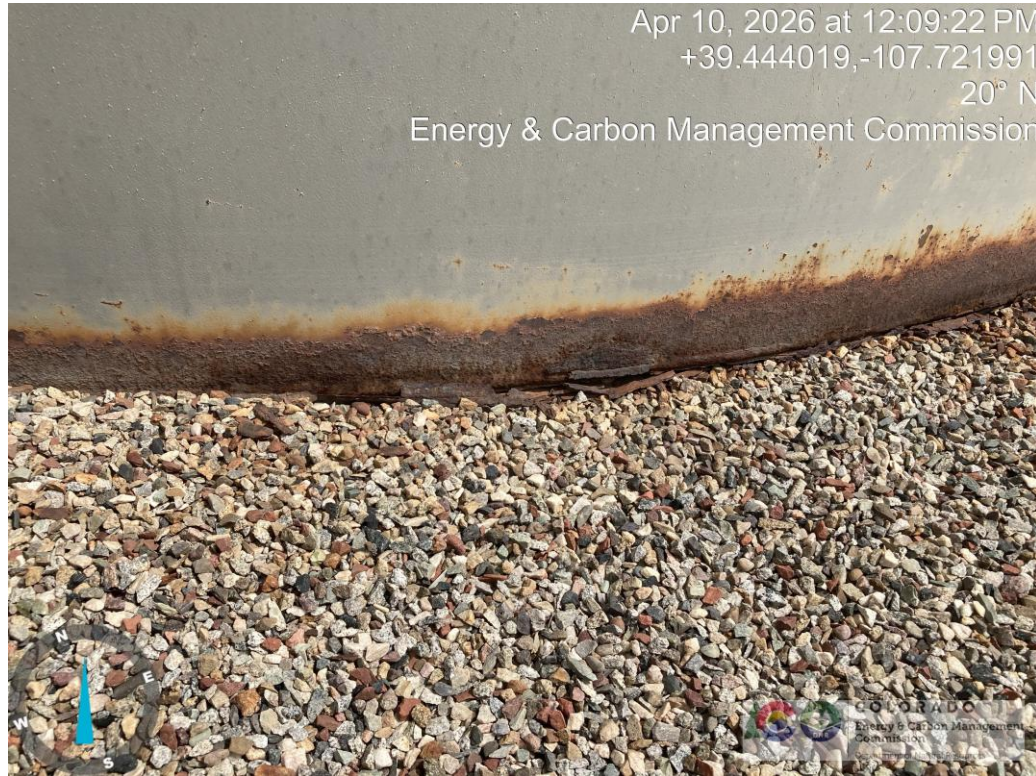
Paint deterioration and areas of rust.

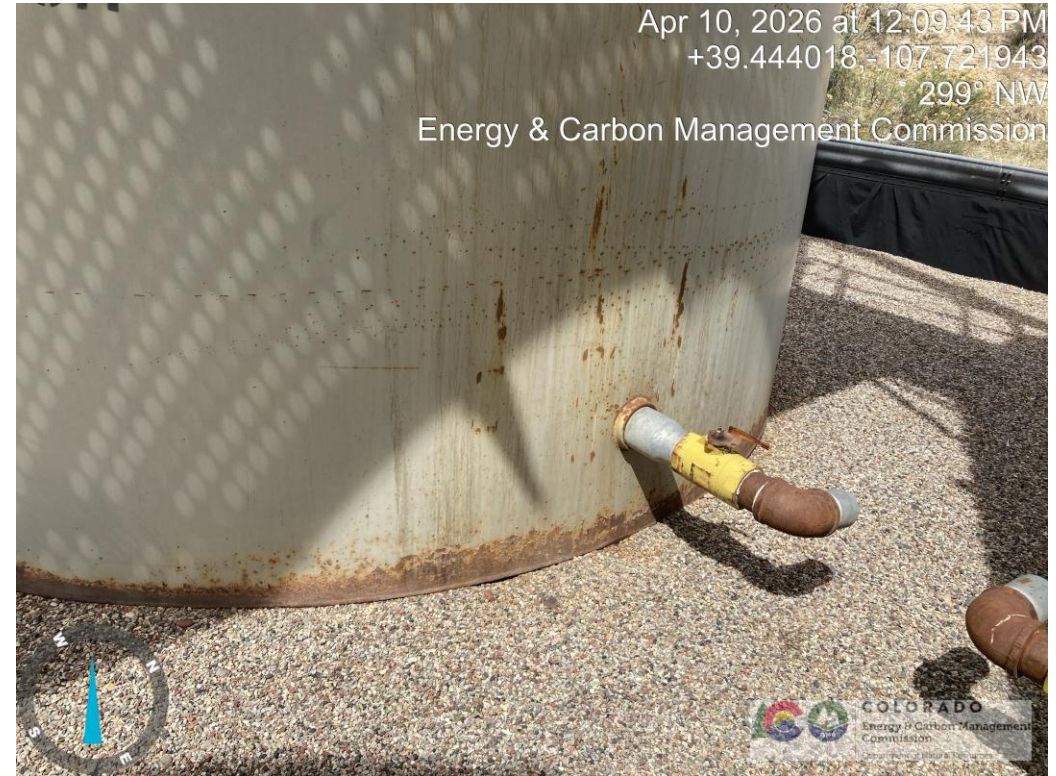
Paint deterioration and areas of rust.

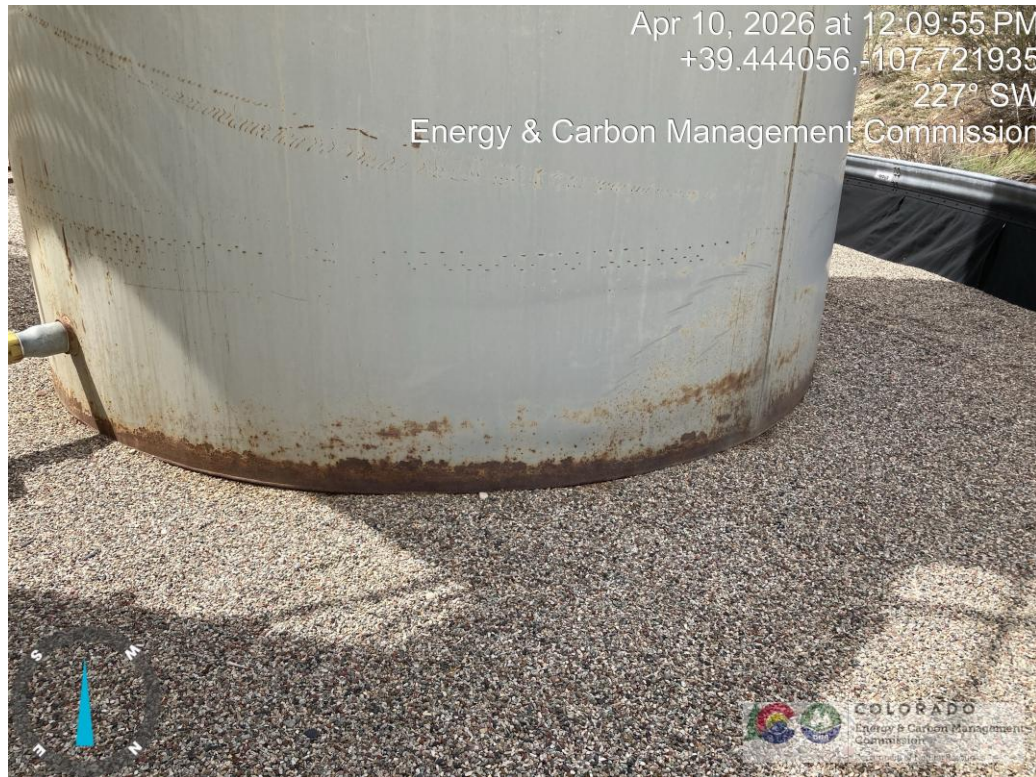
Paint deterioration and areas of rust.

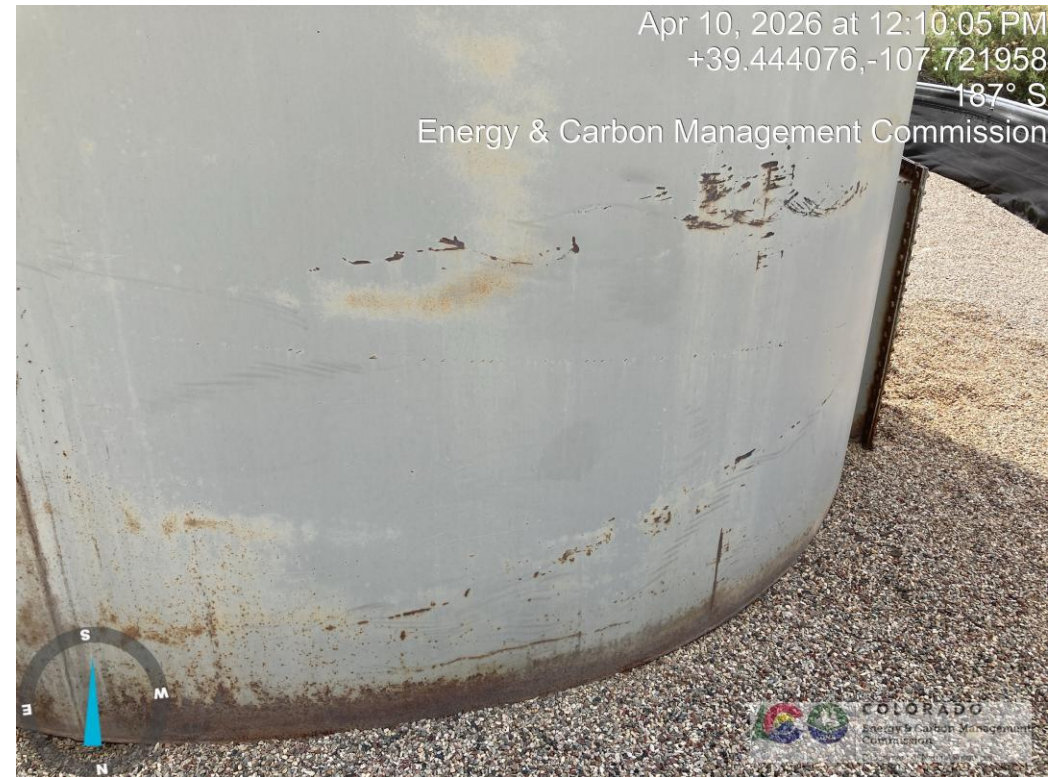
Paint deterioration and areas of rust.

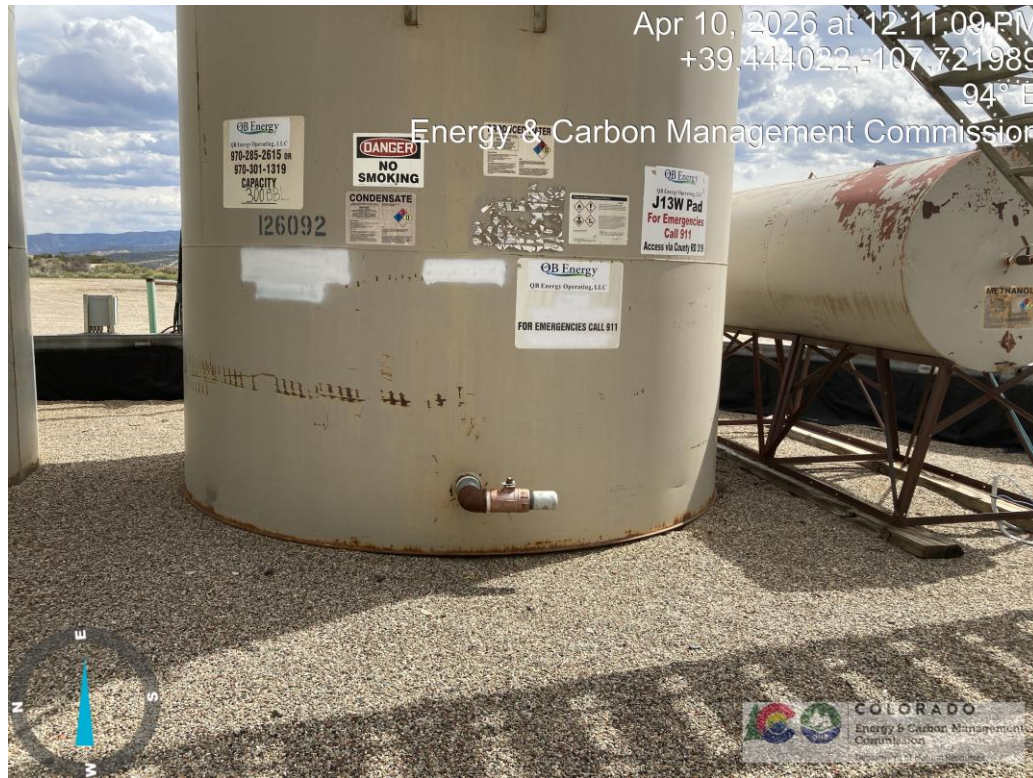
Paint deterioration and areas of rust.

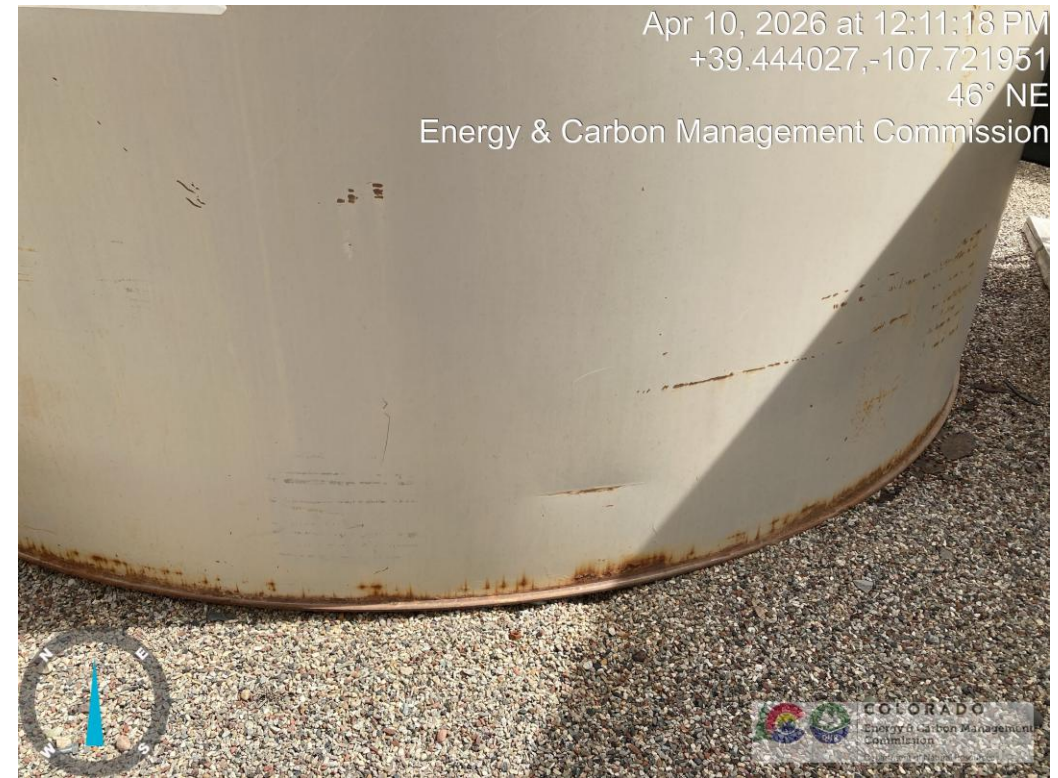
Paint deterioration and areas of rust.

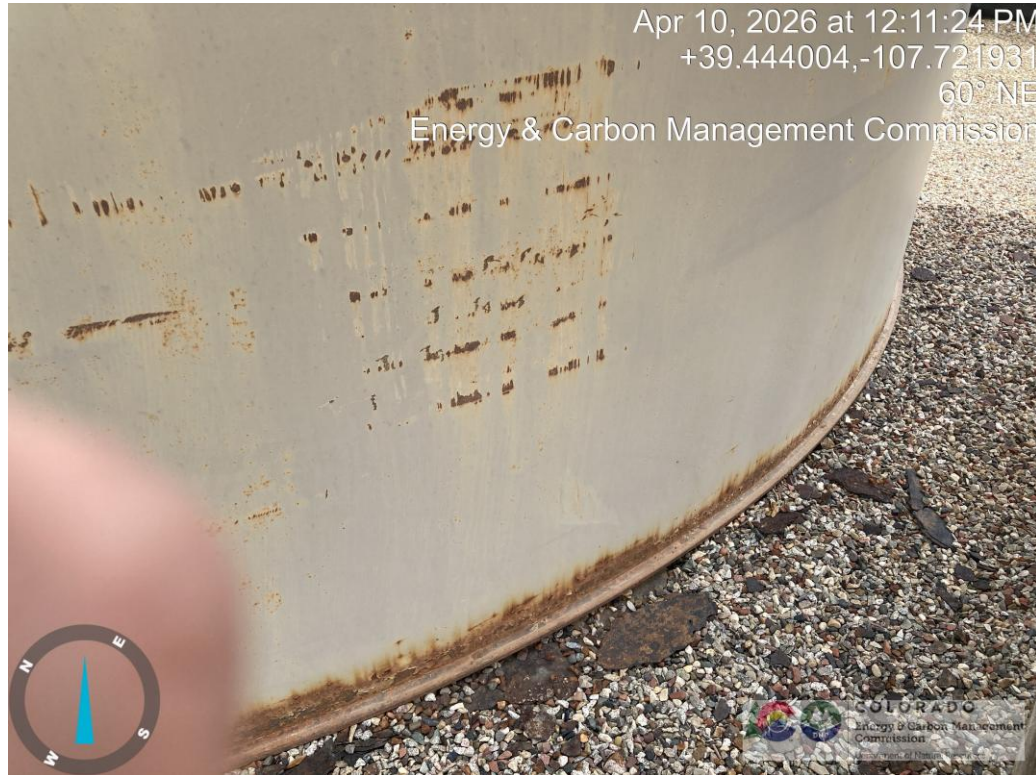
Paint deterioration and areas of rust.

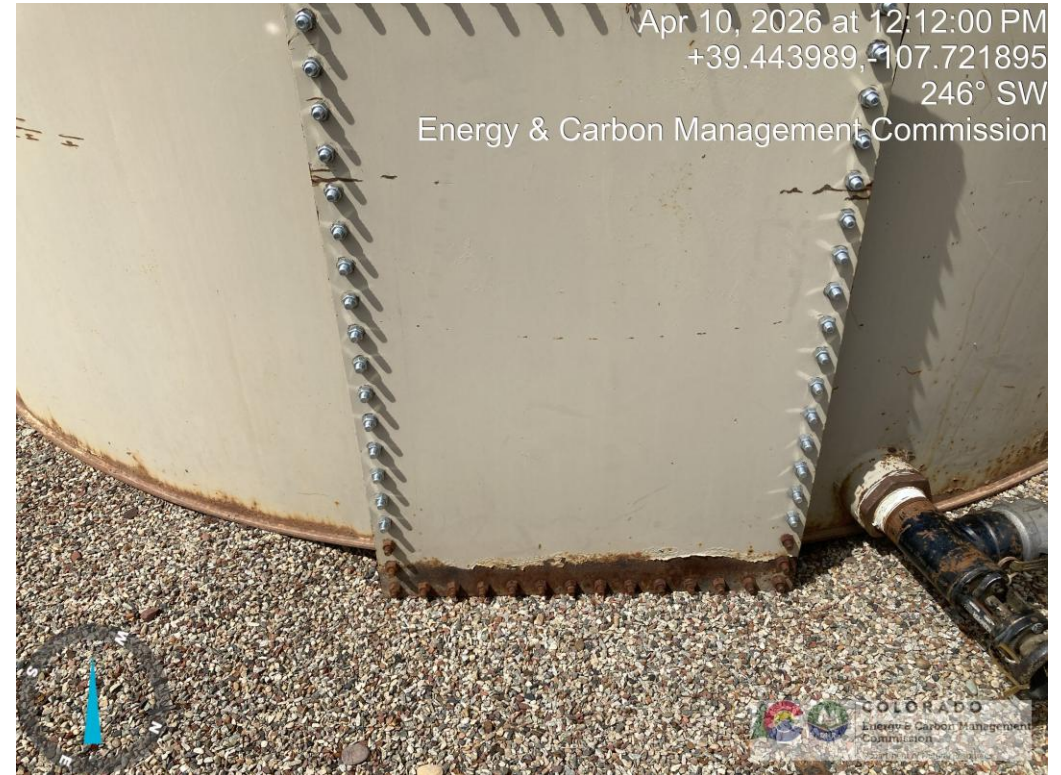
Rusted and flaking tank man hatch and bolts.

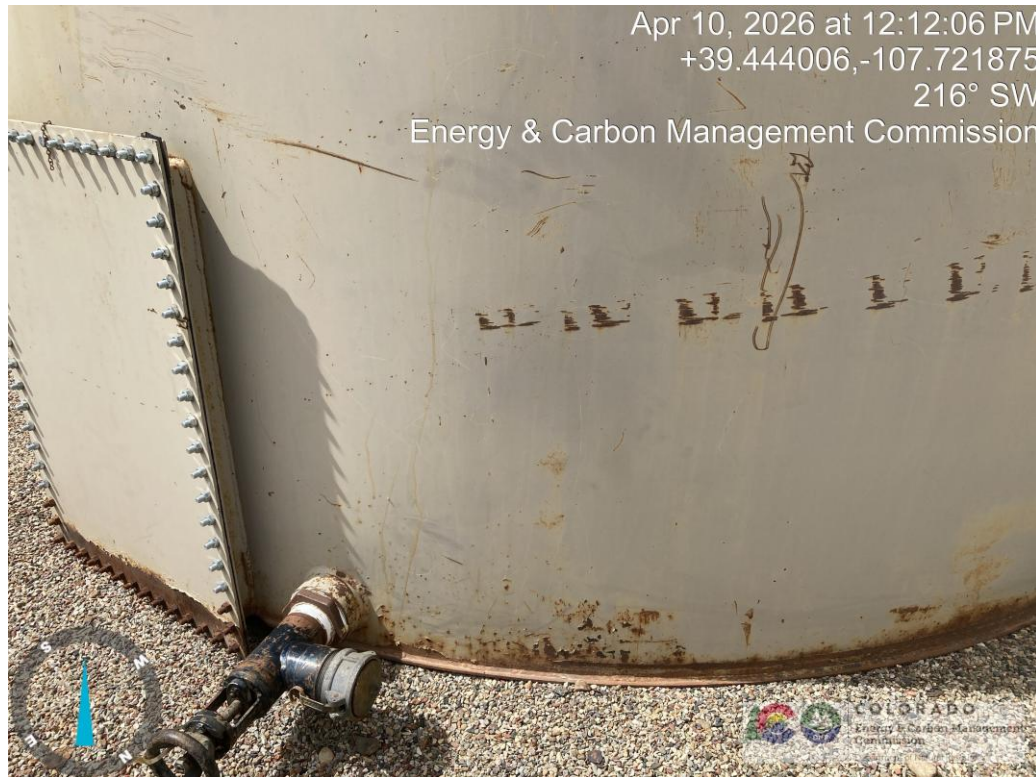
Paint deterioration and areas of rust.

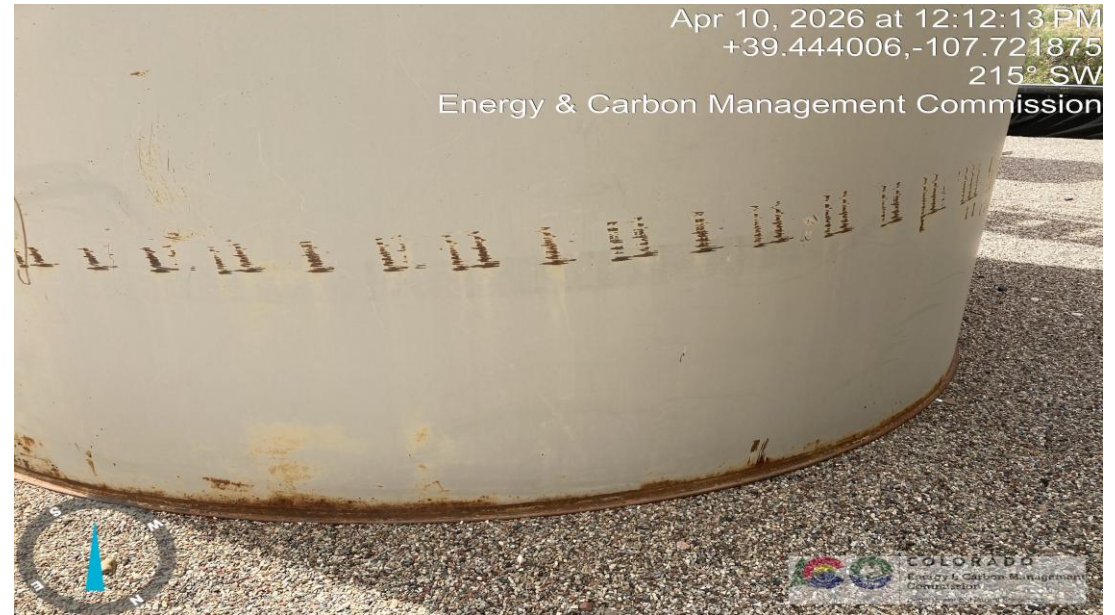
Paint deterioration and areas of rust.

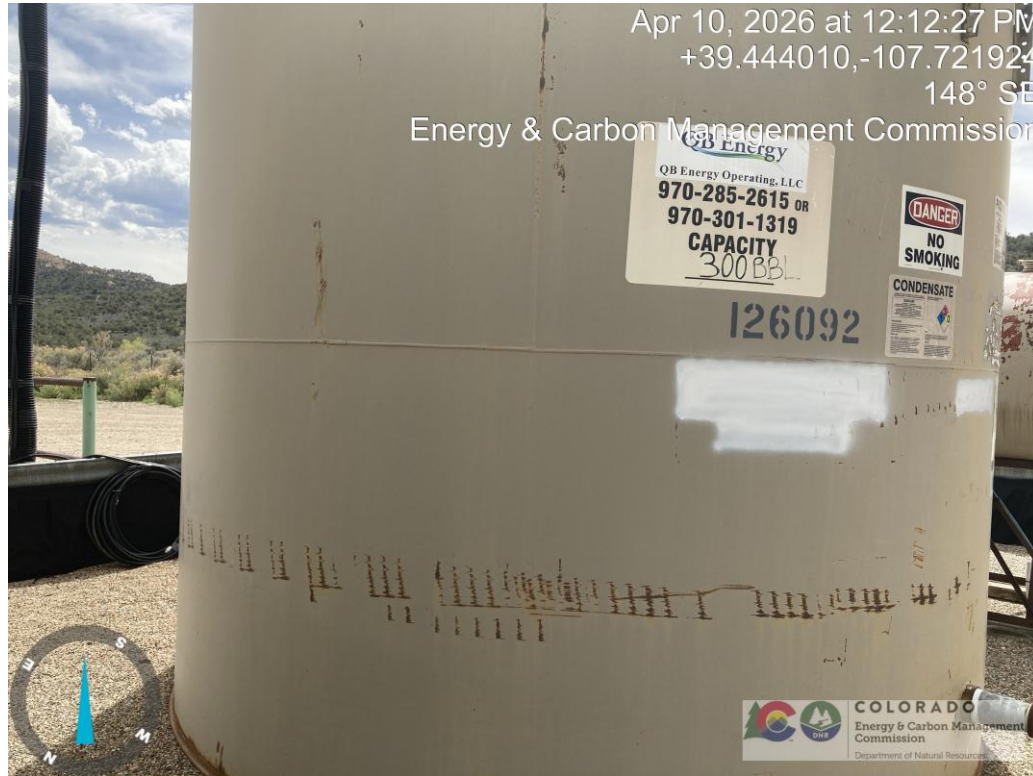
Paint deterioration and areas of rust.

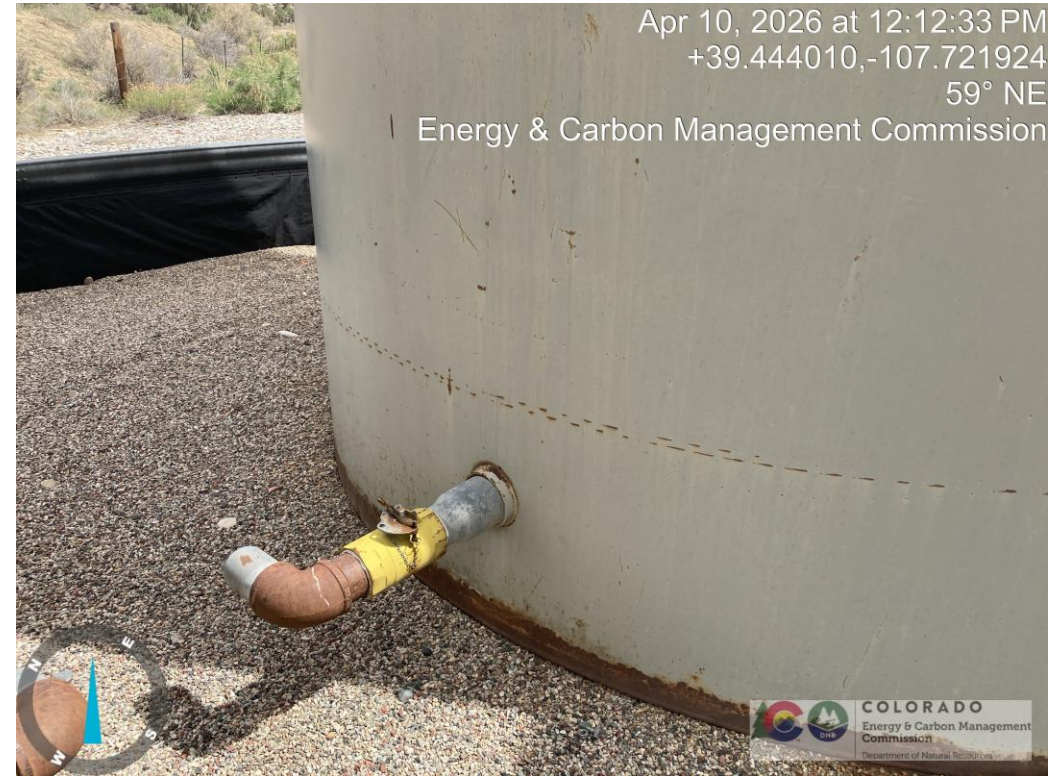
Paint deterioration and areas of rust.

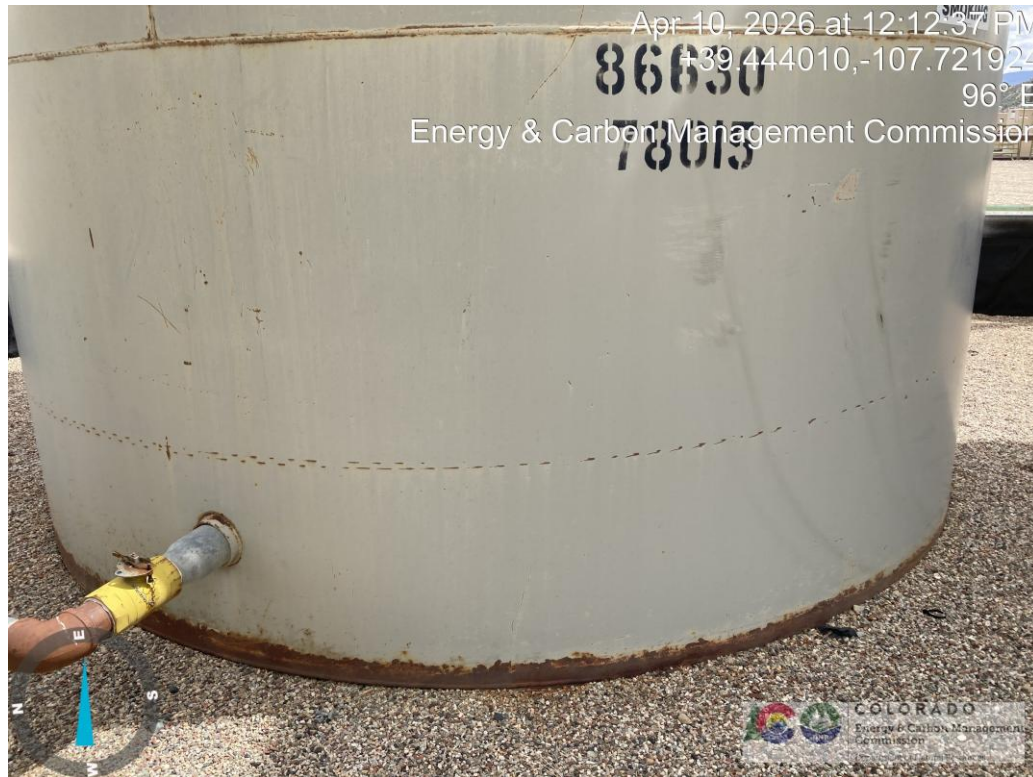
Paint deterioration and areas of rust.

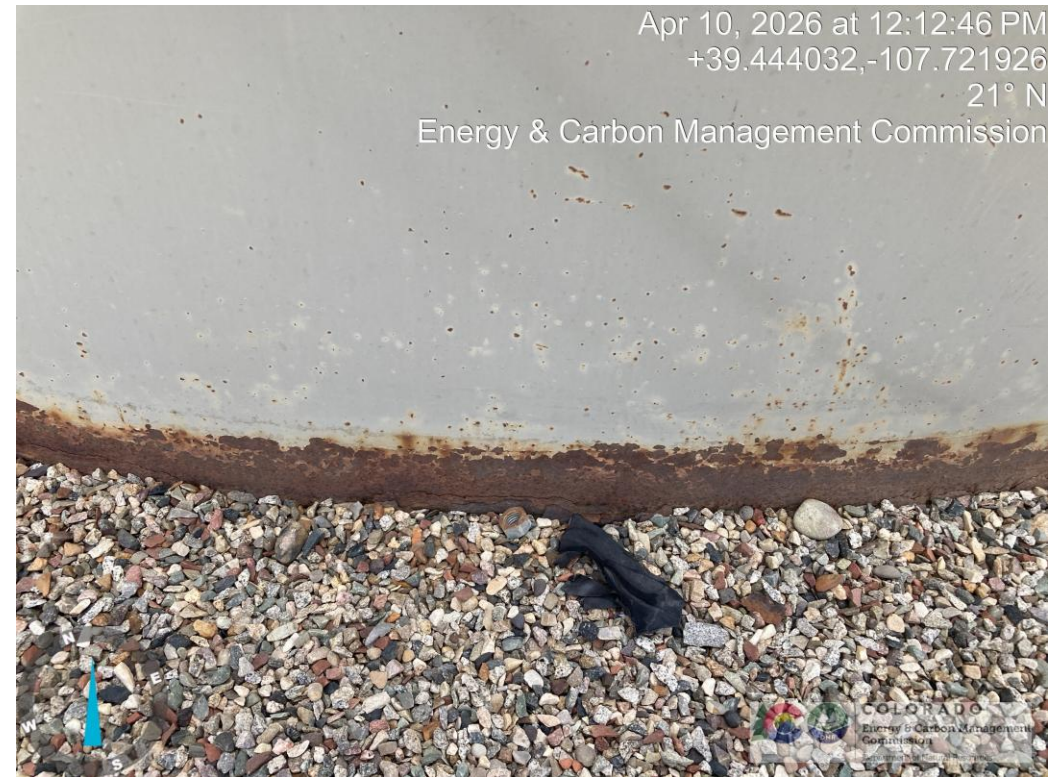
Paint deterioration and areas of rust.
