QB ENERGY OPERATING LLC ROLES-67S93W 13NESE (J13W) Facility # 334558

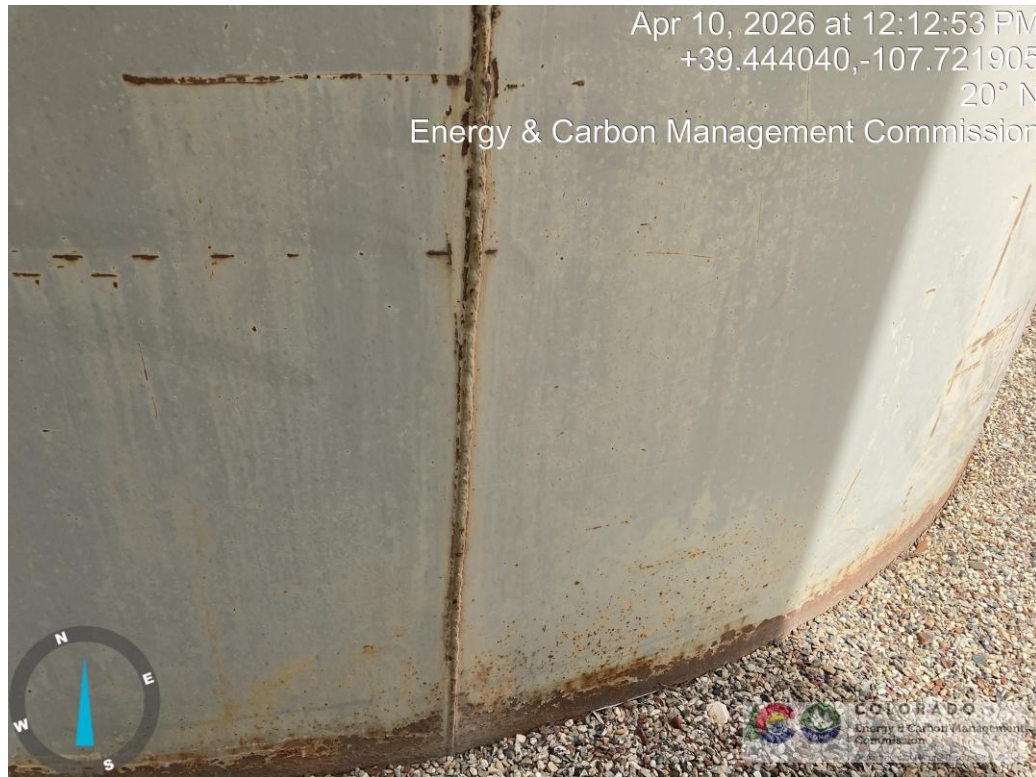
Paint deterioration and areas of rust.

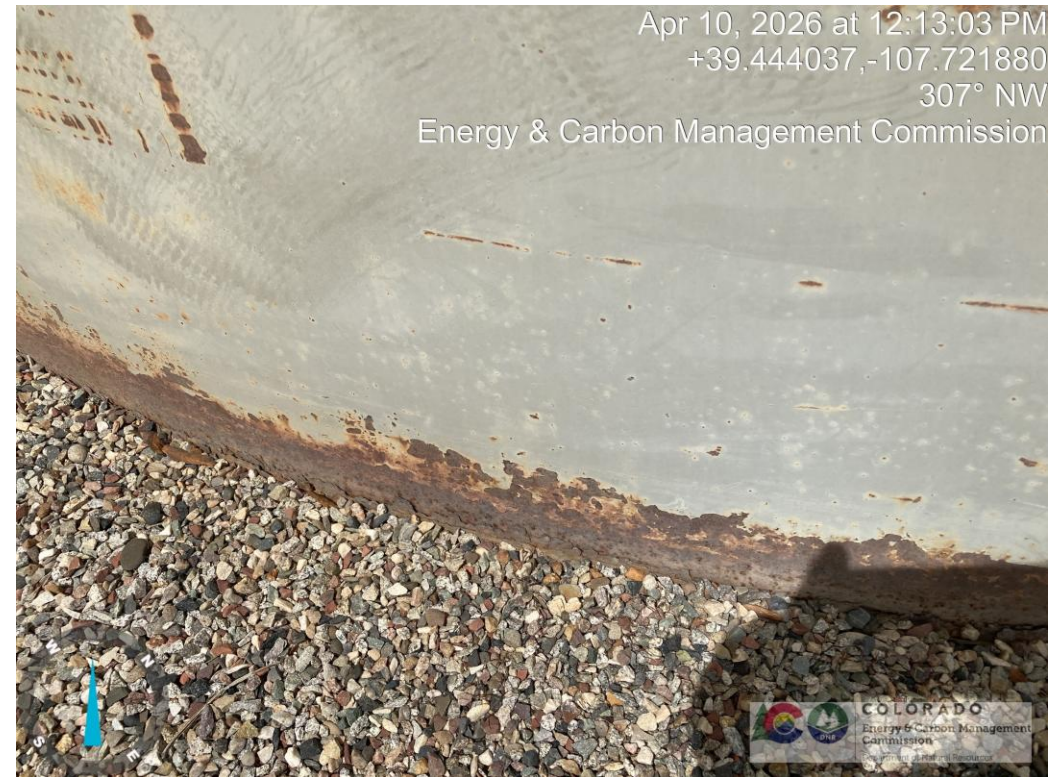
Paint deterioration and areas of rust.

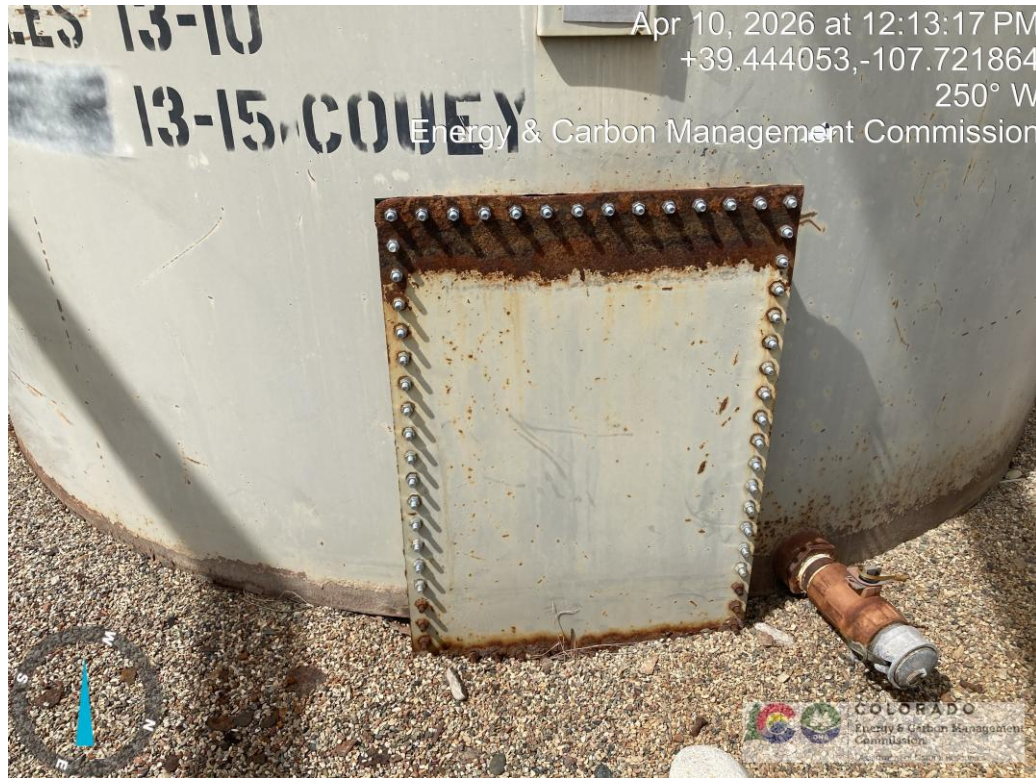
Rusted and flaking tank man hatch and bolts.

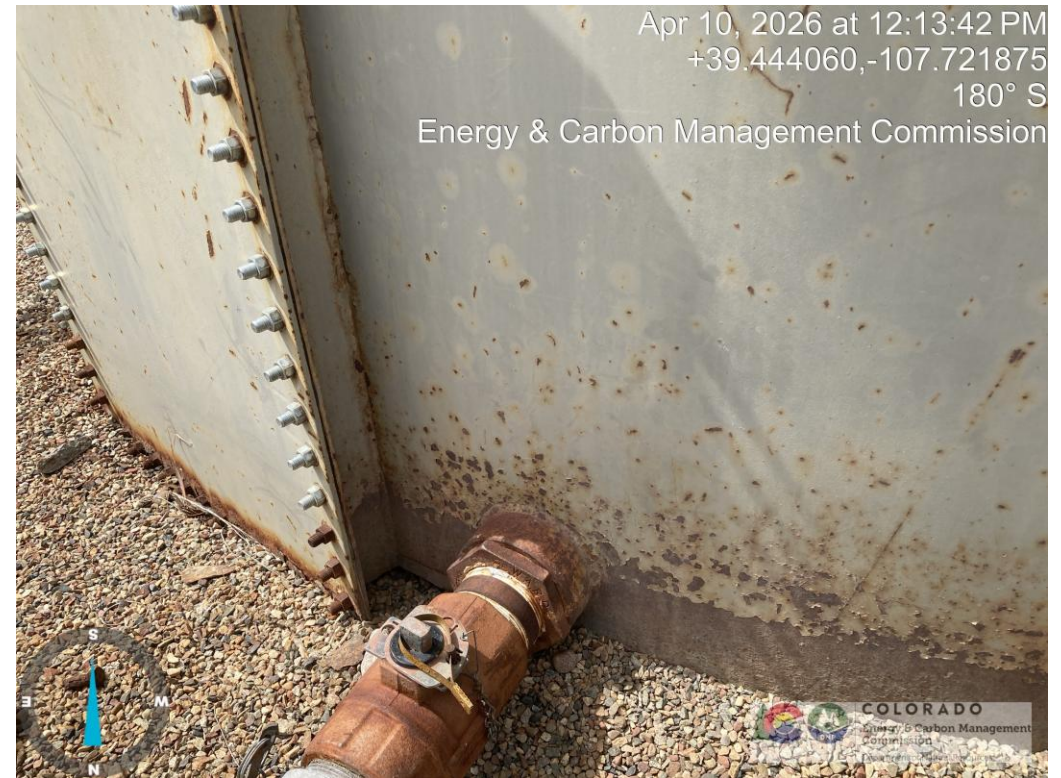
Paint deterioration and areas of rust.

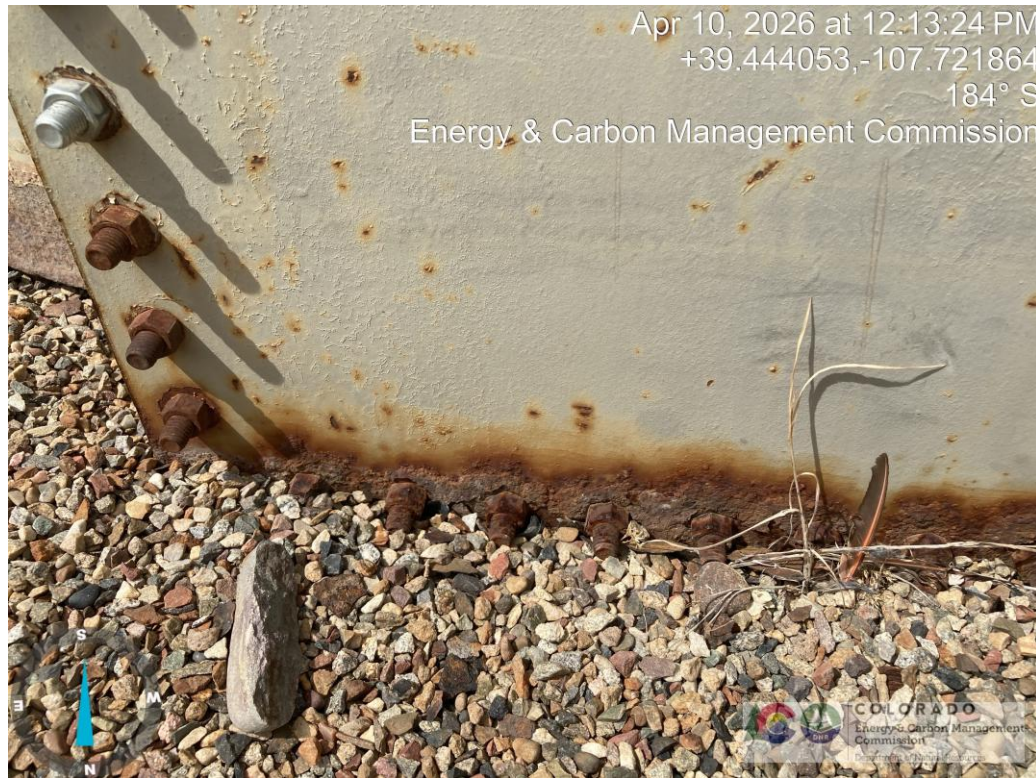
Rusted and flaking tank man hatch and bolts.

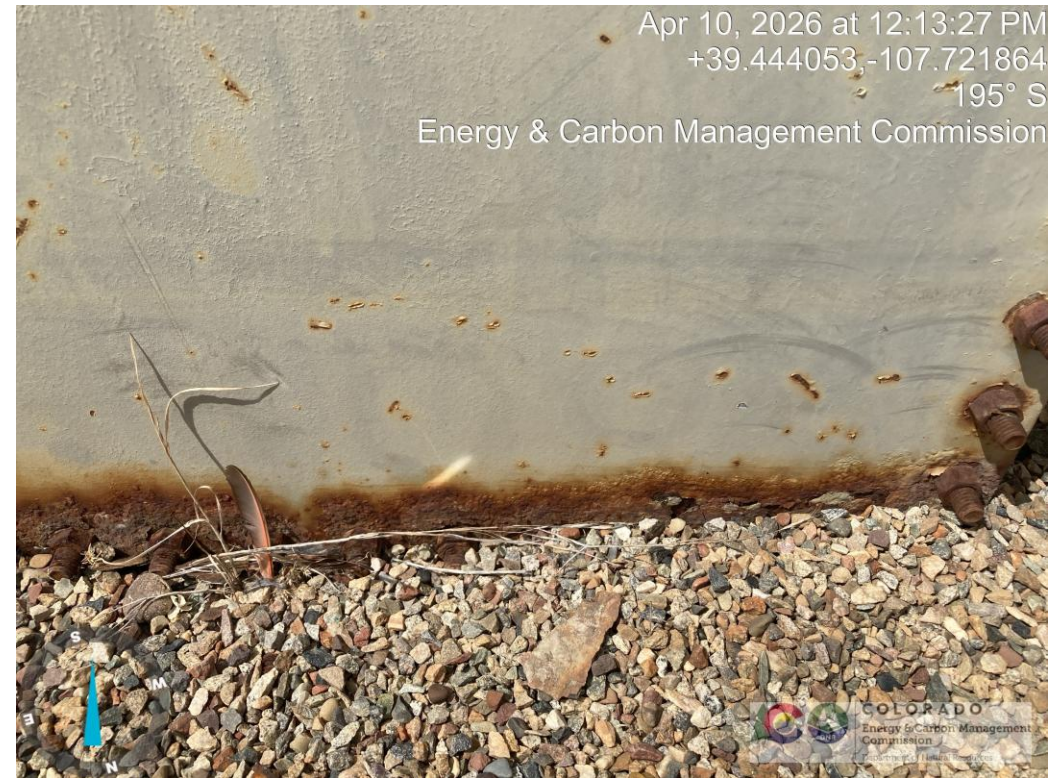
Rusted and flaking tank man hatch and bolts.

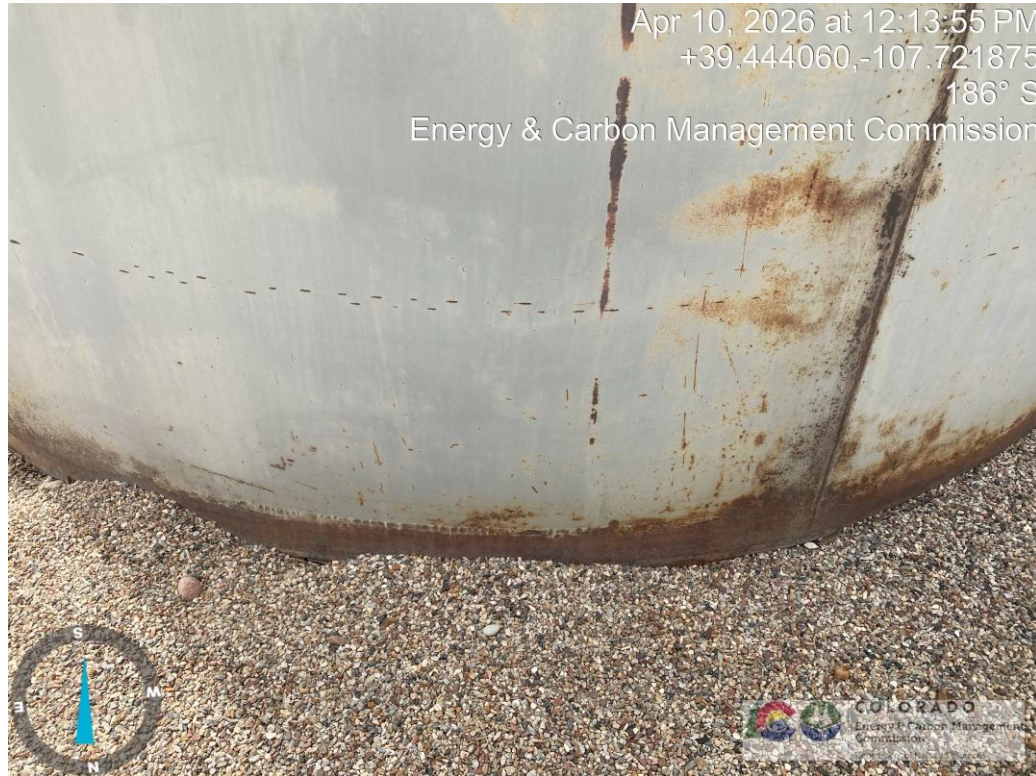
Paint deterioration and areas of rust.

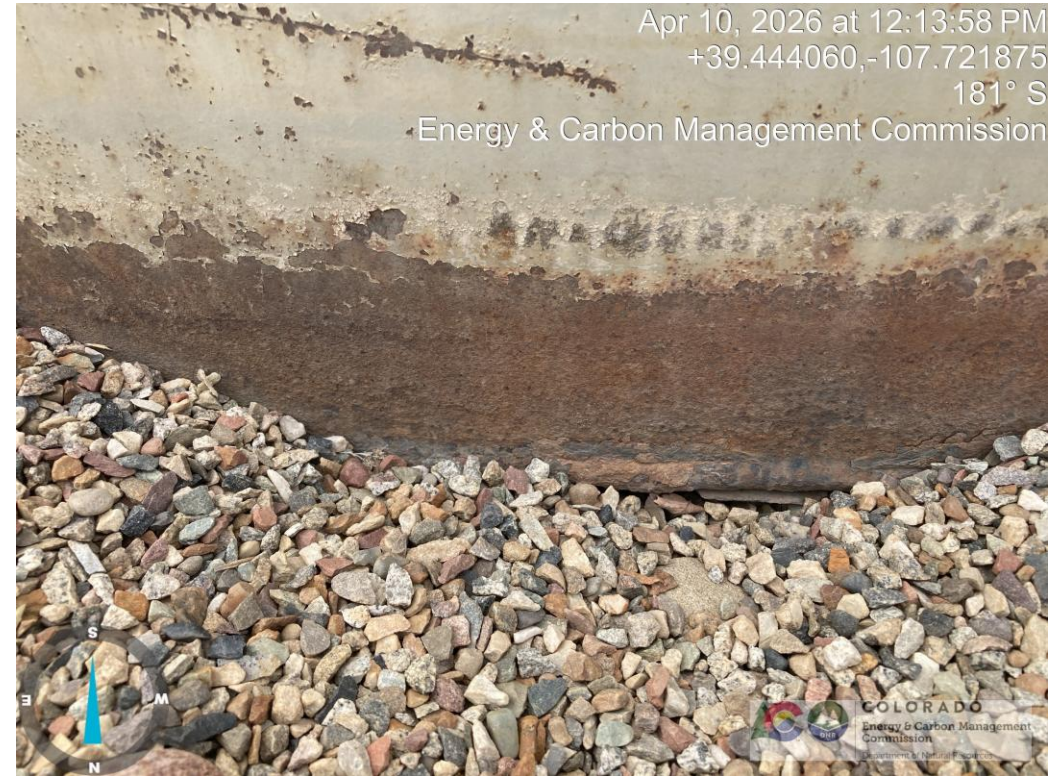
Paint deterioration and areas of rust.

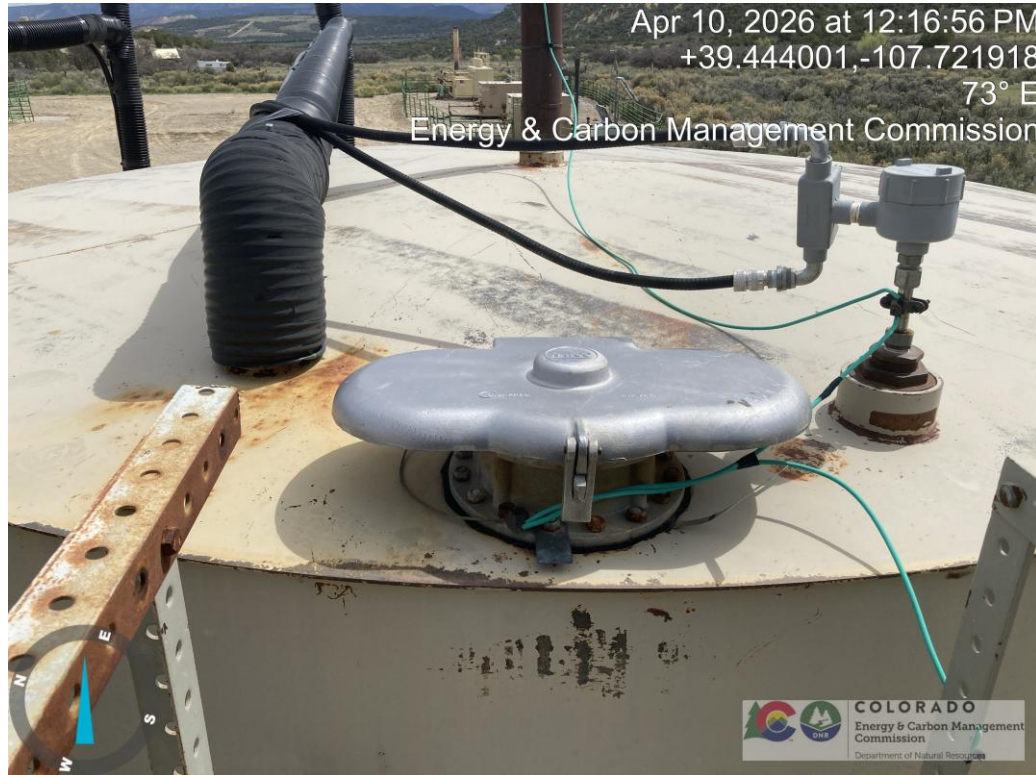
Top of tank is rusted out around the dumphline inlet.

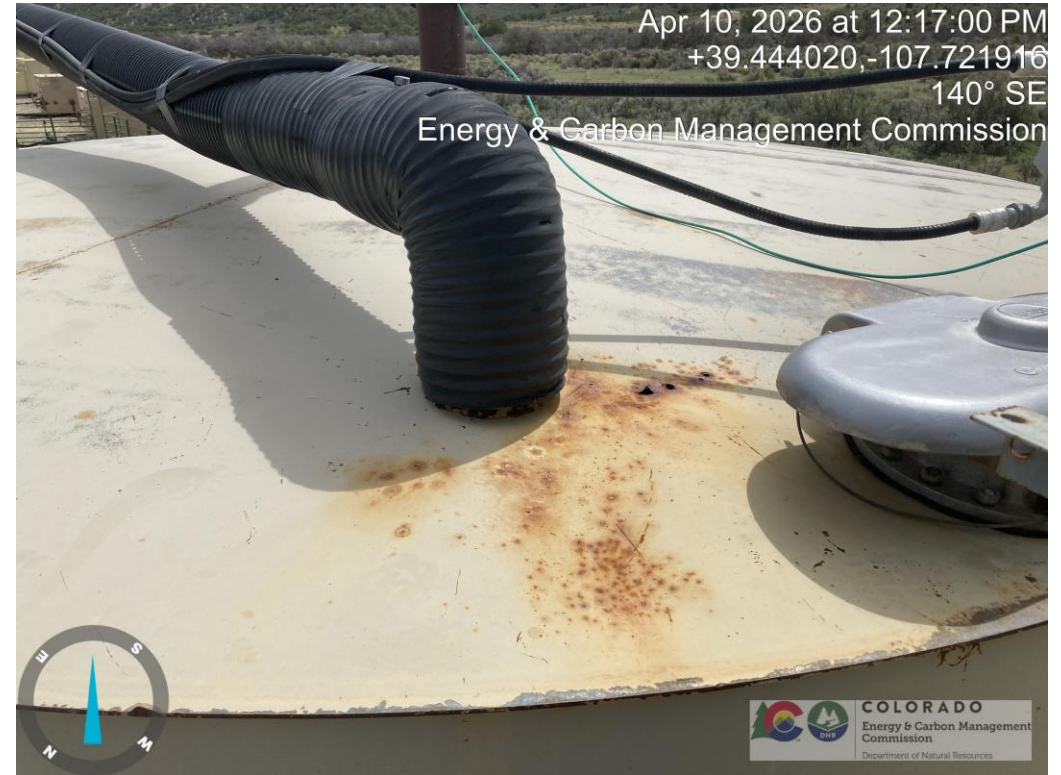
Top of tank is rusted out around the dumphline inlet.

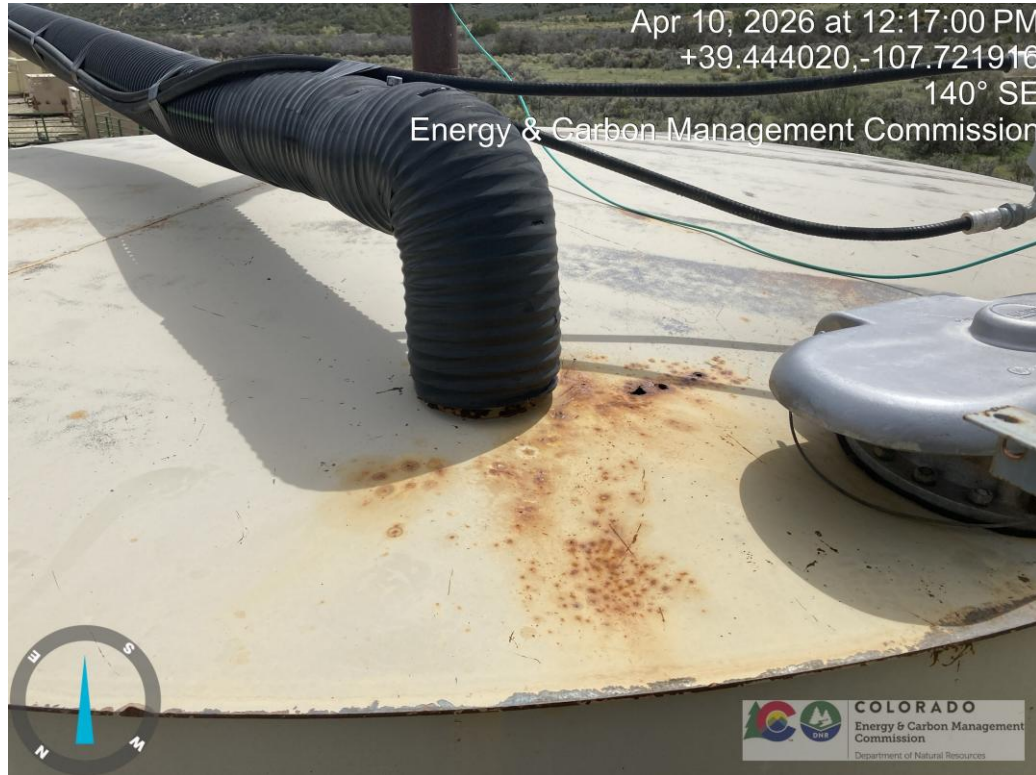
Top of tank is rusted out around the dumlaine inlet.

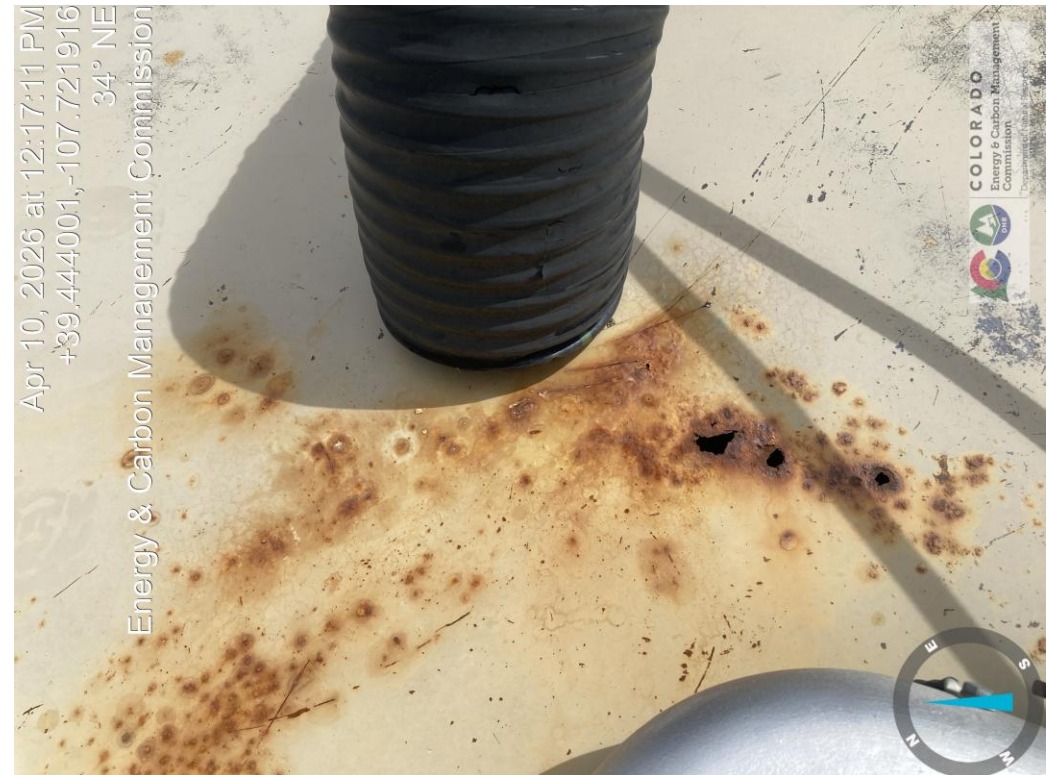
Top of tank is rusted out around the dumlaine inlet.

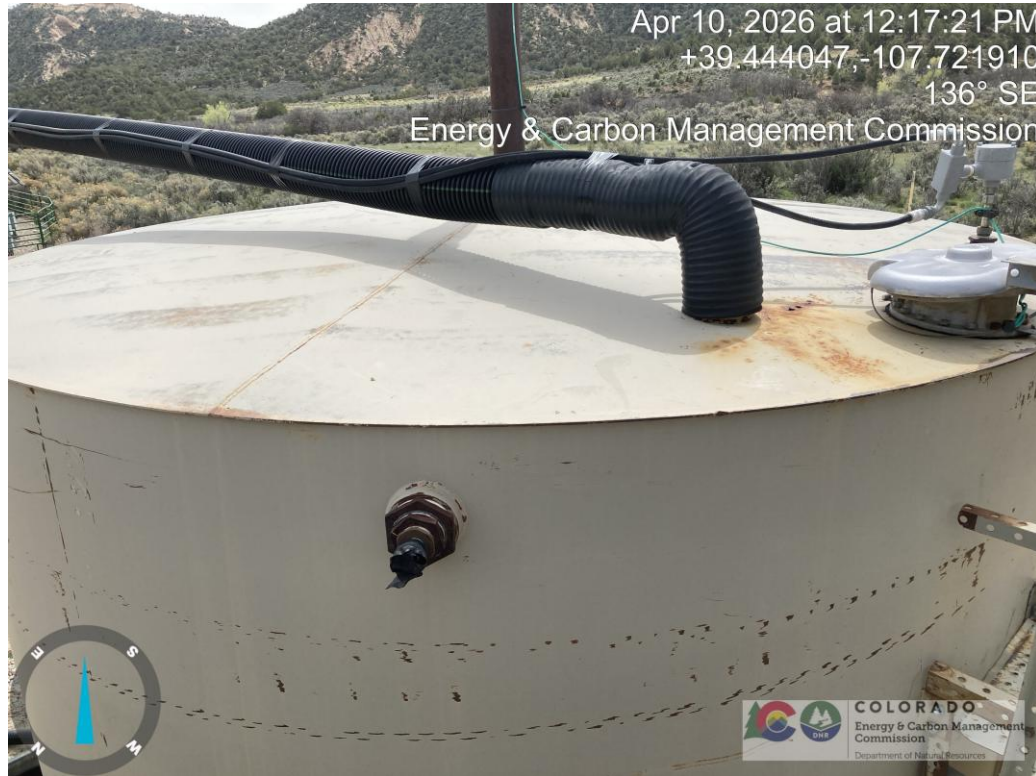
Top of tank is rusted out around the dumlaine inlet.

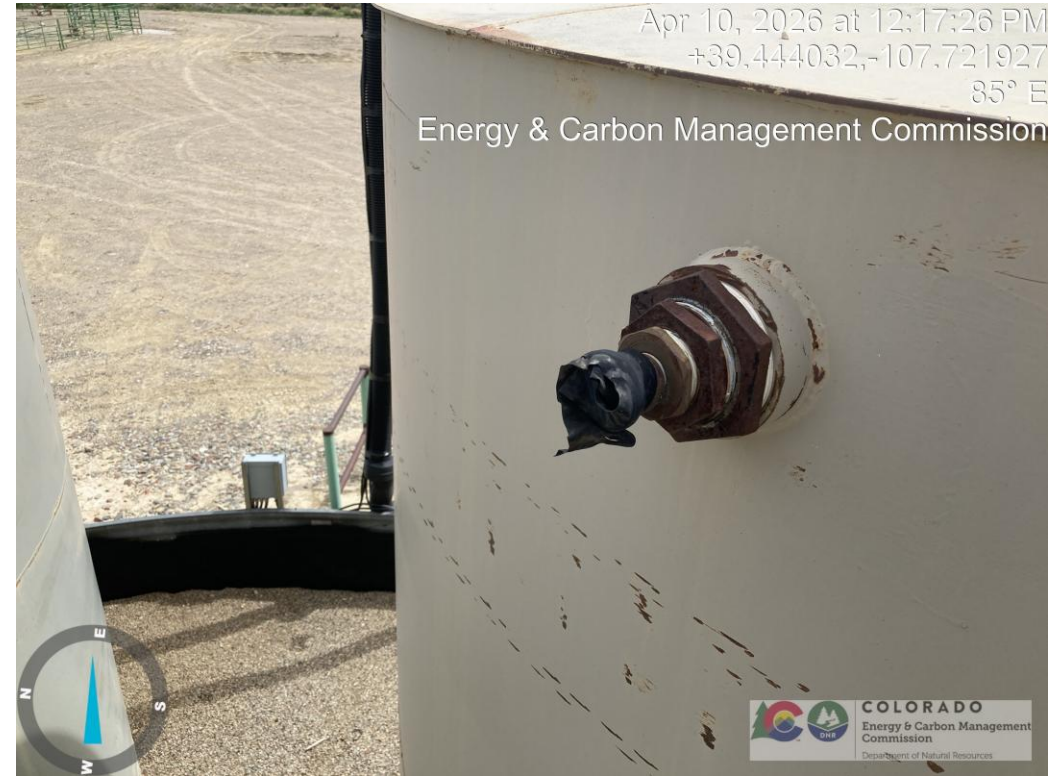
Rusted and tapped inlet fittings

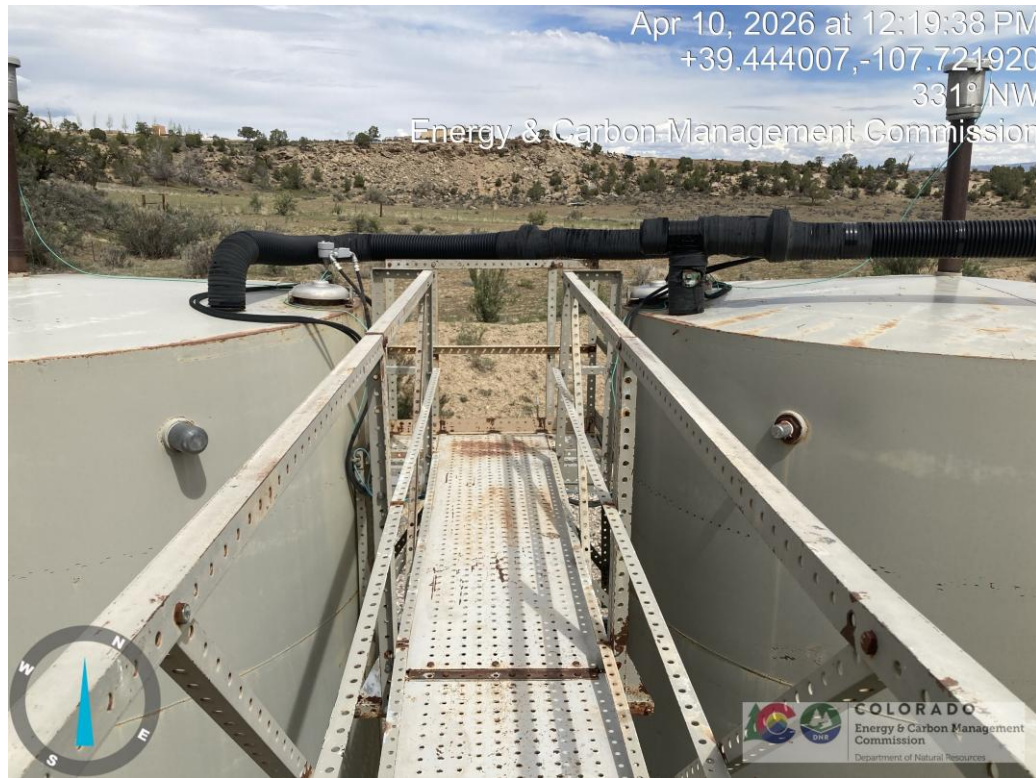
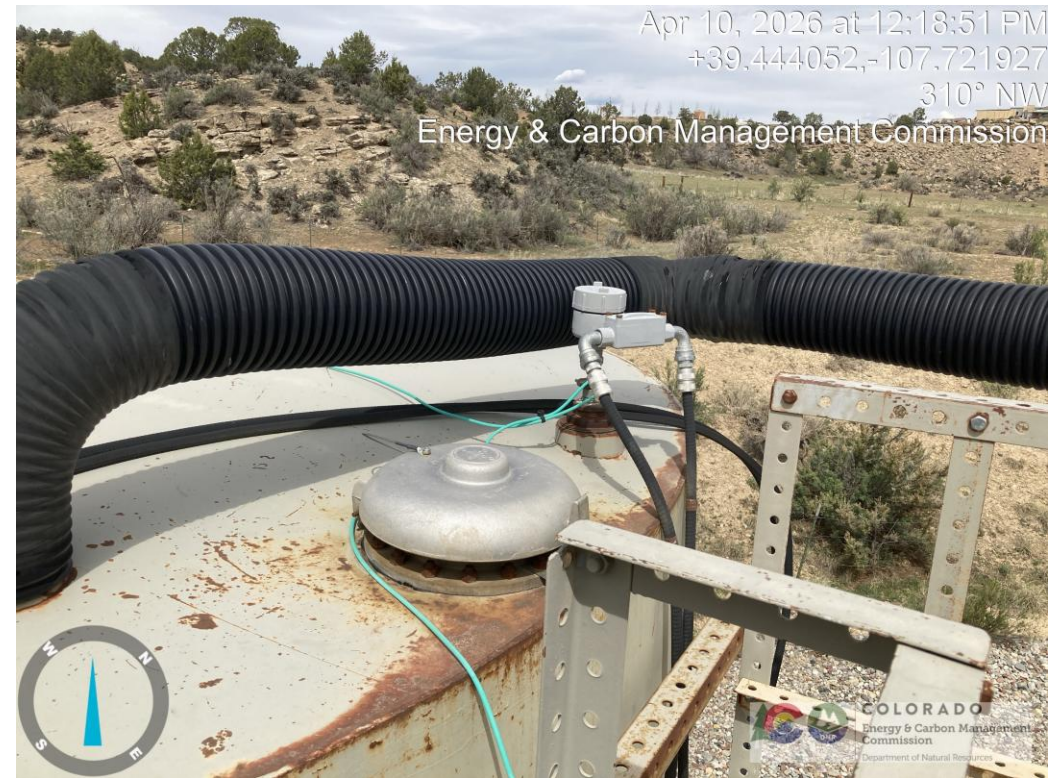
Paint deterioration and areas of rust.

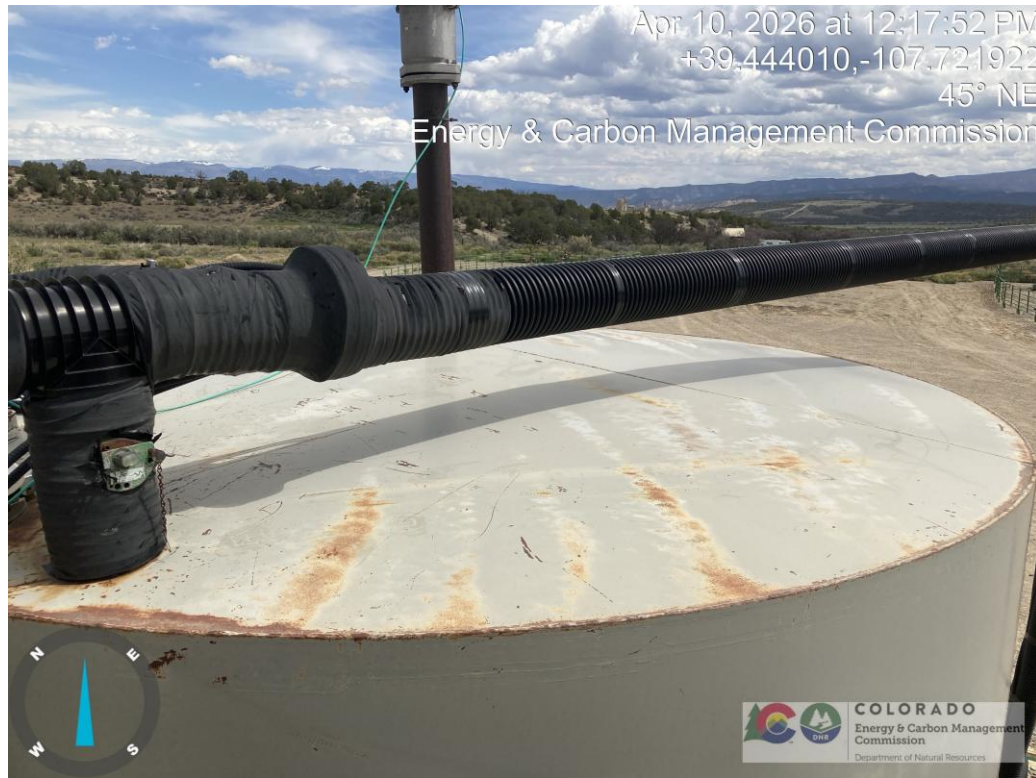
Paint deterioration and areas of rust.

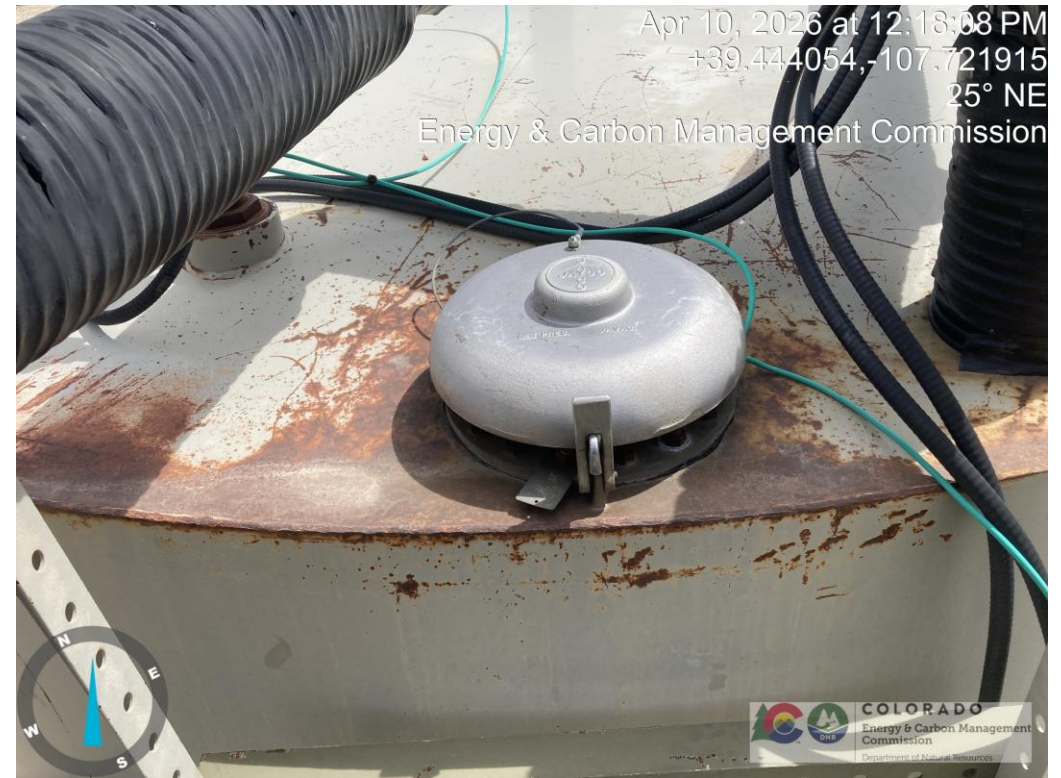
Paint deterioration and areas of rust.

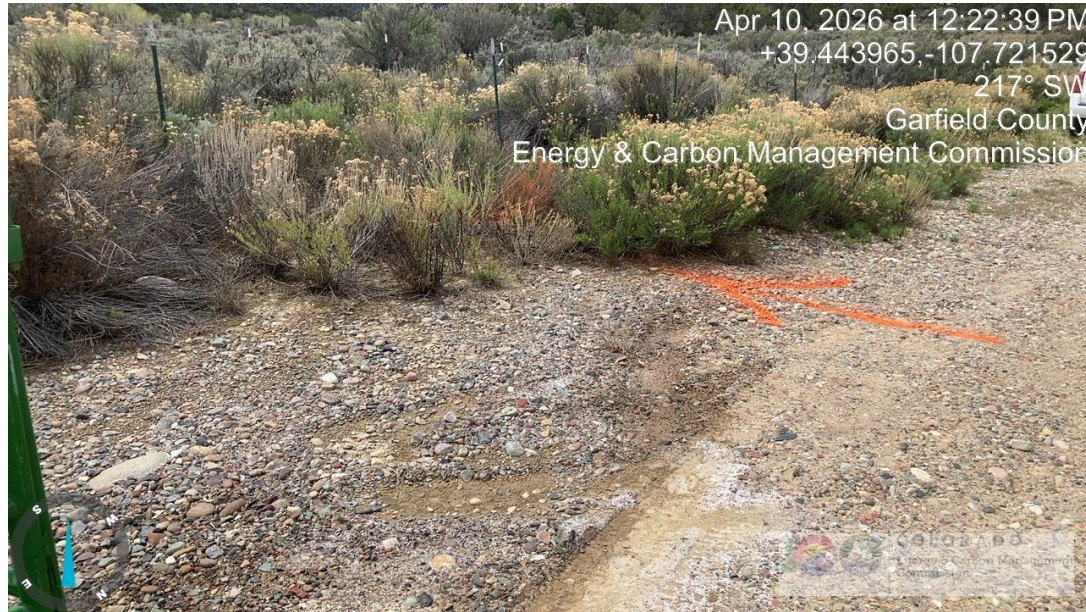
Spill/release area.

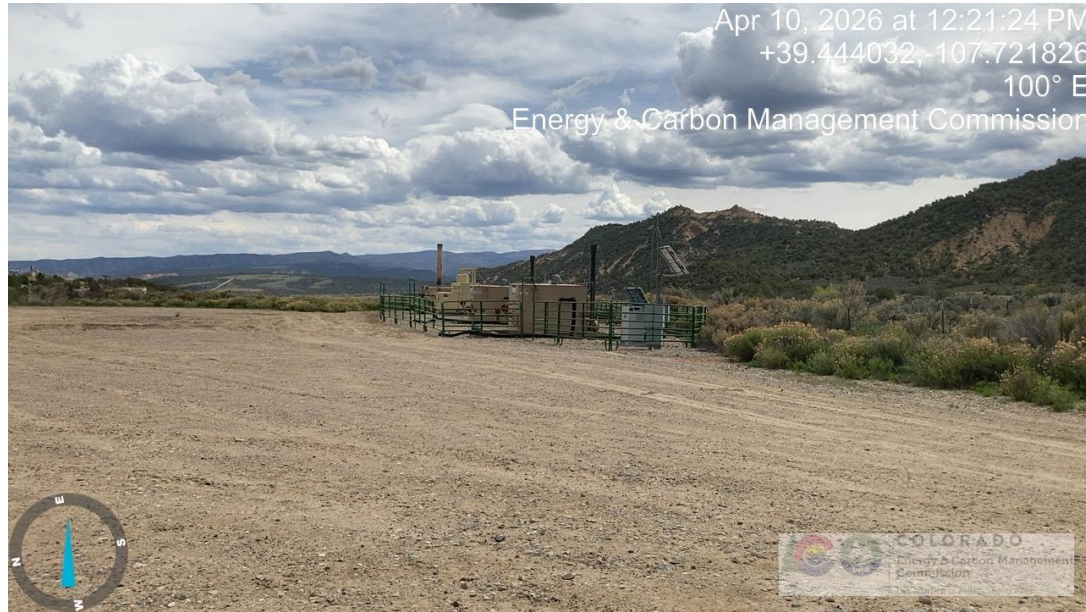
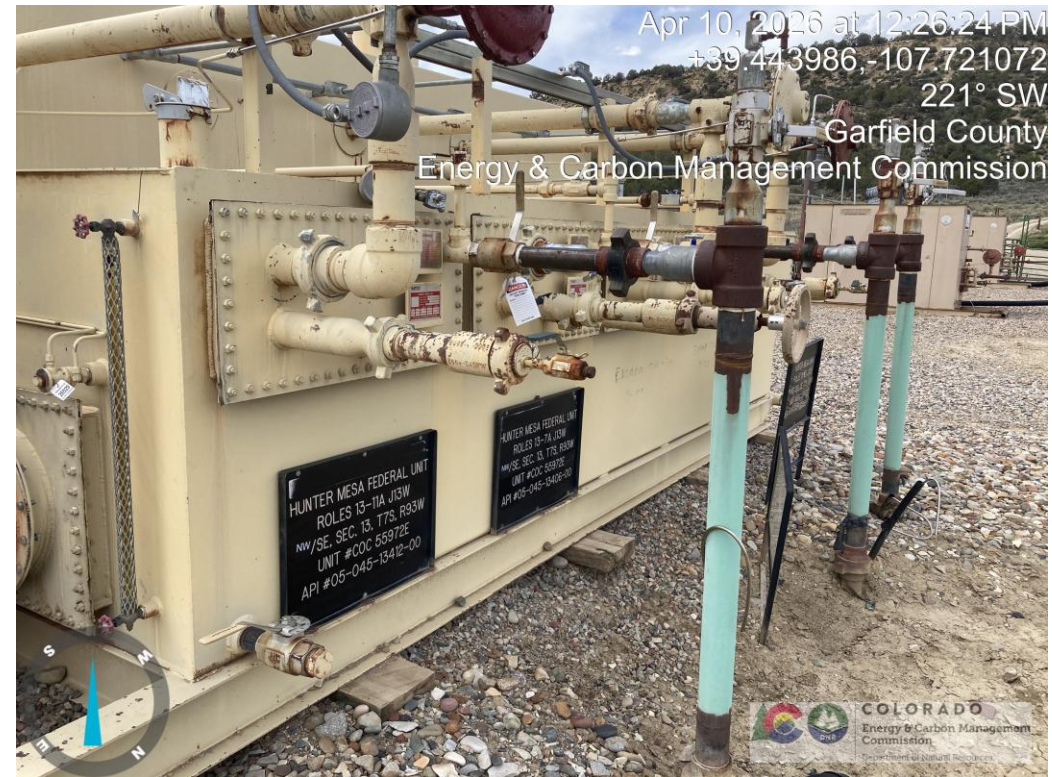
Unpainted flowlines and paint deterioration with areas of rust.

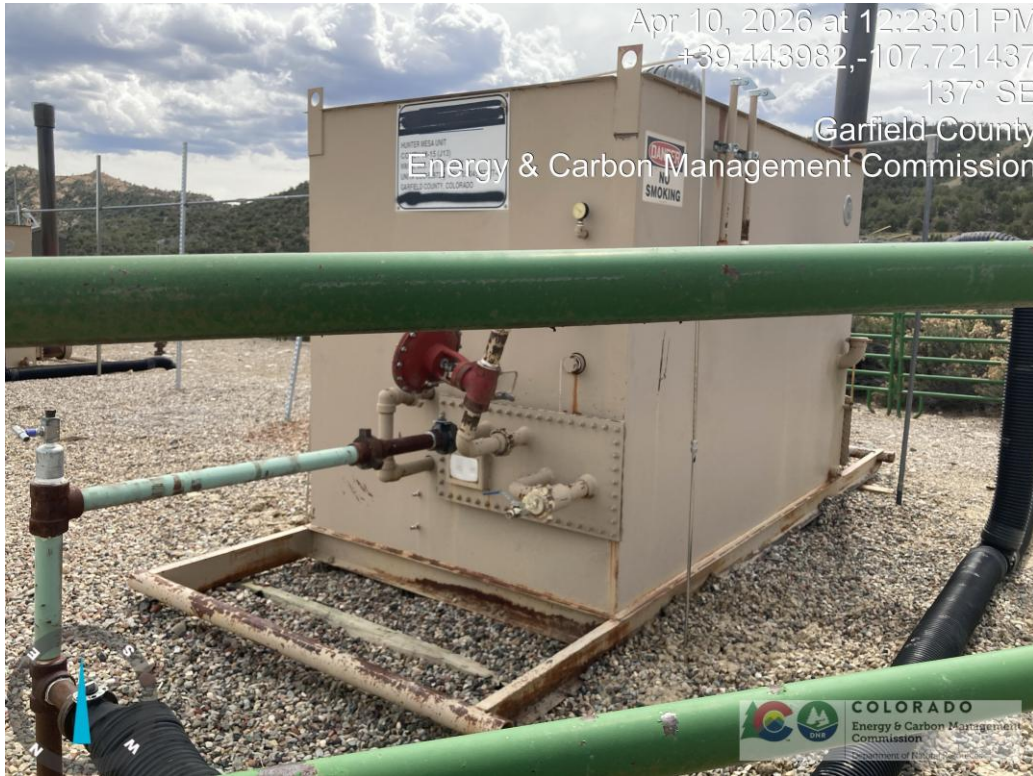
Unpainted flowlines and paint deterioration with areas of rust.

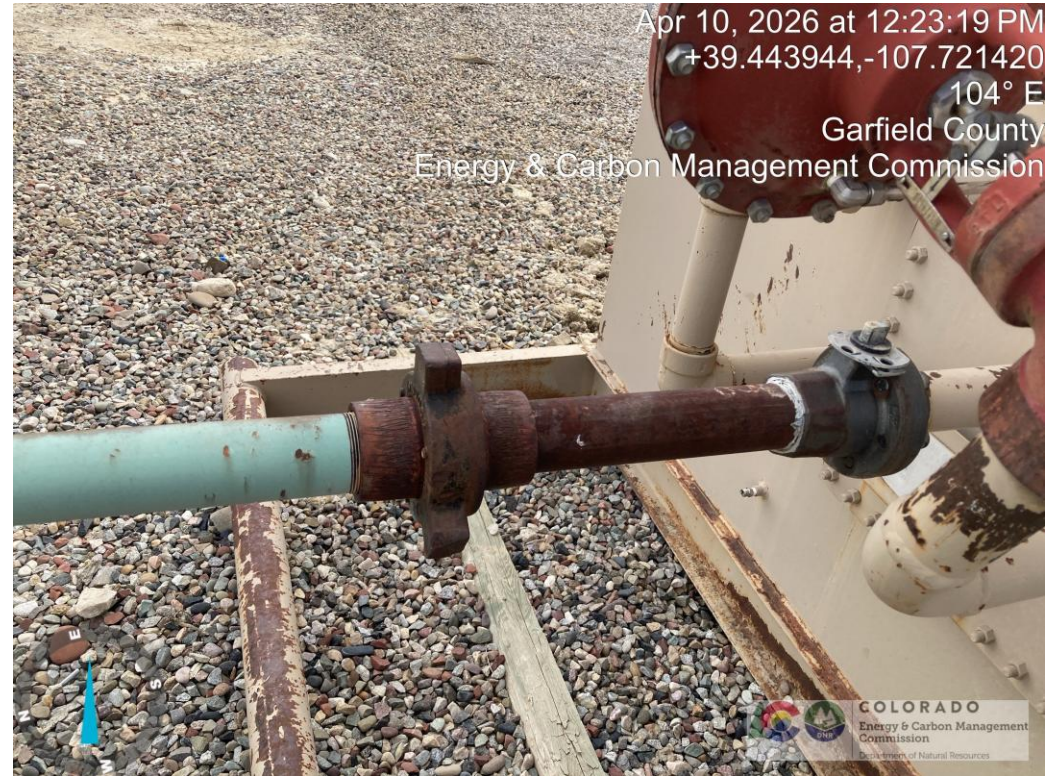
Unpainted flowlines and paint deterioration with areas of rust.

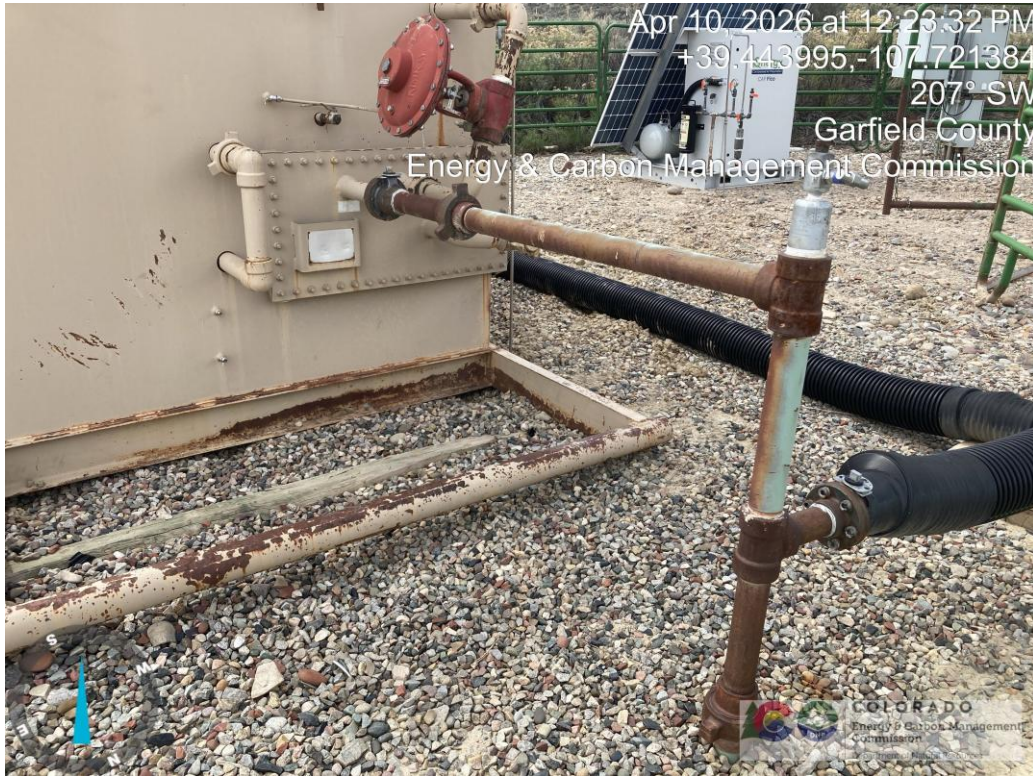
Unpainted flowlines and paint deterioration with areas of rust.

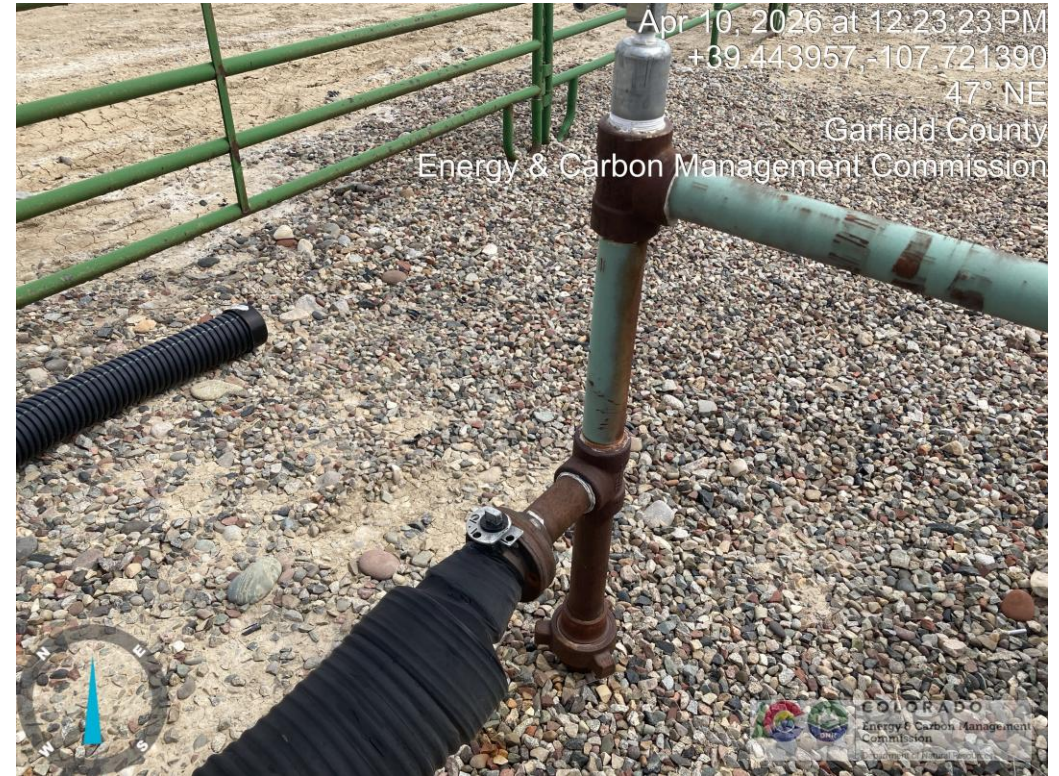
Unpainted flowlines and paint deterioration with areas of rust.

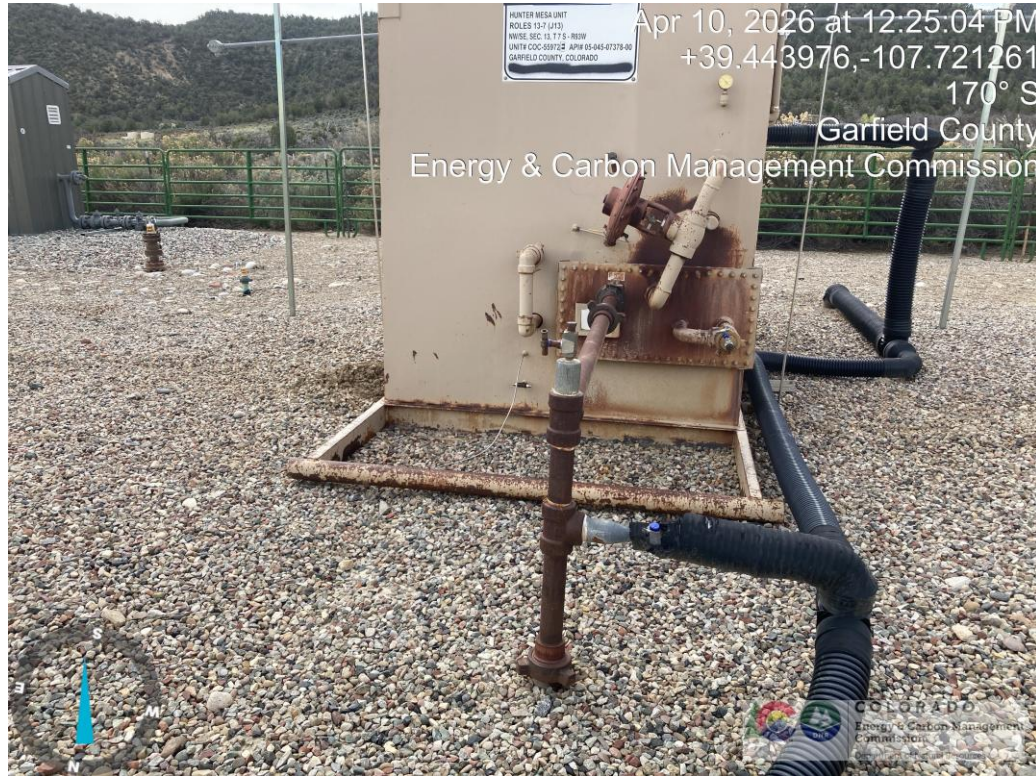
Unpainted flowlines and paint deterioration with areas of rust.

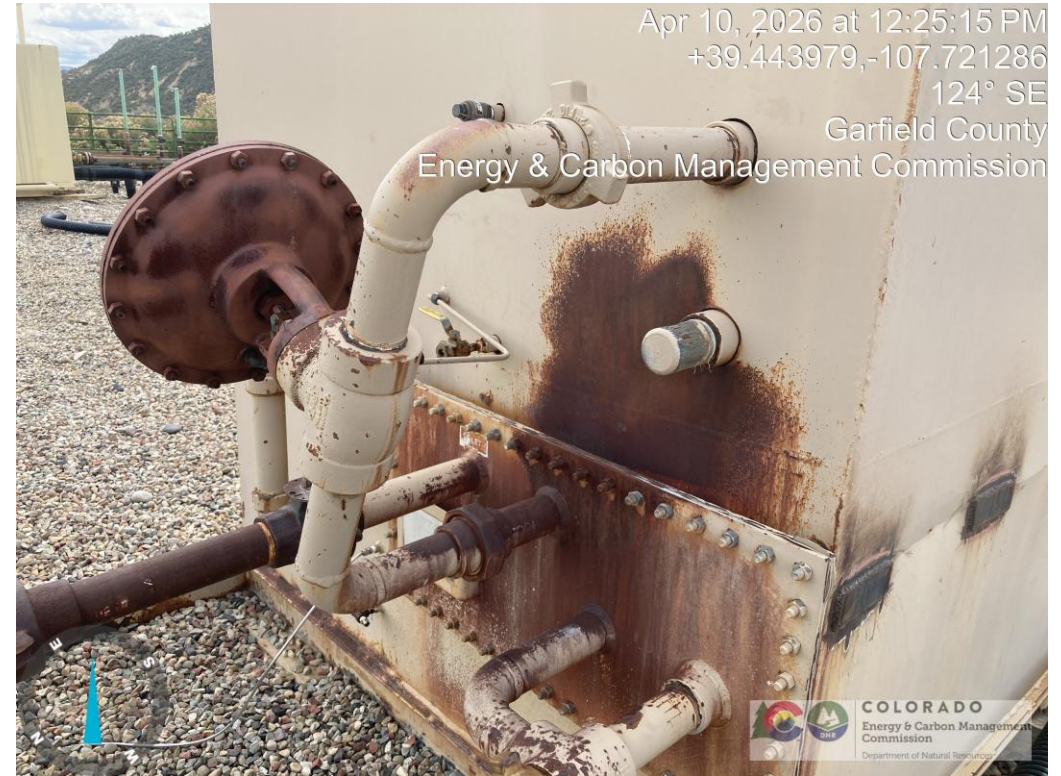
Unpainted flowlines and paint deterioration with areas of rust.

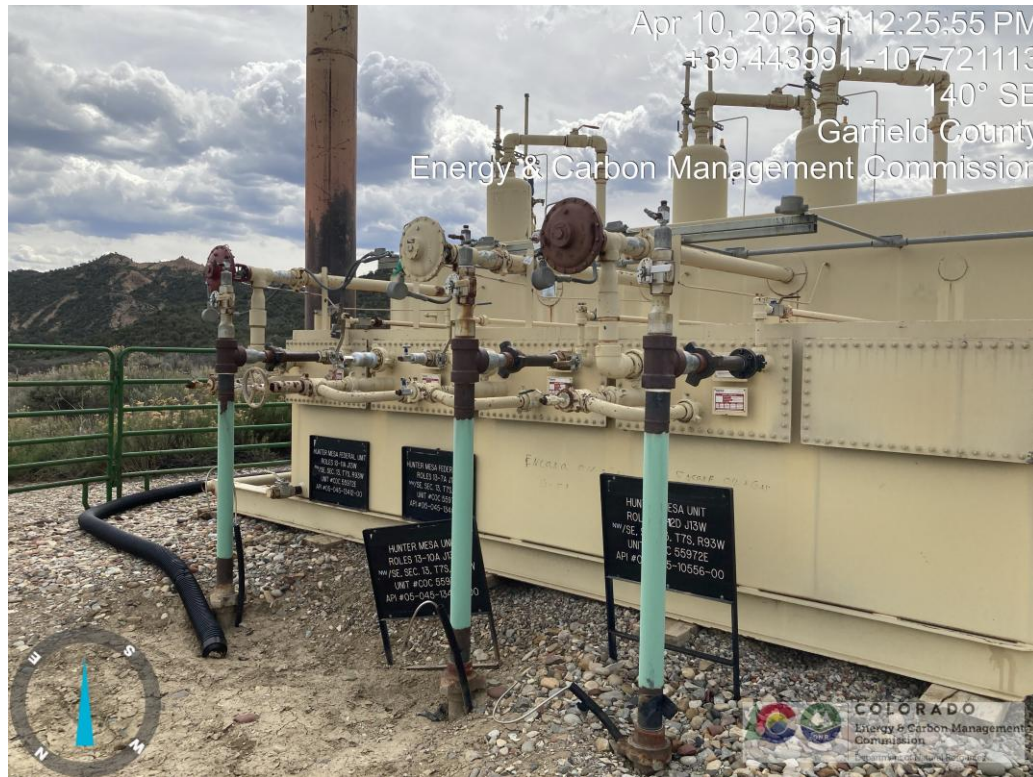
Unpainted flowlines and paint deterioration with areas of rust.
