QB ENERGY OPERATING LLC ROLES-67S93W 13NESE (J13W) Facility # 334558

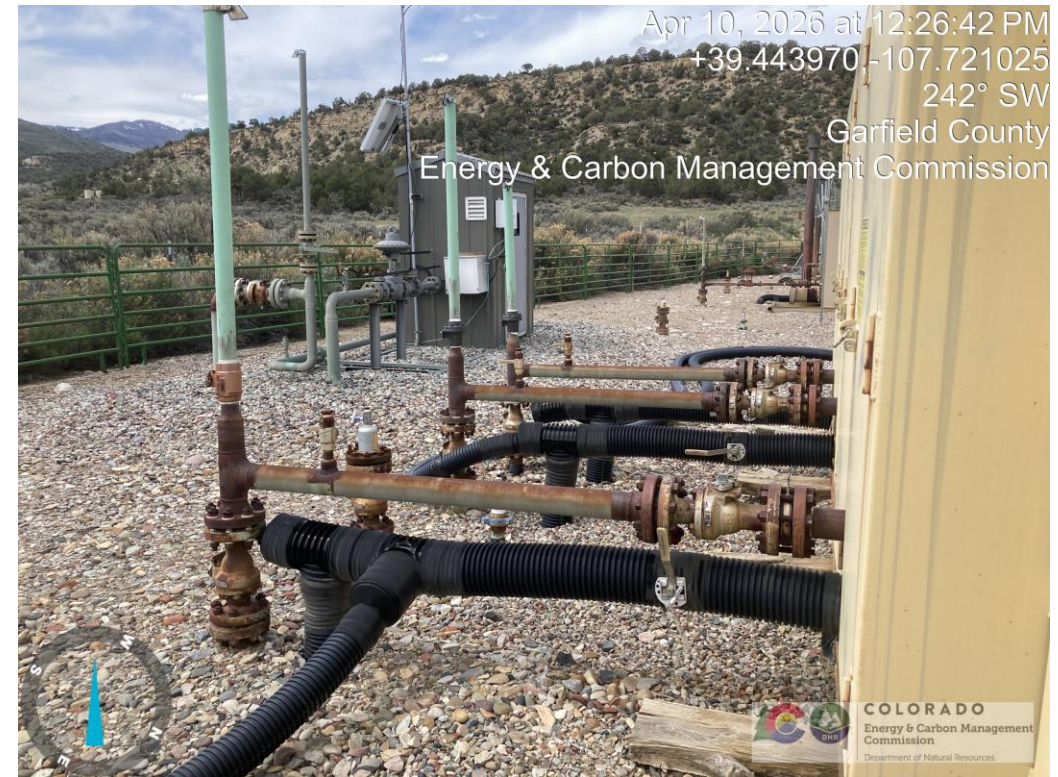
Unpainted flowlines and paint deterioration with areas of rust.

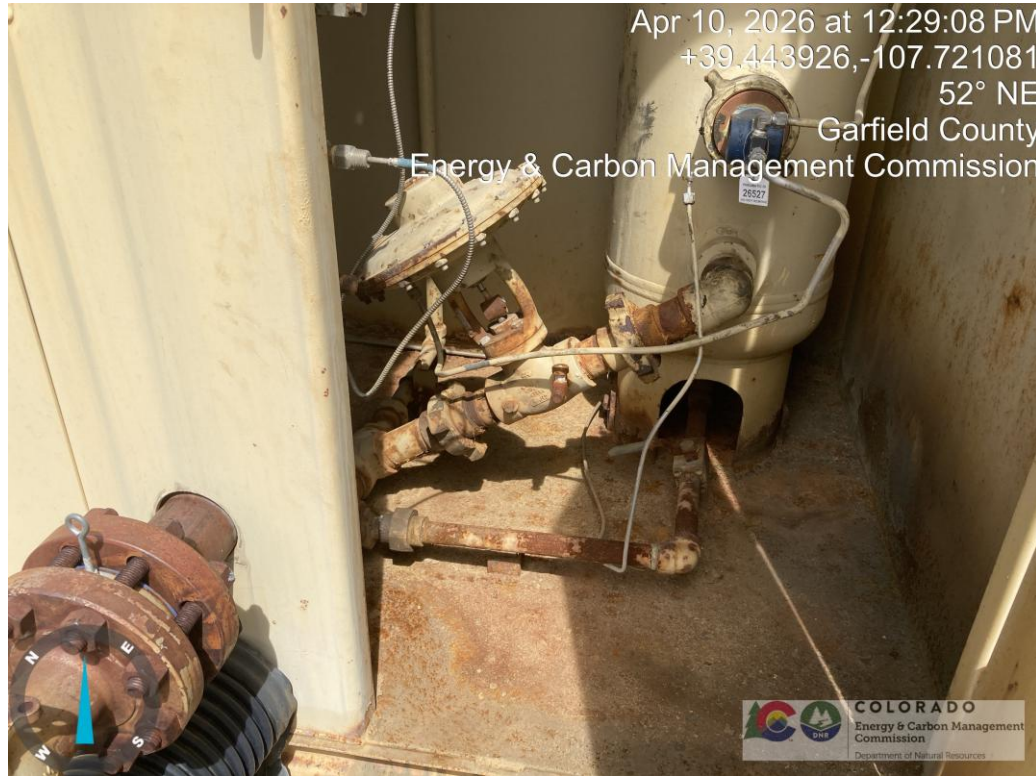
Unpainted flowlines and paint deterioration with areas of rust.

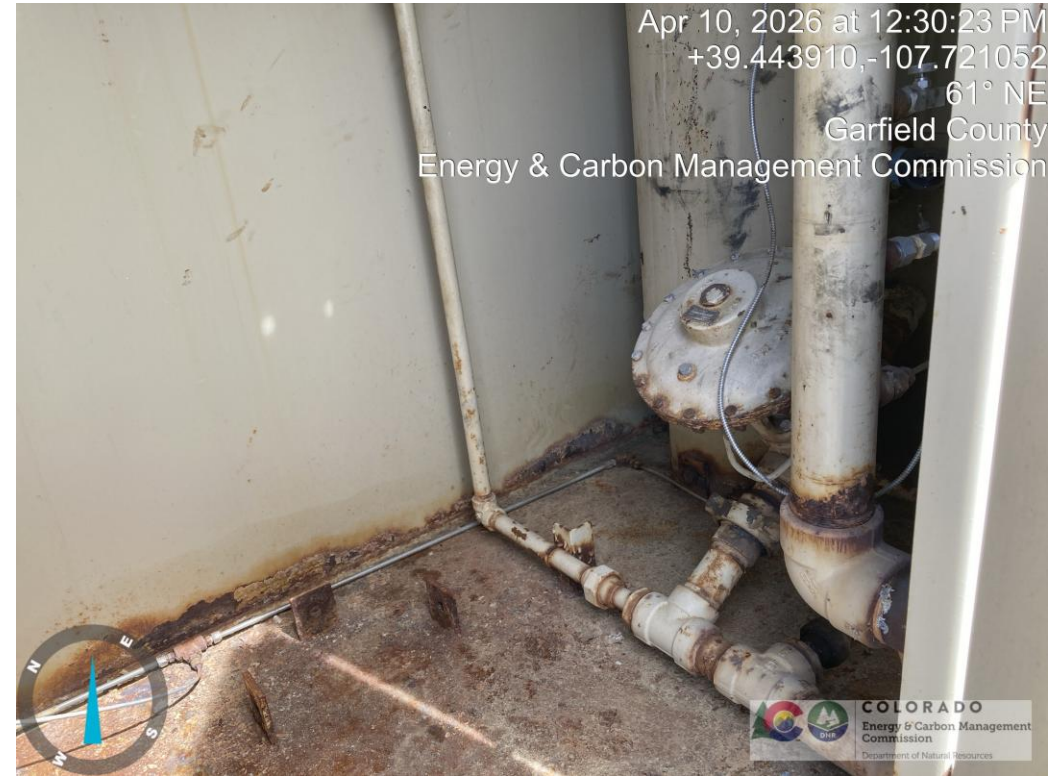
Unpainted flowlines and paint deterioration with areas of rust.

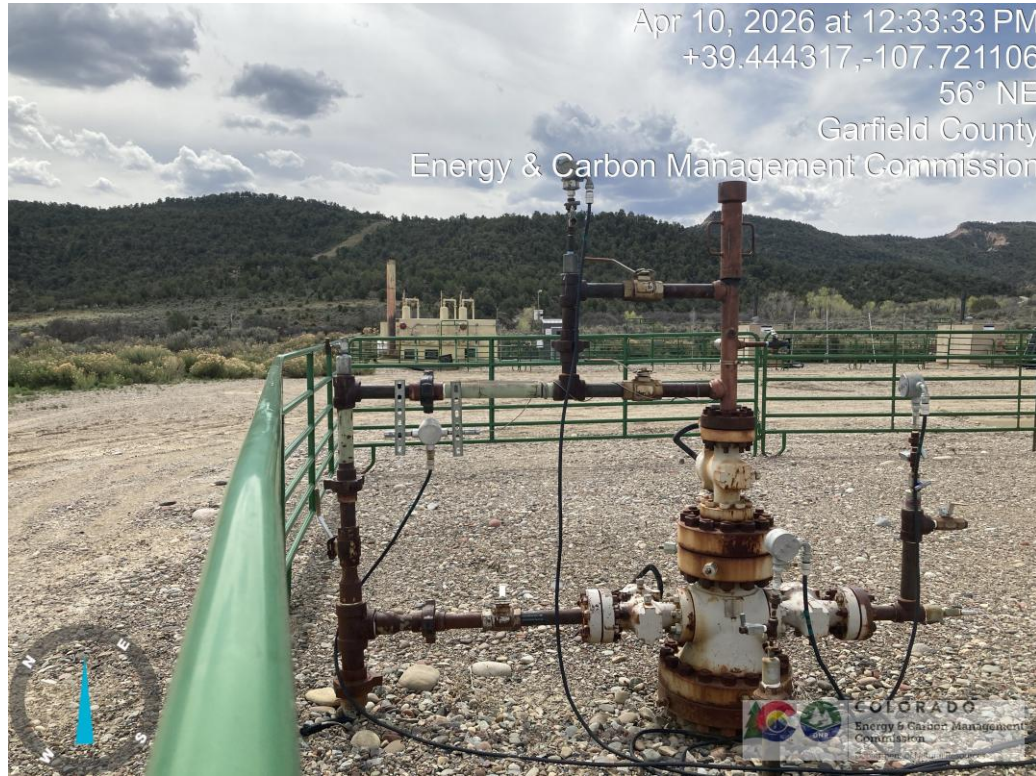
Unpainted and paint deterioration of flowlines and well head equipment with areas of rust.

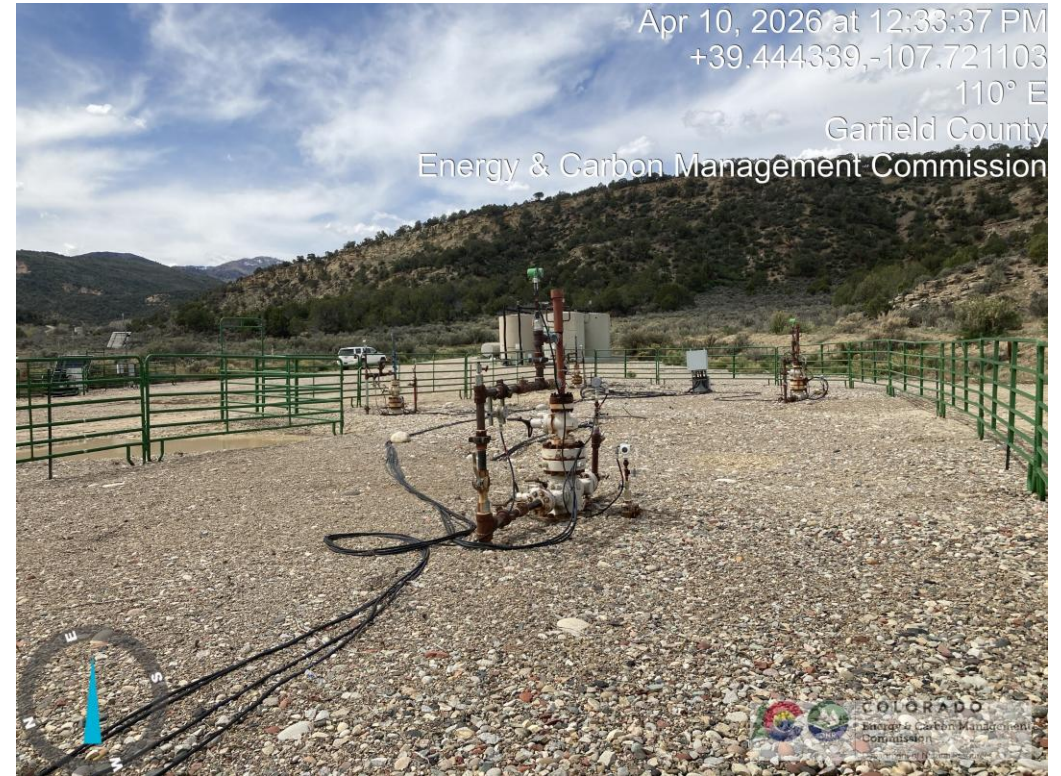
Unpainted and paint deterioration of flowlines and well head equipment with areas of rust.

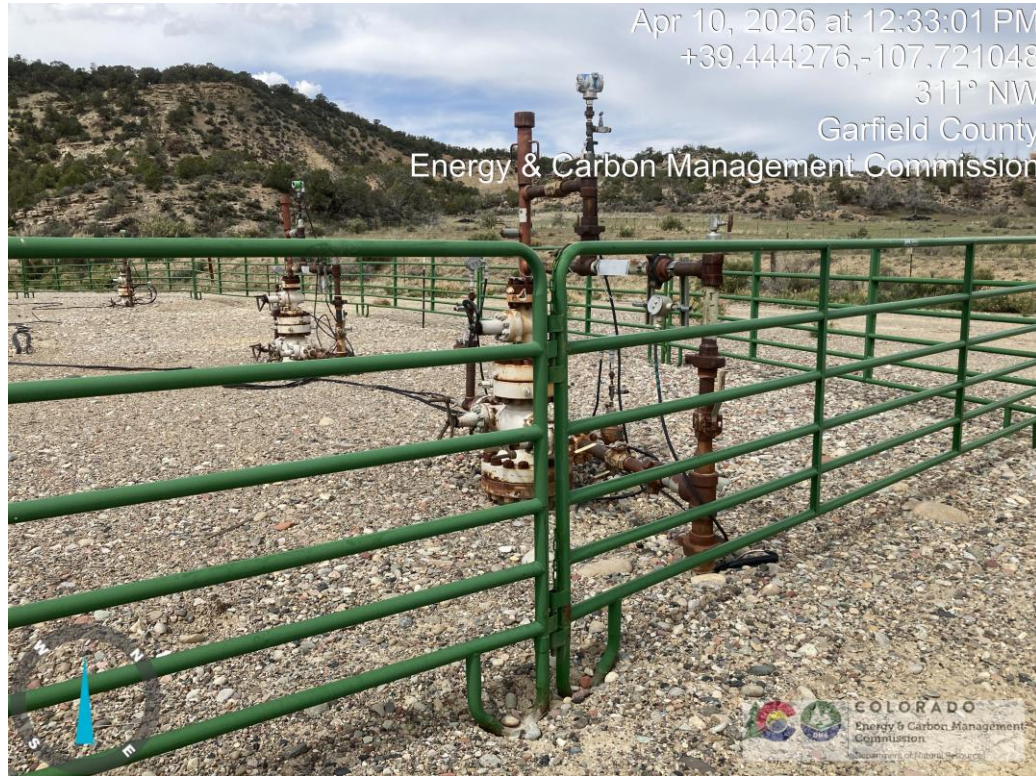
Unpainted and paint deterioration of flowlines and well head equipment with areas of rust.

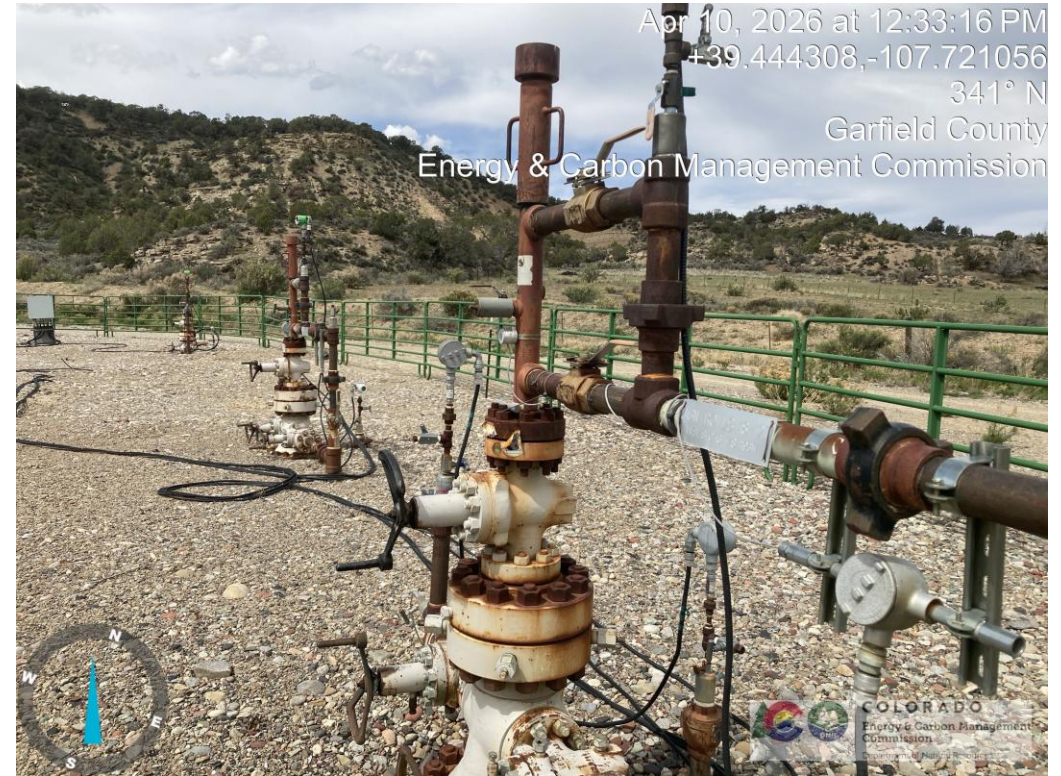
Unpainted and paint deterioration of flowlines and well head equipment with areas of rust.

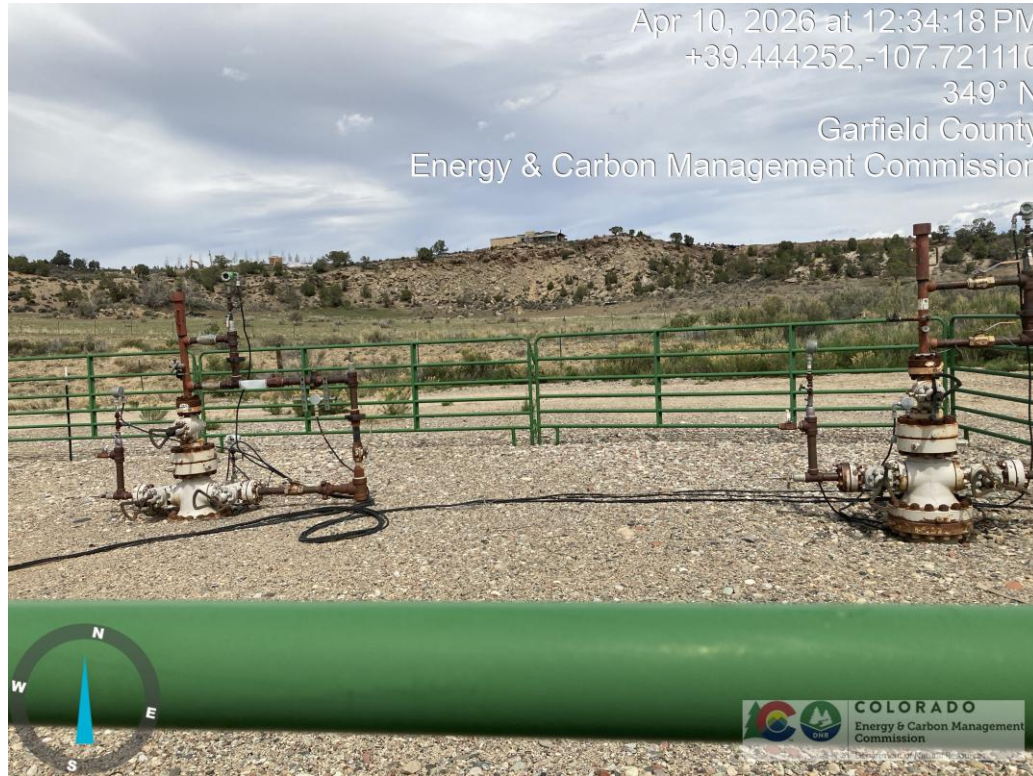
Unpainted and paint deterioration of flowlines and well head equipment with areas of rust.

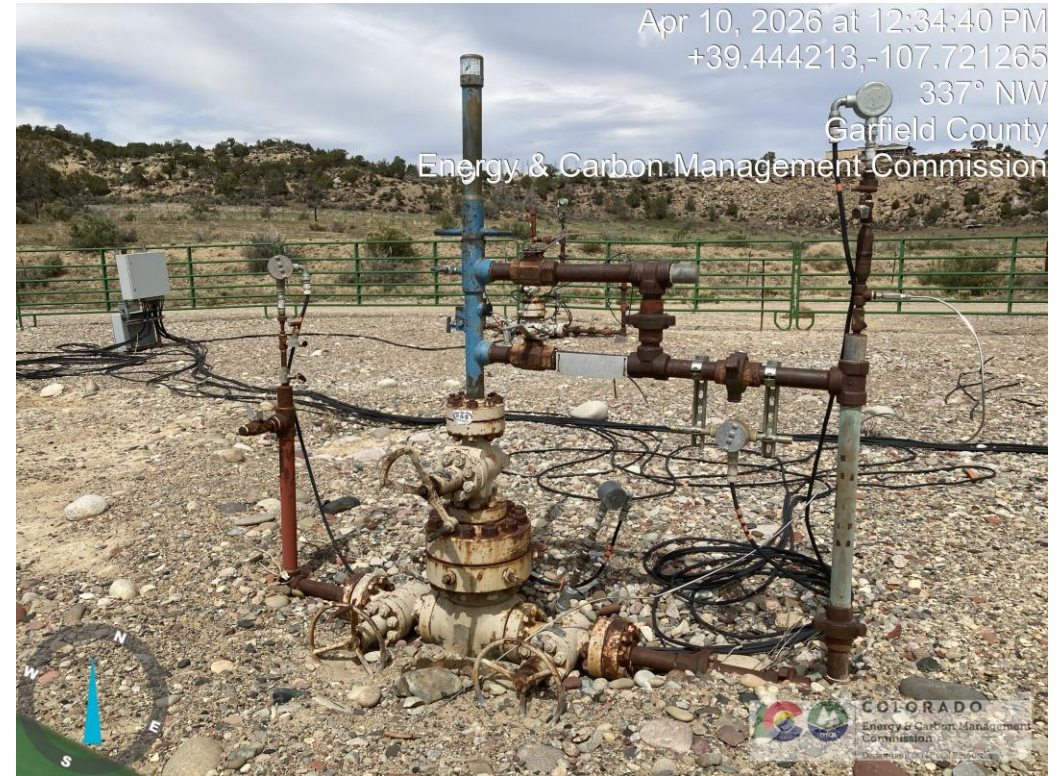
Unpainted and paint deterioration of flowlines and well head equipment with areas of rust.

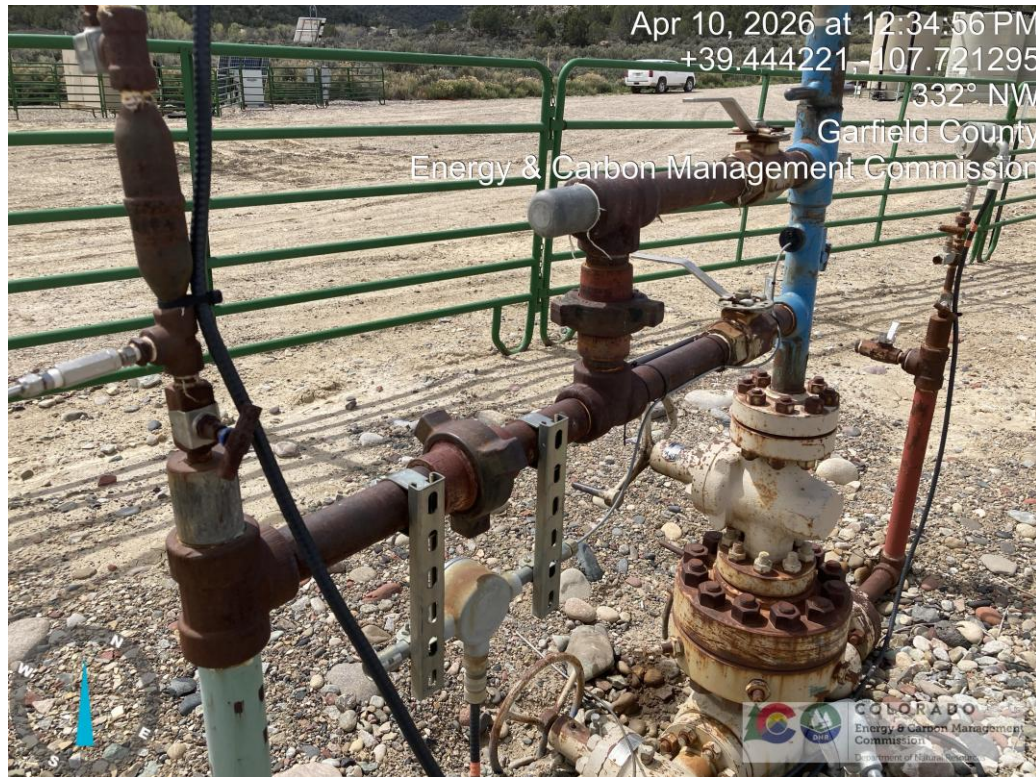
Unpainted and paint deterioration of flowlines and well head equipment with areas of rust.

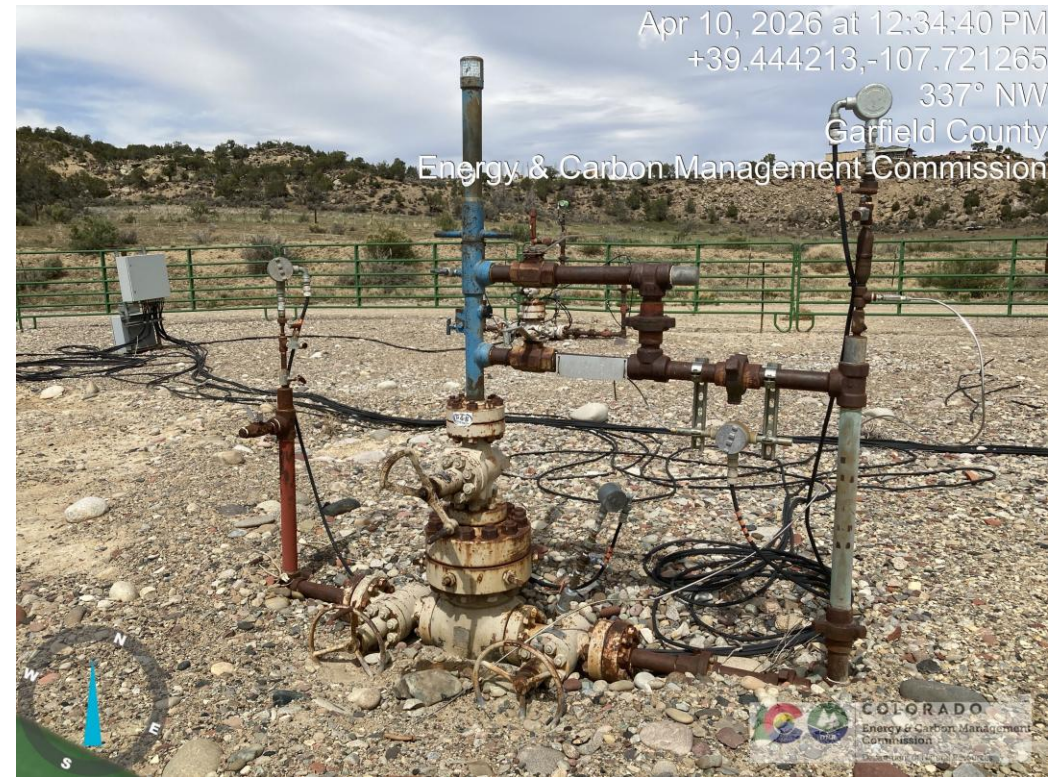
Unpainted and paint deterioration of flowlines and well head equipment with areas of rust.

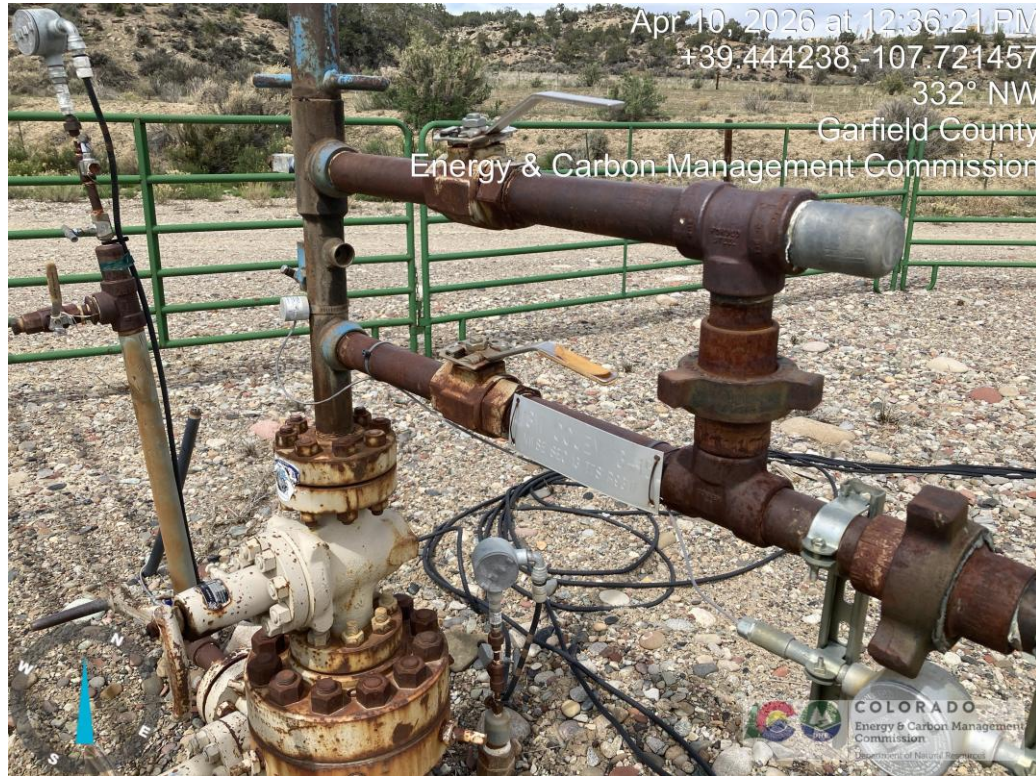
Unpainted and paint deterioration of flowlines and well head equipment with areas of rust.

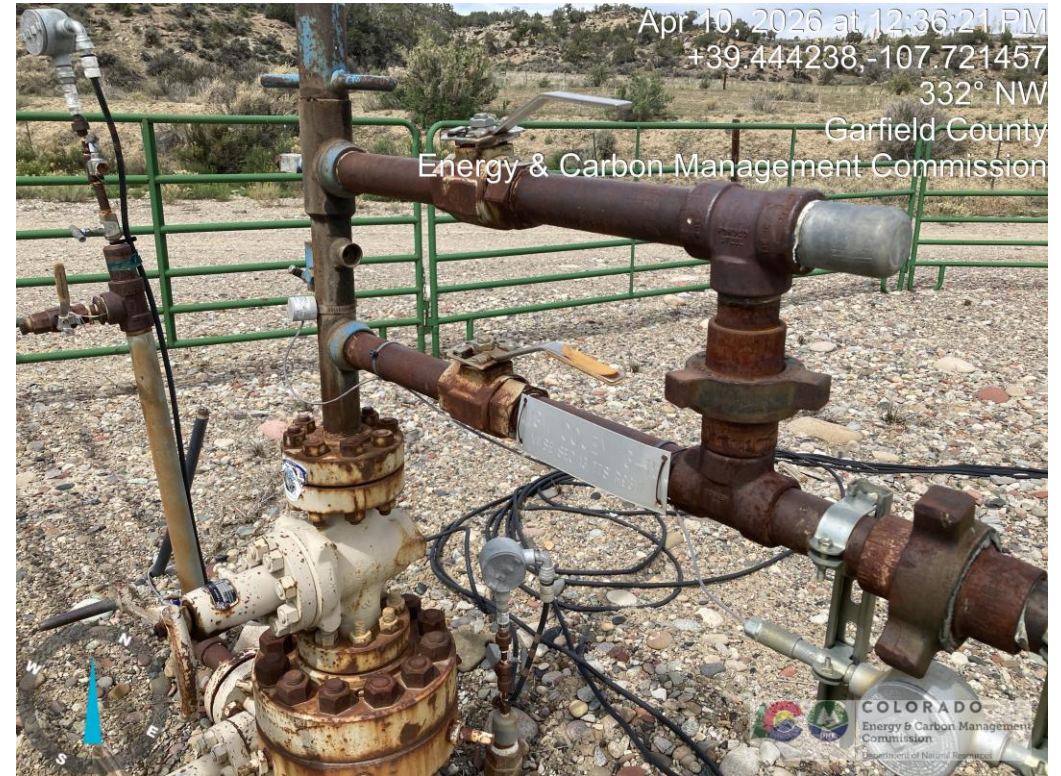
Unpainted and paint deterioration of flowlines and well head equipment with areas of rust.
