# Inspection Photos

API: 061-06844

Operator: JETTA OPERATING COMPANY

Inspection Date: 4/15/2026

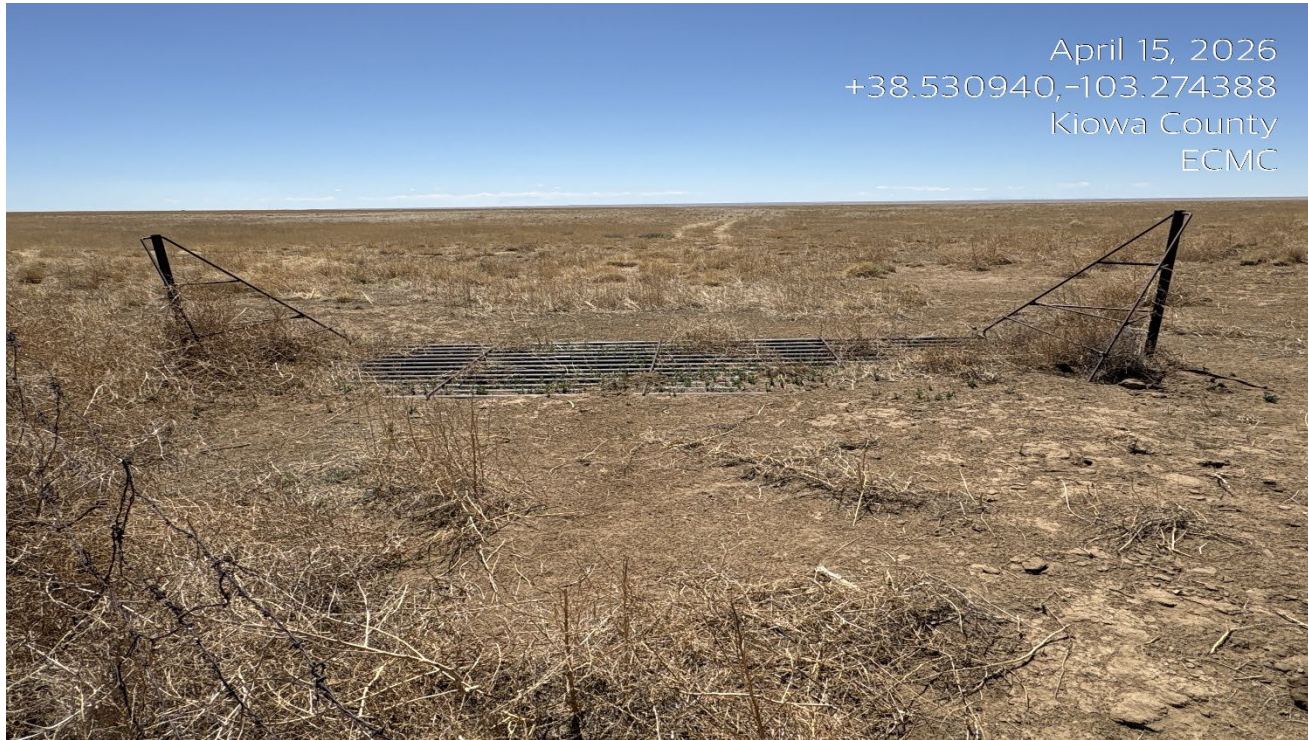
**Photo 1.** Facing southwest at the beginning of the access road. The cattle guard was never removed and is not attached to the fence line.

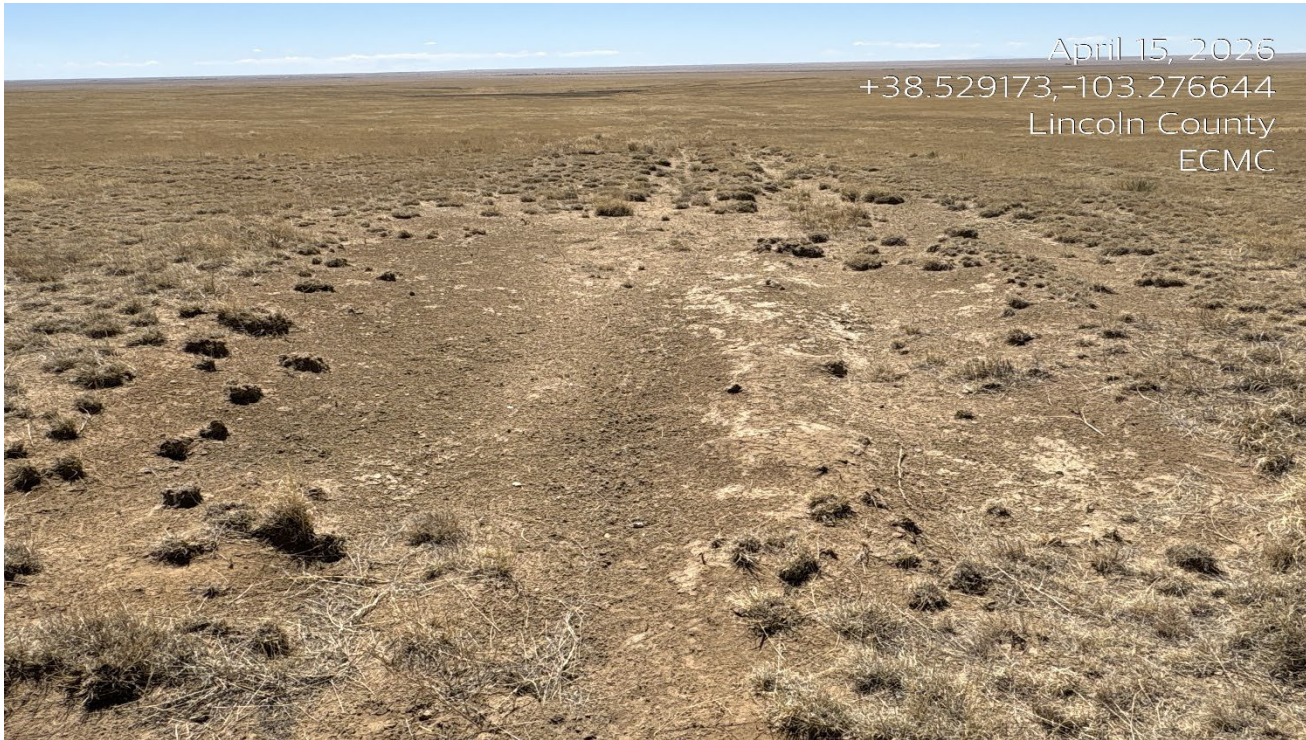
**Photo 2.** Facing southwest along the access road near the location. There are areas bare of vegetation along the former road.

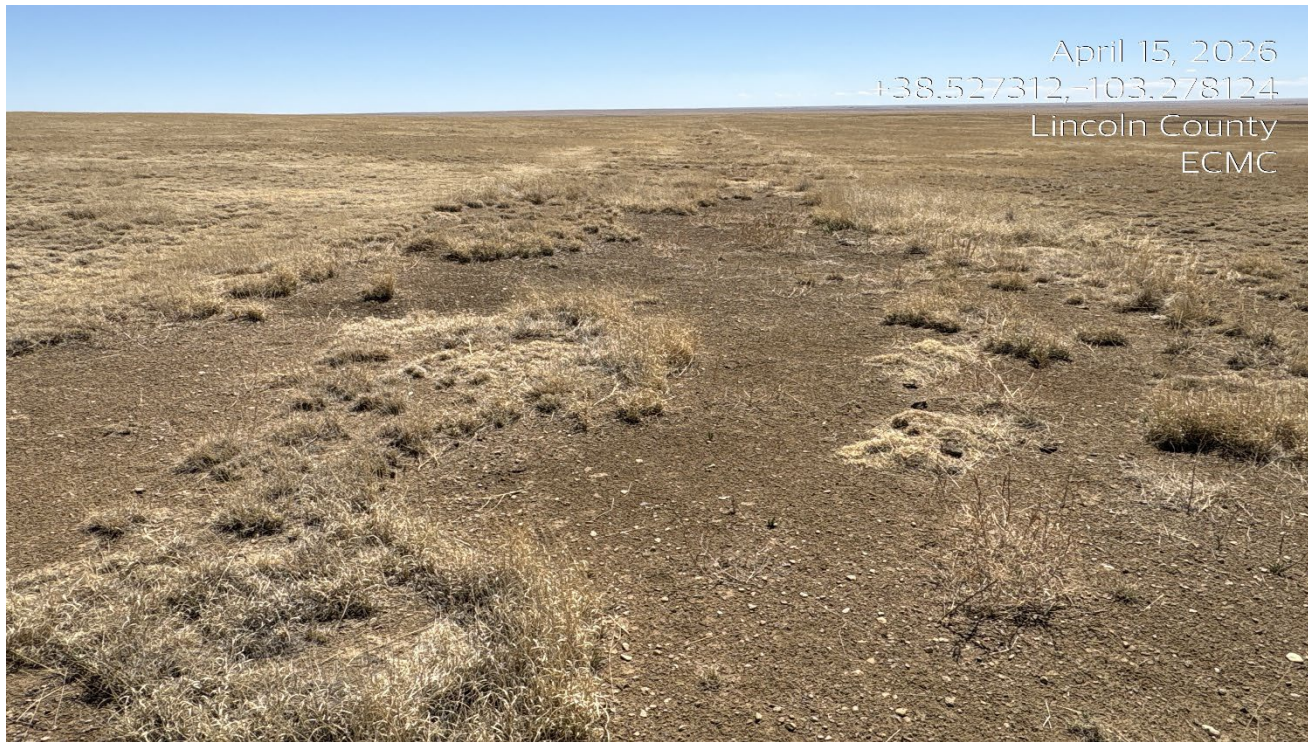
**Photo 3.** Facing south along the access road near the location. There are areas bare of vegetation along the former road.

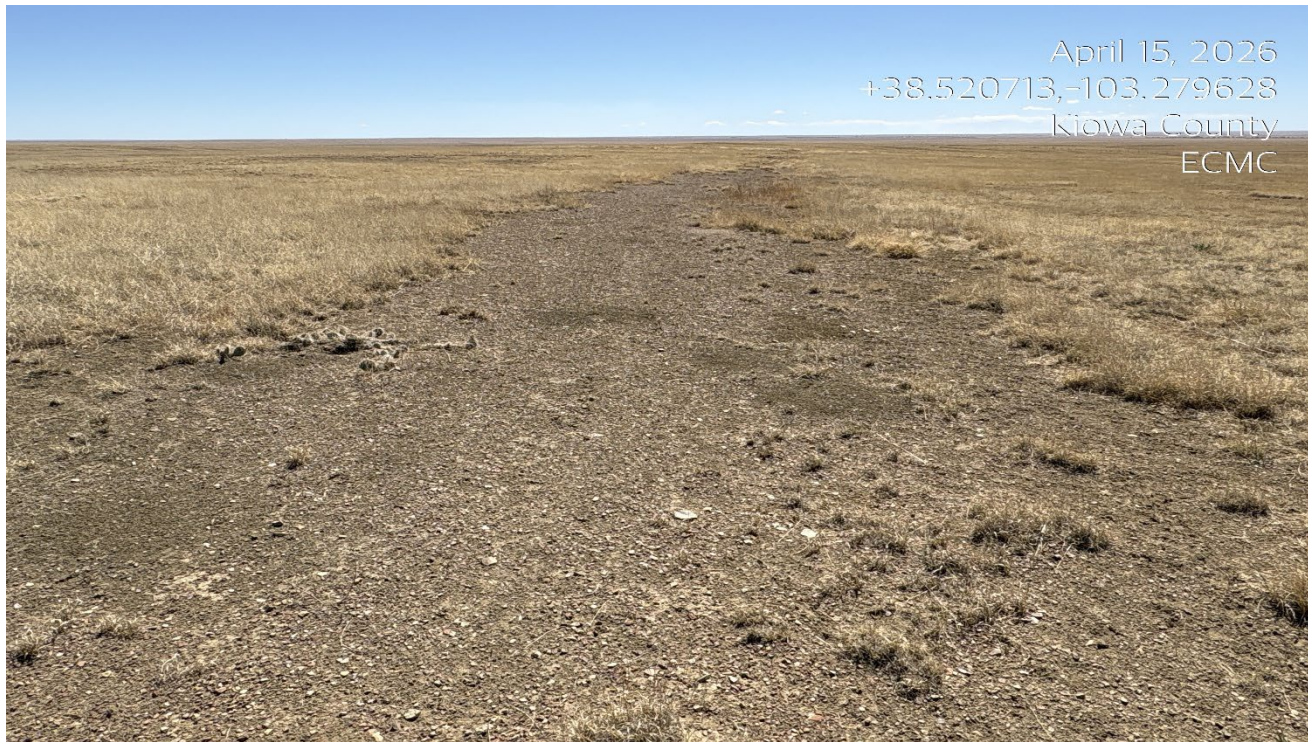
**Photo 4.** Facing south along the access road near the location. There are areas bare of vegetation along the former road.

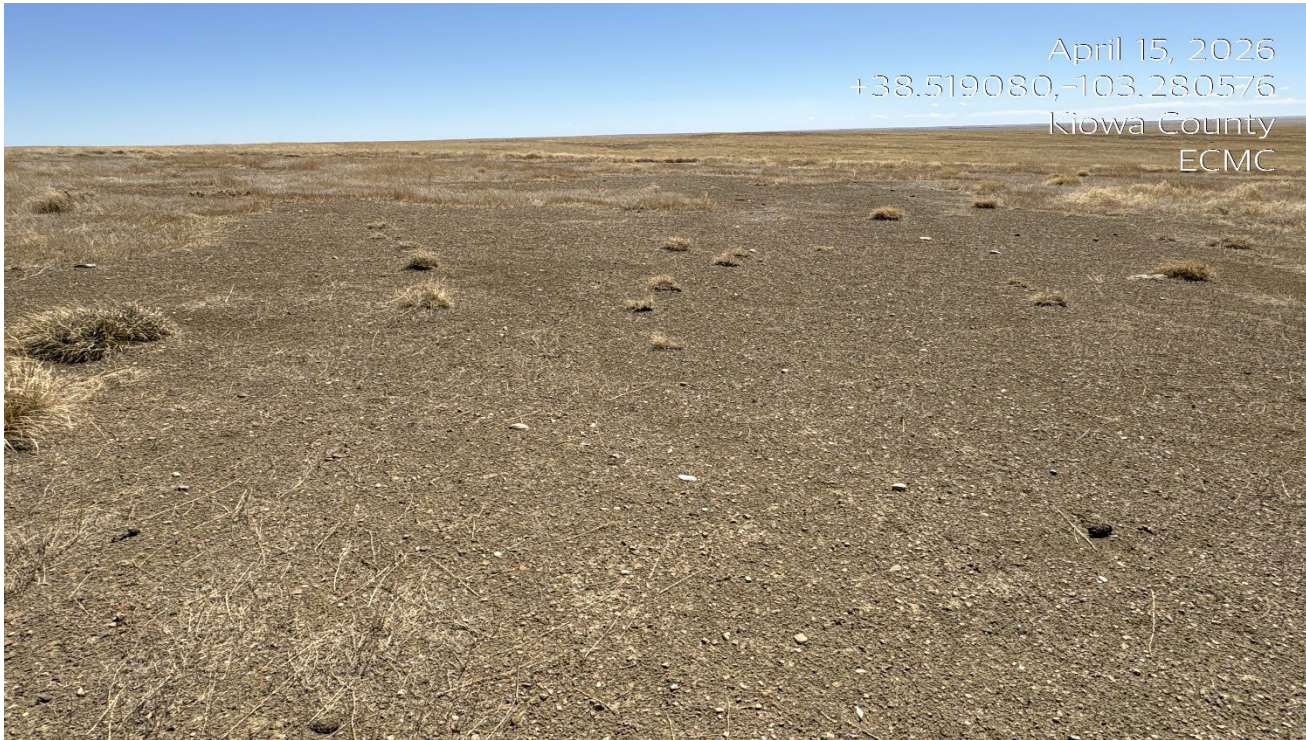
**Photo 5.** Center of the location facing south. The location has not established vegetation and is mostly bare soils.

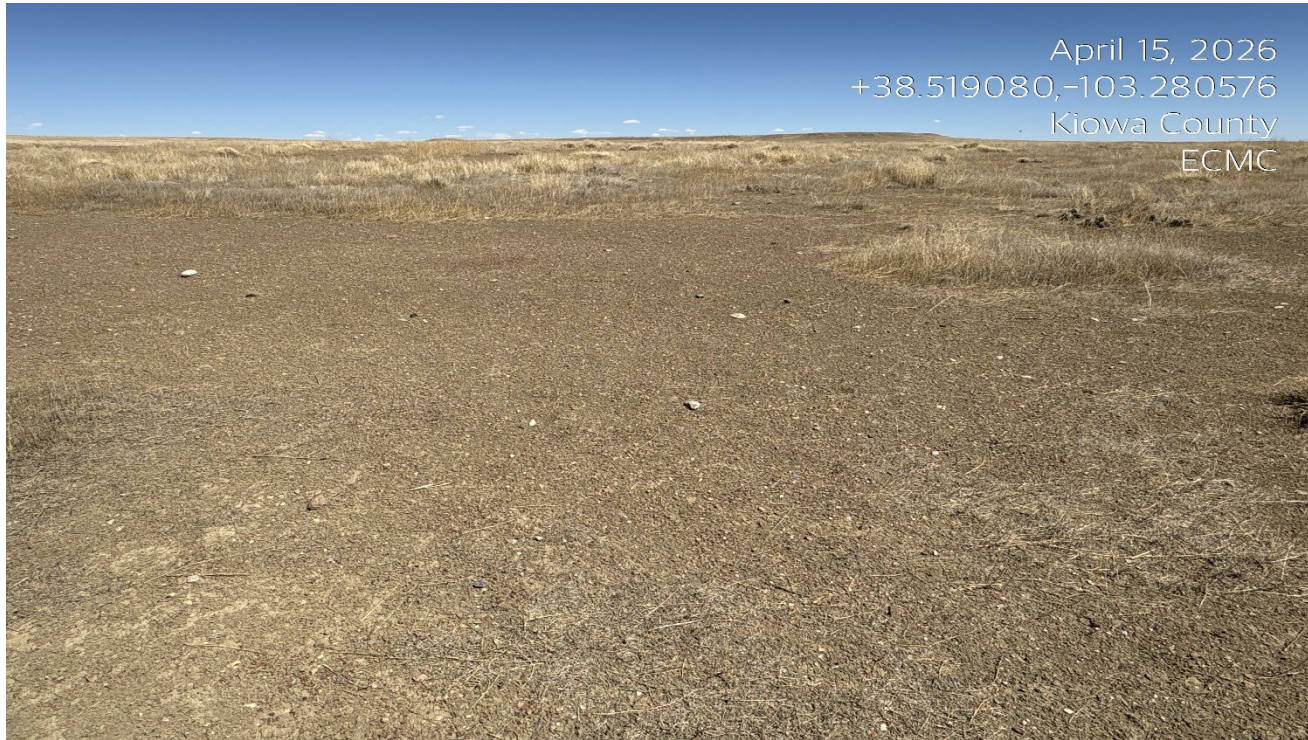
**Photo 6.** Center of the location facing east. The location has not established vegetation and is mostly bare soils.

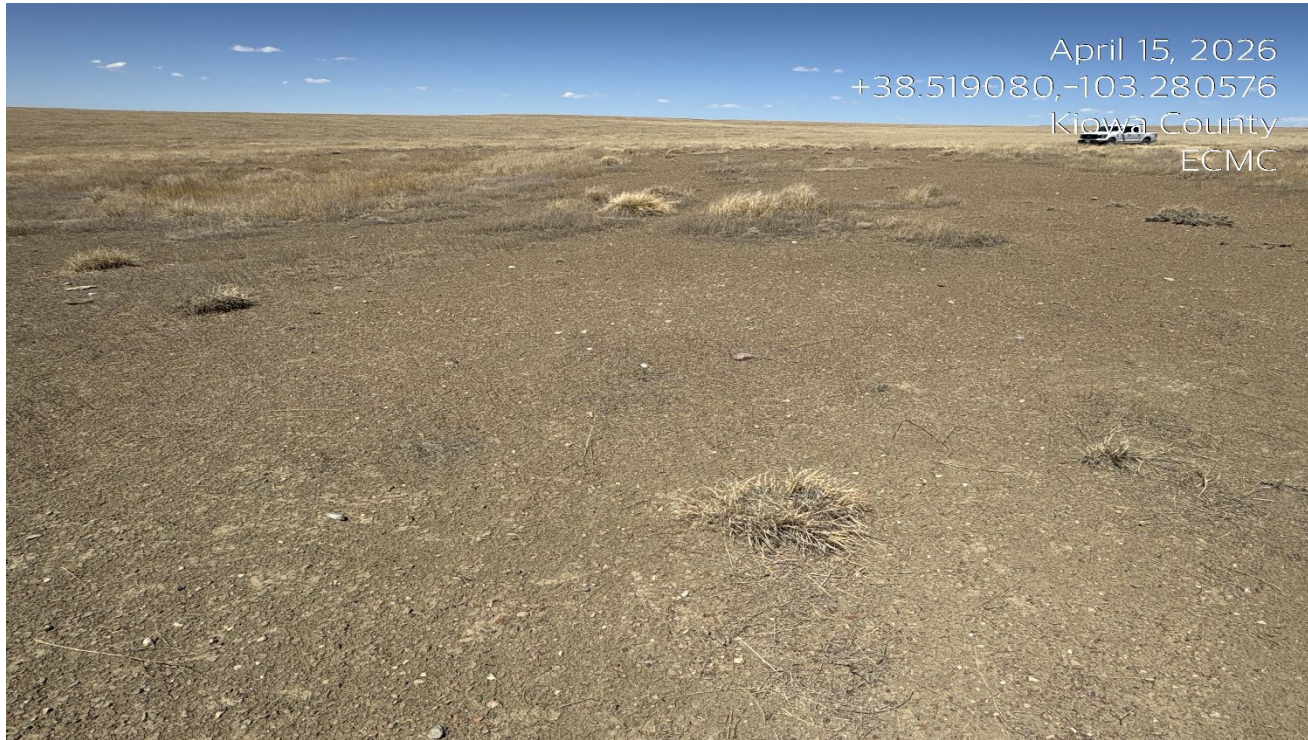
**Photo 7.** Center of the location facing north. The location has not established vegetation and is mostly bare soils.

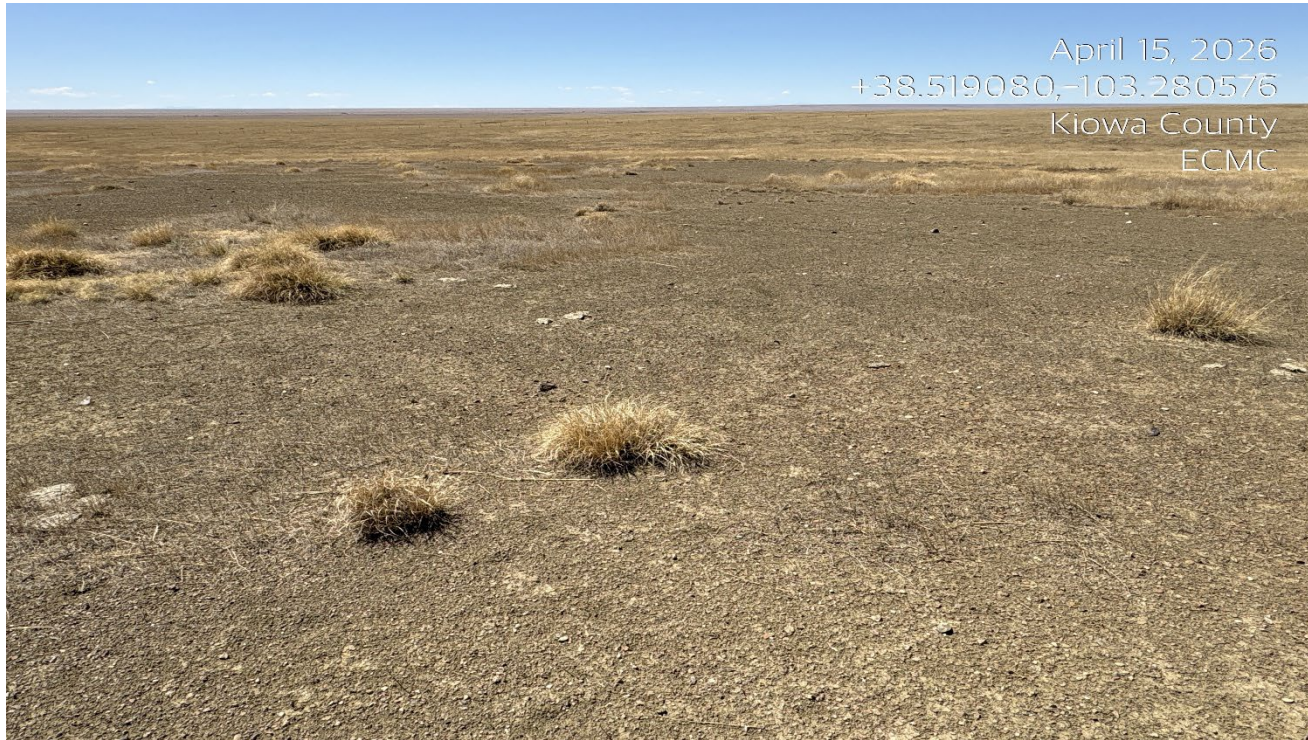
**Photo 8.** Center of the location facing west. The location has not established vegetation and is mostly bare soils.

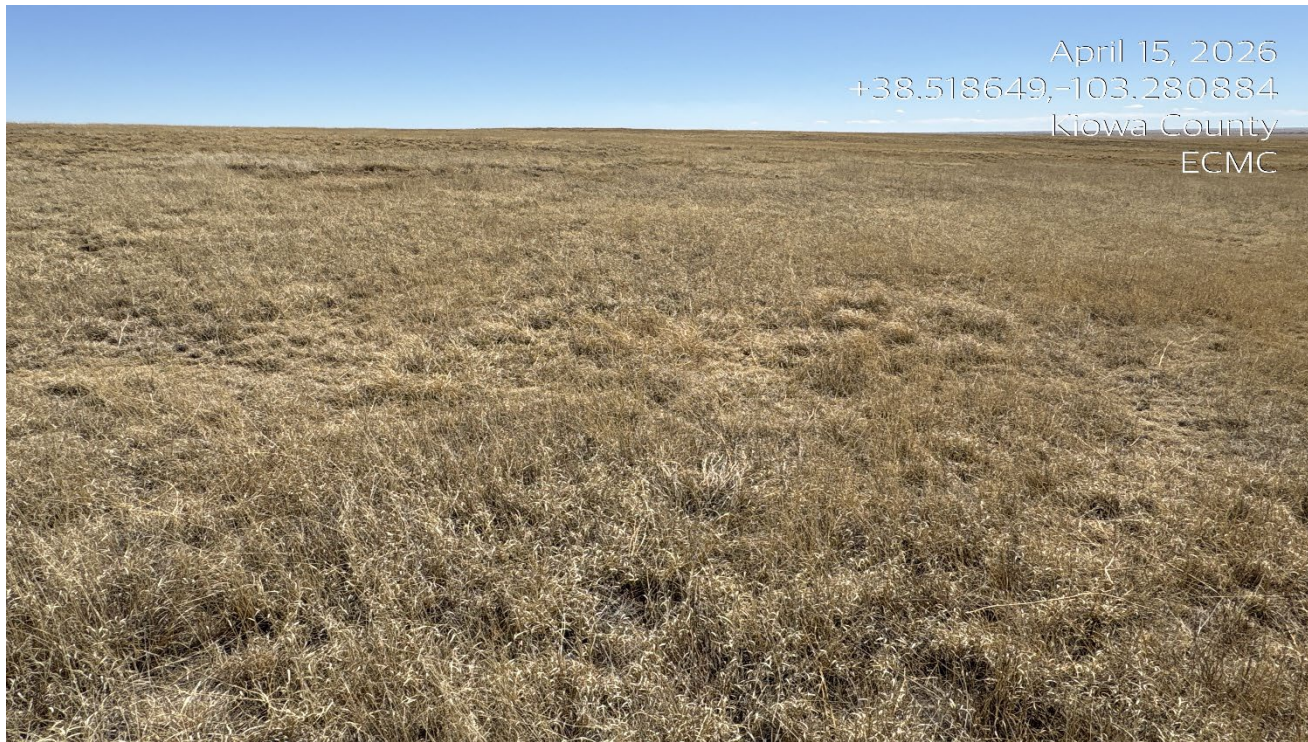
**Photo 2.** Facing south toward the surrounding undisturbed reference area which consists of native Blue grama, Sand dropseed, among other species.
