# Inspection Photos

Location Name: TEP ROCKY MOUNTAIN LLC BOSELY SG 44-27 Pad

Location # 334113

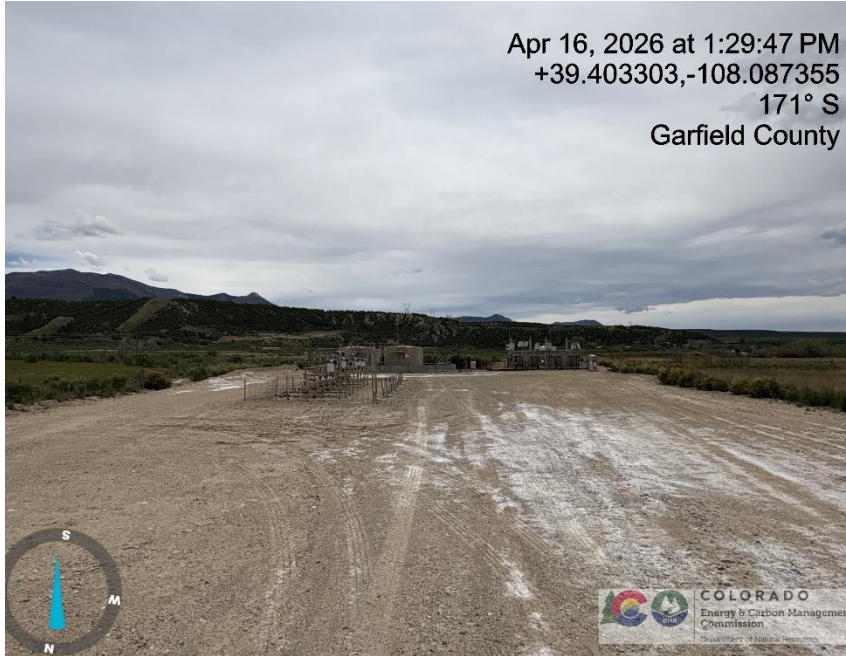
Photo # 138 From entrance to location

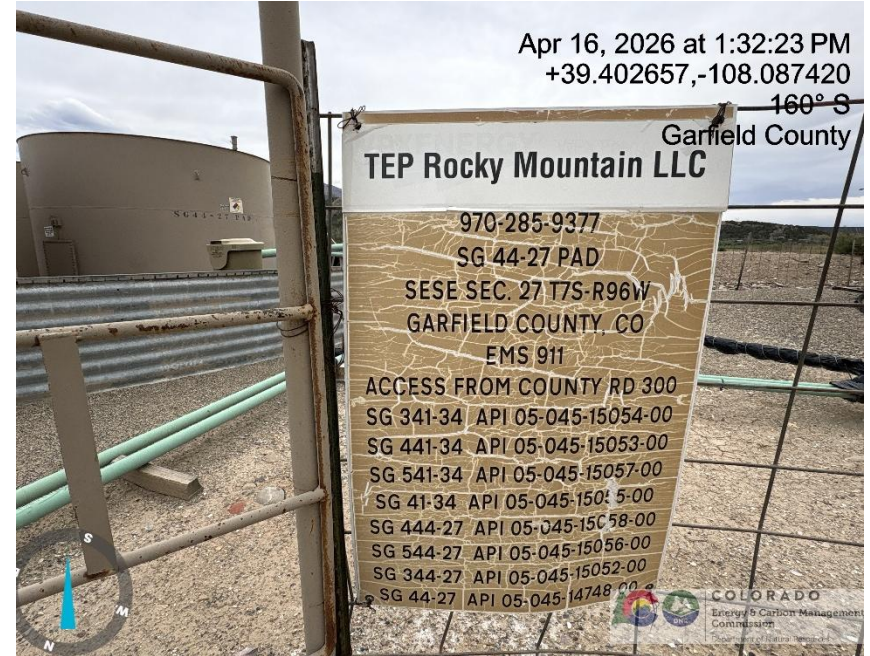
Photo # 139 Battery sign

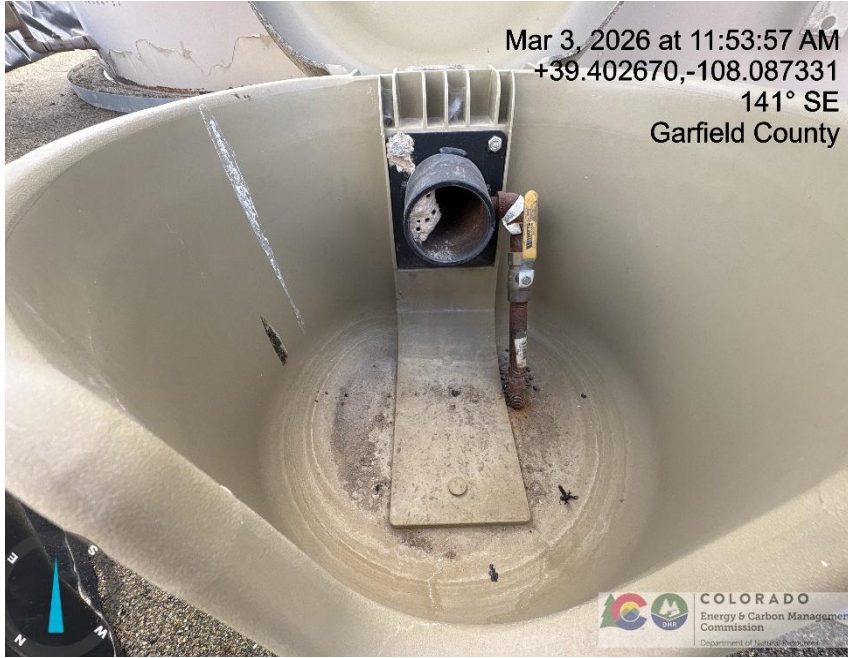
Photo # 4719 From inspection/audit 708908653 conducted on 03/03/2026 - Open ended load line

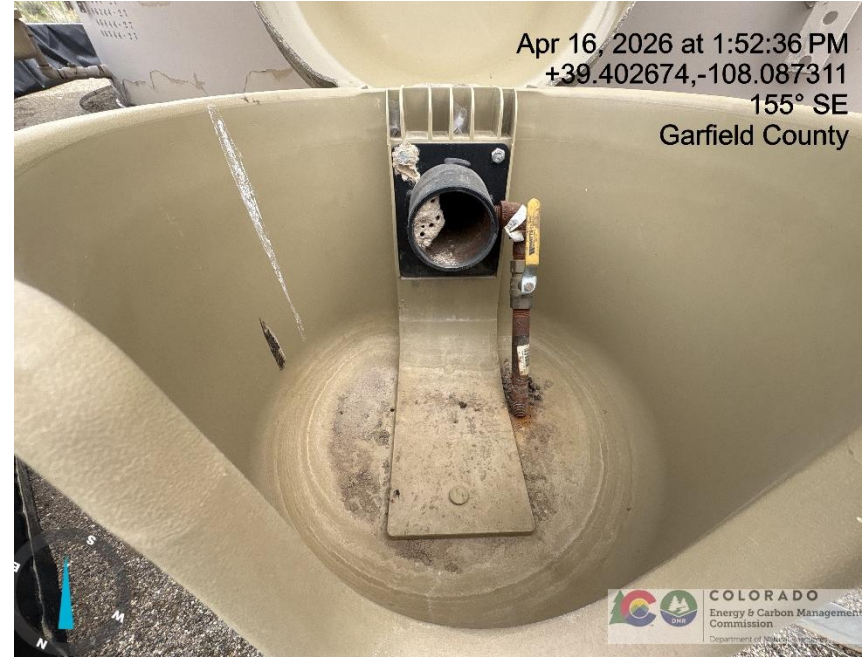
Photo # 146 Open ended load line

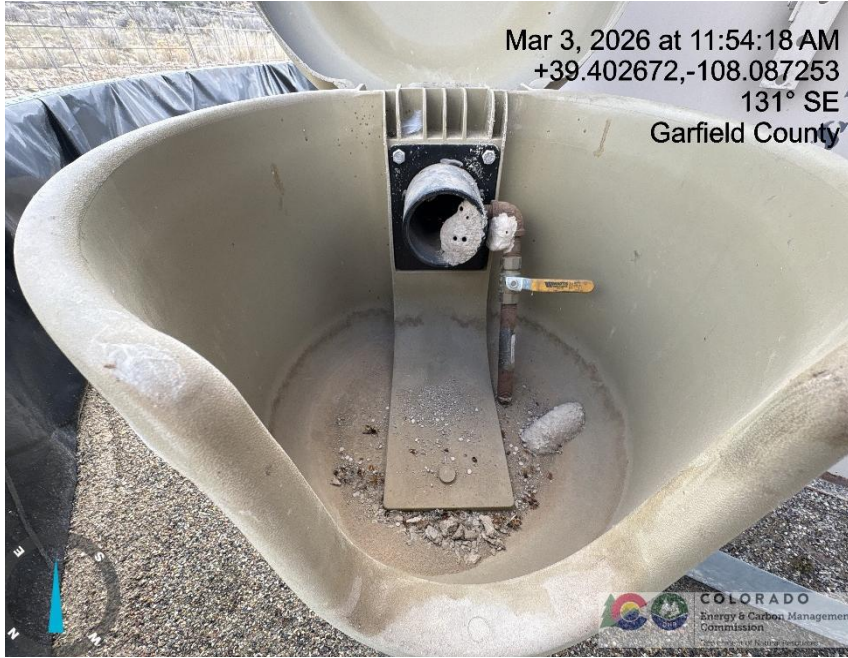
Photo # 4720 From inspection/audit 708908653 conducted on 03/03/2026 - Open ended load line

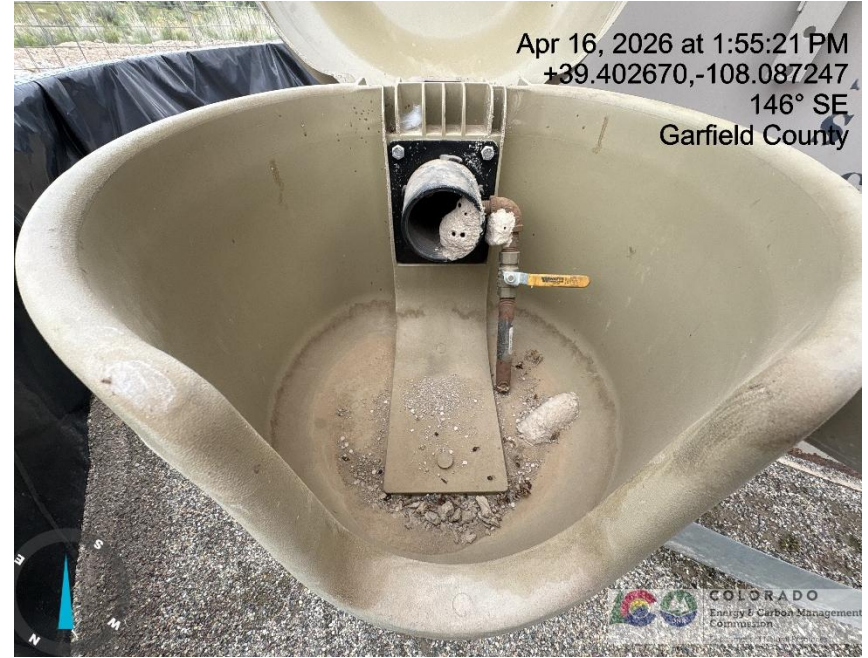
Photo # 147 Open ended load line

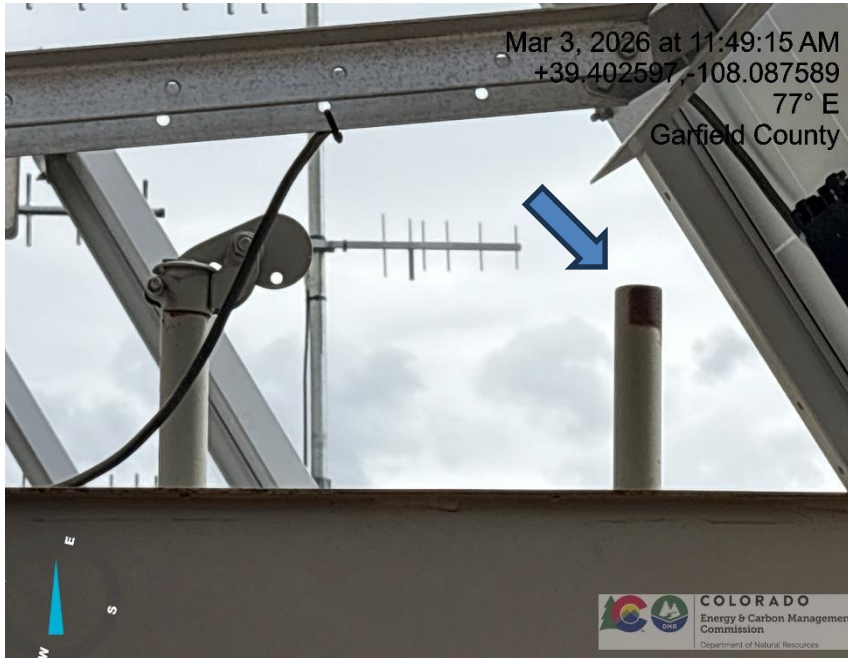
Photo # 4721 From inspection/audit 708908653 conducted on 03/03/2026 - PRV vent line does not comply with CECMC pressure safety device rules

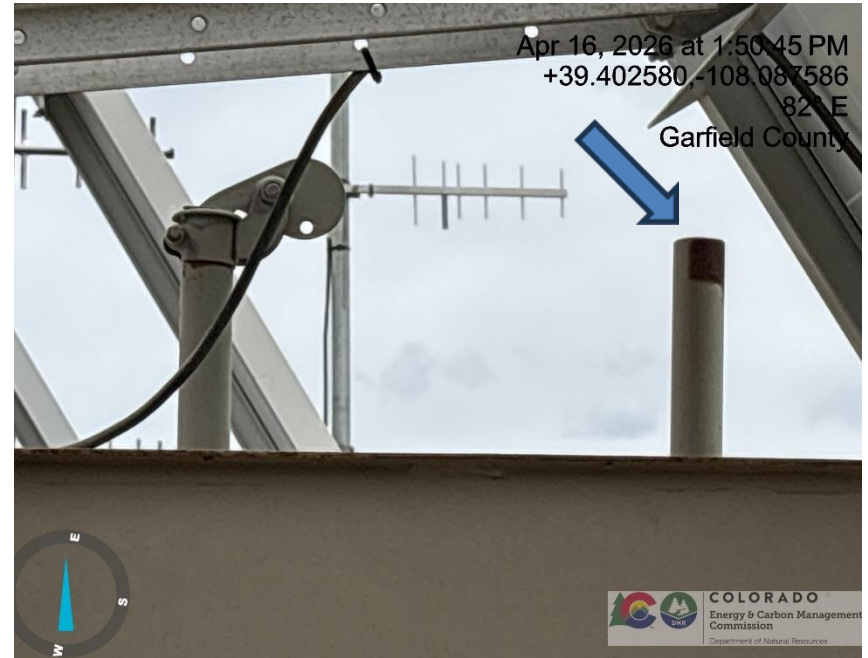
Photo # 148 PRV vent line does not comply with CECMC pressure safety device rules

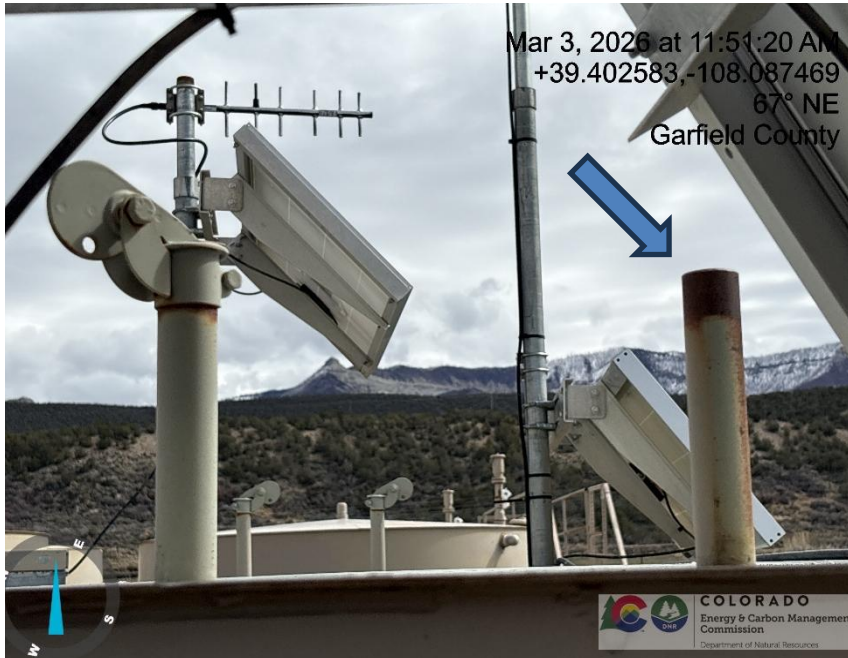
Photo # 4722 From inspection/audit 708908653 conducted on 03/03/2026 - PRV vent line does not comply with CECMC pressure safety device rules

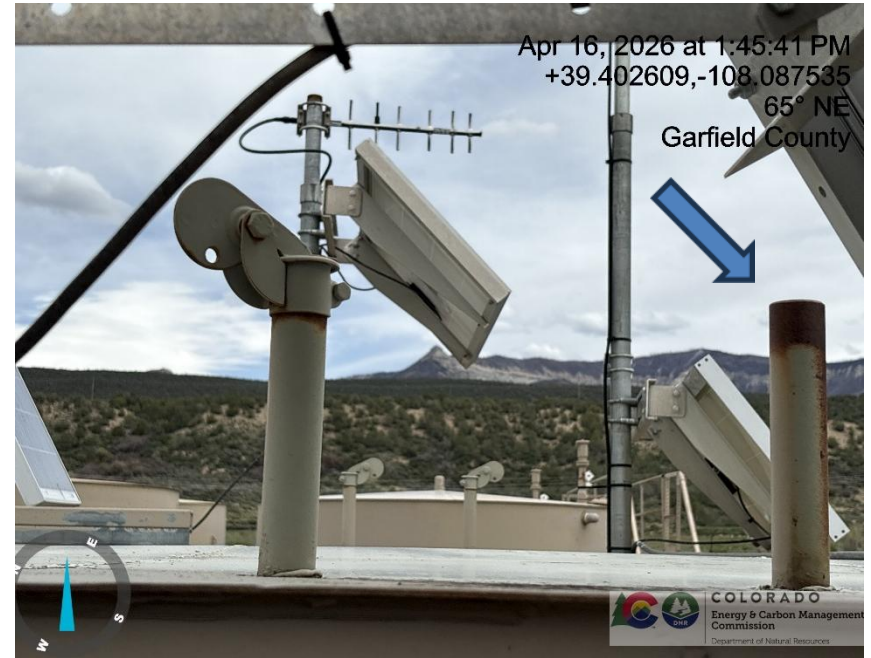
Photo # 149 PRV vent line does not comply with CECMC pressure safety device rules
