# Inspection/Audit Photos

Location: SCOUT ENERGY MANAGEMENT LLC EMERALD #33AX

Location ID: 315790

Date: 04/8/2026

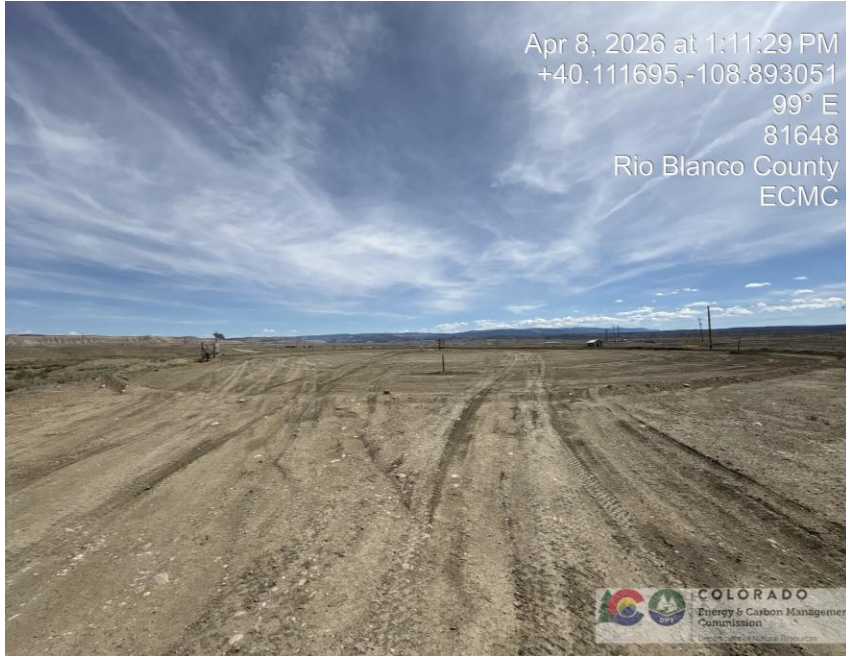
Photo # 4281 Entrance to location

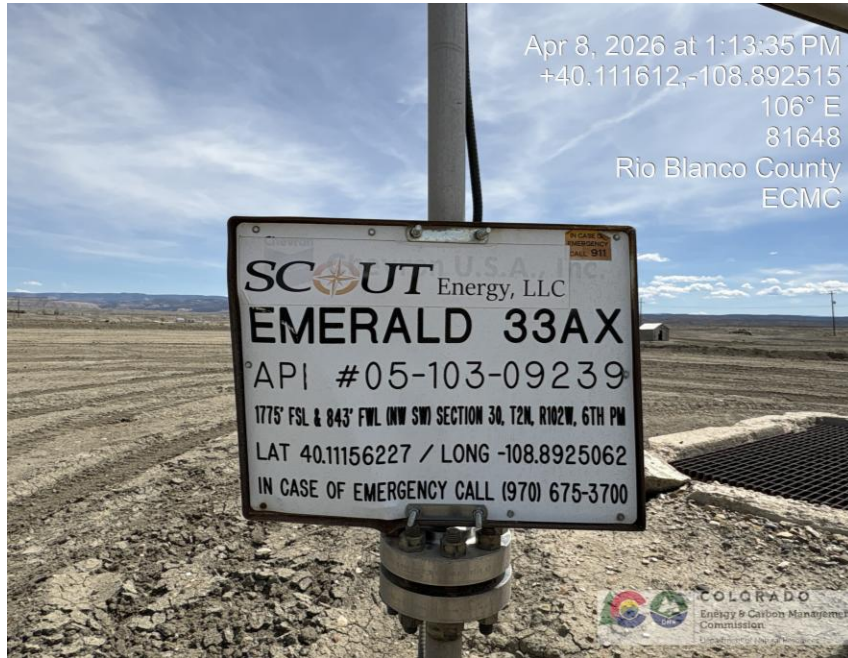
Photo # 4284 Wellhead sign lacks public road used to access the well
