Inspection/Audit Photos

Location: SCOUT ENERGY MANAGEMENT LLC EMERALD #30AX

Location ID: 315771

Date: 04/8/2026

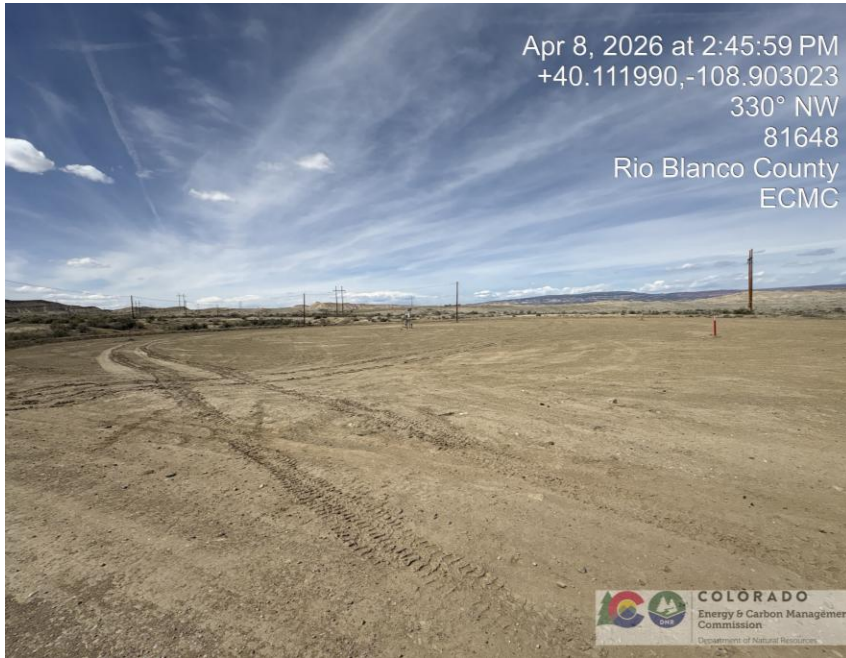
Photo # 4309 Entrance to location

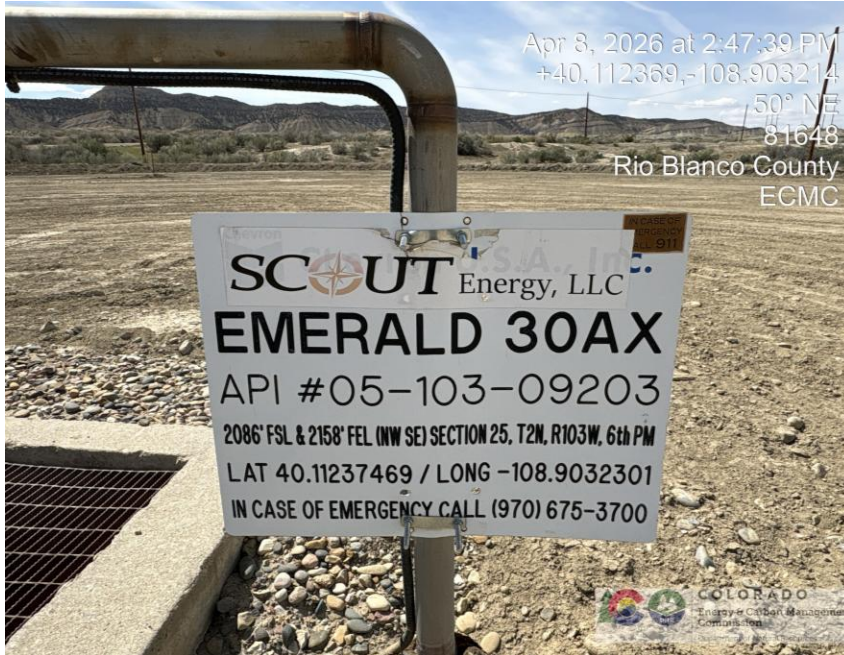
Photo # 4311 Wellhead sign lacks public road used to access the well

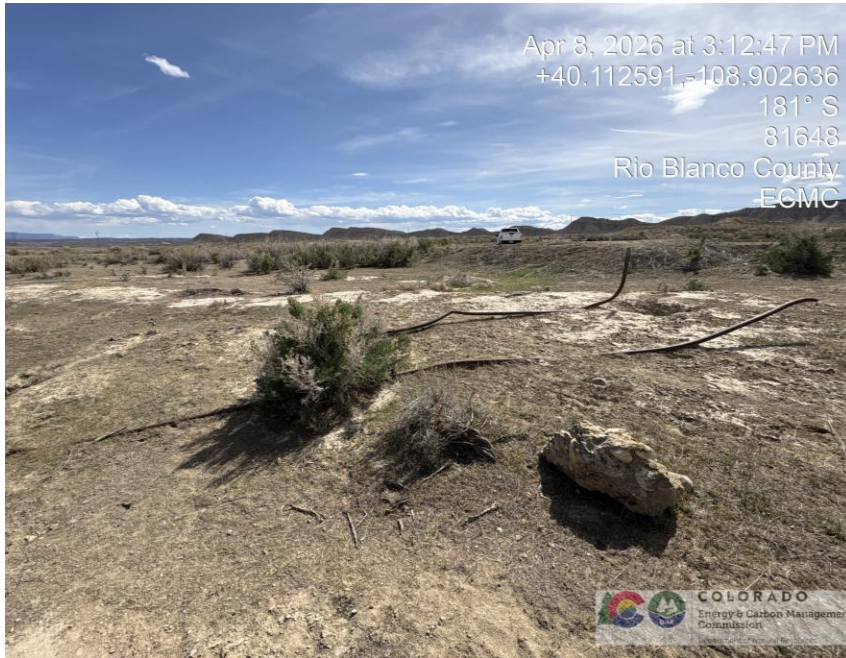
Photo # 4326 Debris

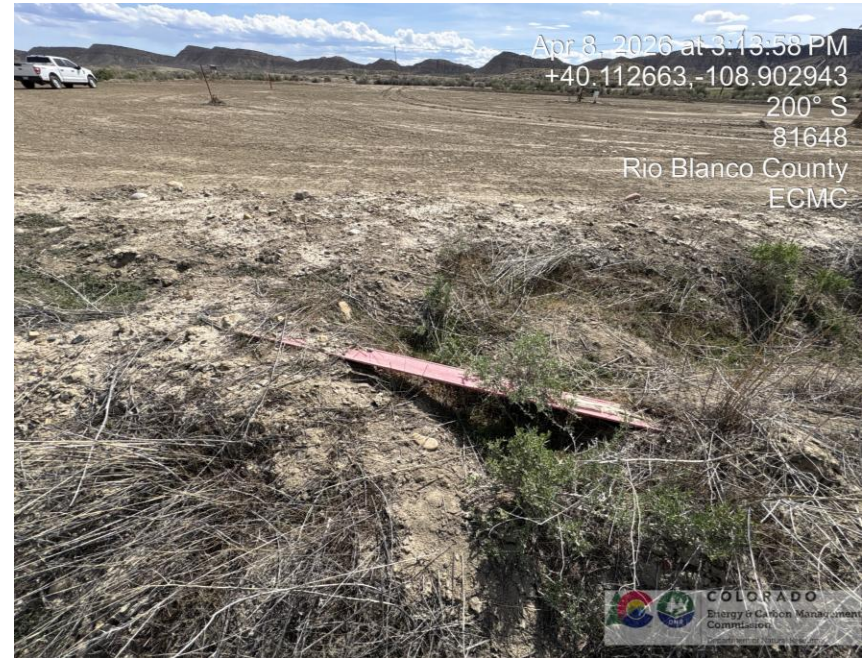
Photo # 4327 Debris

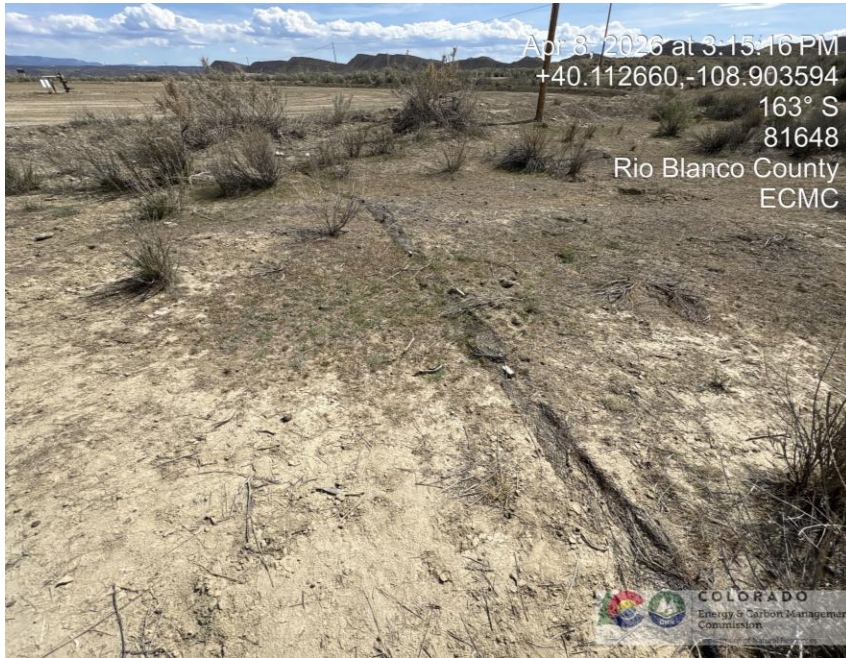
Photo # 4328 Debris

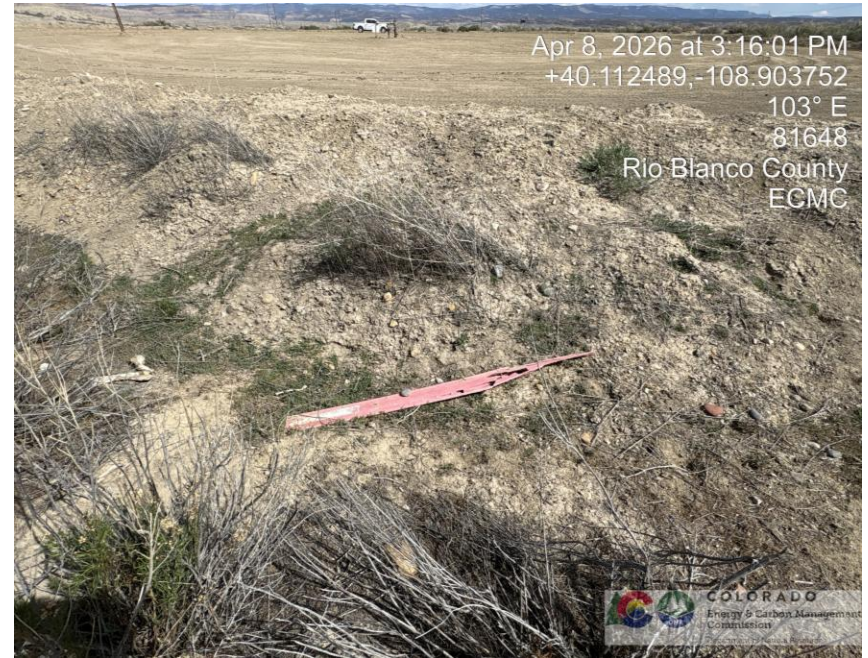
Photo # 4329 Debris

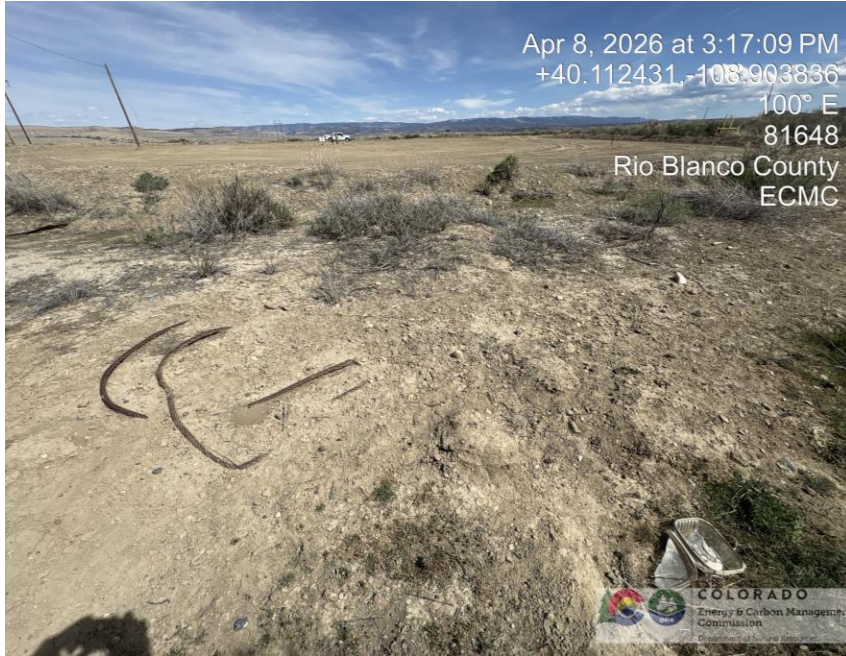
Photo # 4330 Debris

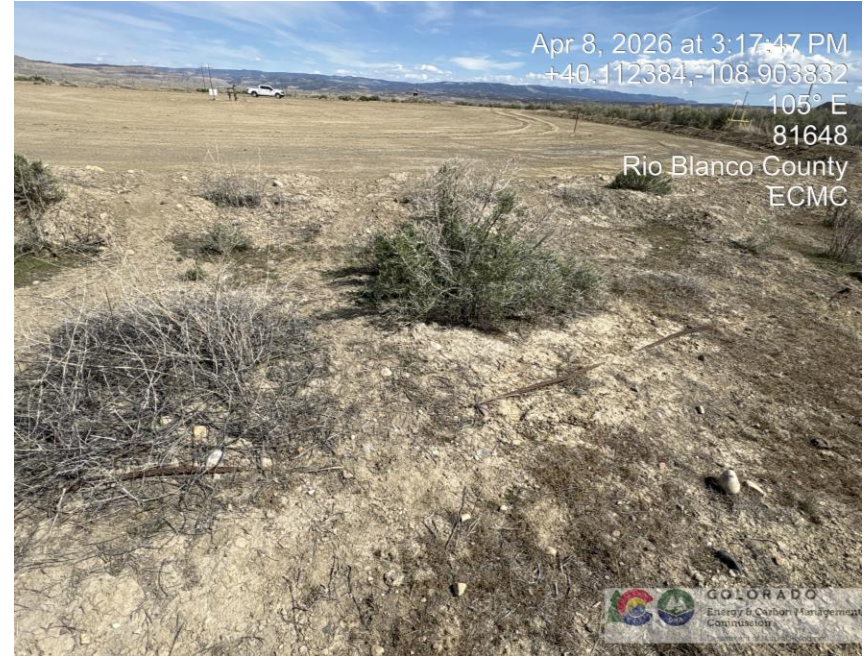
Photo # 4331 Debris

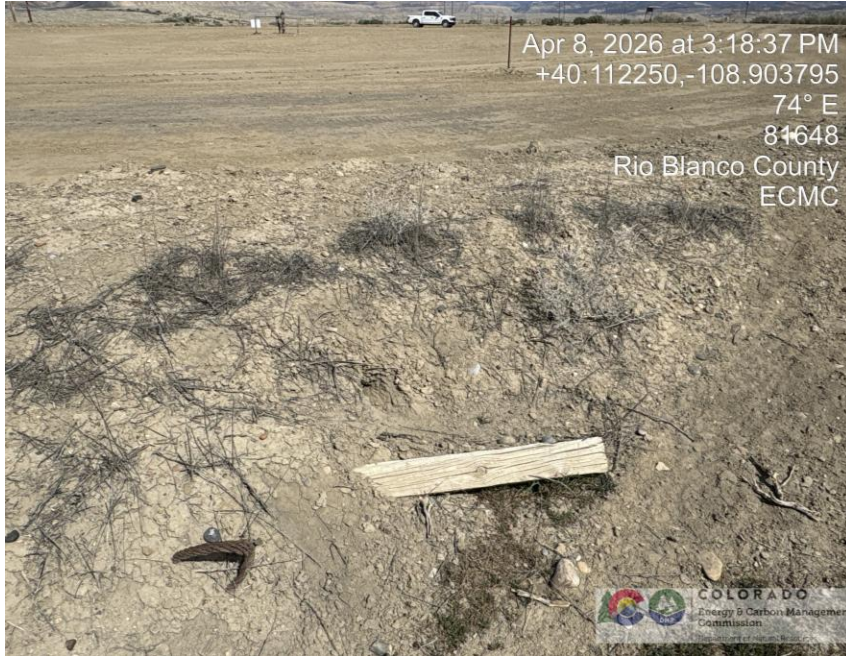
Photo # 4333 Debris

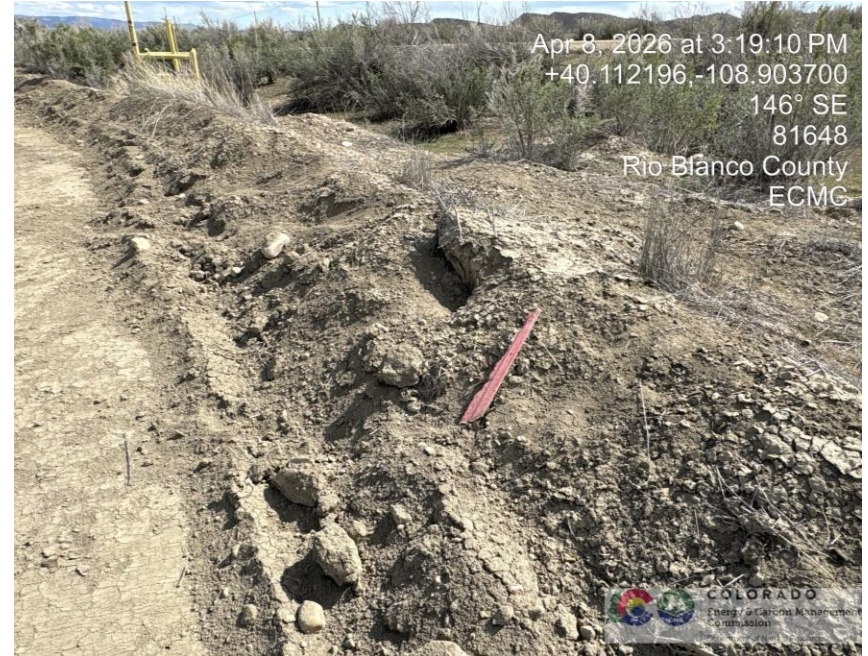
Photo # 4334 Debris

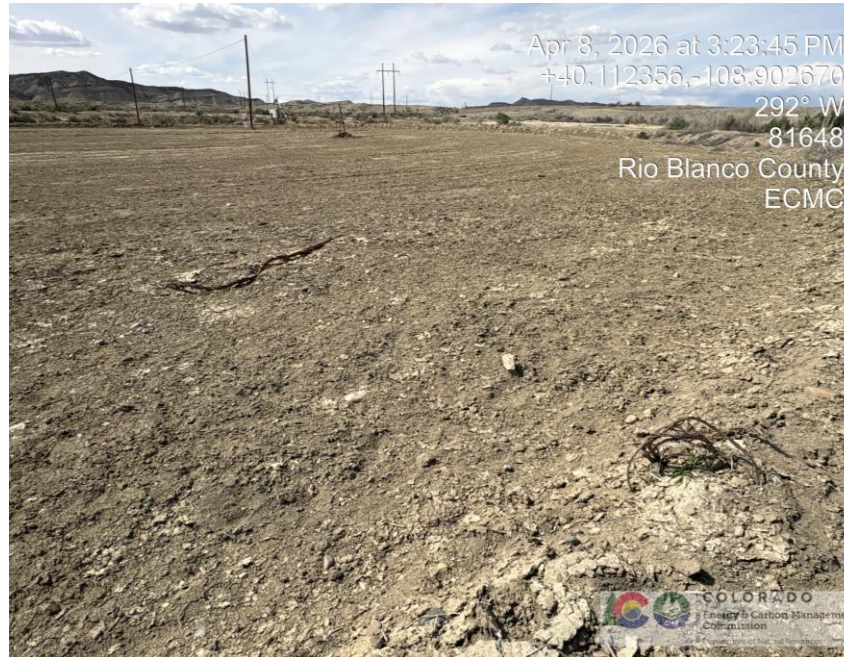
Photo # 4340 Debris
