# Final Reclamation and Stormwater Inspection

April 16, 2026

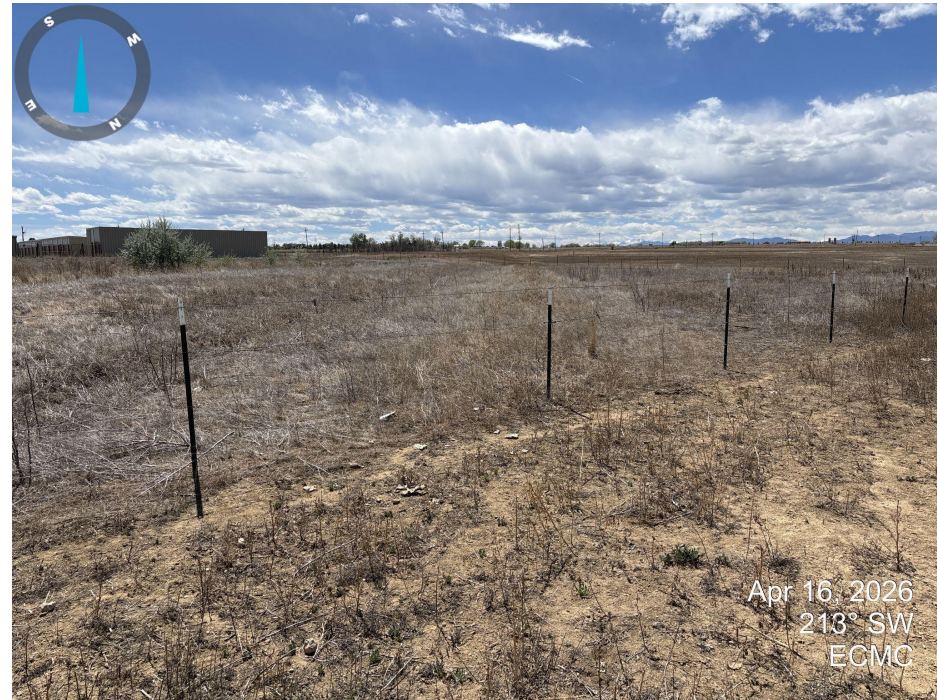
**Photo 2.** A portion of the access road goes through this section that is fenced off from the surrounding rangeland. Desirable perennial species were observed in this area such as smooth brome.
