Inspection/Audit Photos

Location: SCOUT ENERGY MANAGEMENT LLC EMERALD #49AX

Location ID: 316504

Date: 04/8/2026

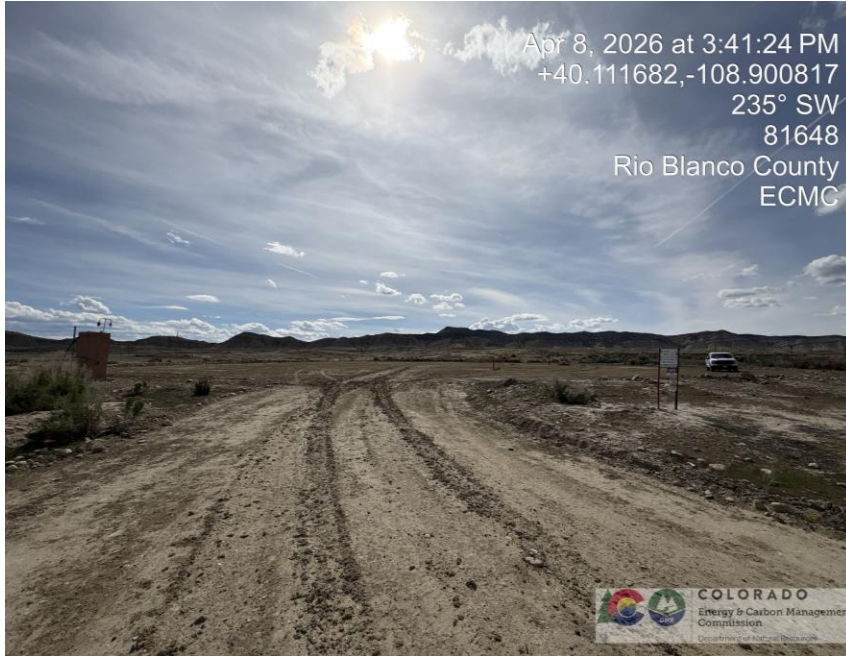
Photo # 4251 Entrance to location

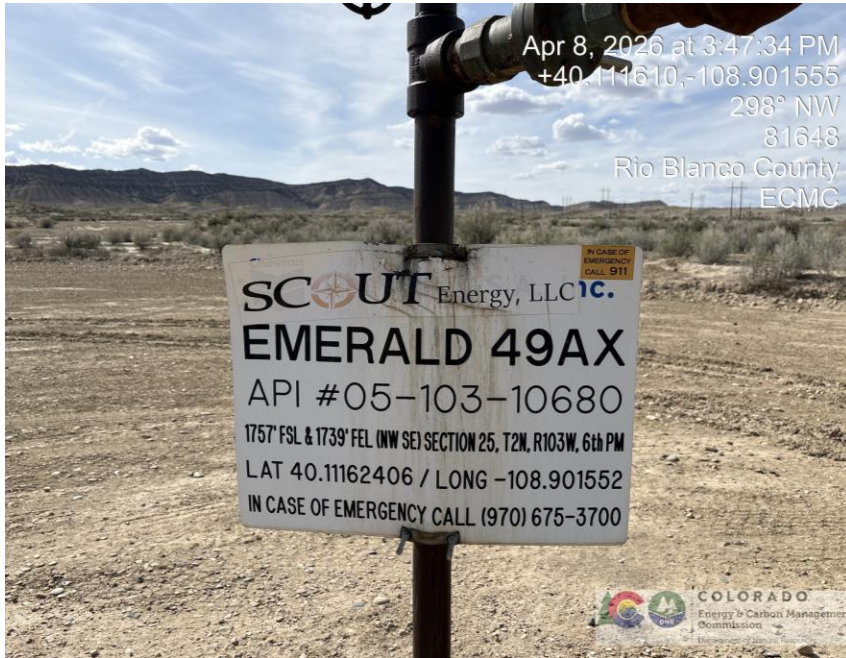
Photo # 4354 Wellhead sign lacks public road used to access the well

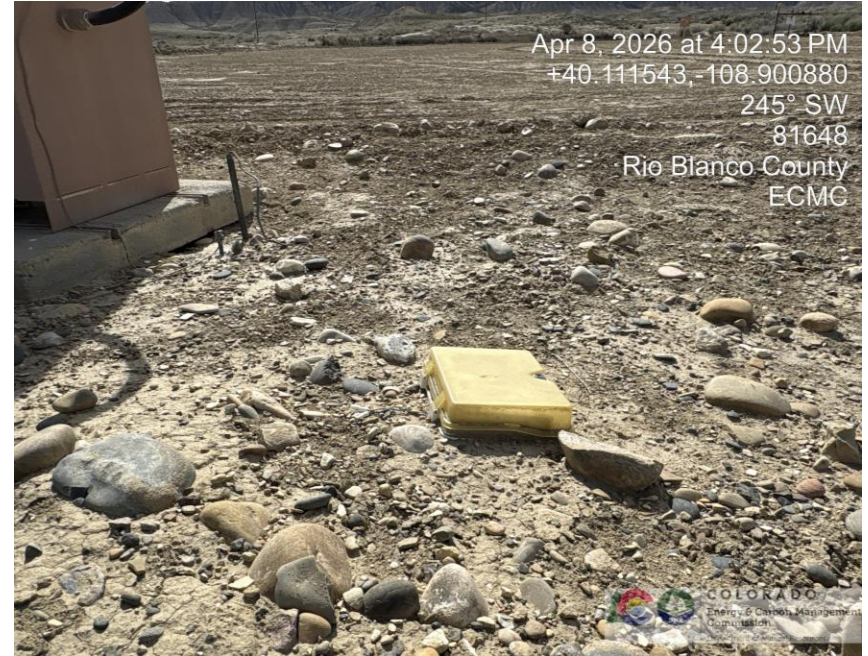
Photo # 4366 Debris

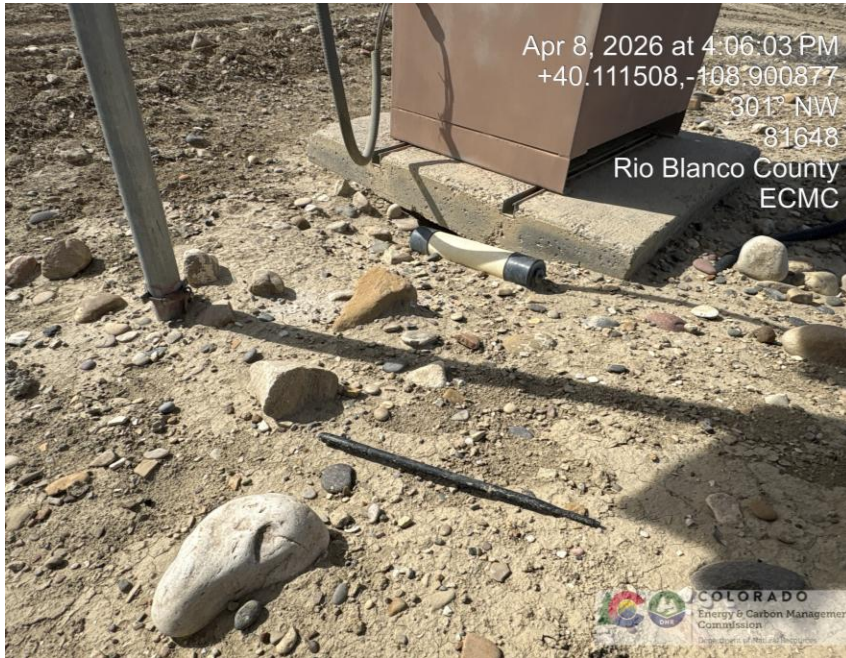
Photo # 4368 Debris

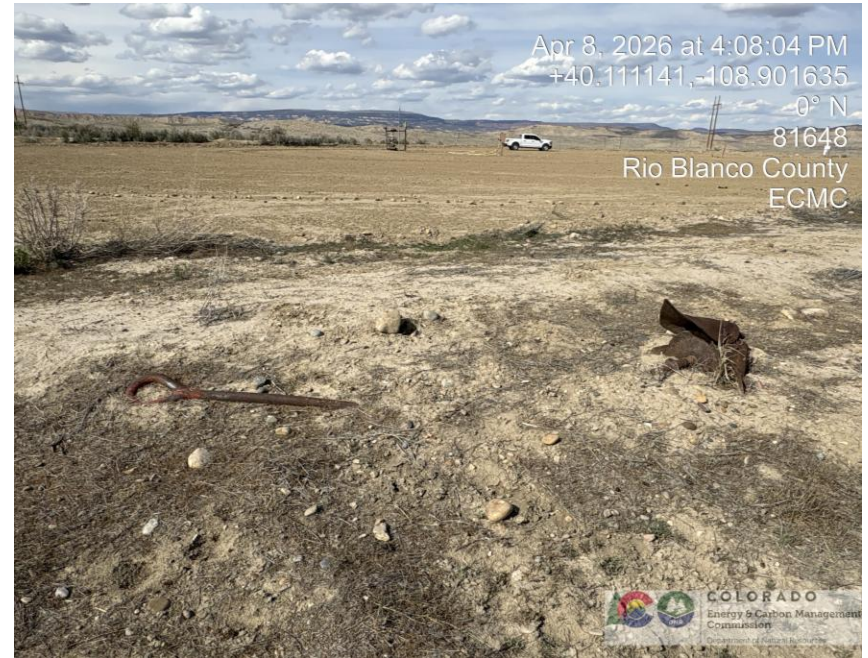
Photo # 4370 Debris
