Audit Photos

Location Name: VISION ENERGY LLC, COYOTE WASH UNIT-68S102W/27NWSW

Location ID: 312521

Date: 4/13/2026

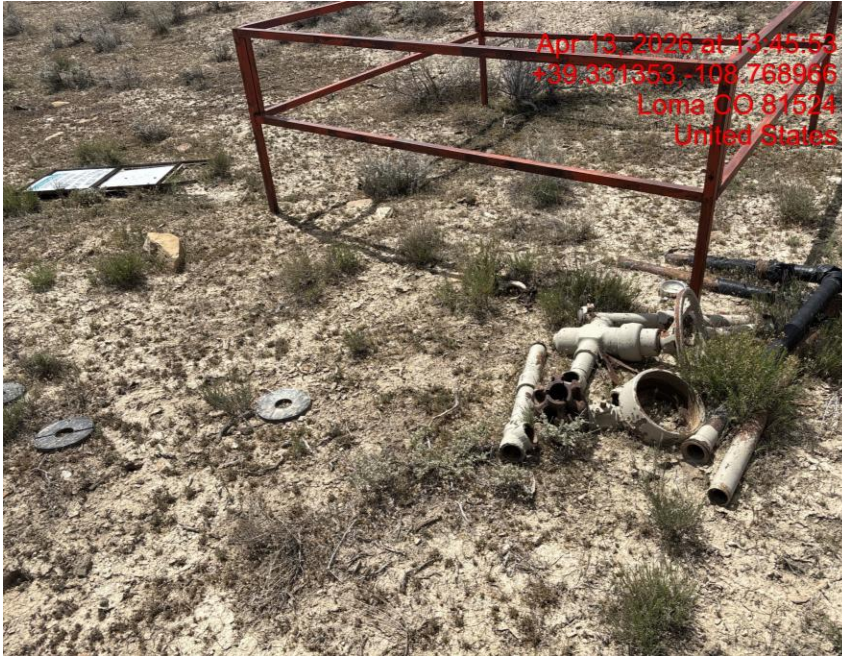
Wellhead Fencing/Debris – Photo #03519

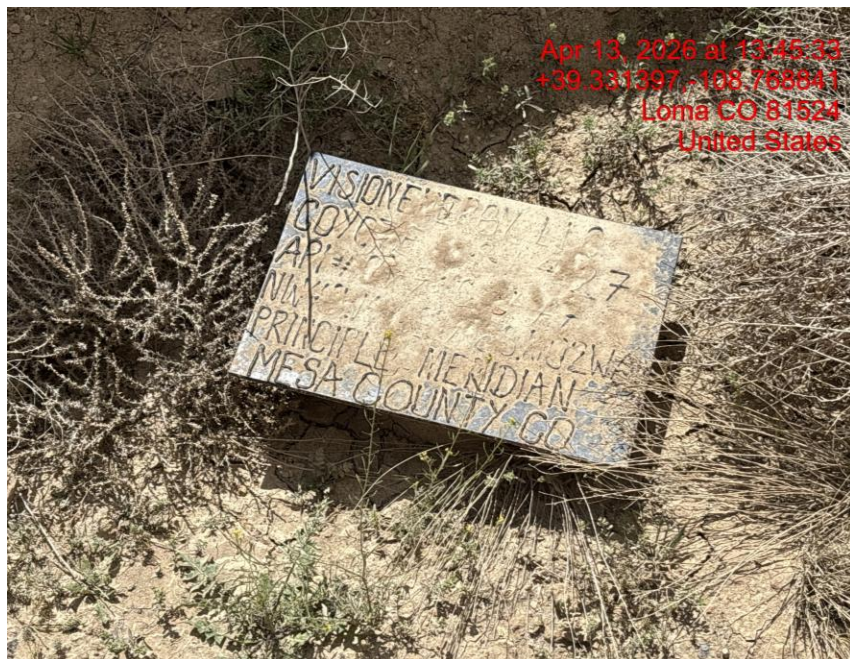
P&A Cutoff Plate – Photo #03517

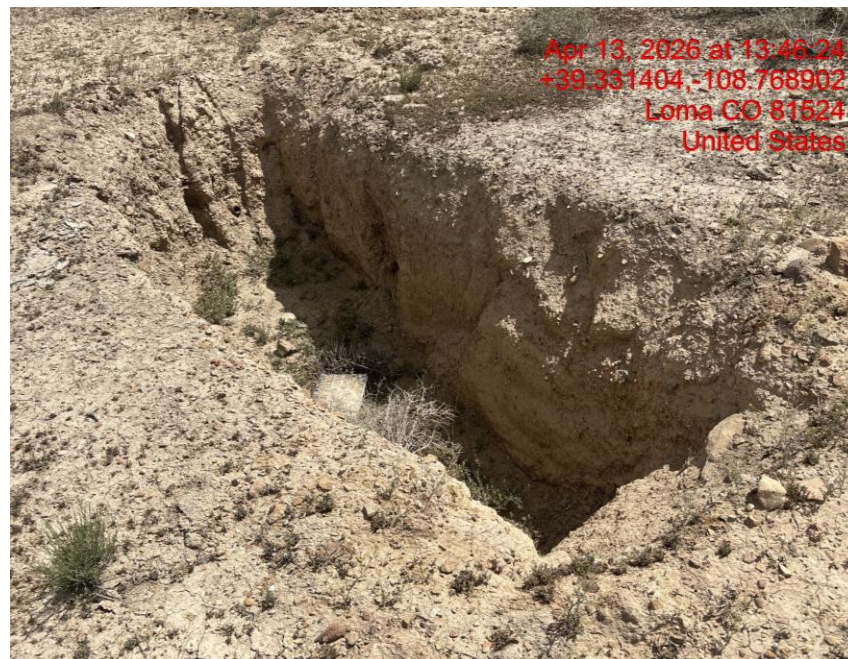
Flowline Excavation – Photo #03521

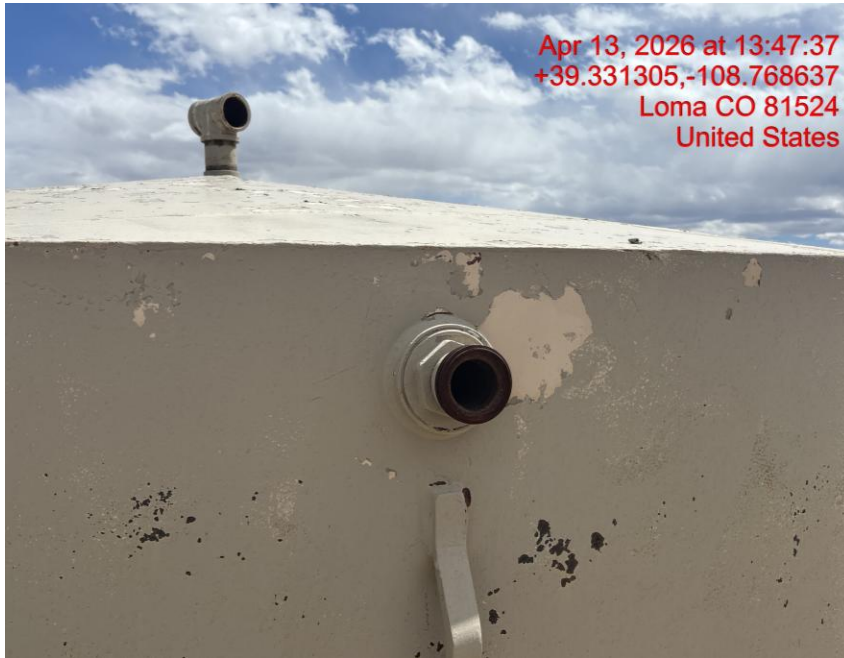
Wildlife Entry Hazard – Photo #03529

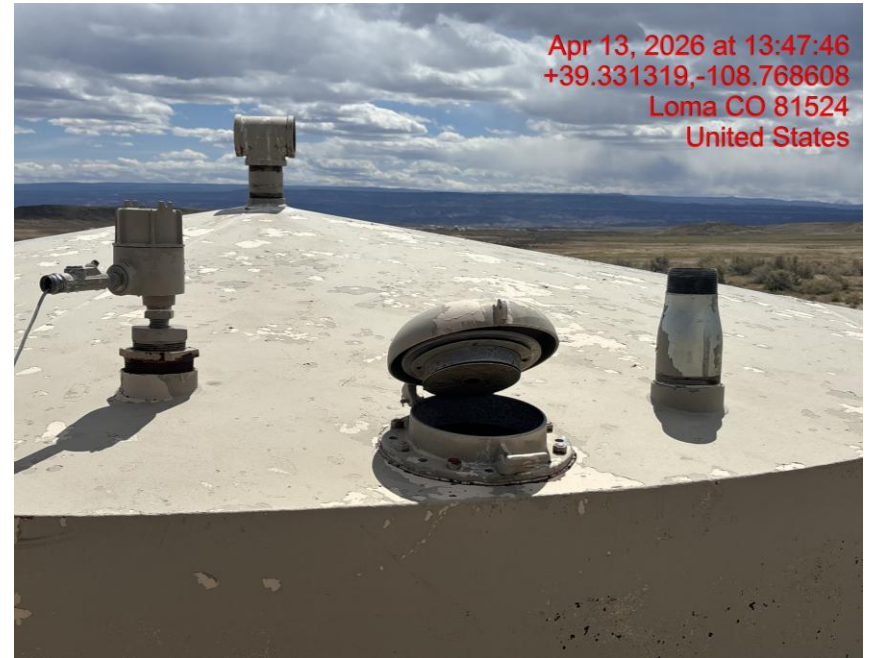
Wildlife Entry Hazard – Photo #03530
