## Audit Photos

Location Name: VISION ENERGY LLC, COYOTE WASH UNIT-68S102W/27NWSW

Location ID: 312521

Date: 4/13/2026

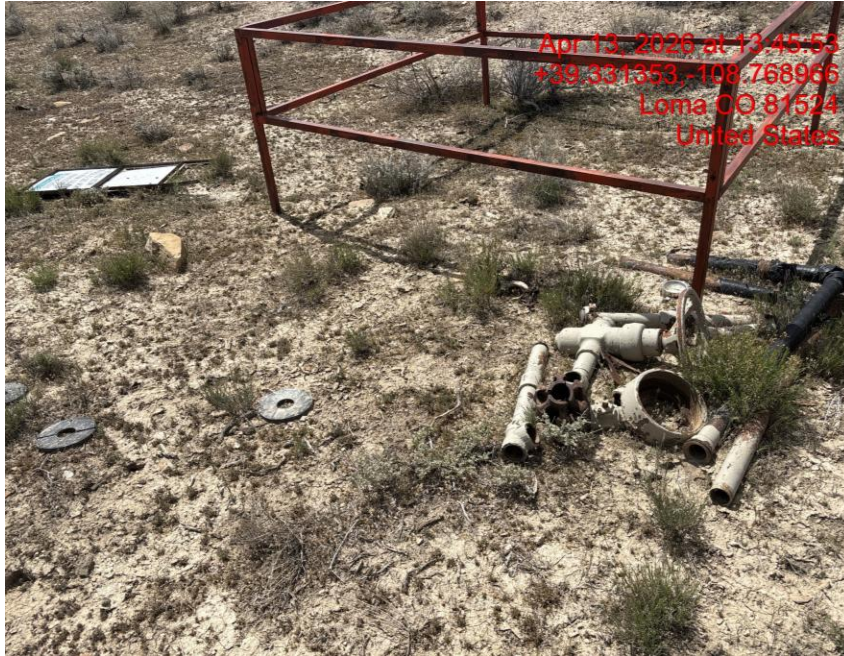
Wellhead Fencing/Debris – Photo #03519

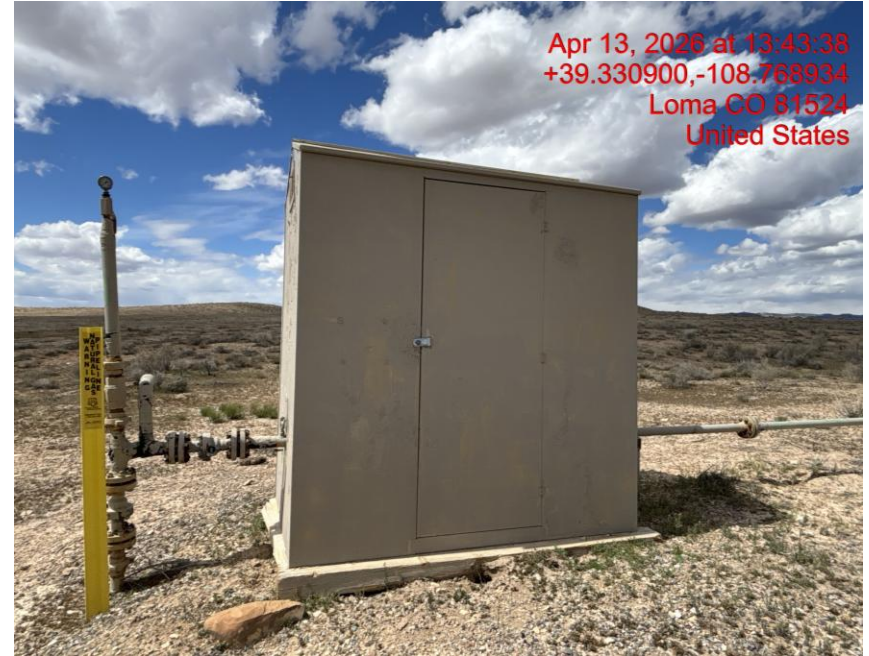
Unused Gas Meter – Photo #03513

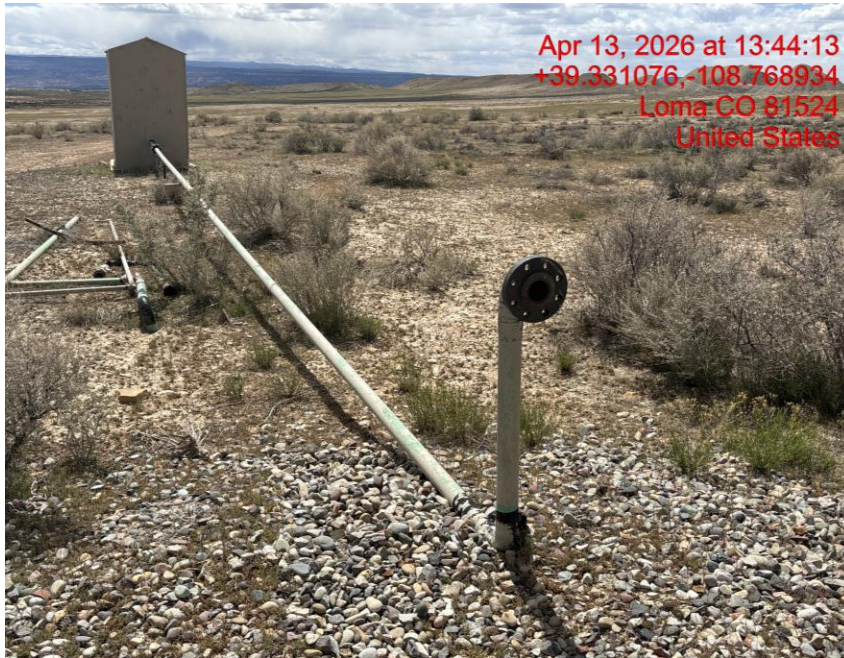
Unused Gas Meter – Photo #03515

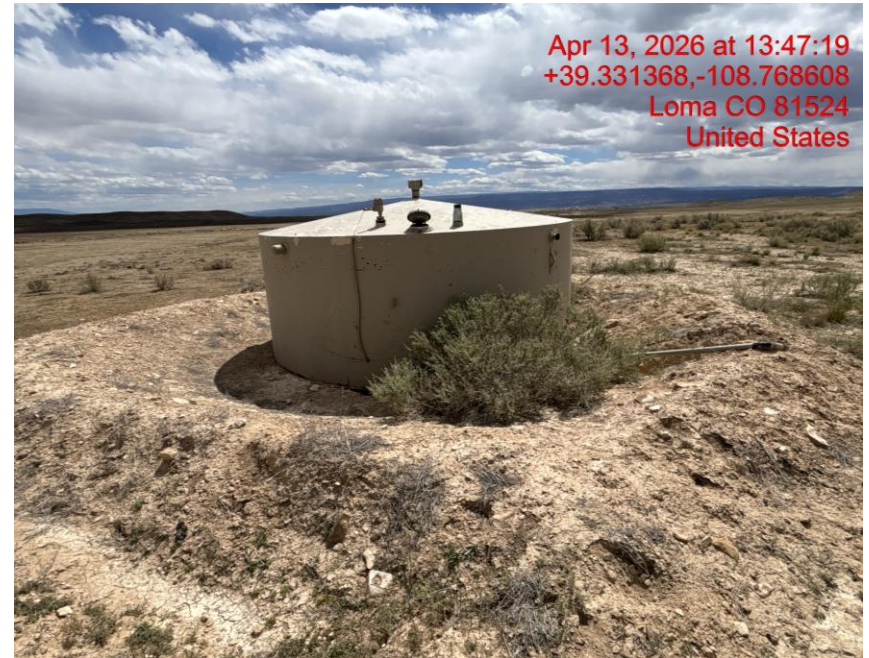
Unused Storage Tank – Photo #03527

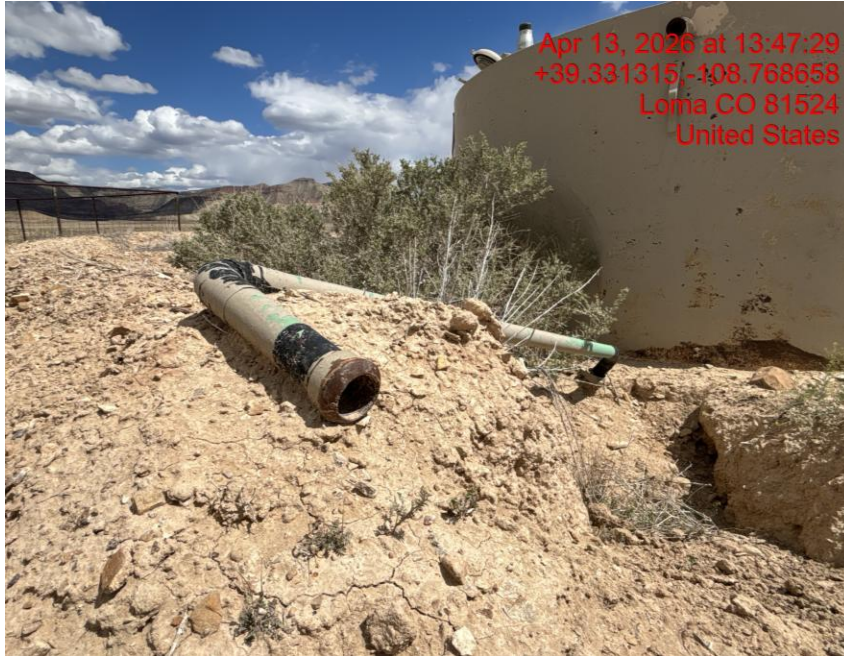
Unused Storage Tank – Photo #03528

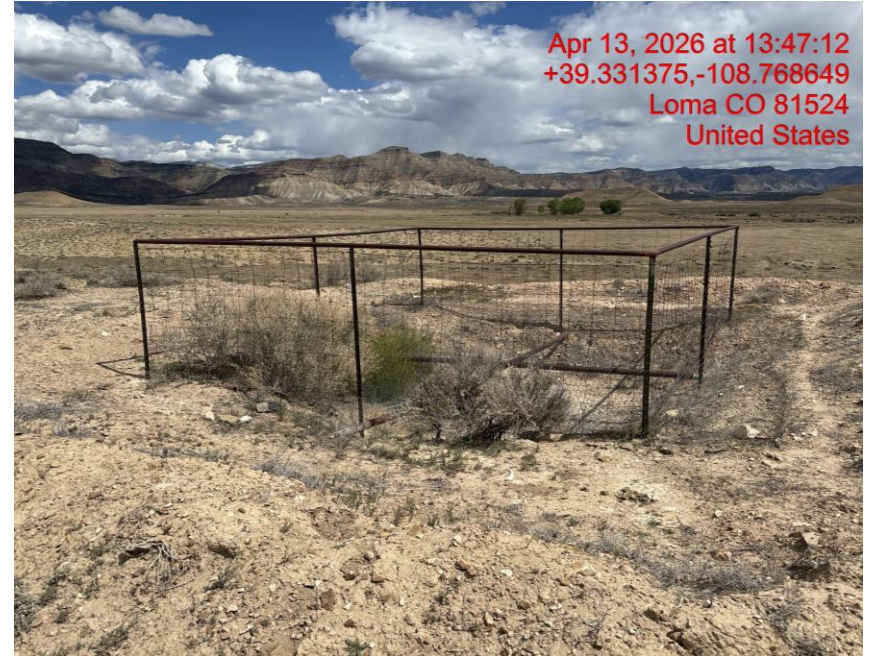
Pit – Photo #03526

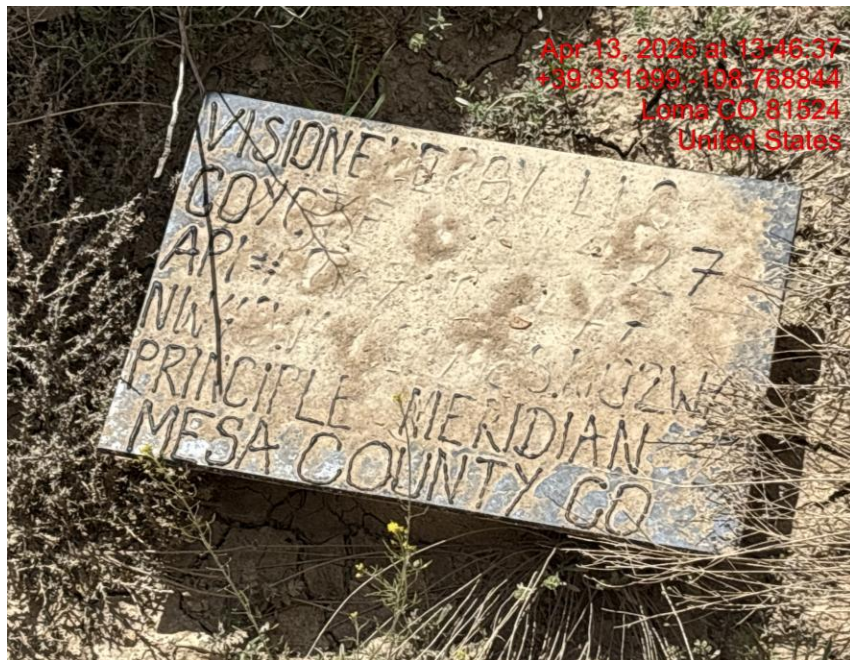
P&A Cutoff Plate – Photo #03522

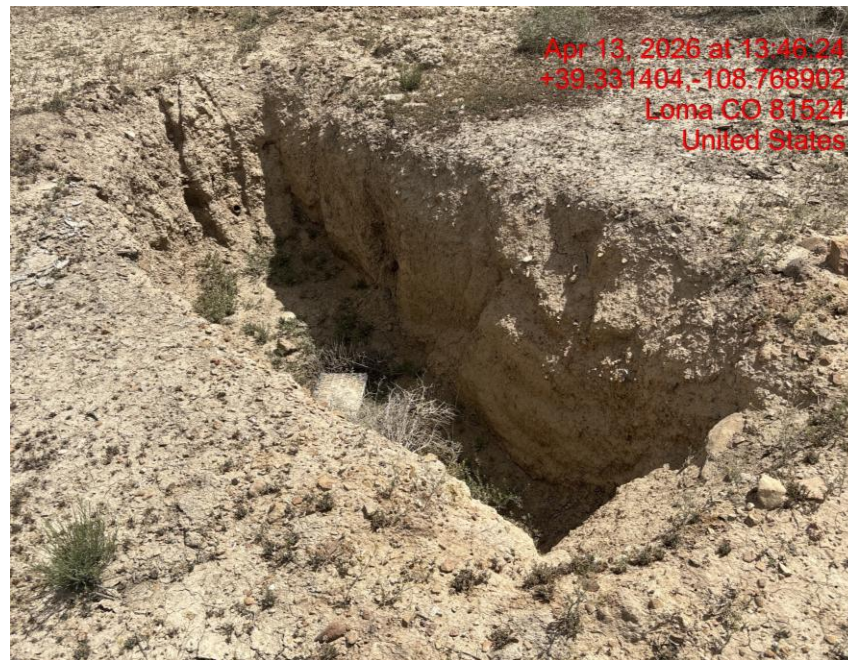
Flowline Excavation – Photo #03521

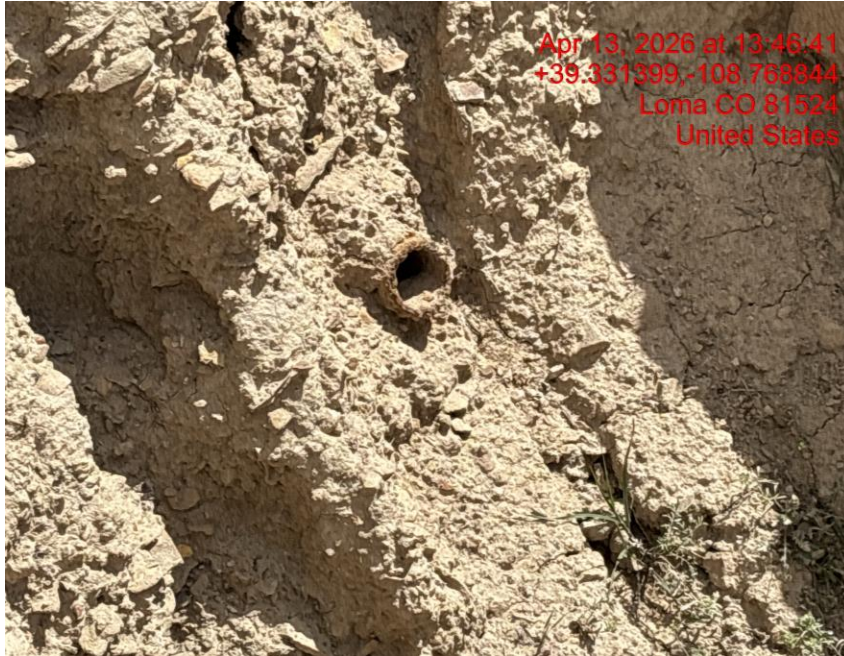
Open-Ended Flowline – Photo #03523

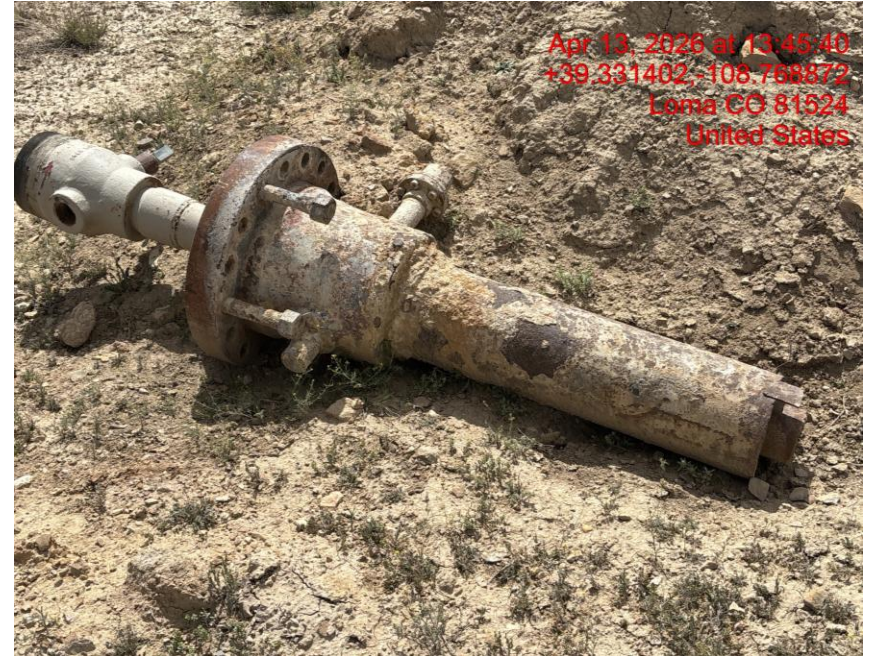
Debris – Photo #03518

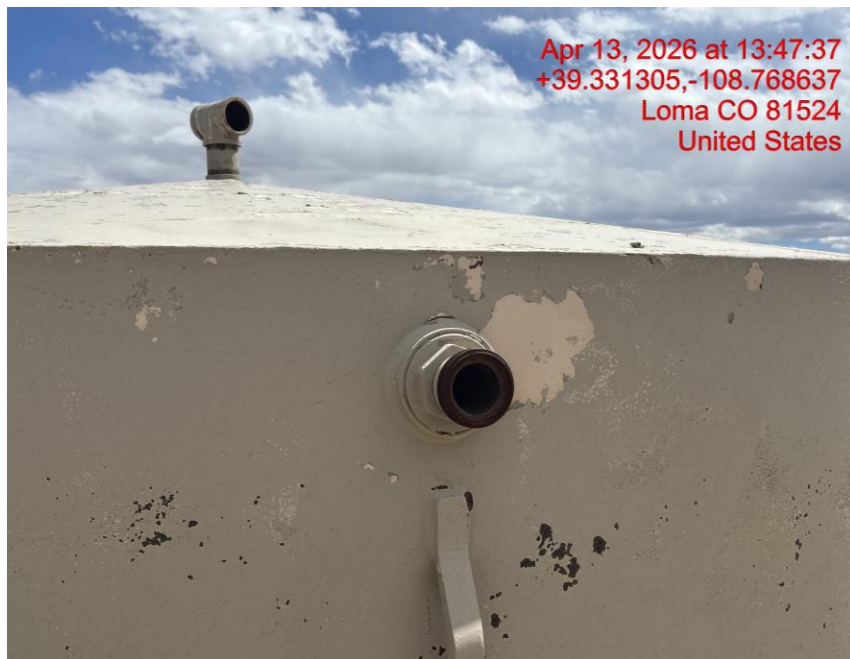
Wildlife Entry Hazards – Photo #03529

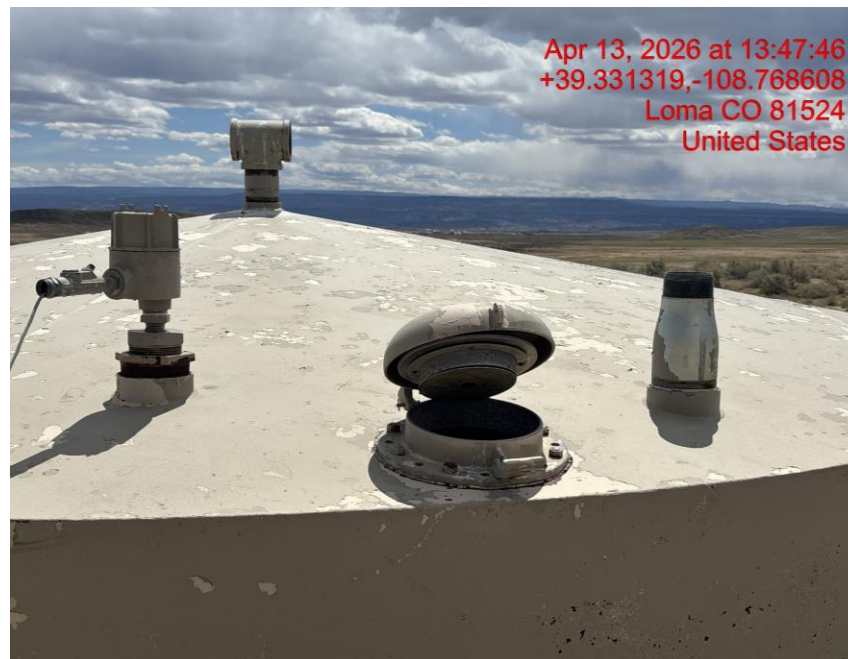
Wildlife Entry Hazard – Photo #03530
