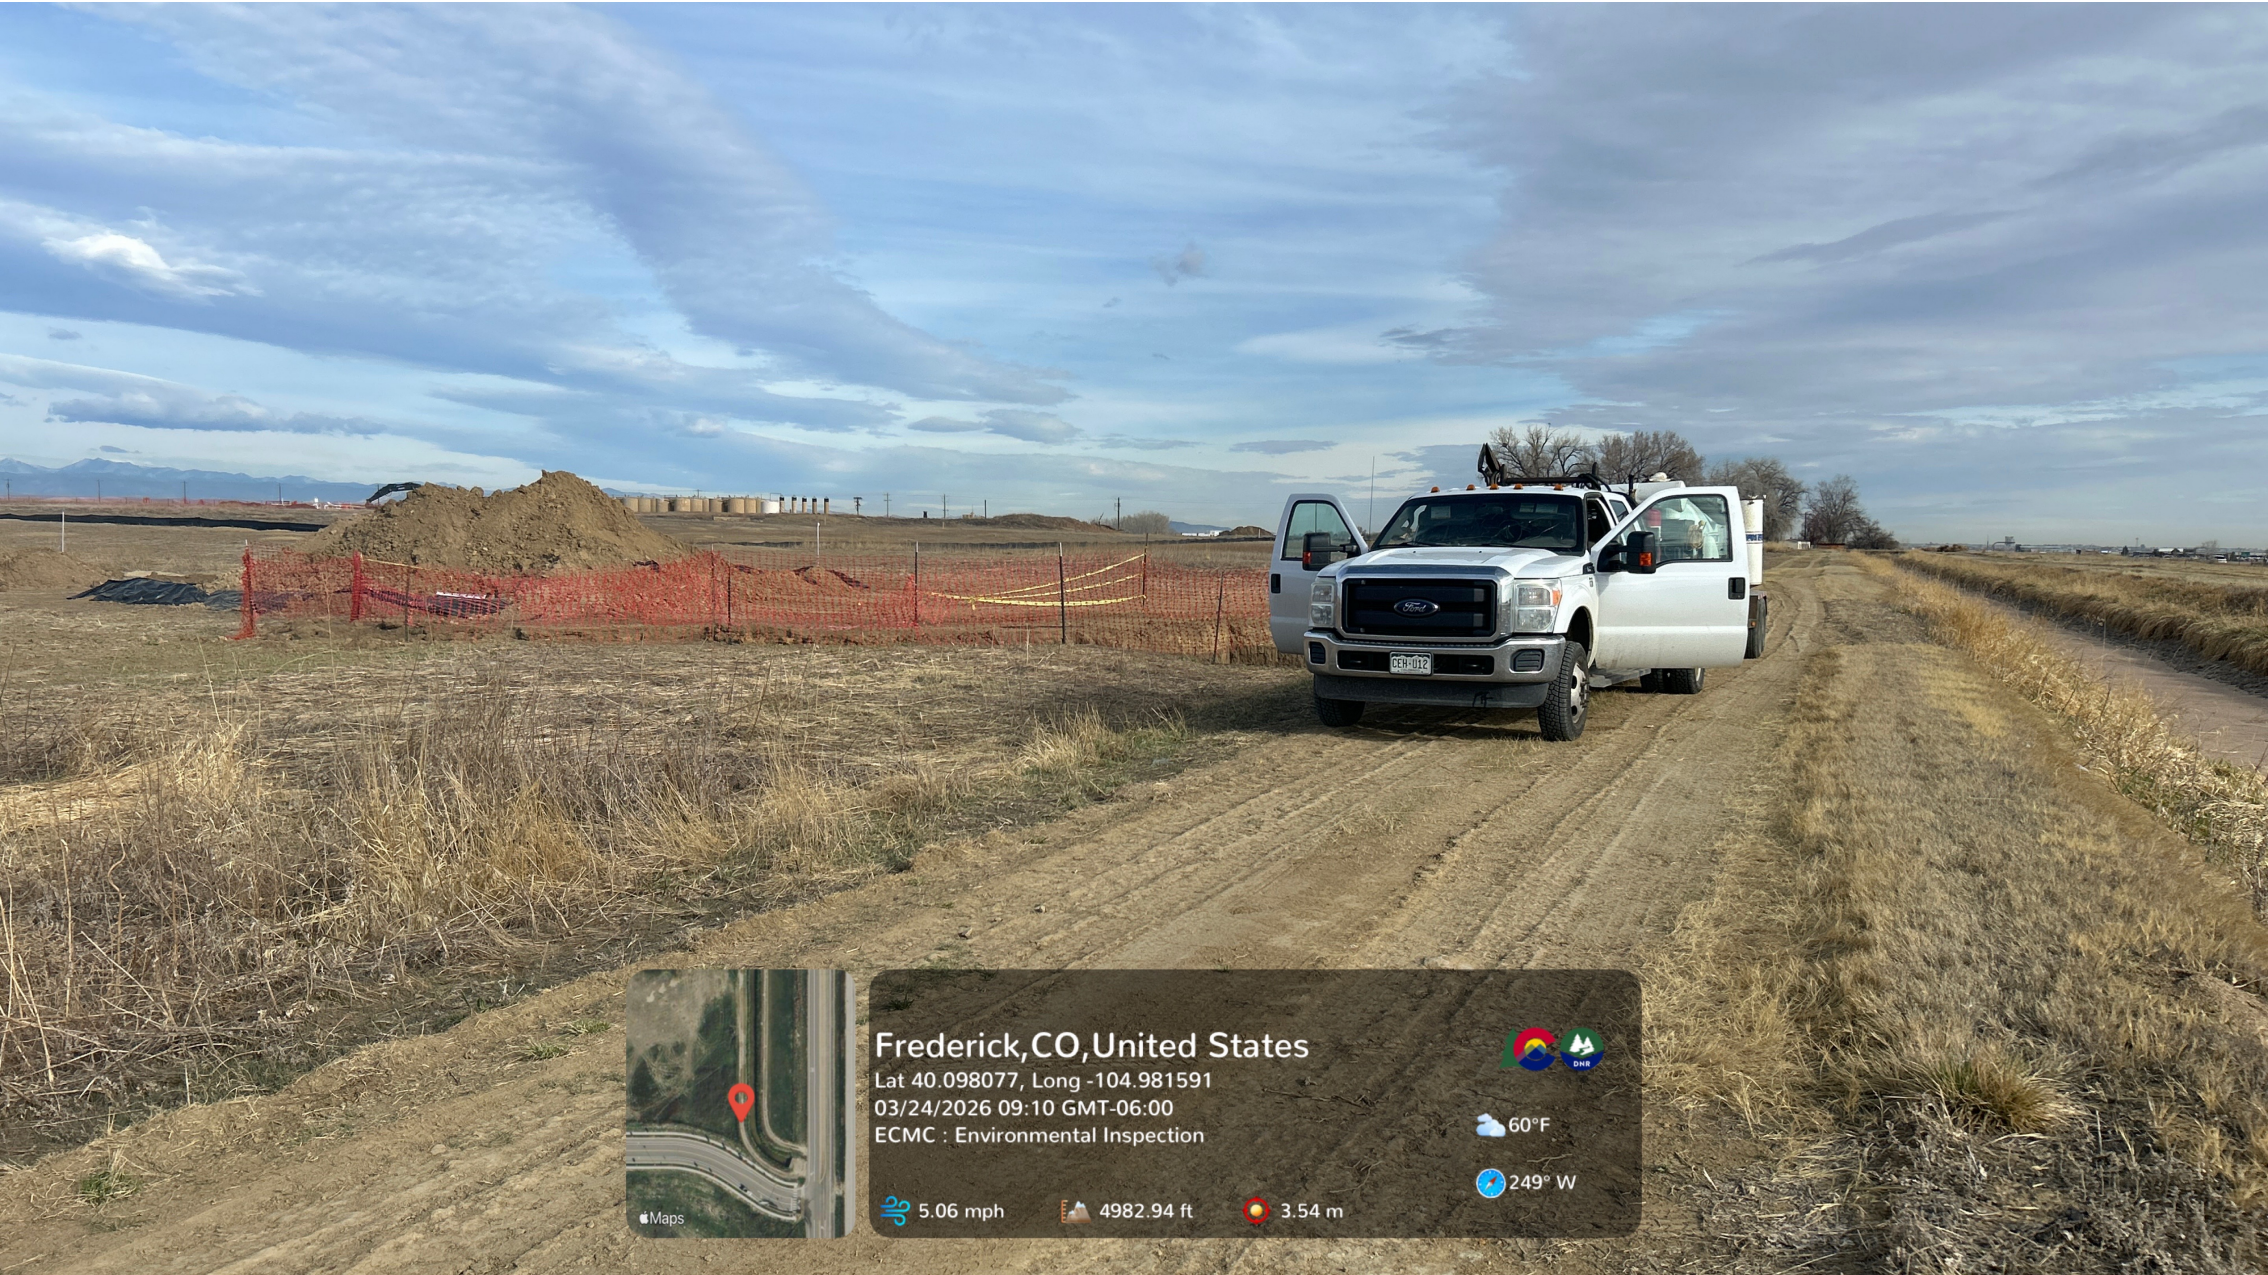
Sullivan Ditch was dry at the time of the inspection. Operator personnel and equipment were on location at the time of inspection.

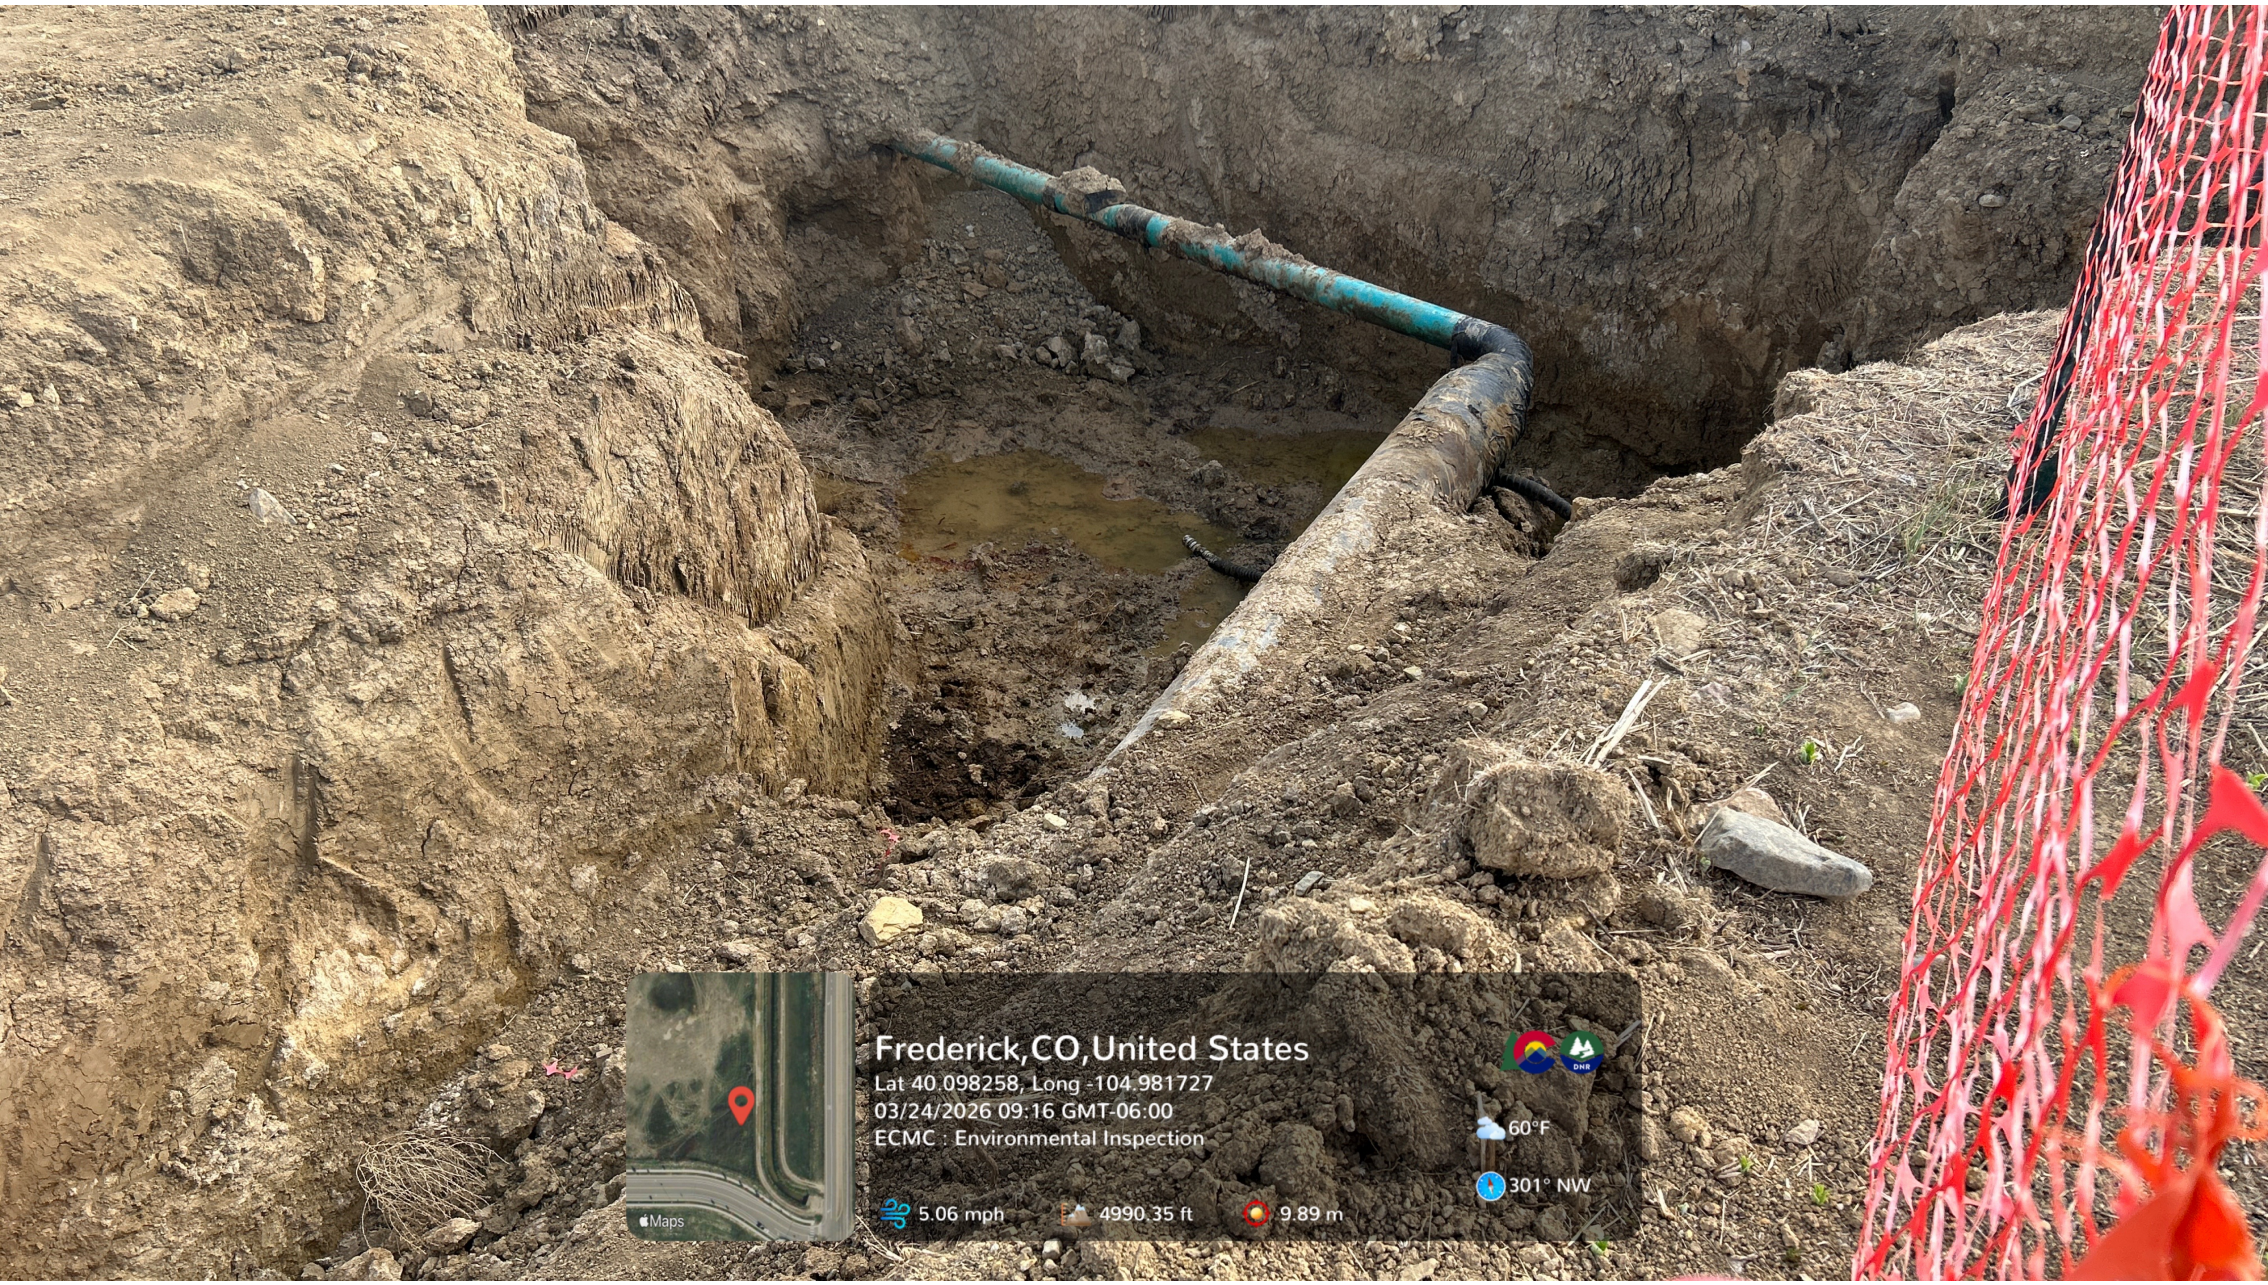
Stained soil and groundwater with free product are visible in situ.

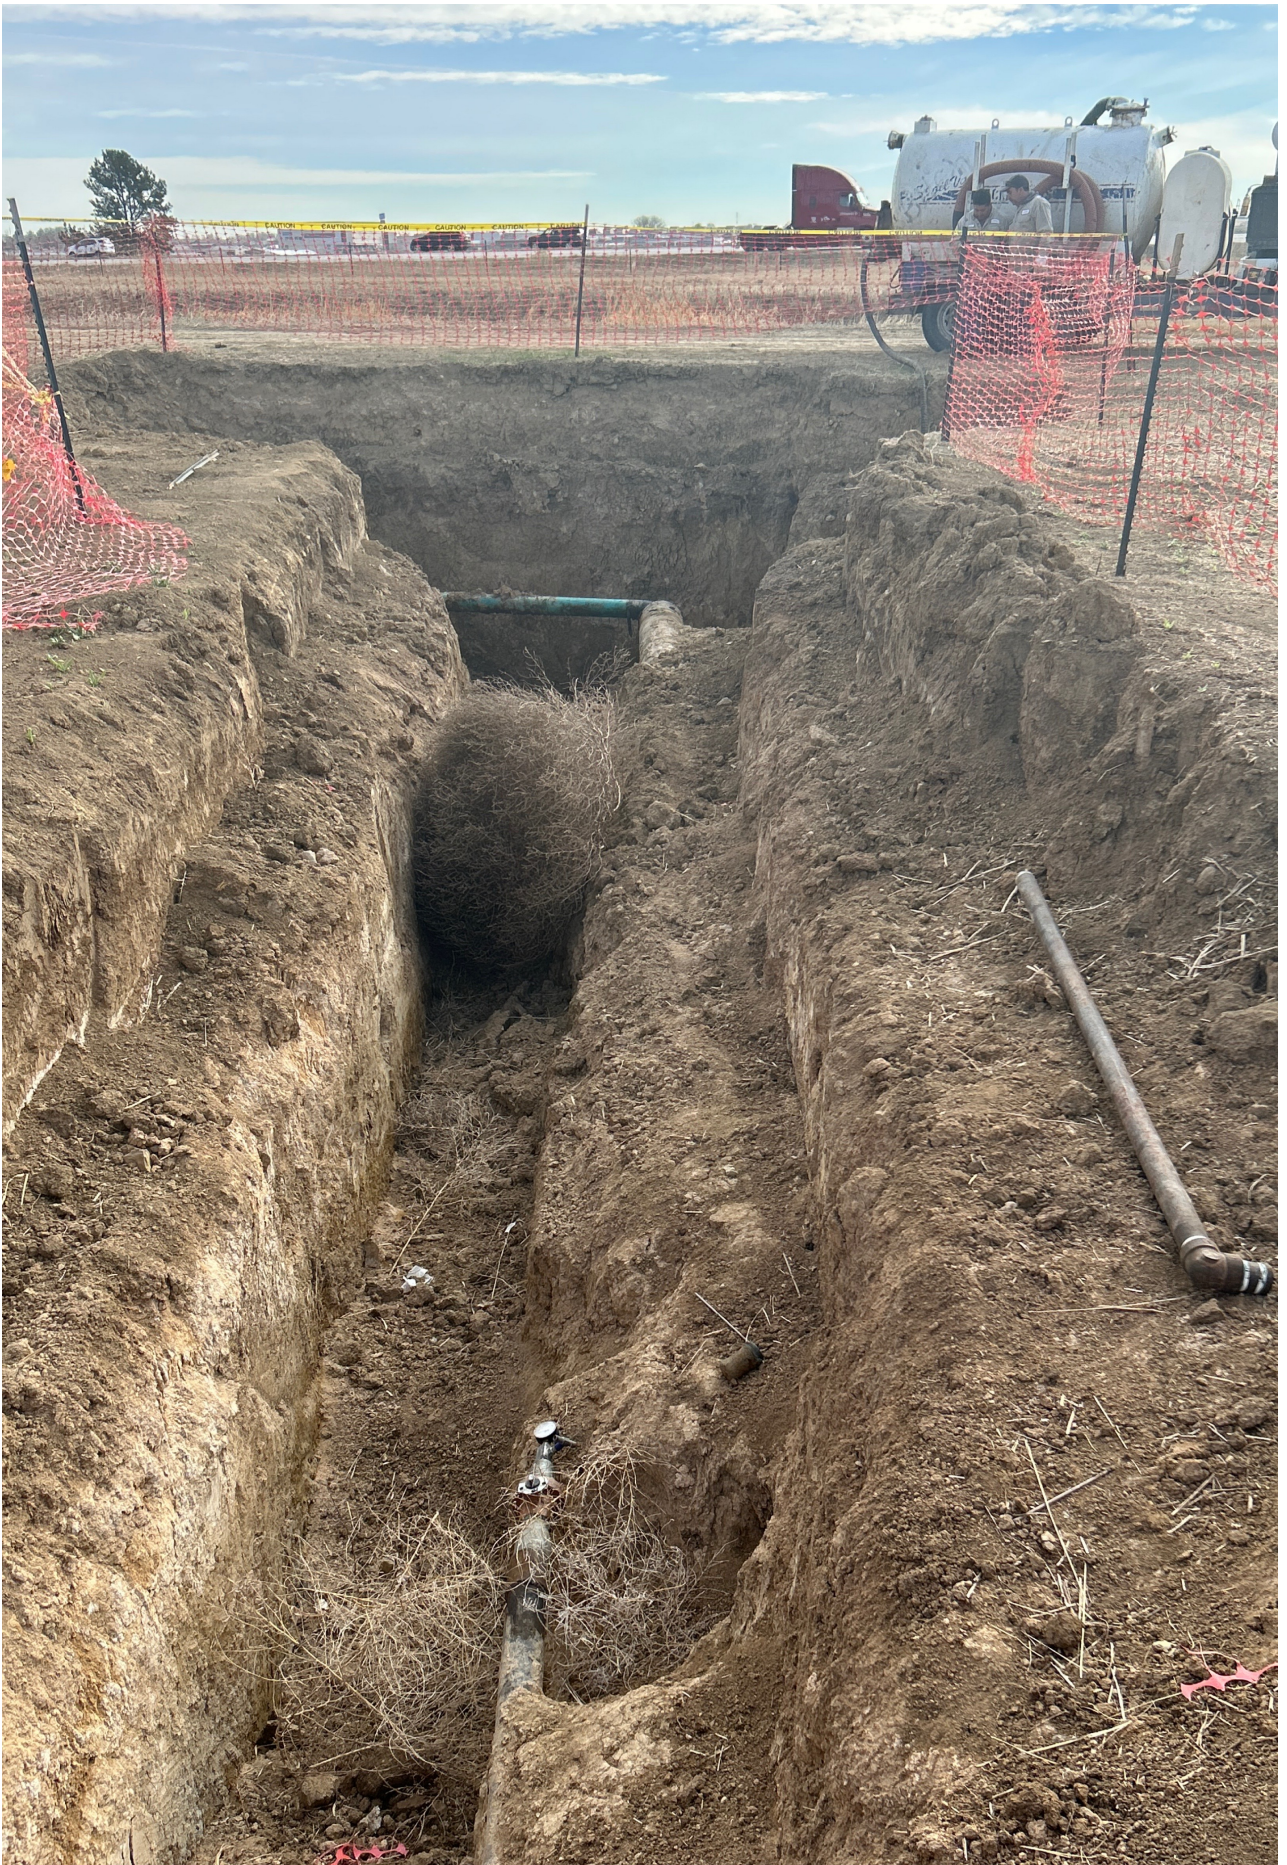
Two flowlines are visible within the excavation.

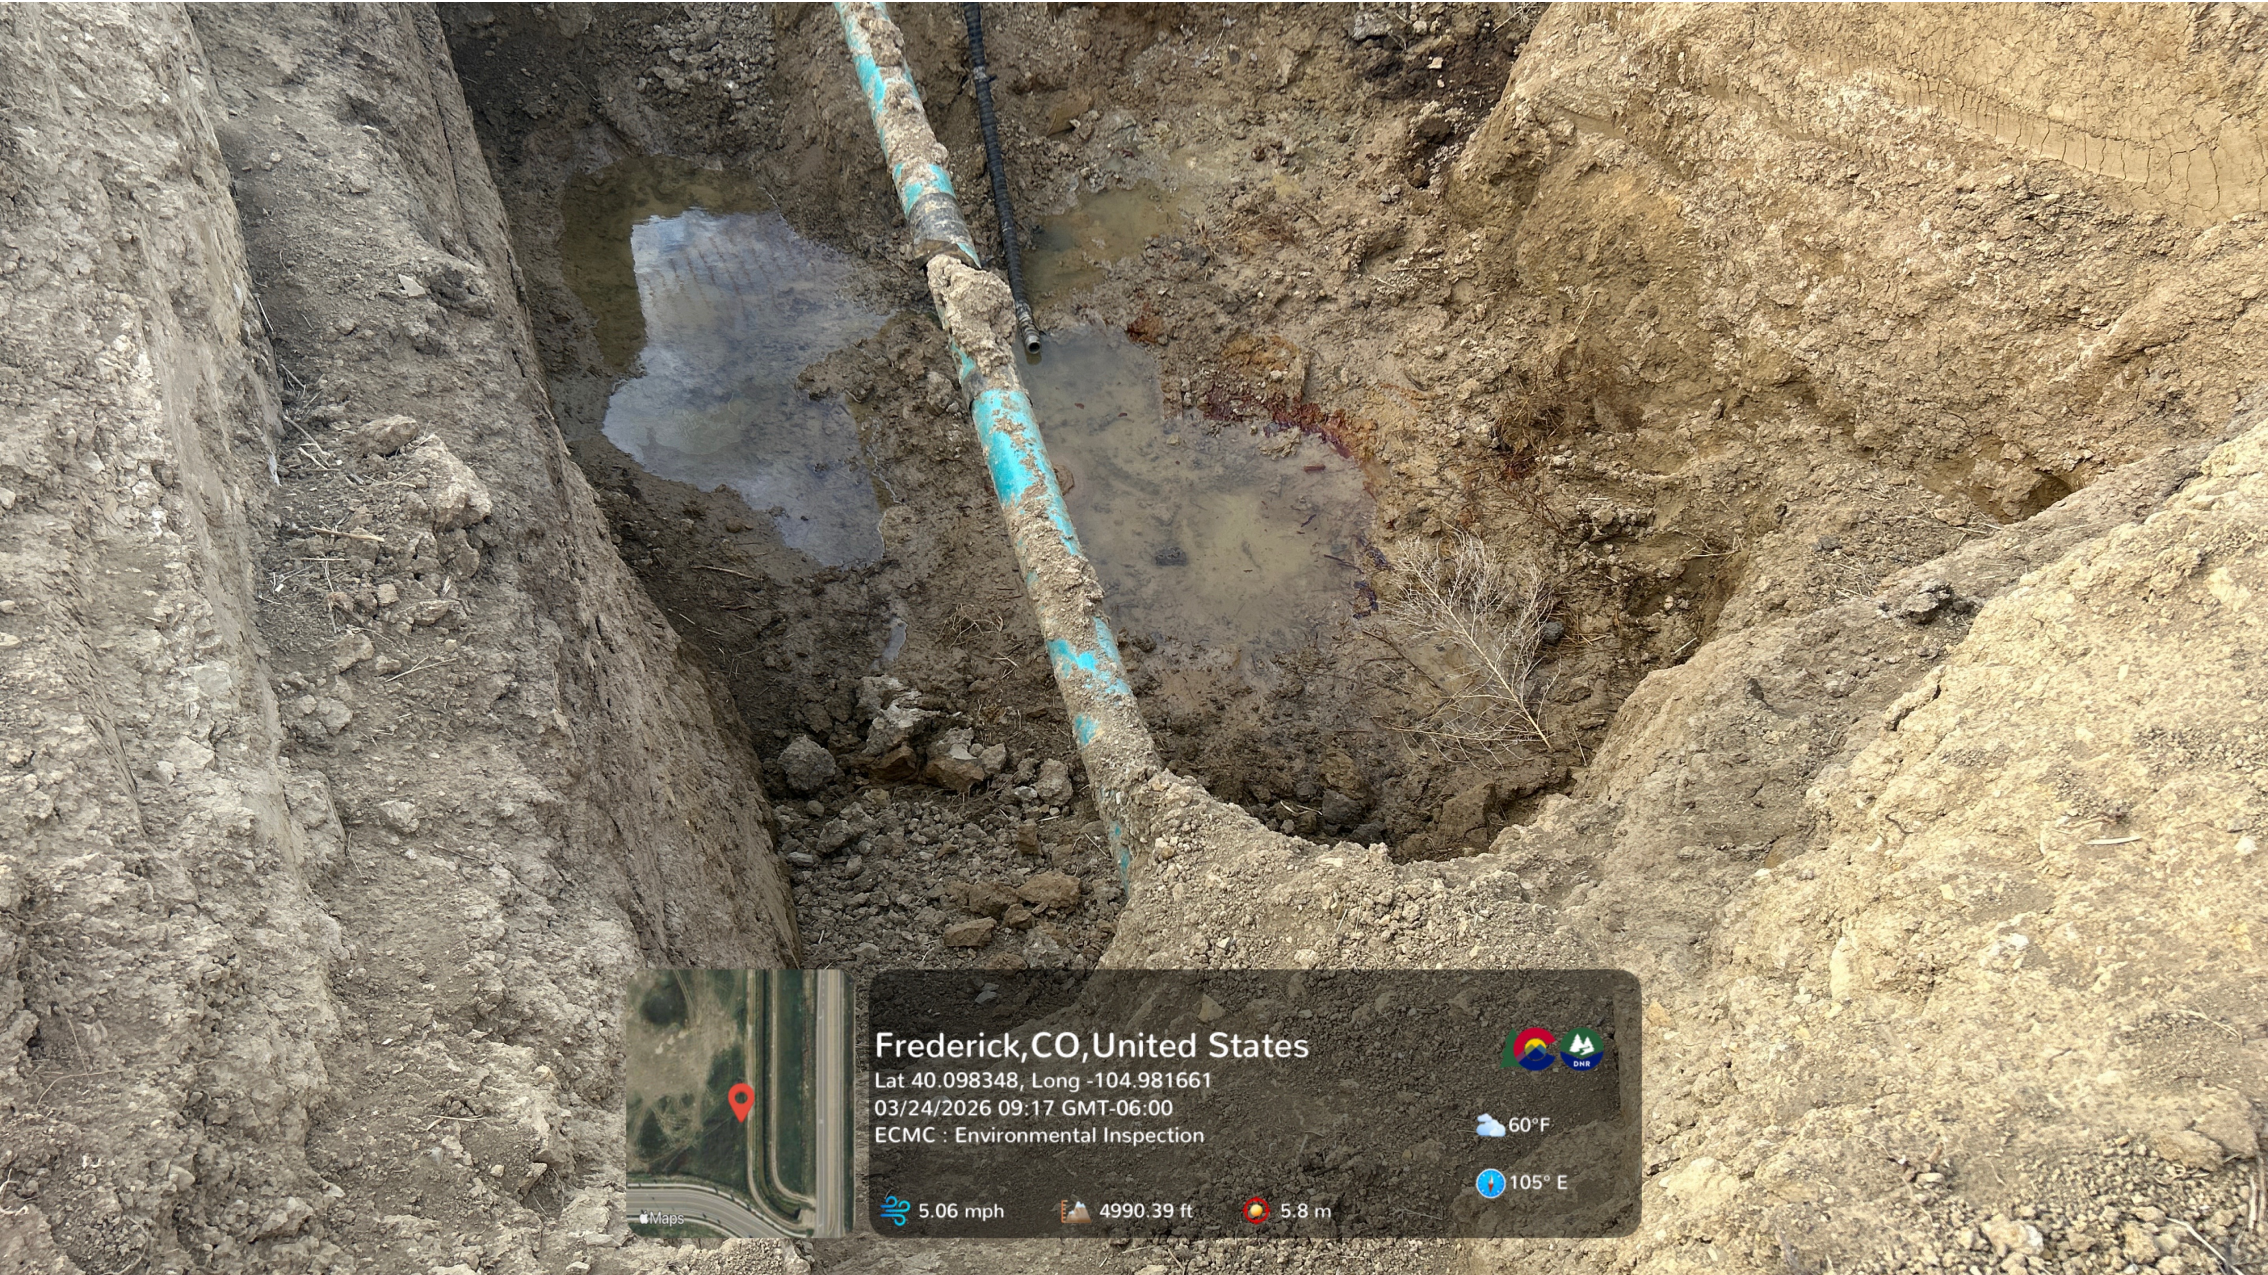
Groundwater with free product is visible at the base of the excavation at the spill location. Operator personnel and equipment were on location at the time of inspection. Operator personnel were using a hydrovac to skim free product off of groundwater at the base of the excavation.

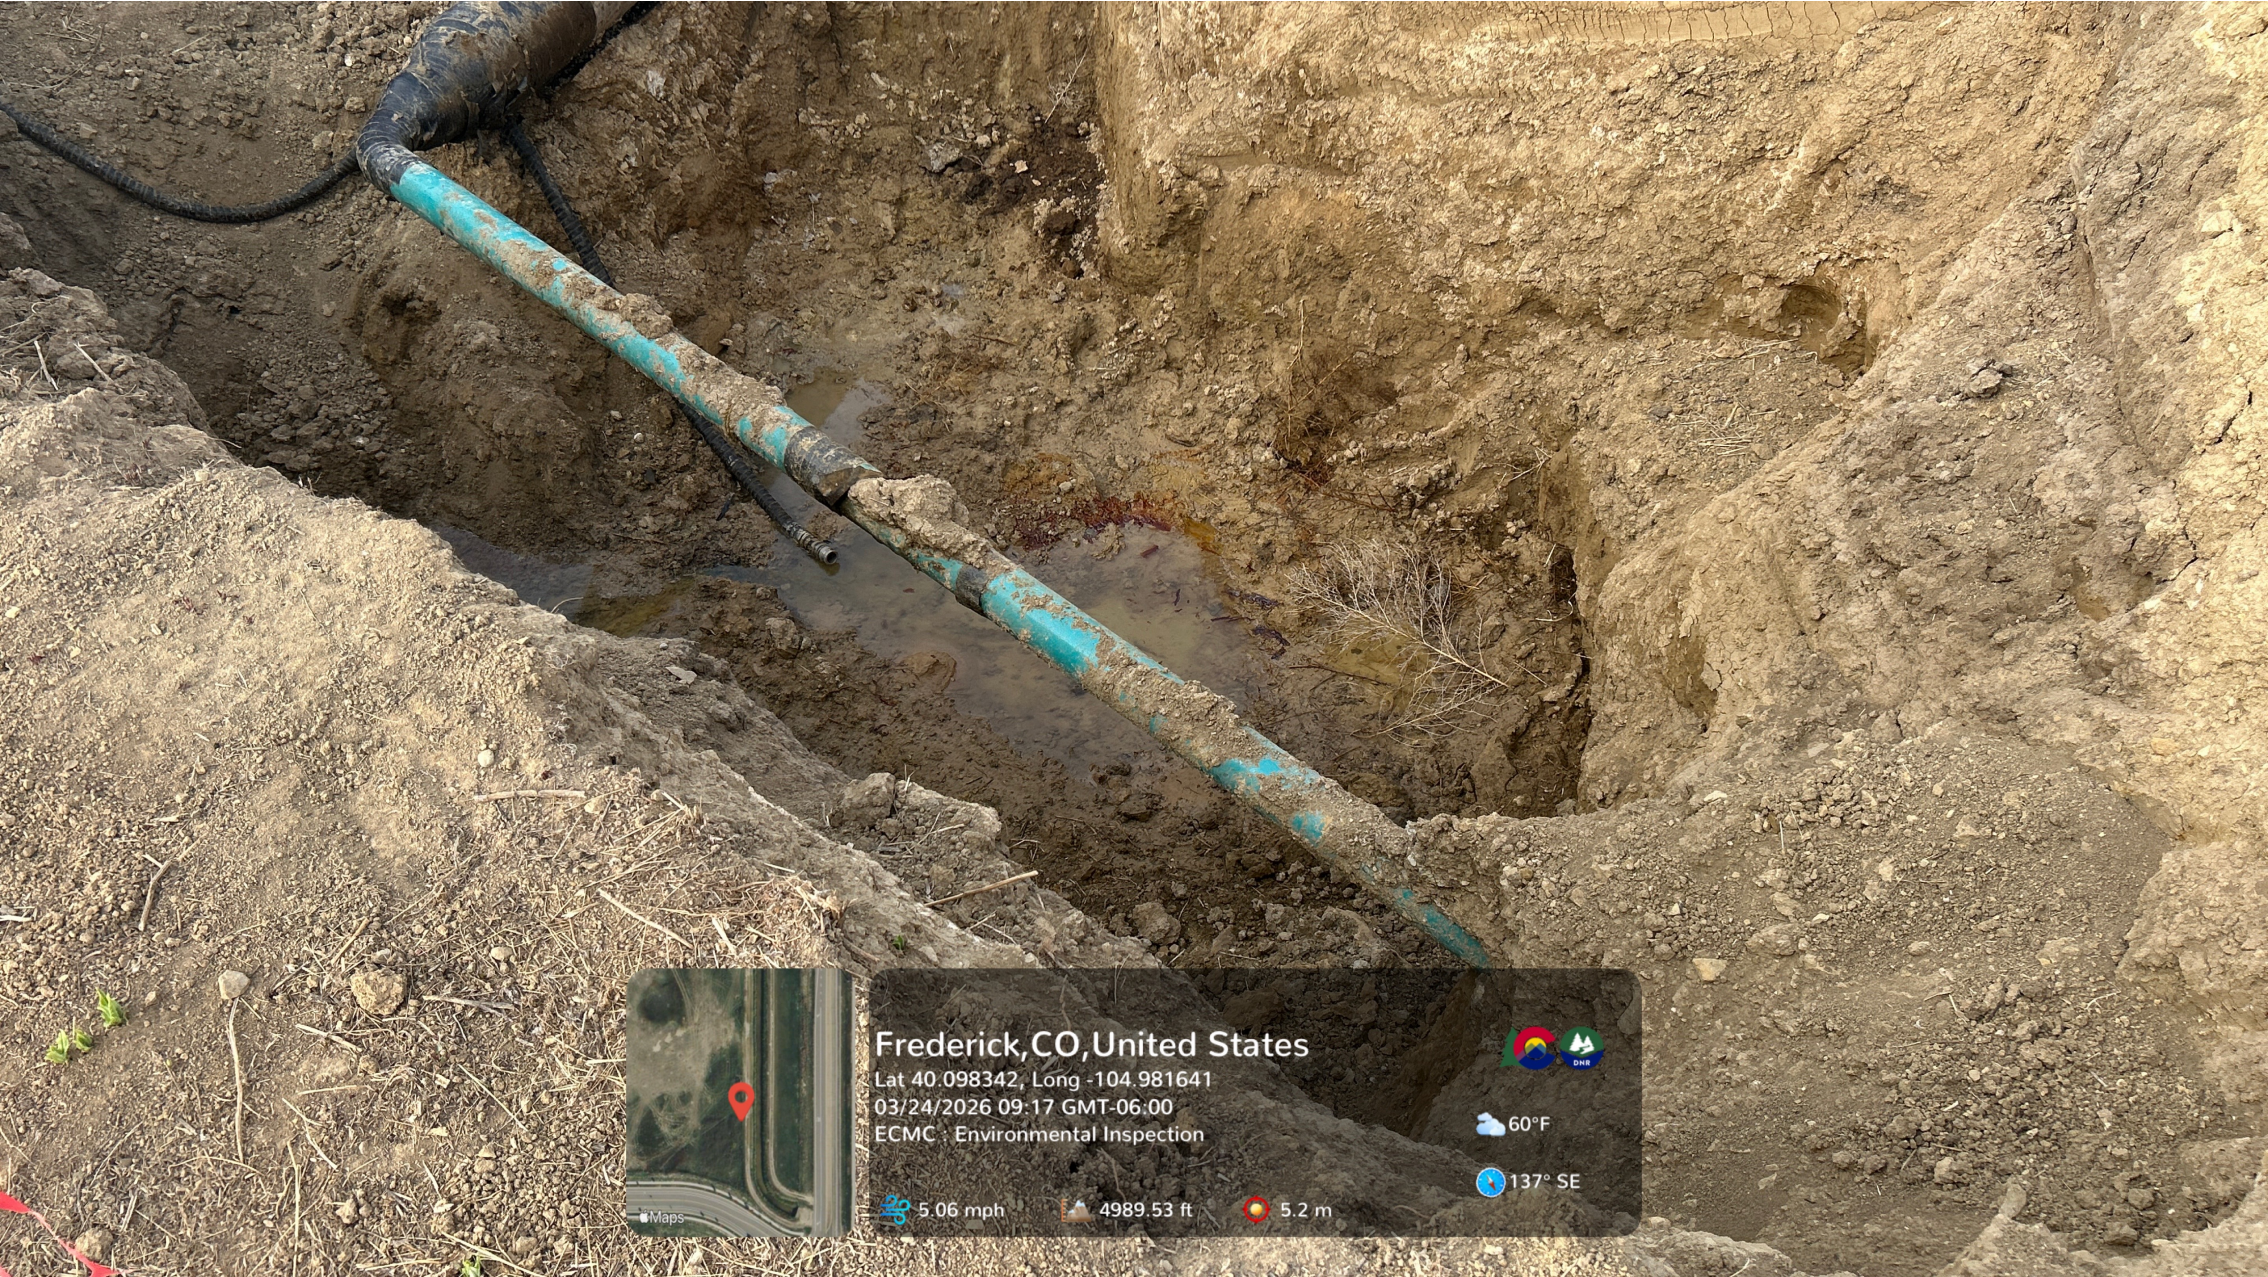
Stained soil is visible in situ.

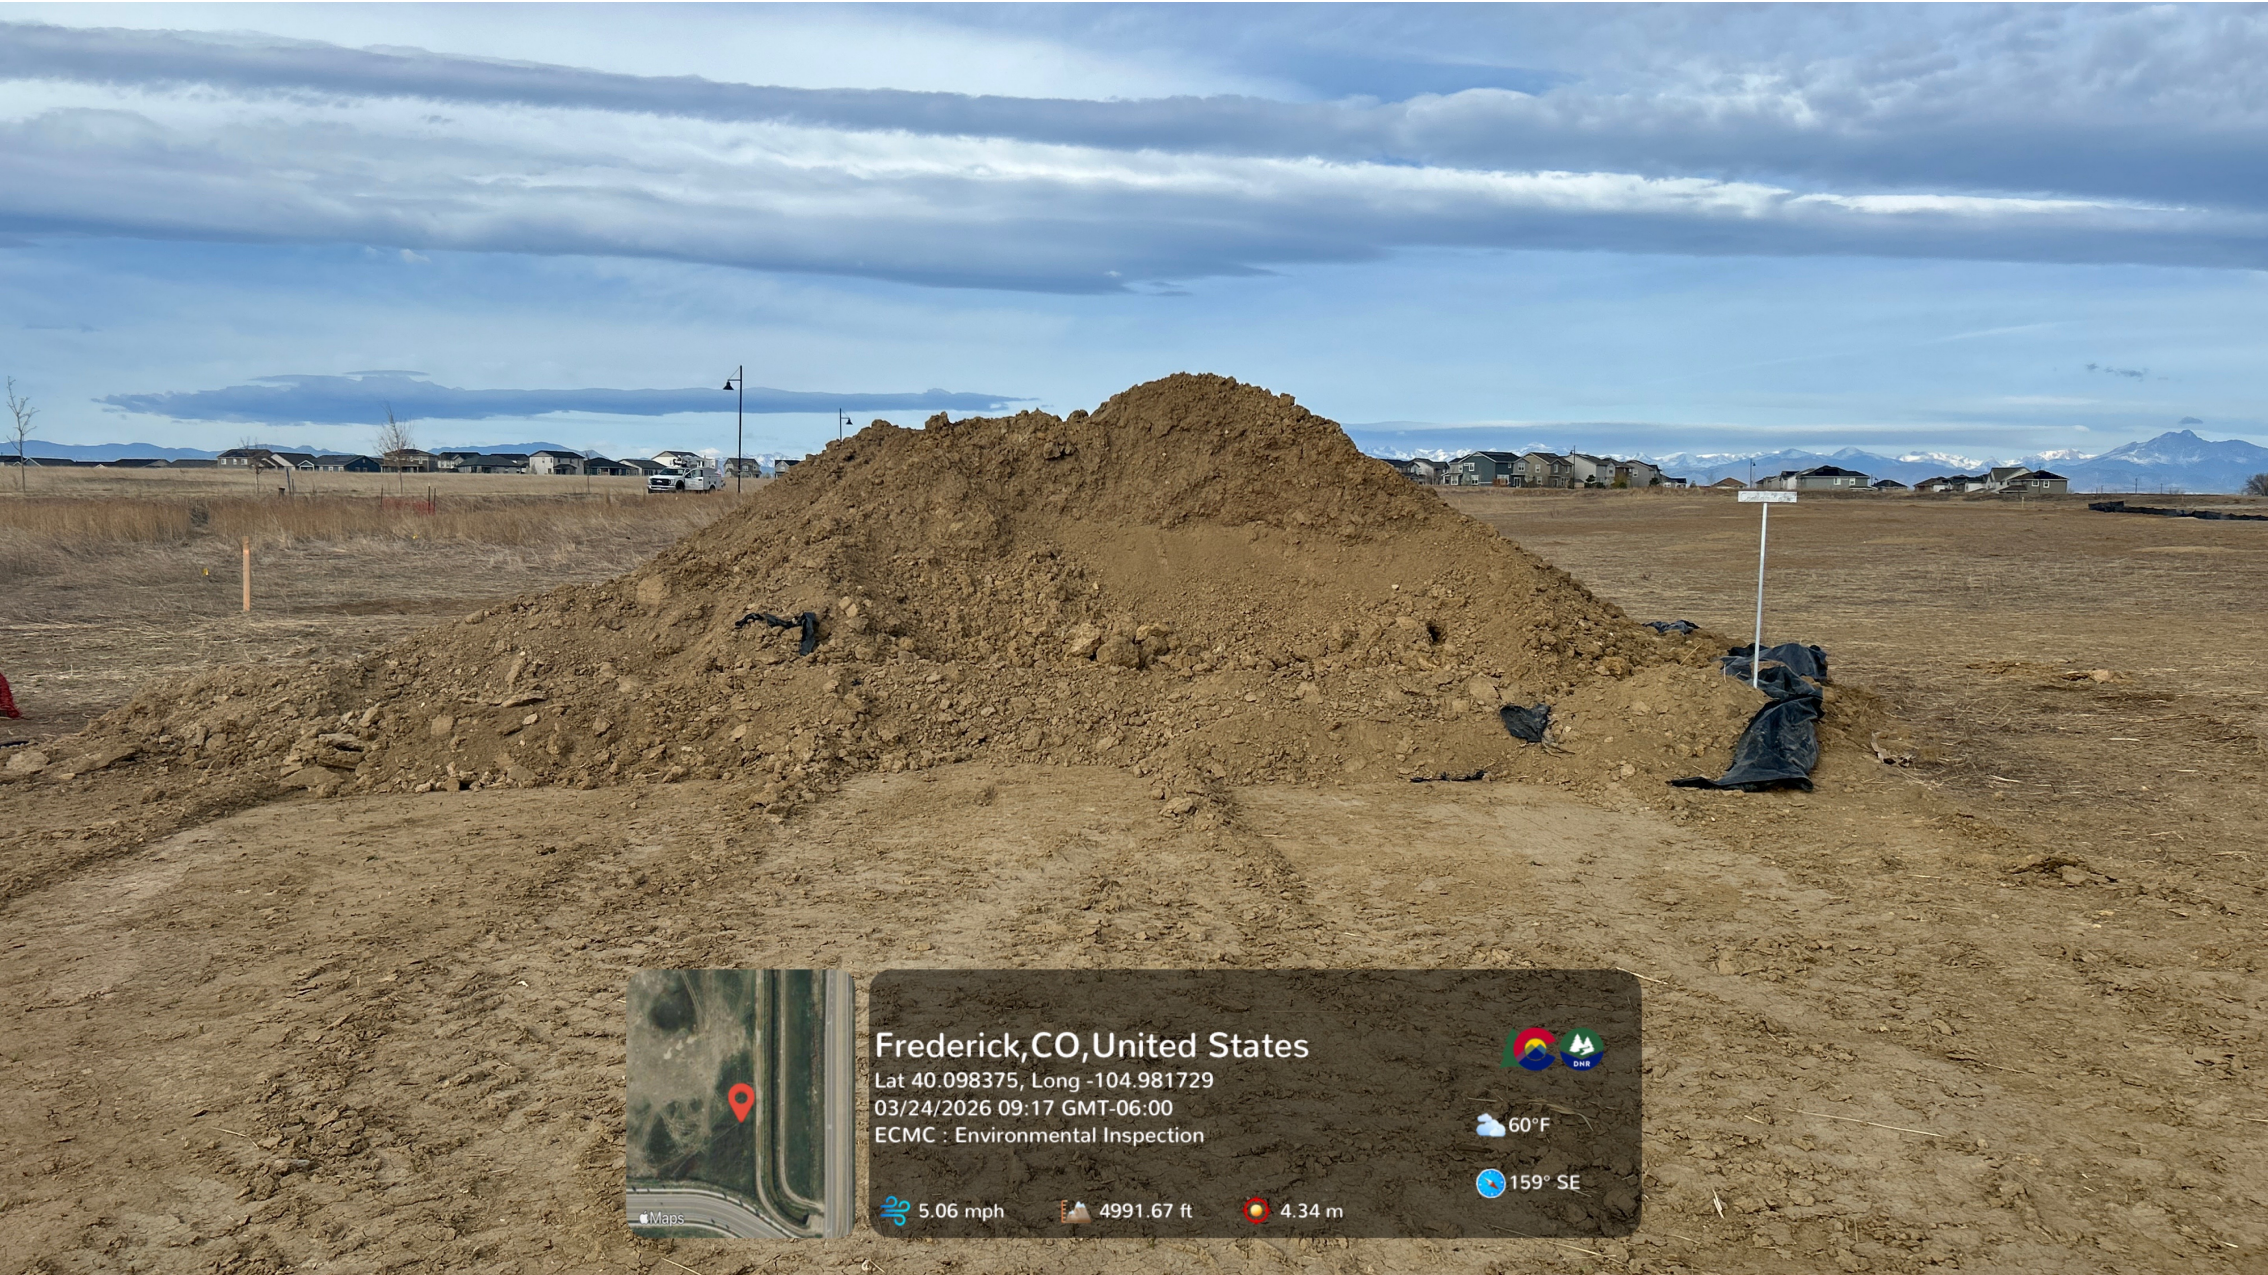
A liner is visible under the contaminated stockpile but has been overtopped by soil in some areas.

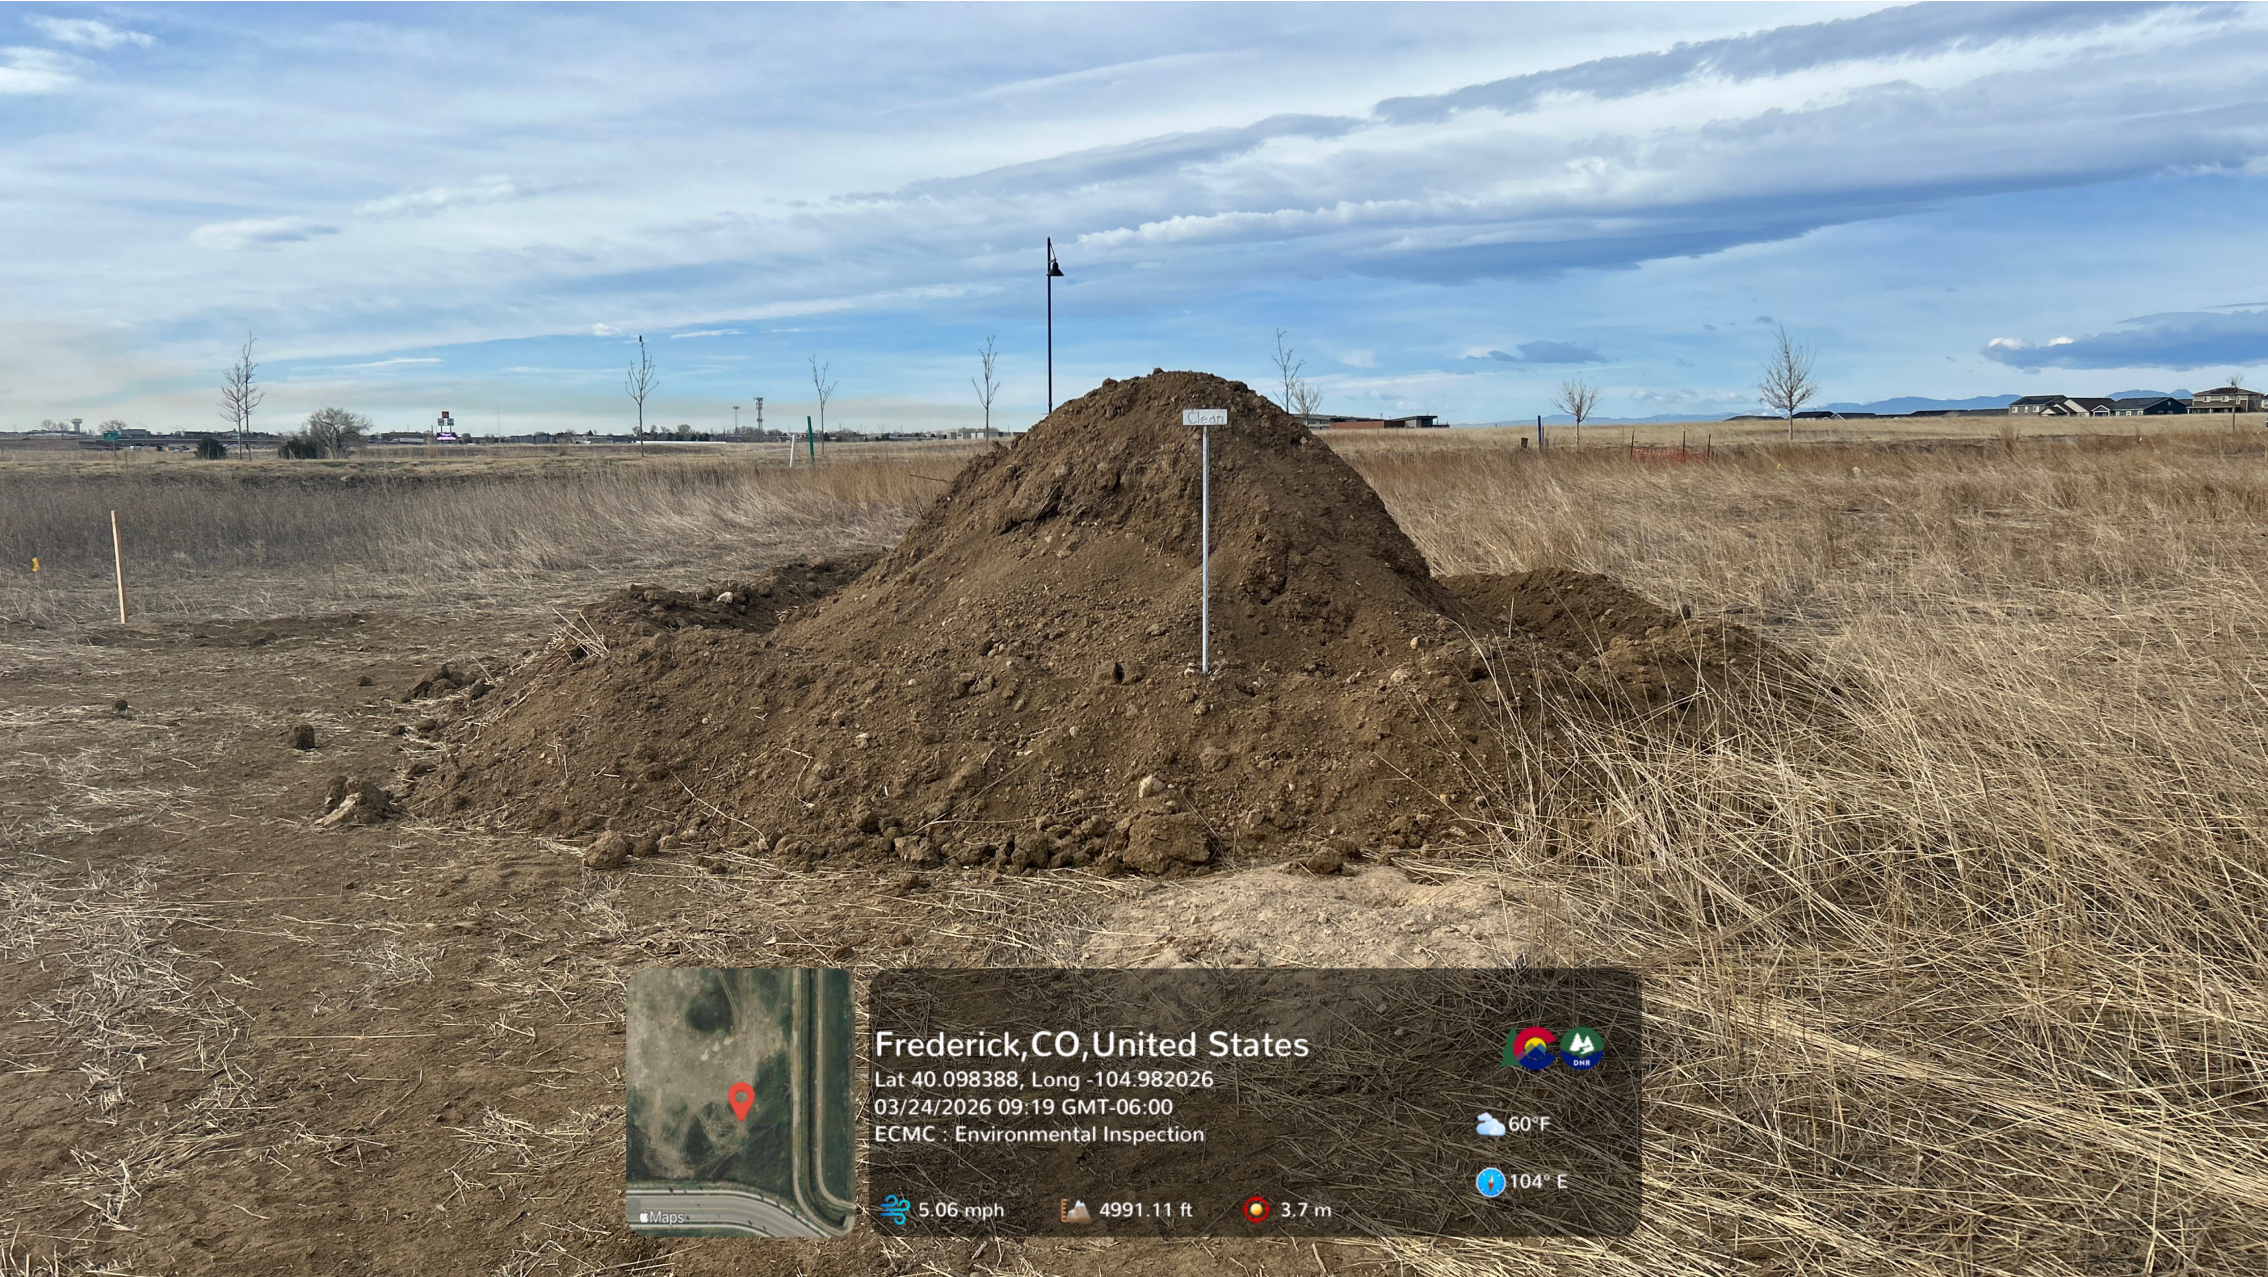
Stockpile marked "clean".
