**Frederick, CO, United States**
Lat 40.097682, Long -104.981409
03/25/2026 14:17 GMT-06:00
ECMC : Environmental Inspection

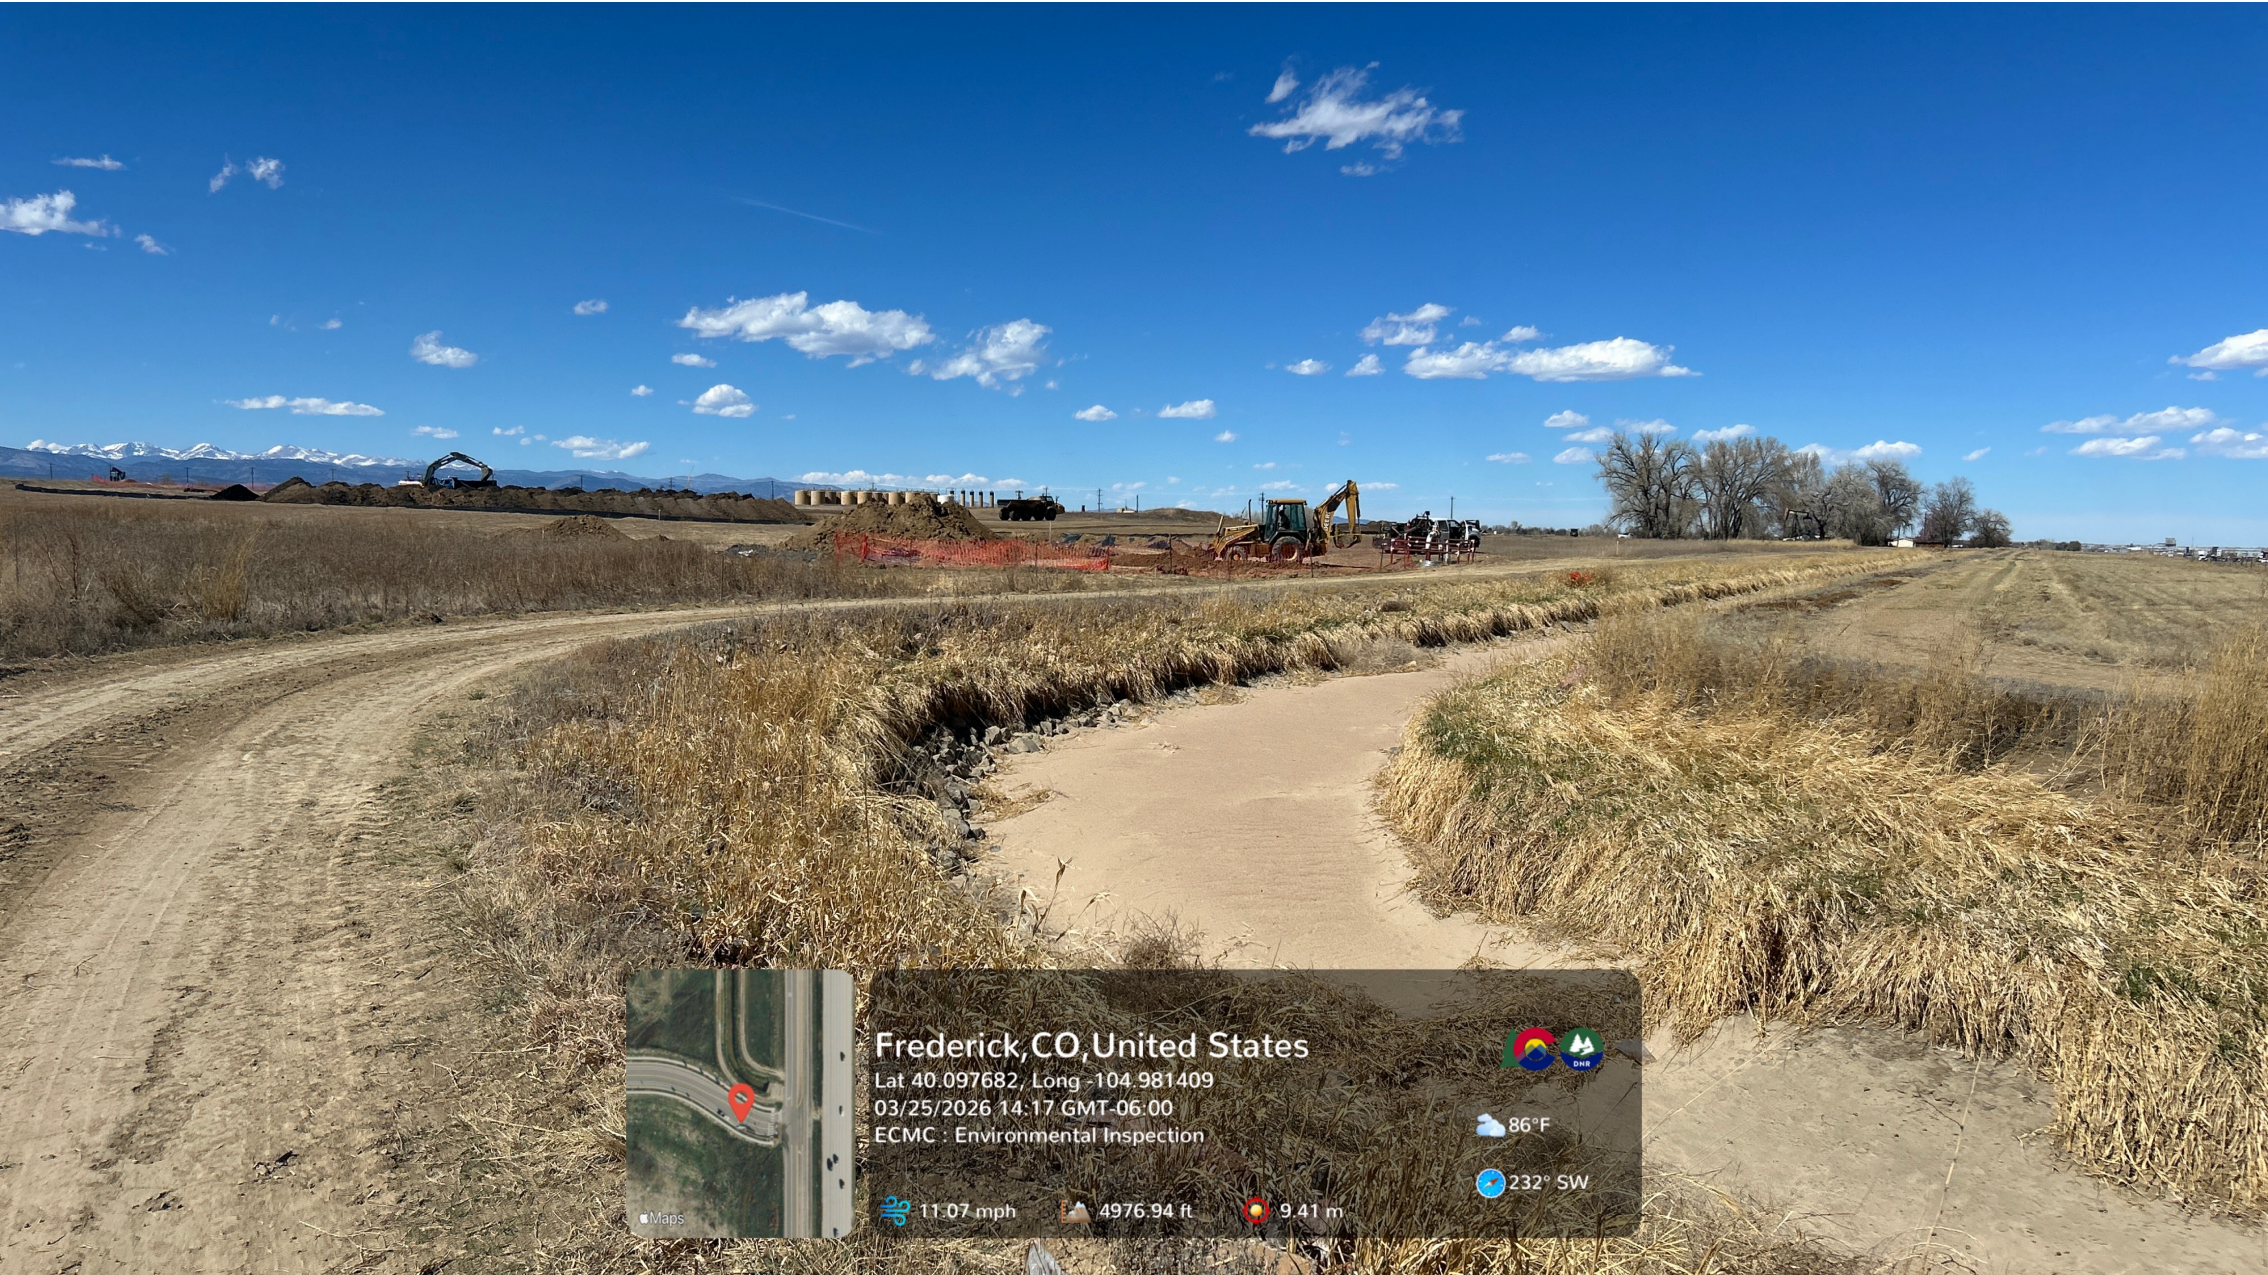
Sullivan Ditch was dry at the time of the inspection. Operator personnel and equipment were on location at the time of inspection.

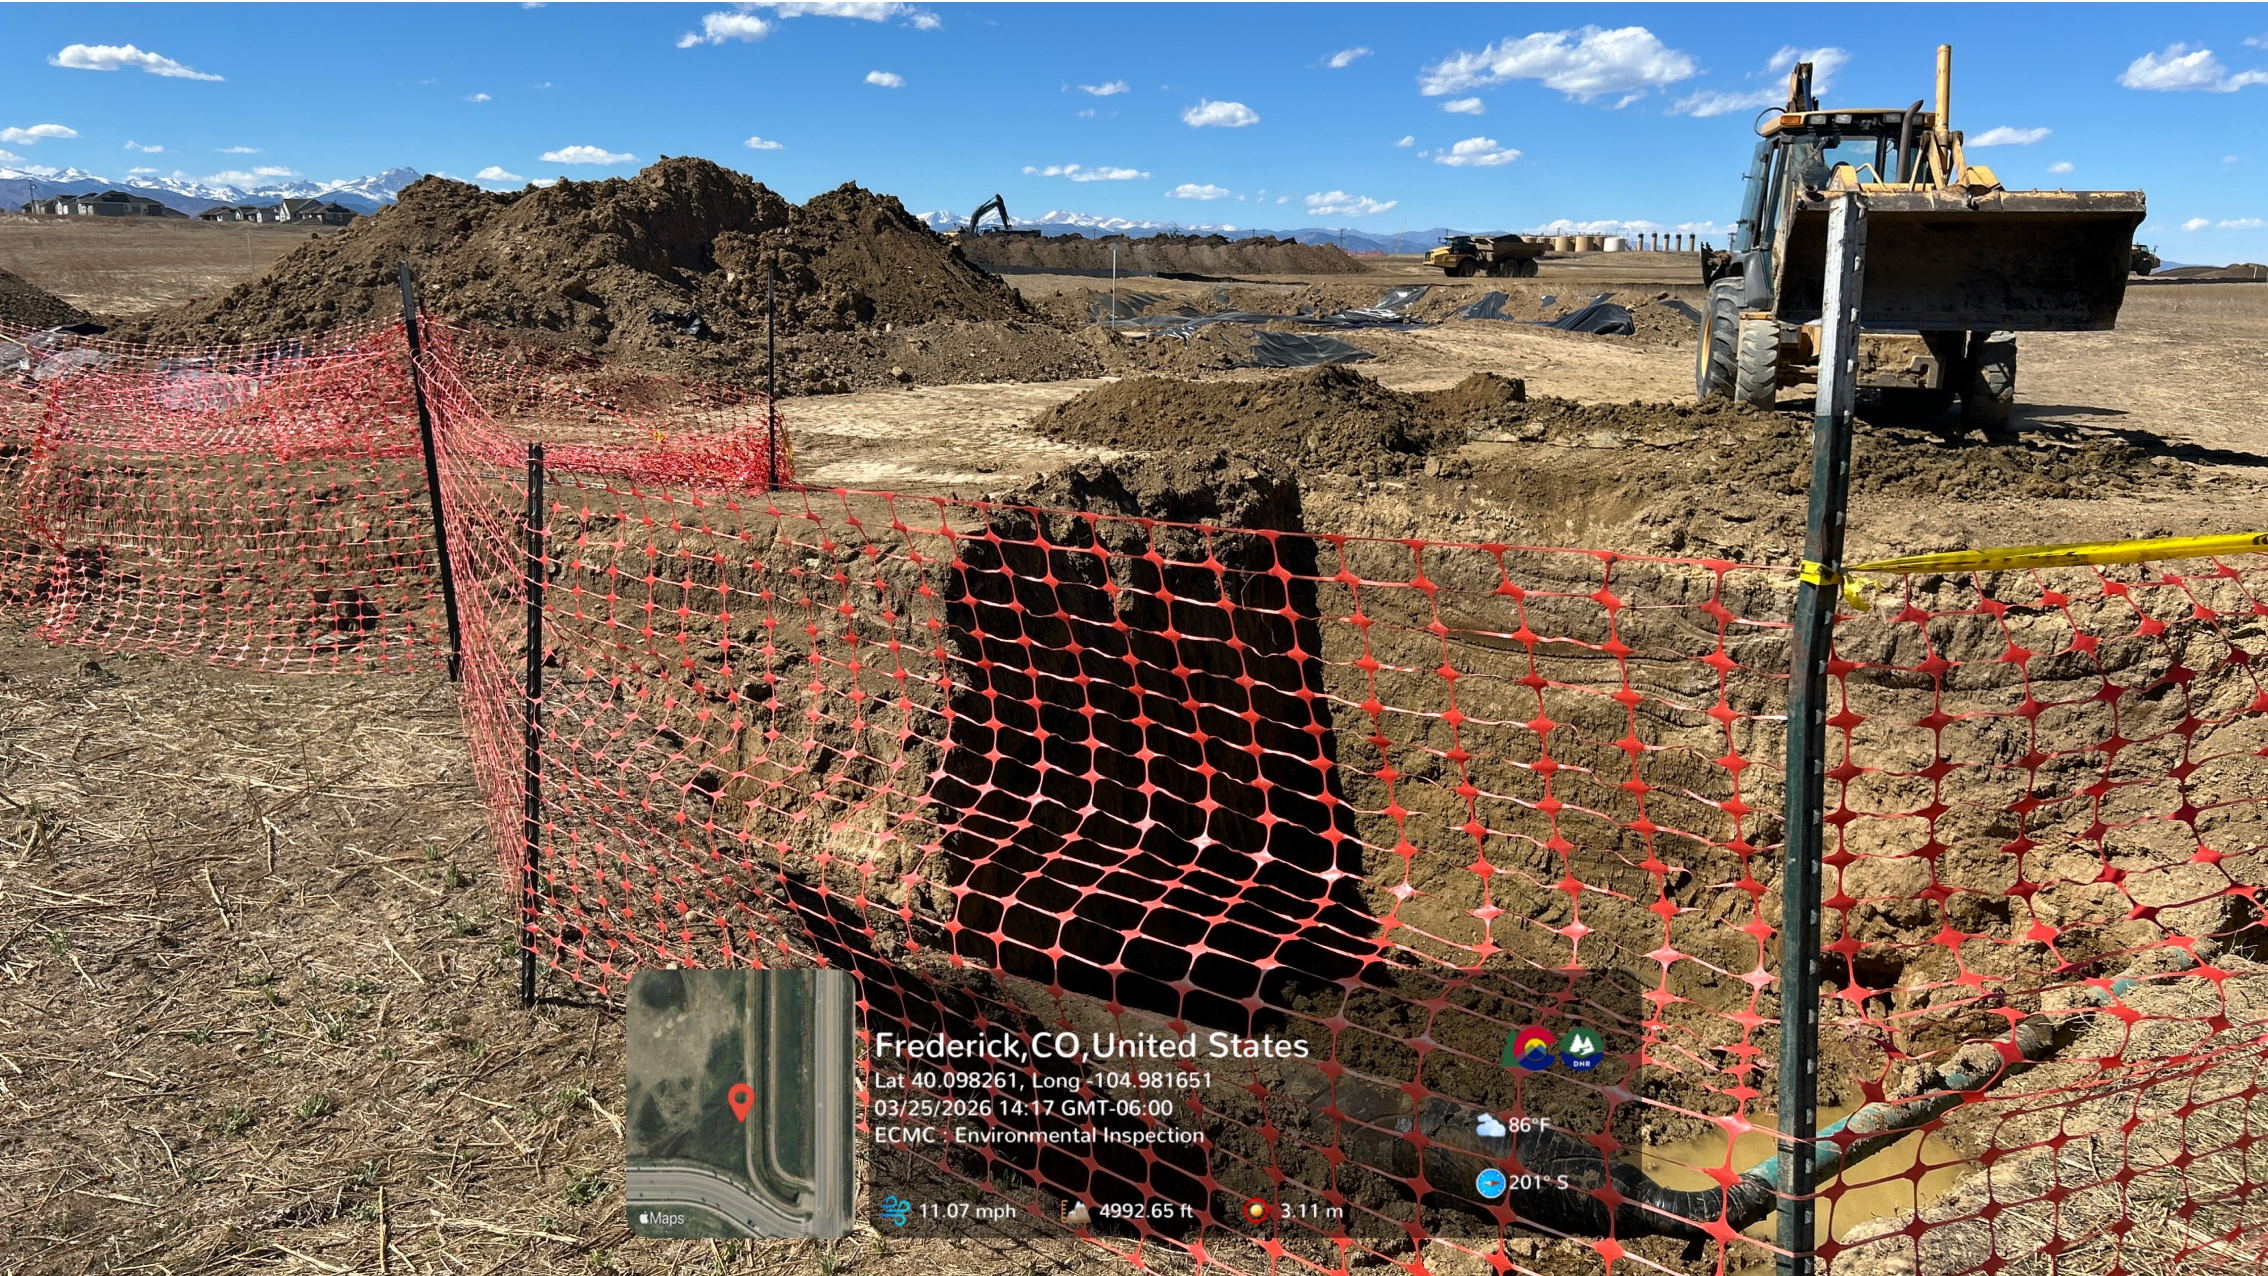
Operator personnel were adding additional soil to the contaminated stockpile, driving equipment over the liner.

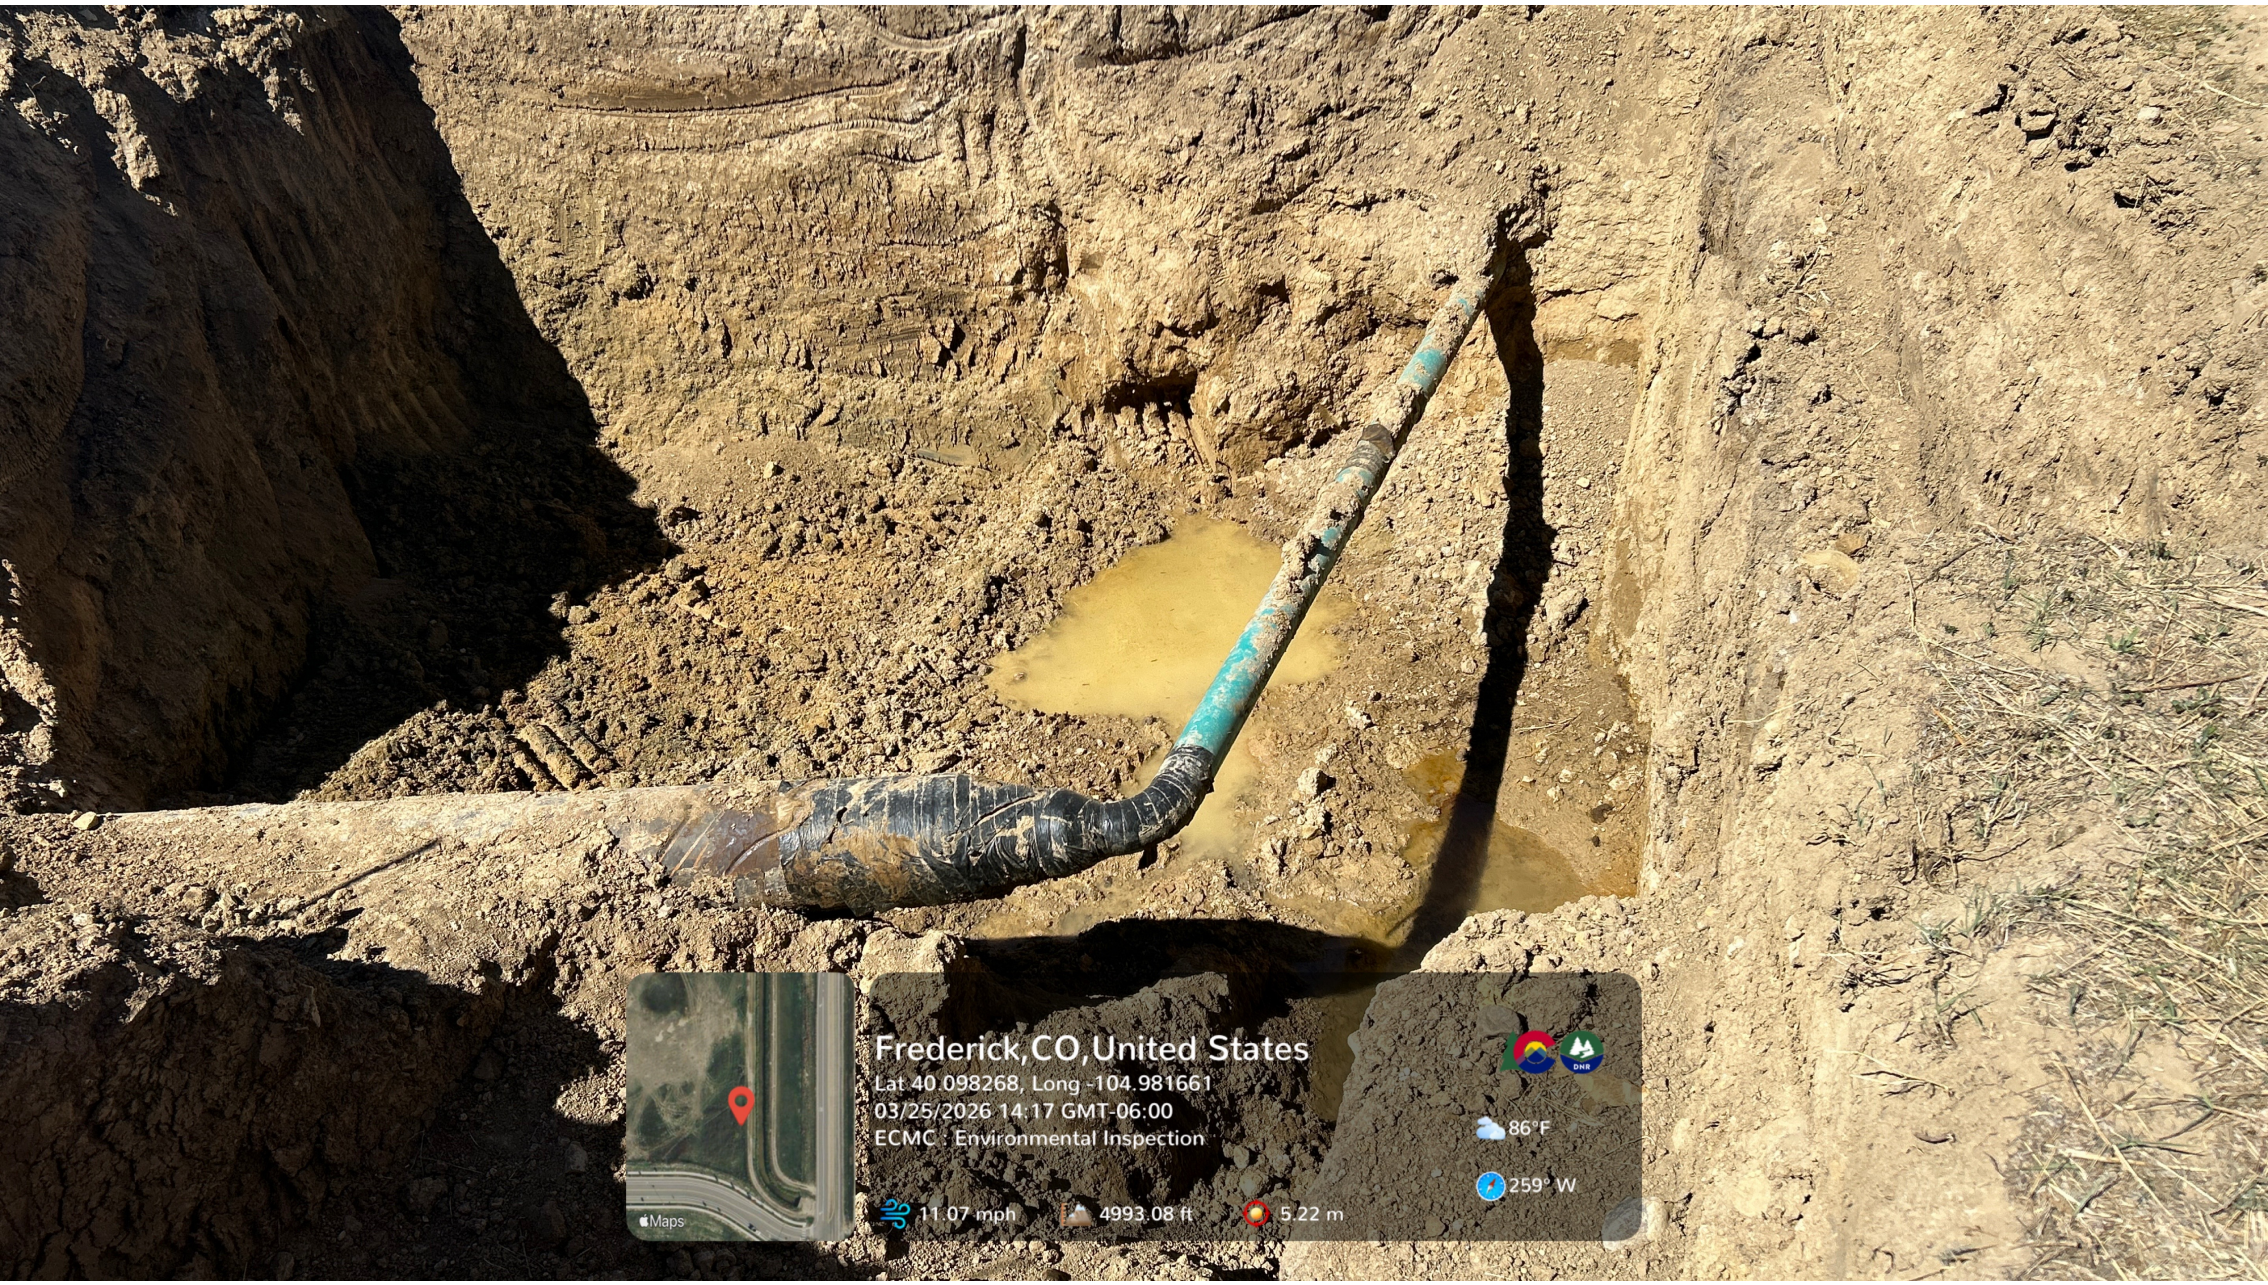
Stained soil and groundwater with free product are visible in situ.

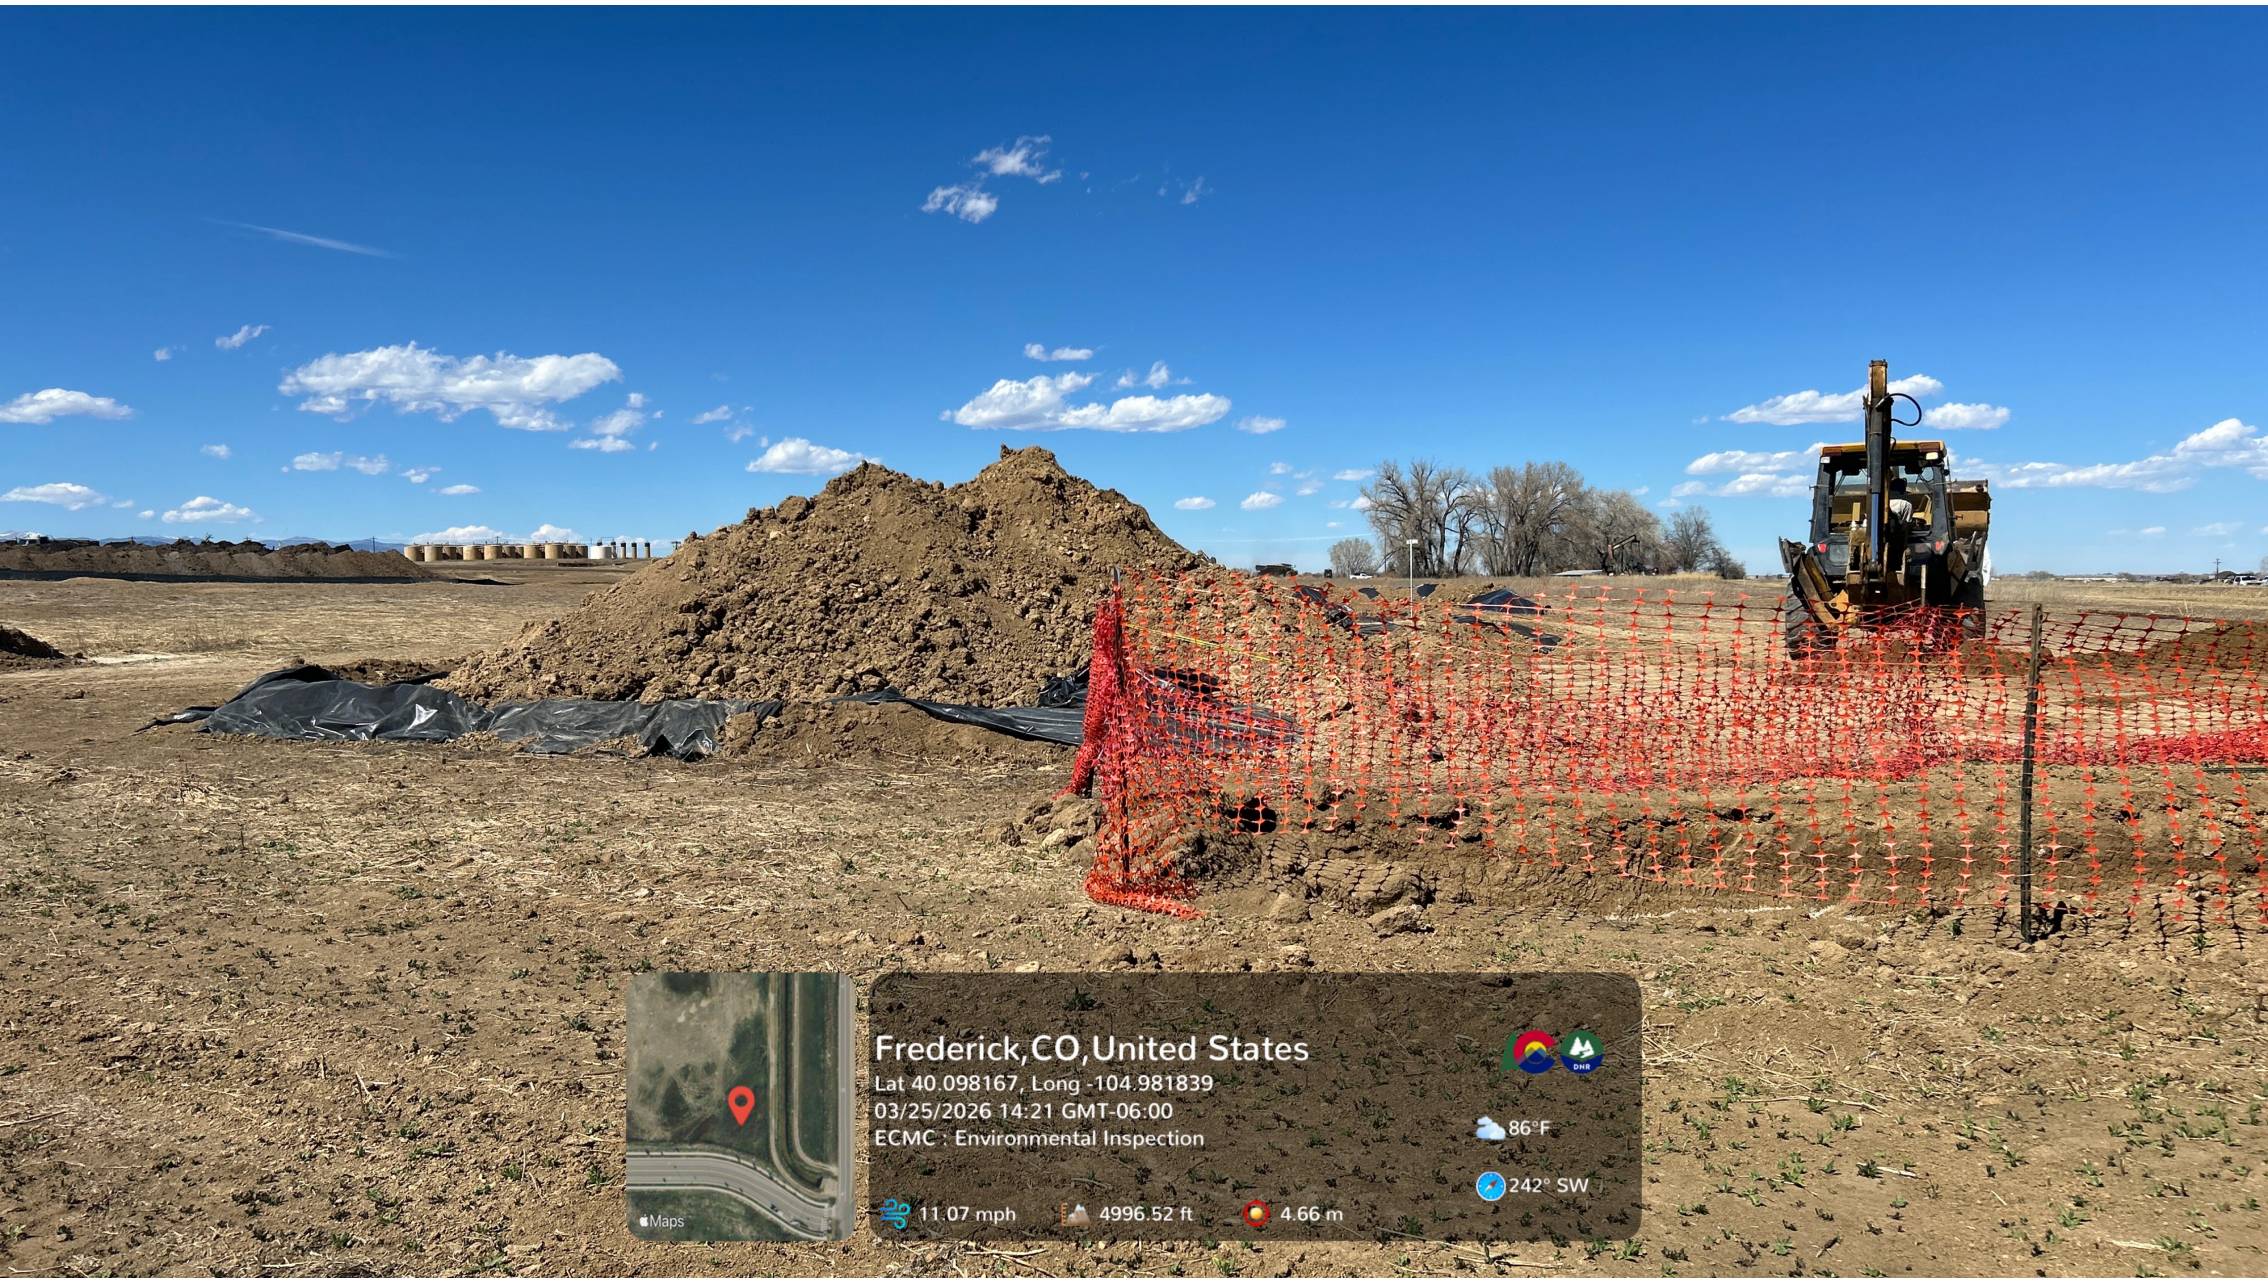
Stockpile marked "contaminated".

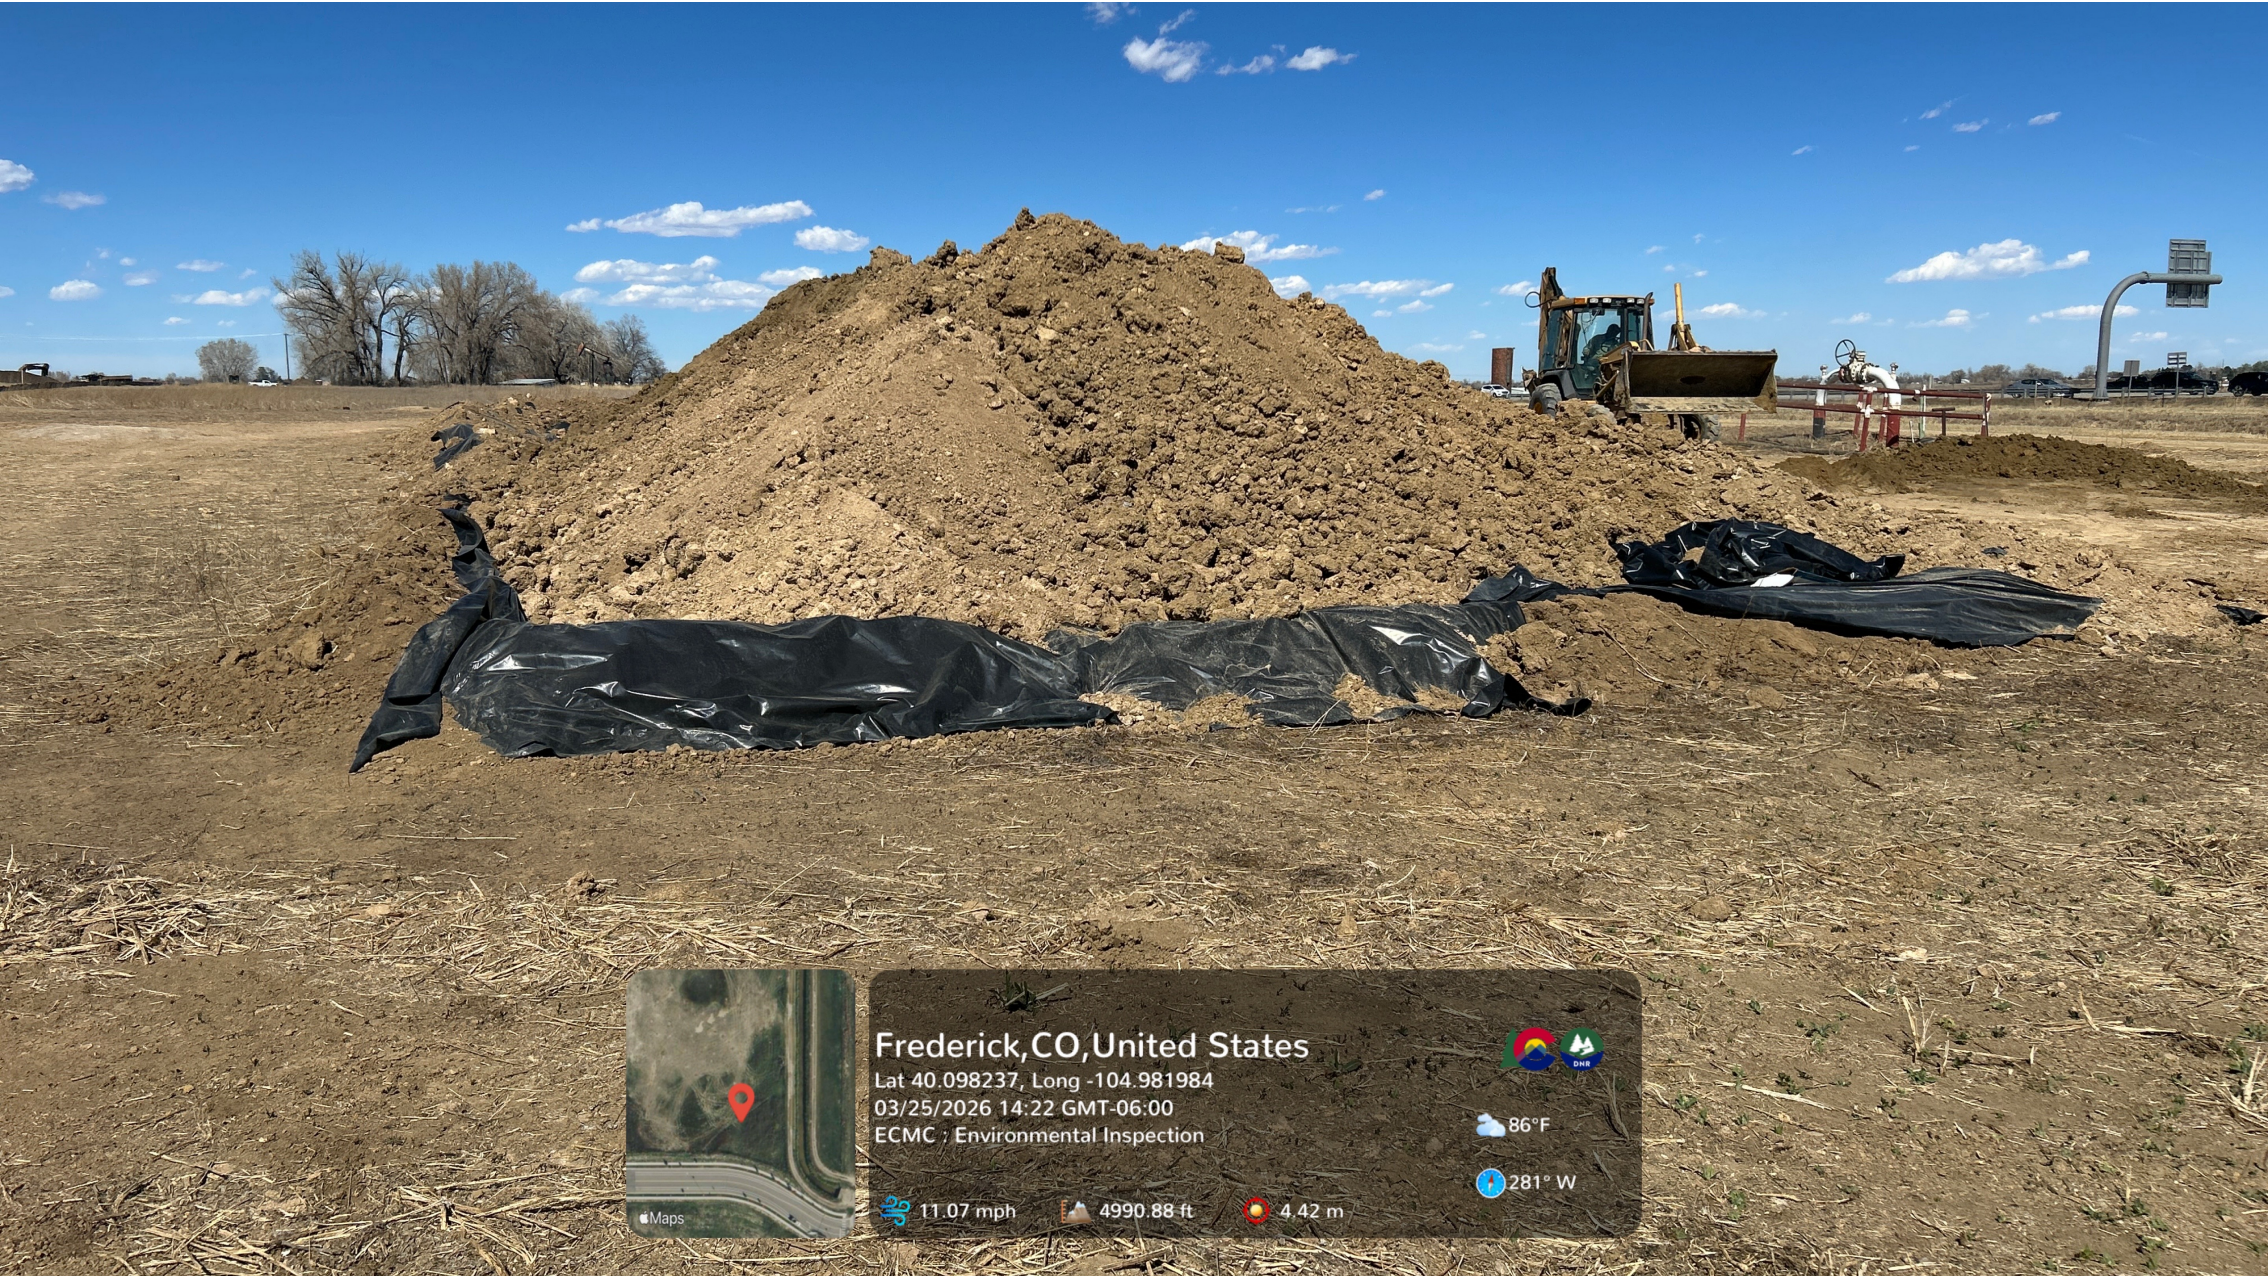
Stockpile marked "contaminated".

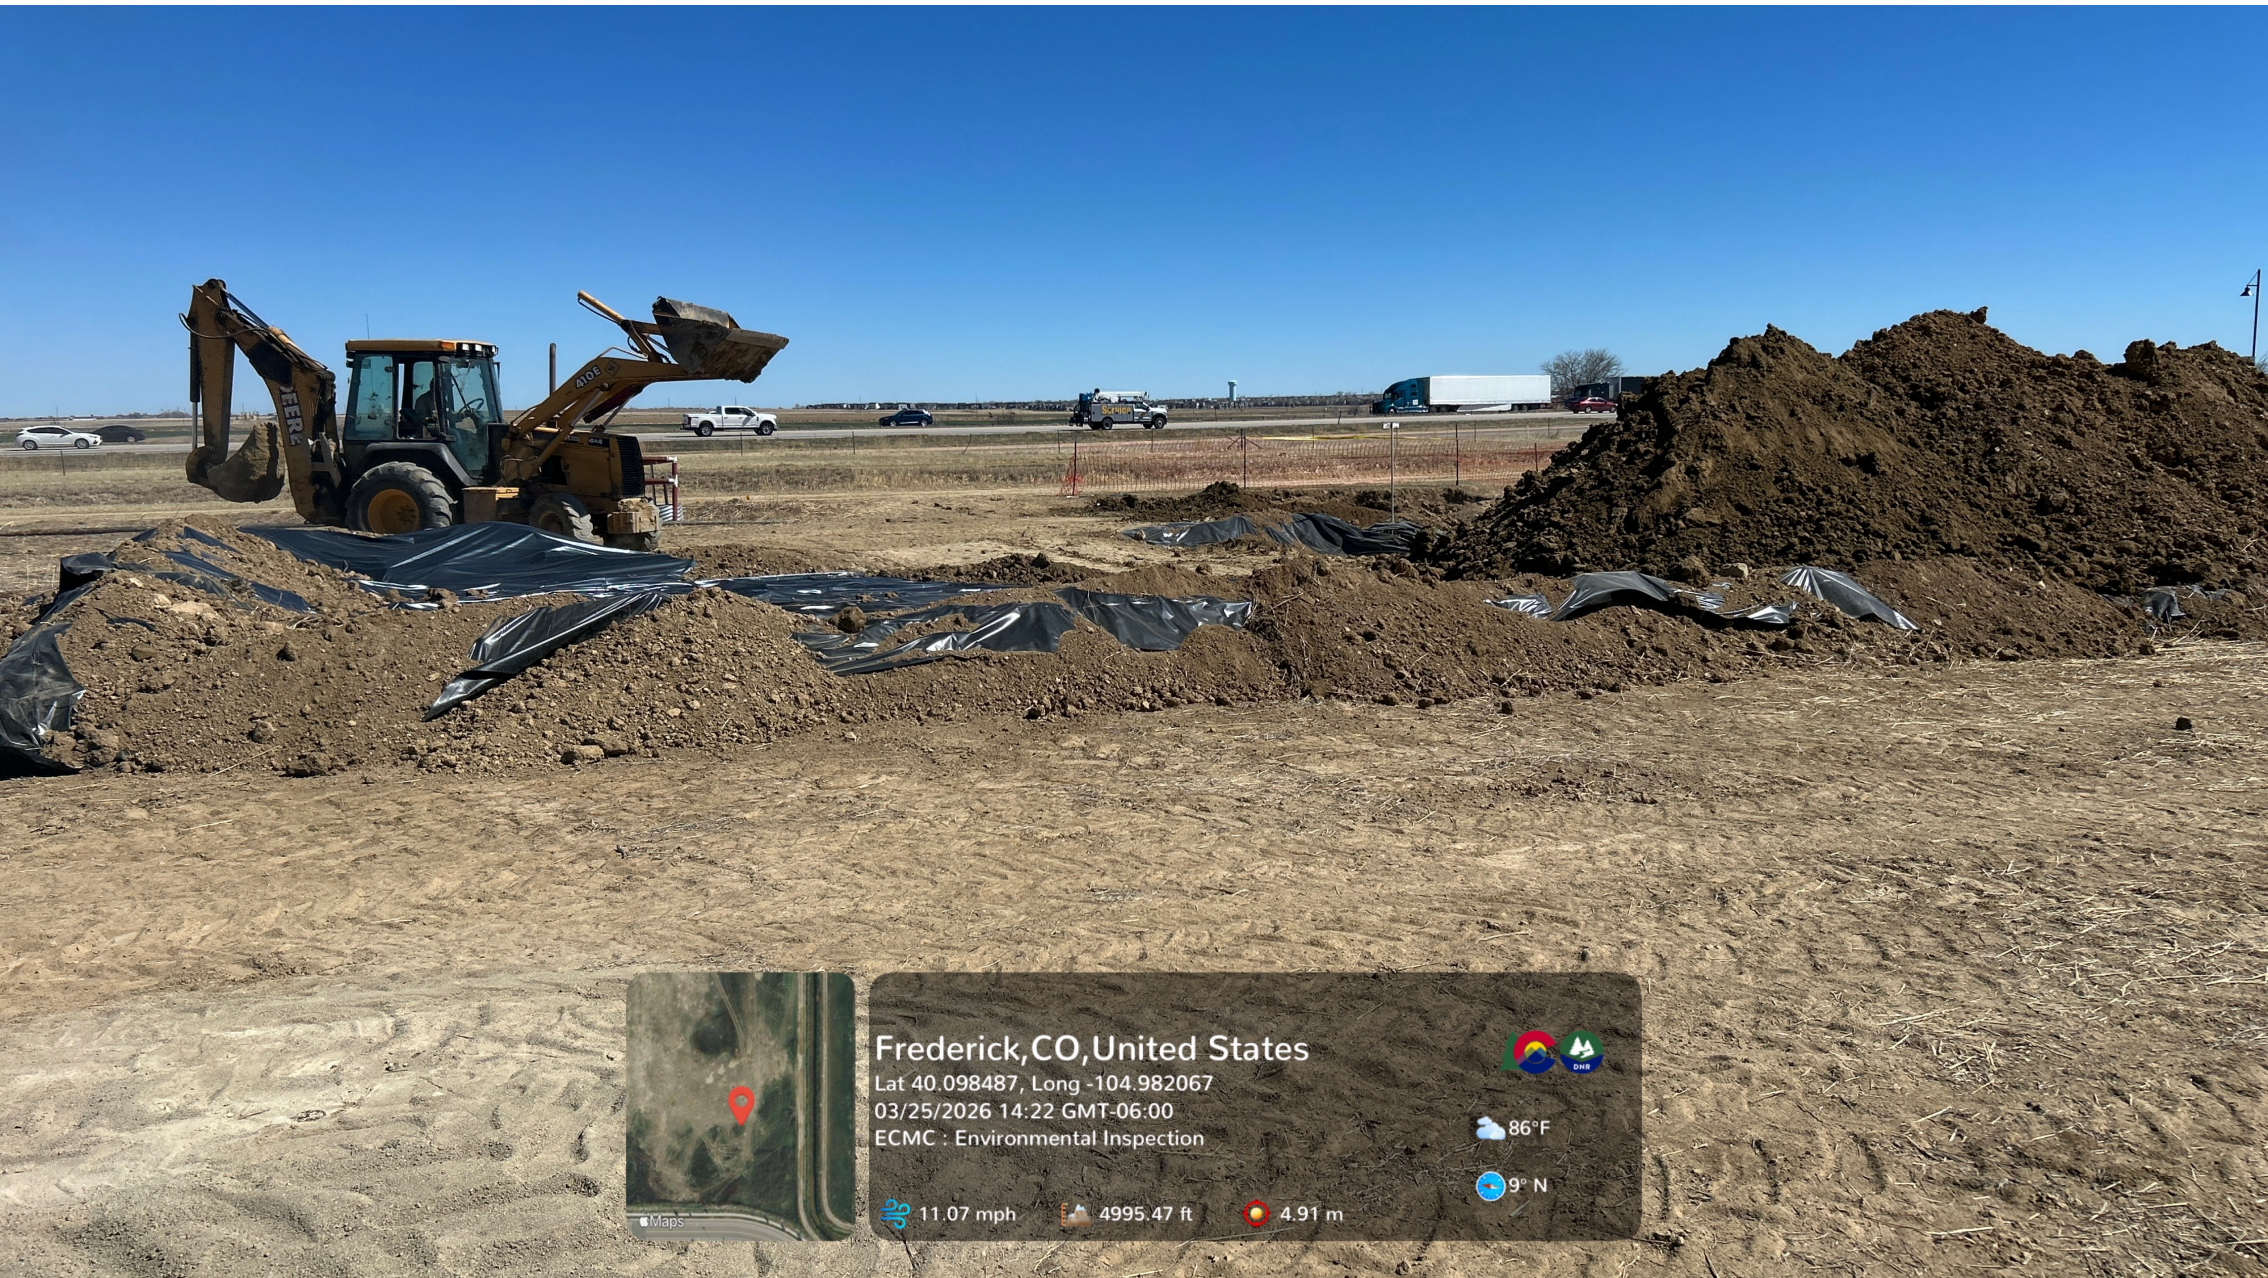
Additional liner has been added and the previously documented stockpile marked “contaminated” has been expanded.

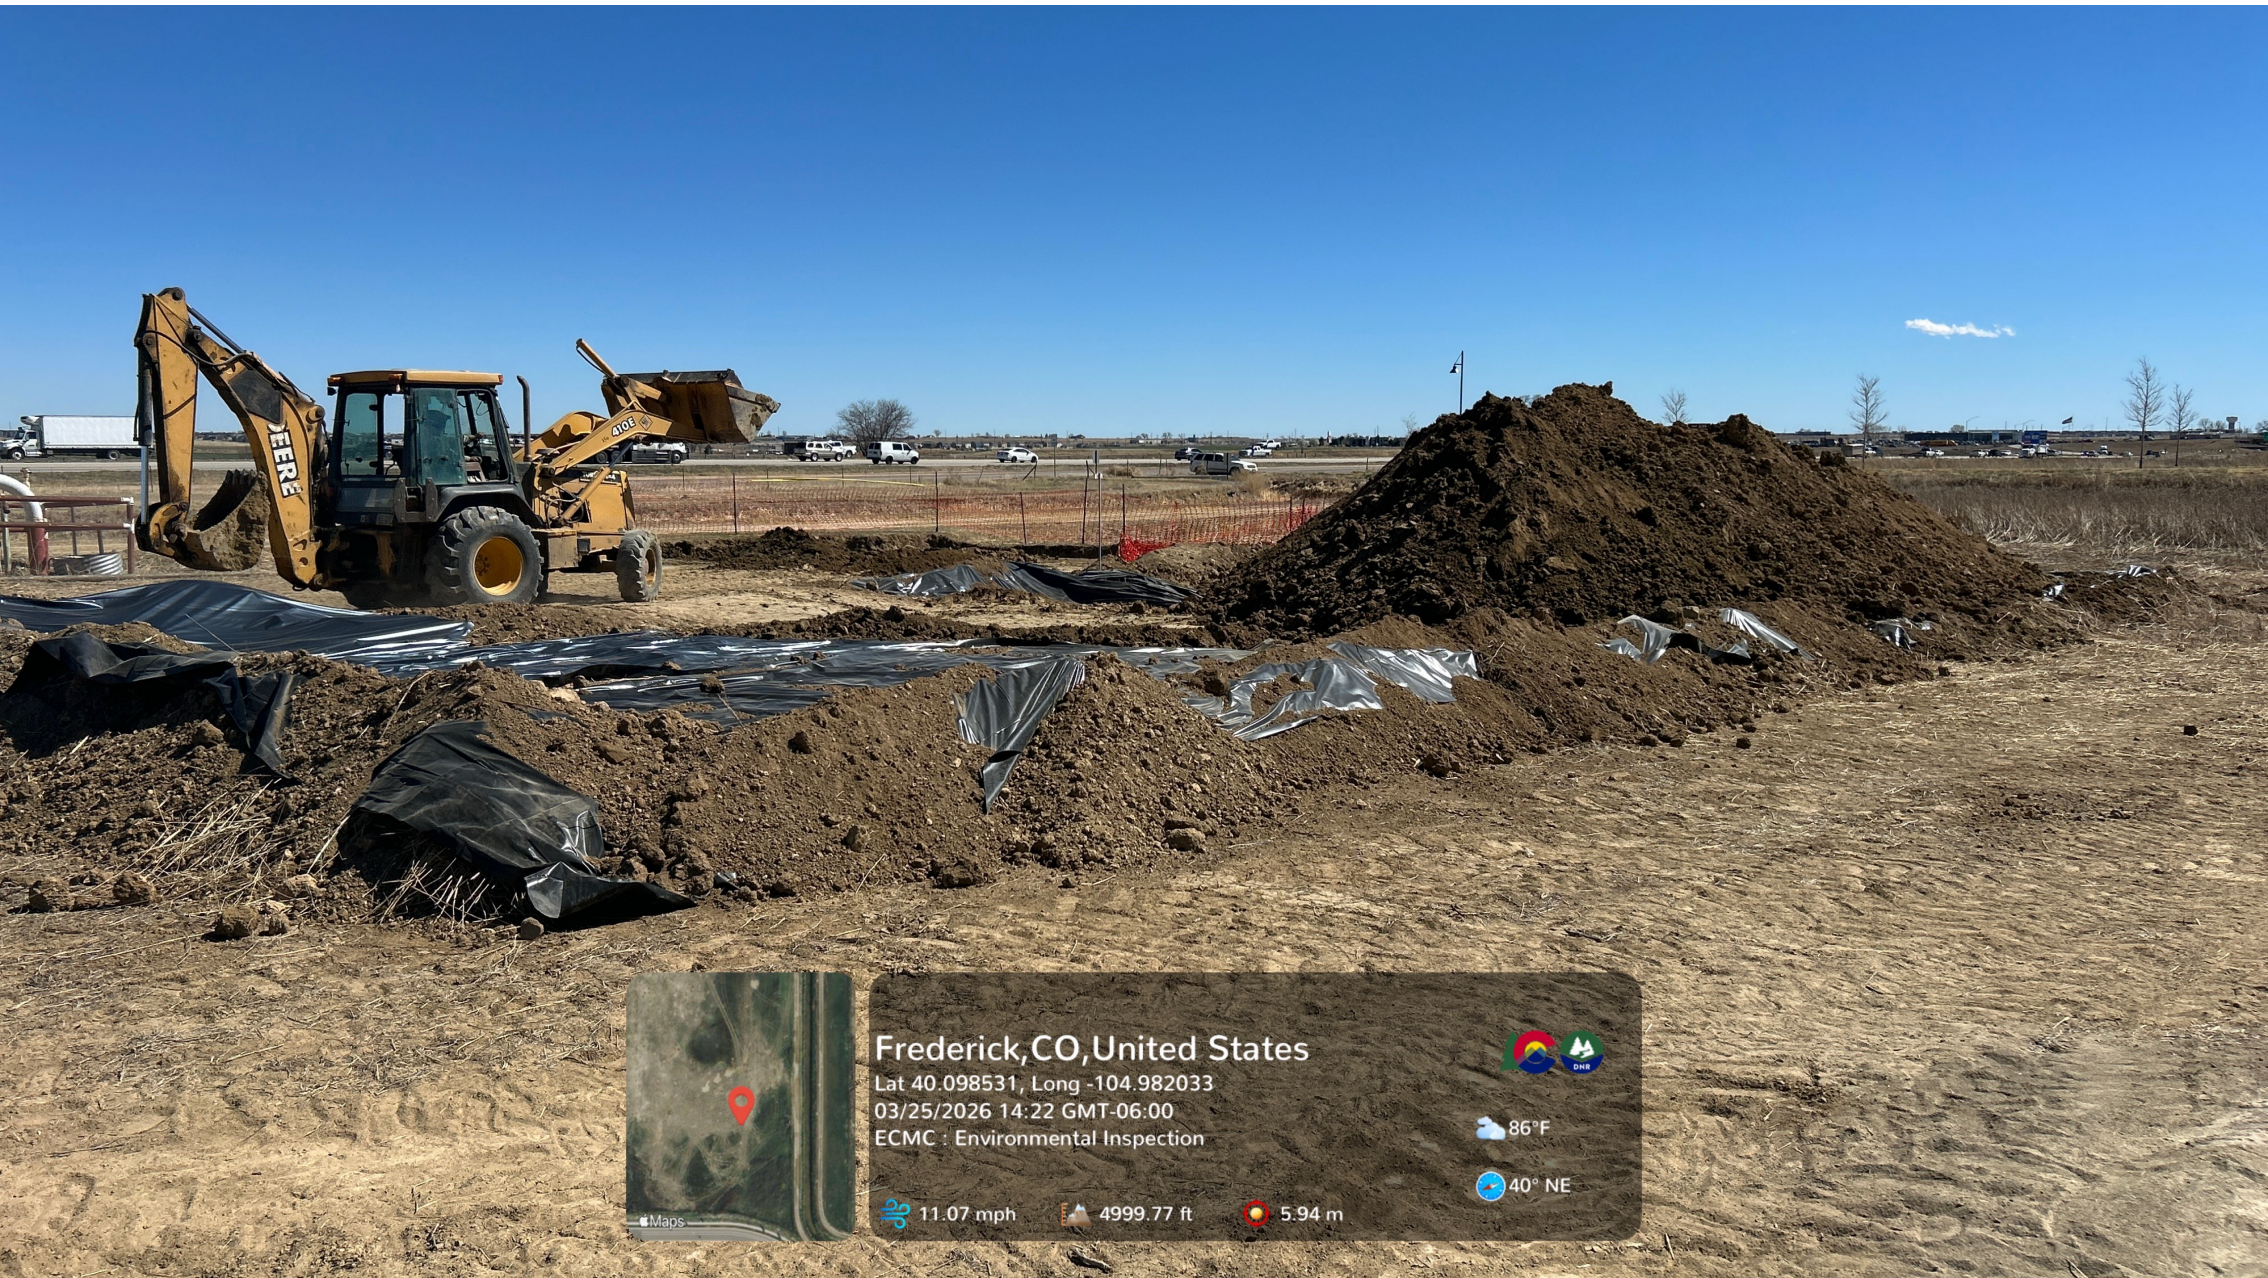
Additional liner has been added and the previously documented stockpile marked “contaminated” has been expanded.

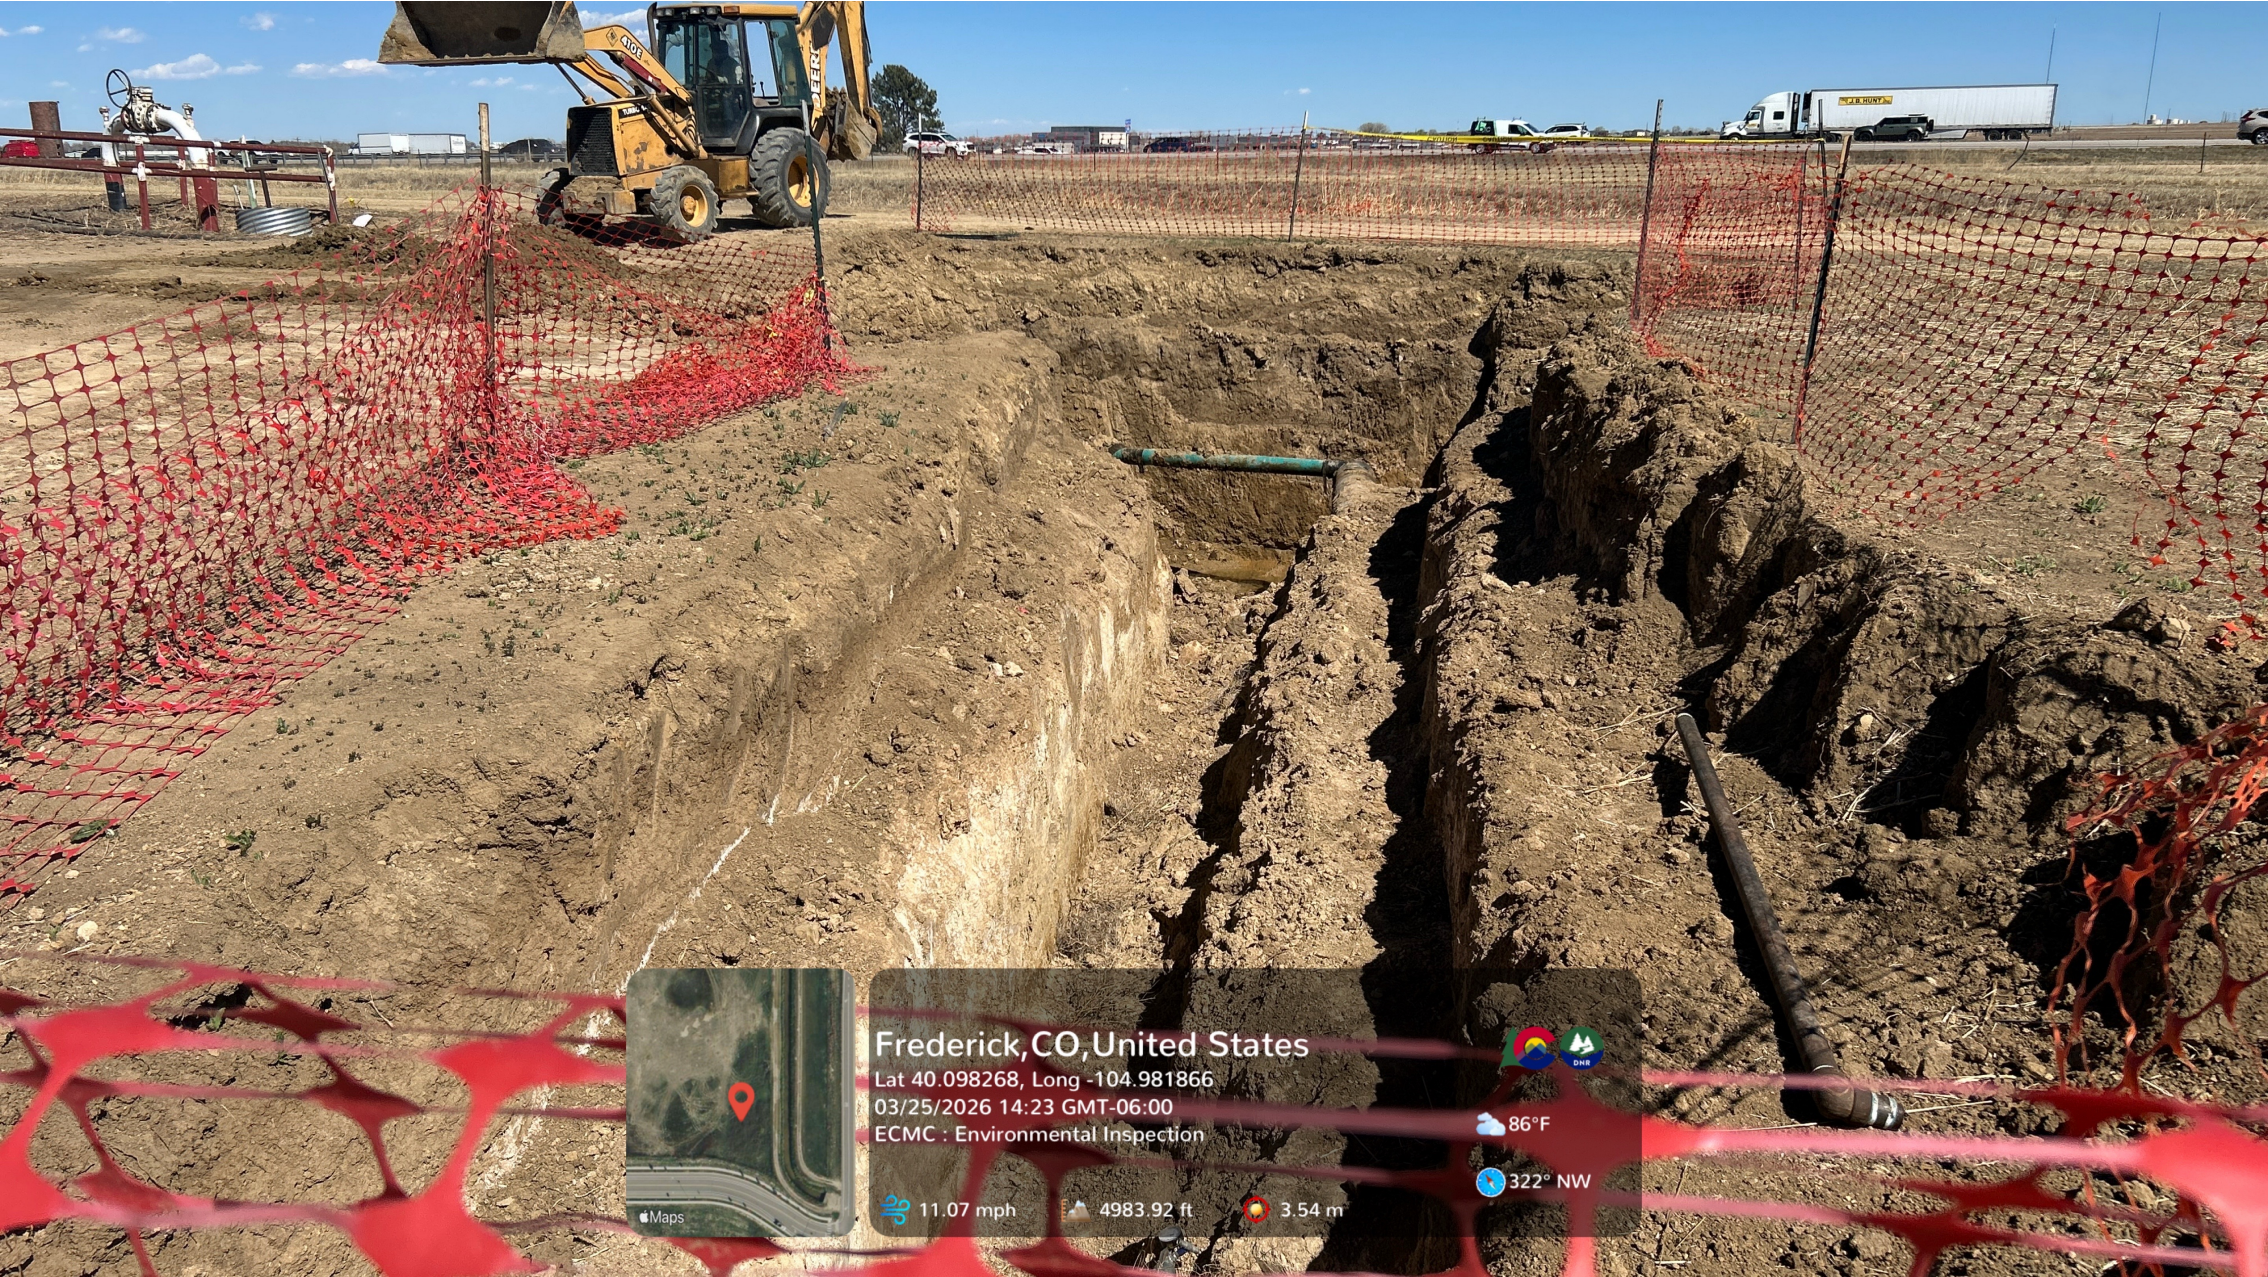
Two flowlines are visible within the excavation.
