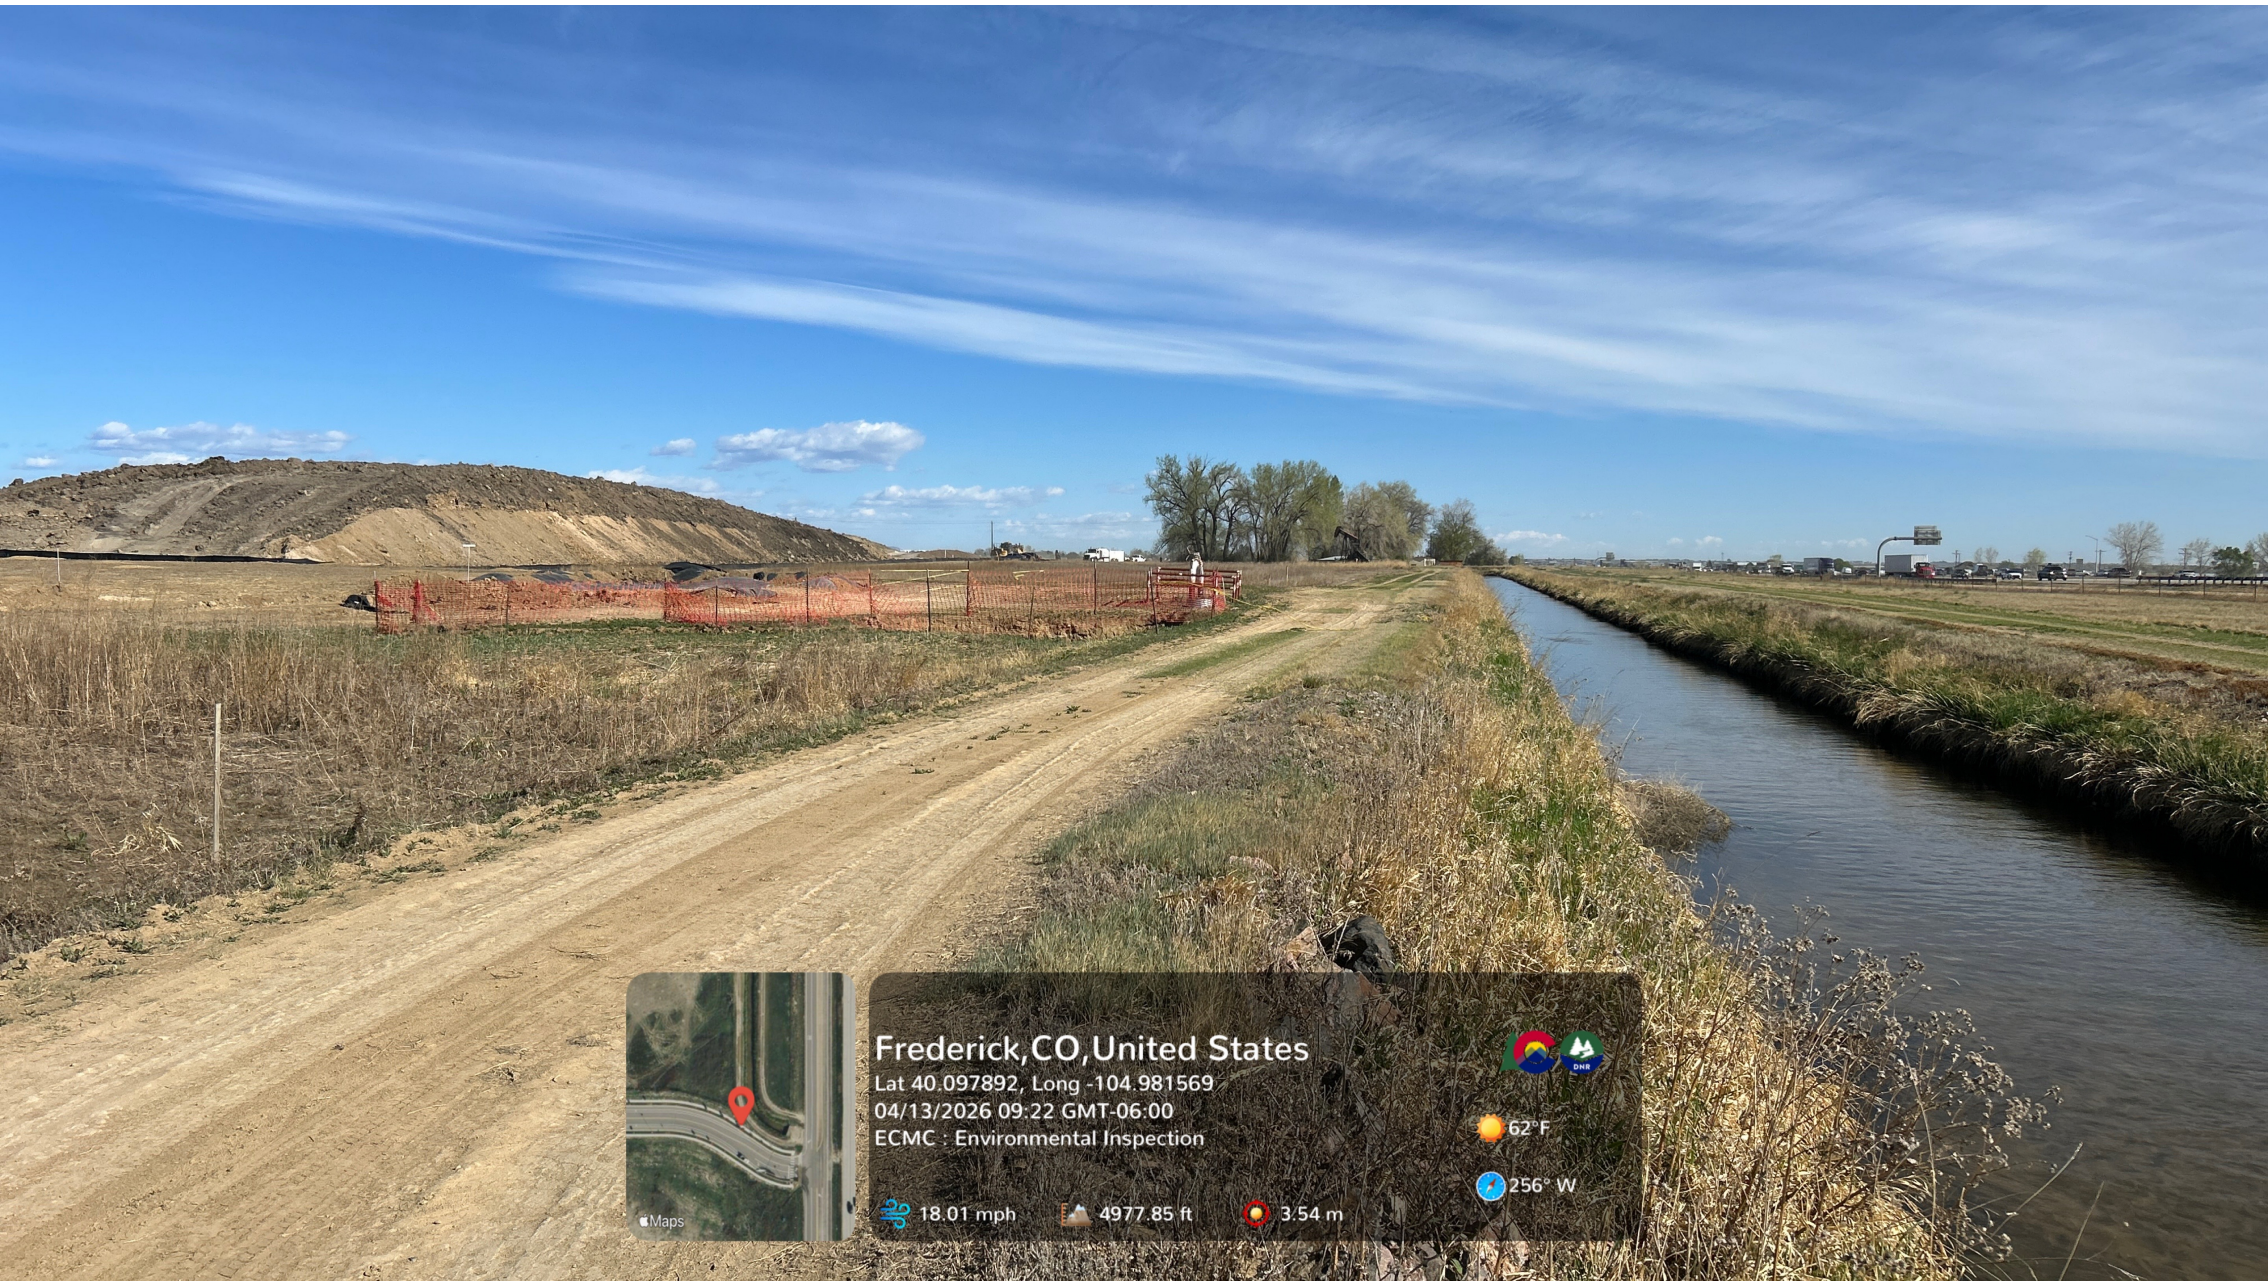
Sullivan Ditch was running (north to south) the time of the inspection. An open excavation remains on location. Large stockpile/truck traffic in background is unrelated to the Spill/Release.No Operator personnel or equipment were on location at the time of inspection.

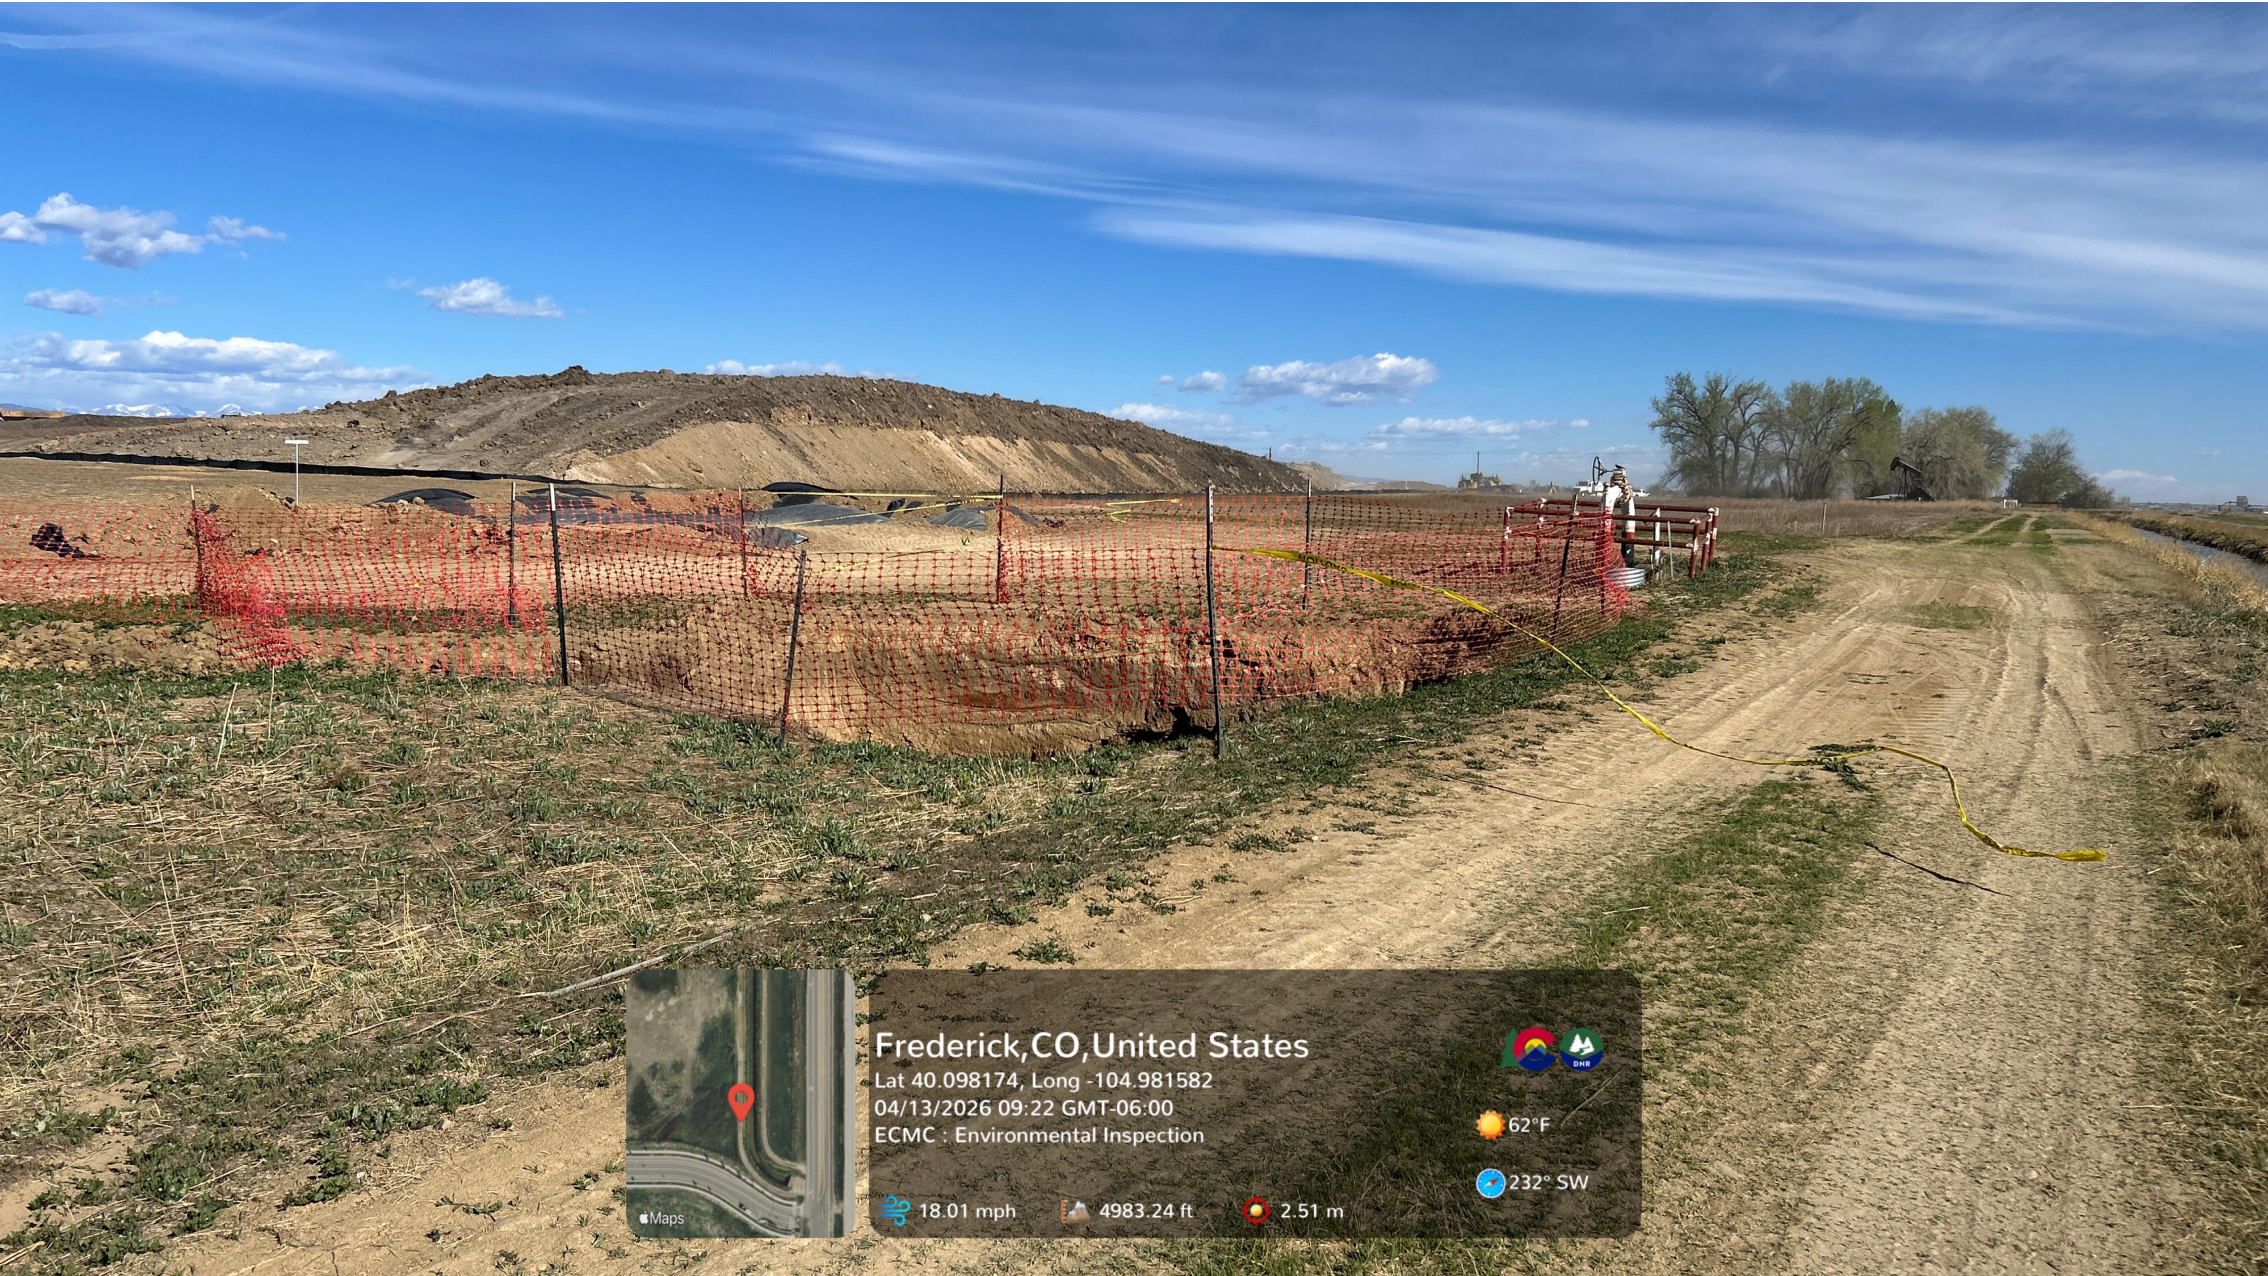
An open excavation remains on location. Large stockpile/truck traffic in background is unrelated to the Spill/Release.

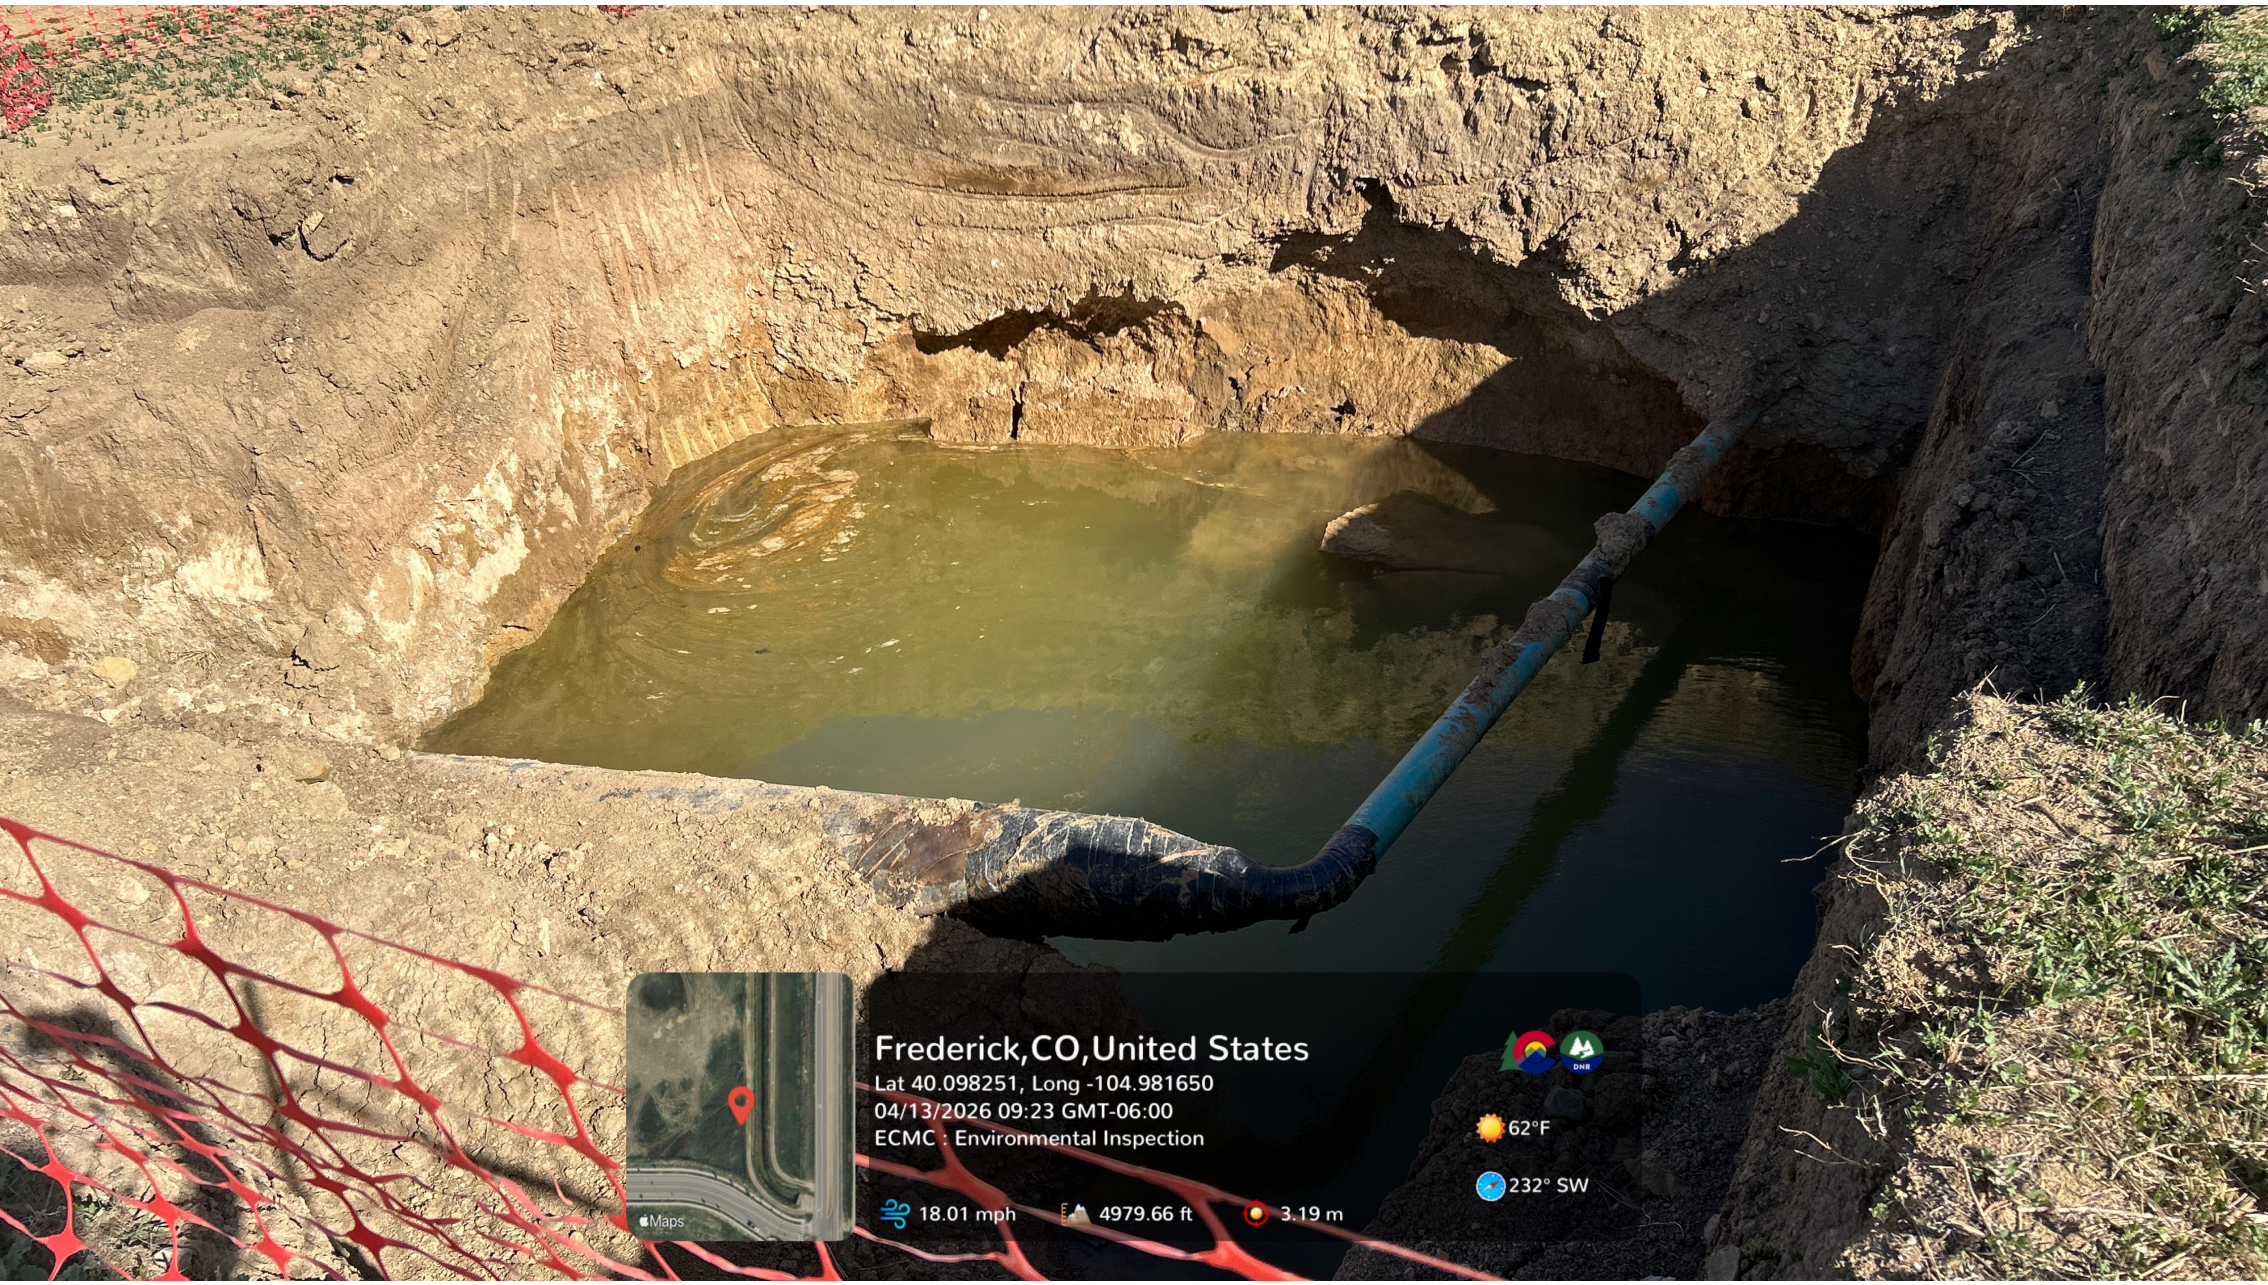
Stained soil and groundwater with free product are visible in situ. Soil mass failures are visible on the excavation sidewalls.

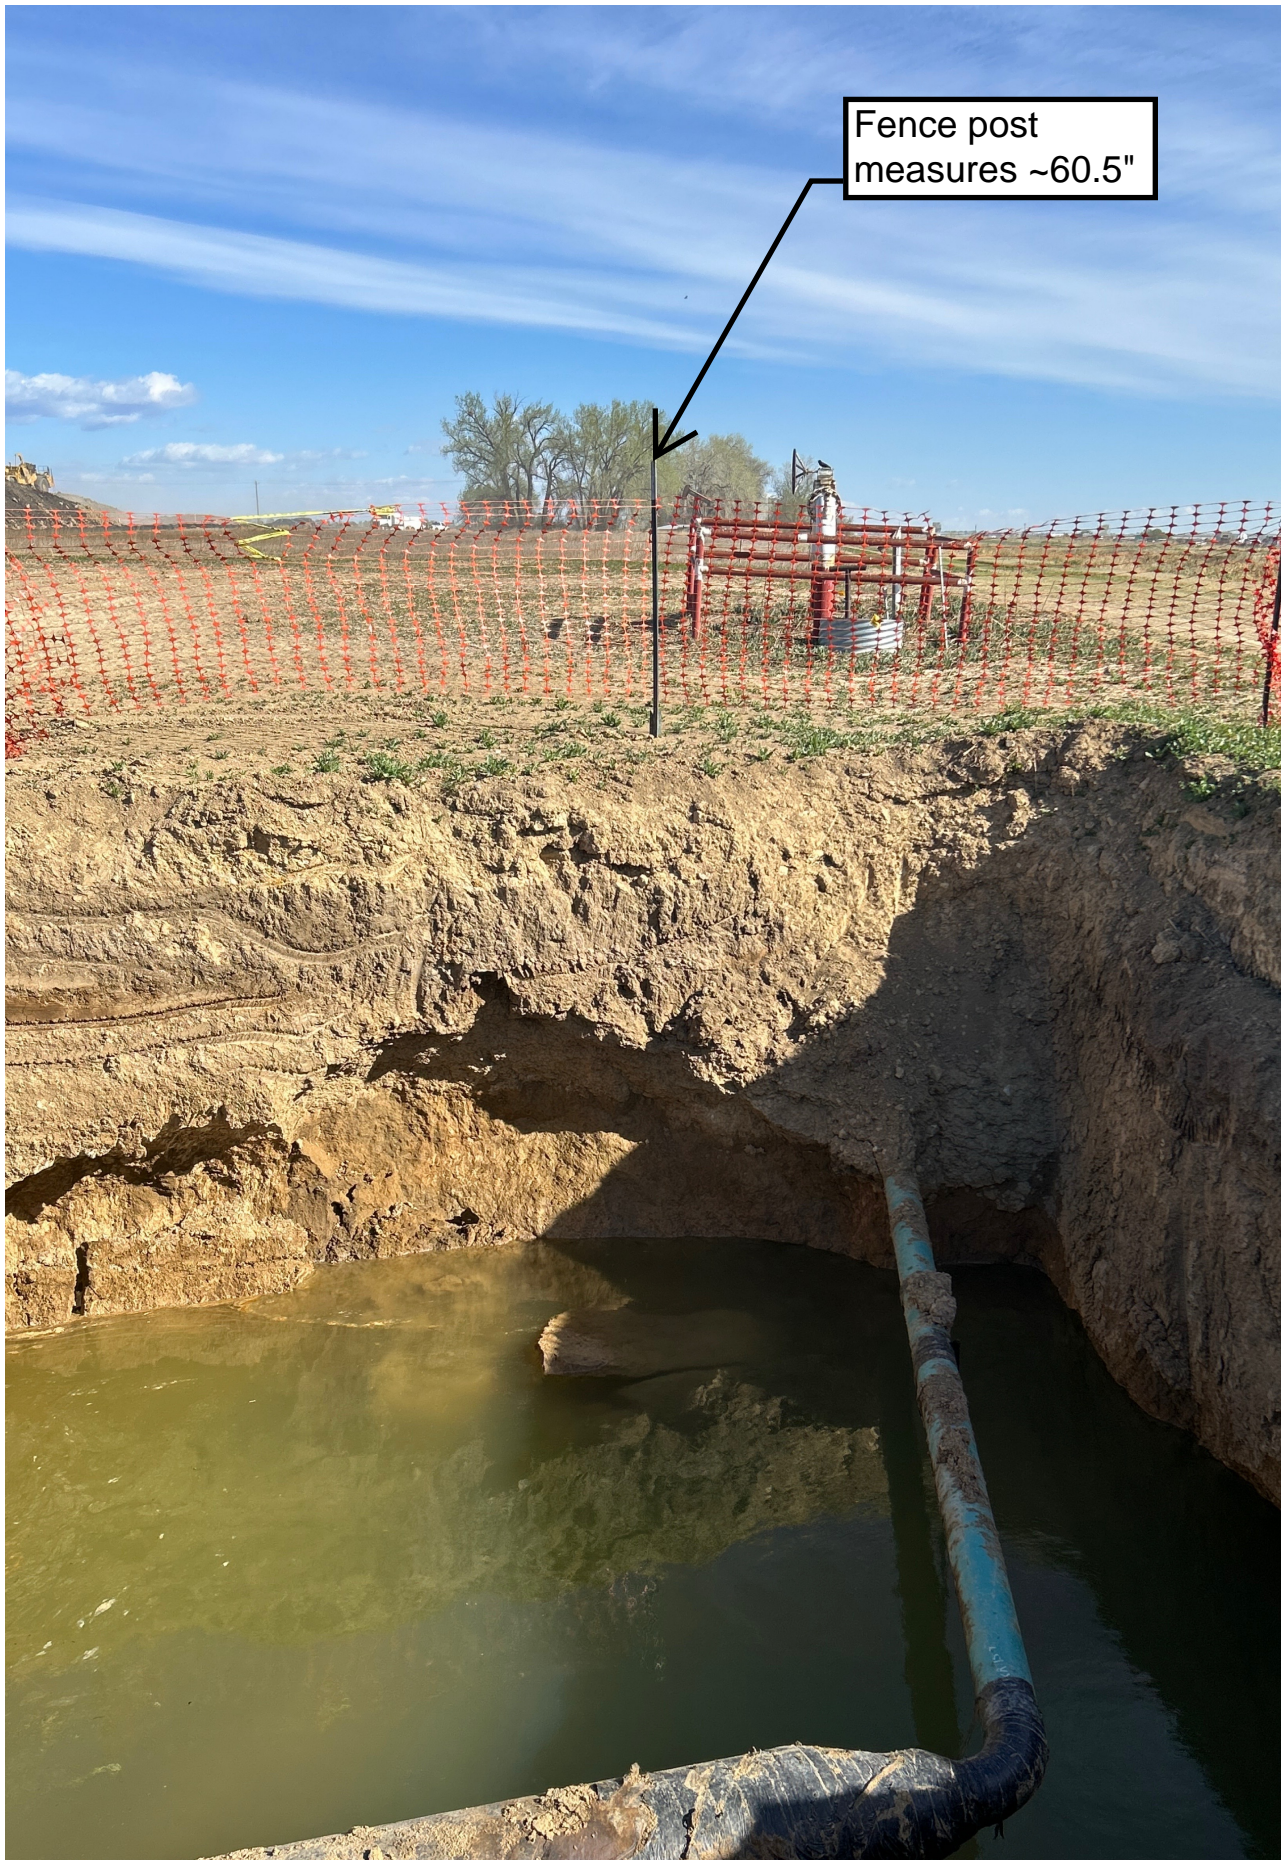
ECMC staff estimate the depth to groundwater to be ~9-10 feet.

Fence post  
measures ~60.5"

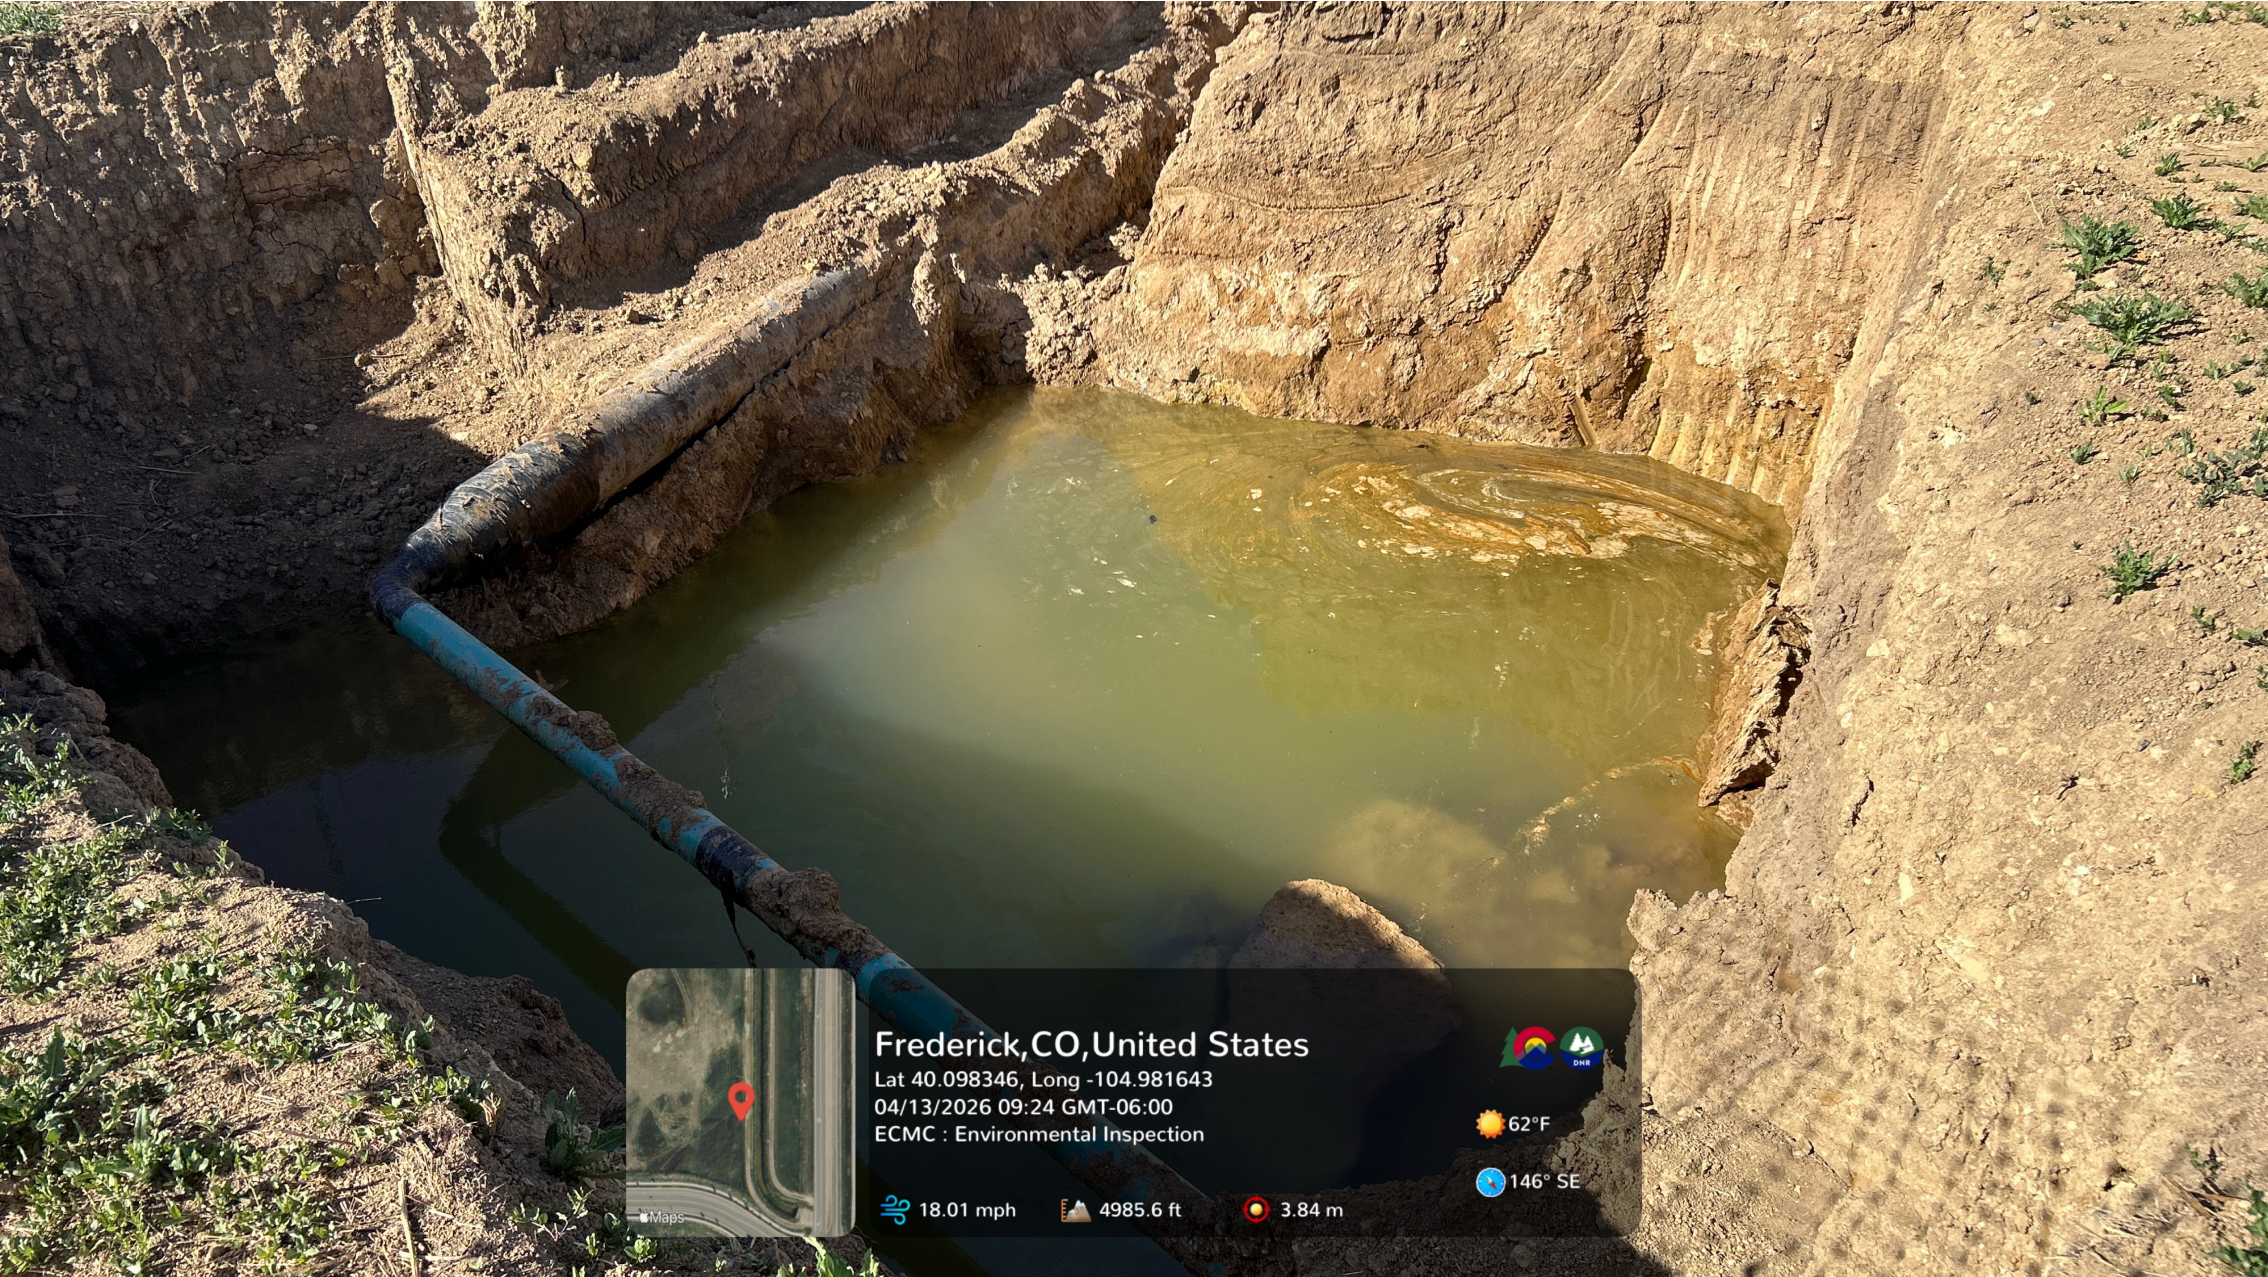
Stained soil and groundwater with free product are visible in situ.

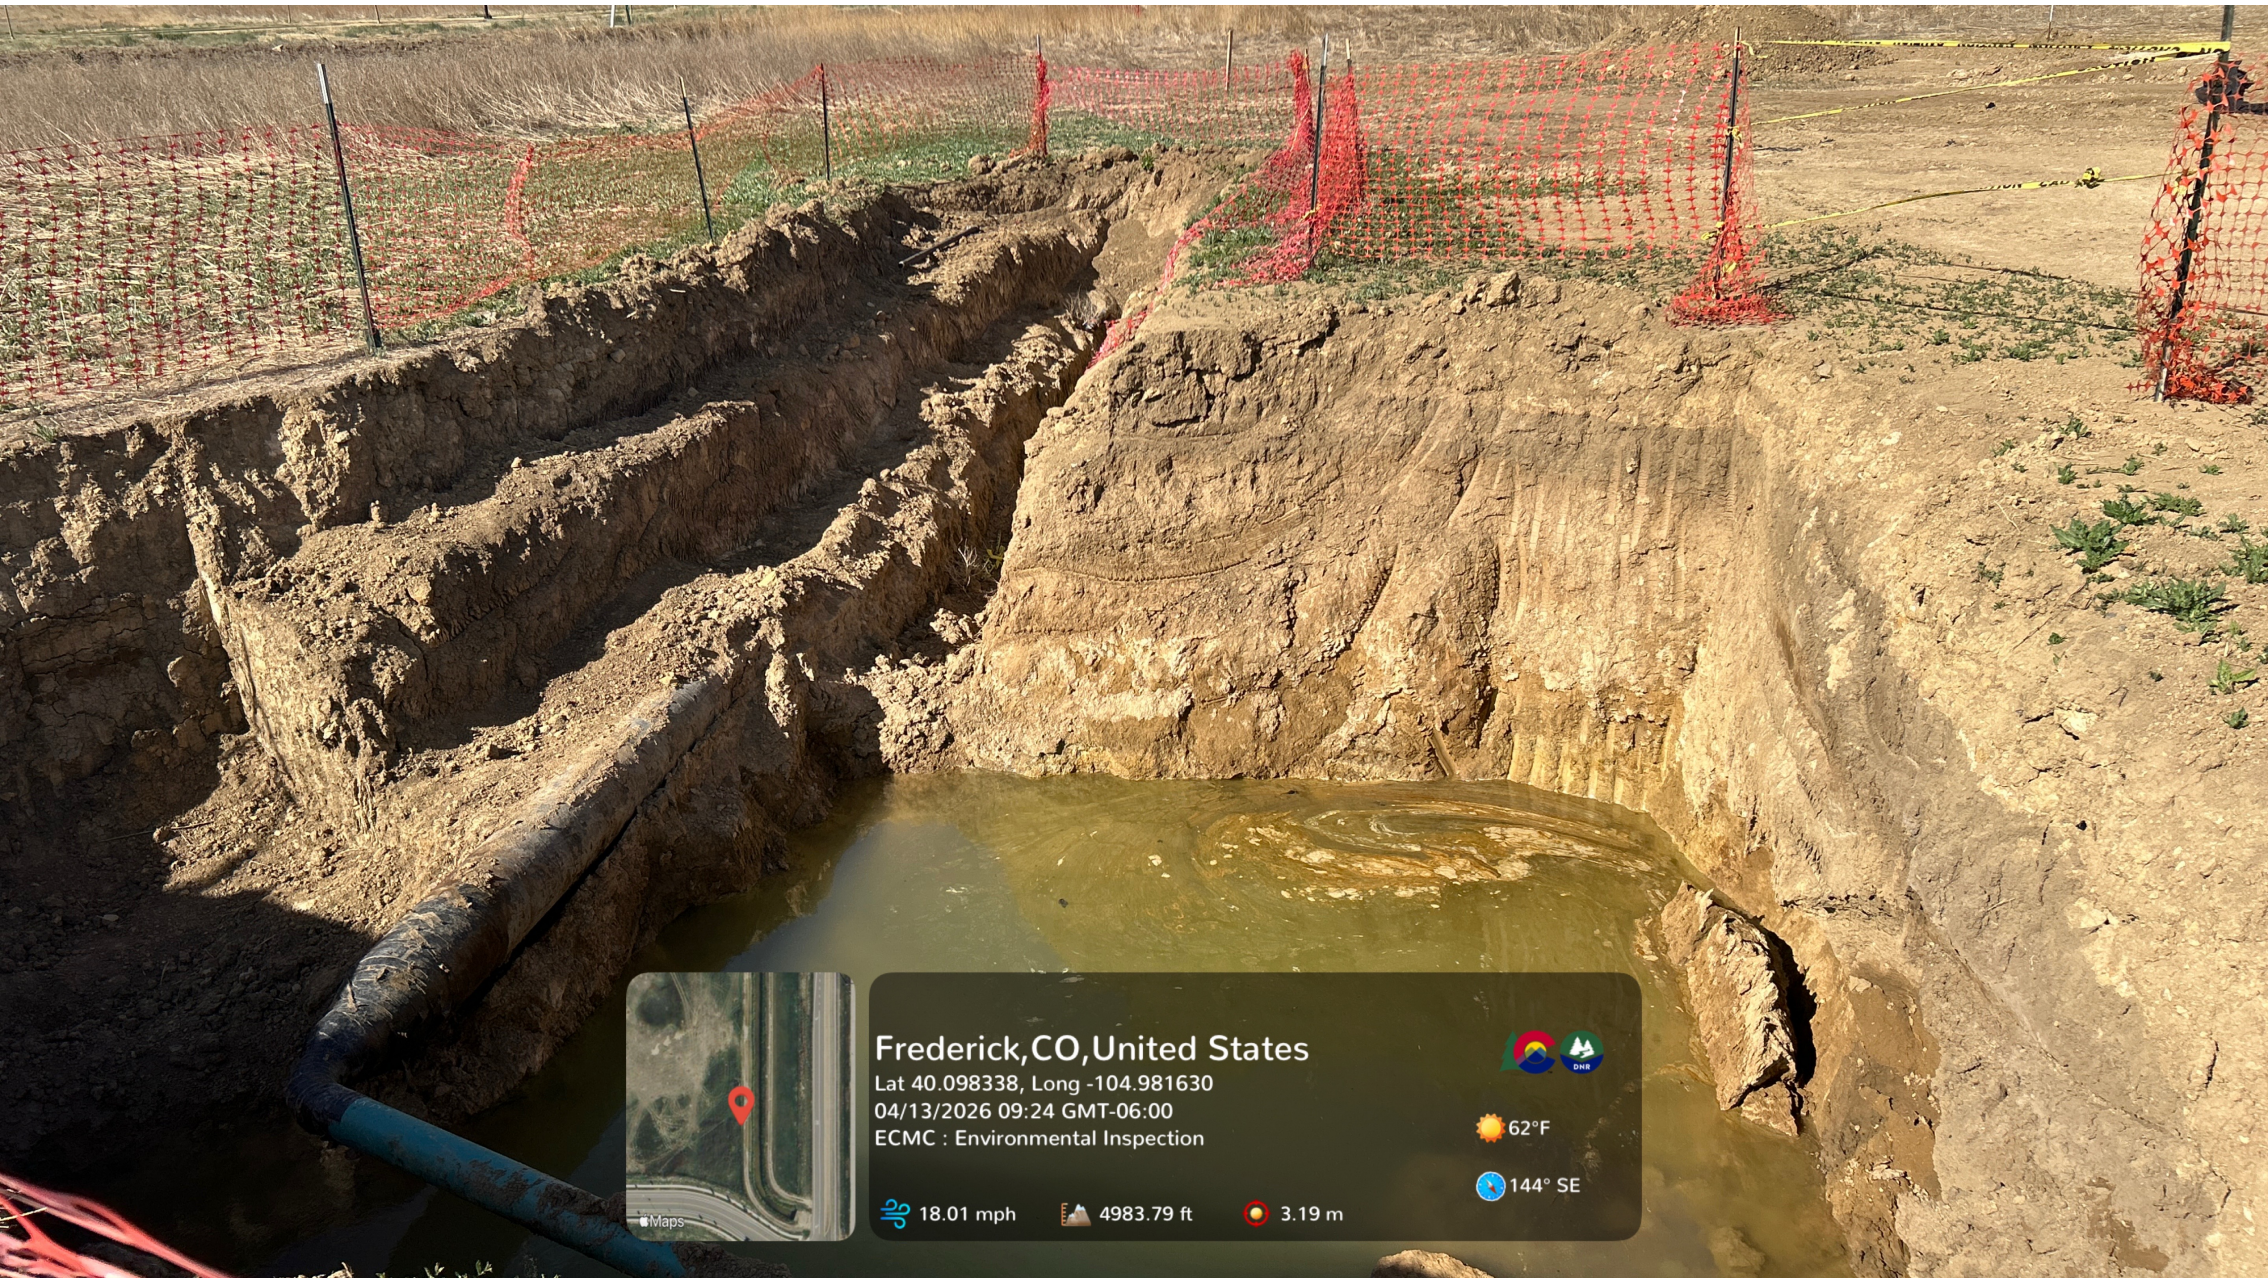
Stained soil and groundwater with free product are visible in situ. Yellow caution tape extends across a gap in orange construction fencing.

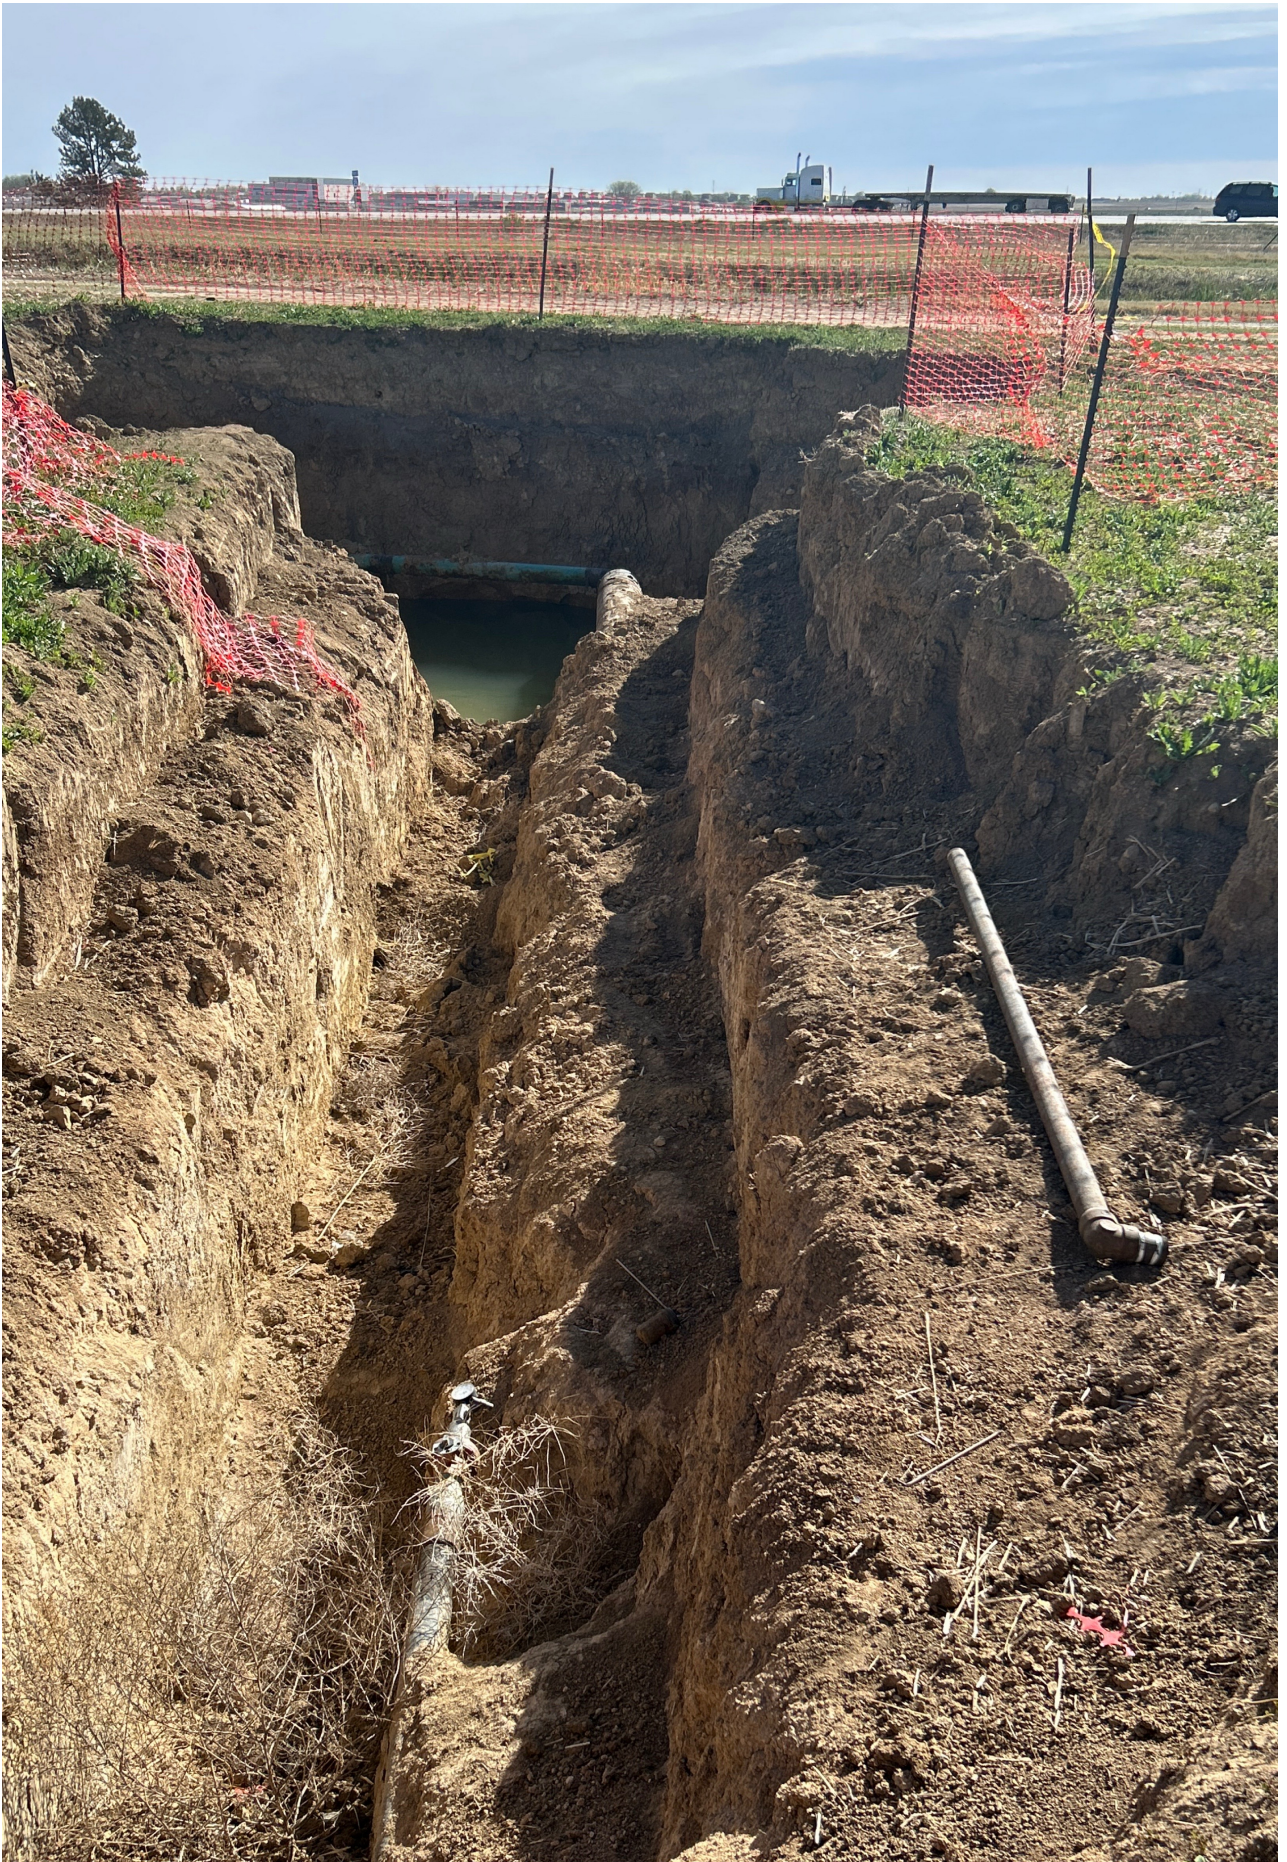
Two flowlines are visible within the excavation.

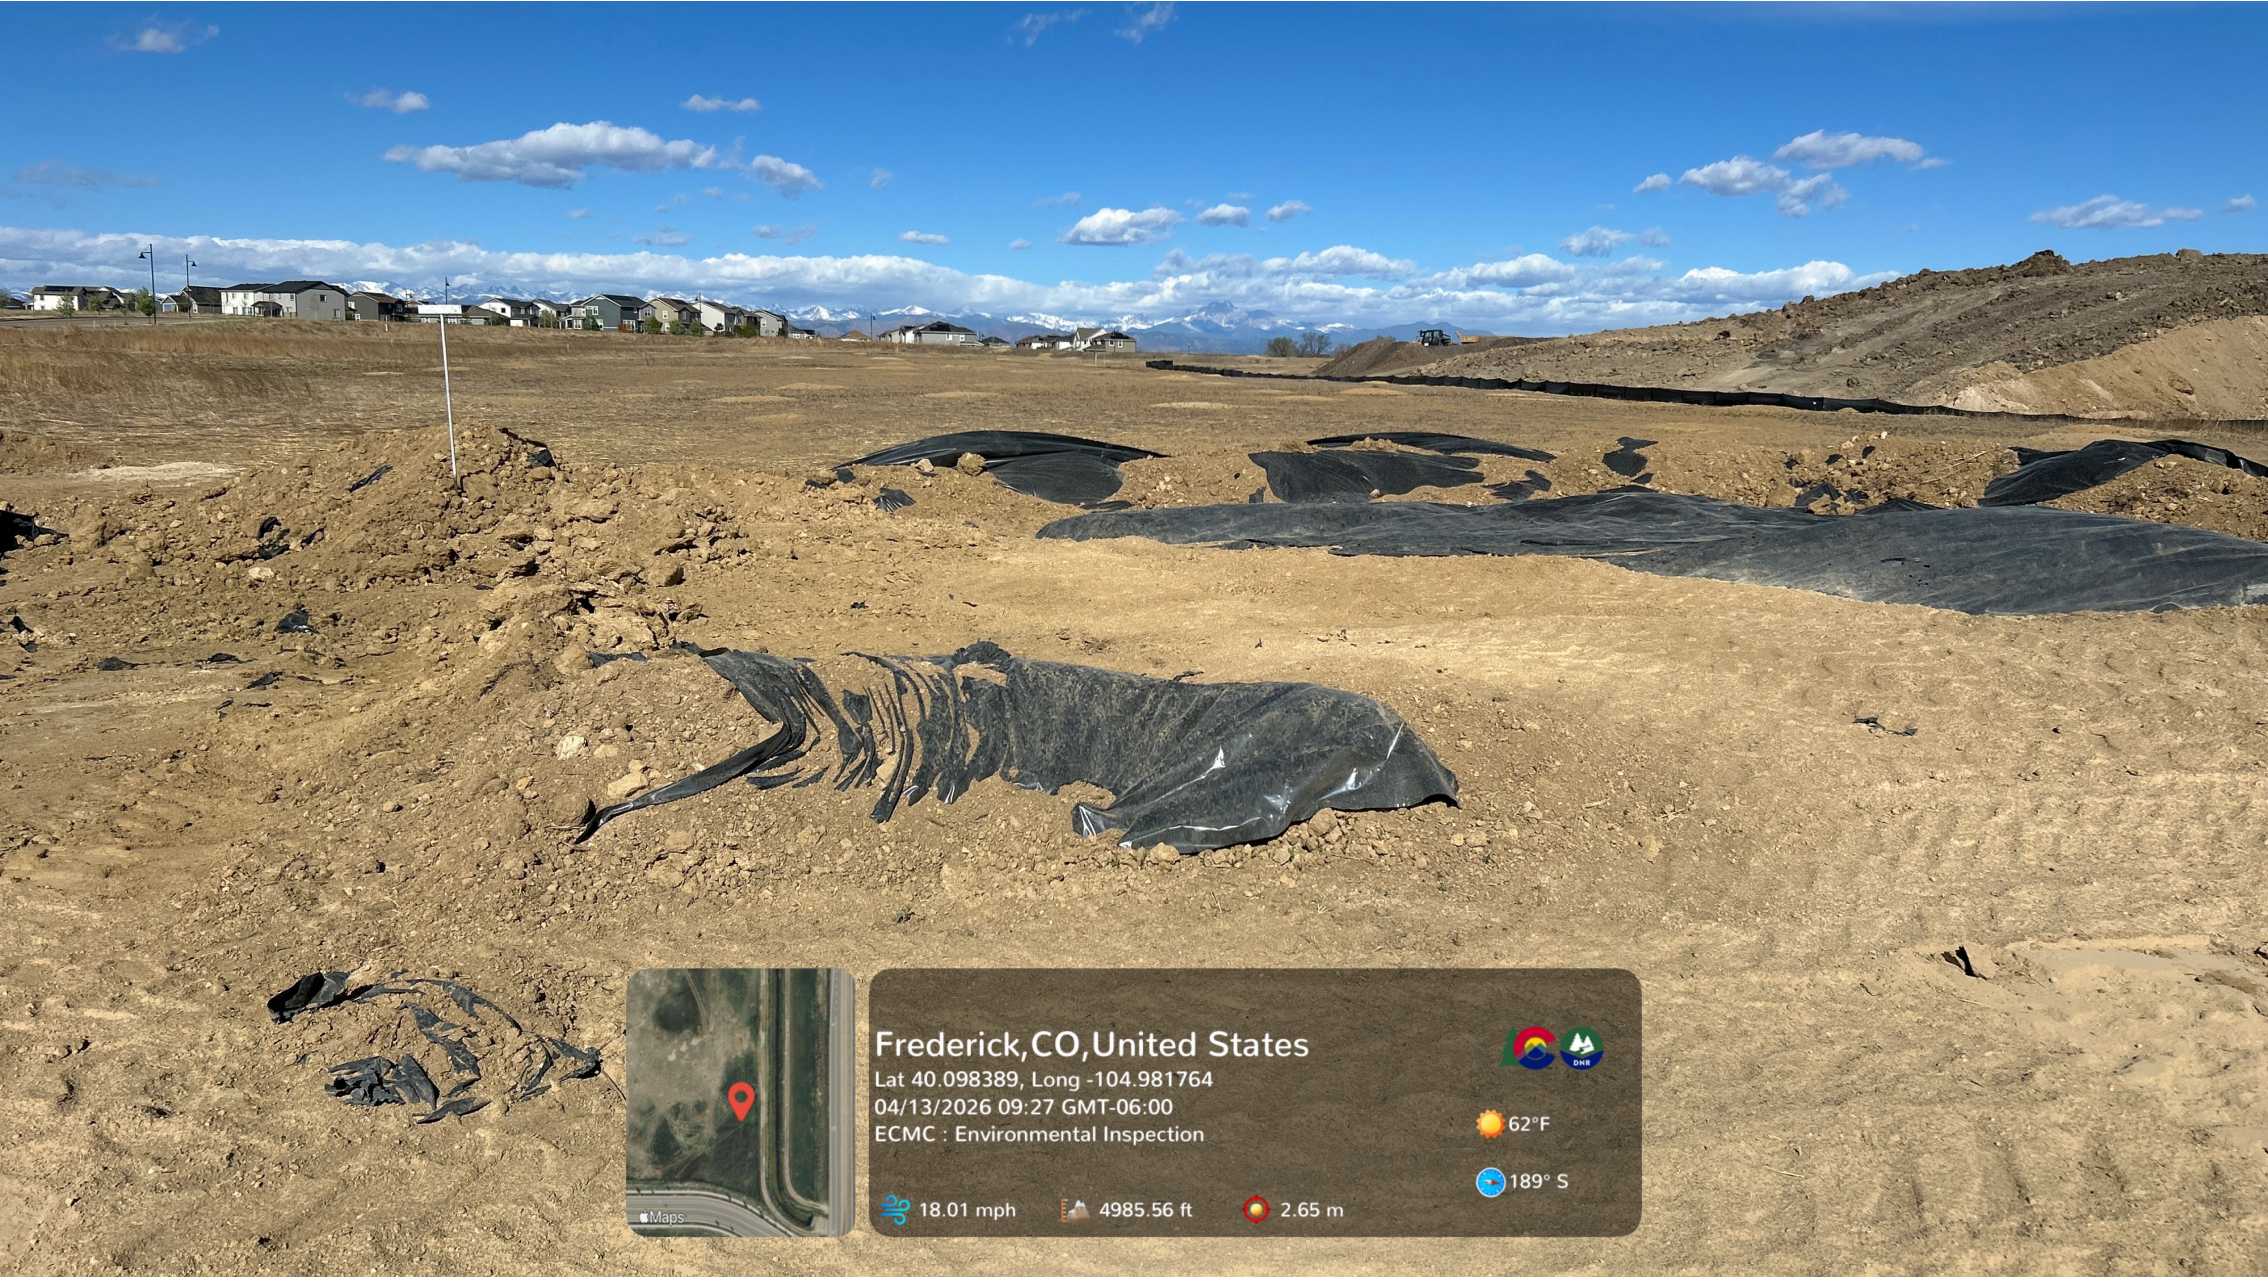
Soil stockpile marked "contaminated". Much of the soil has been removed from the contaminated stockpile. Some stockpiled, contaminated soil and the liner remain on location.
