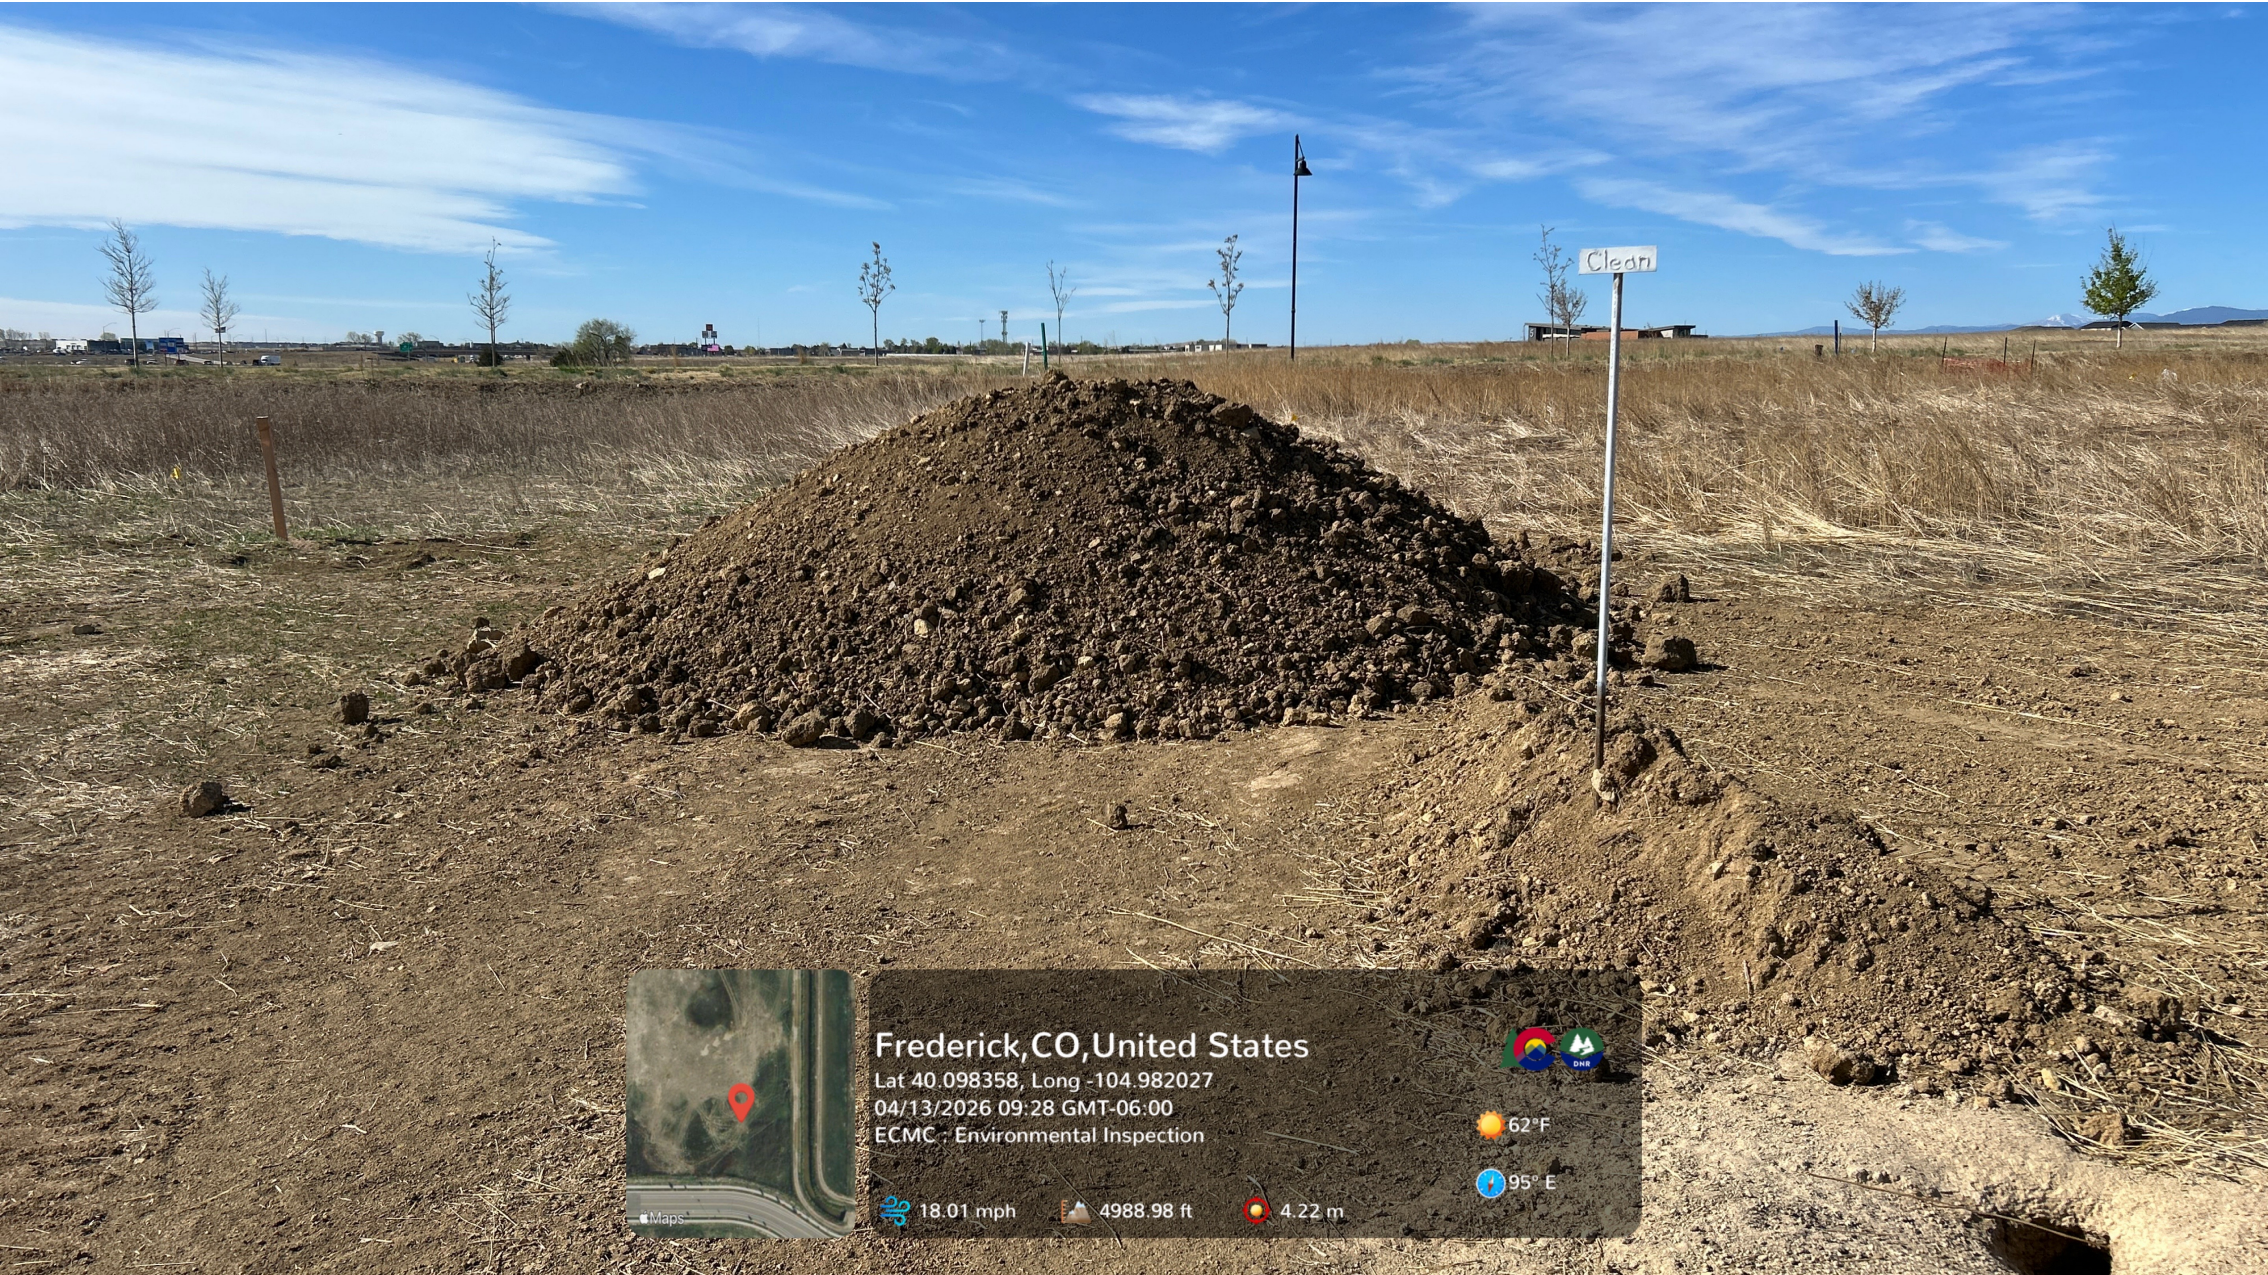
Soil stockpile marked "clean". No stormwater BMPs are visible at the clean stockpile.
