## Inspection Photos

Location Name: High River Resources. Bondad 34-10 No. 1-36 DK/MV

Location ID: 05-067-05614

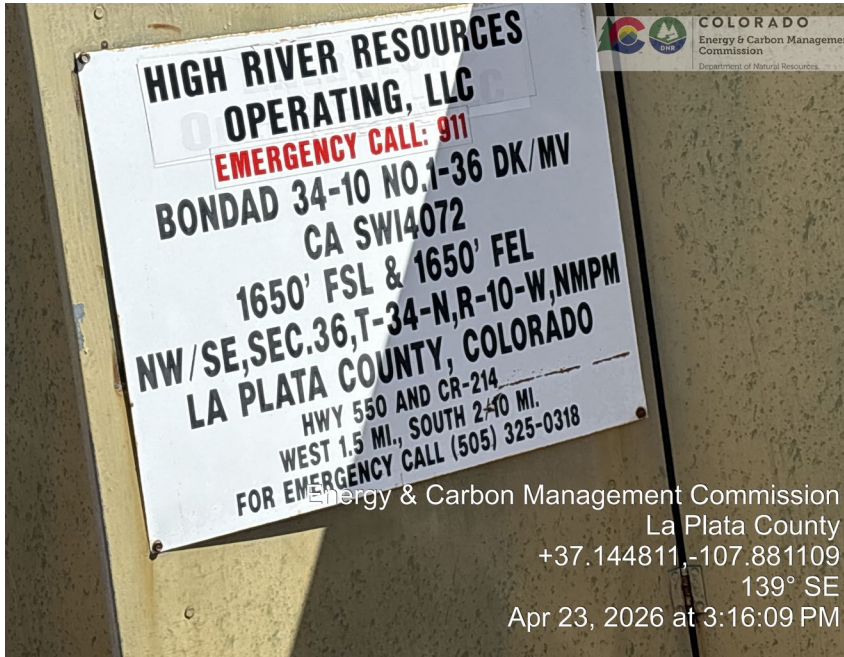
1. Well Sign. Note: API number.

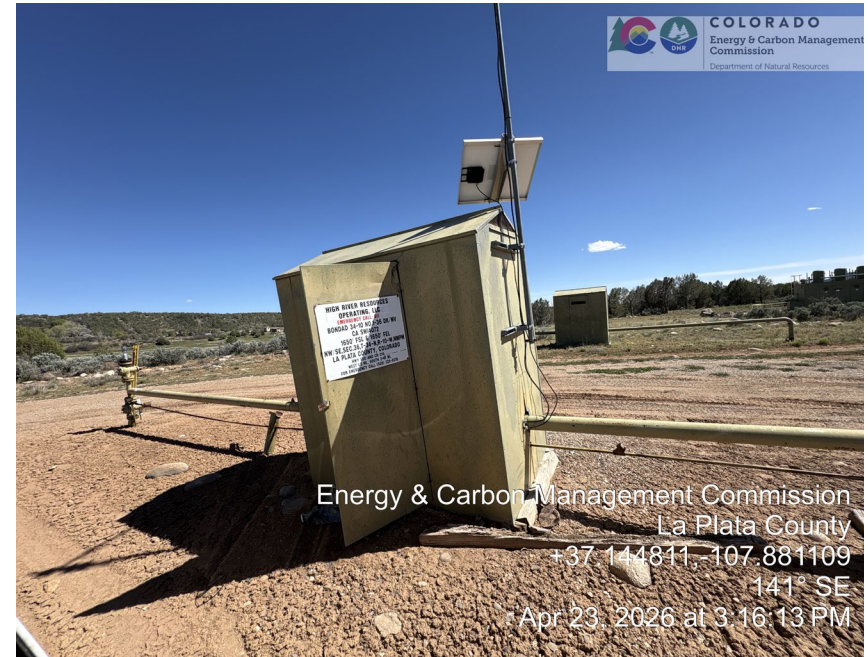
2. Meter run shed. Structure is in poor condition. Doors do not appear to latch. Meter card not conspicuously displayed inside, is inside meter control box.

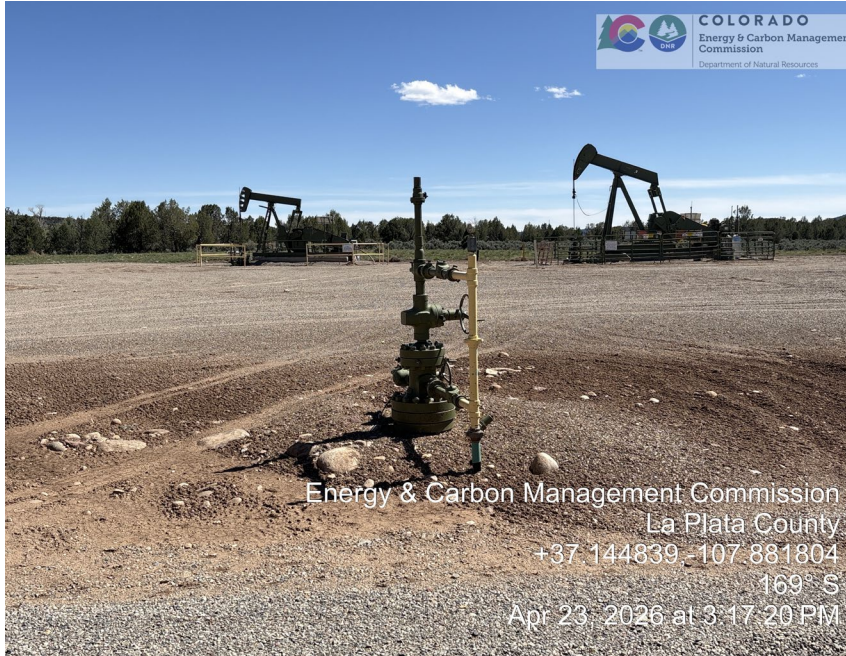
**3. Wellhead. There is no sign indicating what production equipment this well is associated with.**

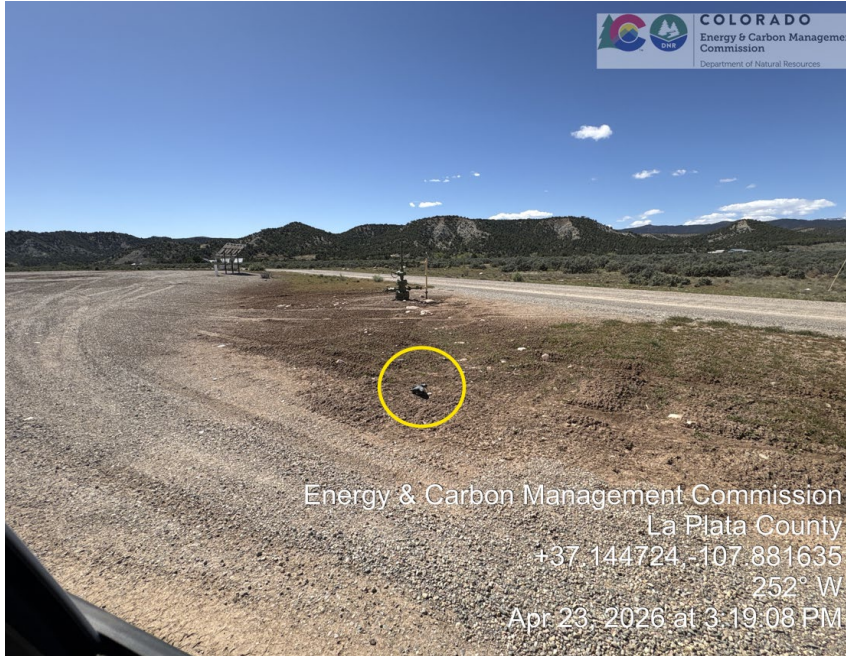
**5. Wellhead. There is a piece of liner material protruding through the dirt inside the yellow circle. It looks like a buried pit liner.**

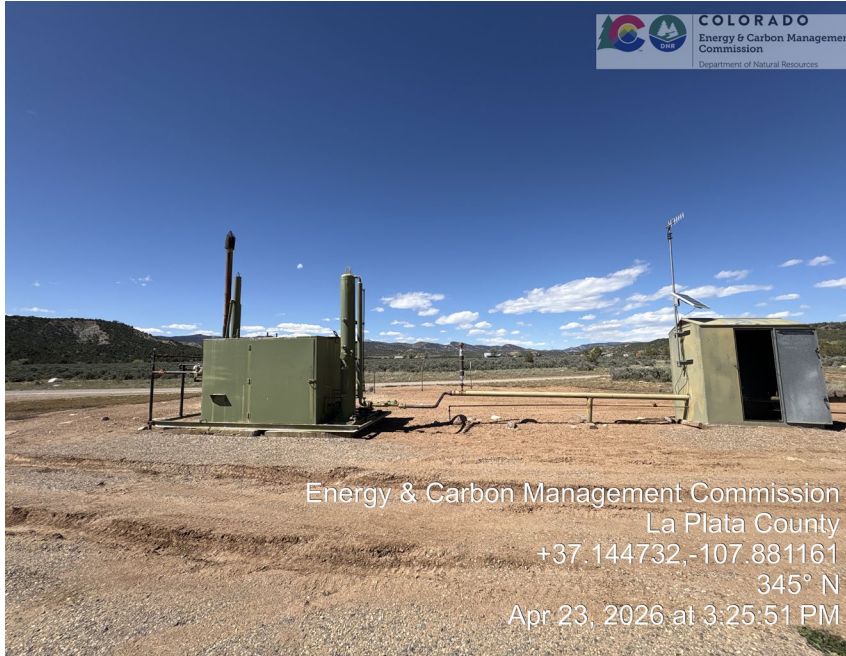
**7. Dehydrator with bird protector on heater stack connected to meter run shed by pipeline.**

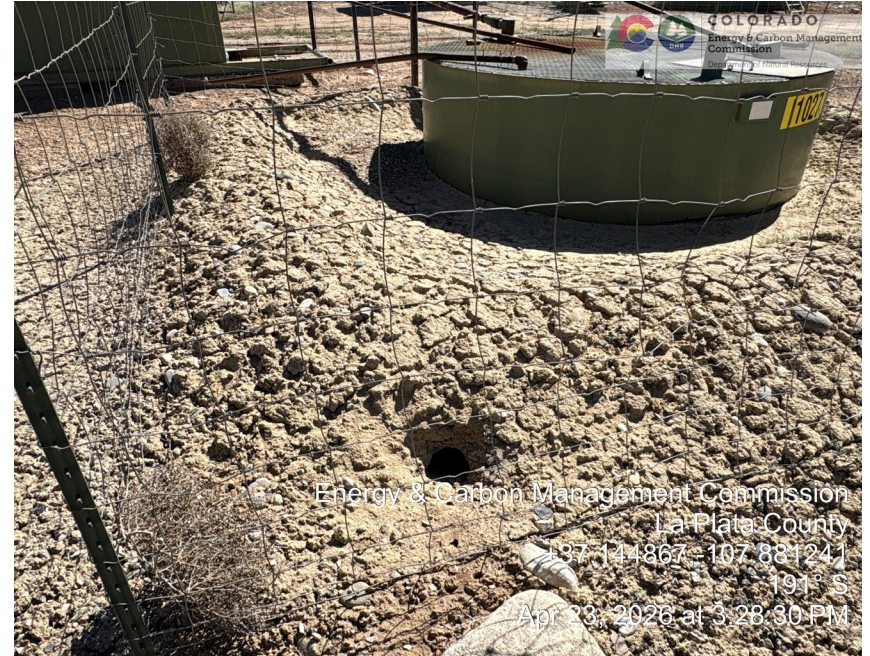
**8. 20 BBL open top AST behind earthen berm. ID # I1027. Note animal burro in lower center of photo. Berm permeability is inadequate and volume appears to be inadequate.**

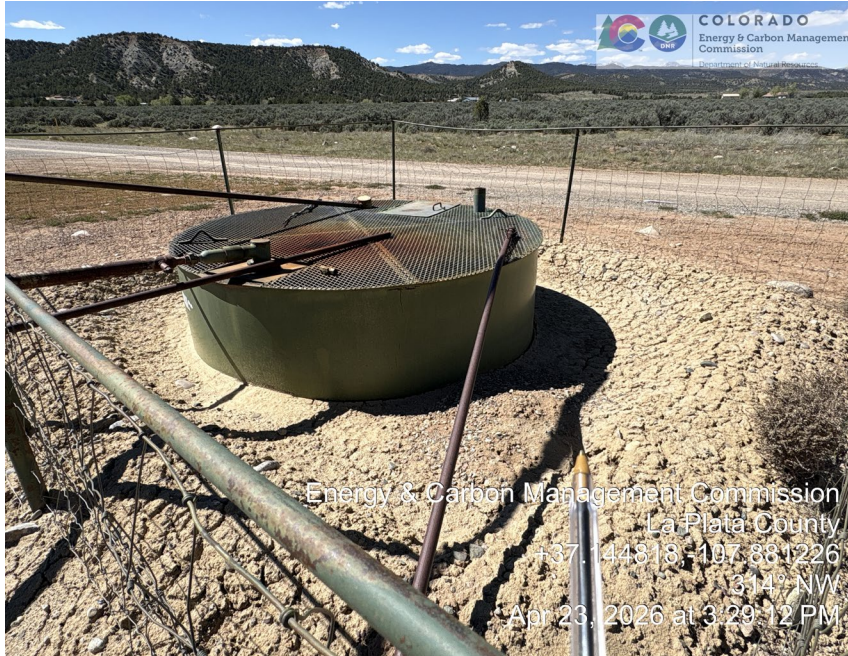
9. 20 BBL open top AST from SE corner. Pen is pointing a second animal burrow that has compromised the permeability of the berm.

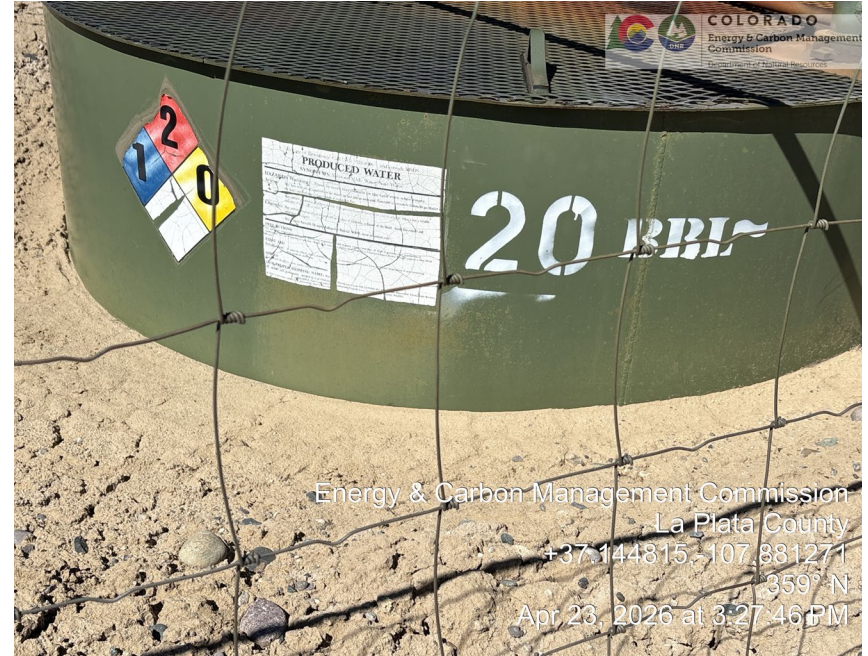
10. 20 BBL open top steel AST has contents, volume and NFPA diamond.

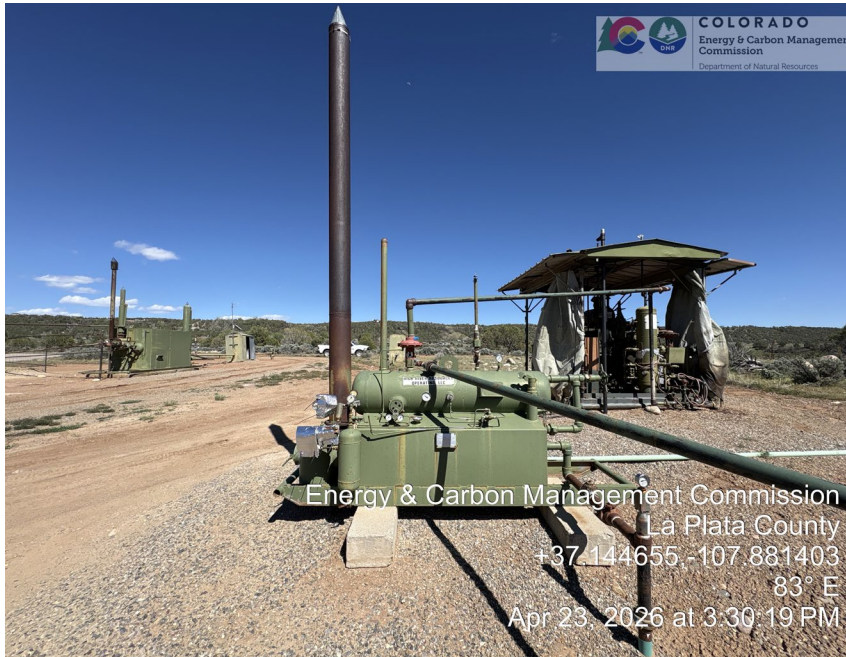
**11. Horizontal heated separator with bird protector on heater stack.**

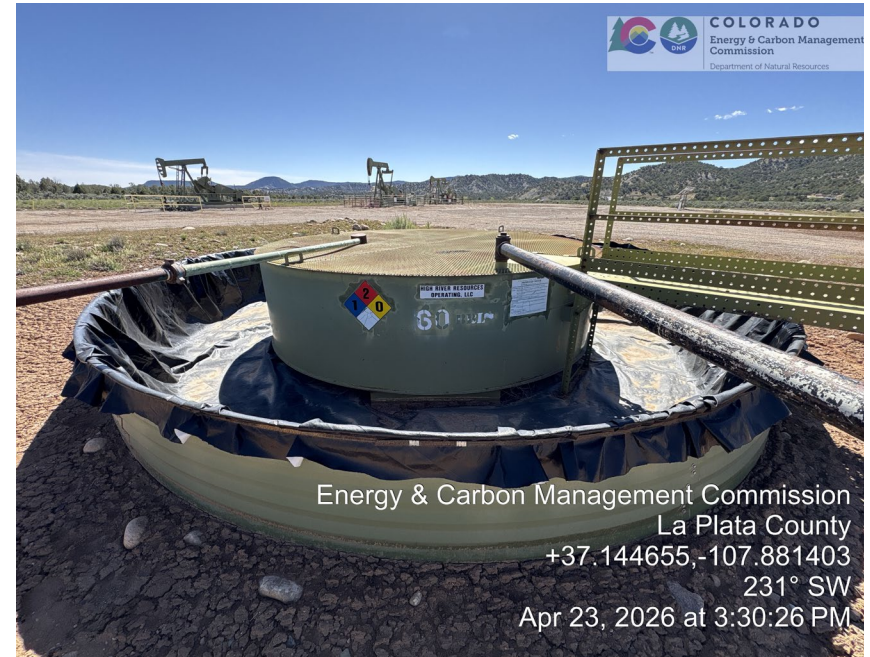
**12. 60 BBL Steel AST inside of metal secondary containment with impermeable plastic liner. Has labels for contents, volume, and NFPA diamond.**

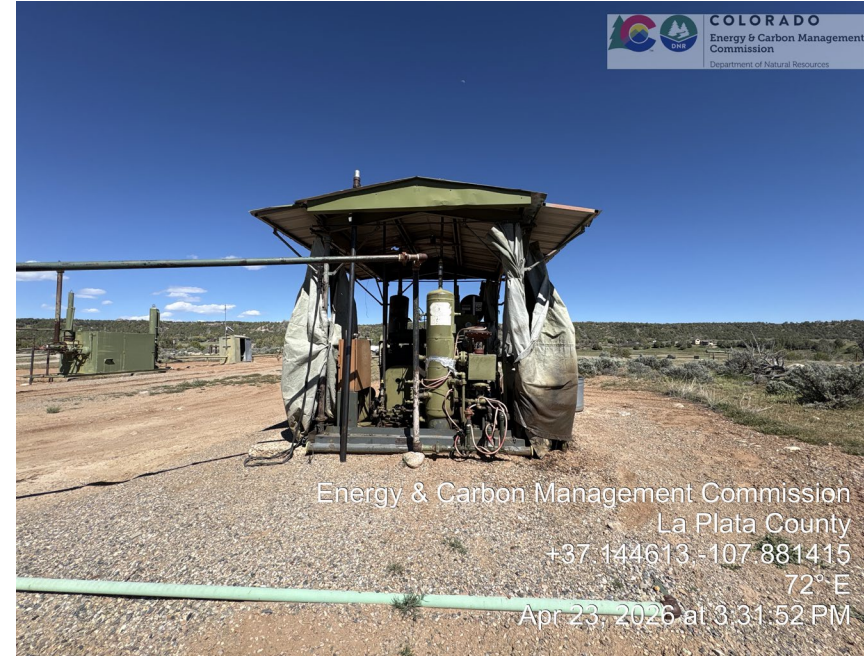
**14. Compressor inside shelter structure with canvas curtain sides. Curtains are saturated with oil or antifreeze.**

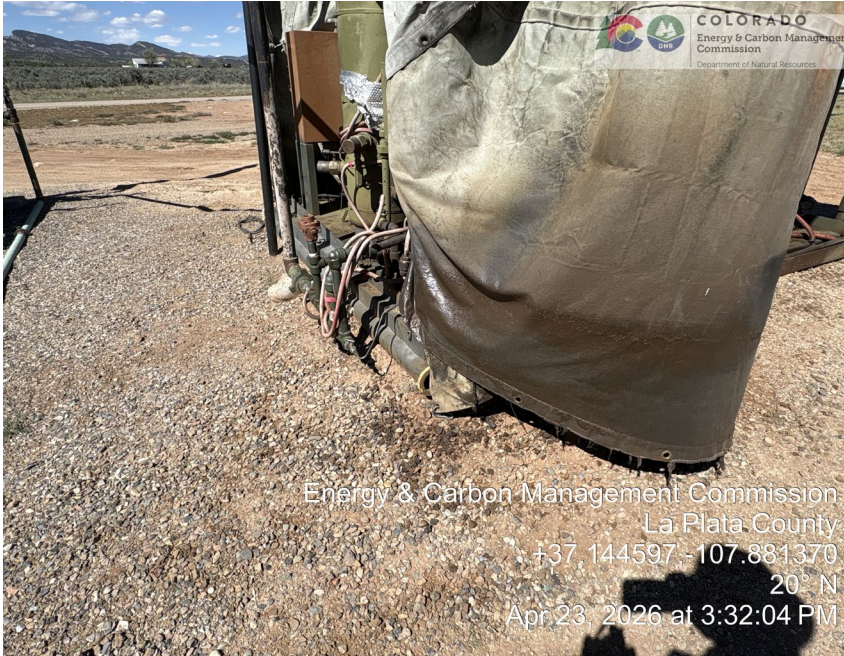
**15. Curtain around compressor structure. Saturated with lube oil and/or antifreeze.**

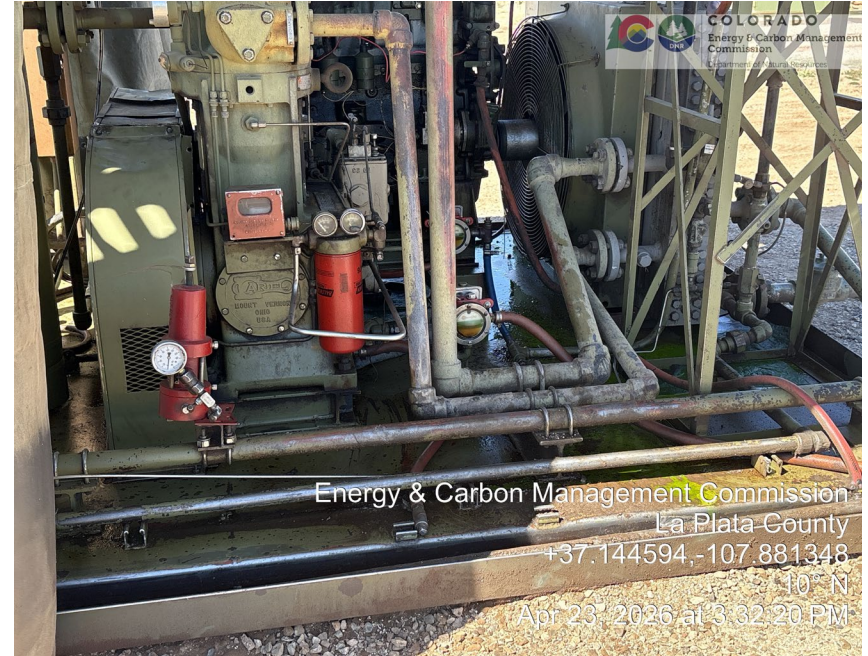
**16. Floor of compressor skid has standing free fluid that appears to be antifreeze based on bright green color. Also appears to have oil mixed in.**

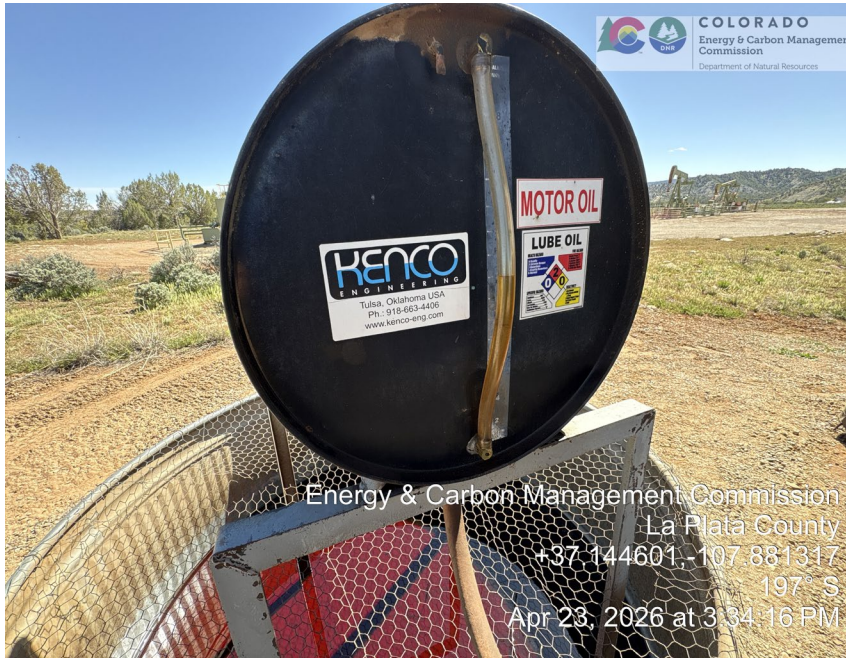
17. One of two lube oil tanks by compressor.

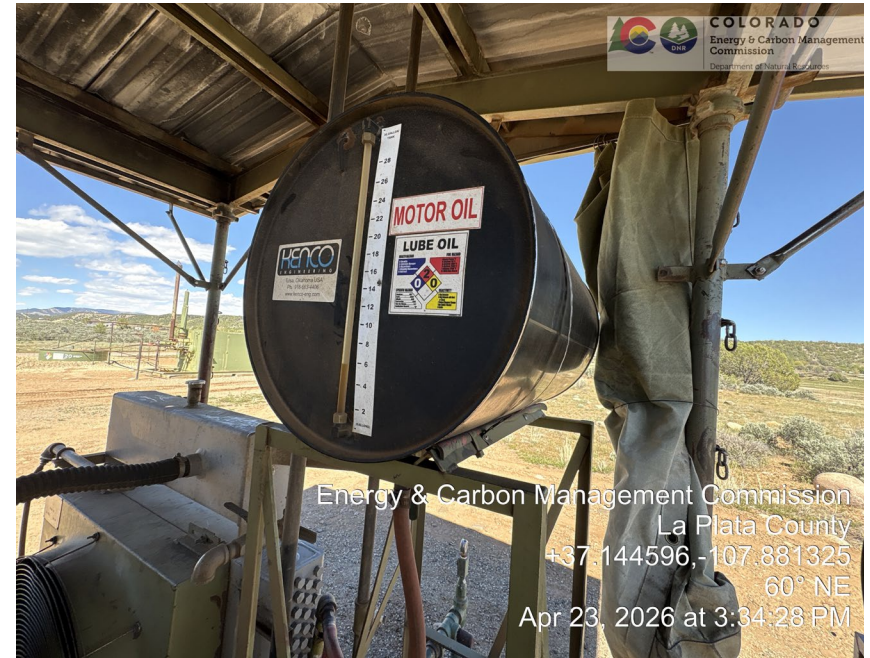
18. Second of two lube oil tanks by compressor.

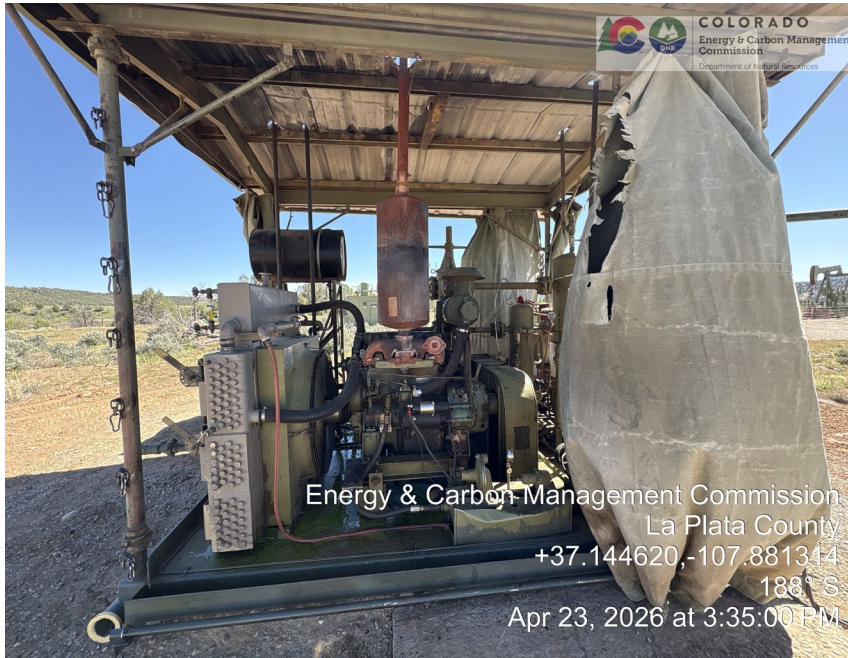
**19. Inside compressor shed. Barrier curtain is shredded in upper right corner of photograph.**

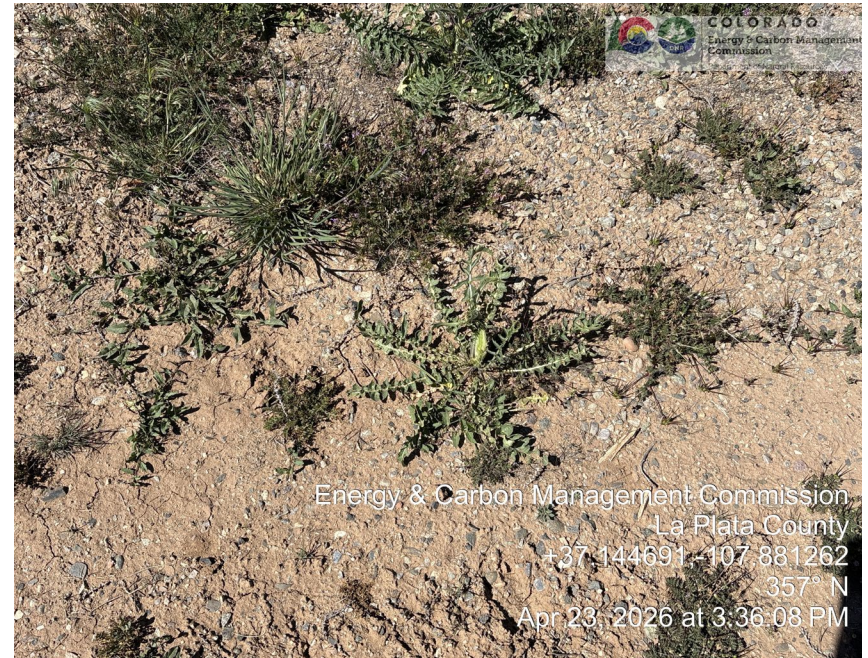
**20. Weeds growing on location in production area teardrop. Appears to be musk thistle, Colorado list B.**

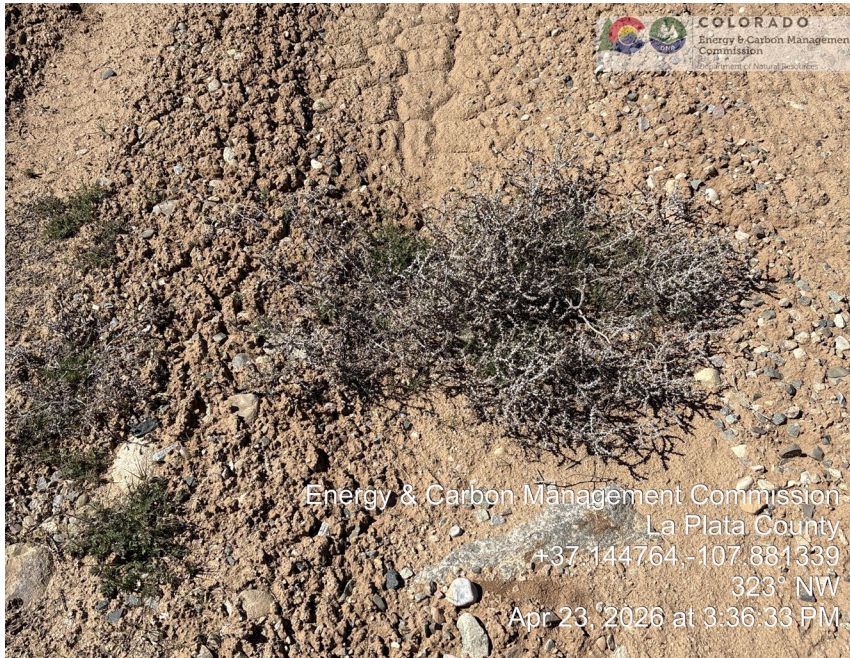
**21. Undesirable vegetation in production area teardrop. Russian thistle (tumbleweed).**

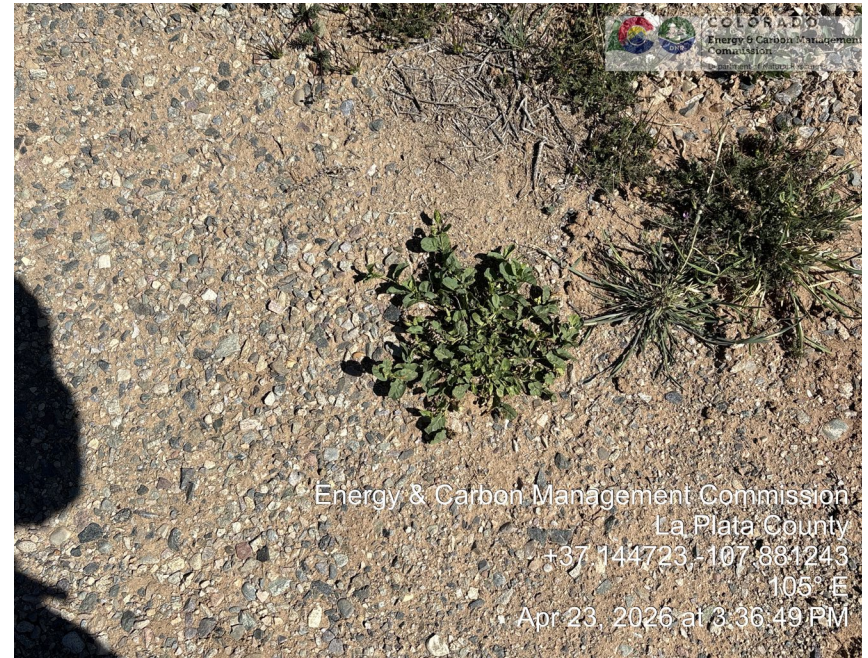
**22. Weeds inside production area teardrop. Field bind weed. Colorado C-list.**

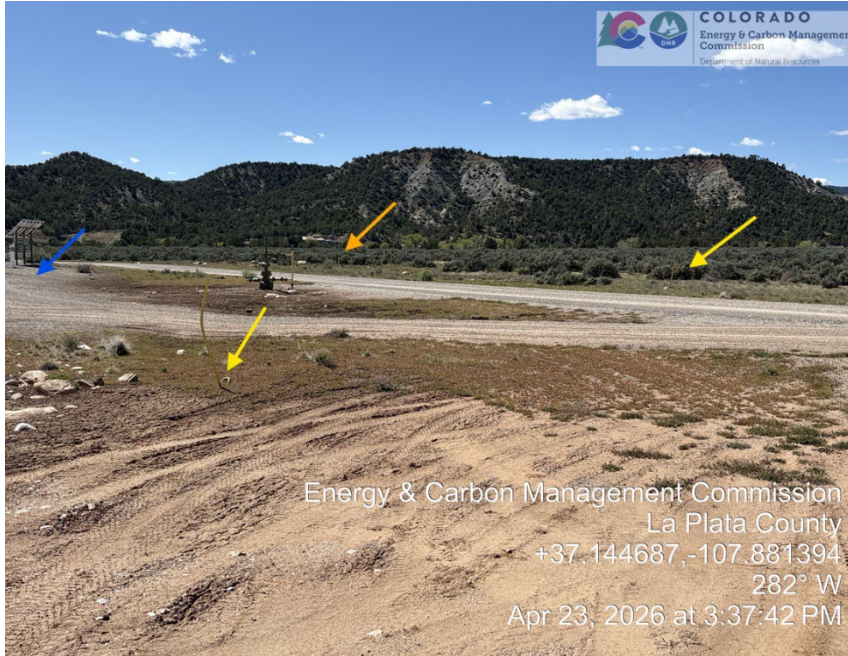
**23. Rig anchor markers. Yellow arrows are marked anchors. Orange arrow is marker but rig anchor not present or buried. Blue arrow is expected location of anchor, but no marker or anchor found.**
