Pete Montoya B Tank Battery (Facility ID 478288), PETE MONTOYA B-62N67W35SWNW (Location ID 317803). Pitting/peeling paint on 300-bbl steel crude oil AST is visible. Faded signage is visible. Weeds are visible on/within the secondary containment berm.

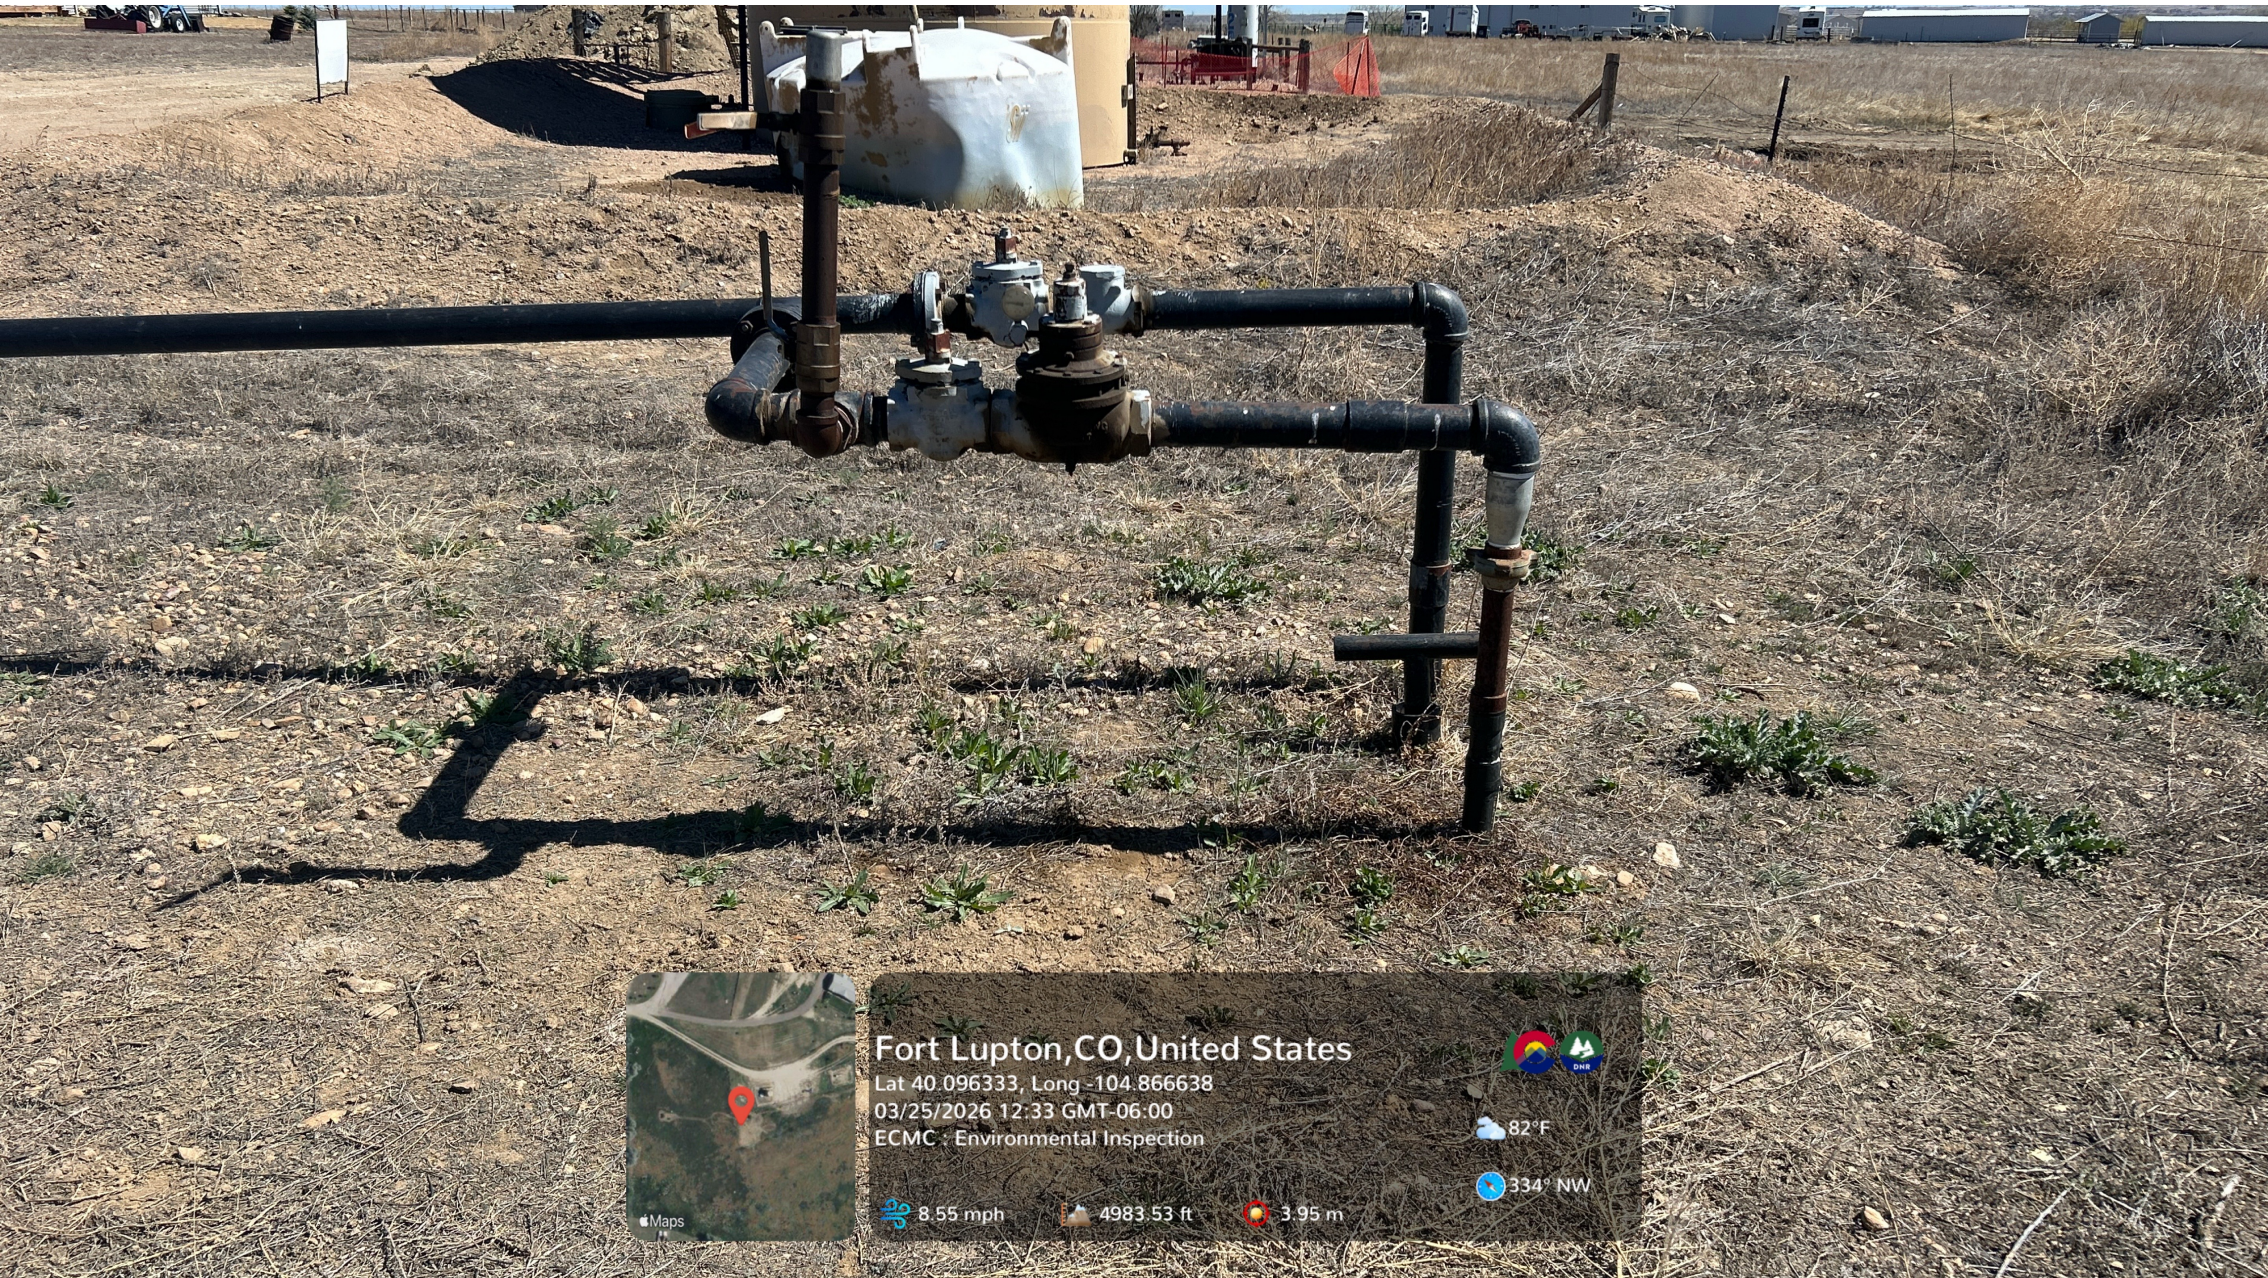
Oily residue on connections/fittings on gas sales line piping and stained soil beneath the connections/fittings is visible.

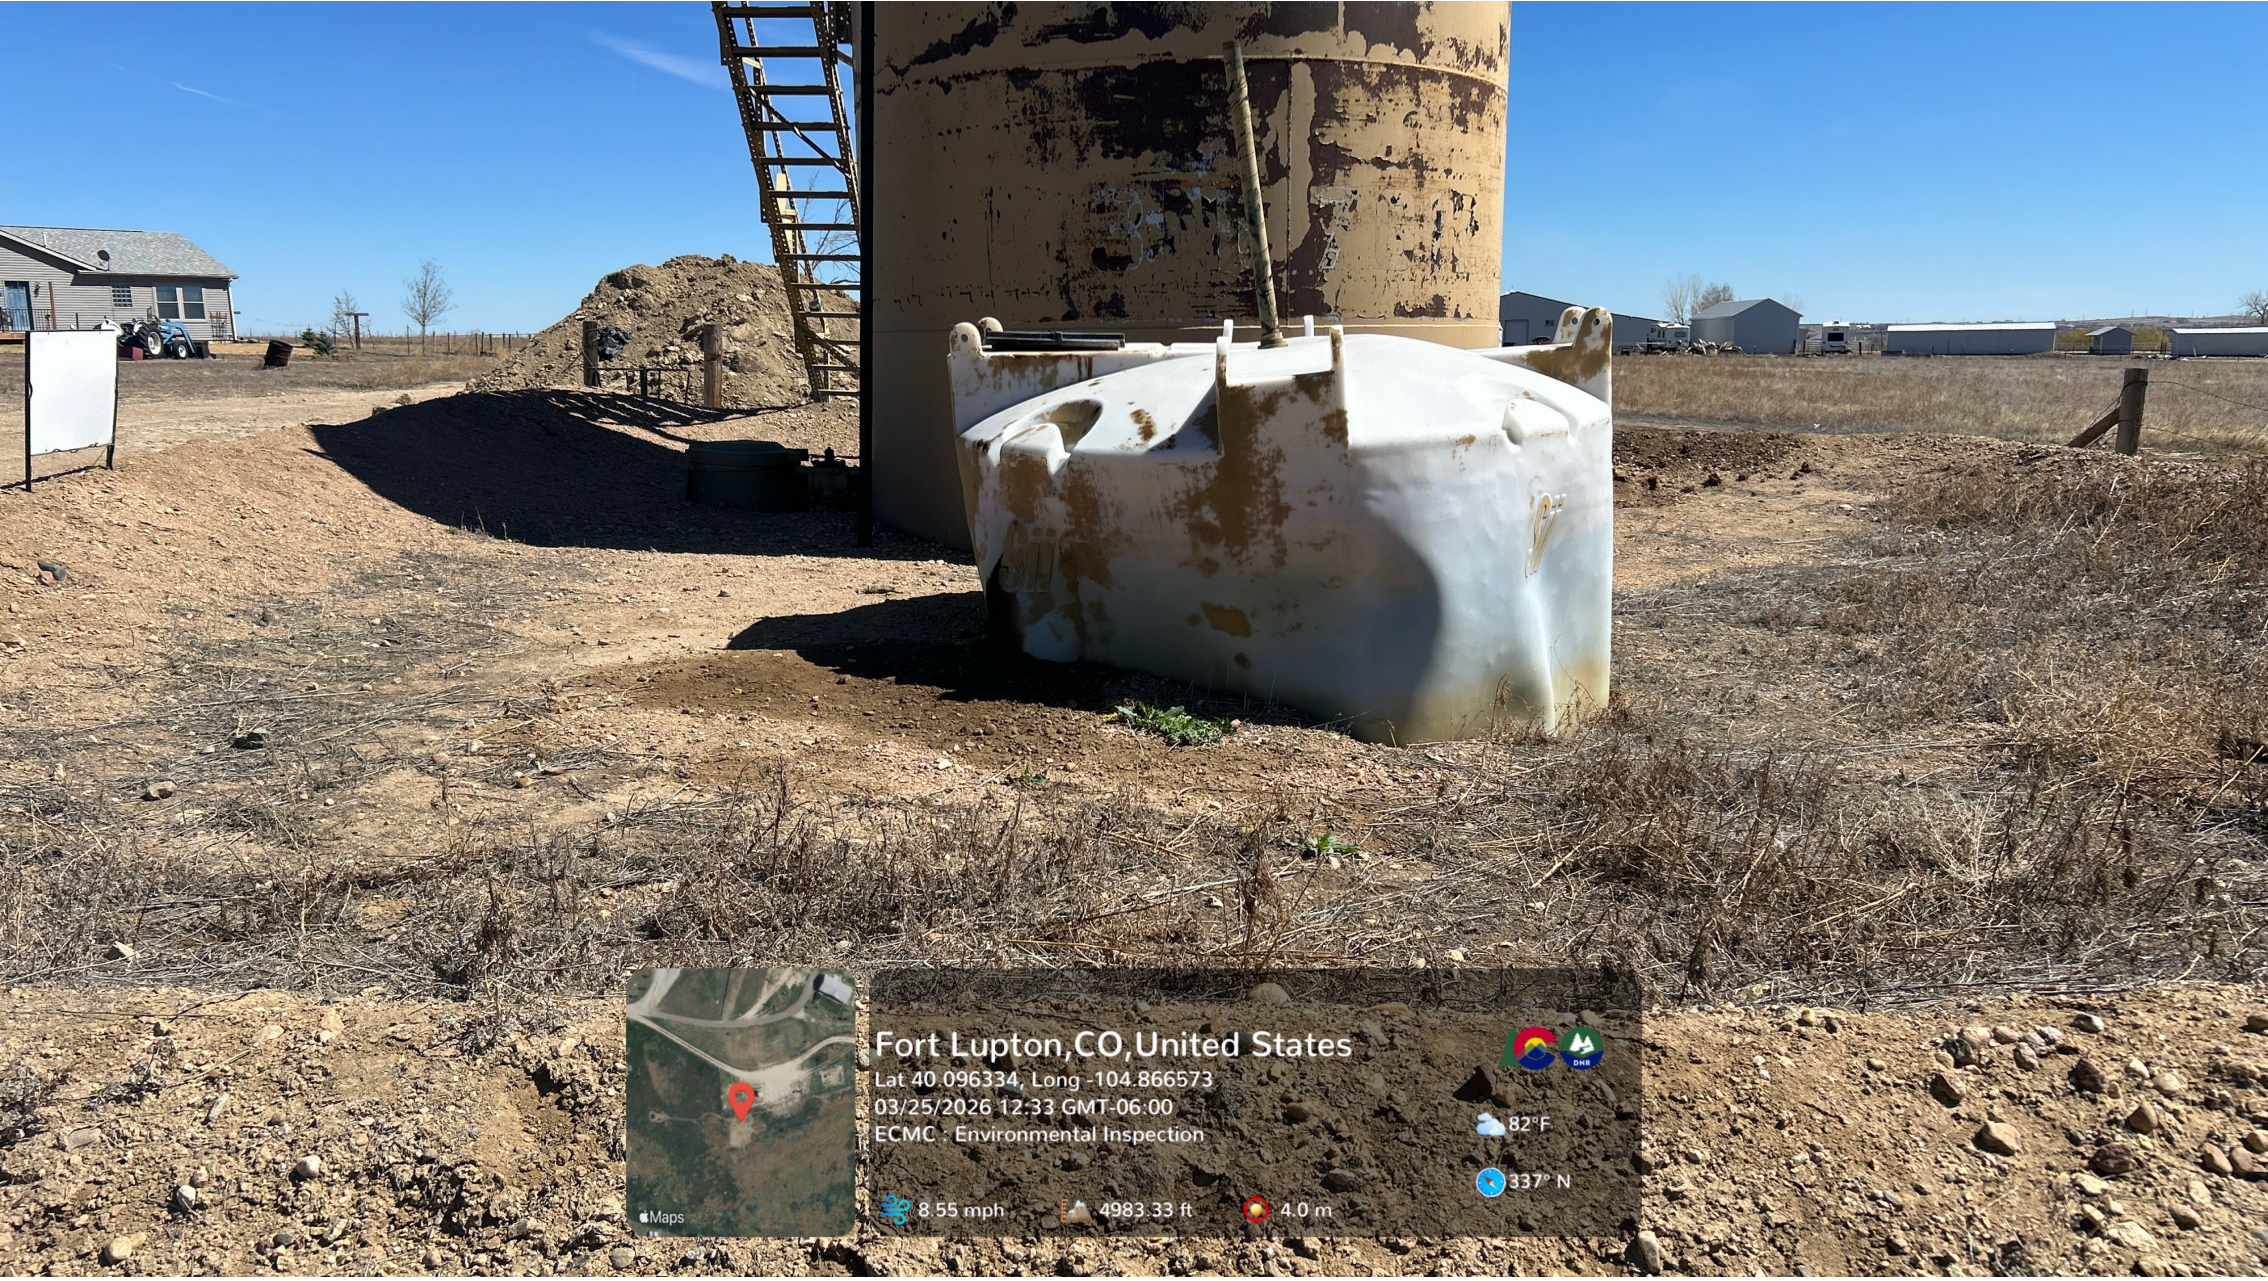
Stained soil is visible beneath a crack in the 50-bbl partially buried polyethylene produced water tank.

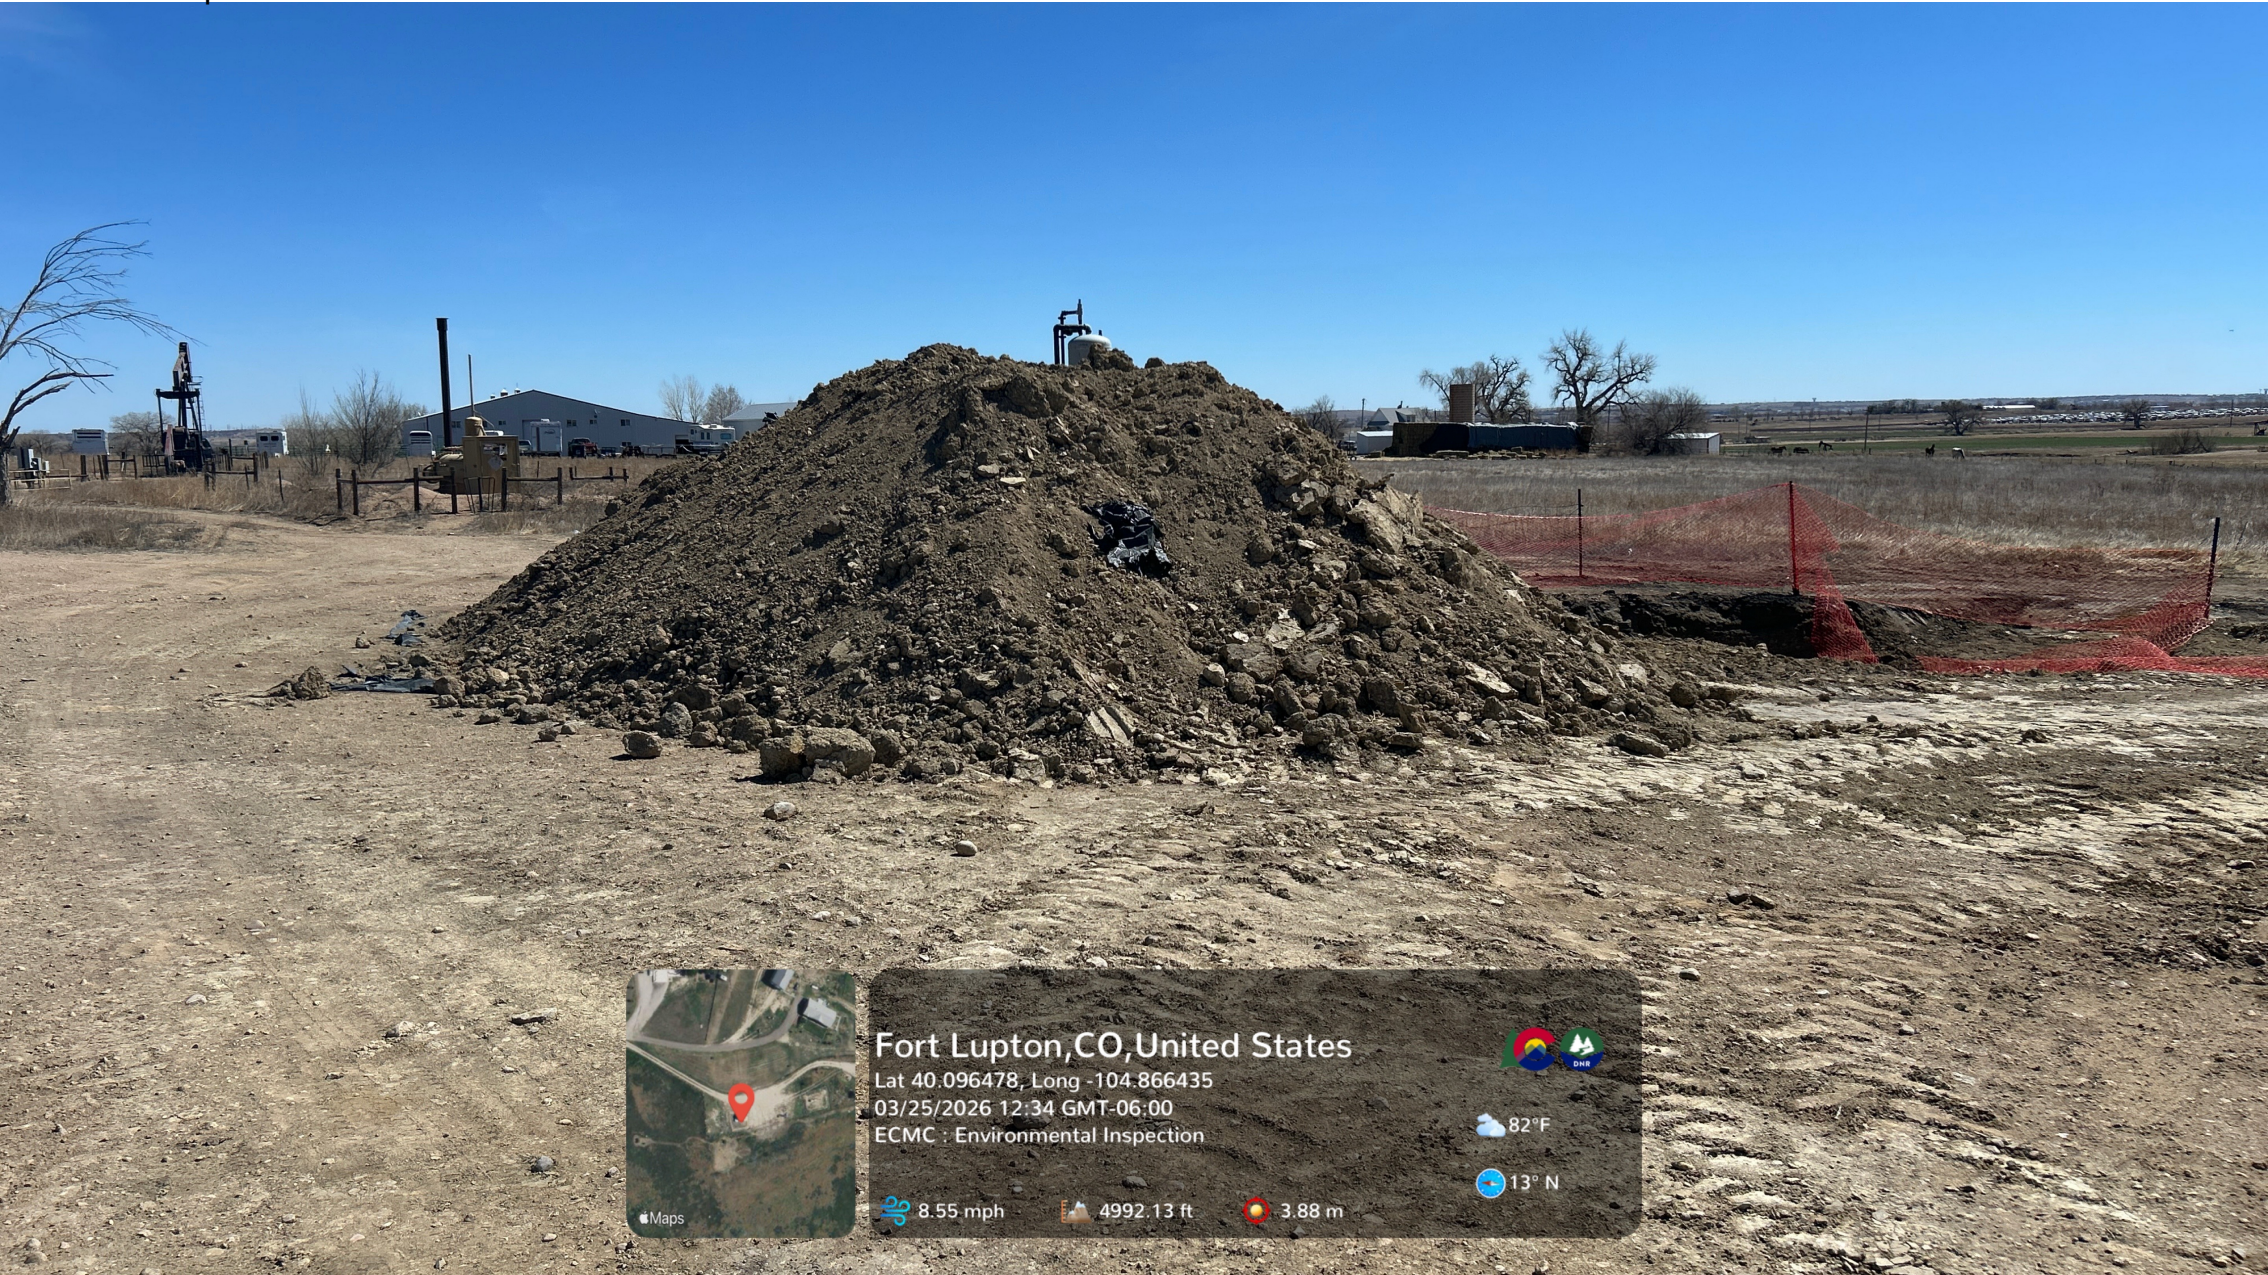
Hydrocarbon stained soil (E&P waste) is being stockpiled on plastic liner adjacent to the open excavation. A petroleum hydrocarbon odor was observed. Hydrocarbon stained soil is being stockpiled on a plastic liner but has spread/spilled outside the stockpile liner. No erosion controls have been installed around stockpiled E&P waste.

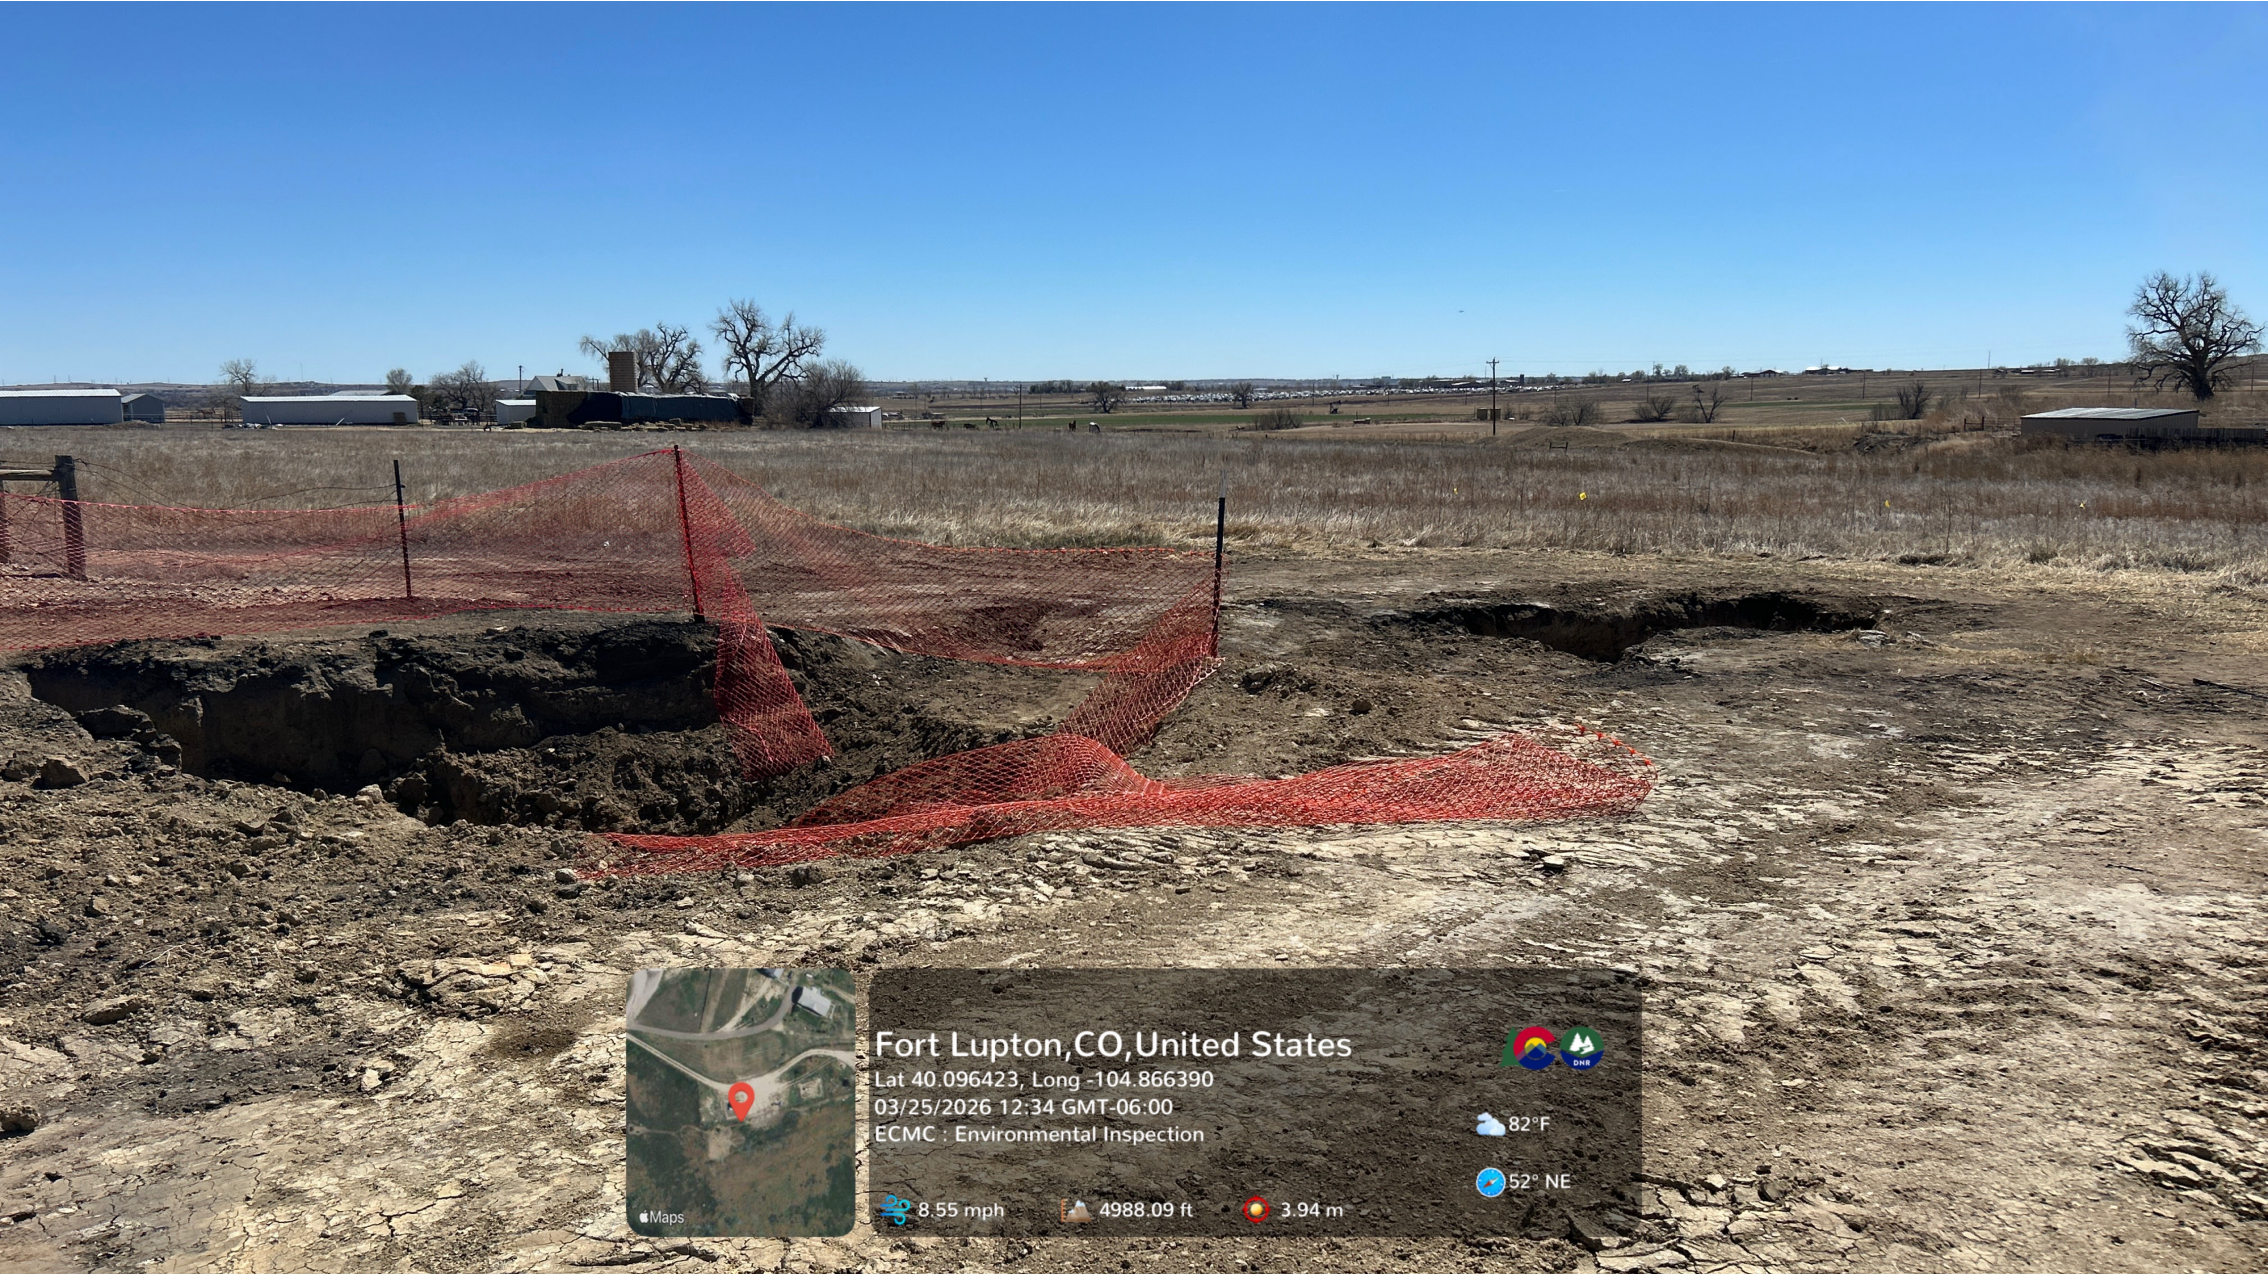
Pete Montoya B Sales Line (Spill ID: 493337) - Hydrocarbon stained soil remains in situ within and south of the open excavation. A petroleum hydrocarbon odor was observed. Fencing around the open excavation has fallen. Portions of 3-strand barbwire fencing along the southern portion of the location have been removed.

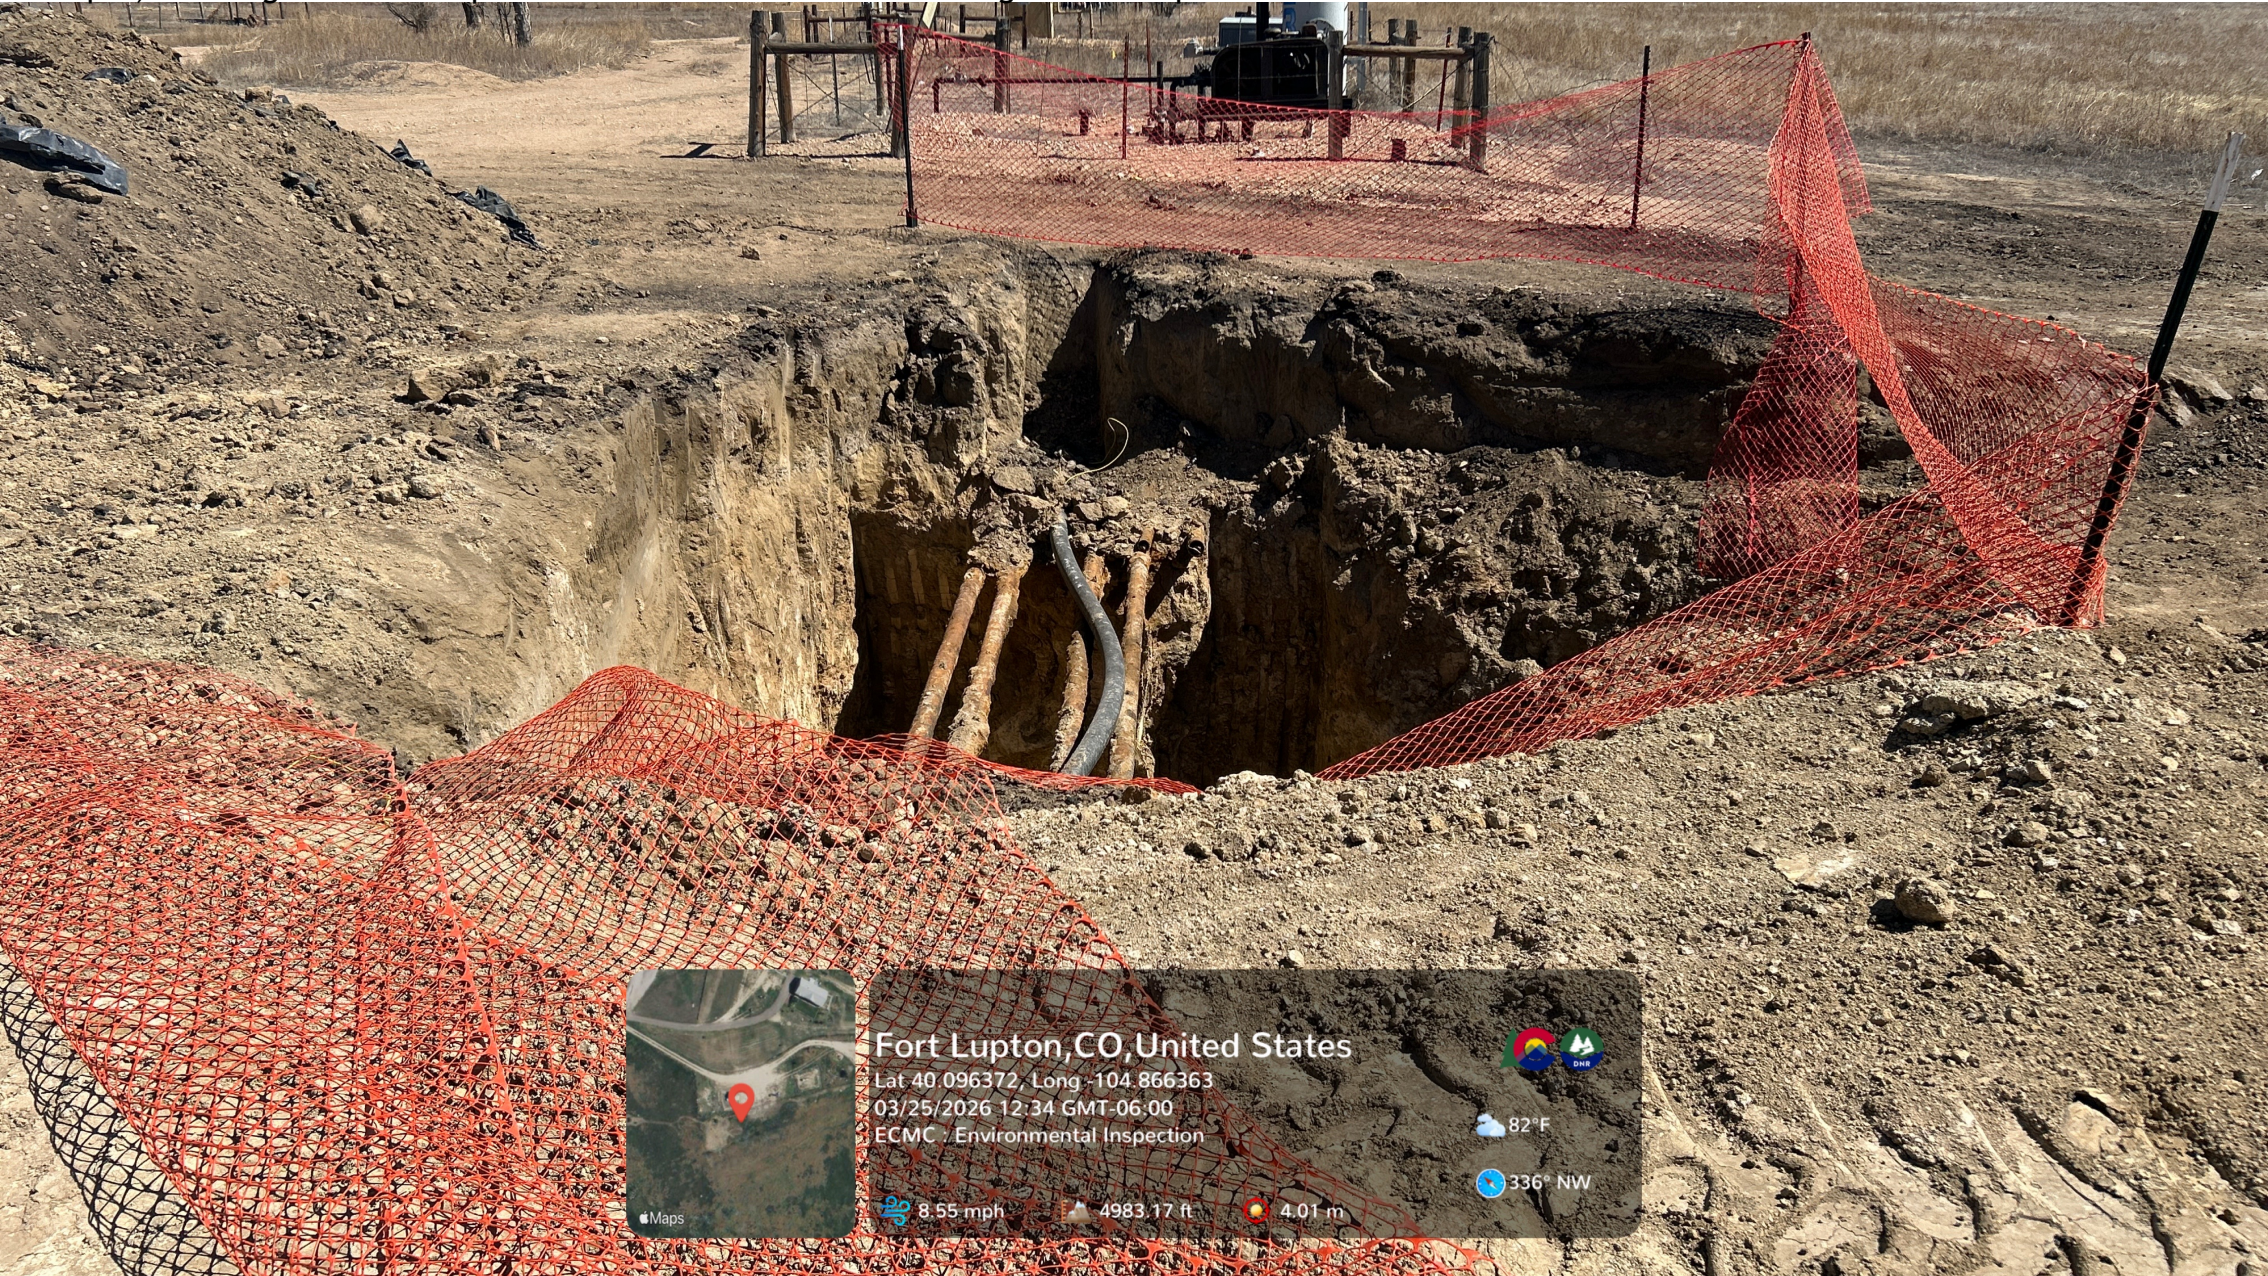
Pete Montoya B Sales Line (Spill ID: 493337) - A petroleum hydrocarbon odor was observed. Hydrocarbon stained soil remains in situ within the open excavation. Operator appears to have made repairs to a section of flowline. Excavation sidewalls are near vertical and unstable (showing signs of collapse). Fencing around the open excavation has fallen and fencing is not adequate for site conditions.

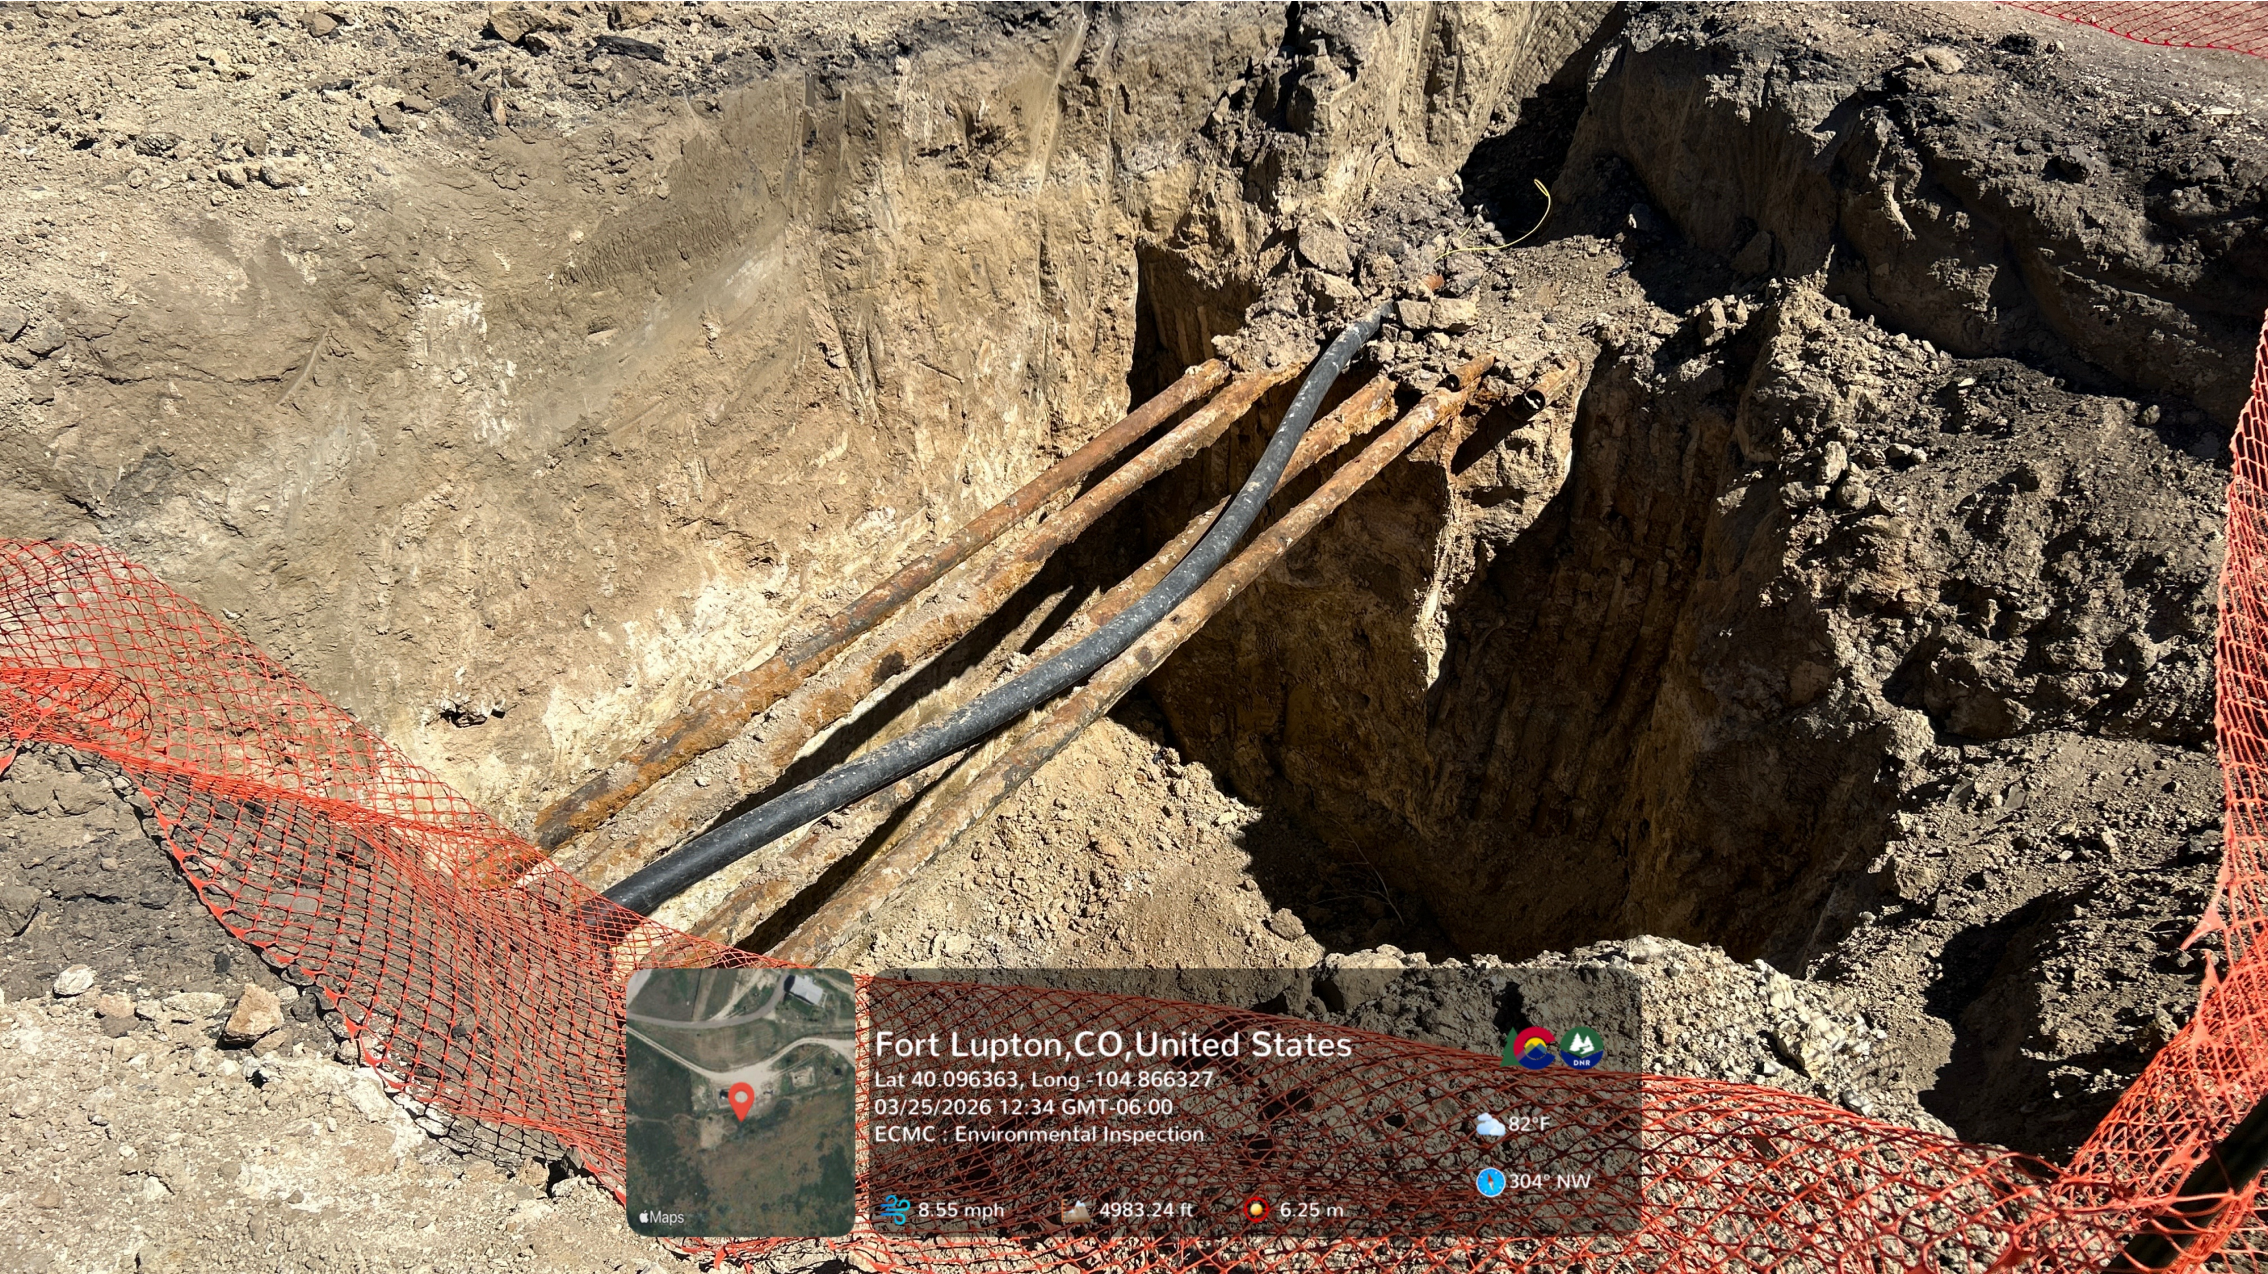
Pete Montoya B Sales Line (Spill ID: 493337) - A petroleum hydrocarbon odor was observed. Hydrocarbon stained soil remains in situ within the open excavation. Operator appears to have made repairs to a section of flowline. Excavation sidewalls are near vertical and unstable (showing signs of collapse). Fencing around the open excavation has fallen and fencing is not adequate for site conditions.

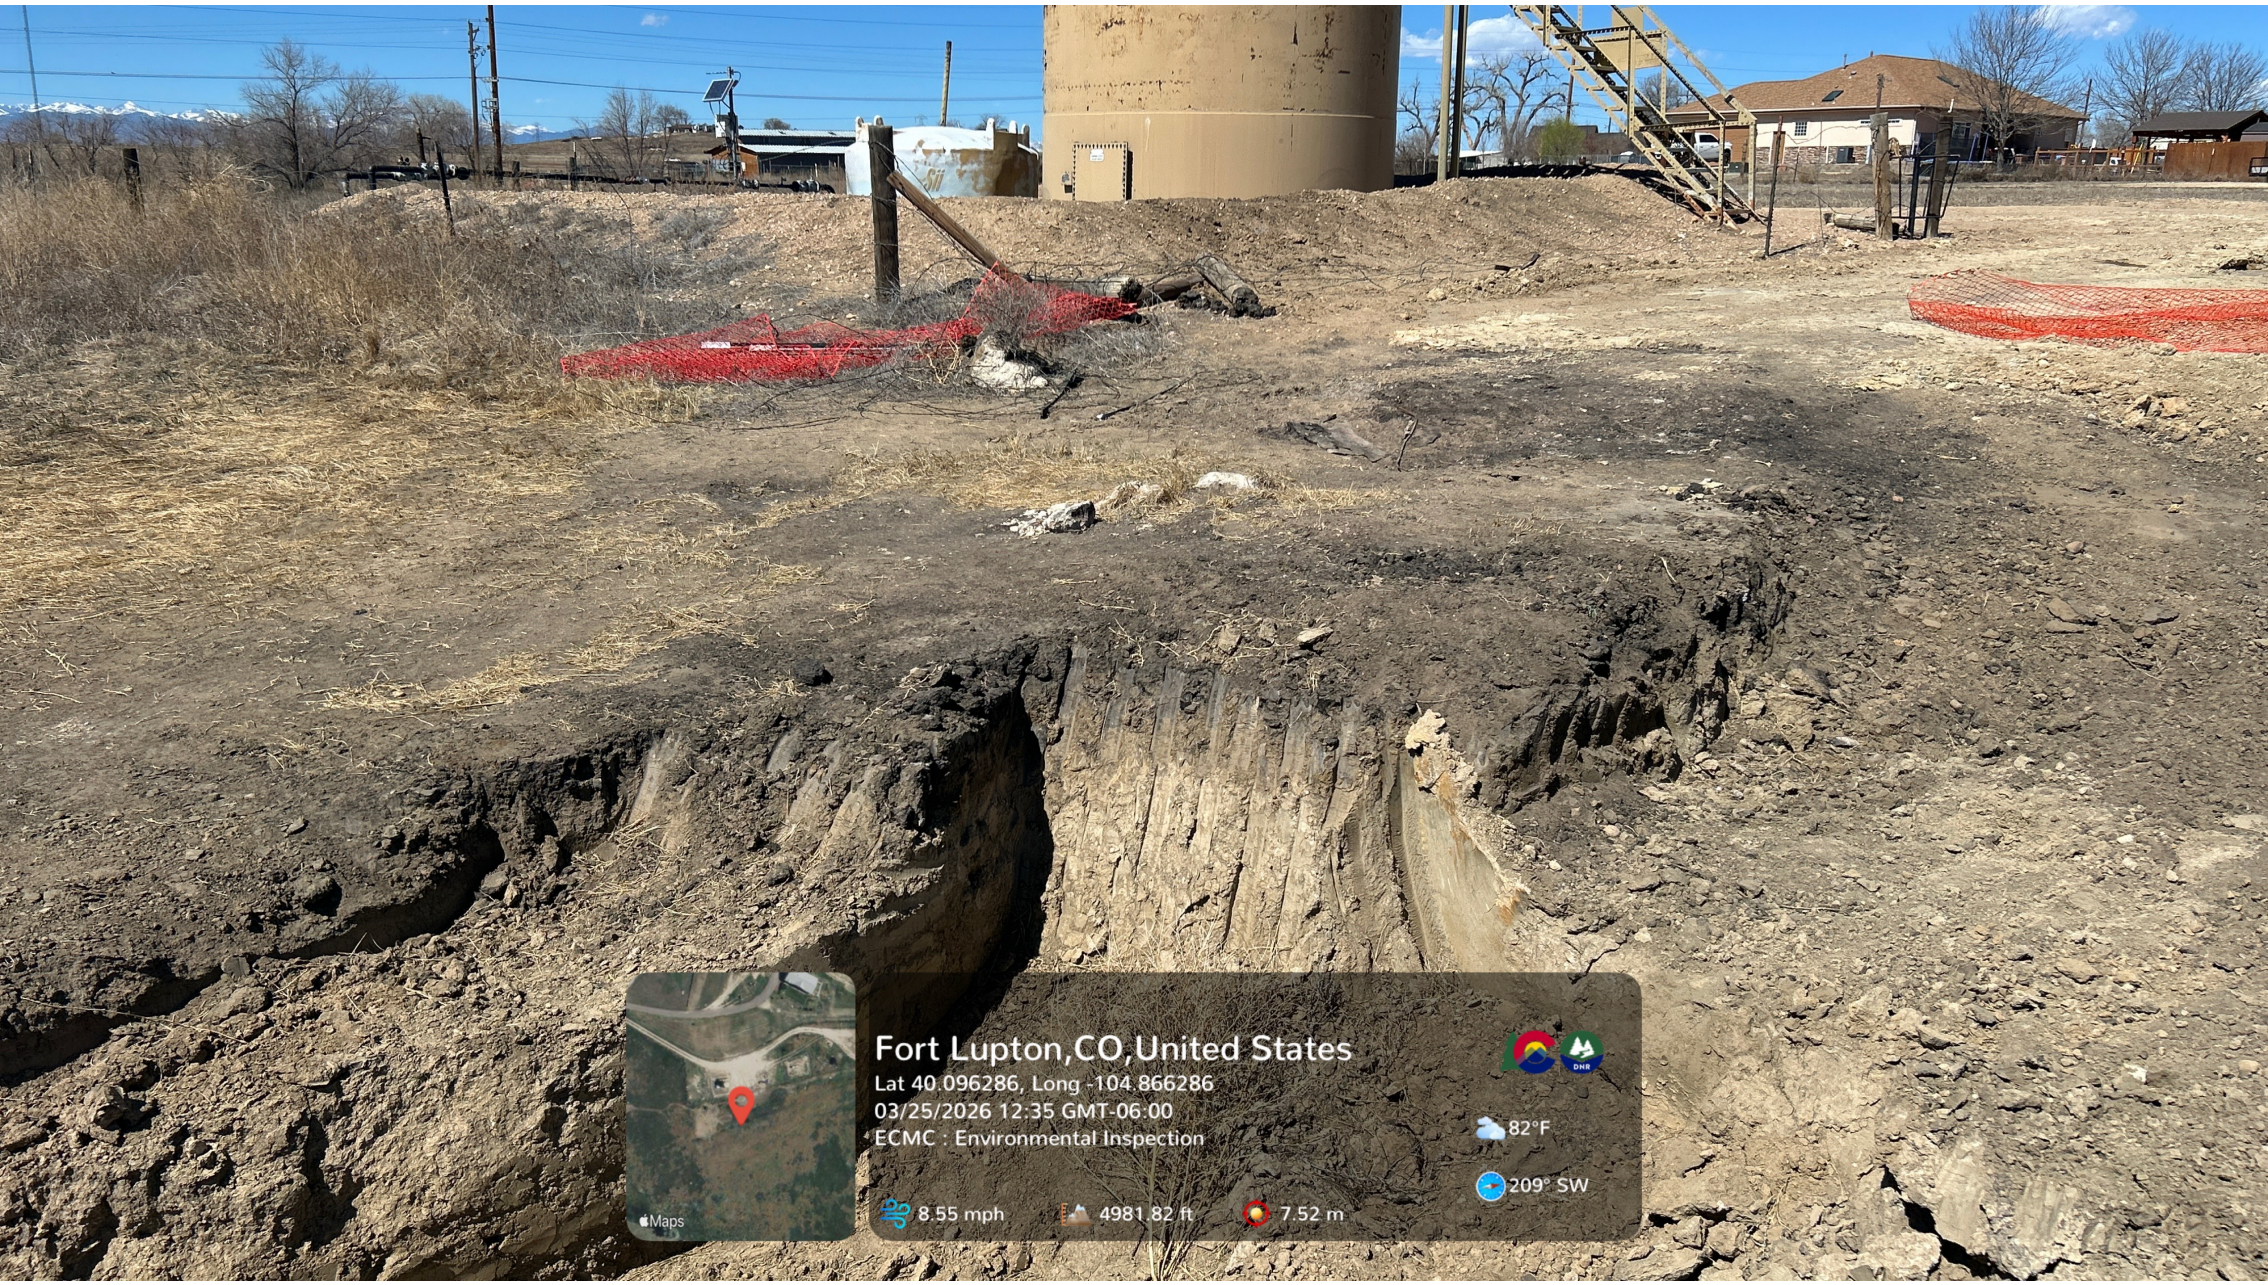
Trash/debris.
