Pete Montoya B Tank Battery (Facility ID 478288), PETE MONTOYA B-62N67W35SWNW (Location ID 317803). Pitting/peeling paint on 300-bbl steel crude oil AST is visible. Faded signage is visible. Weeds are visible on/within the secondary containment berm.

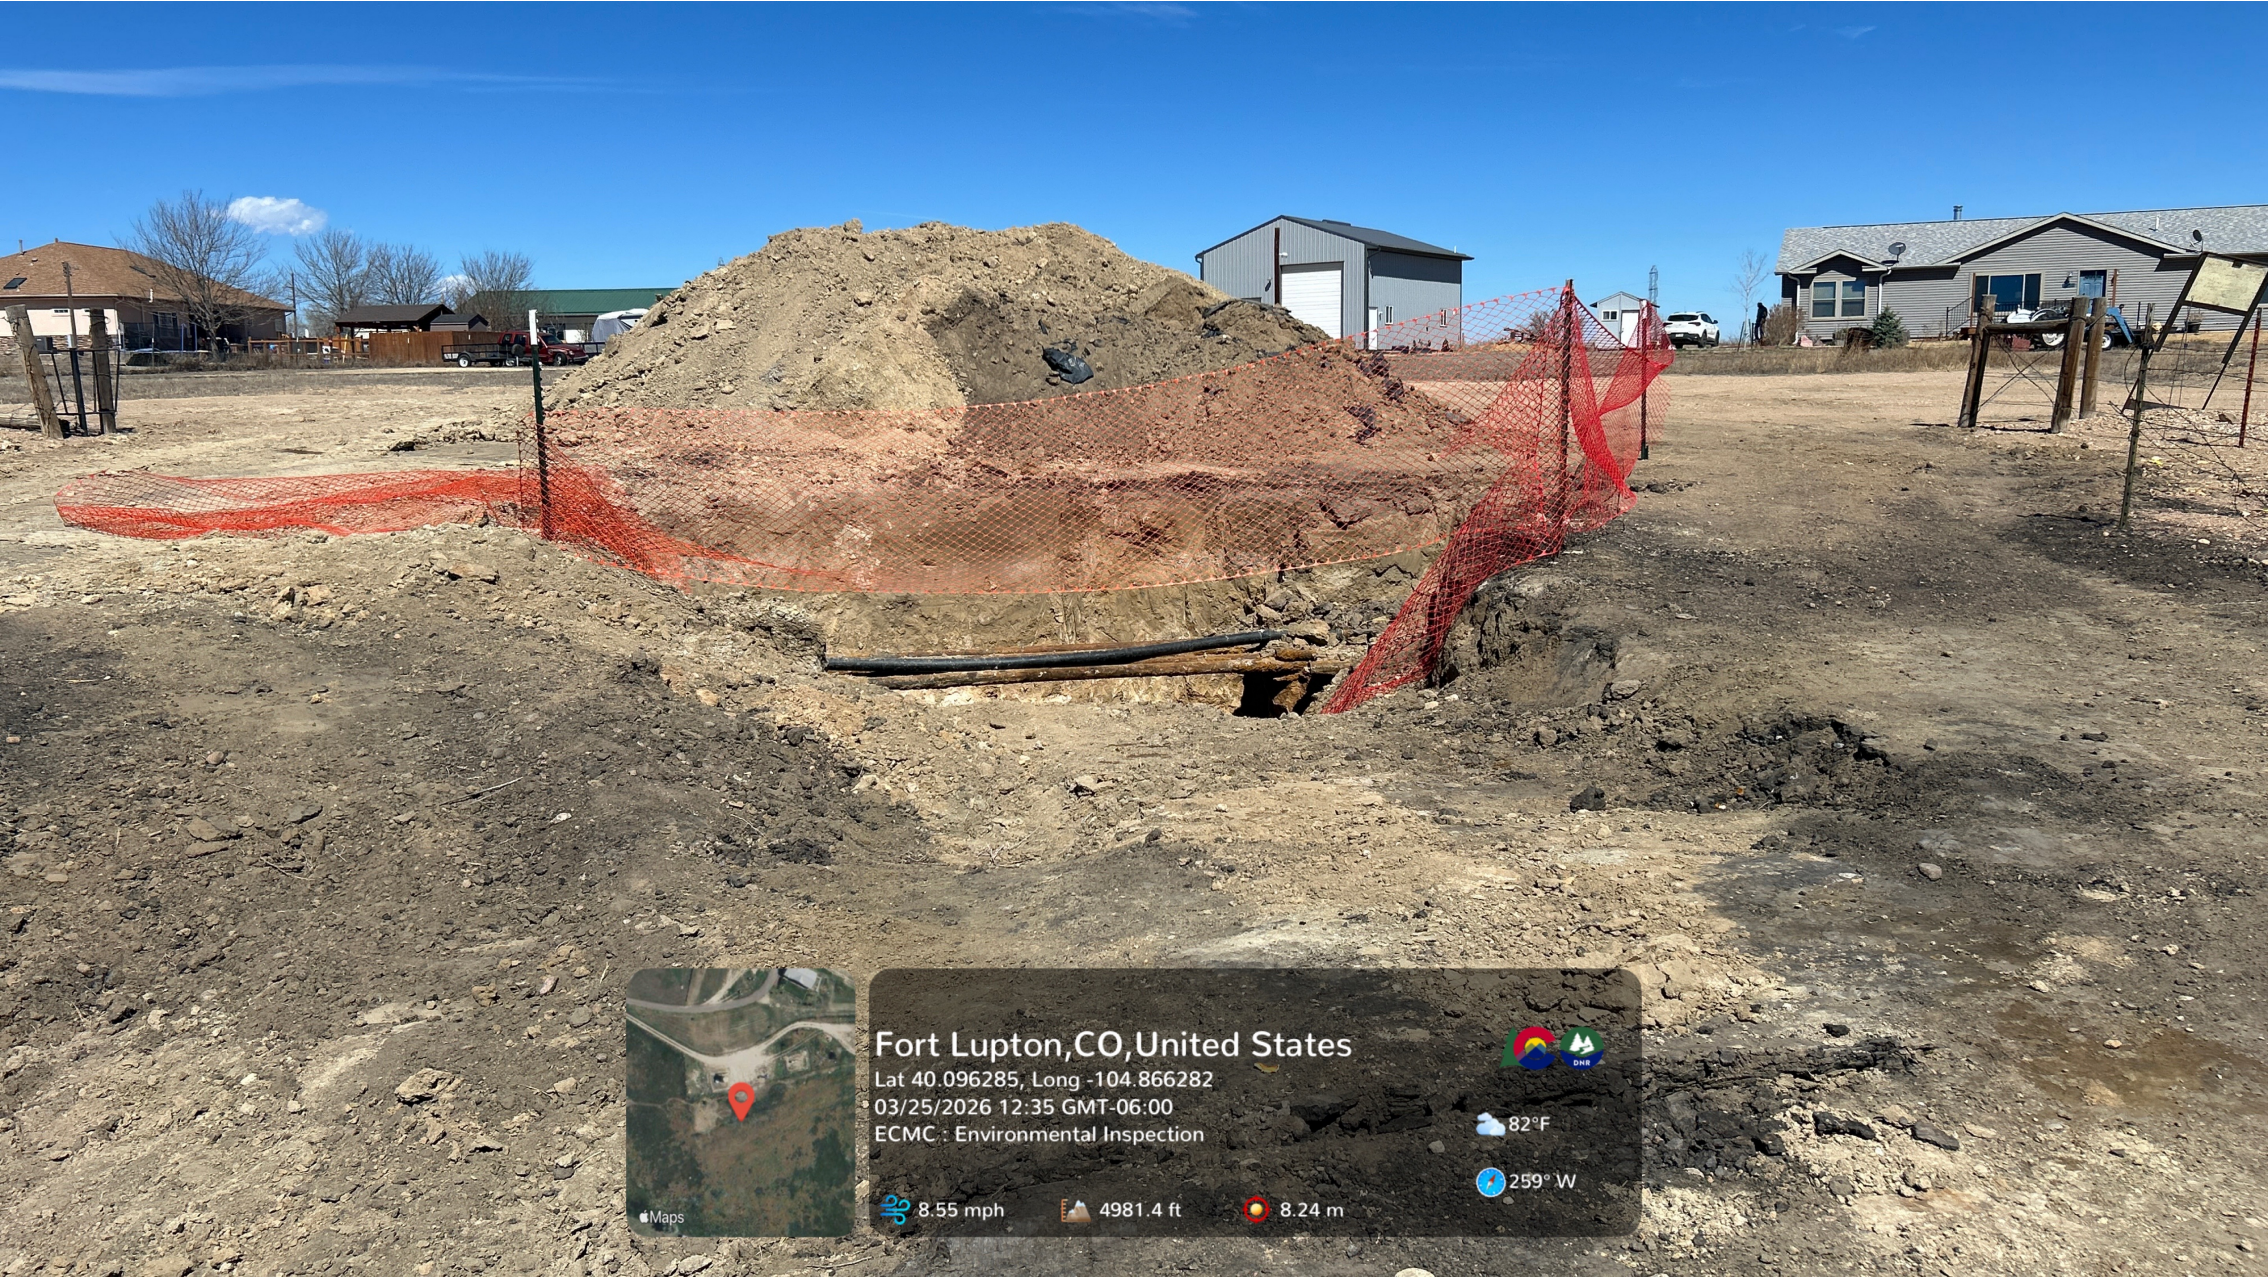
Hydrocarbon stained soil at the surface to the west and south of the excavation.

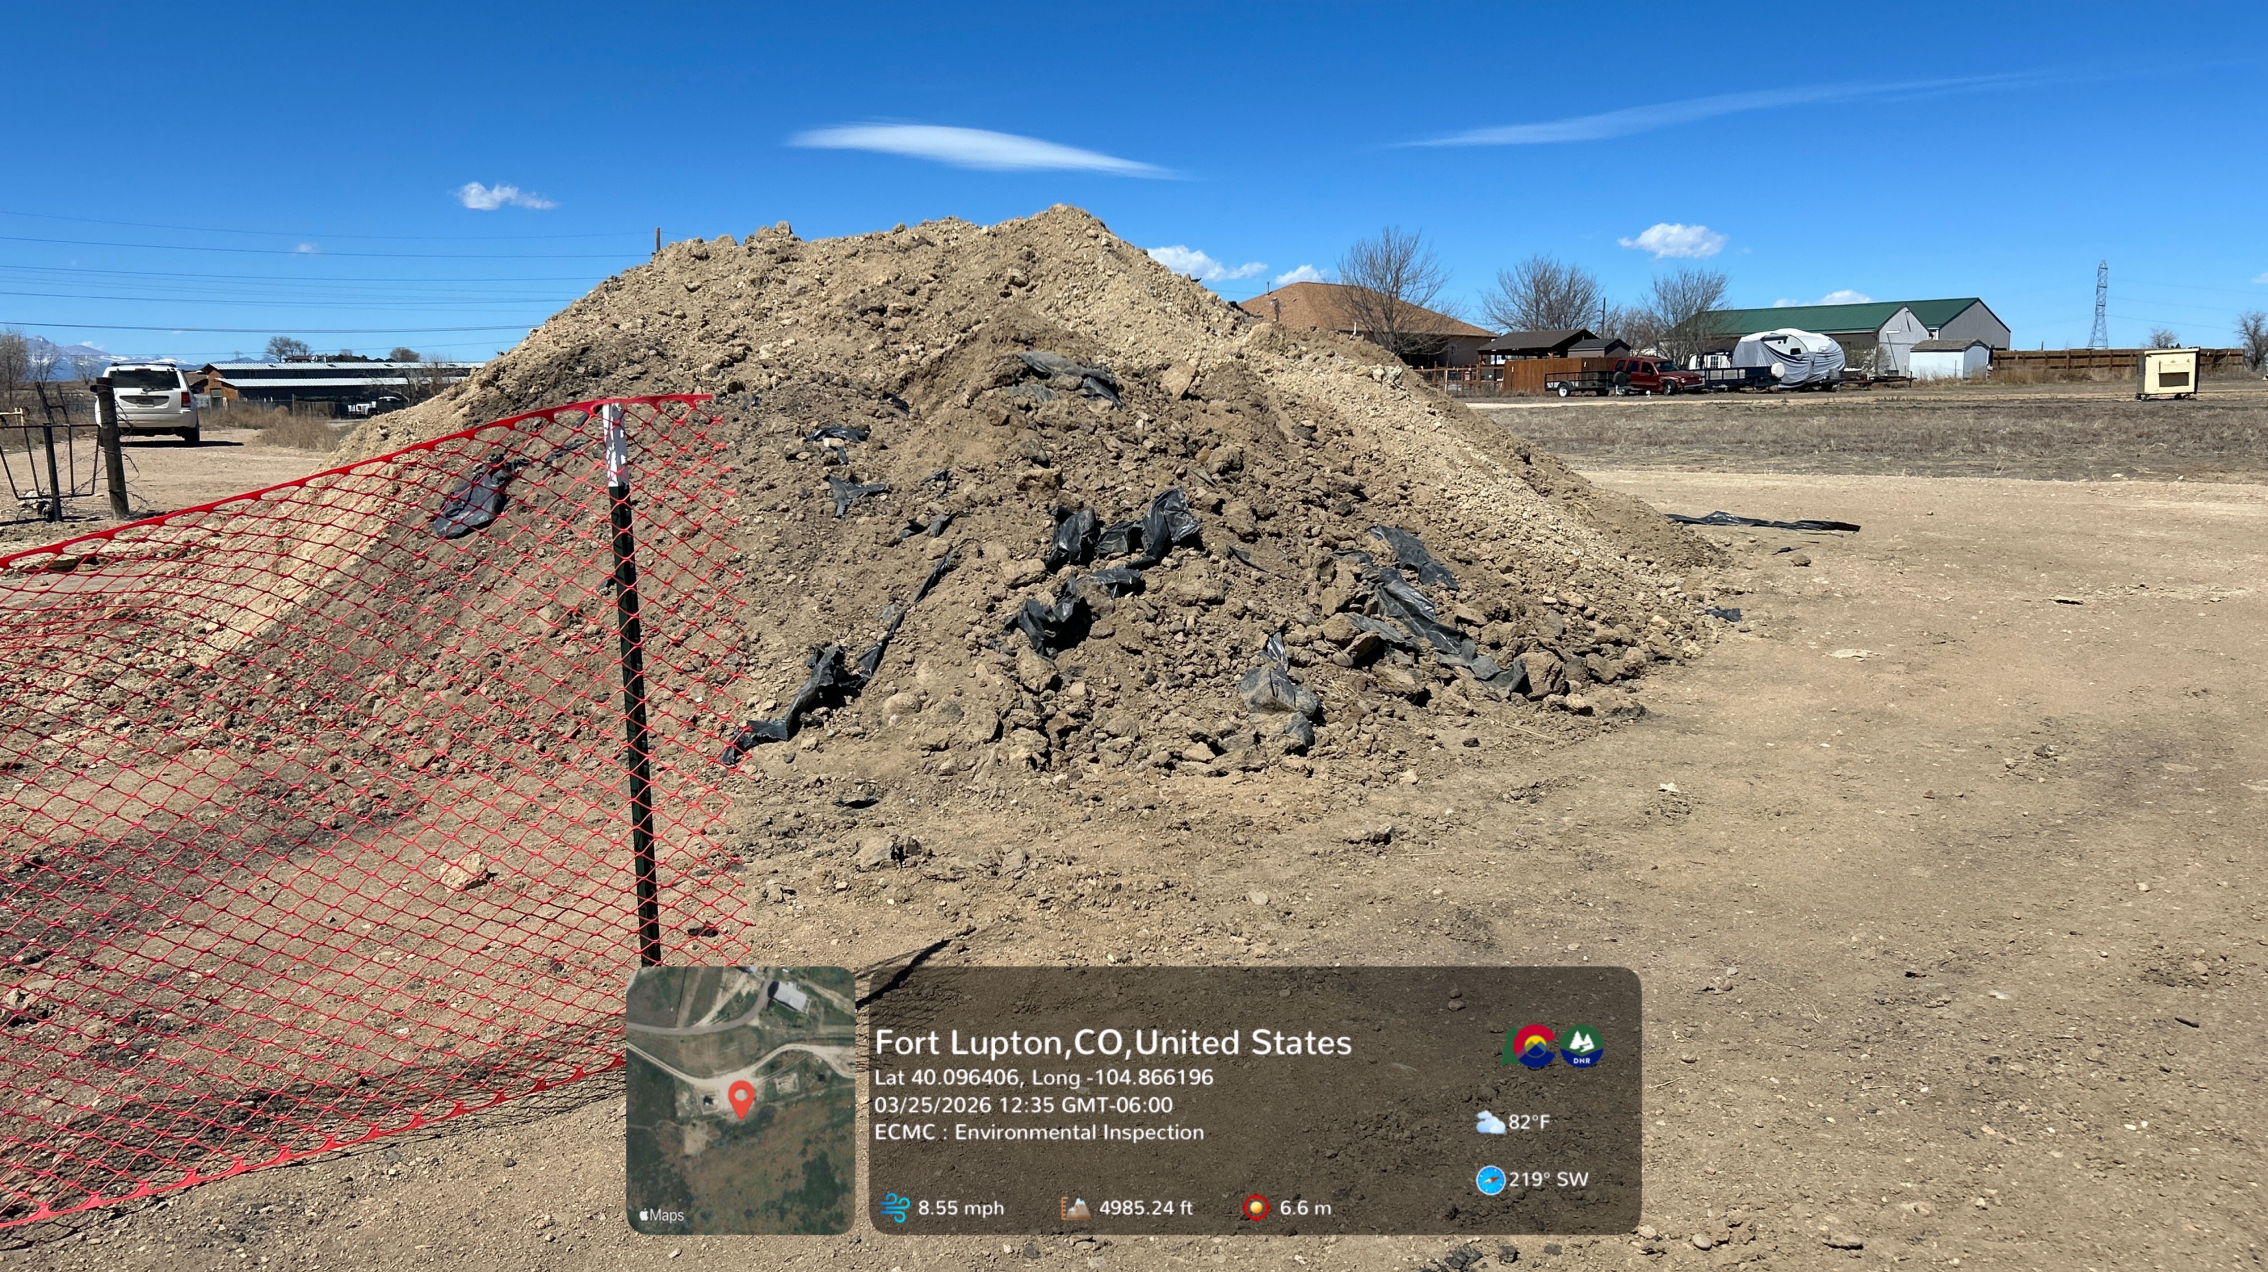
Hydrocarbon stained soil (E&P waste) is being stockpiled on plastic liner adjacent to the open excavation. A petroleum hydrocarbon odor was observed. Hydrocarbon stained soil is being stockpiled on a plastic liner but has spread/spilled outside the stockpile liner. No erosion controls have been installed around stockpiled E&P waste.
