### Fort Lupton, CO, United States

Lat 40.094441, Long -104.780451  
03/25/2026 12:56 GMT-06:00  
ECMC : Environmental Inspection

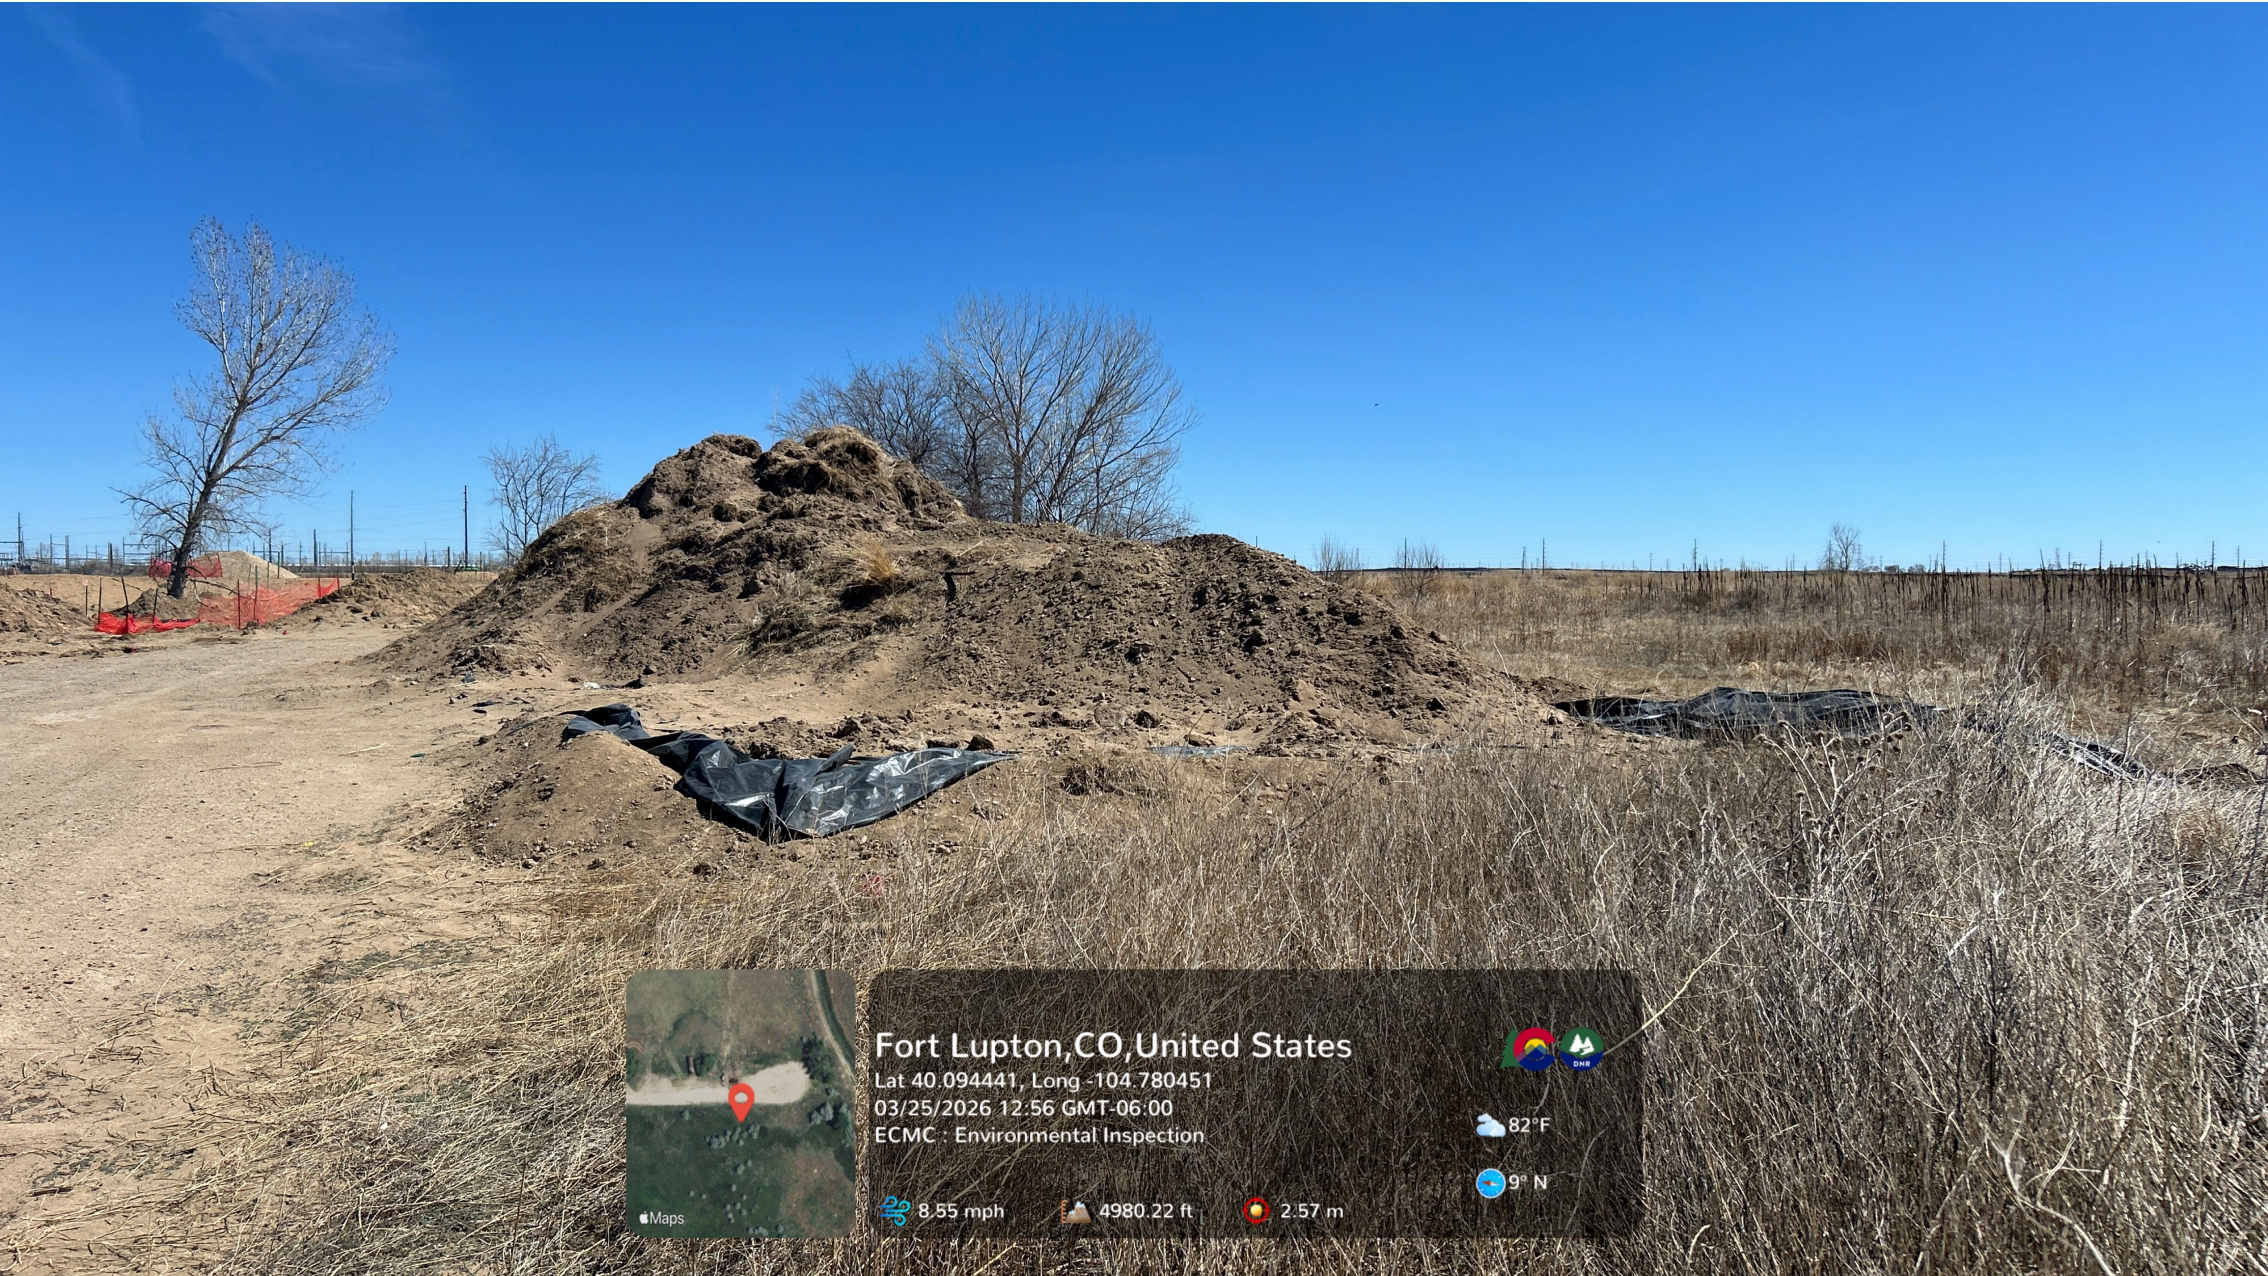
Looking at Facility 2 Consolidation 1/4/26 spill (Spill ID 492701) and a large unmarked soil stockpile. A liner is present beneath the stockpile, but is discontinuous and appears to have been driven over.

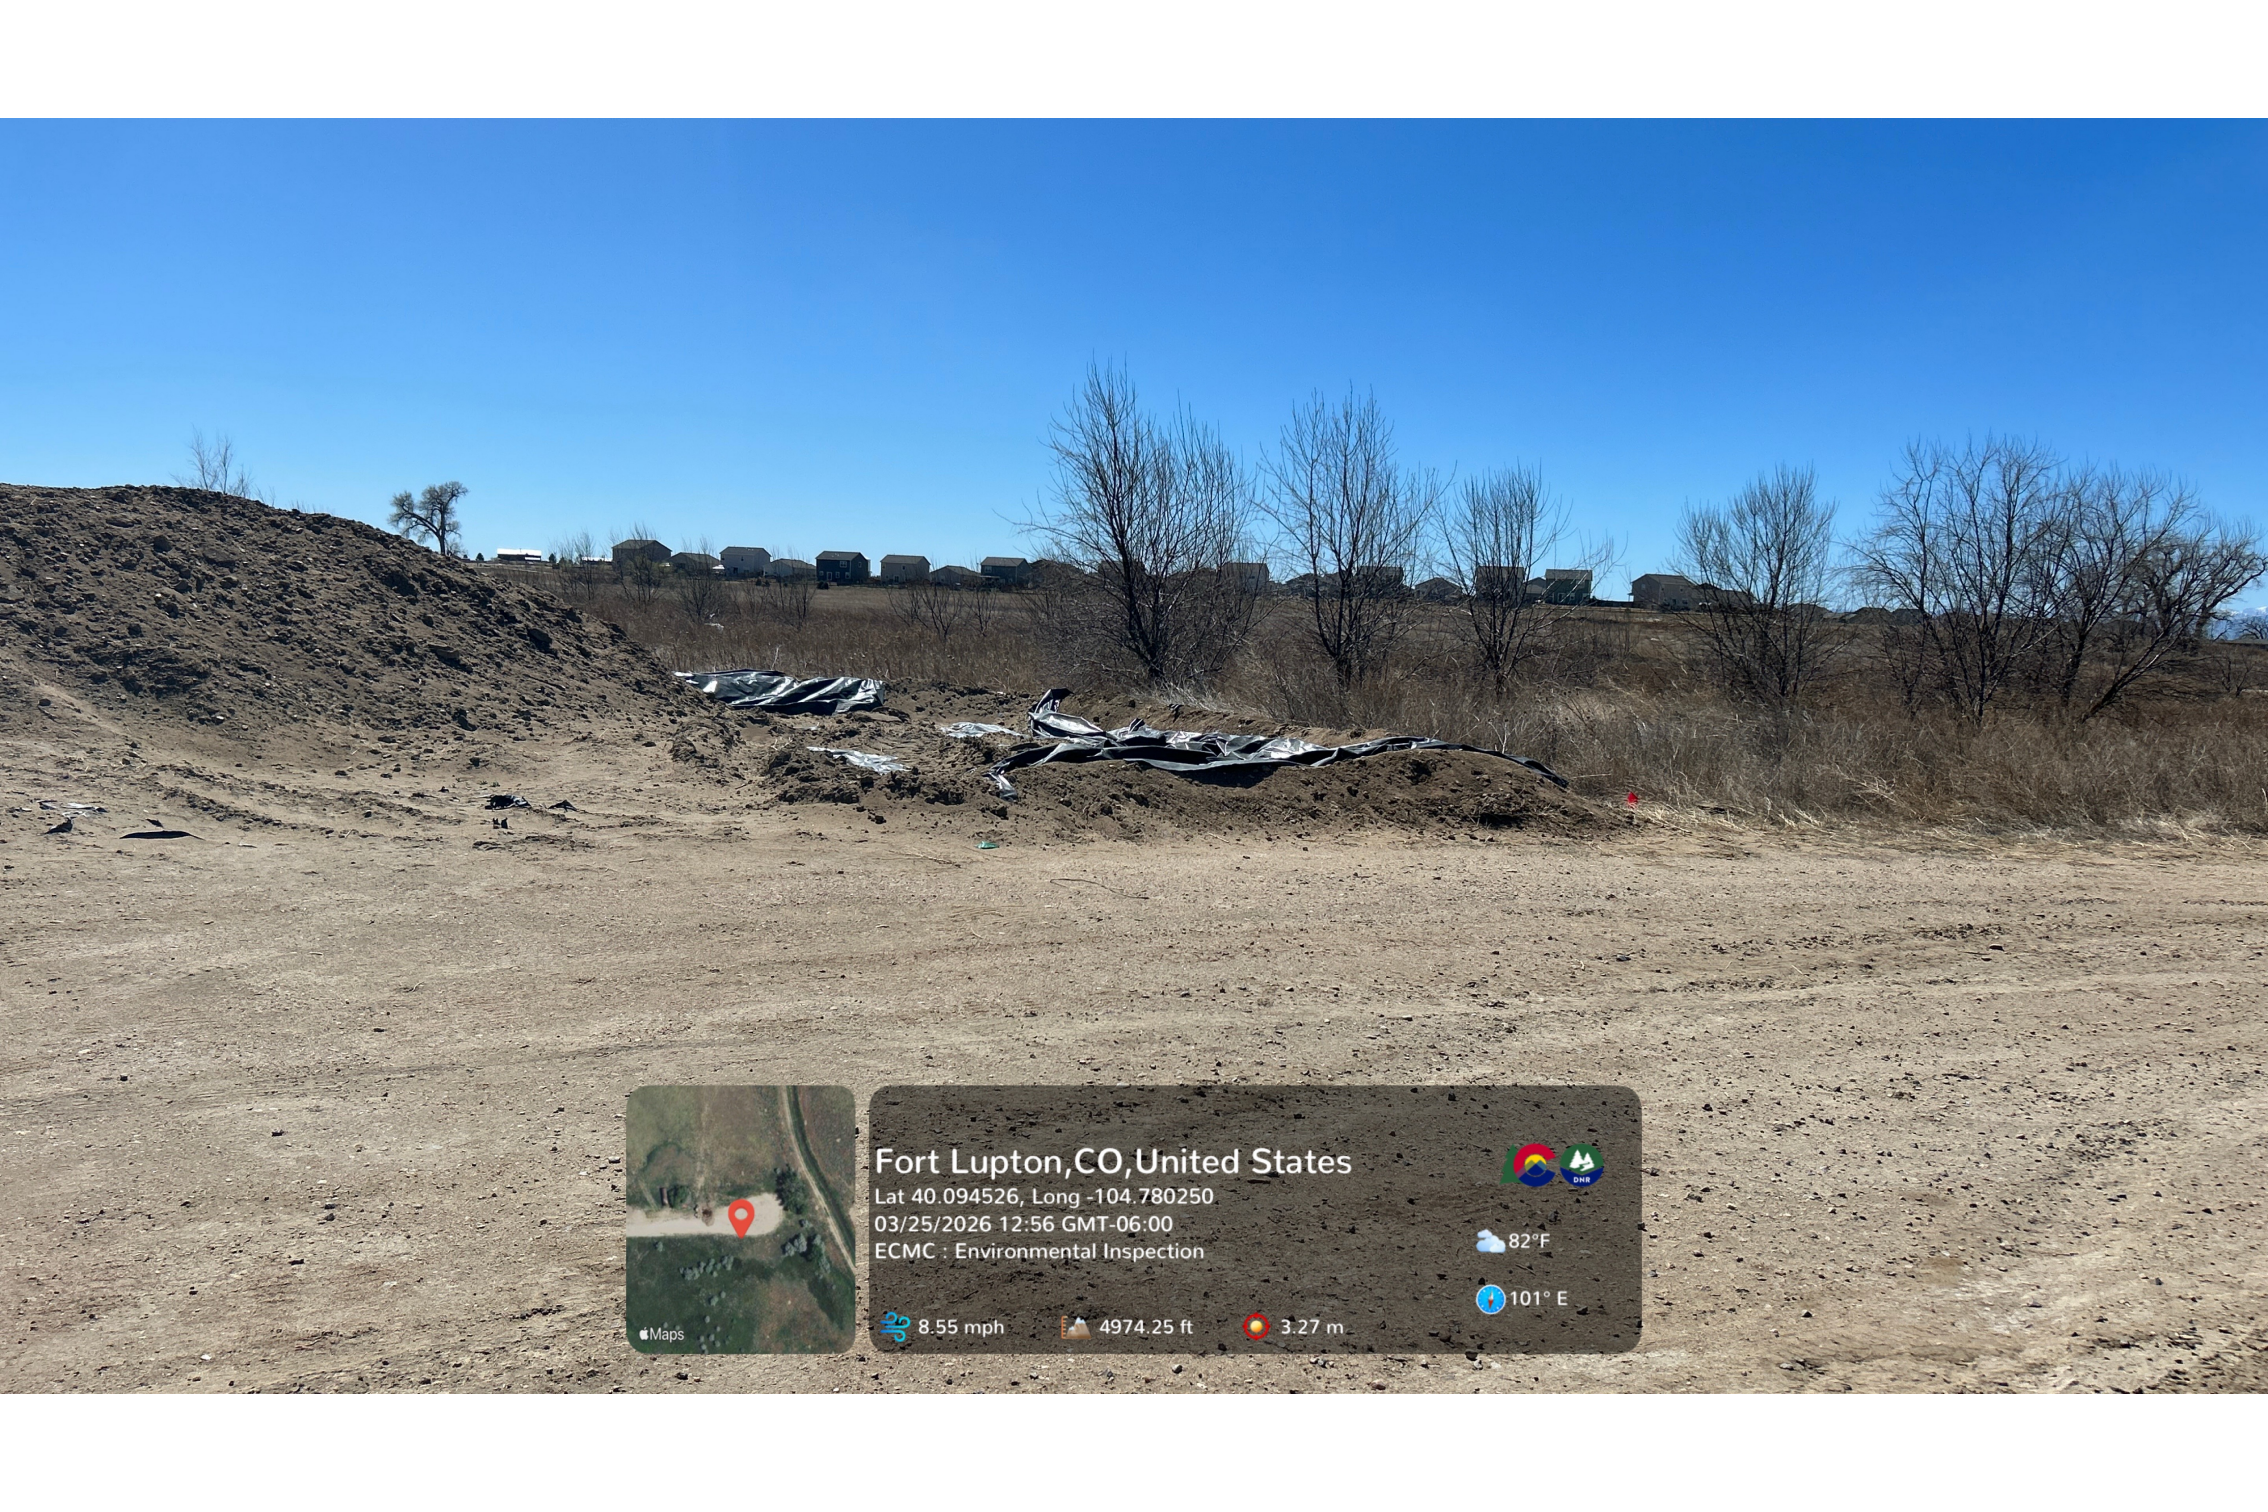
Looking at Facility 2 Consolidation 1/4/26 spill (Spill ID 492701). An excavation remains open at the spill location. Orange construction fencing has been installed but has fallen. Unmarked soil stockpiles with no liners or stormwater BMPs are visible adjacent to the excavation. Stained soil is visible on the ground surface adjacent to the excavation. Unrelated construction equipment is visible in the background.

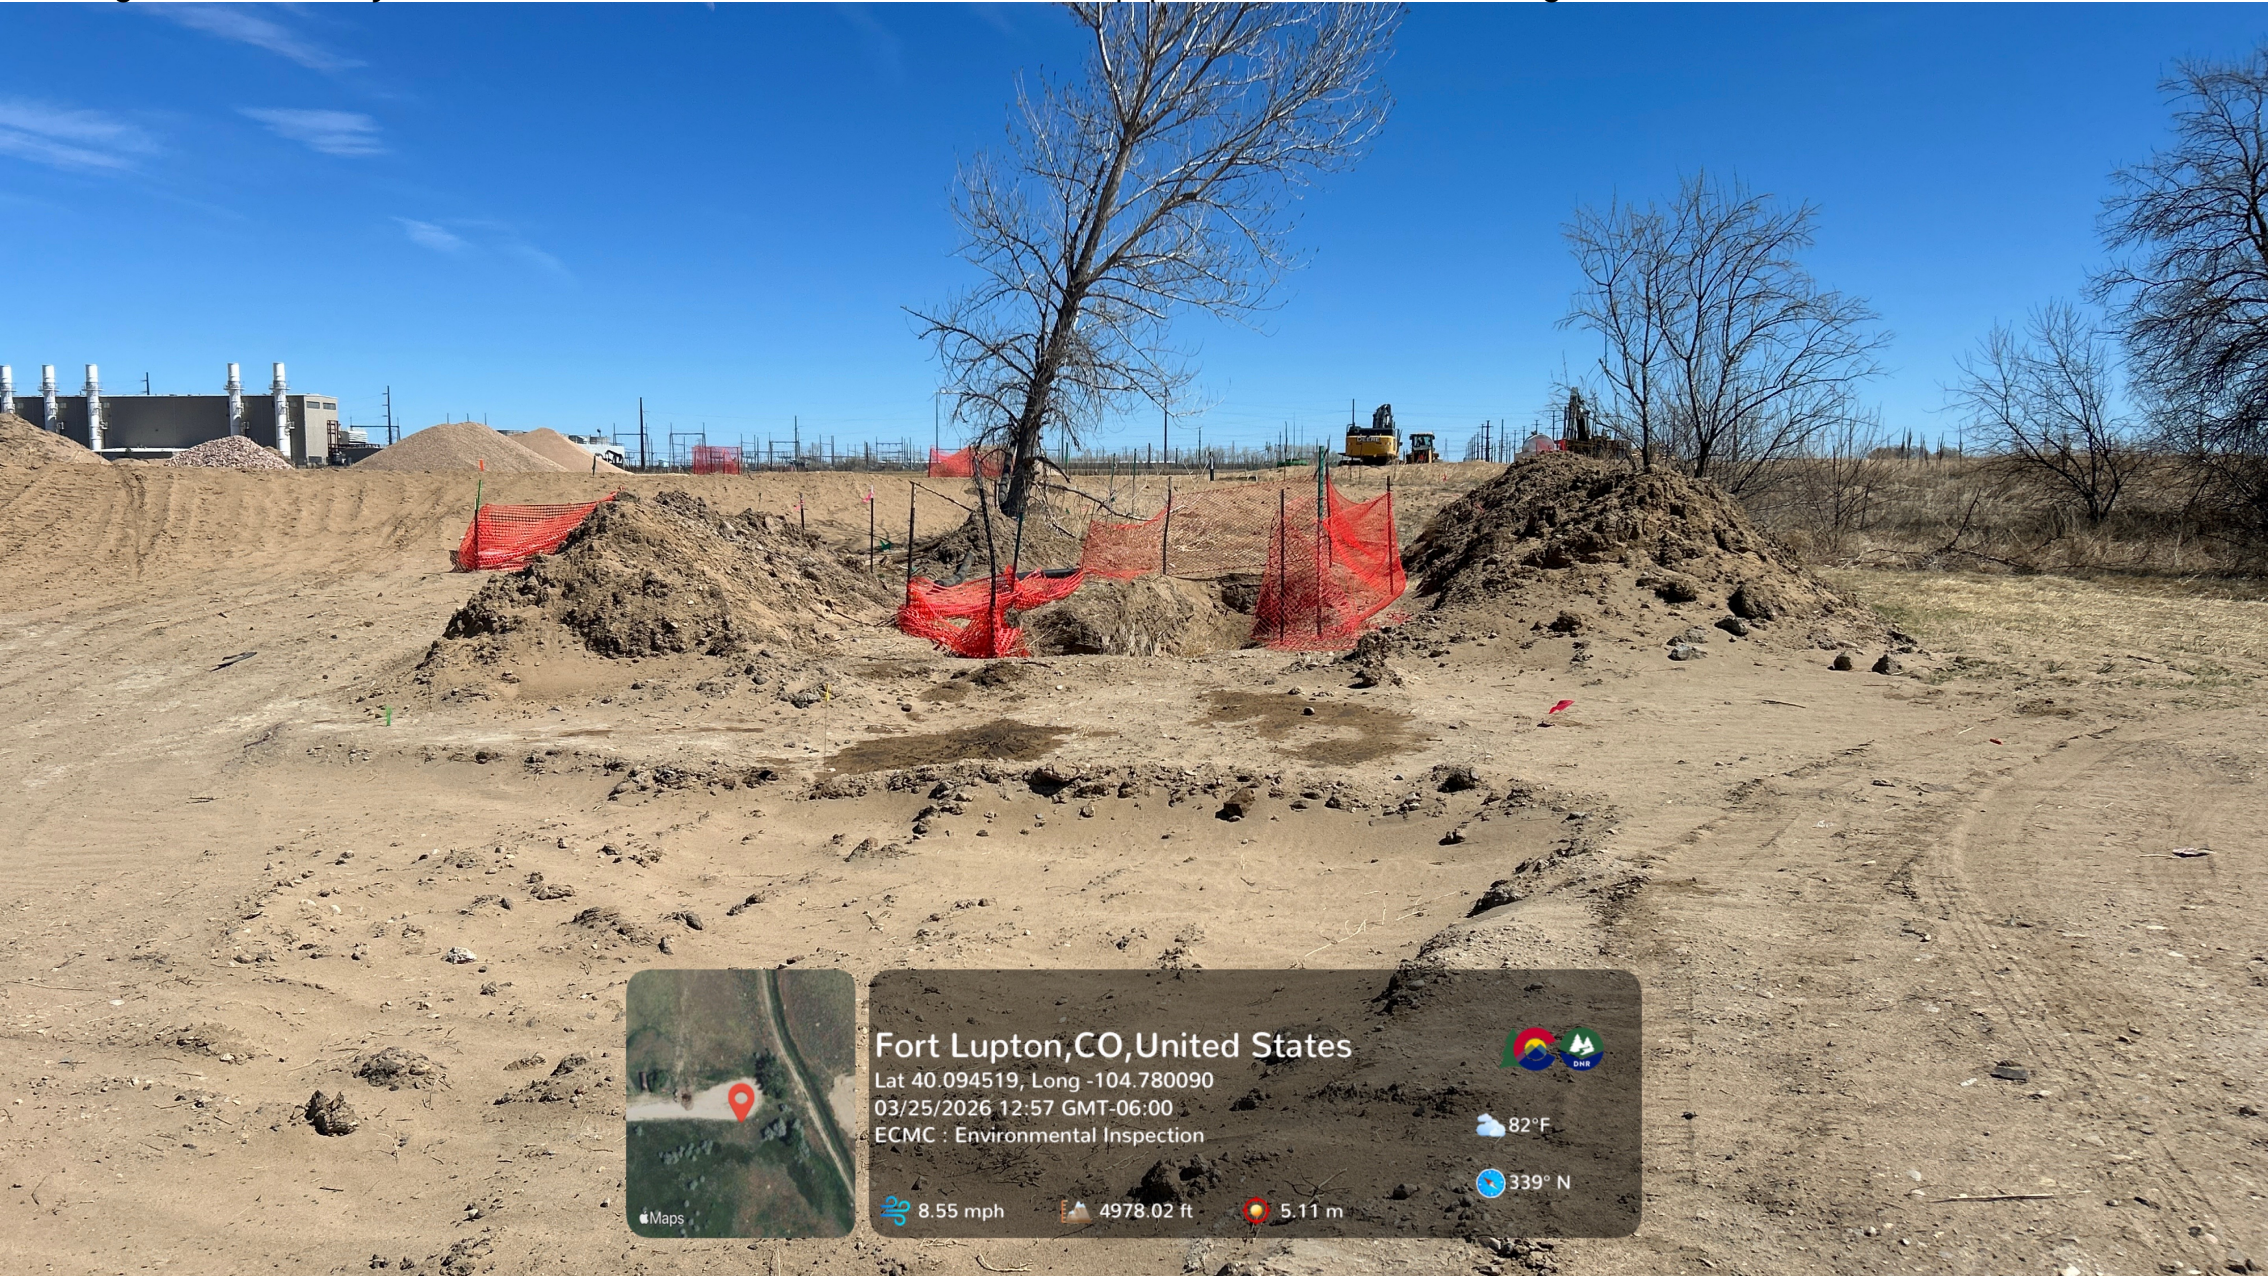
Looking at storage of supplies/equipment. Trash is also visible adjacent to the location.

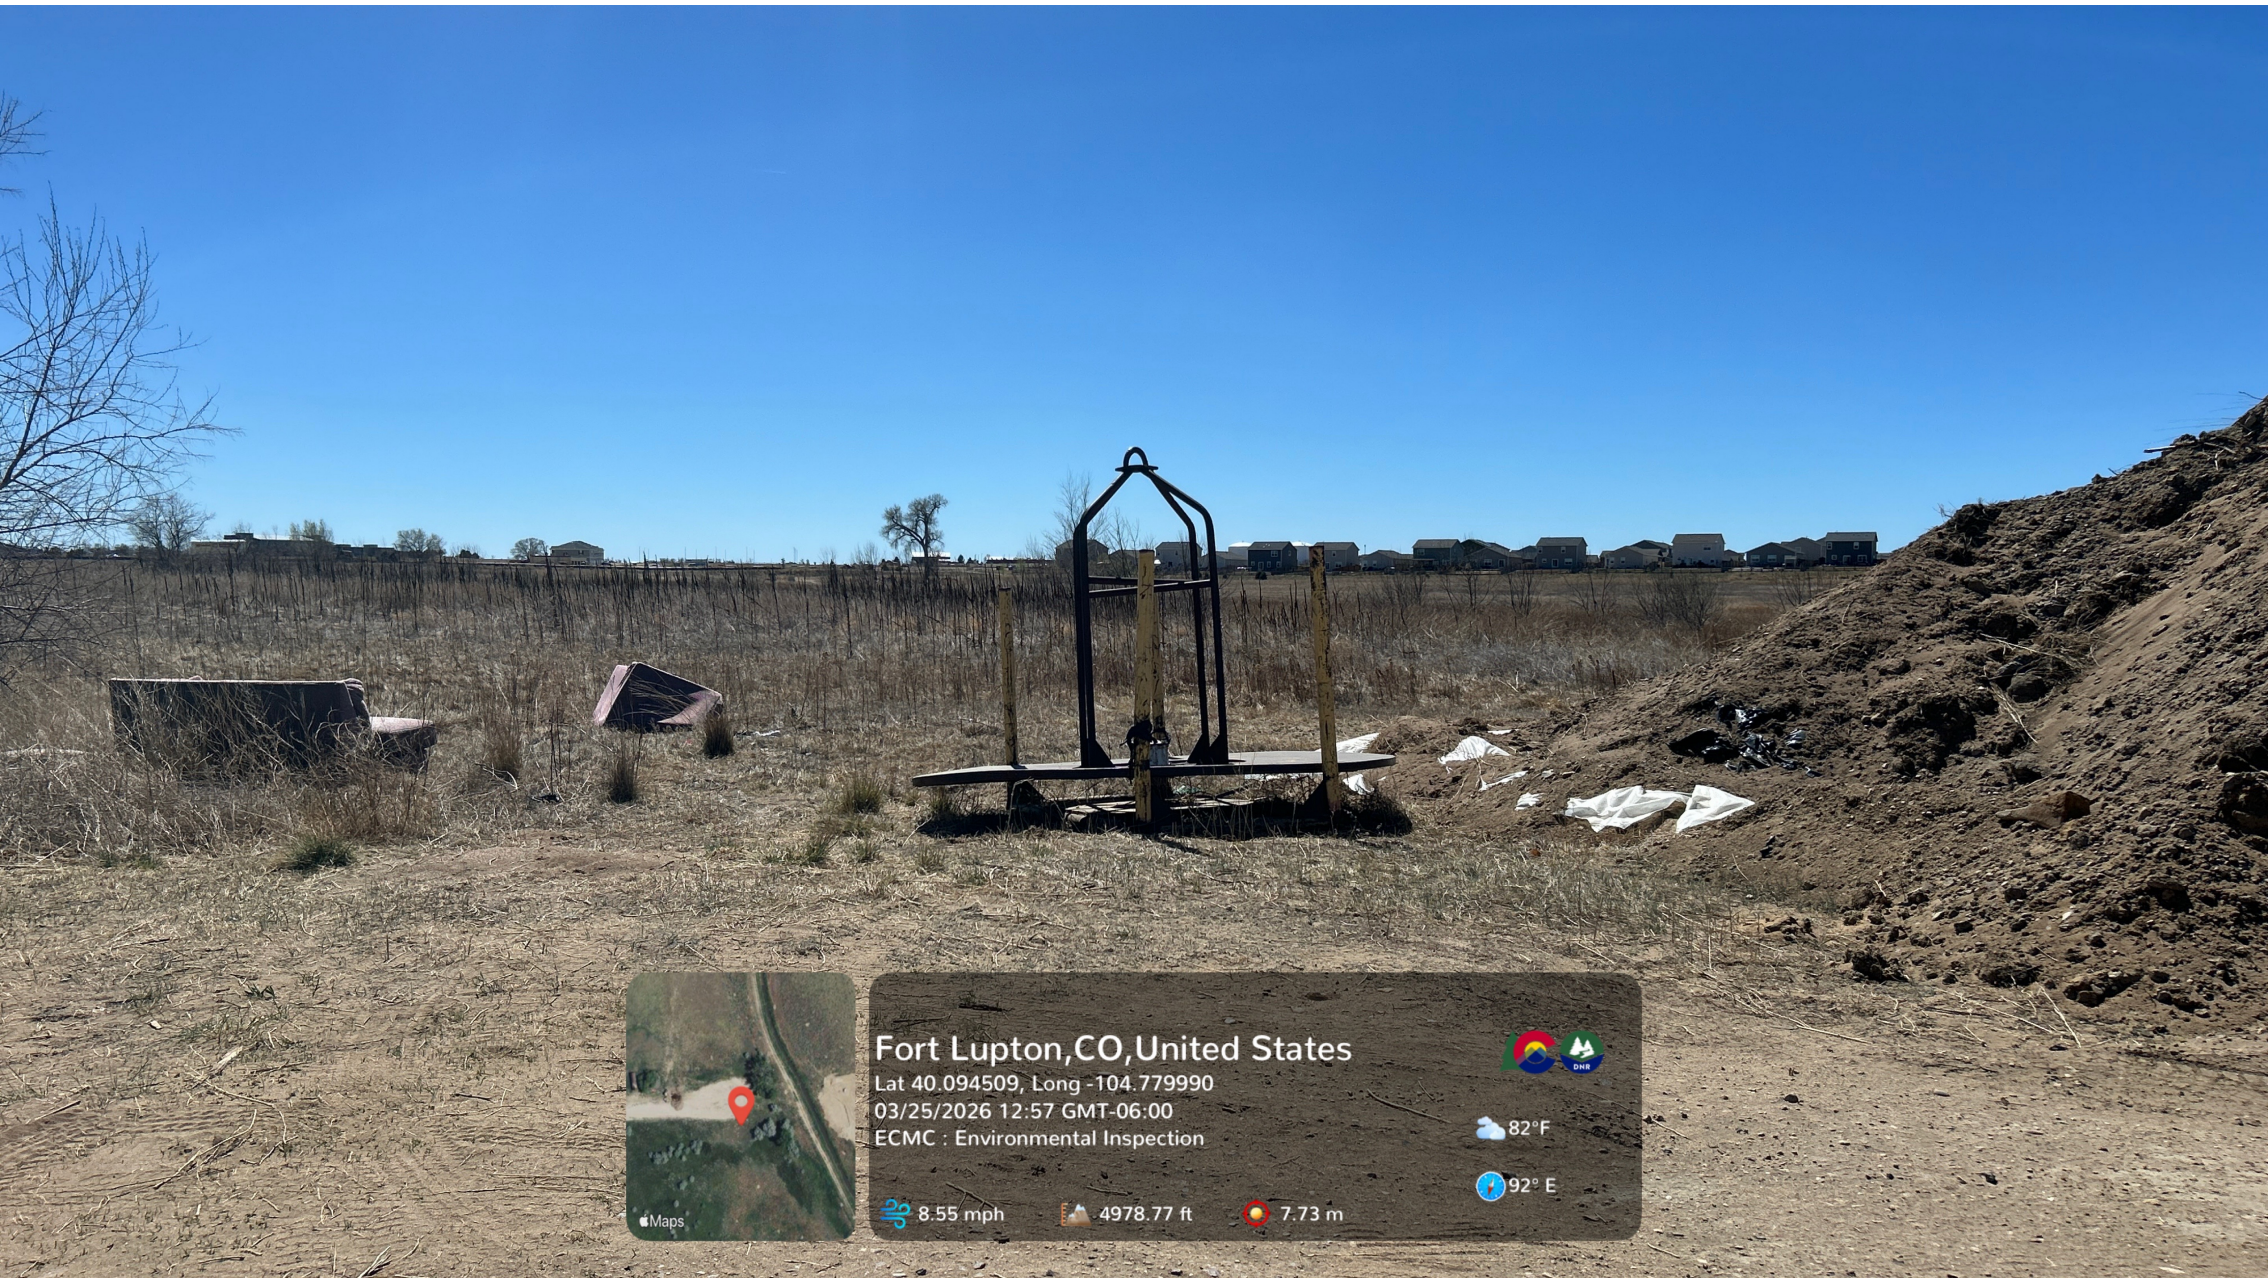
Flowlines are visible within the open excavation. Debris and soil mass failures obscure full visibility of the excavation base and sidewalls.

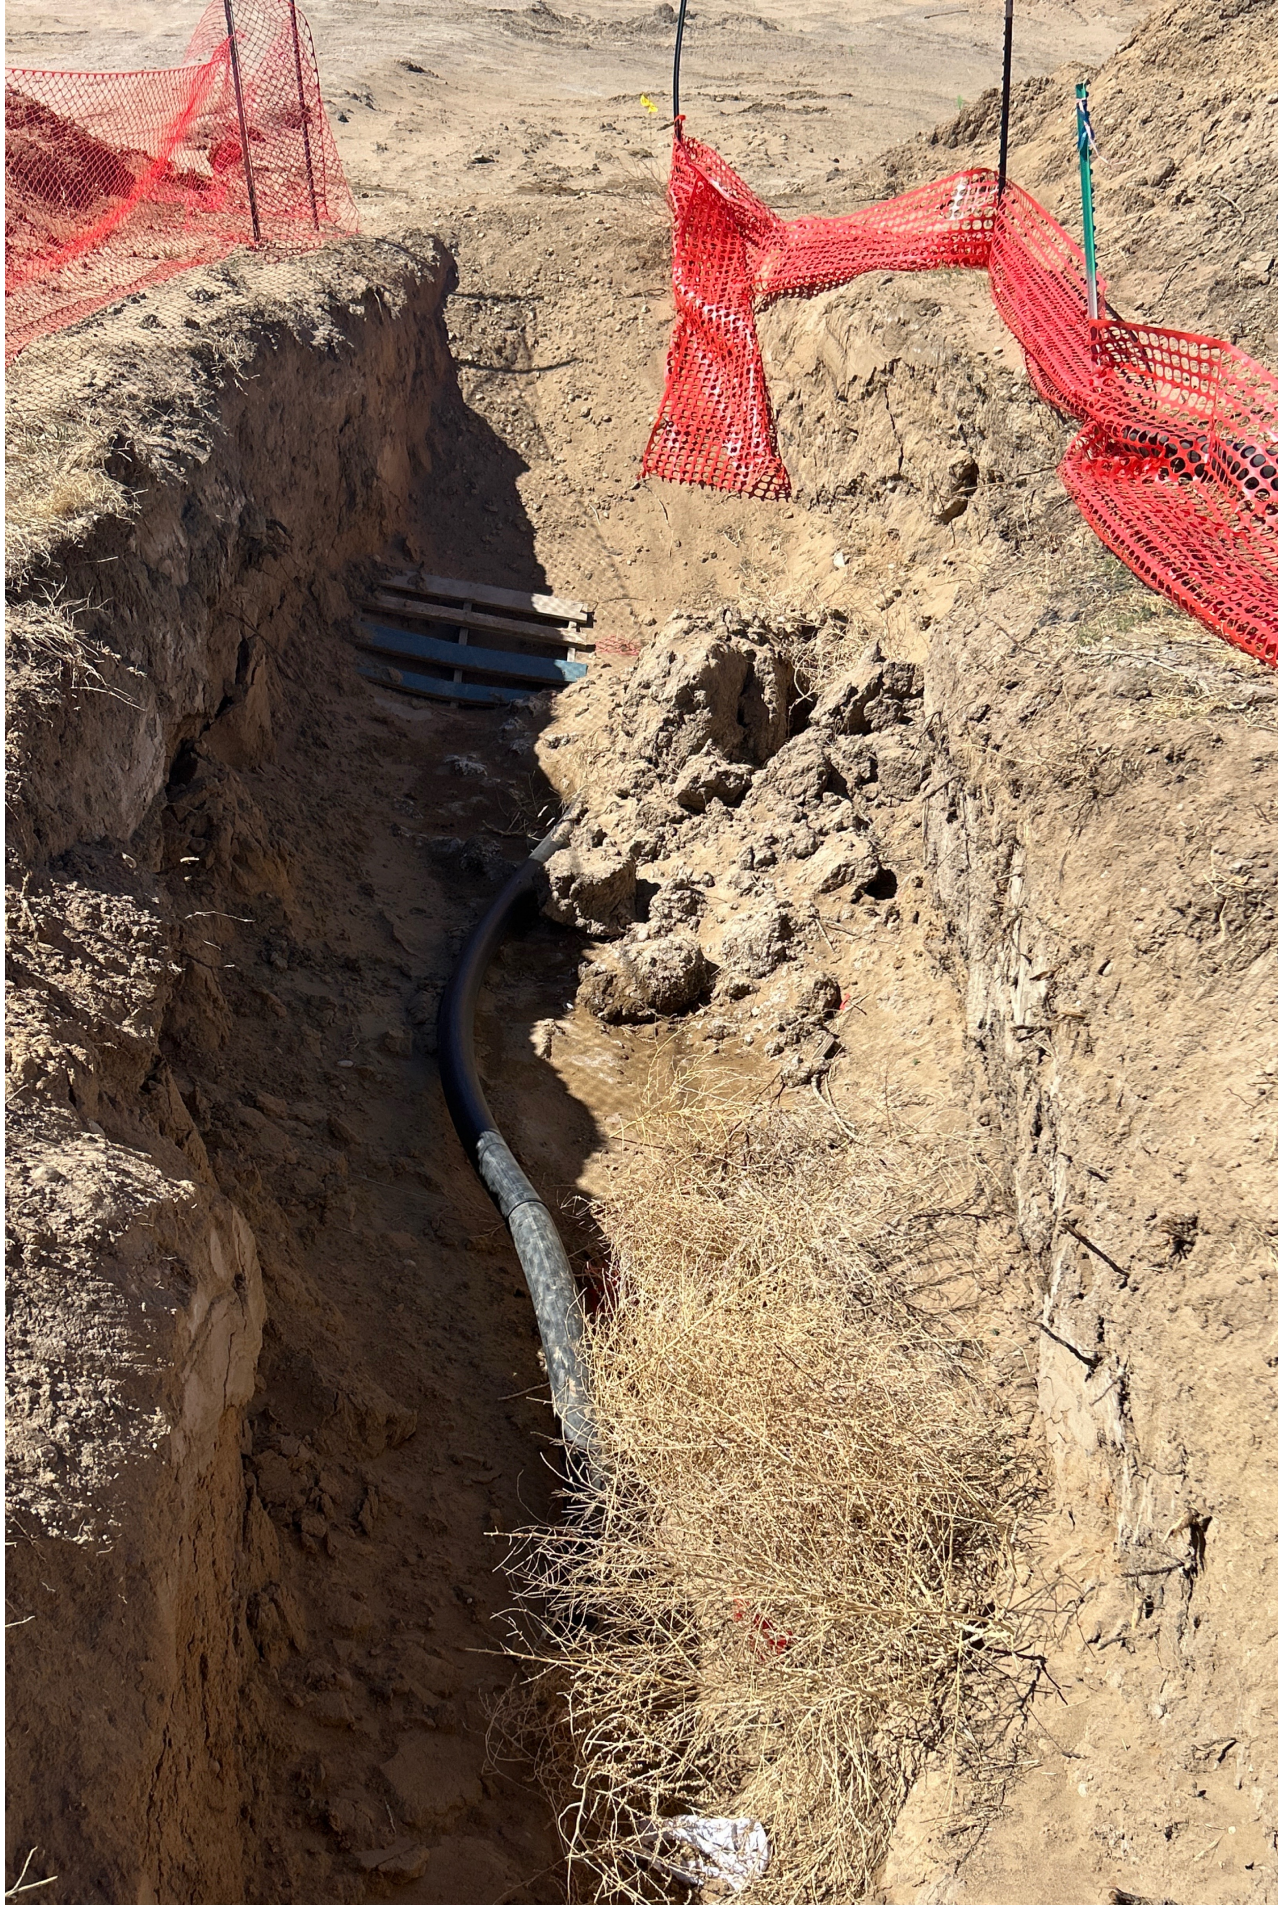
Looking at the surface adjacent to and down topographic gradient of the Facility 2 Consolidation 1/4/26 spill (Spill ID 492701). Construction (utility installation) appears to have occurred adjacent to the spill.

Approximate spill area and direction of fluid flow (arrow)

Construction area

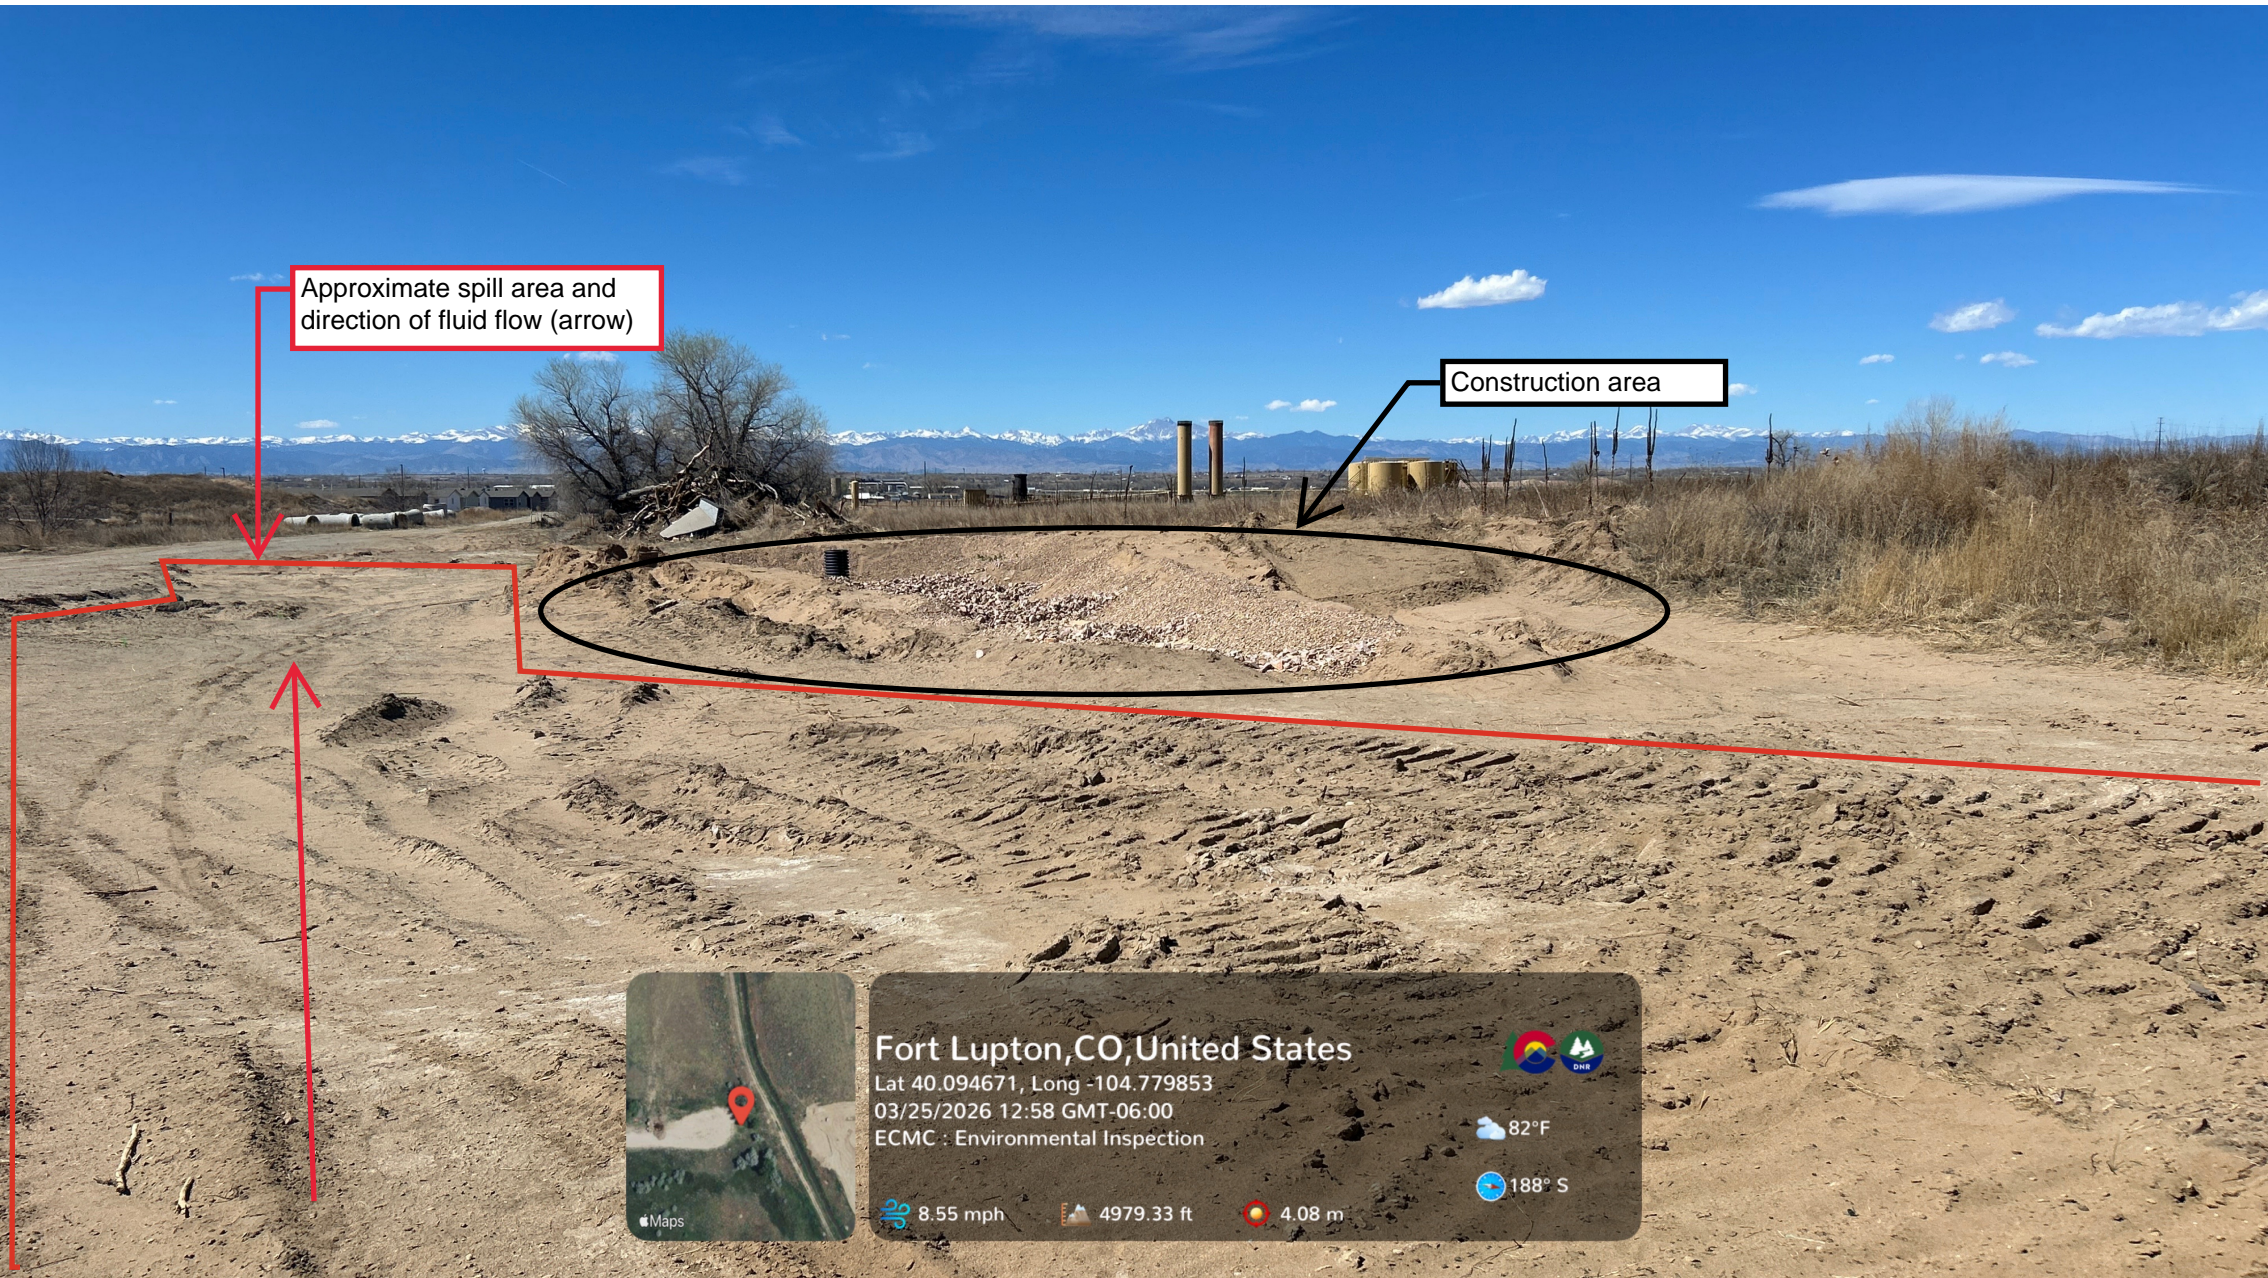
Continuing down topographic gradient of the Facility 2 Consolidation 1/4/26 spill (Spill ID 492701). Debris is visible.

Approximate spill area and direction of fluid flow (arrow)

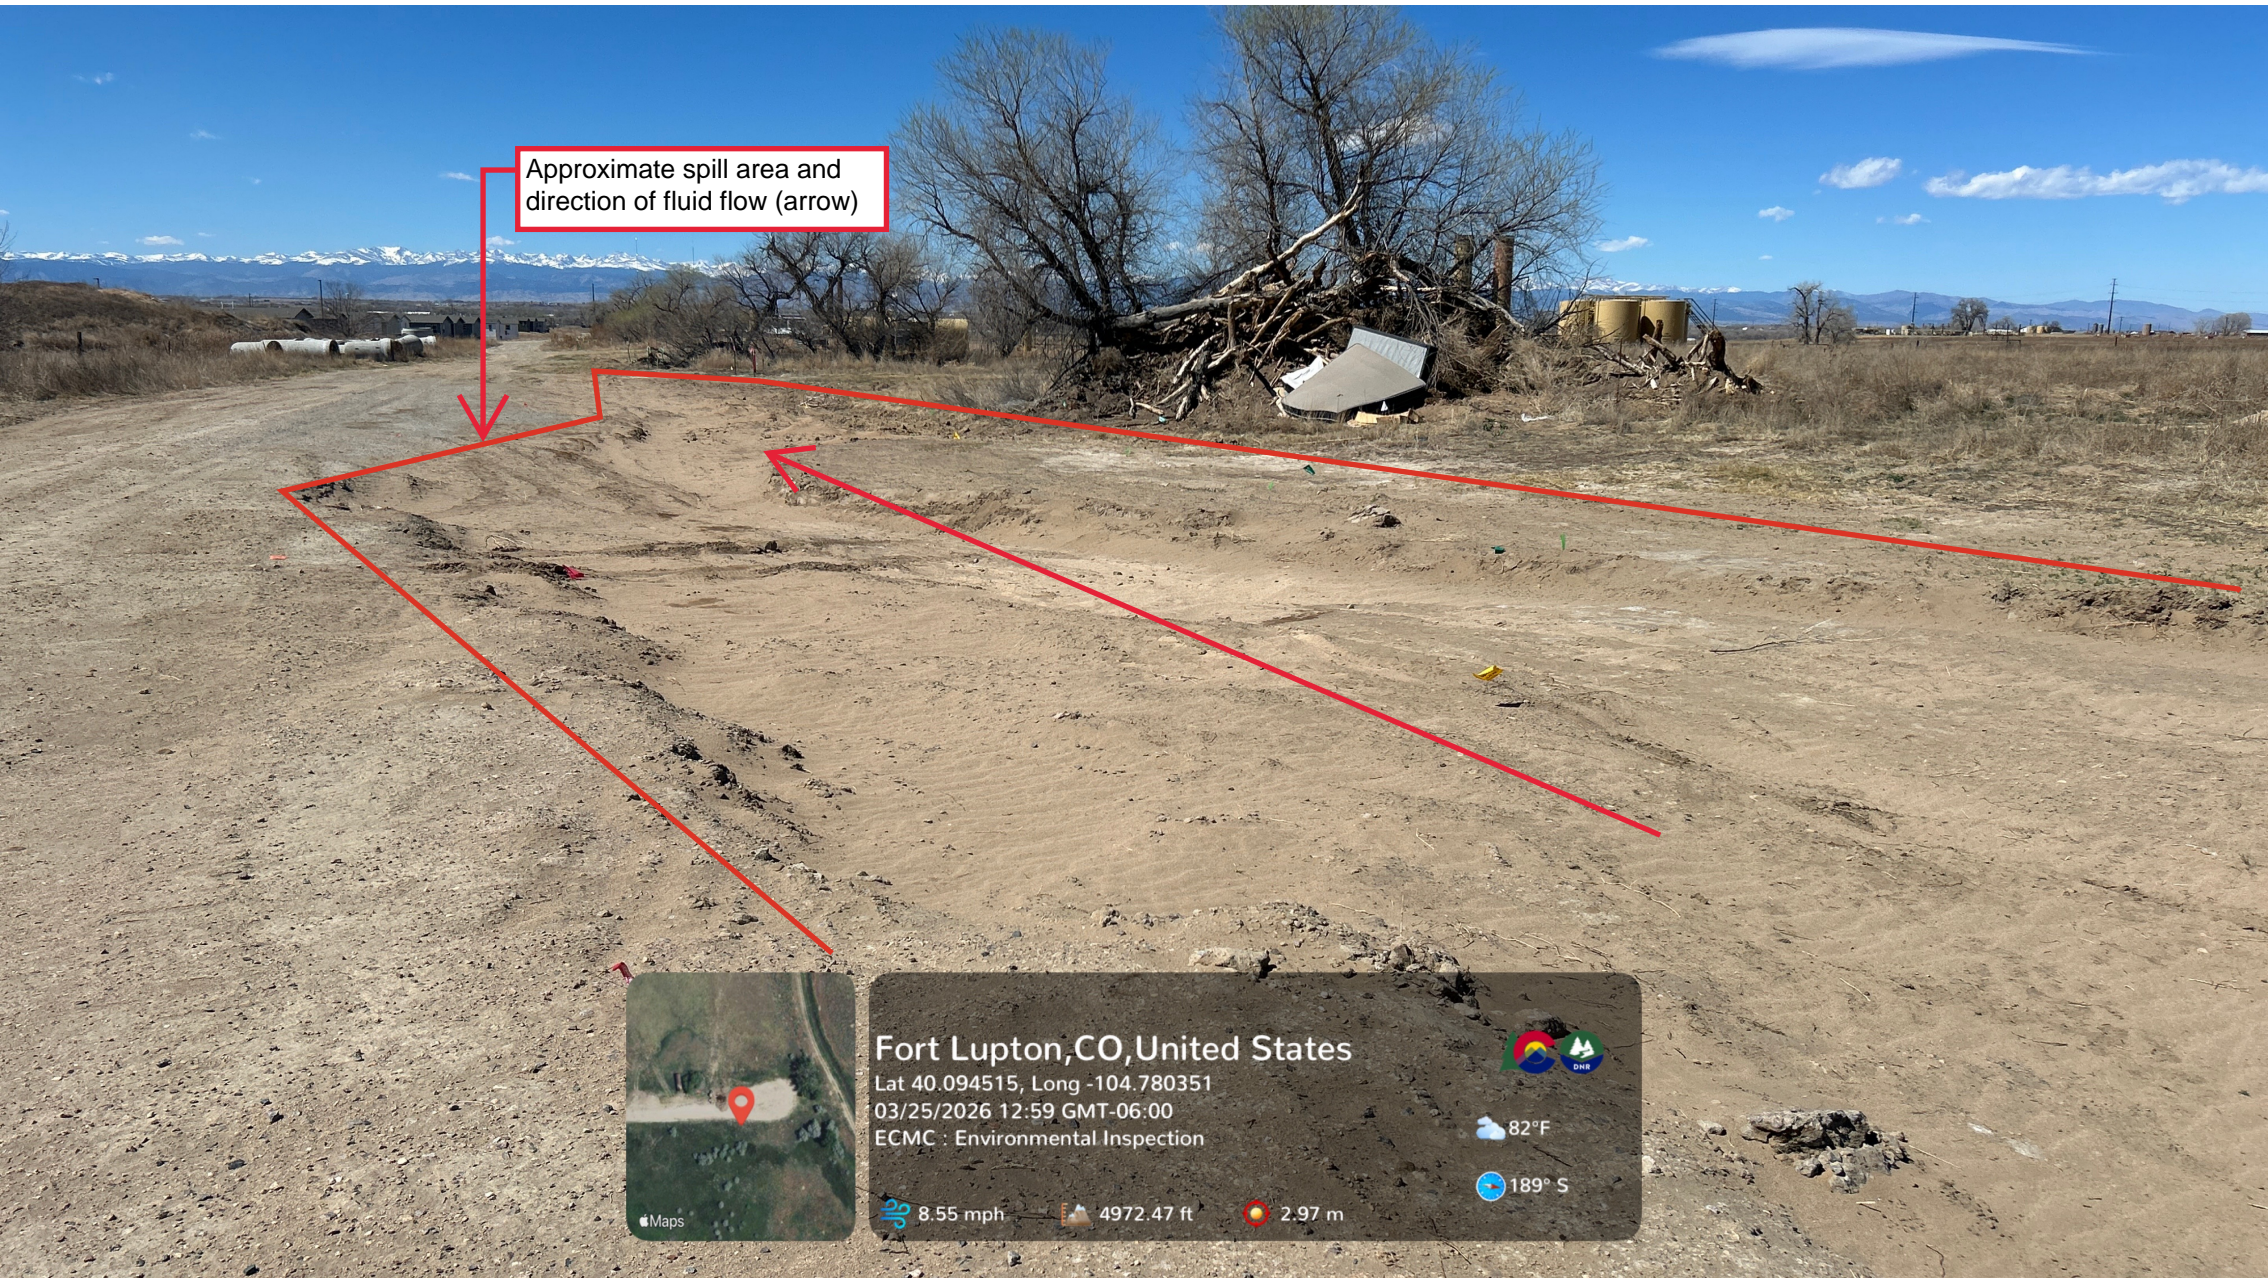
Continuing down topographic gradient of the Facility 2 Consolidation 1/4/26 spill (Spill ID 492701). Stained soil is visible. No BMPs in place to control stormwater runoff.

Approximate spill area and direction of fluid flow (arrow)
