### Fort Lupton, CO, United States

Lat 40.094441, Long -104.780451  
03/25/2026 12:56 GMT-06:00  
ECMC : Environmental Inspection

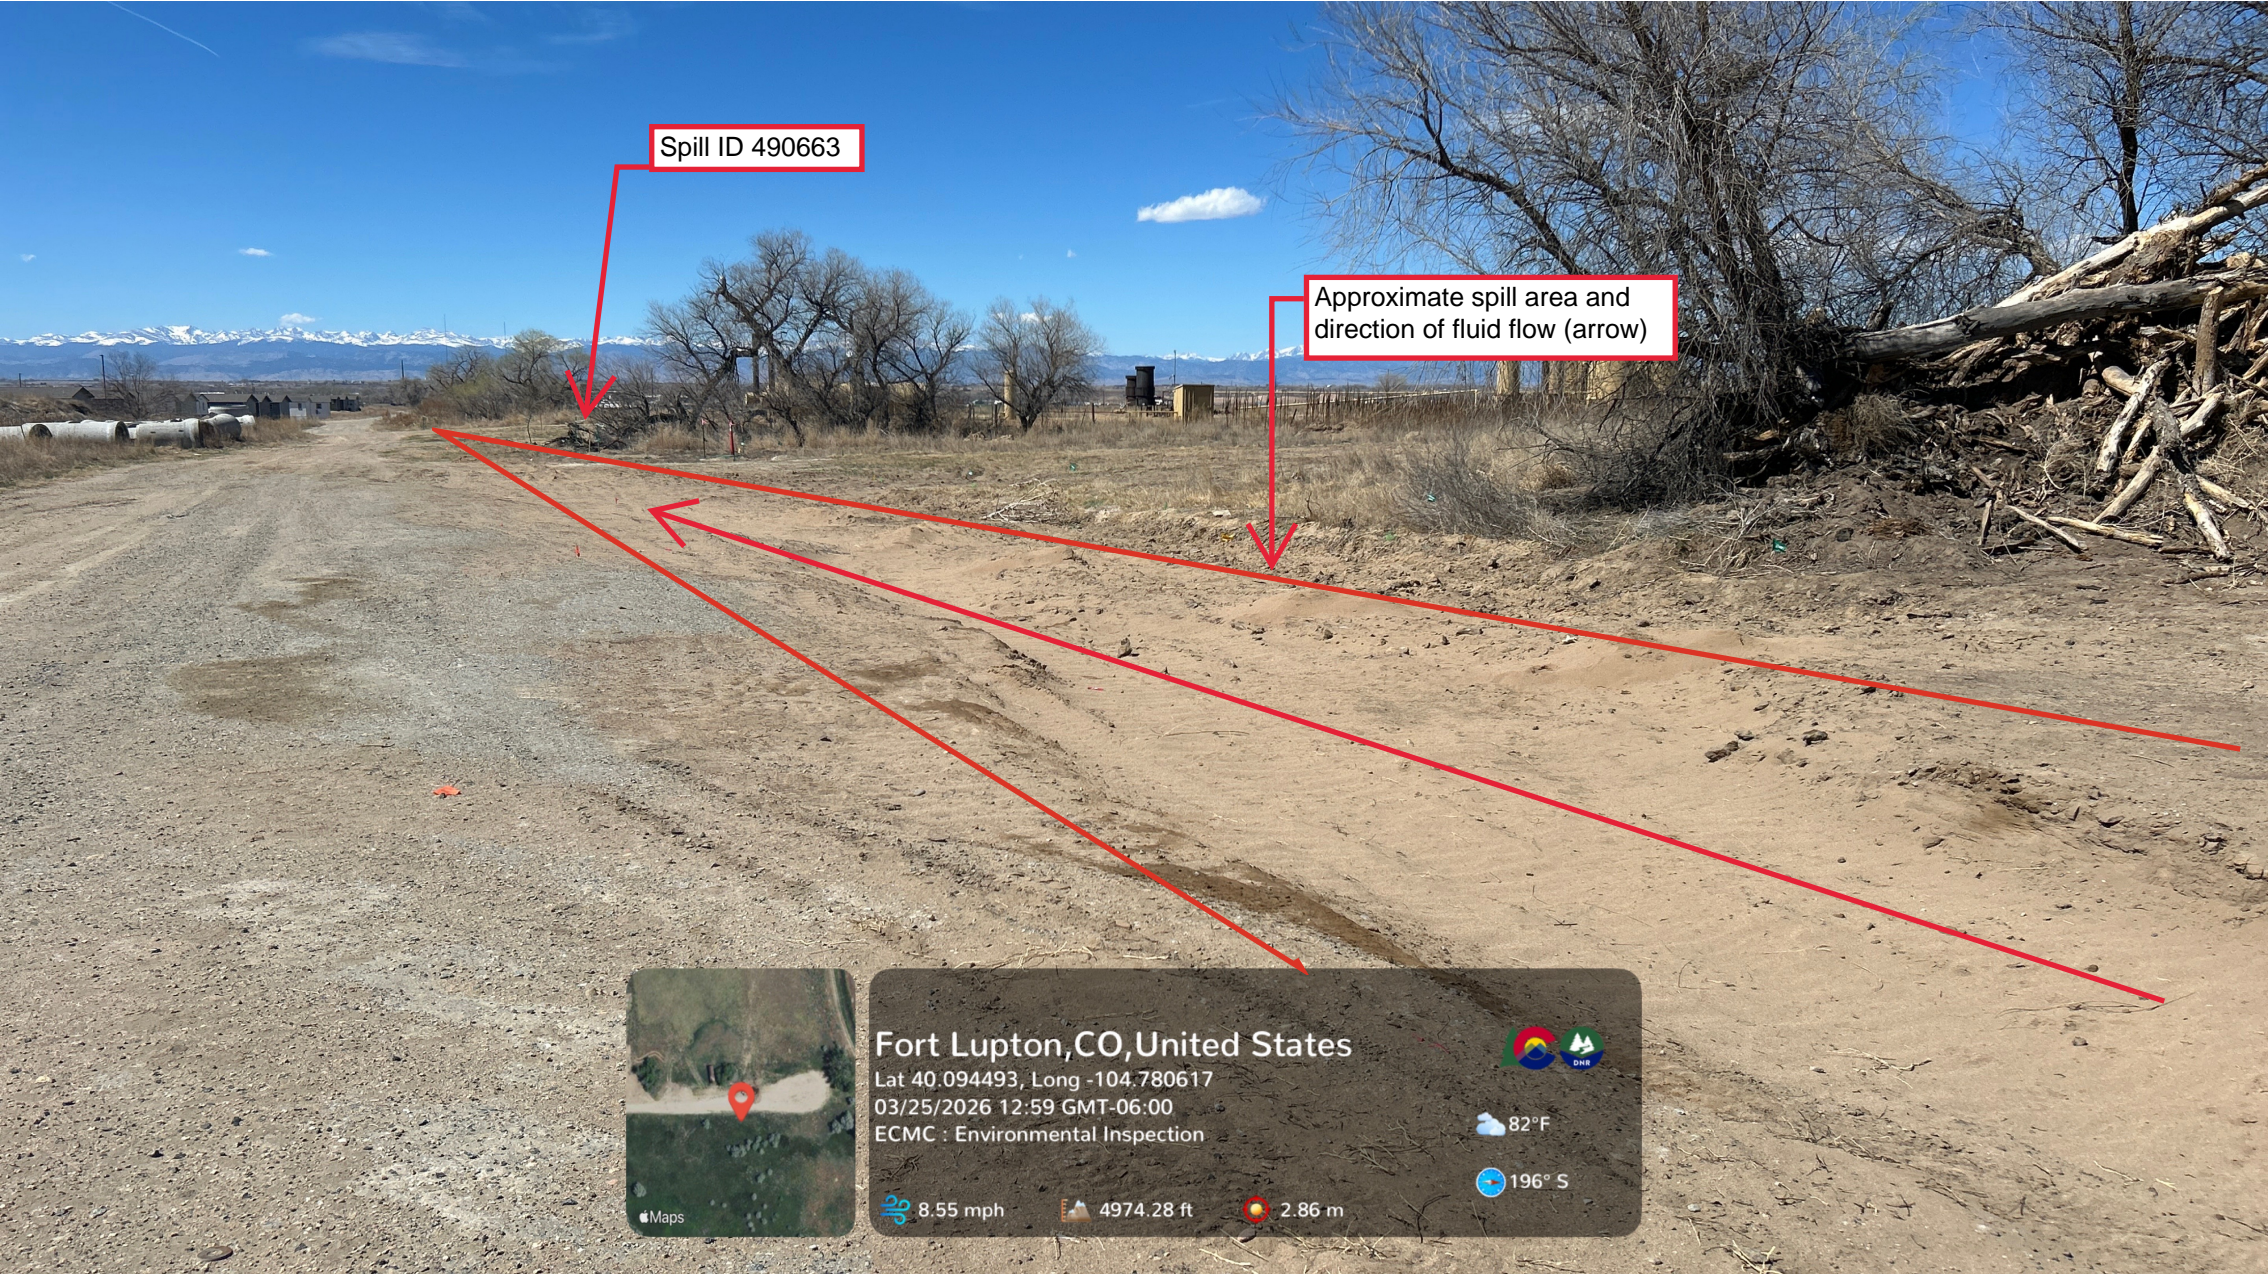
Spill ID 490663

Looking at the Facility 2 Consolidation spill (Spill ID 490663). The excavation at the spill location has been backfilled. The Facility 2 tank battery is visible in the background.
