Frederick, CO, United States

ECMC ; Environmental Inspection

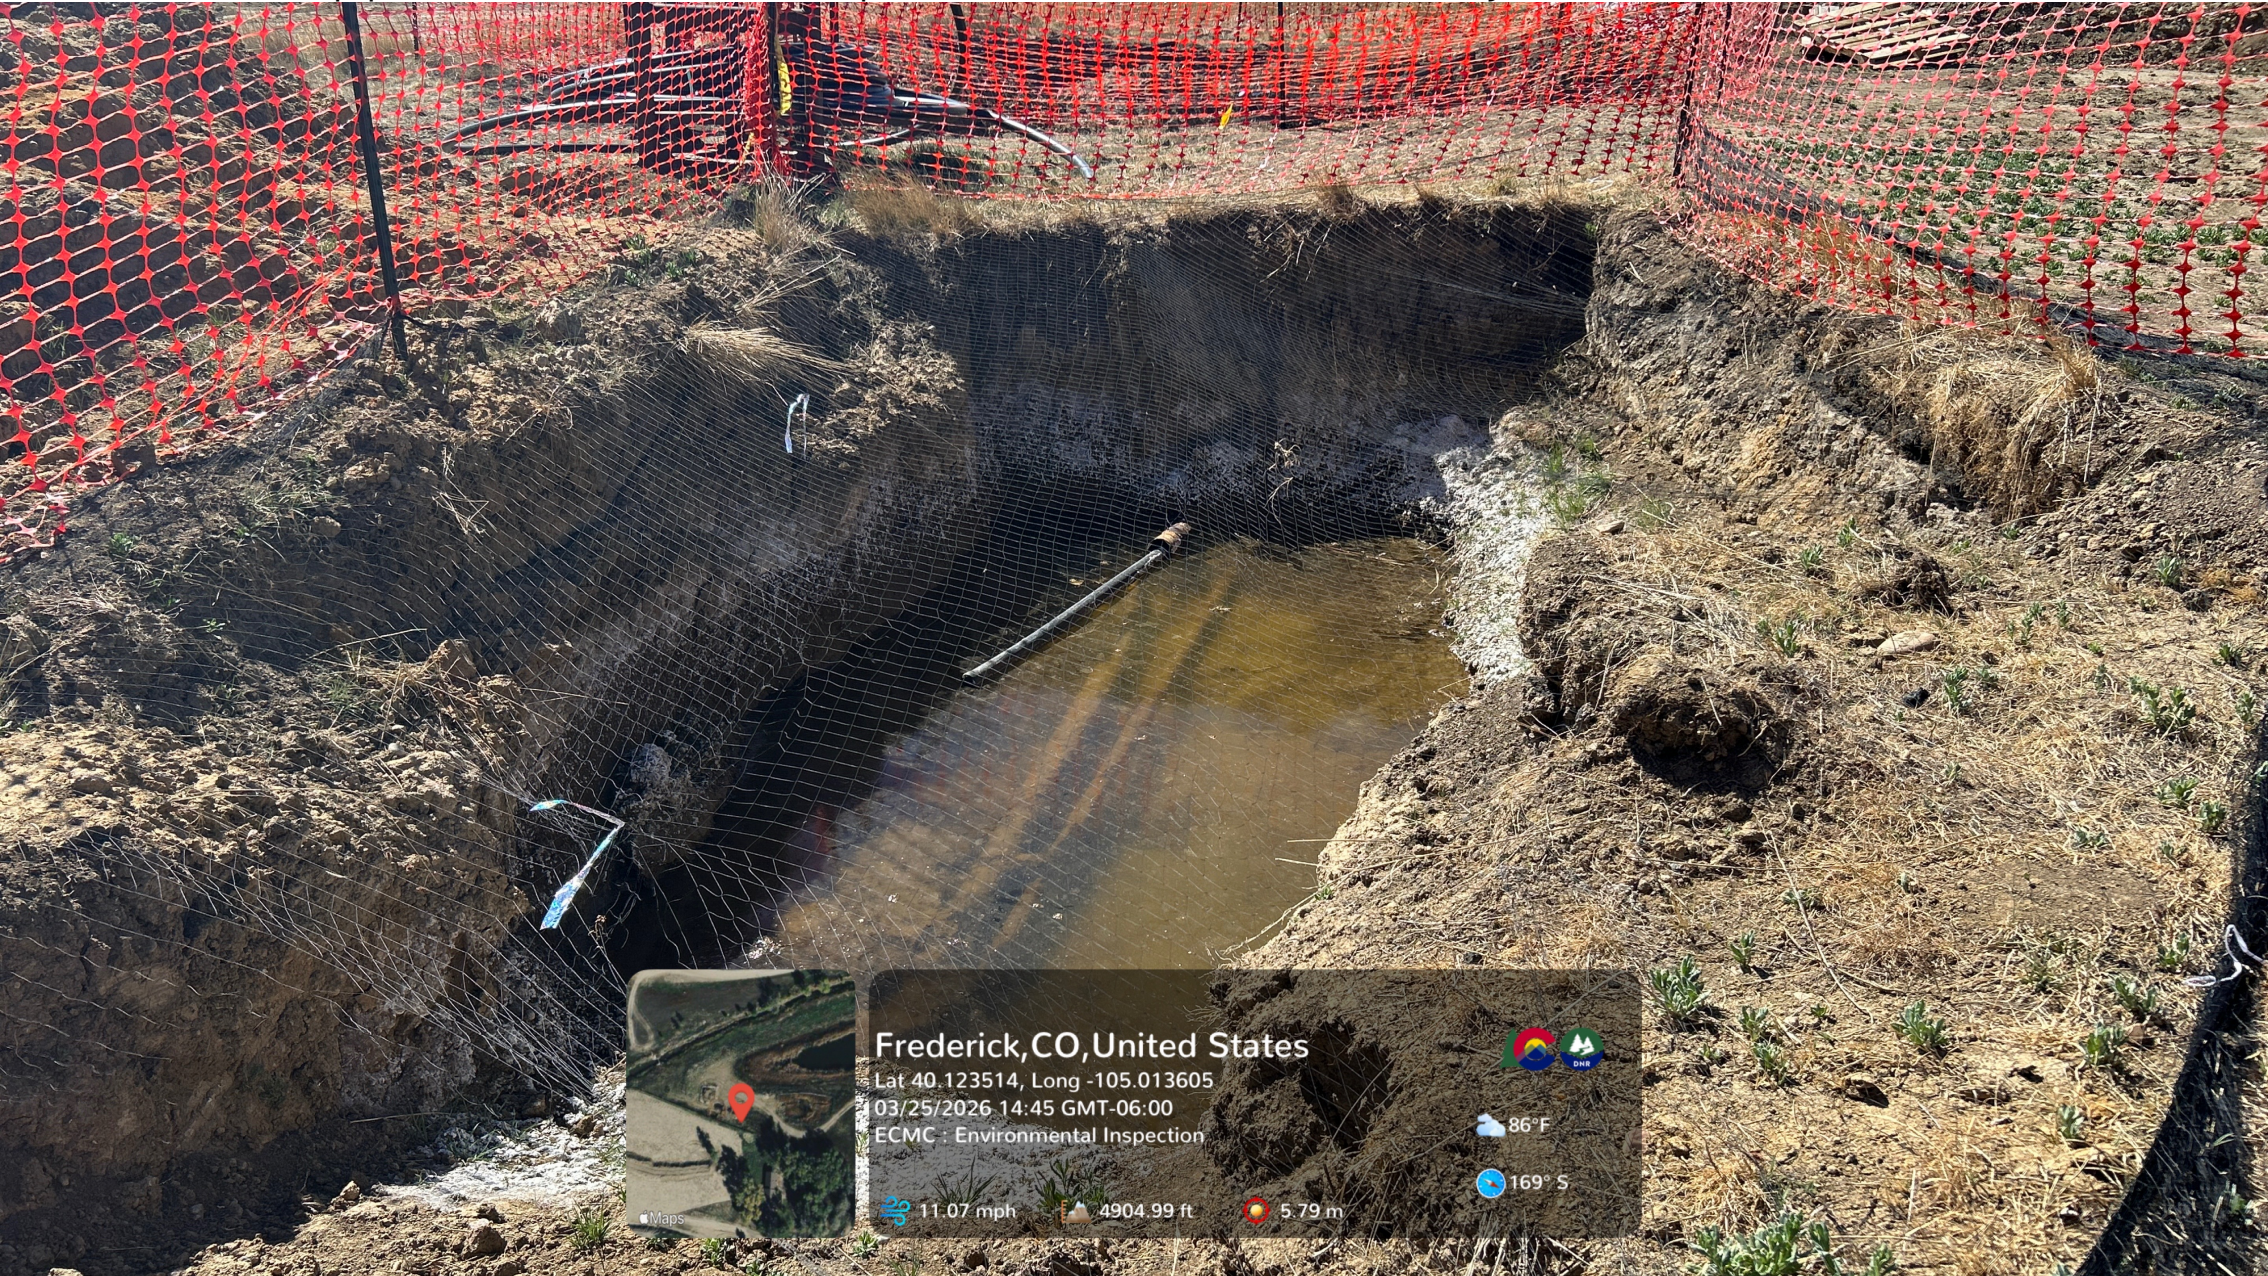
Looking at an open excavation, located immediately east of the initial spill/release point. Stained soil and salt crusting are visible on the excavation sidewalls. A sheen is visible on groundwater at the base of the excavation. Bird netting has been installed. Flowlines are visible within the excavation. Unused equipment and an unmarked soil stockpile with no stormwater BMPs are visible adjacent to the excavation.

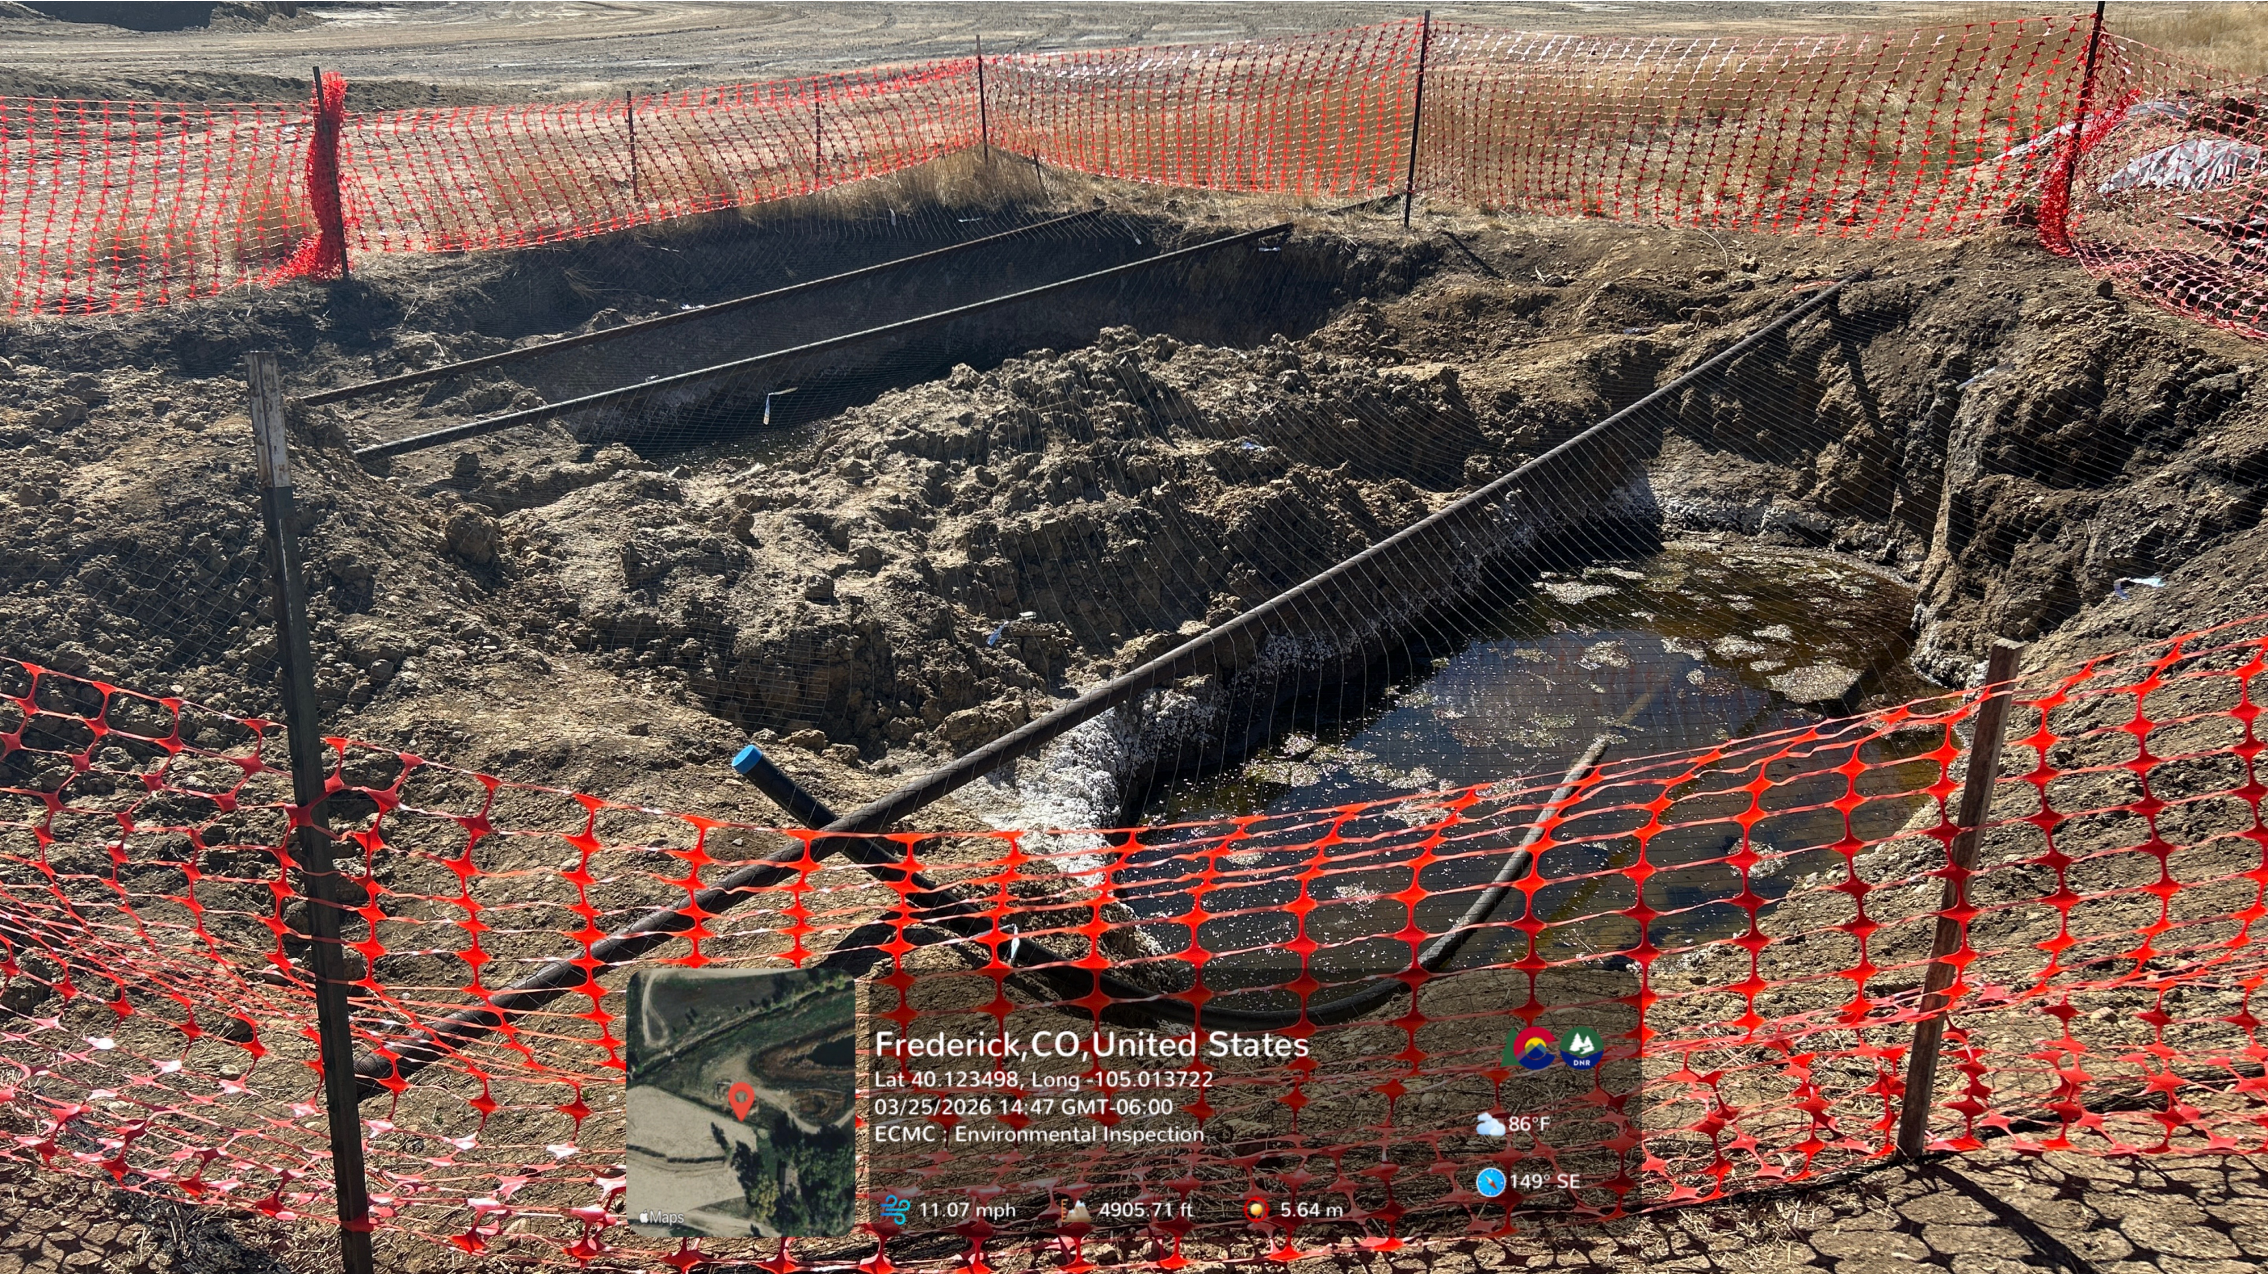
Looking at the northern excavation open at the spill location. Stained soil and salt crusting are visible on the excavation sidewalls. A sheen is visible on groundwater at the base of the excavation. Bird netting has been installed over the open excavations. A segment of flowline is visible protruding from the excavation.

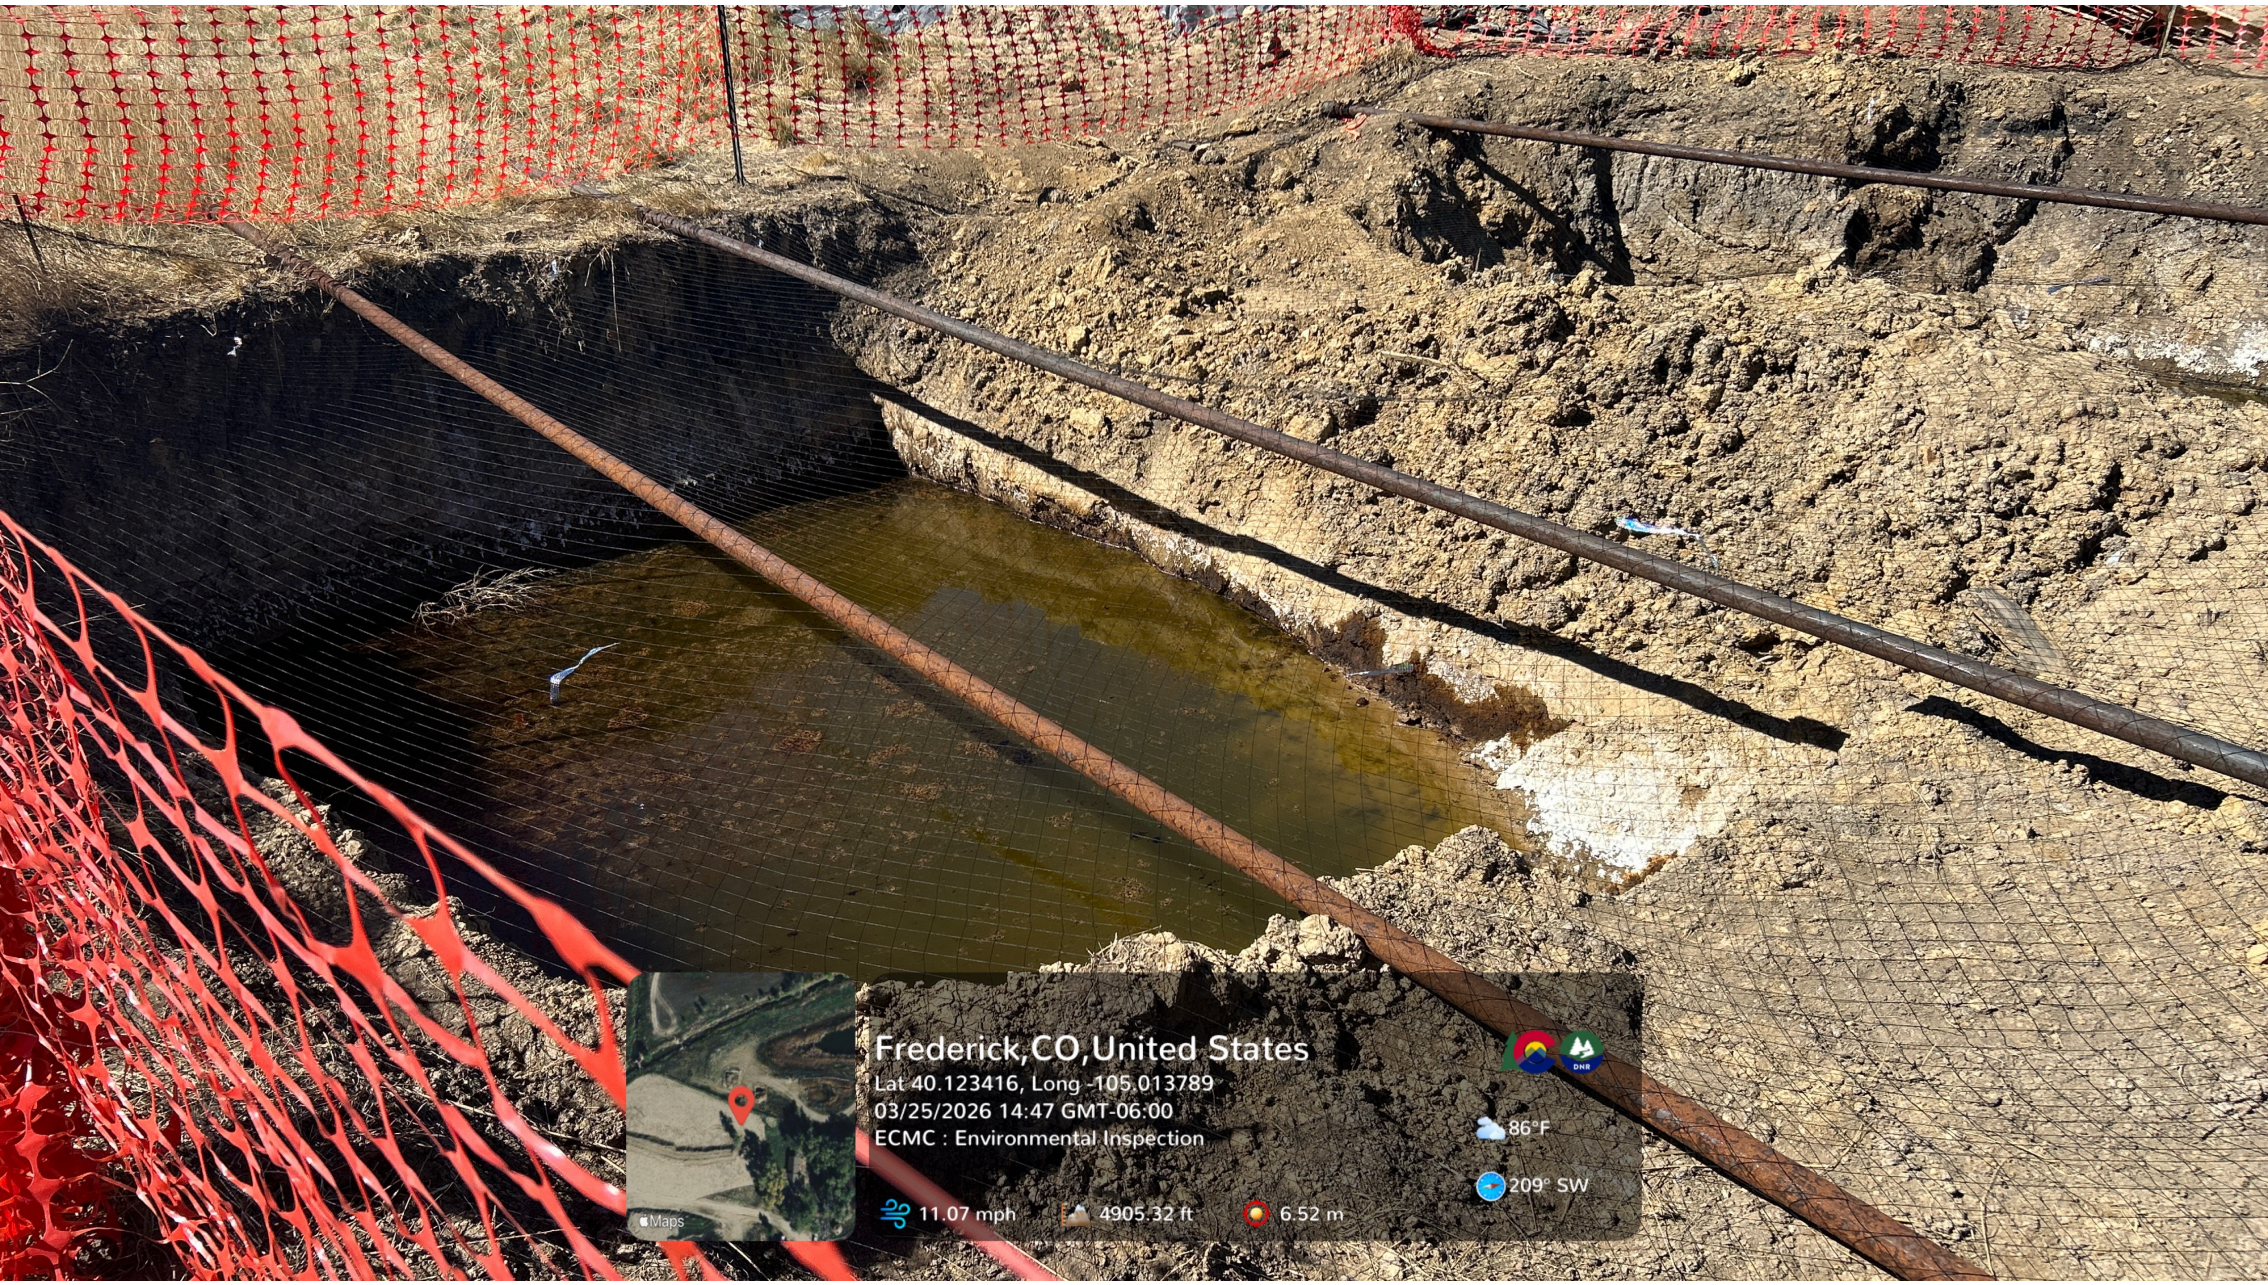
Looking at the southern excavation open at the spill location. Petroleum hydrocarbon saturated soil and salt crusting are visible on the excavation sidewalls. Free product is visible on groundwater at the base of the excavation. Bird netting has been installed over the open excavations.

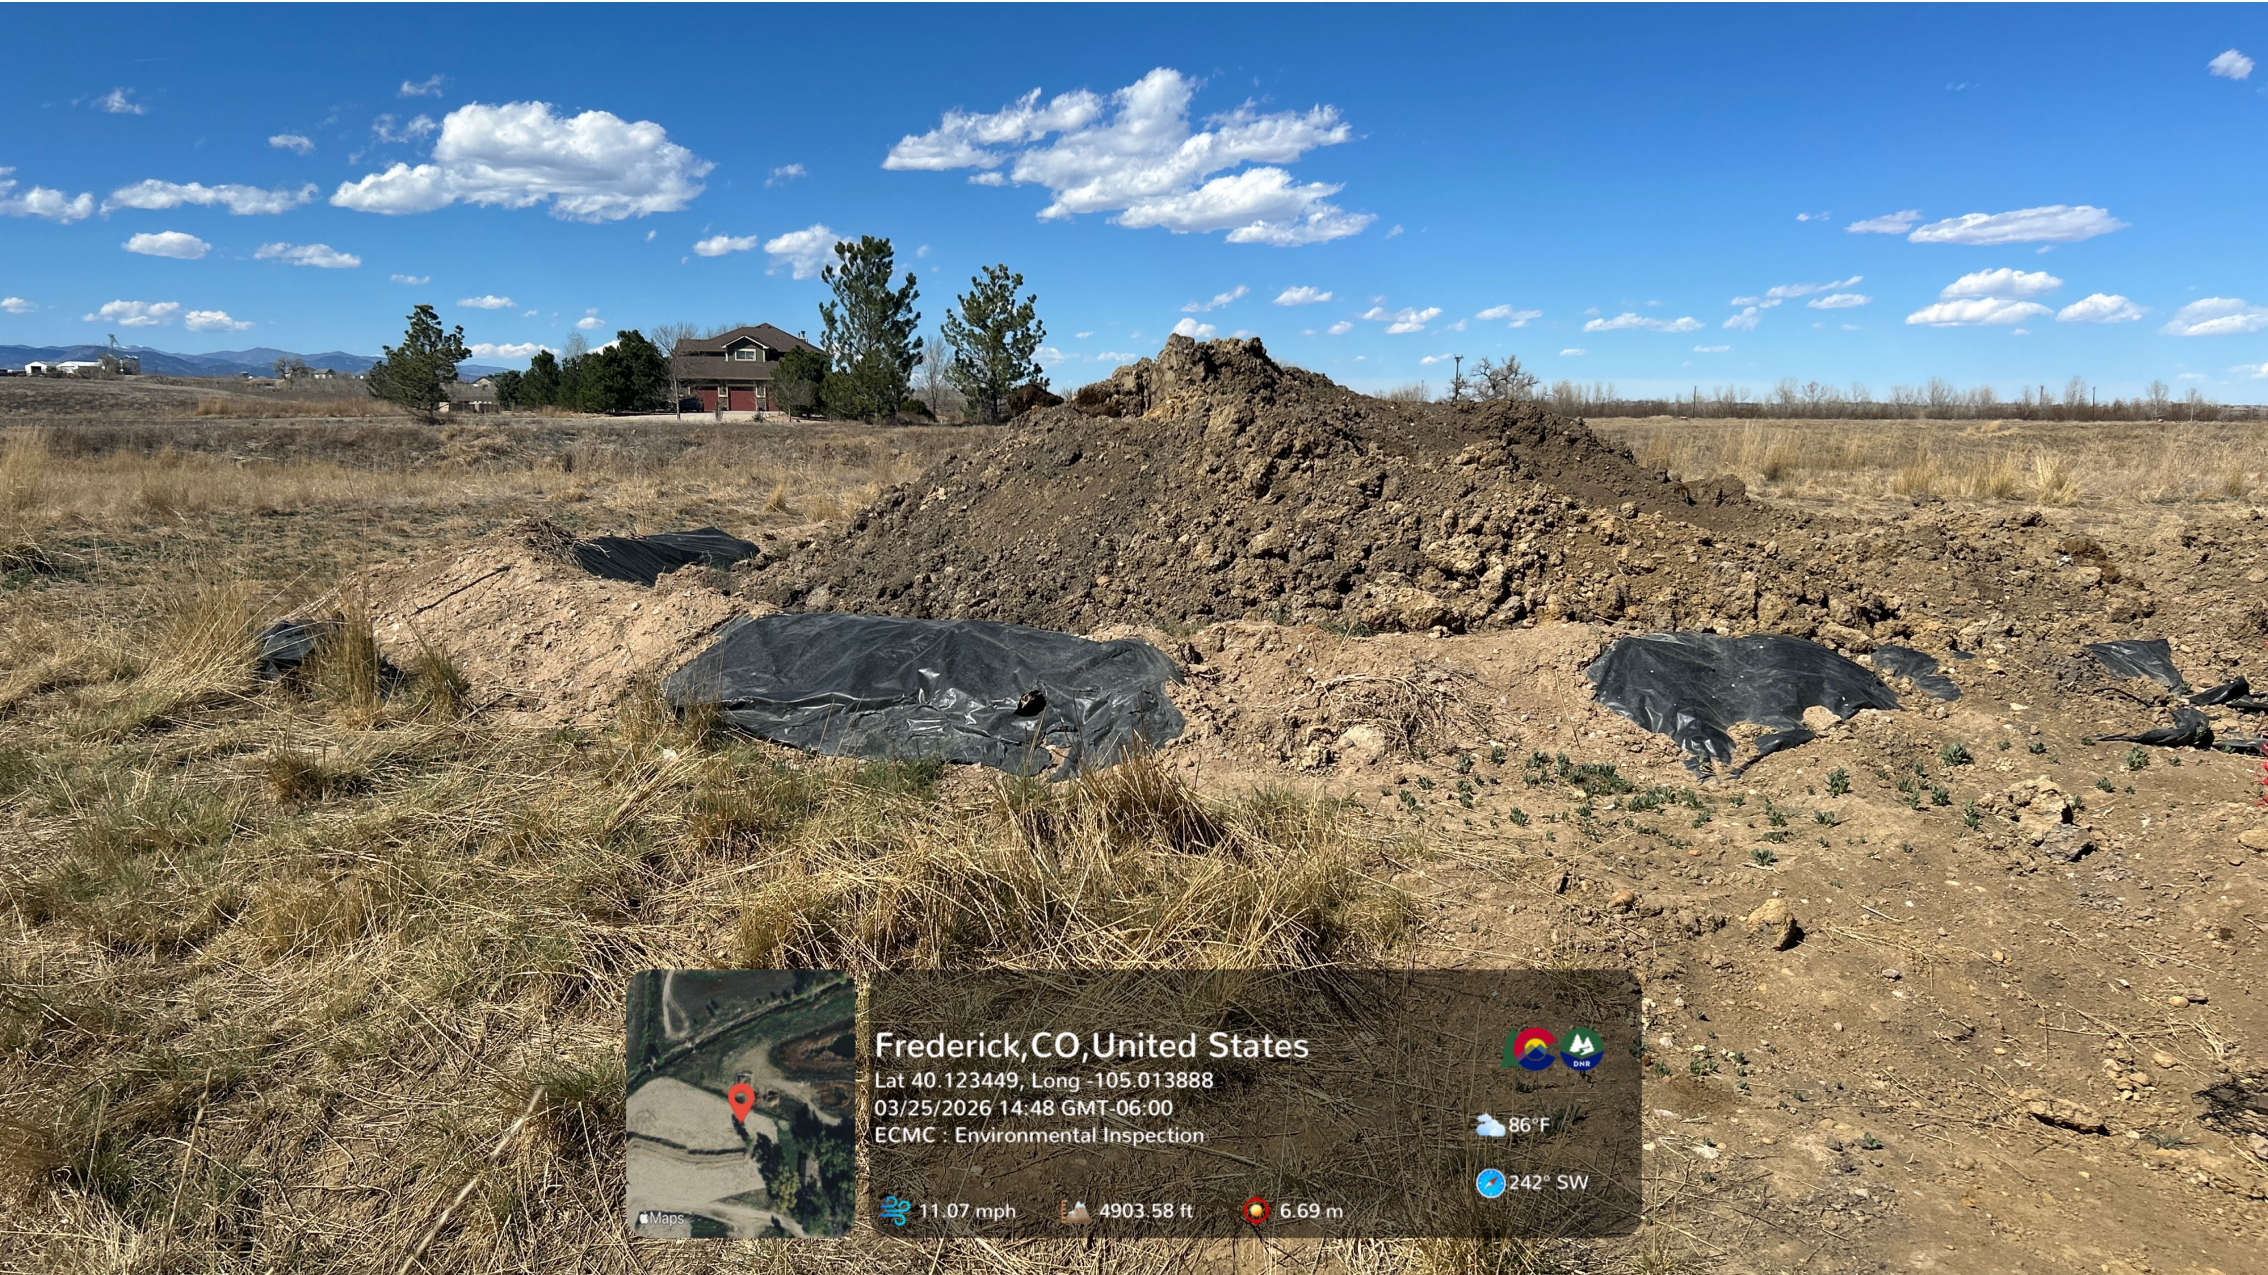
Looking at a soil stockpile marked "contaminated".

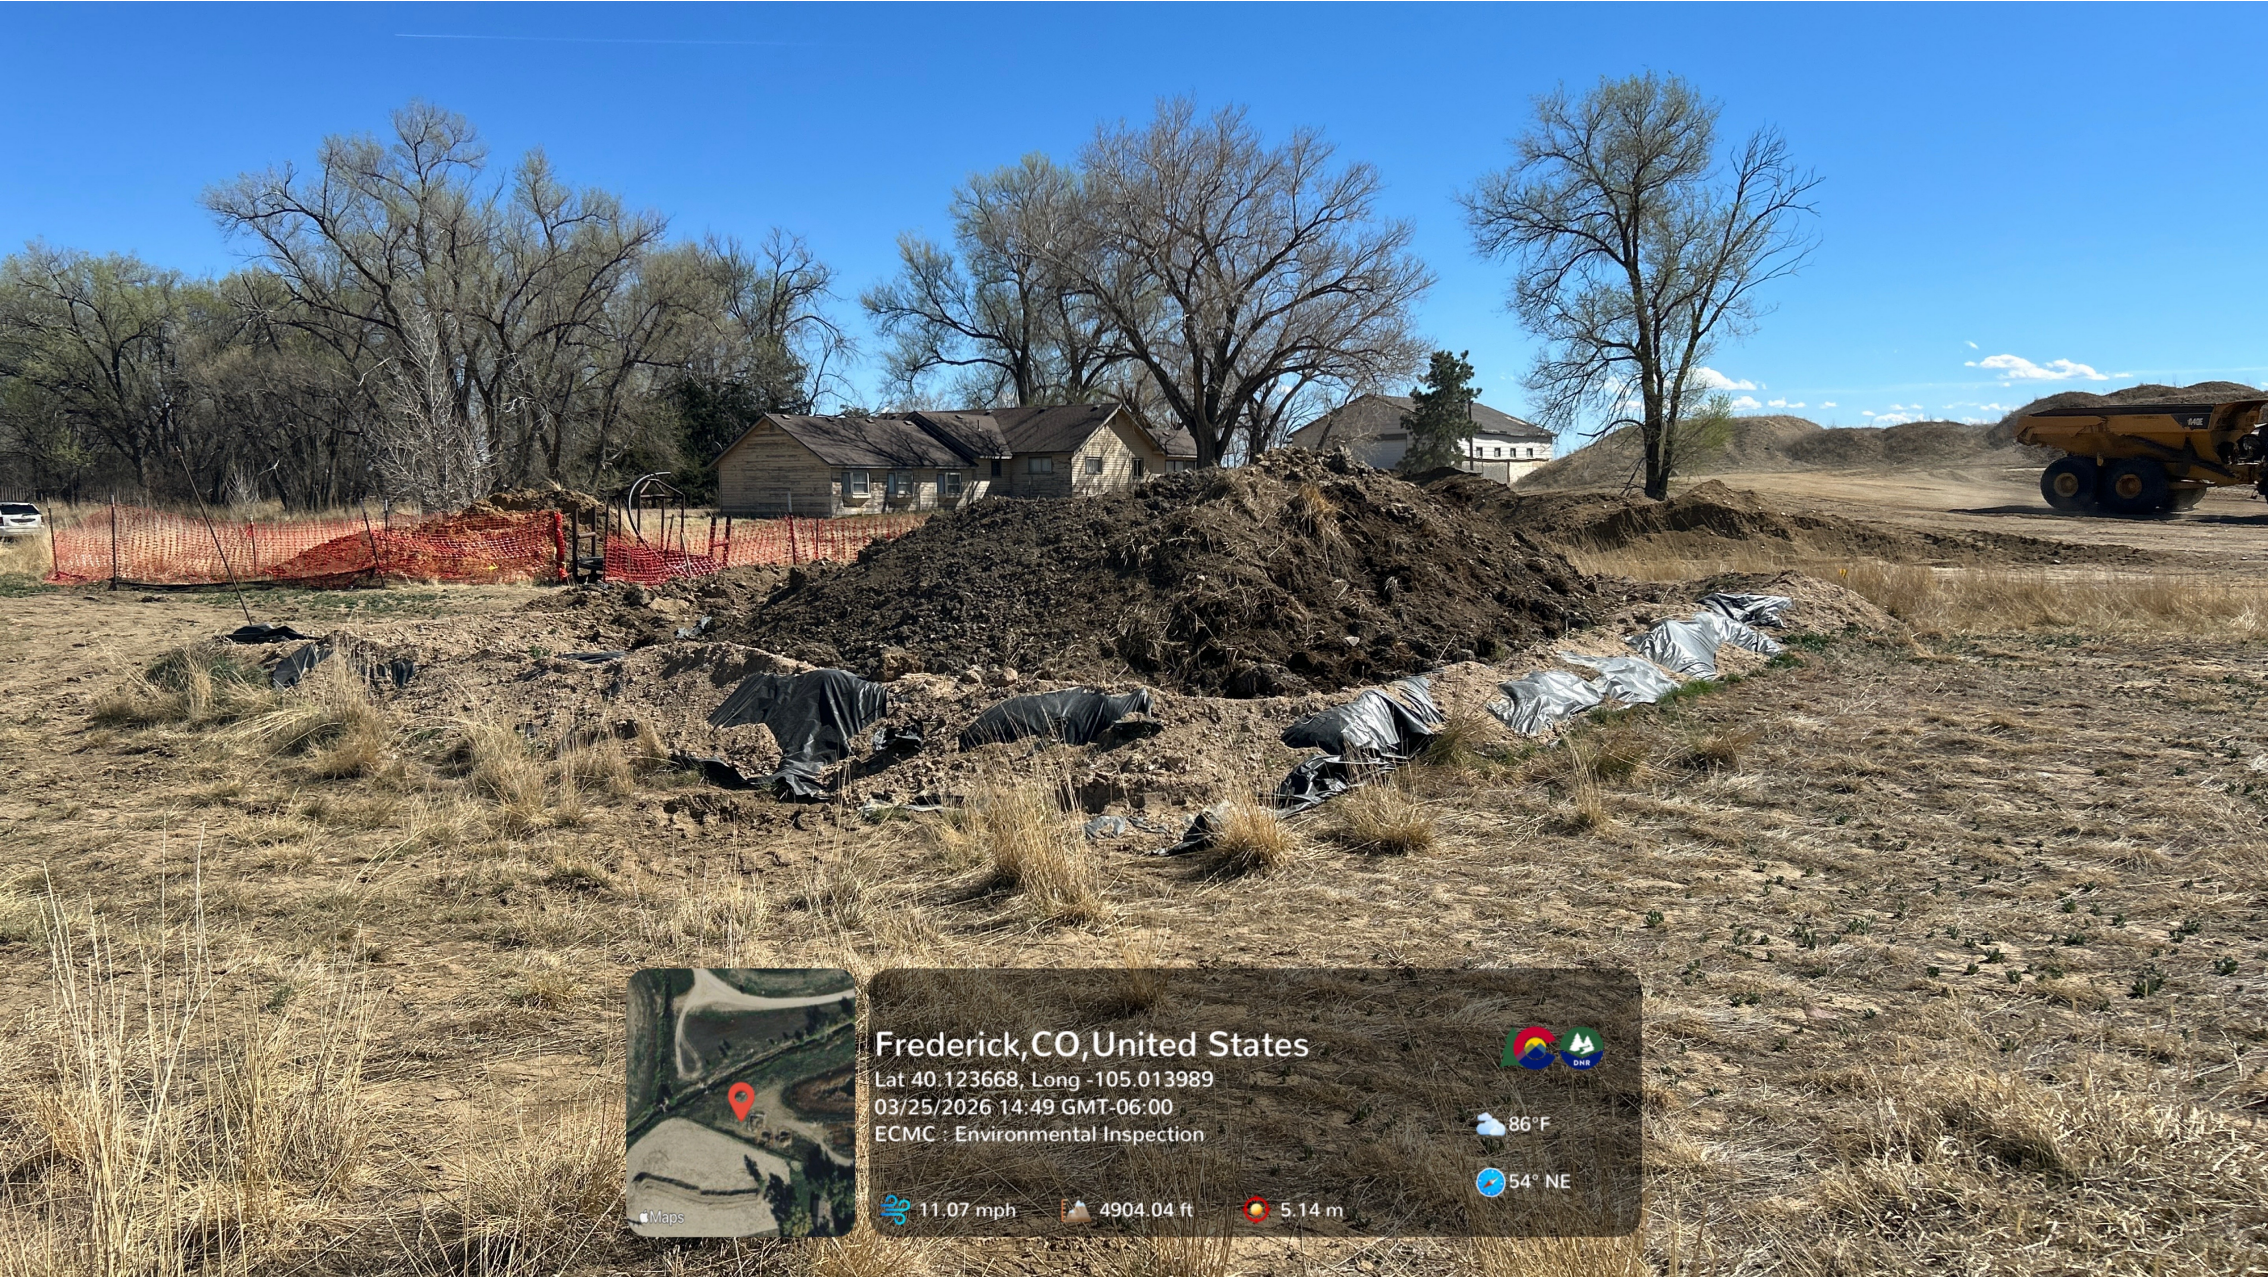
Looking at a soil stockpile marked "contaminated" (foreground) with no liner or BMPs (background, left). A liner is visible beneath the contaminated stockpile but has been compromised by holes/tears; soil has spilled outside of containment. Unused equipment is also visible in the background.
