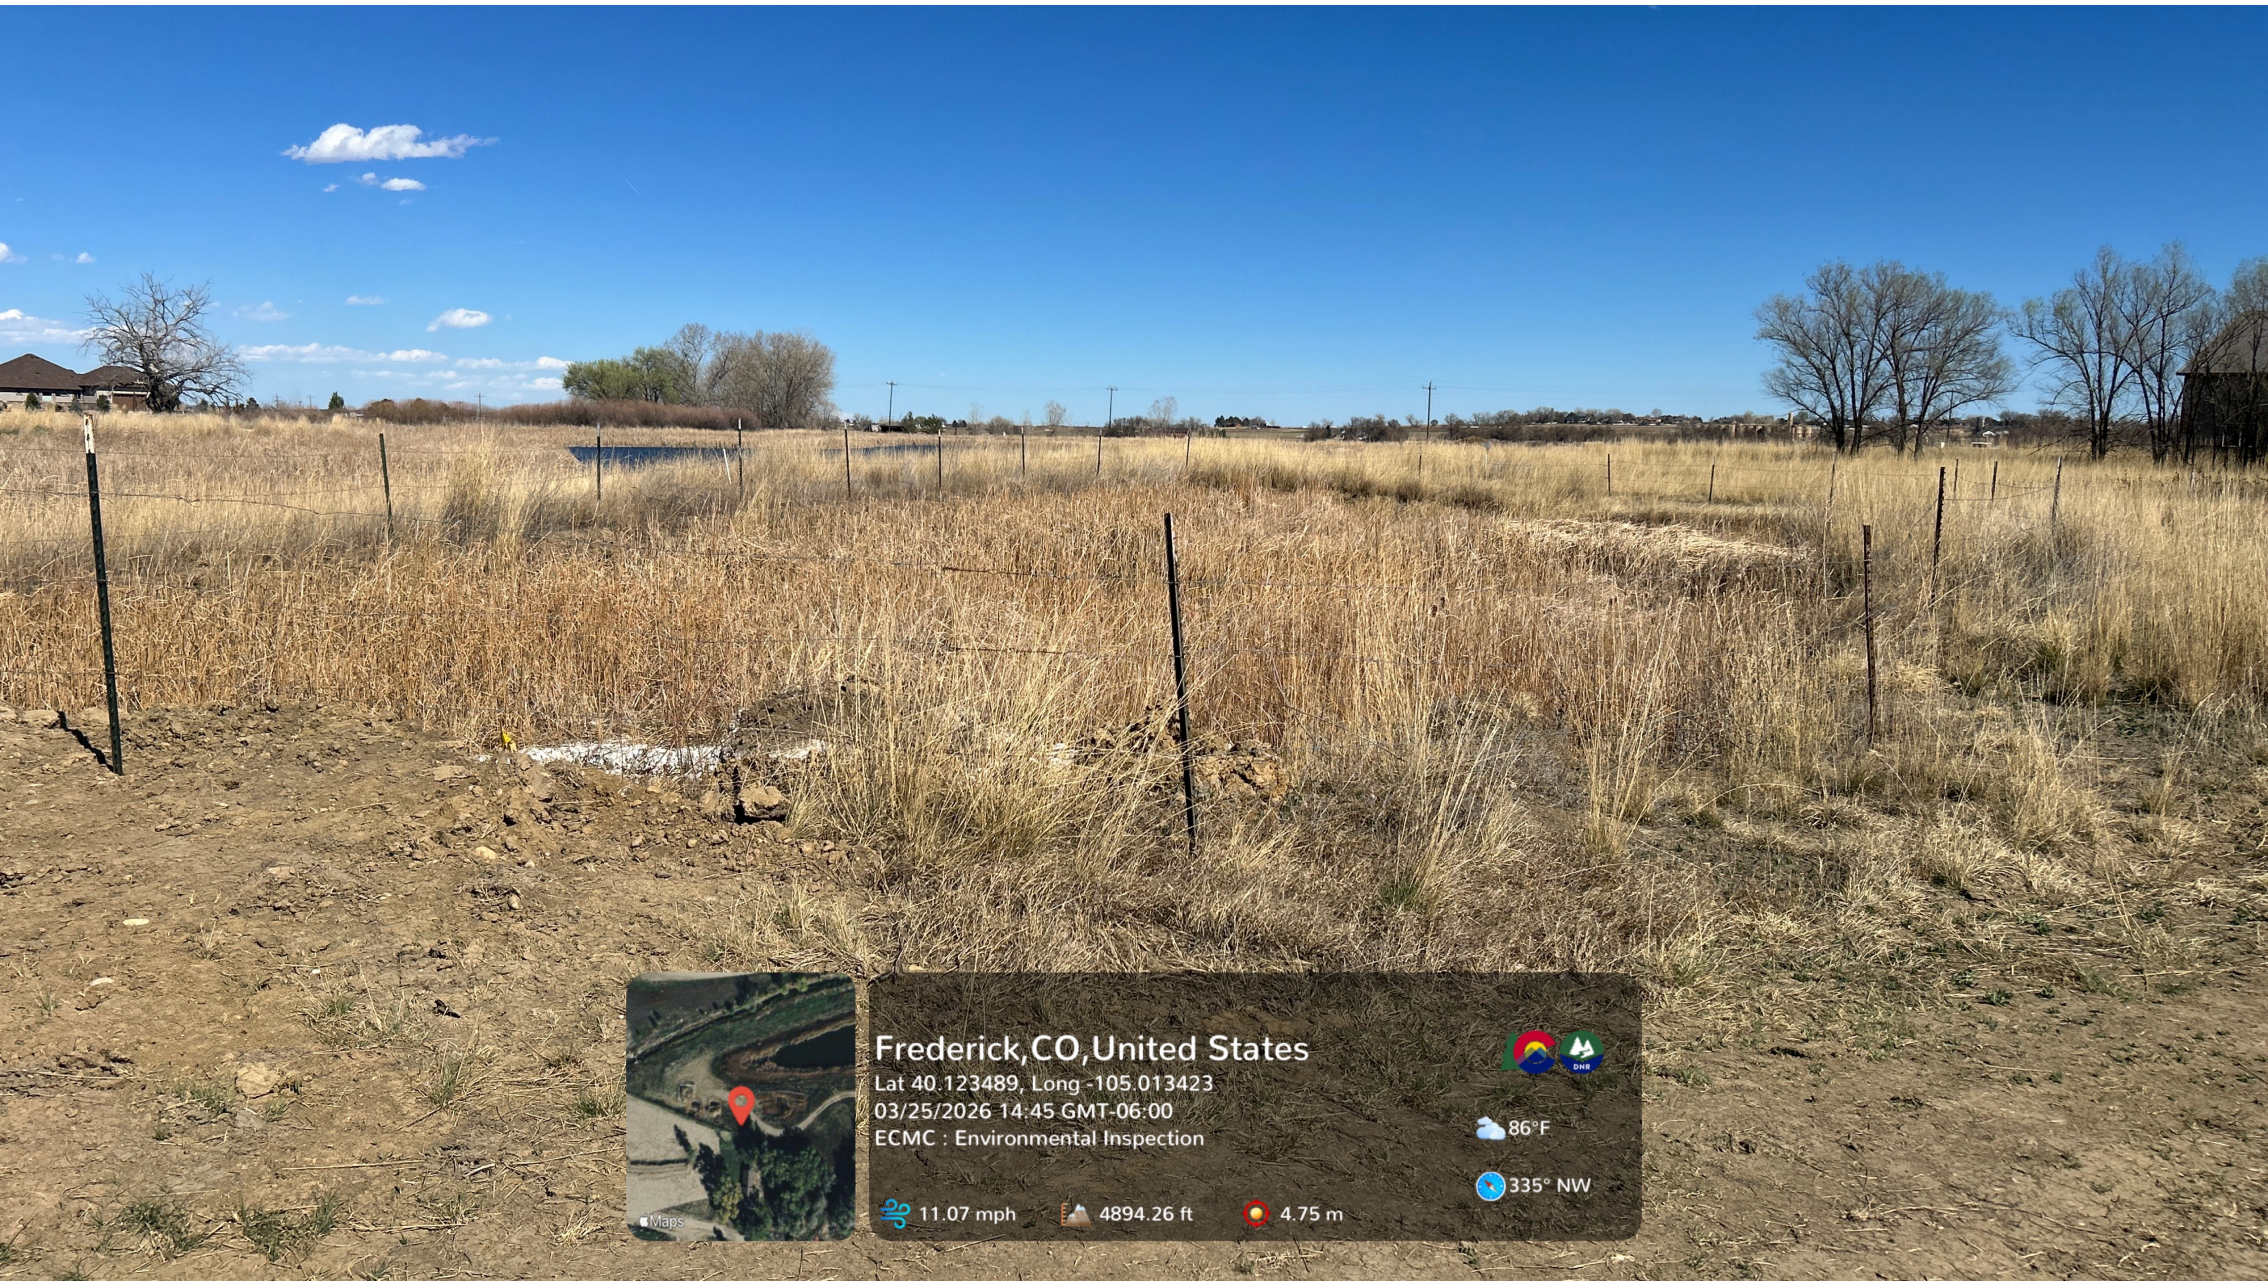
The excavation at the spill location remains open. Weeds obscure visibility of the majority of the excavation base and sidewalls. Barbed wire fencing surrounds the excavation.

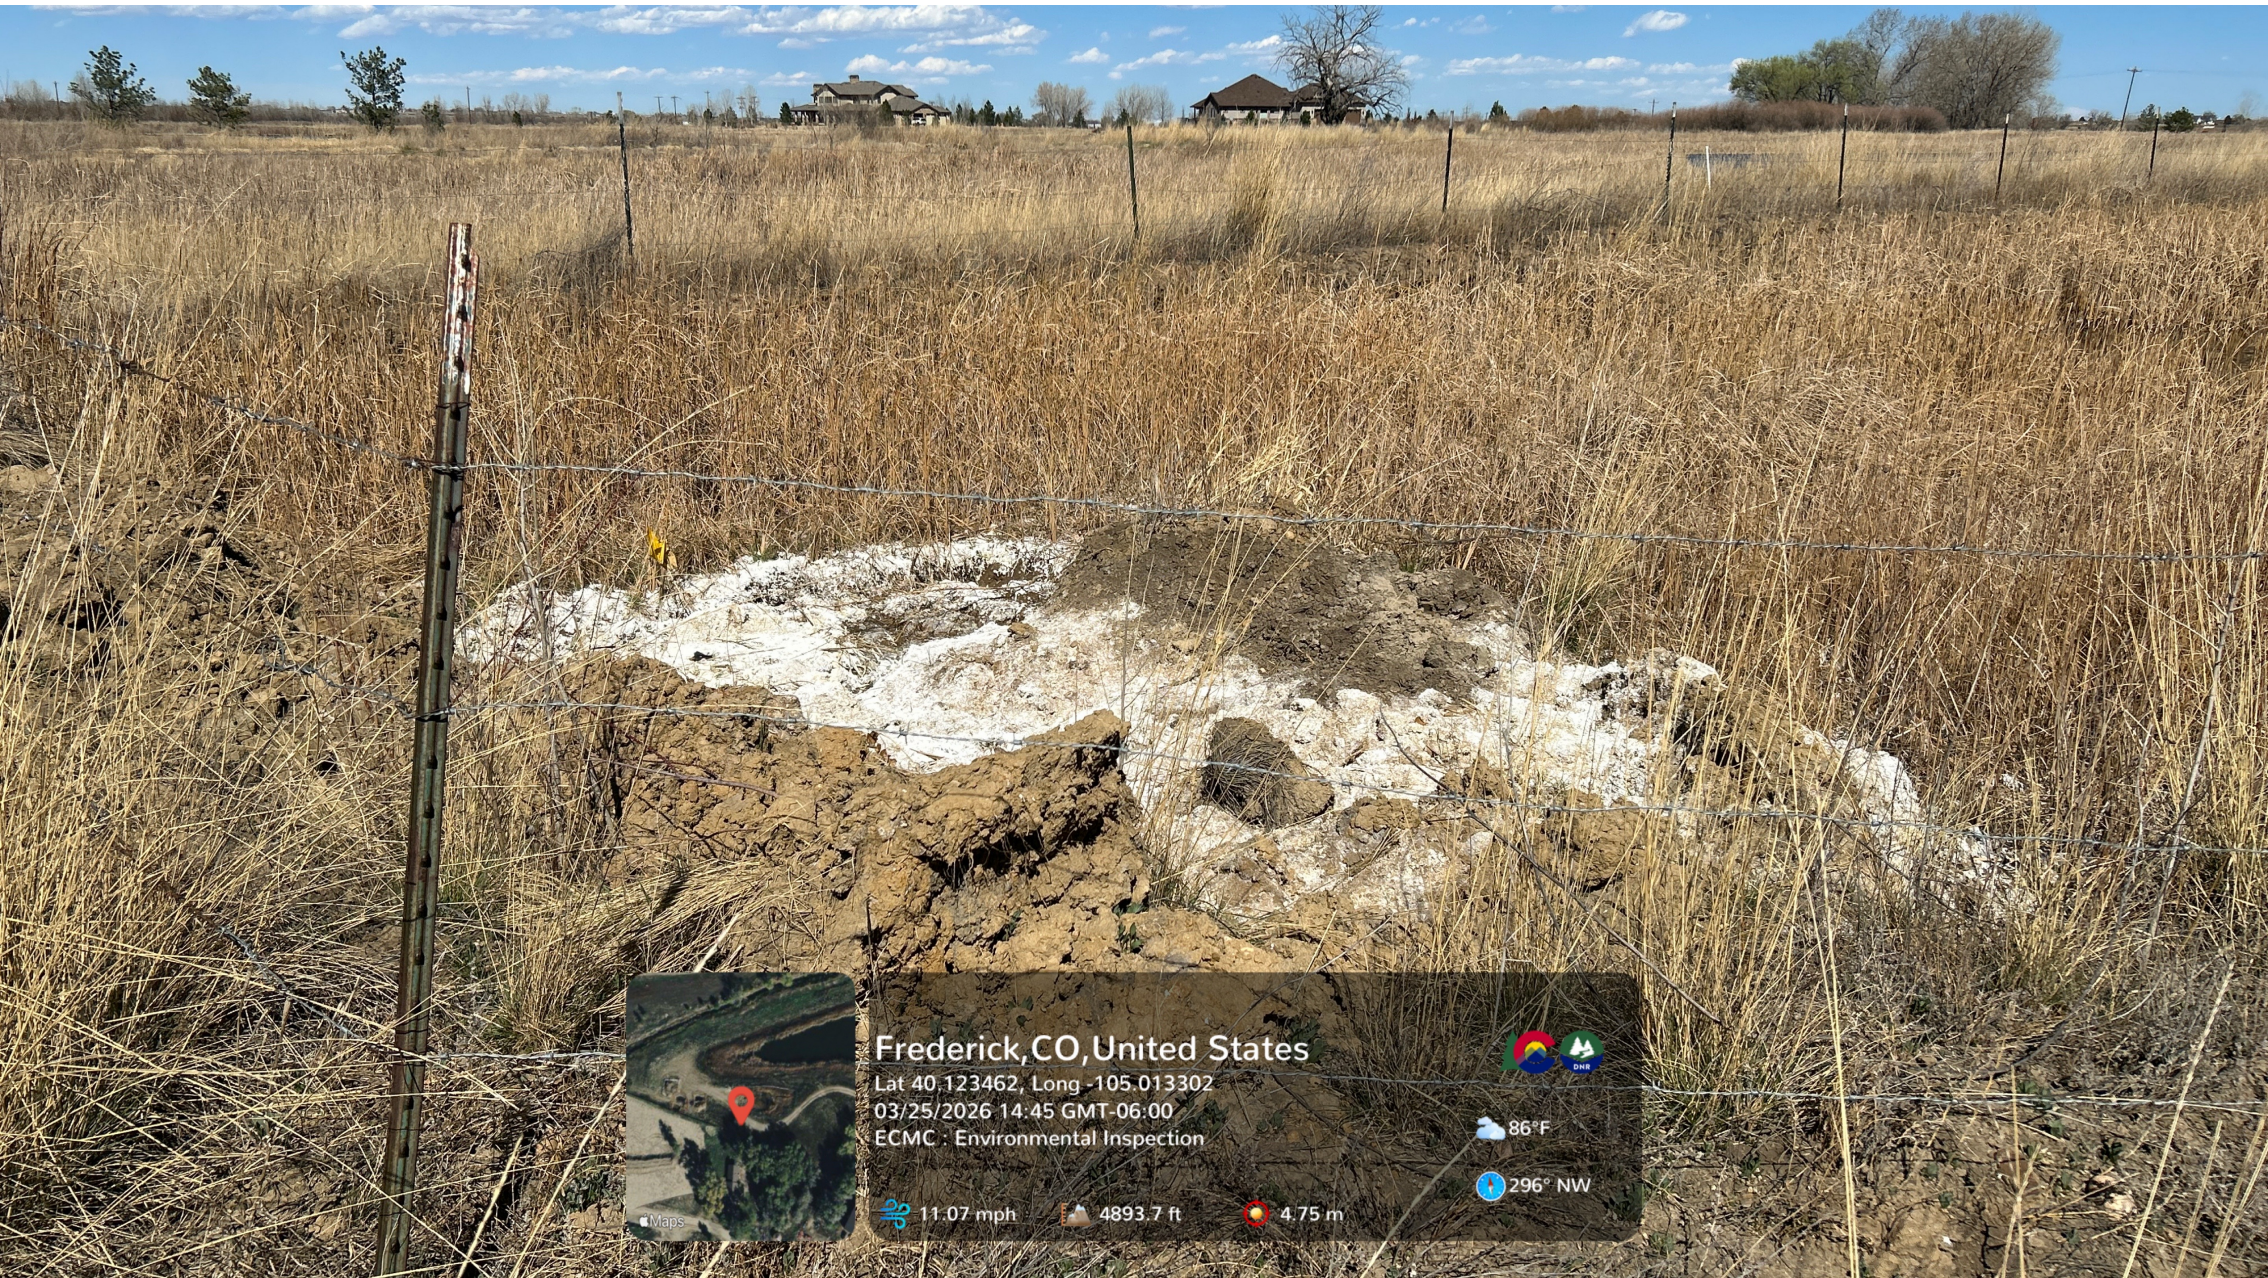
Salt crusting is visible within the excavation.

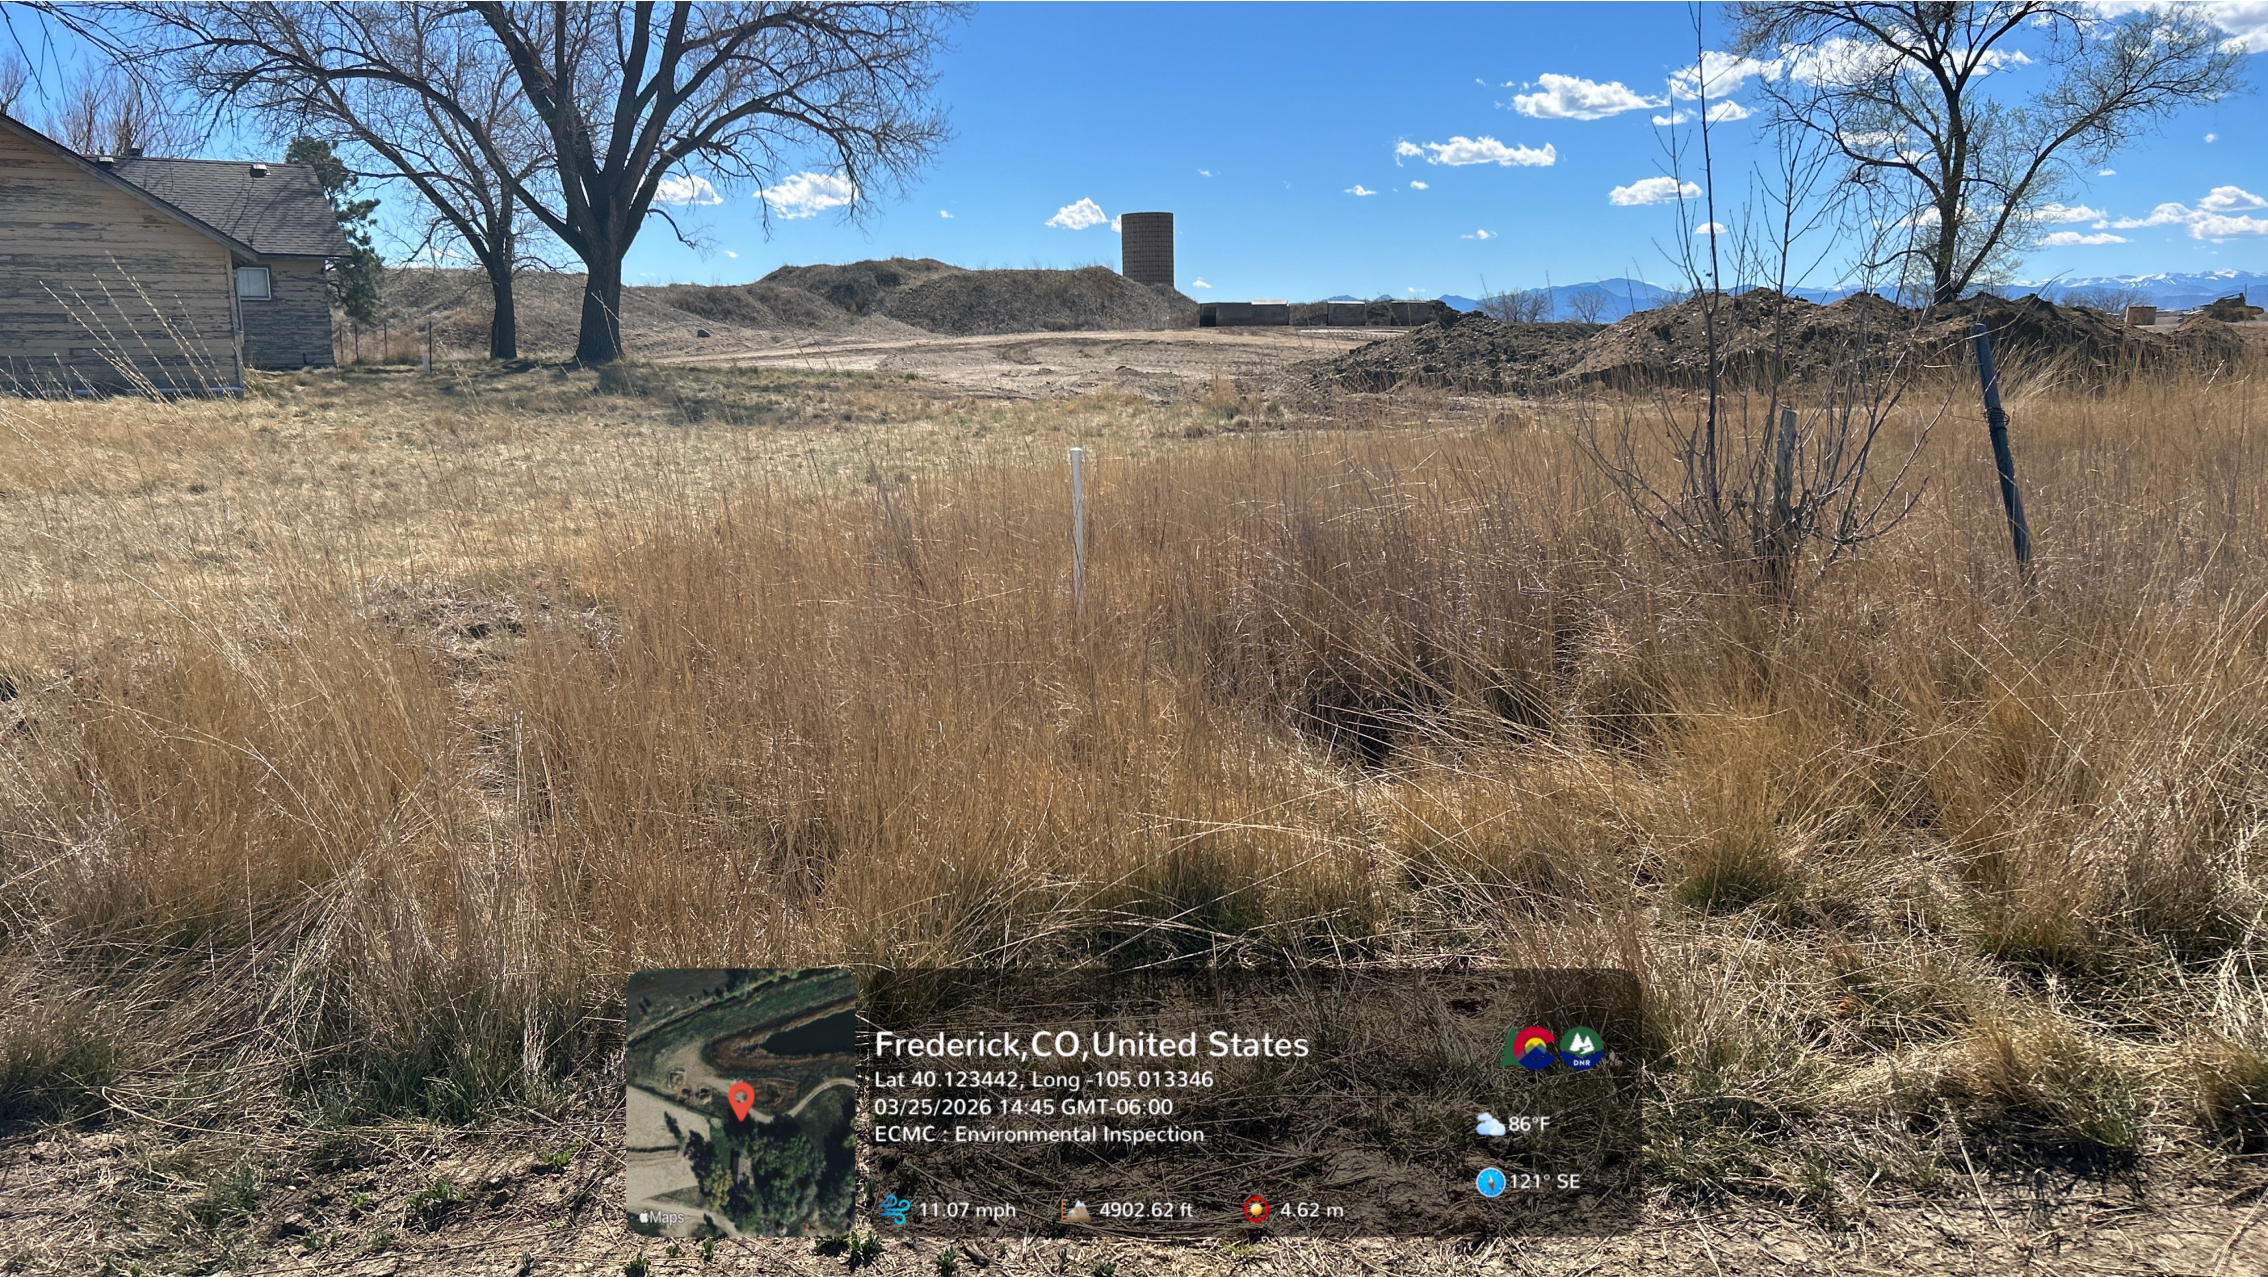
A network of monitoring wells completed as PVC stickups was observed on location.
