Inspection Photos

Location Name: Hilcorp Animas 34-10-M34N10W #36NWSE

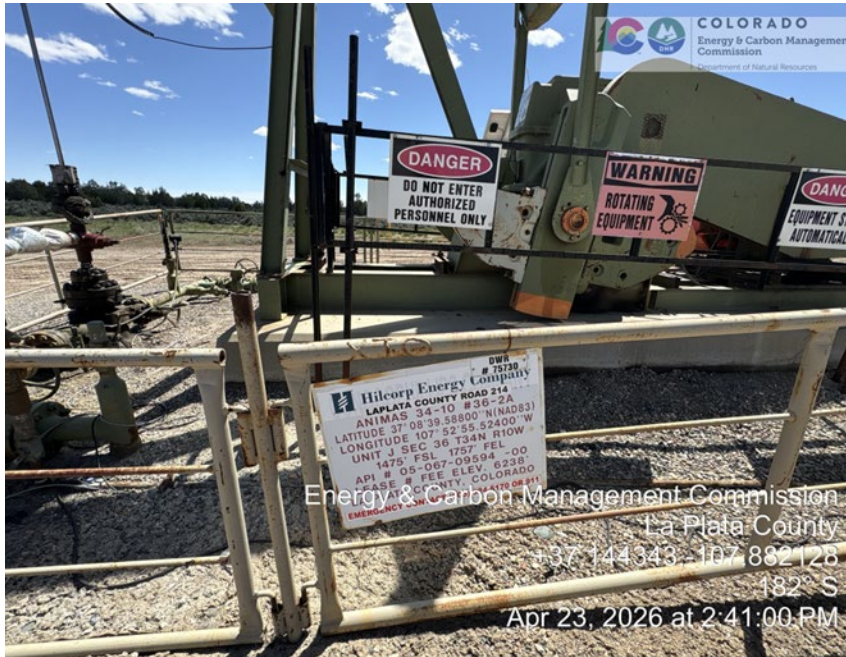
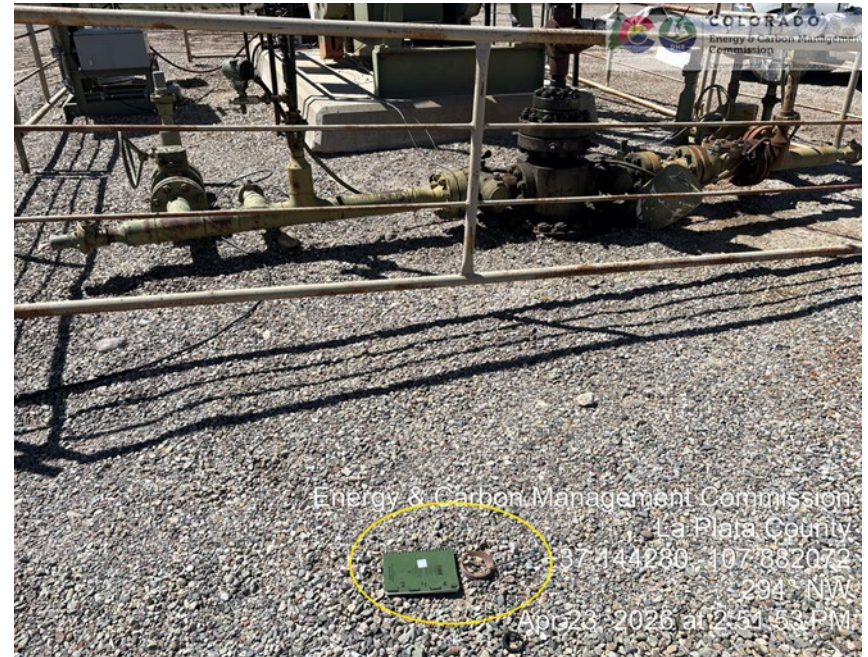
Inspection Photos
Location Name: Hilcorp Animas 34-10-M34N10W #36NWSE
Location ID: 312052
FOLLOW UP 04/24/2026

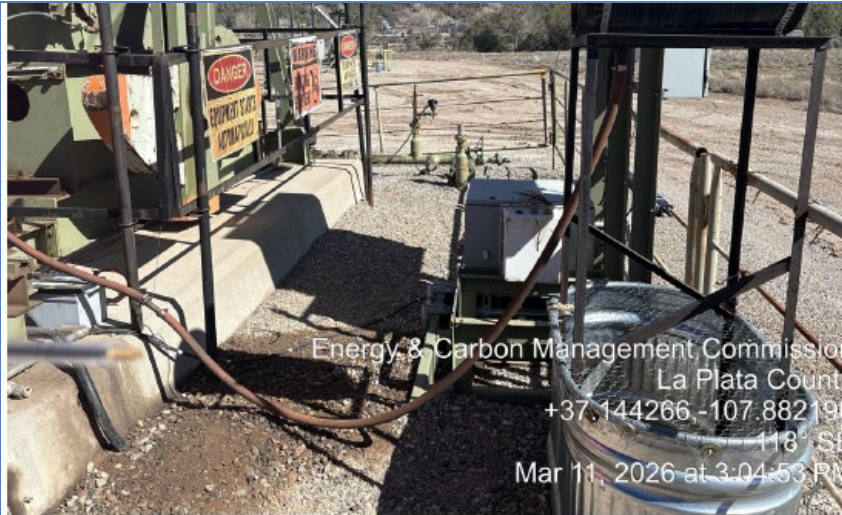
19. 36-2A lube oil tank above secondary containment. The gravity fed hose from the lube tank appears to be leaking and staining the ground, possibly from the location where two segments of hose are connected with a pipe nipple and two hose clamps.

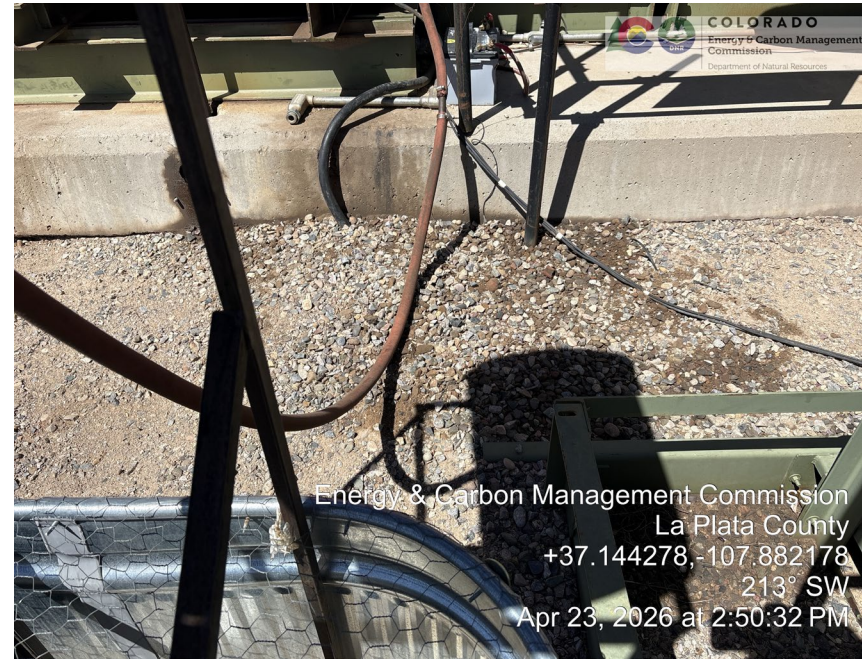
10. After. Gravel has been sprinkled over top of stained material but not cleaned up. Different angle.

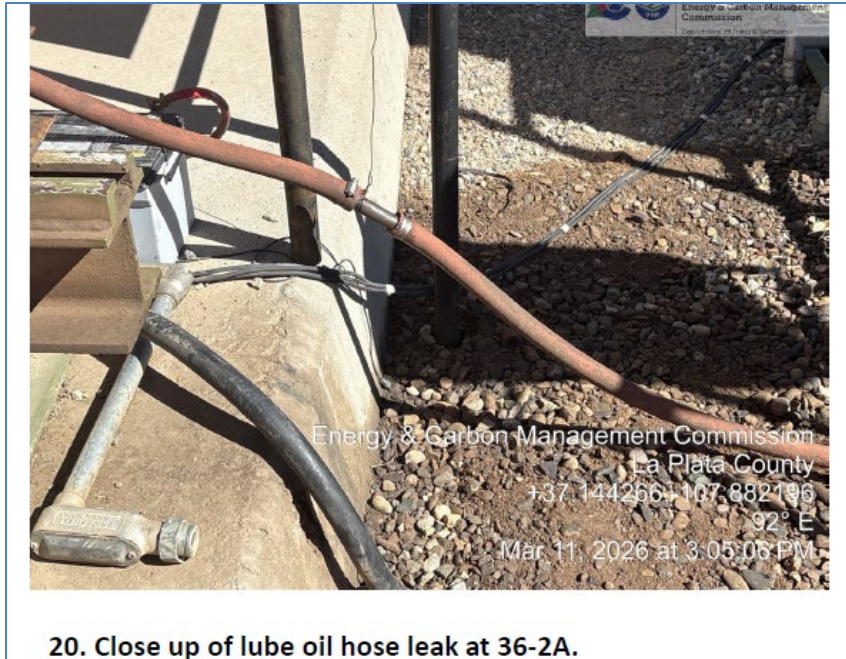
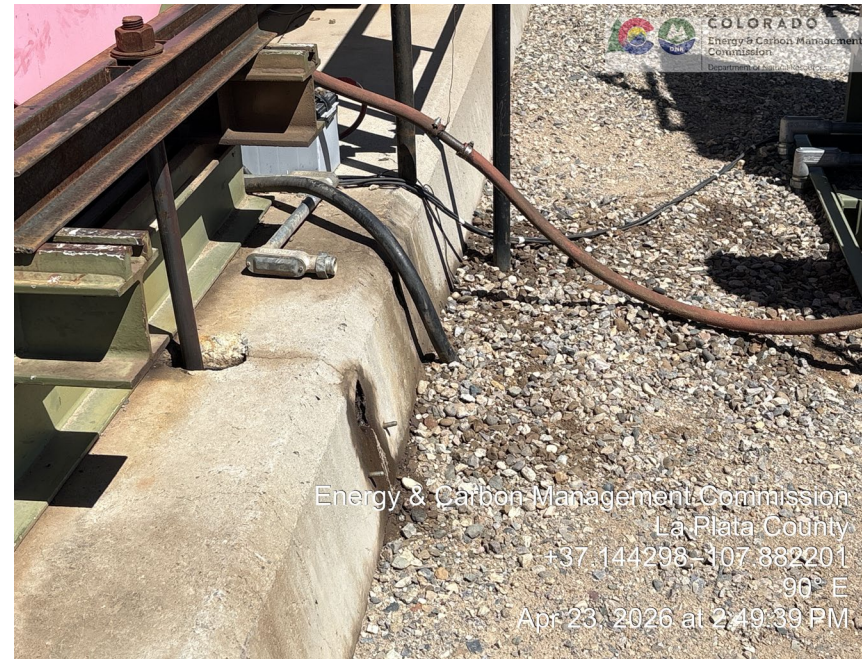
FOLLOW UP 04/24/2026

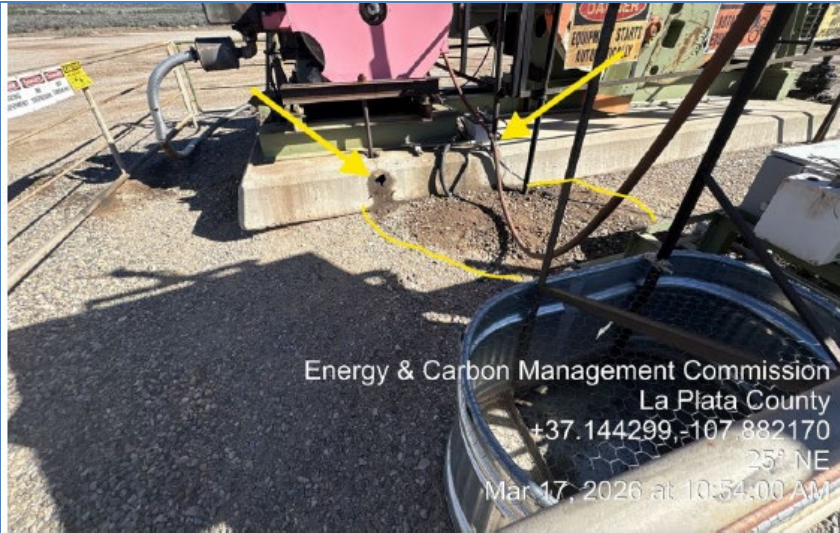
33. Lube tank hose leak and prime mover drain leak in foundation.

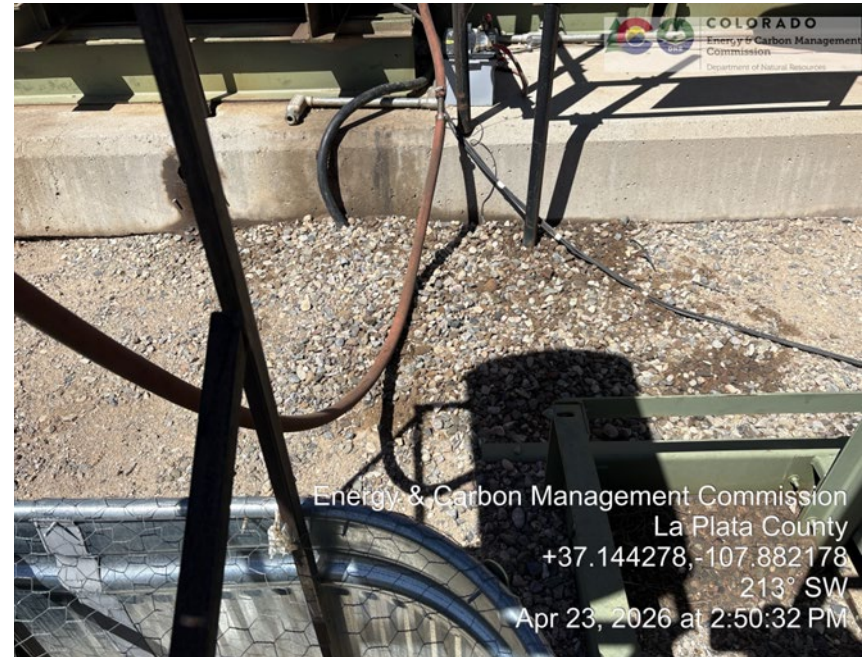
14. After. Gravel sprinkled over top, not cleaned up, leak does not appear to be repaired.

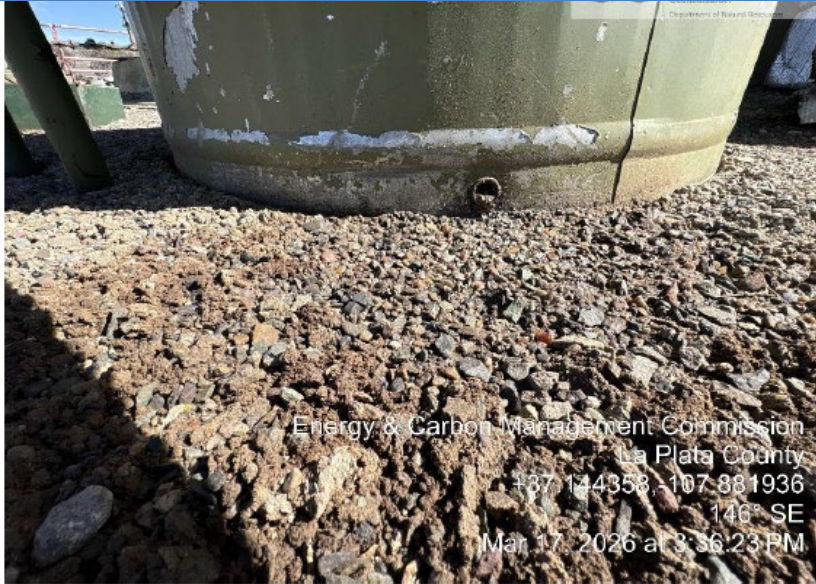
39. Drain plug missing from lube oil tank at 36-1A

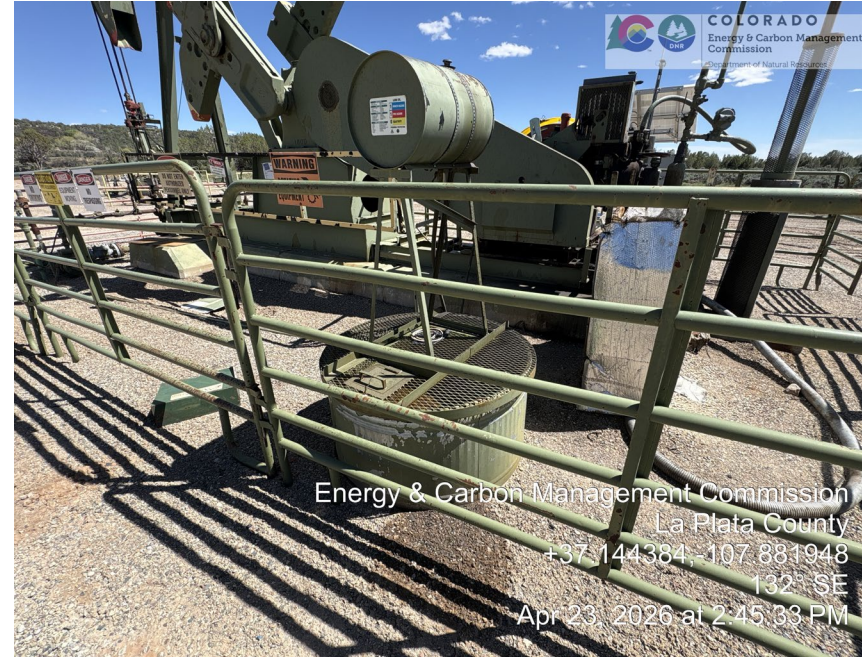
16. After. Stain not cleaned up. Plug still missing.

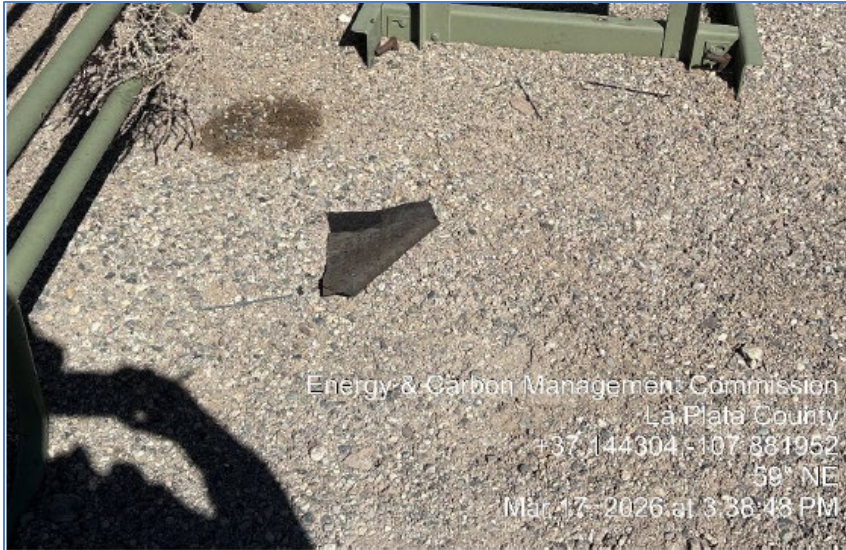
42. Example of trash including absorbent pads, zip tie ends. Vegetative debris. Oil stained gravel.

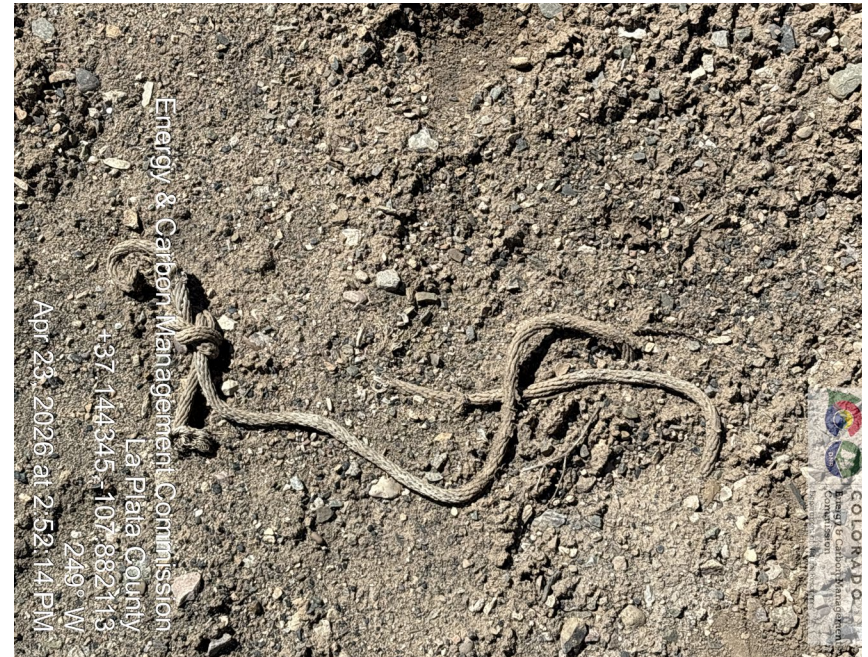
20. After. Different example of trash on pad. Previous example may have blown away.

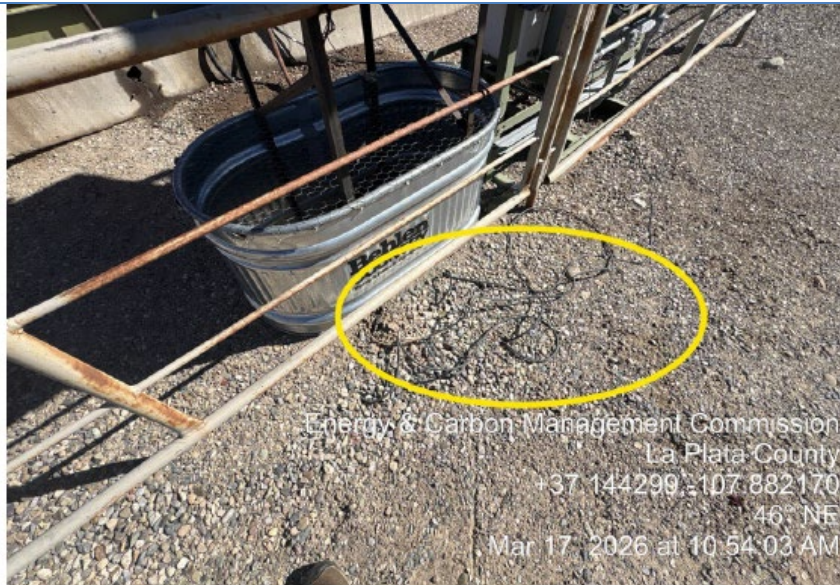
34. Loose/frayed wires.

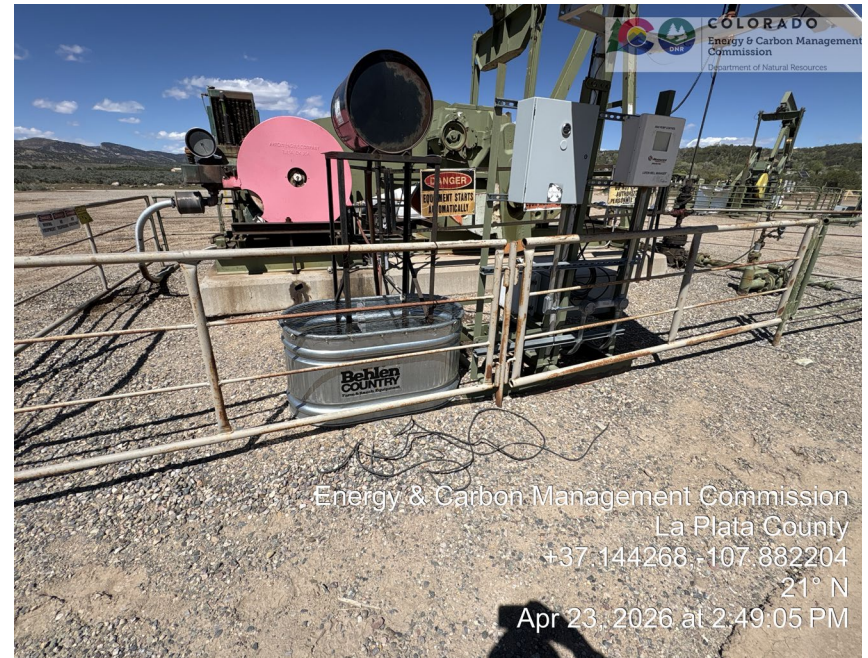
28. After. Wires remain on ground.

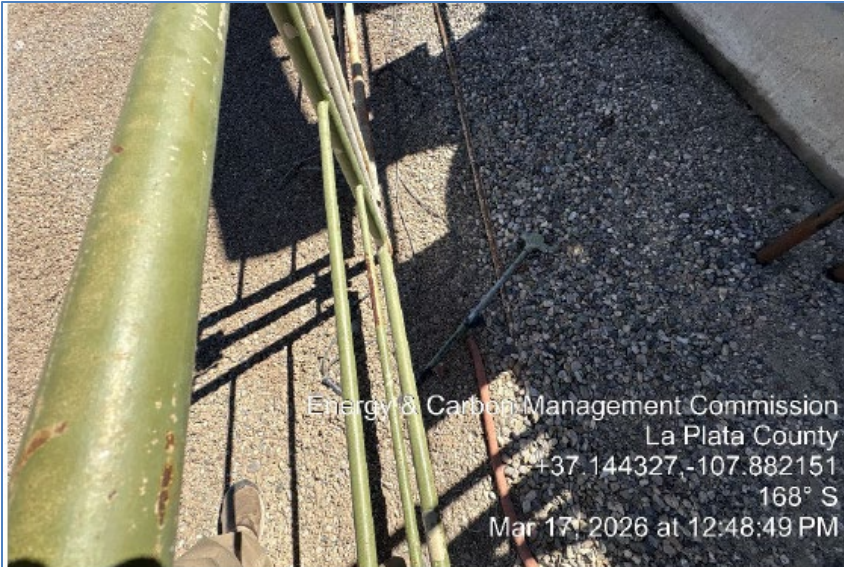
40. Conduit and loose wire at 36-1A.

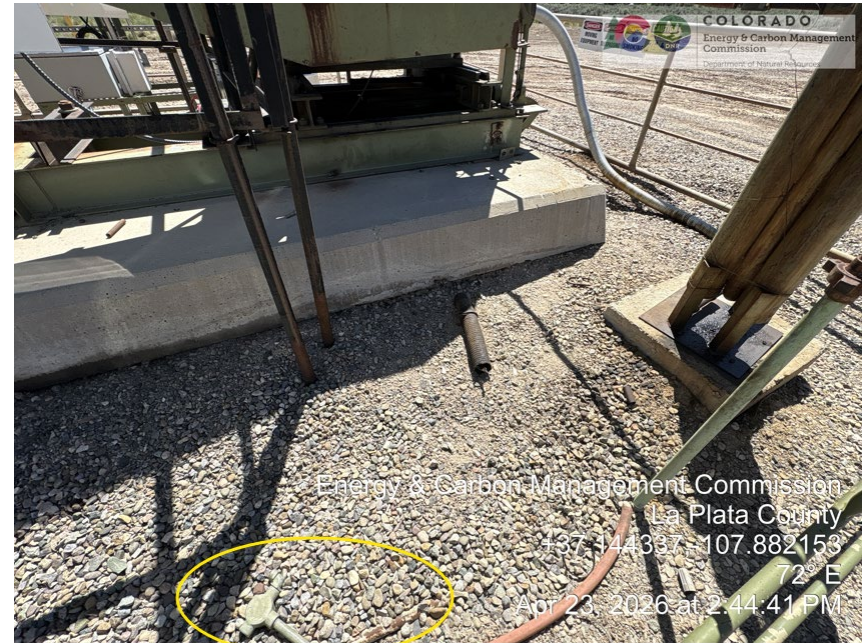
30. After. Conduit and wires remain on ground. Different angle. Same conduit in yellow circle.

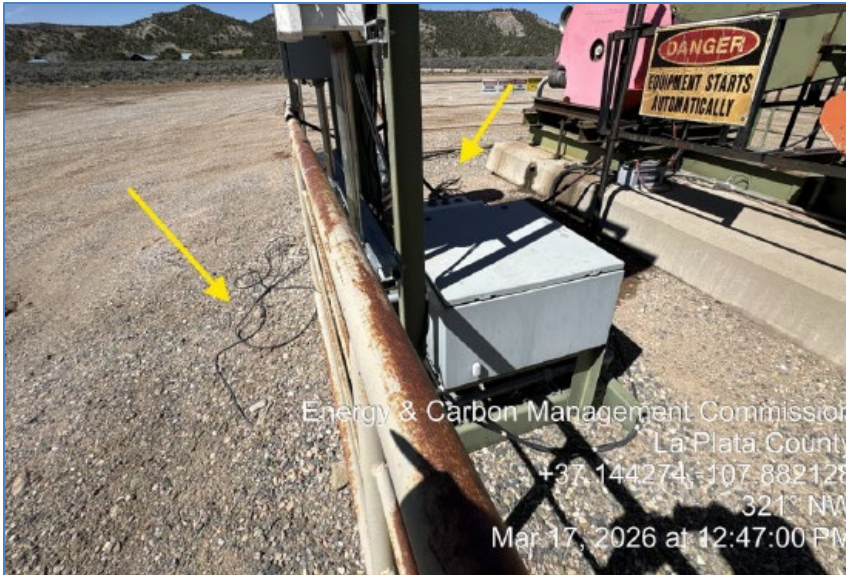
41. Loose/frayed wire at 36-2A telemetry.

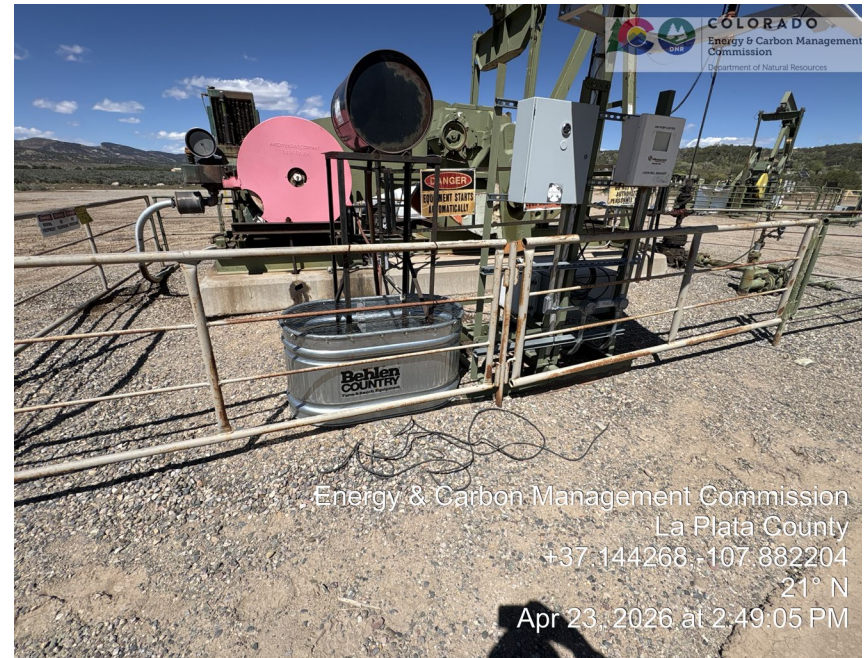
32. After. Same wires, different angle.

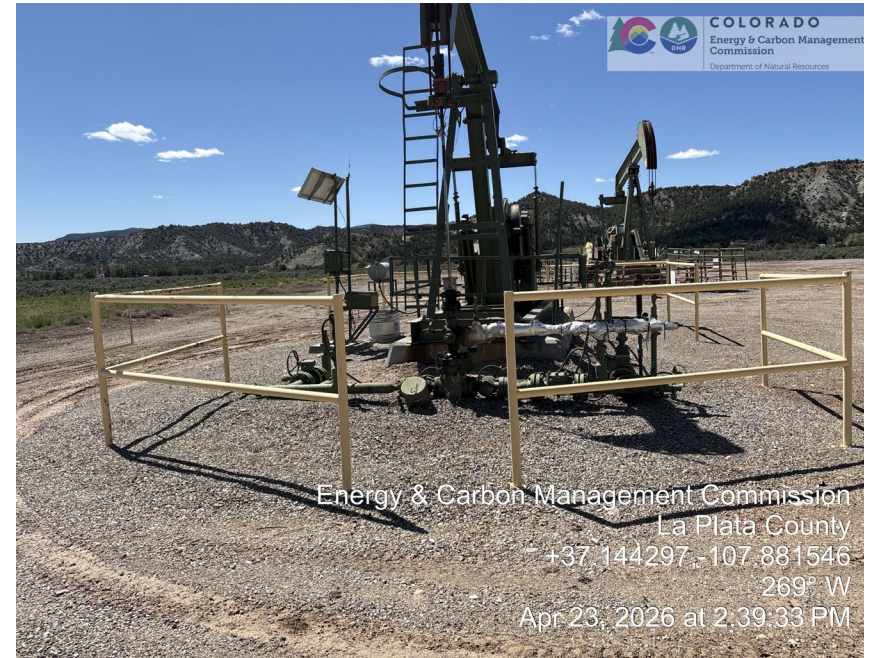
34. After. Leakage appears to have stopped. Photo 49 of this report is a zoomed and cropped version of this photo that shows better detail.

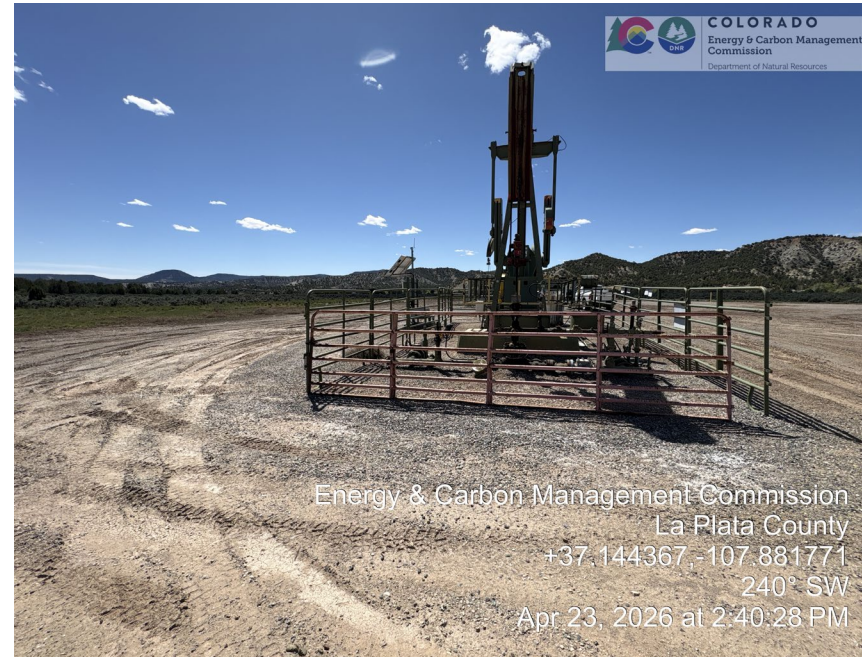
36. After. Leak from wellhead has been resolved. Mineralized crust appears to have been removed for the most part.

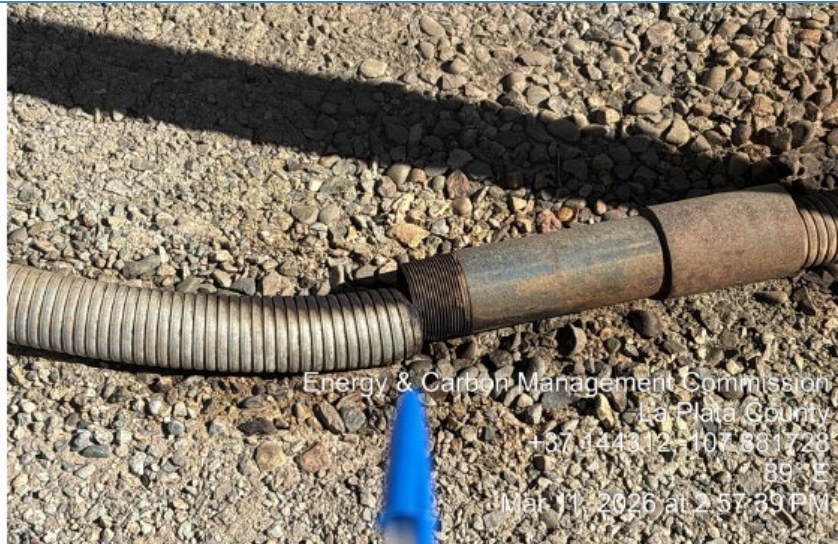
11. Close up of broken exhaust hose at 36-1. Hose appears to be resting next to and not attached to 2" NPT pipe nipple and union being used to connect 2 segments of flex hose.

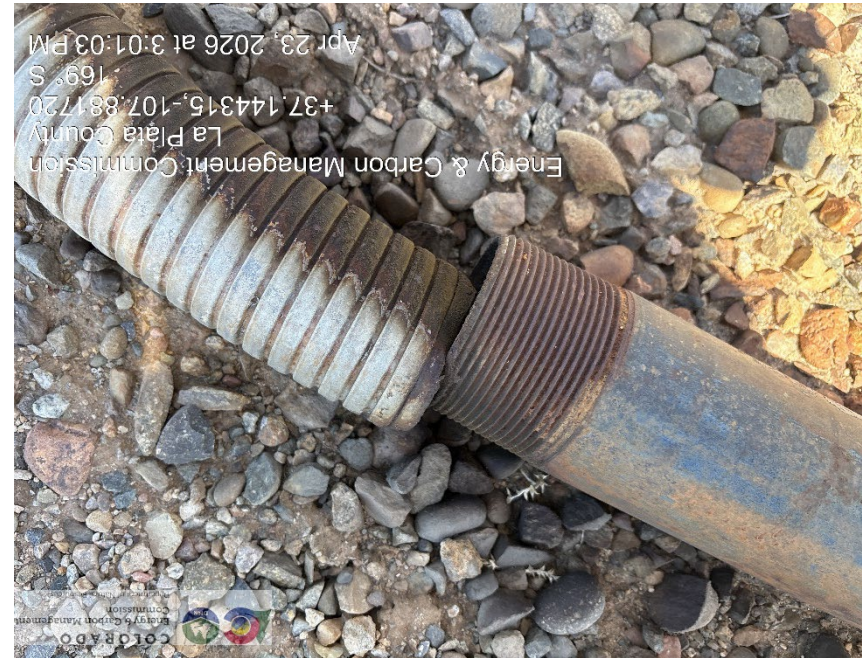
38. After. Exhaust not repaired.

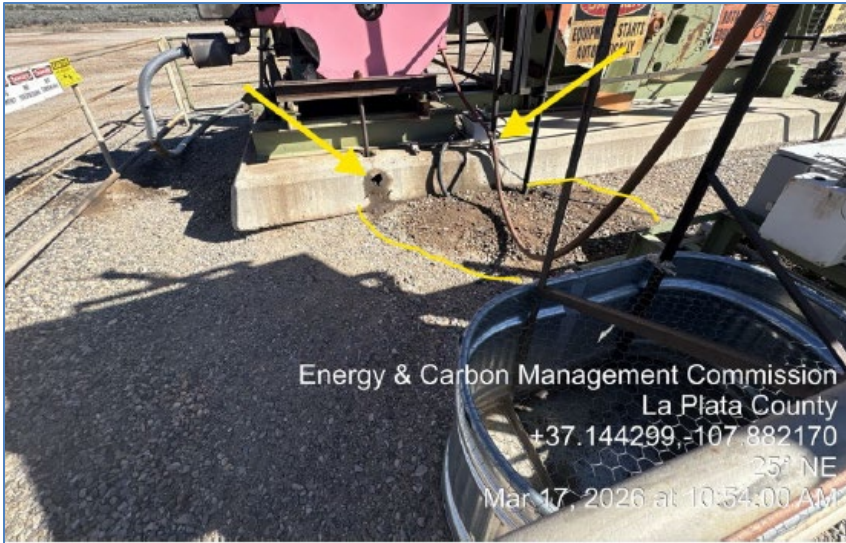
33. Lube tank hose leak and prime mover drain leak in foundation.

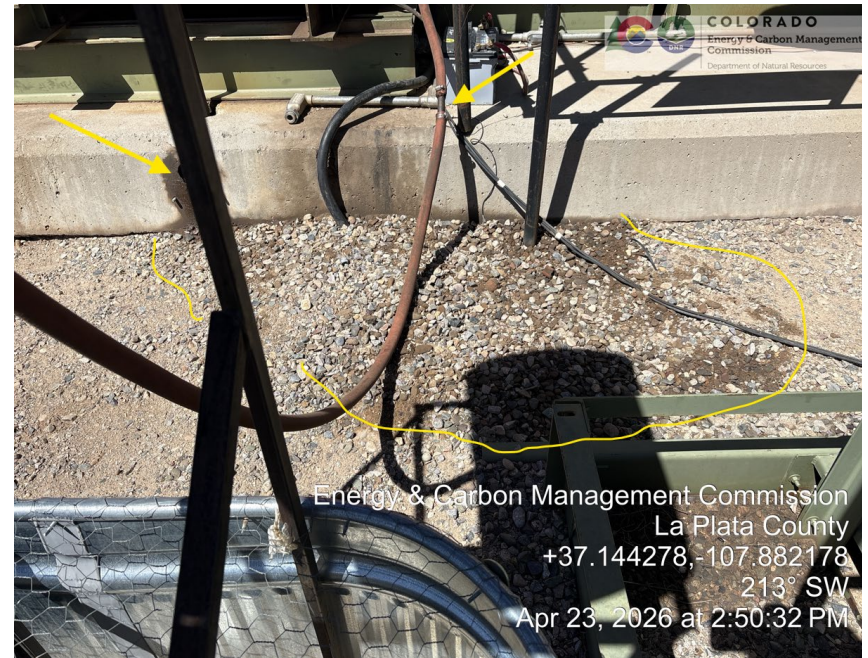
42. After. Oil stain remains with gravel sprinkled over top. Oil still leaking from hole in foundation and from joint in hose.

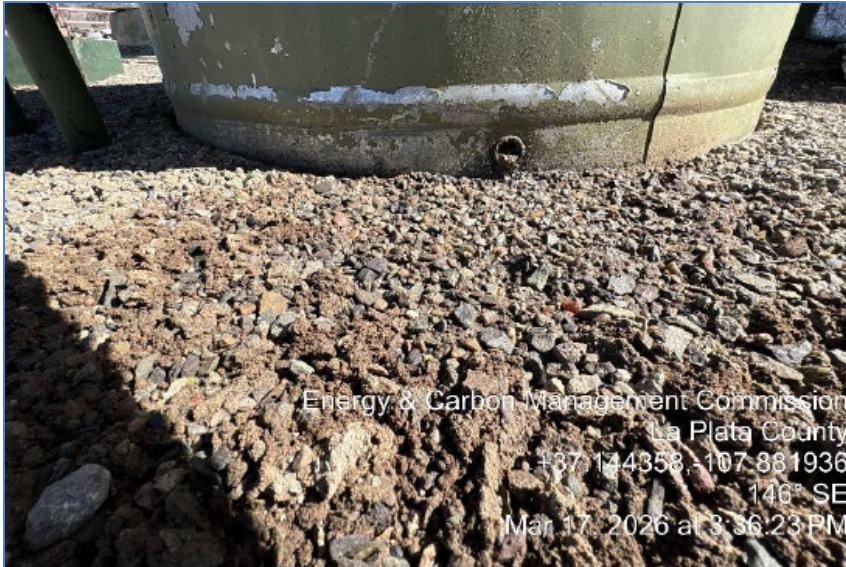
39. Drain plug missing from lube oil tank at 36-1A

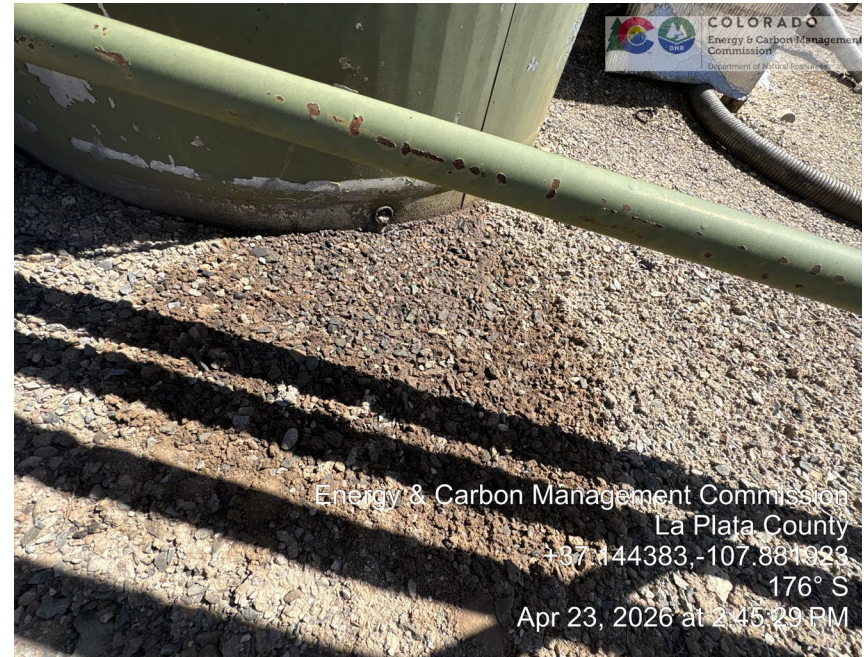
44. After. Drain plug remains missing. Soil remains stained.
