## Inspection Photos

Operator: **AMERICAN HELIUM OPERATING LLC - 10841**

Location Name: **STATE 1-36H**

API #: **05-113-06047**

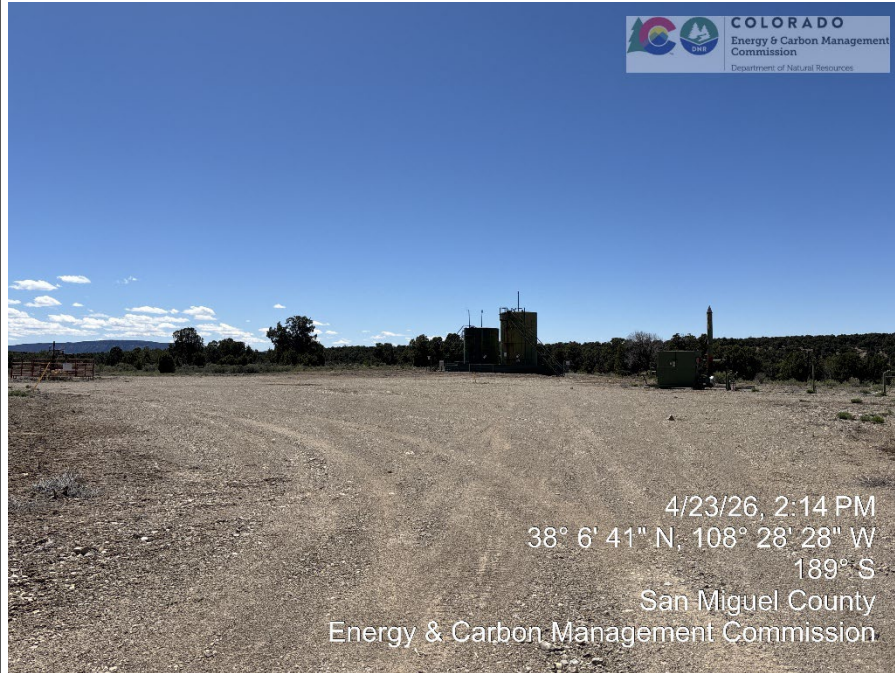
**Location overview looking S**

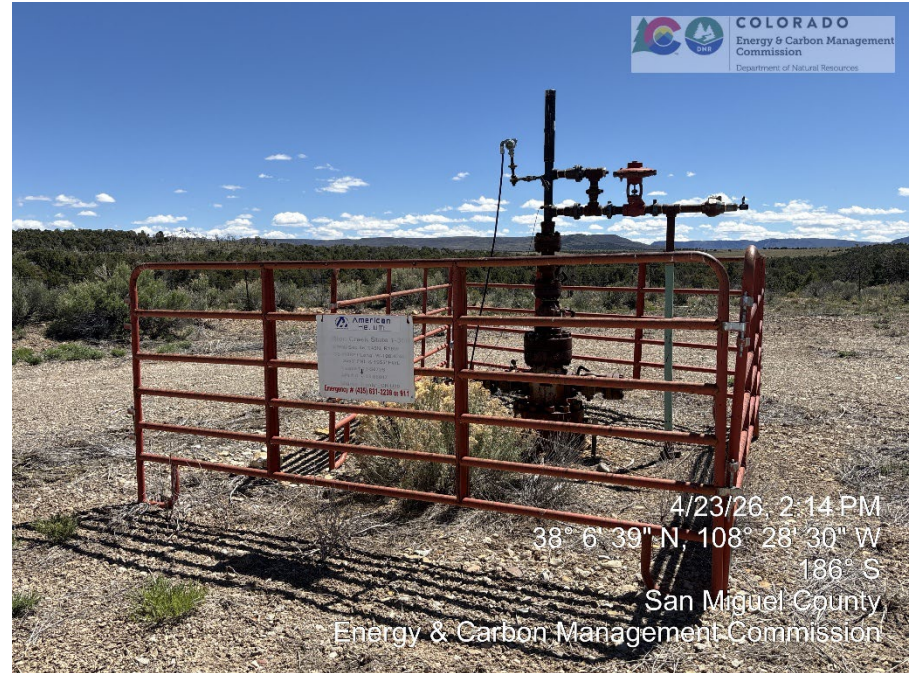
**Wellhead with fence and sign**

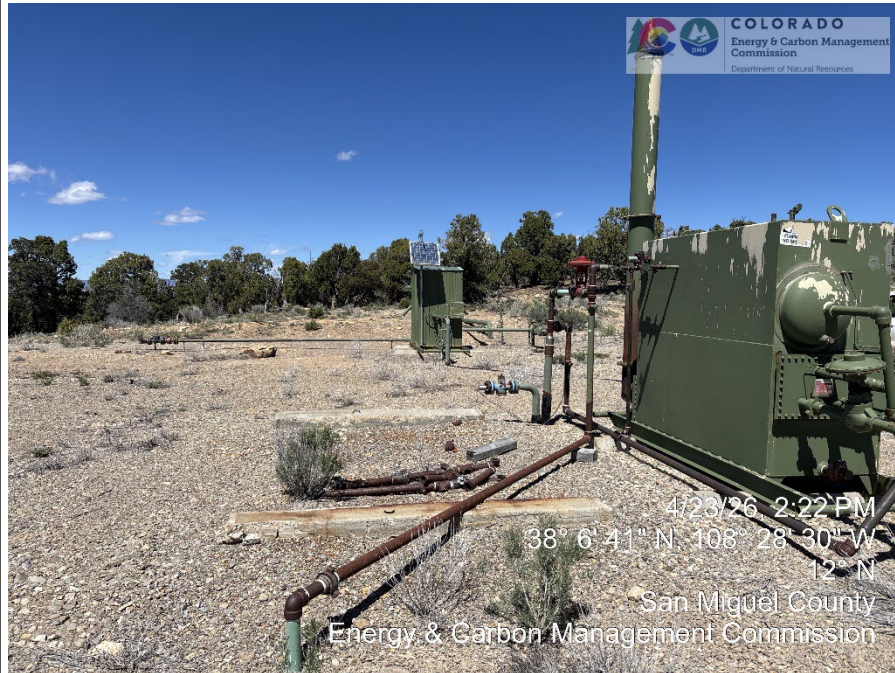
**Separator and Meter housing  
Disconnected and blind flanged**

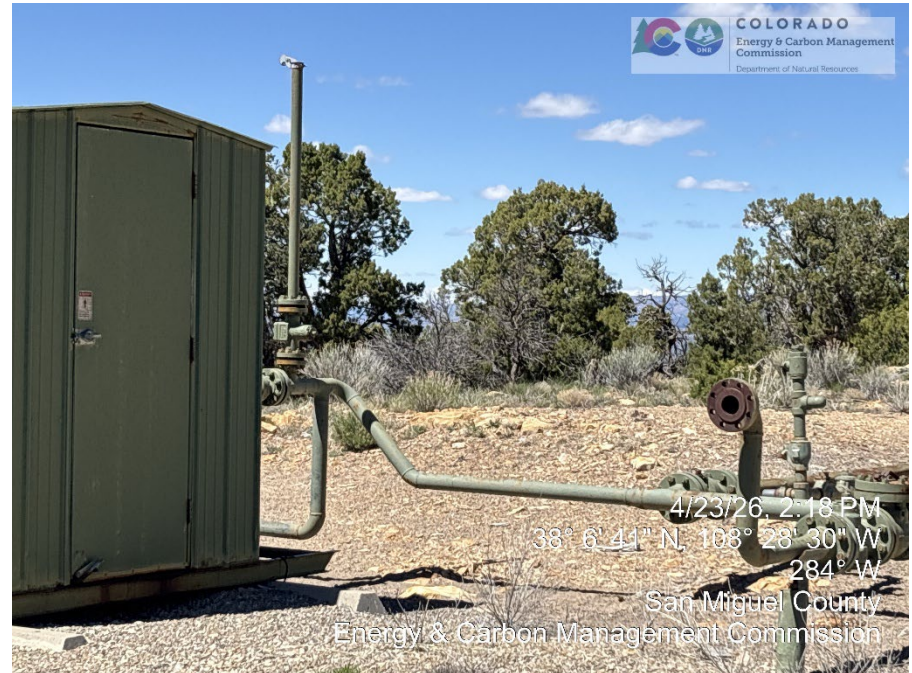
**Open ended flowline at meter housing**

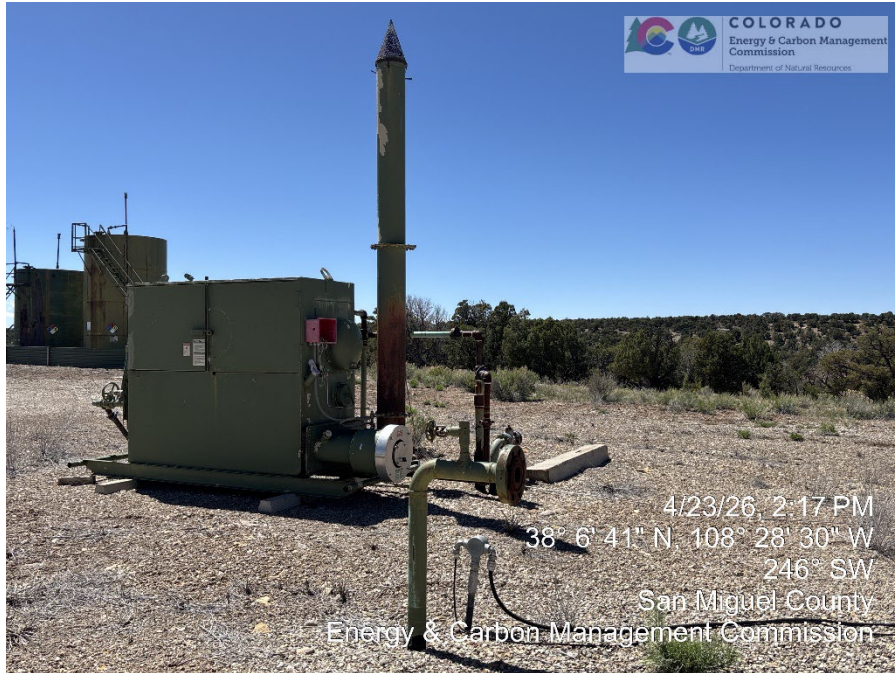
**Open ended flowline at separator**

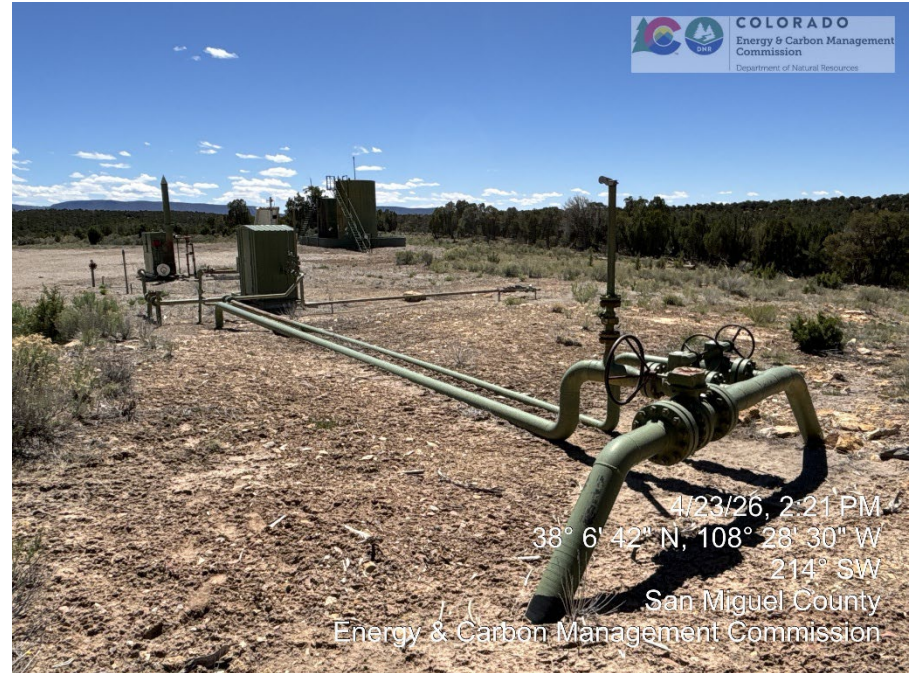
**Off location flowline**

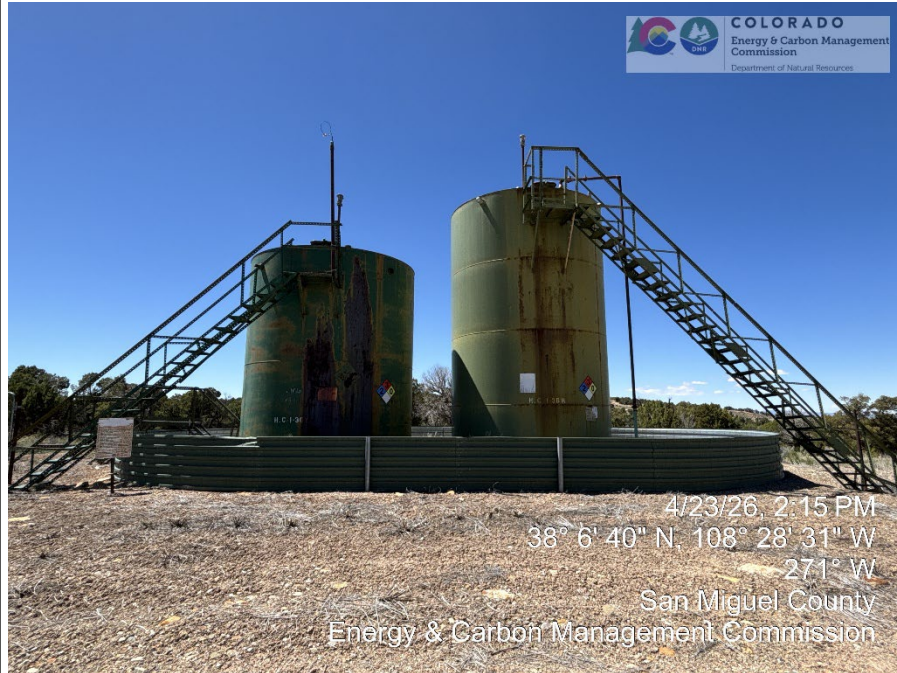
**Tank Battery**

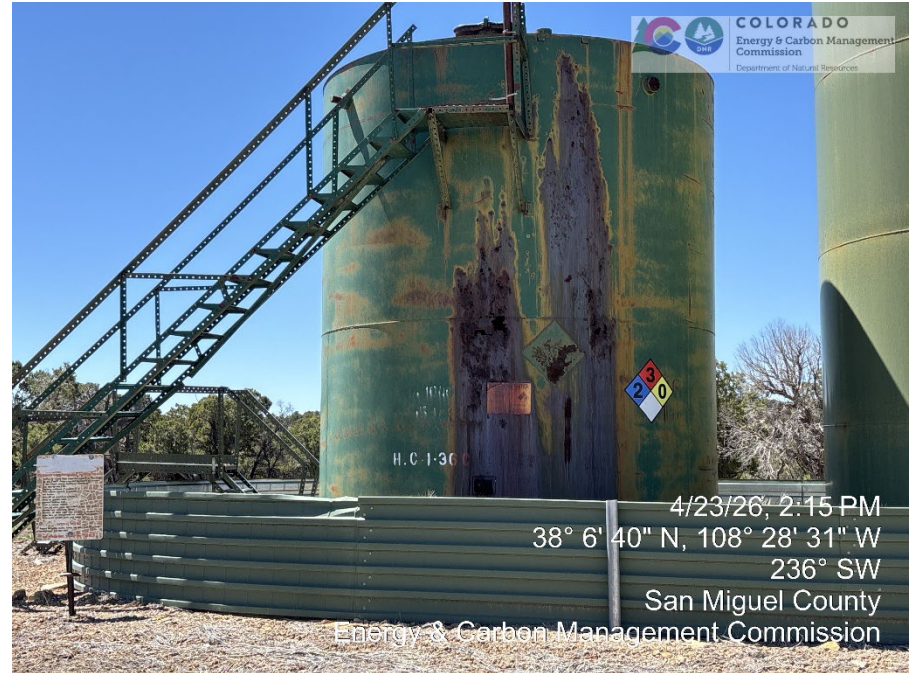
**Tank with rust holes**
