Inspection Photos

Location Name: Enduring Resources Indian Creek Wheeler 12U-4

Location ID: API 05-067-08658

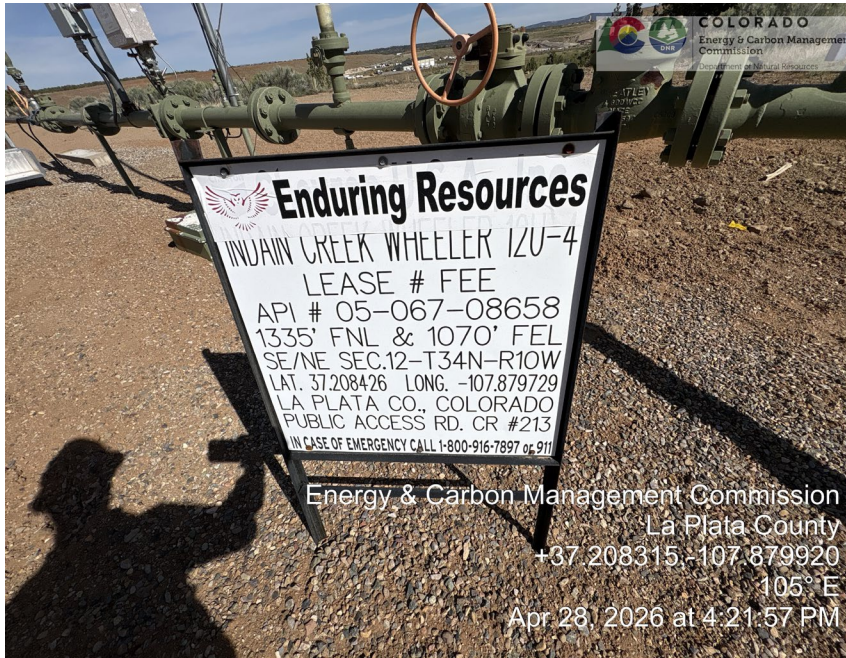
1. Well sign.

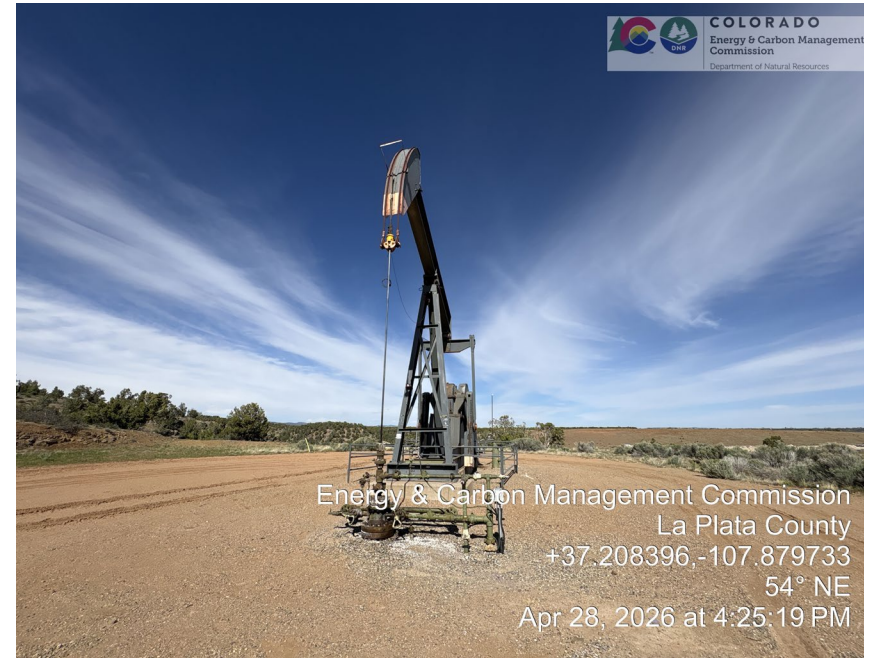
2. Pump jack and wellhead. Note mineral crust near base

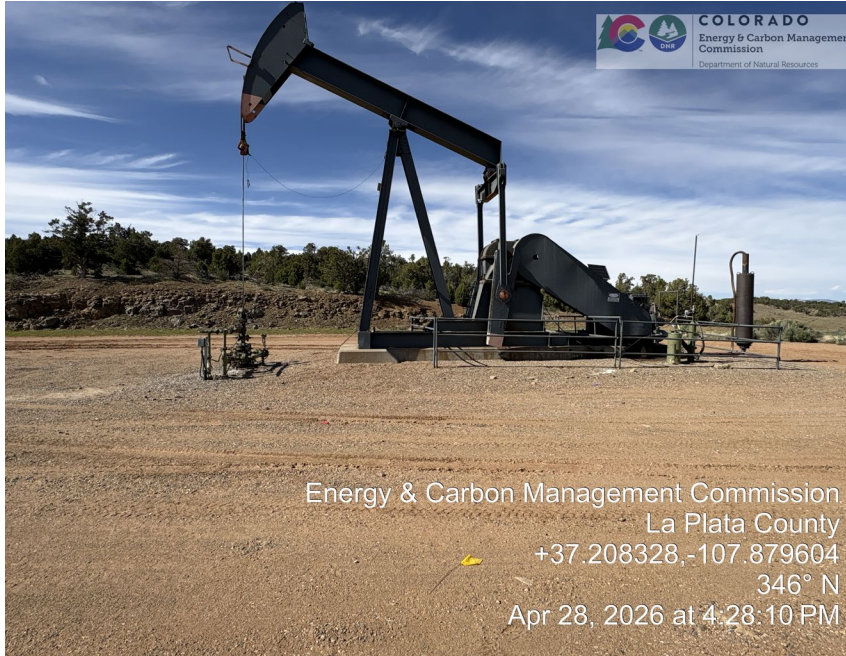
3. Wellhead, pump jack and prime mover (behind cattle panel fence).

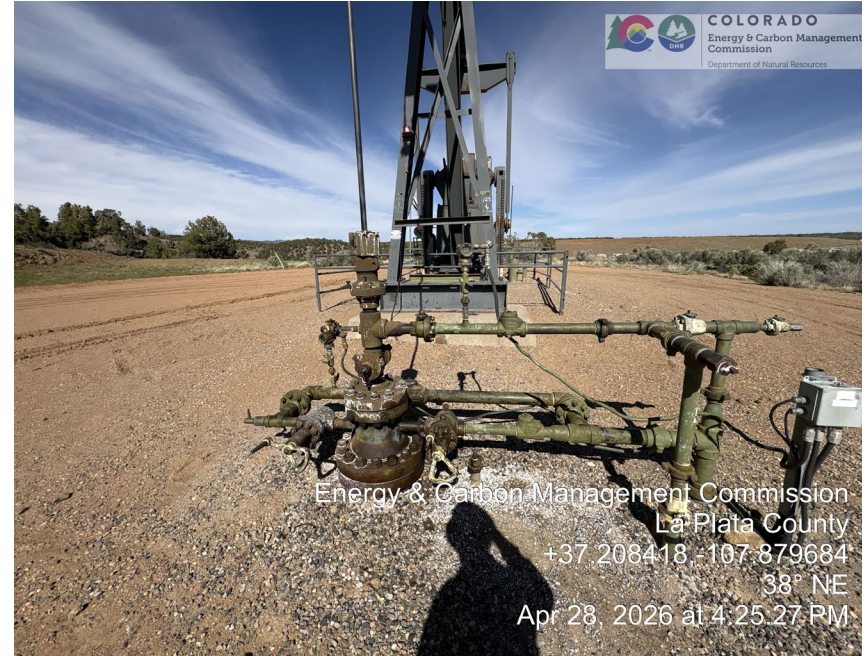
4. Wellhead. Mineral crust building up, but no active leaks observed.

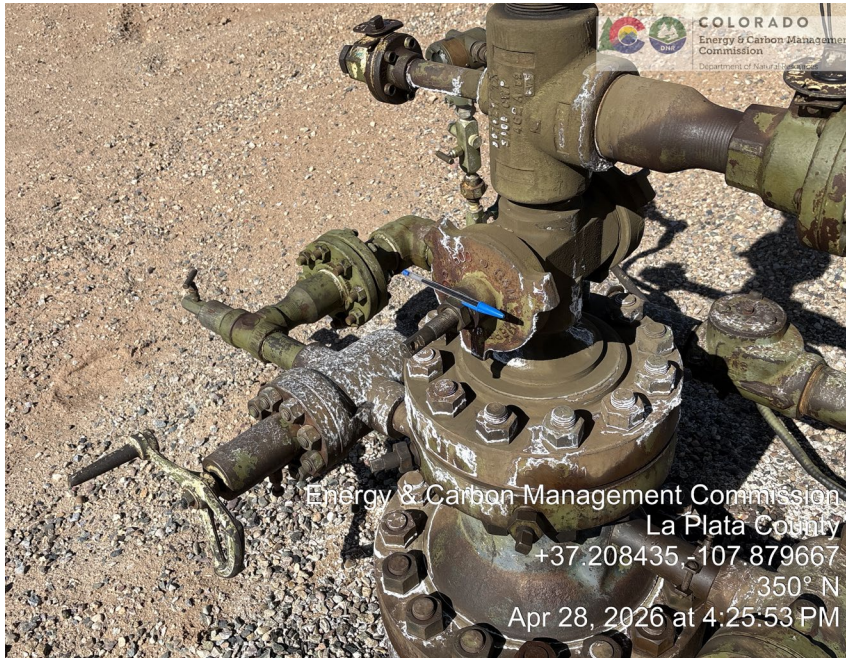
5. Close up of wellhead. Valve handle removed below pen.

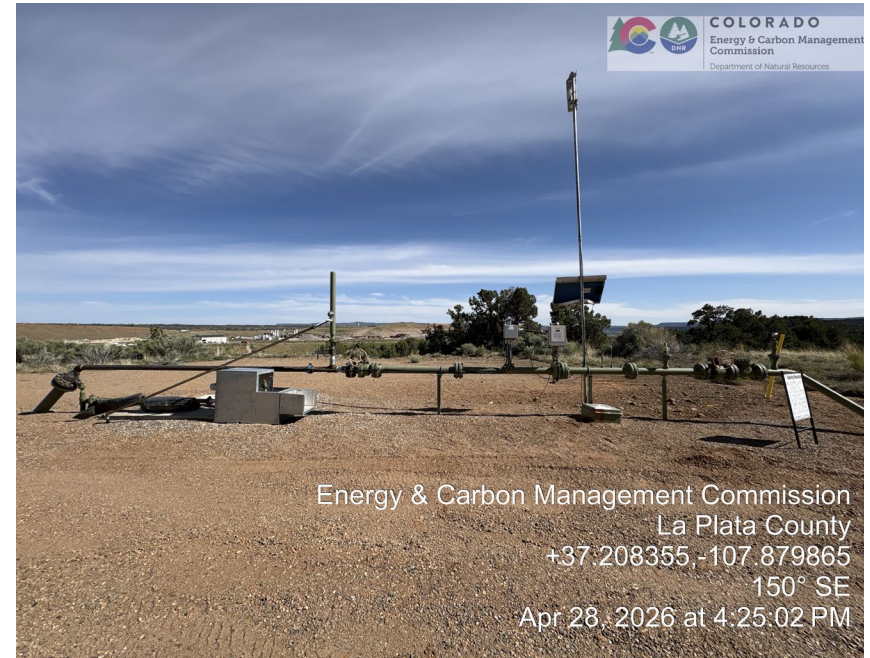
6. Flow line, meter run and solar telemetry. Meter calibration inside box.

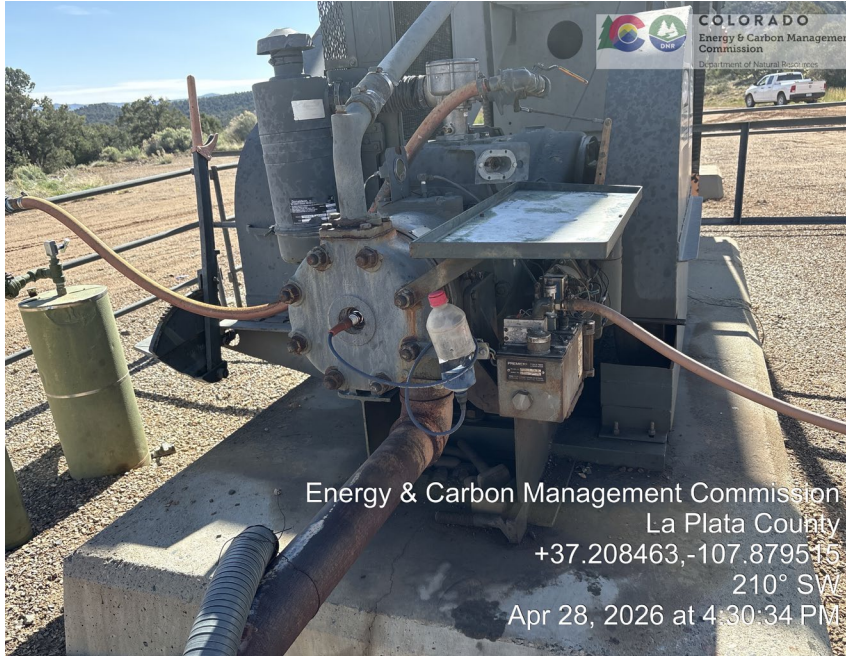
7. Prime mover. Appears to be in working condition but not operating during inspection.

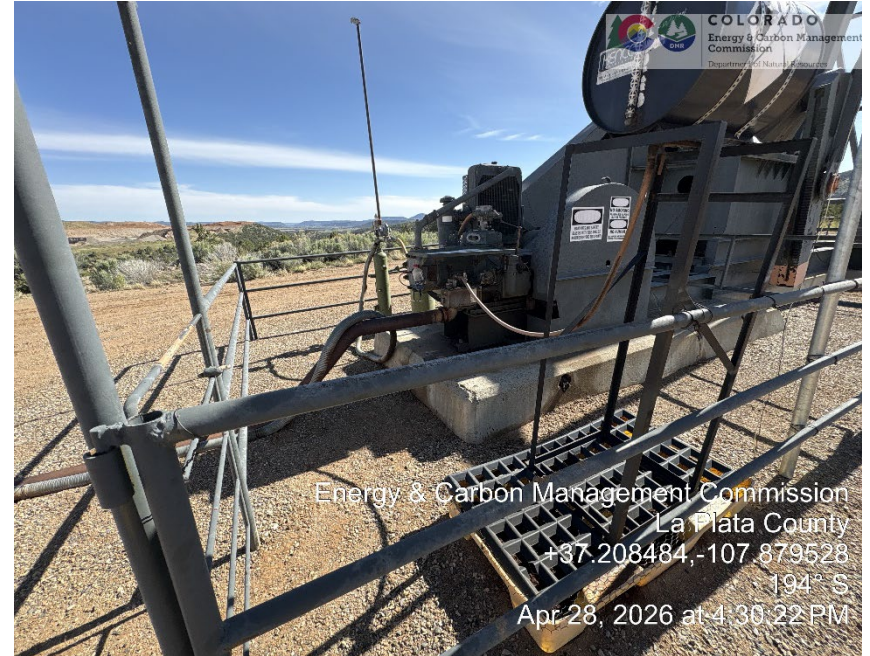
8. Lube oil container for prime mover above spill prevention.

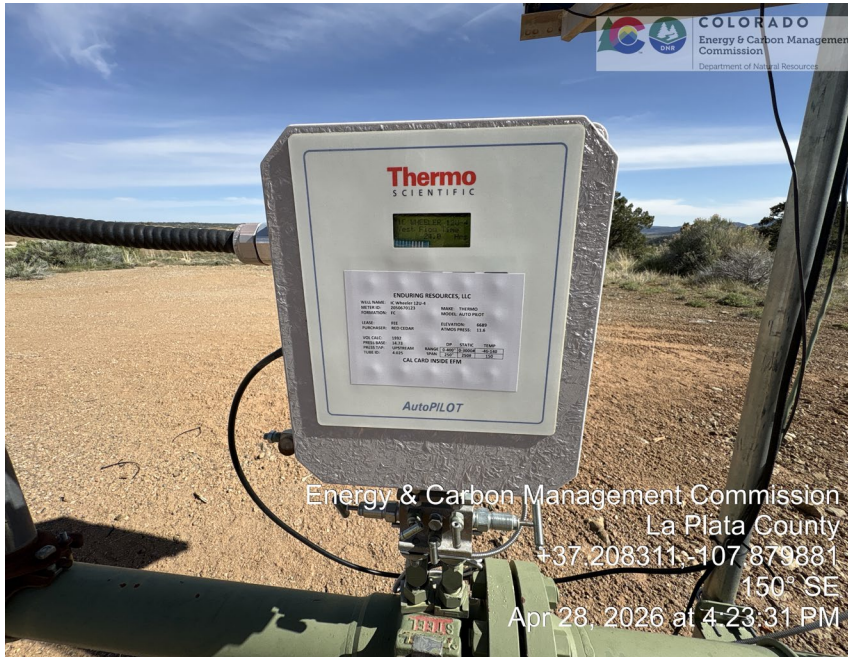
9. Meter run. Label says calibration card is inside box. Not prominently displayed.

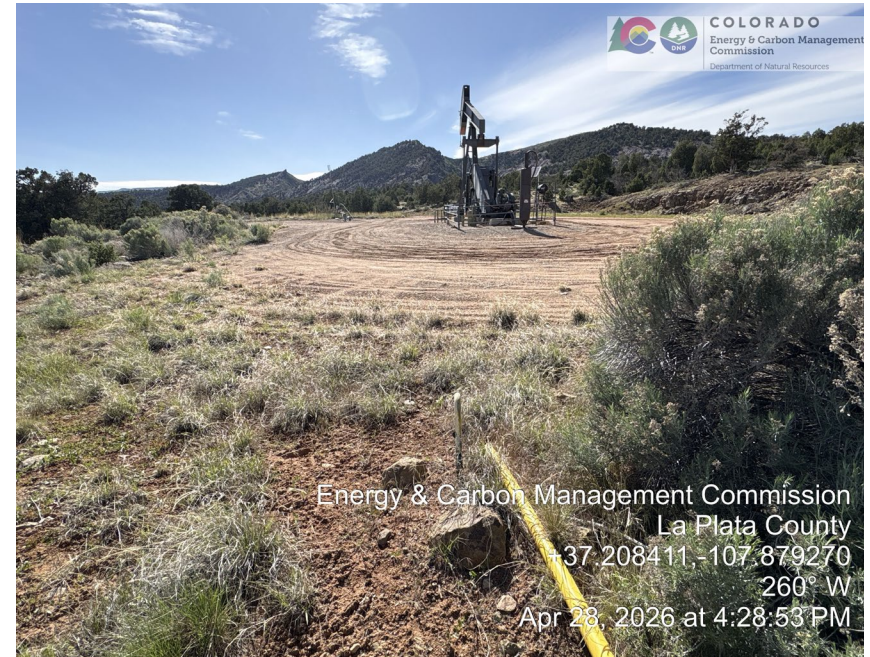
10. Interim reclamation vegetation. Rig anchor marker is down.

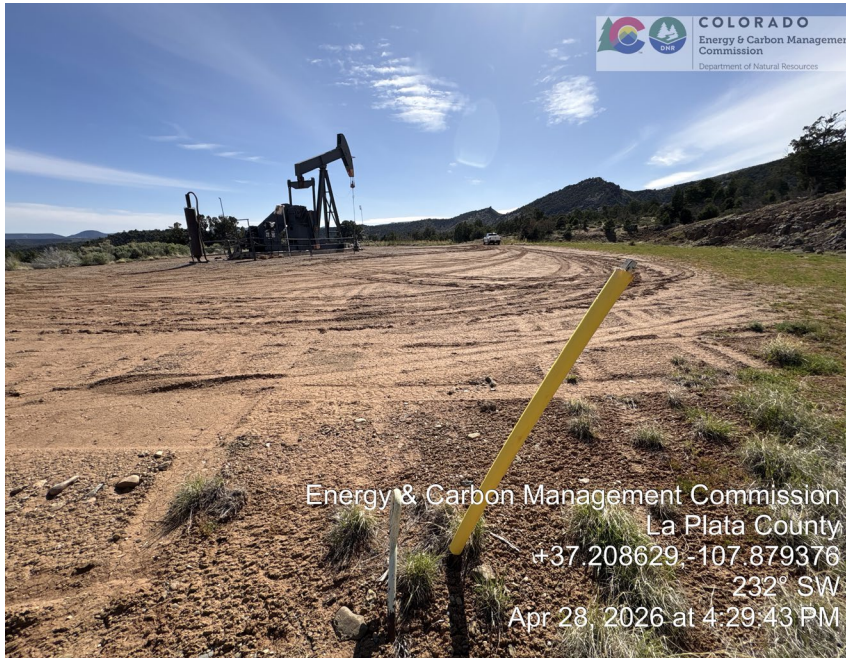
11. Rig anchor marker in NE corner looking west.

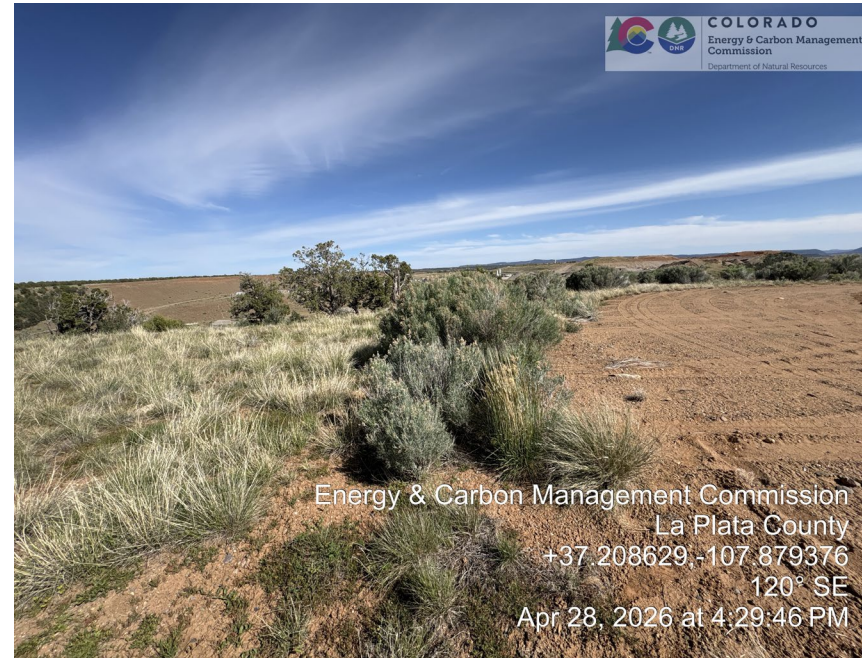
12. Reclamation vegetation on east edge looking south.

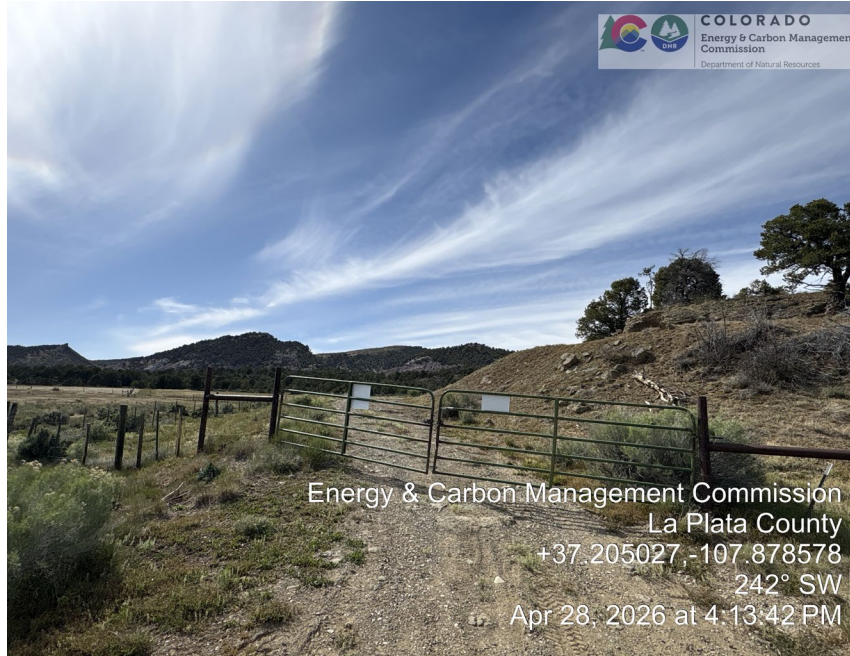
13. Access gate at bottom of access road.

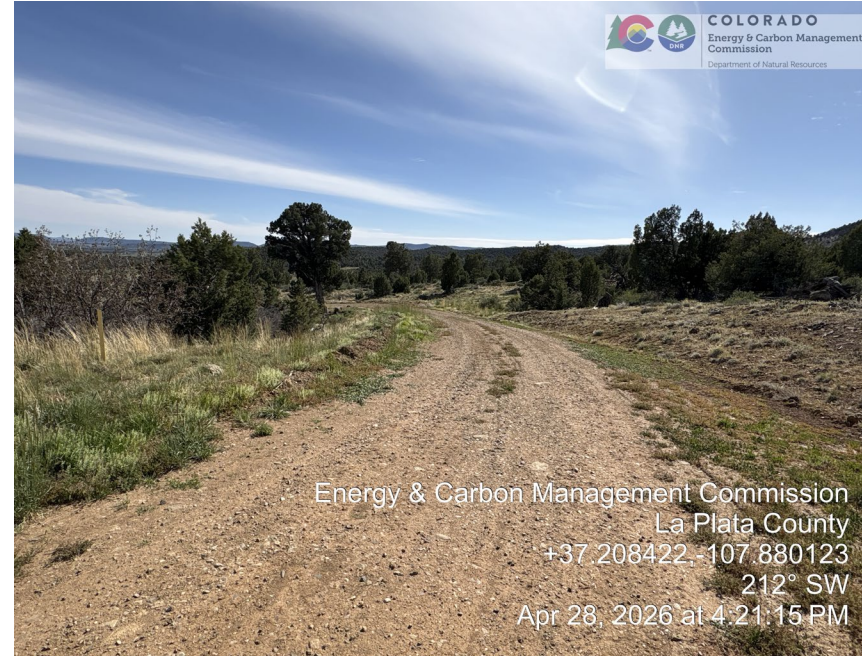
14. Access road from well pad.
