## Inspection Photos

Location Name: Endruing Resources Indian Creek Wheeler #12-U

Location ID: API 05-067-07636

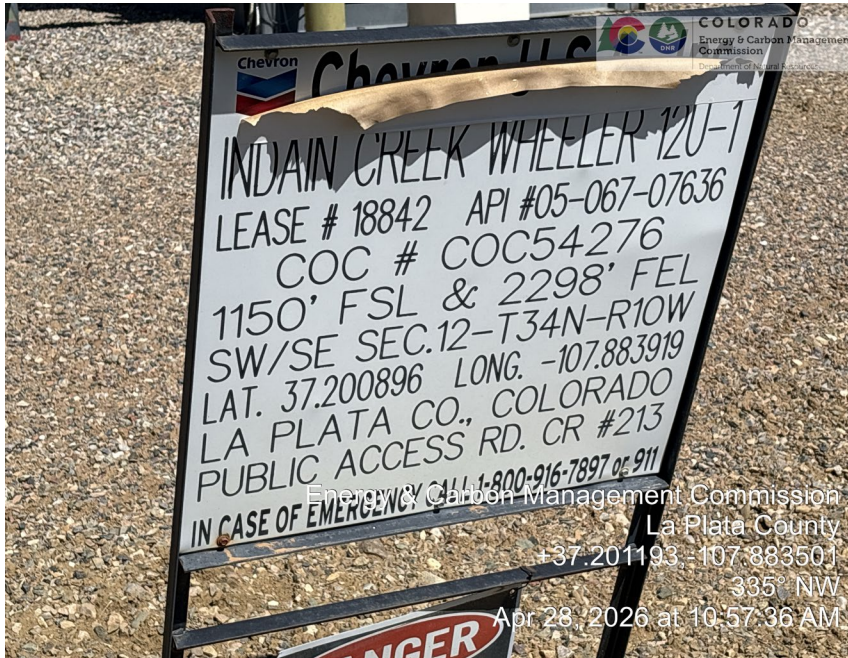
1. Well Sign by pad entrance and separator. Operator name is peeling off and is not legible. Phone number confirmed to be Enduring 24 Hour contact.

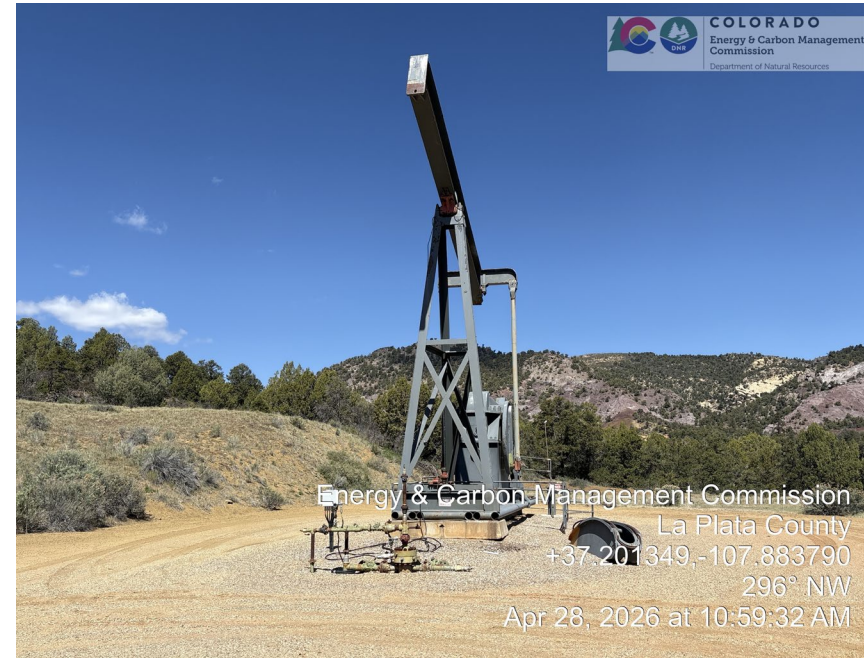
2. Wellhead and pumpjack. Horsehead is removed from walking beam. Polished rod not present or in hole.

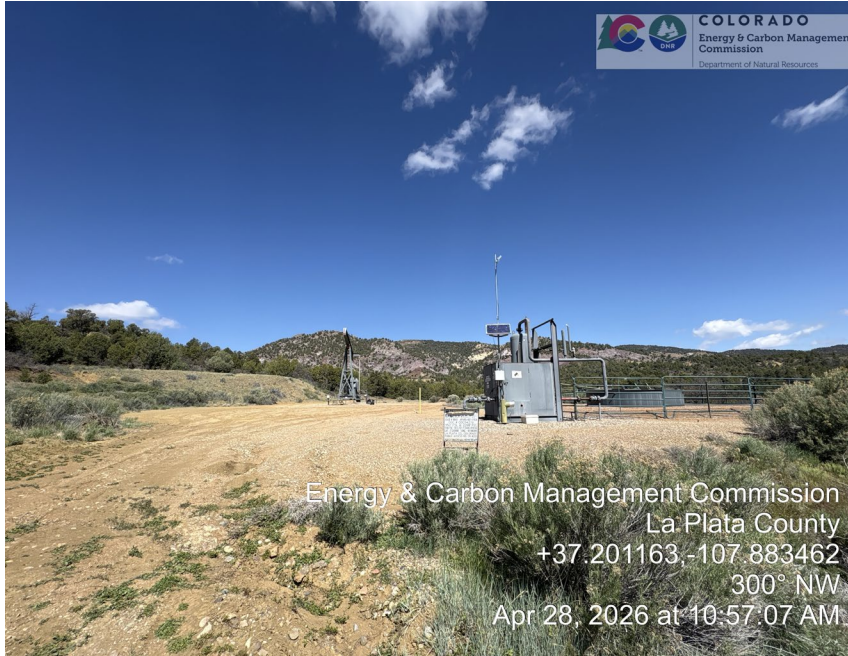
**3. Location overview from pad entrance near well sign.**

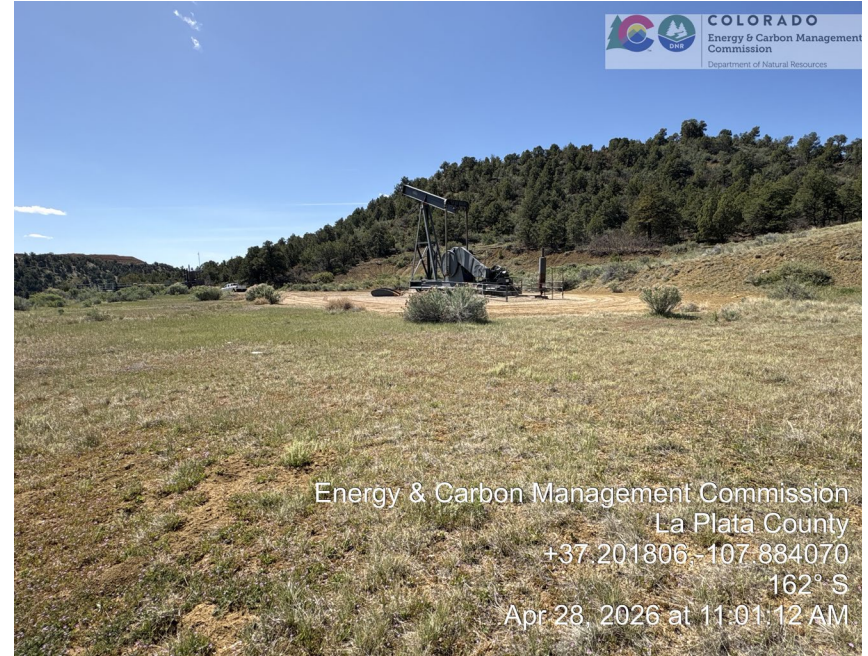
**4. Location overview from interim reclamation area.**

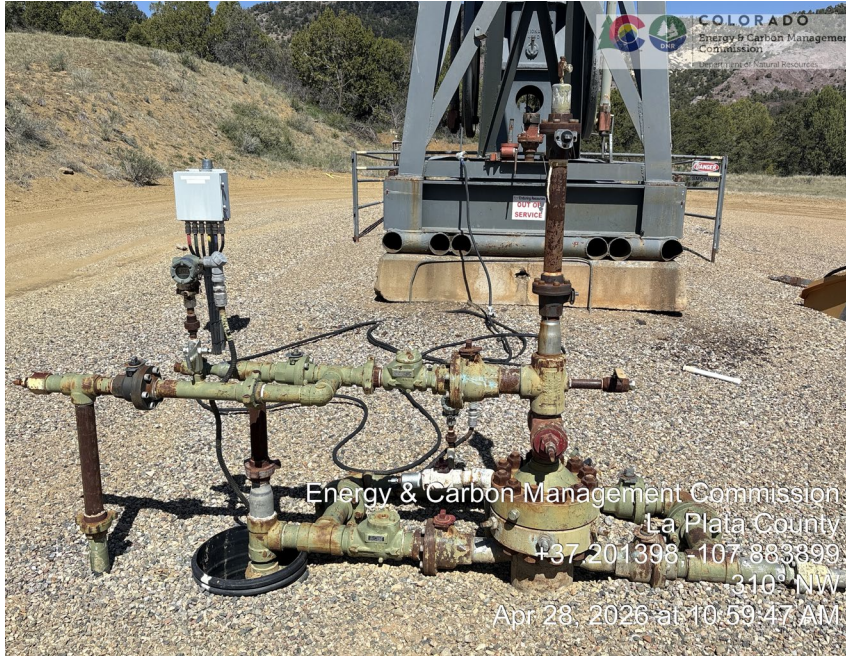
5. Wellhead.

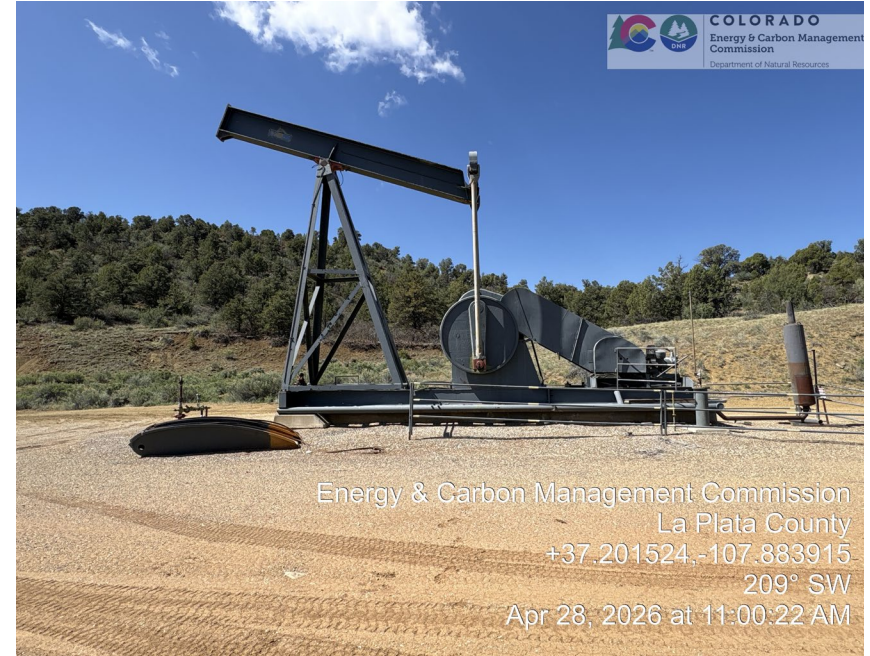
6. Side view of pump jack with horsehead removed and lying on ground.

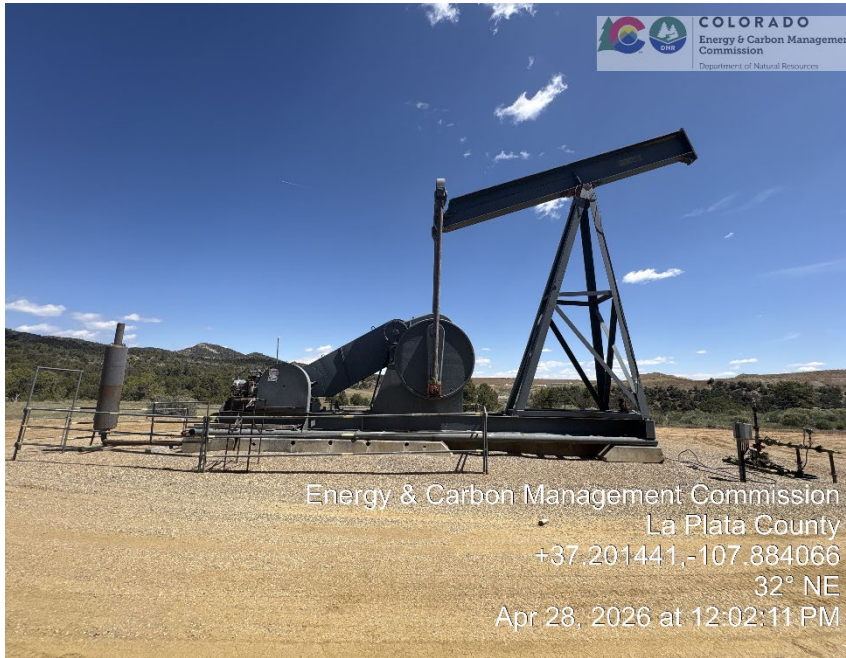
**7. Side view of pumpjack and wellhead.**

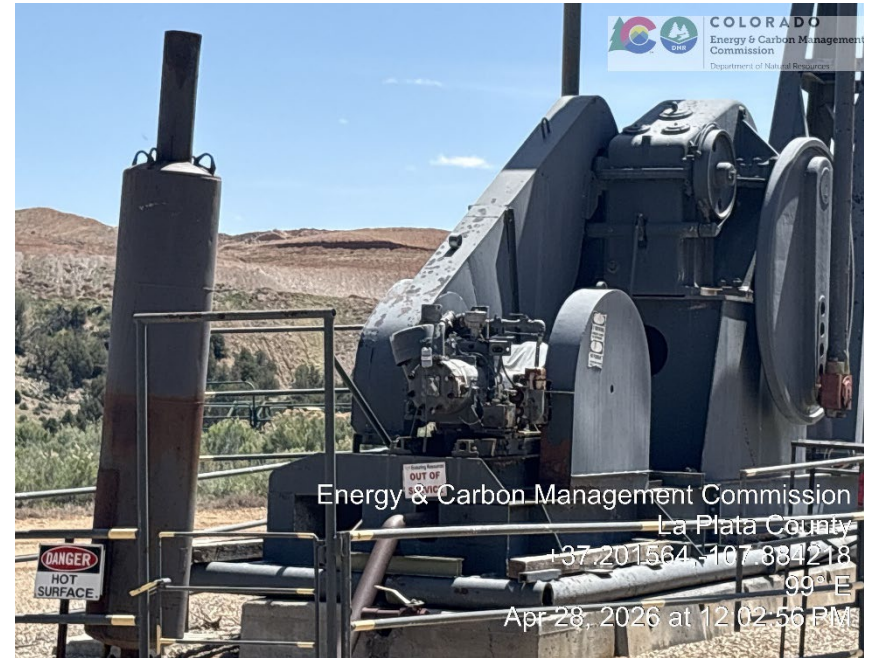
**08. Prime mover. Motor appears to have electrical and fuel supply disconnected.**

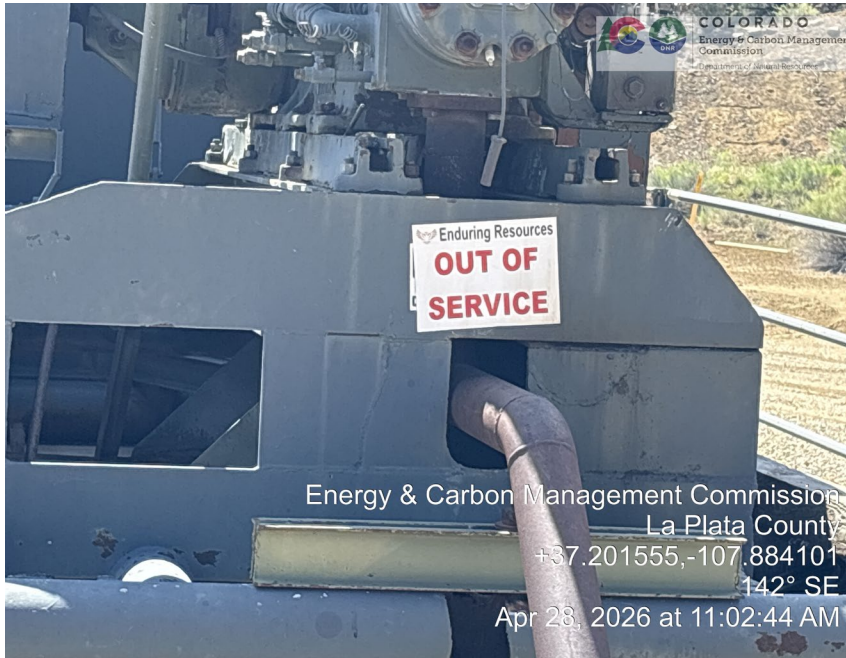
9. Pumpjack labelled out of service by prime mover.

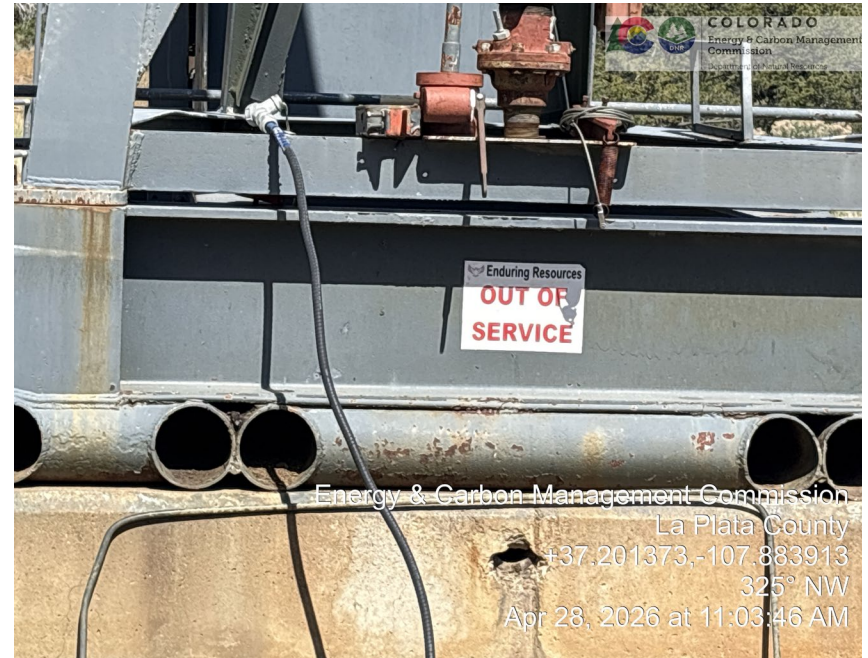
10. Pumpjack labelled out of service near wellhead.

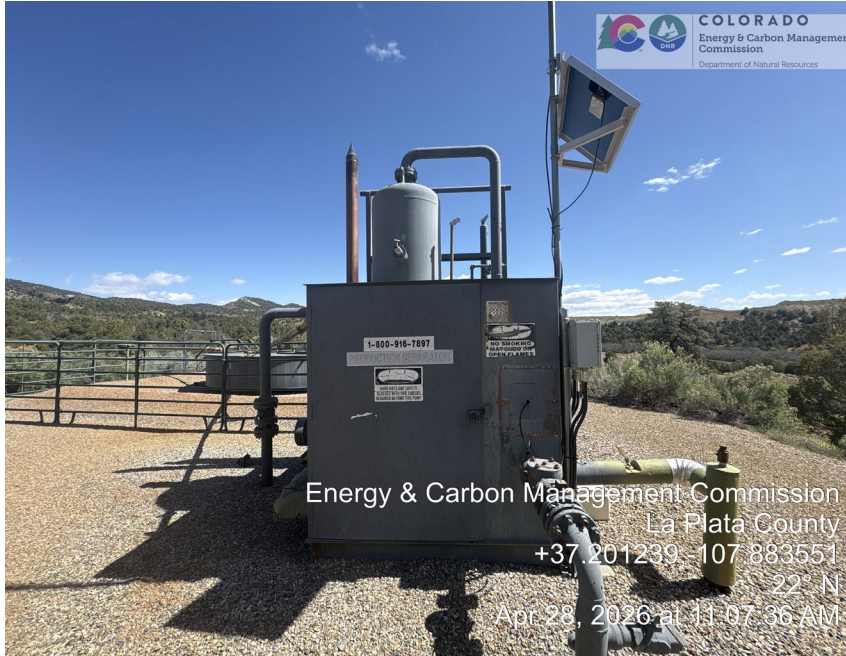
11. Vertical heated separator/meter run combination. Meter calibration card displayed inside door on right side inside plastic sleeve. Dated 07/07/2023. Labelled “Chevron Midstream” not “Enduring Resources”.

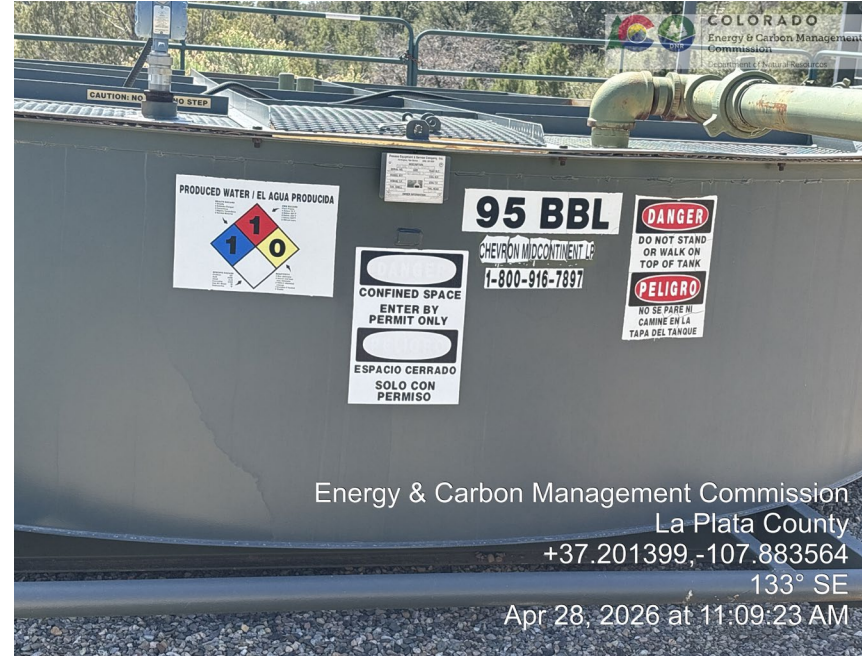
12. Produced water tank. Labelled “Chevron Midcontinent” not “Enduring Resources”. Other required info present.

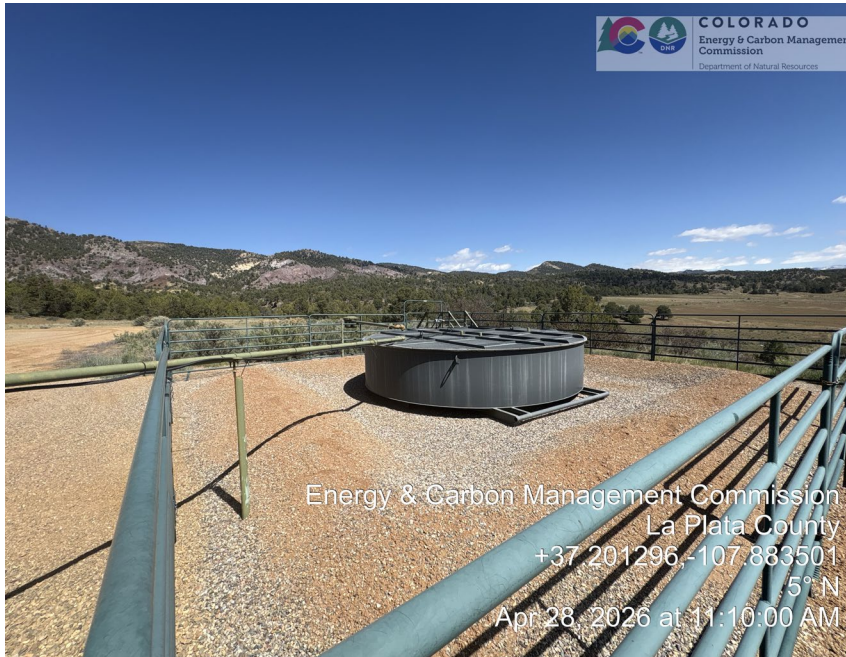
**13. Open topped steel produced water tank from SE Corner. Lat Long = 37.201296/-107.863501. Berm appears to be adequate.**

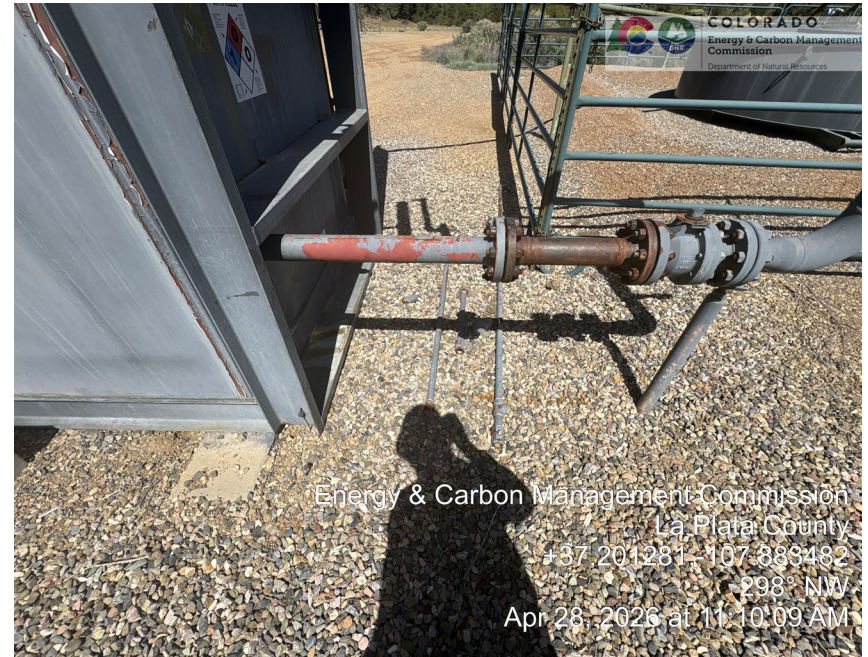
**14. Various pipe segments on ground between separator and tank.**

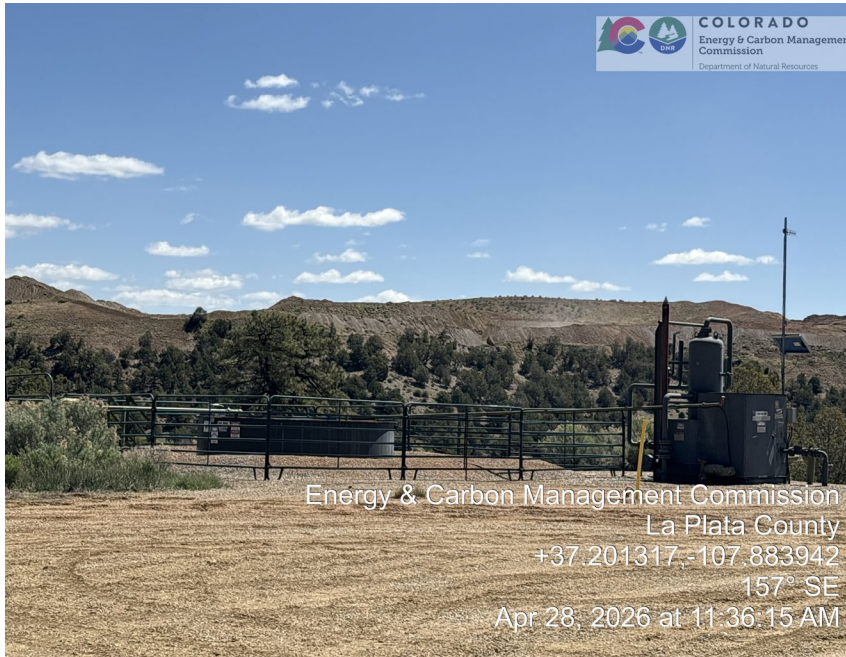
**15. Tank behind cattle panel fence and heated separator/meter run structure. Bird protector on heater stack. Solar telemetry.**

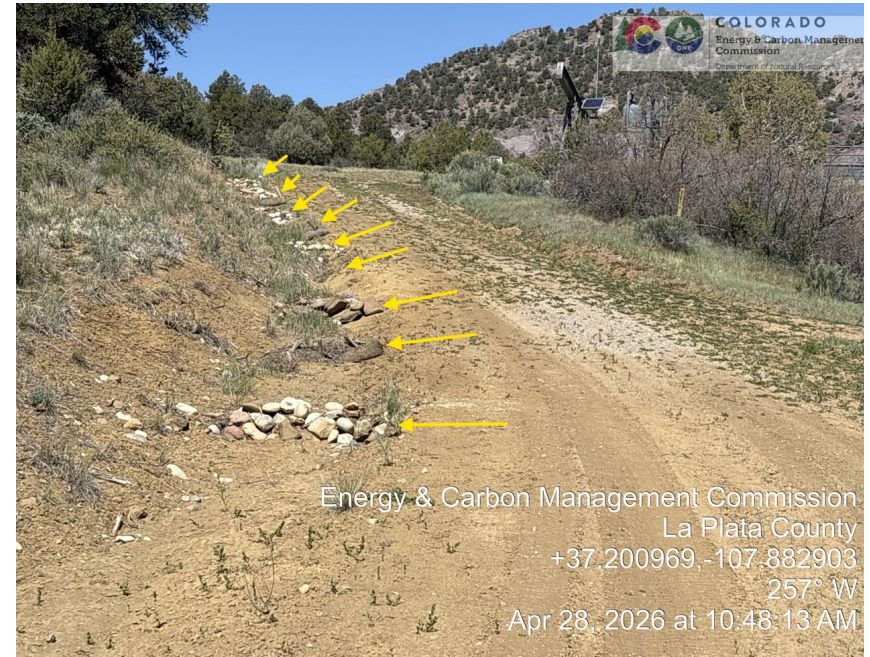
**16. Ditch on road approaching pad. Alternating cobble check dams and straw wattles. All appear to be full of sediment and water is flowing around causing erosion.**

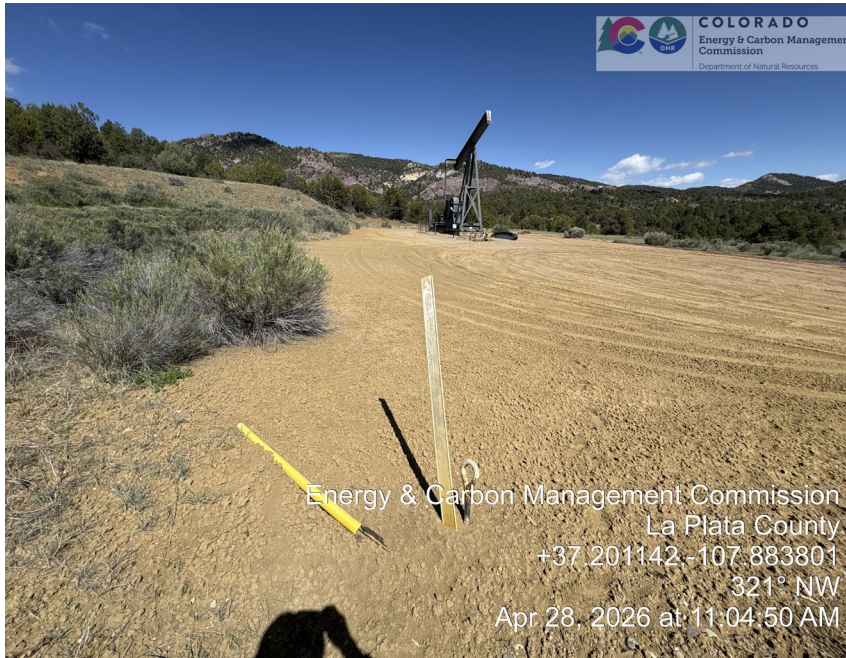
**17. Overview of well pad from SE corner looking NW. Rig anchor marker is down. Also marked with "Gas Pipeline" fiberglass marker.**

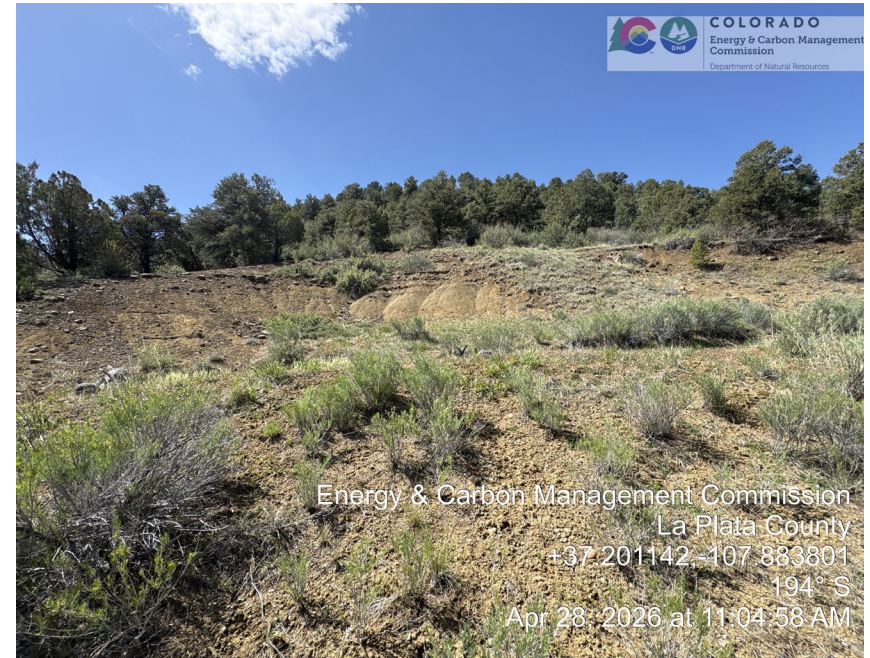
**18. Diversion berm on southern reclamation area cut slope.**

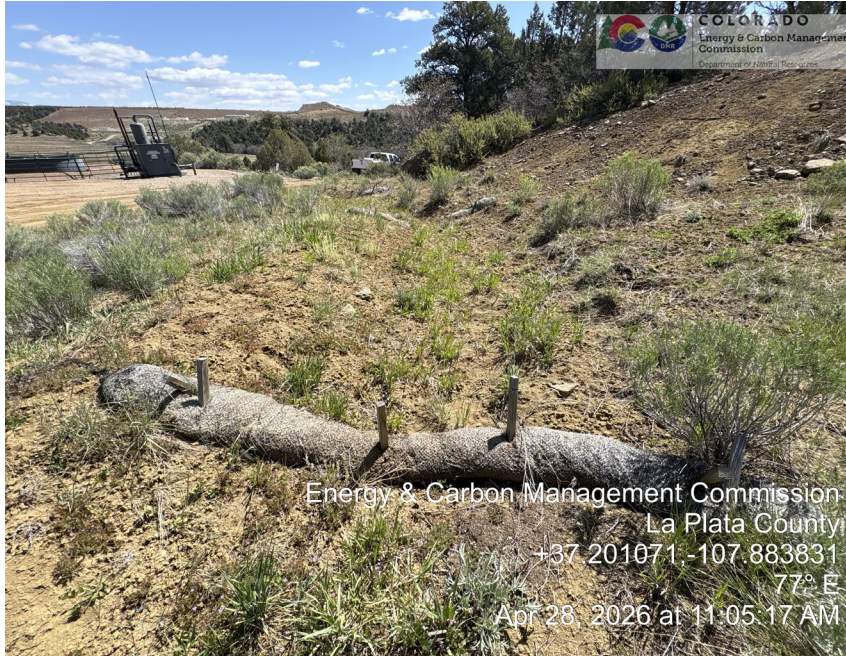
**19. Straw wattles in southern reclamation area run-on diversion ditch are full of sediment.**

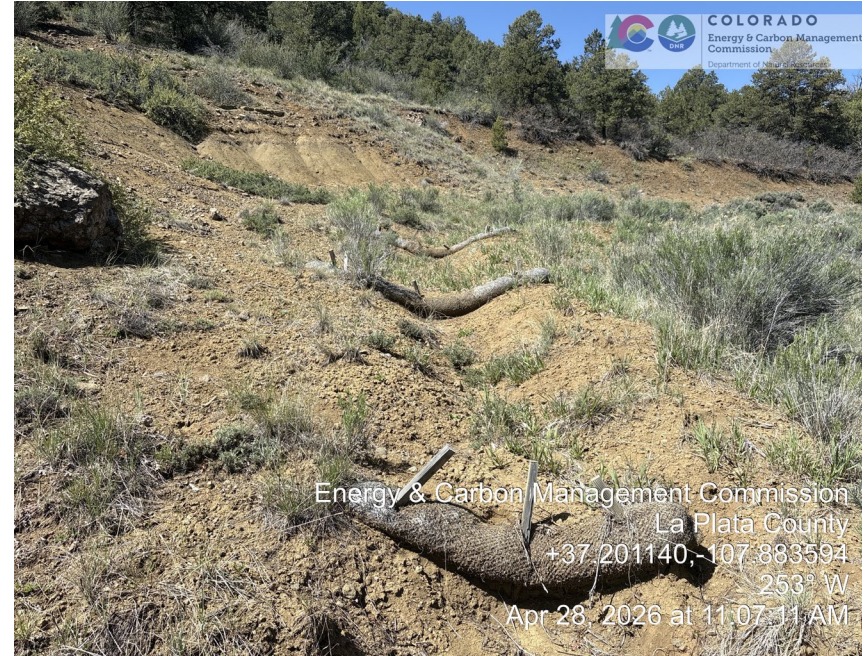
**20. Straw wattles in run-on diversion ditch are full of sediment.**

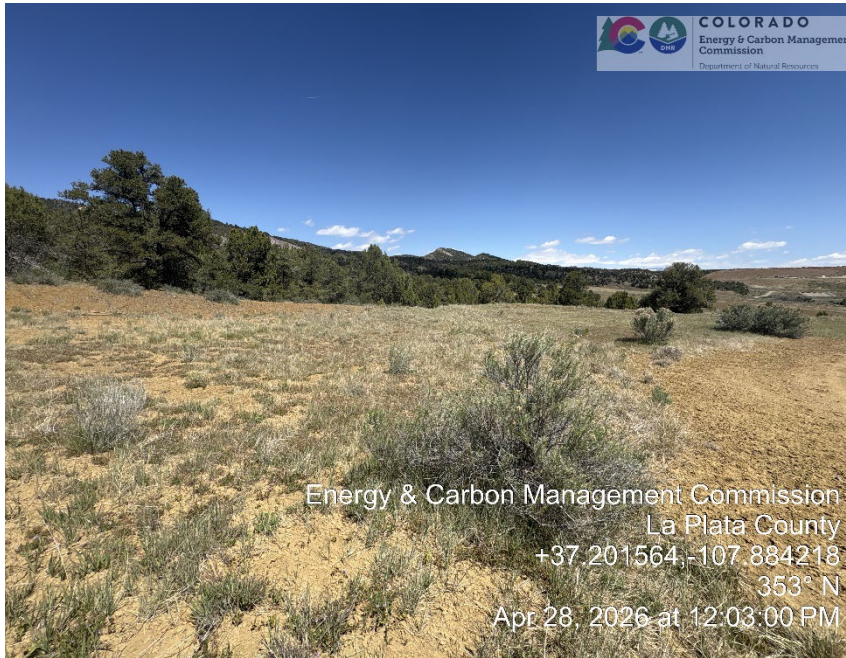
**21. Interim reclamation and drainage ditch on east end of well pad.**

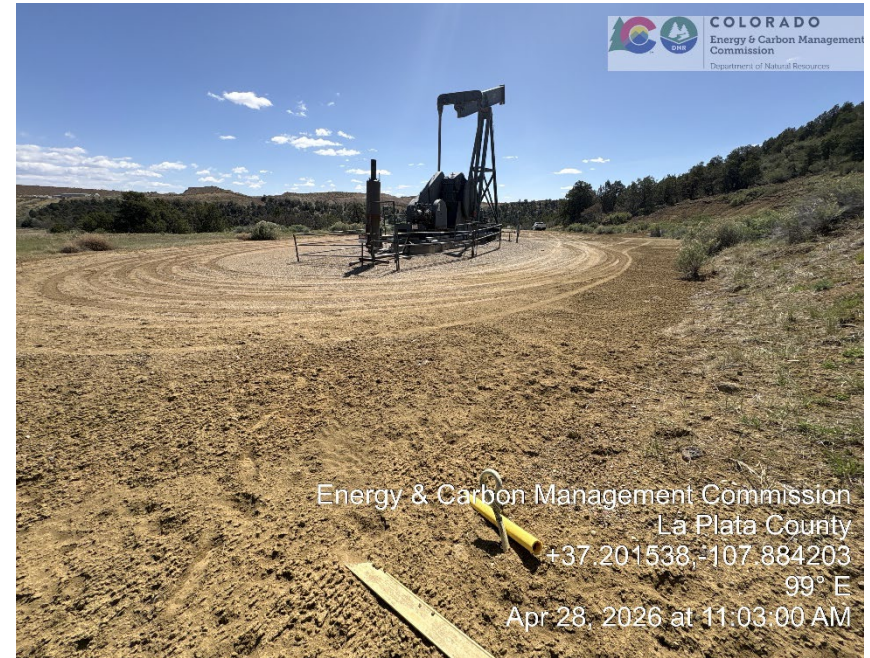
**22. Down rig anchor marker in SW corner.**
