Inspection Photos

Location Name: Enduring Resources - Indian Creek Wheeler 13-4

Location ID: 05-067-08647

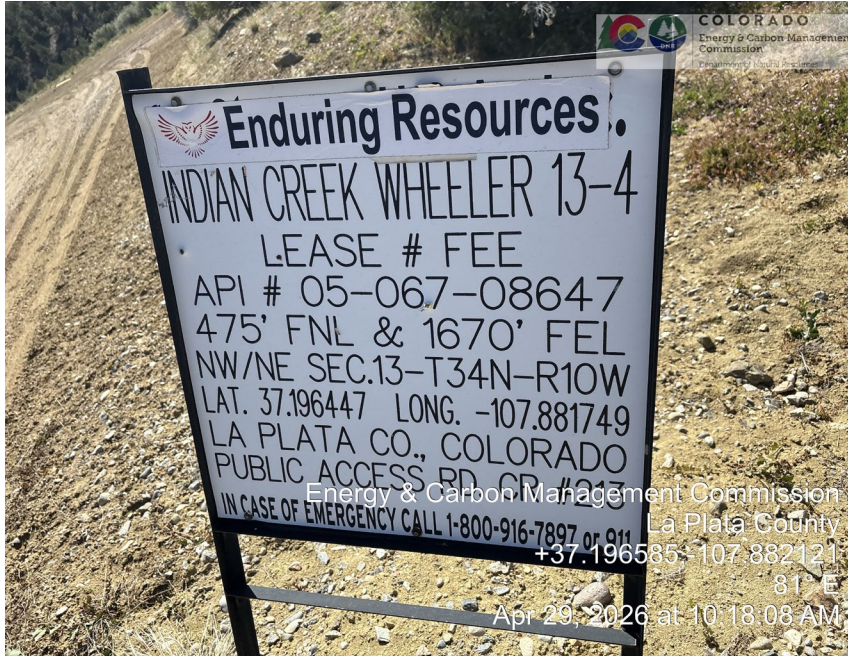
1. Well sign.

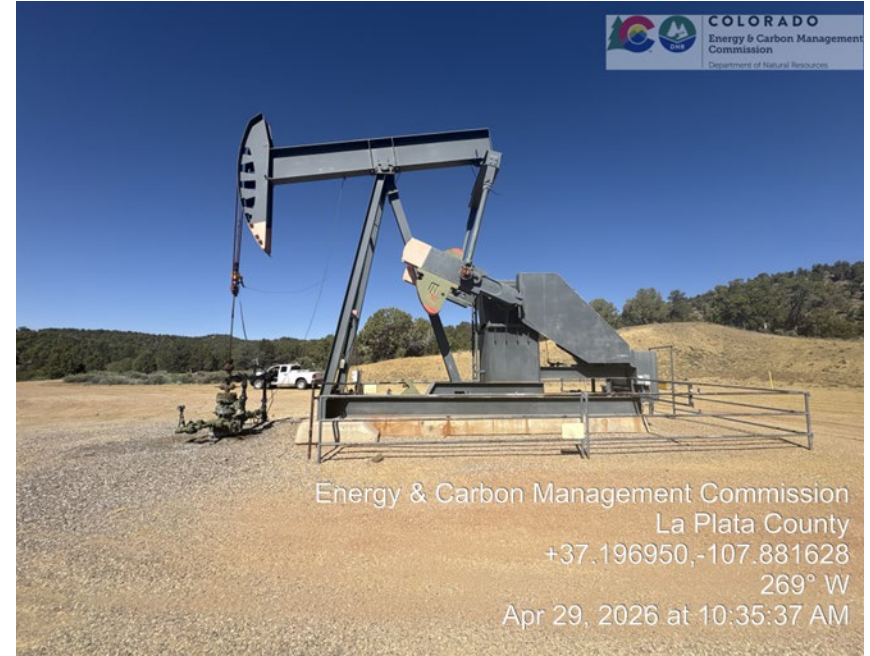
2. Wellhead, and pumpjack.

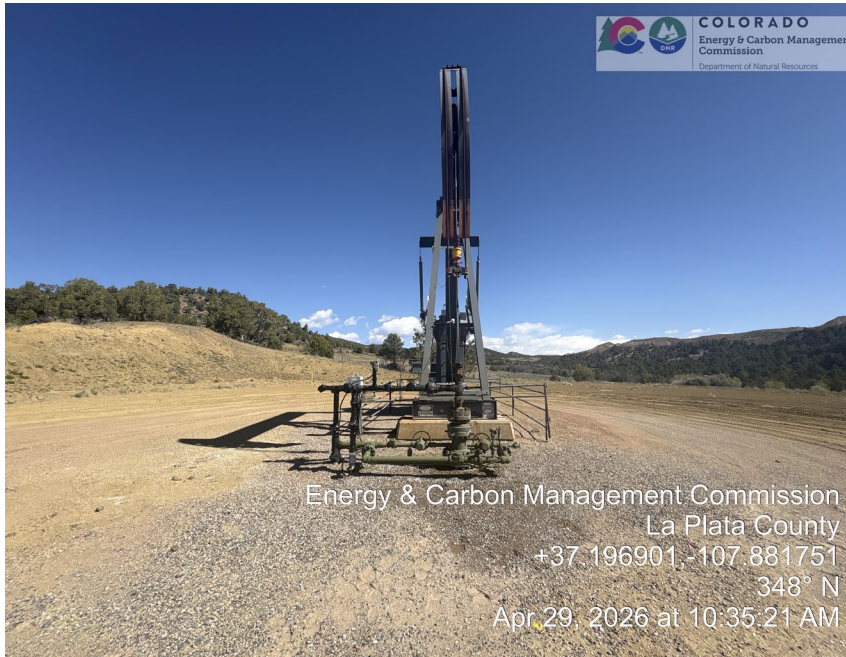
3. Wellhead and pumpjack. There was produced water leaking from the stuffing box at the beginning of the inspection. The operator was contacted and a pumper showed up, tightened and greased the fitting, and stopped the leak during the inspection. There is a damp spot beneath the wellhead that resulted from the leak, but no standing water.

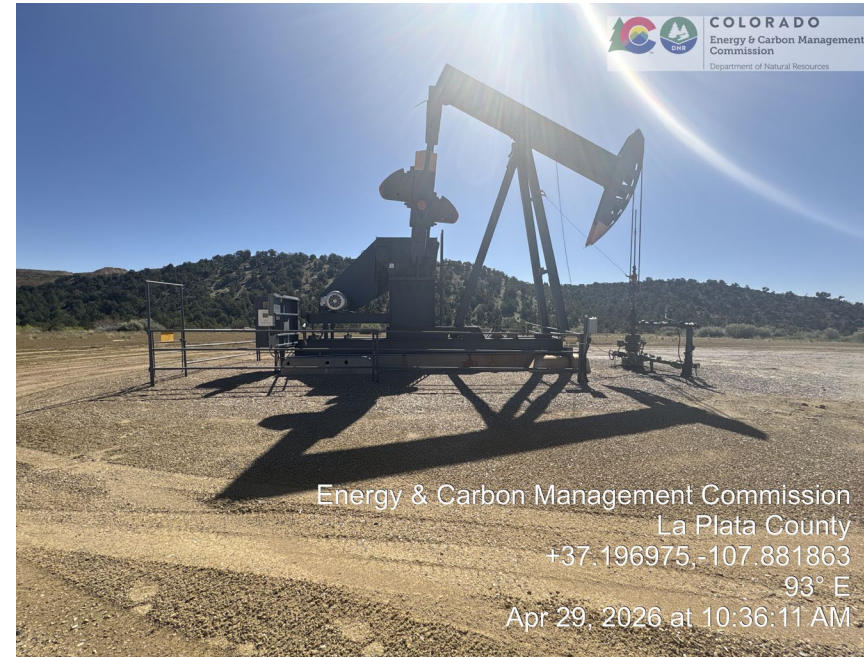
4. Pumpjack, wellhead and electric prime mover.

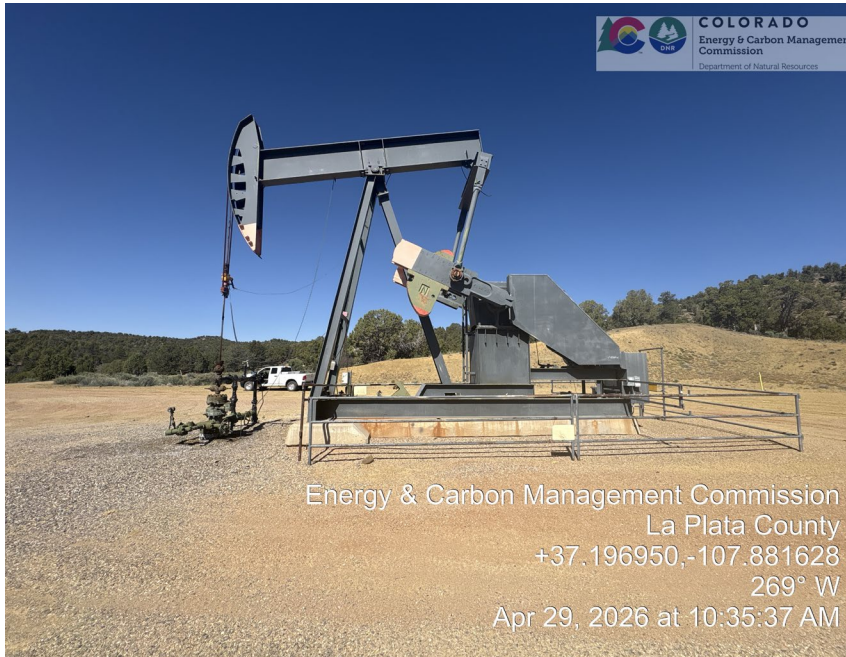
5. Wellhead and pumpjack. Cattle panel fence surrounds pump jack.

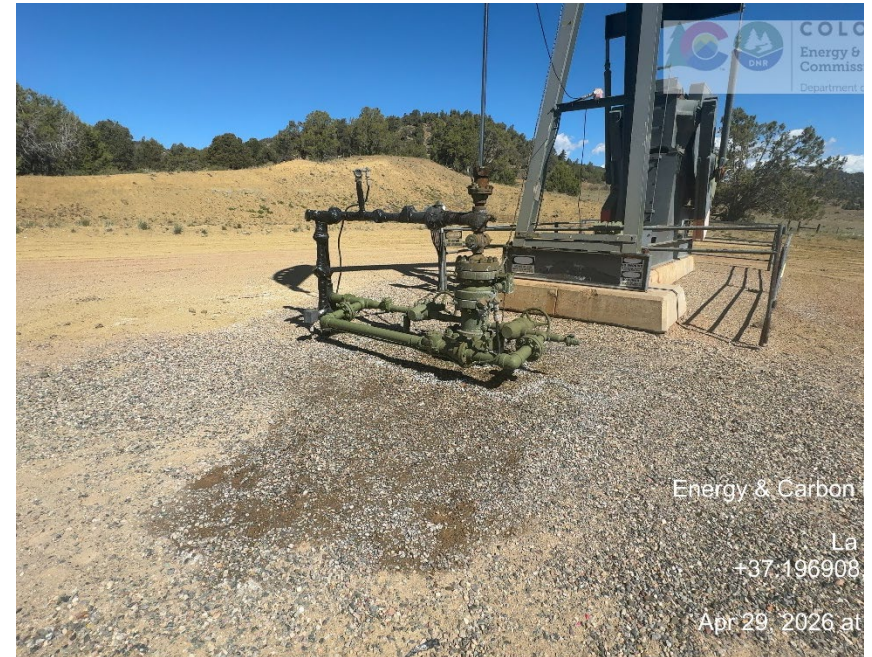
6. Wellhead. 4'x8' estimated damp spot caused by leak observed during inspection. Operator was contacted about leak, which was fixed, but affected material remains.

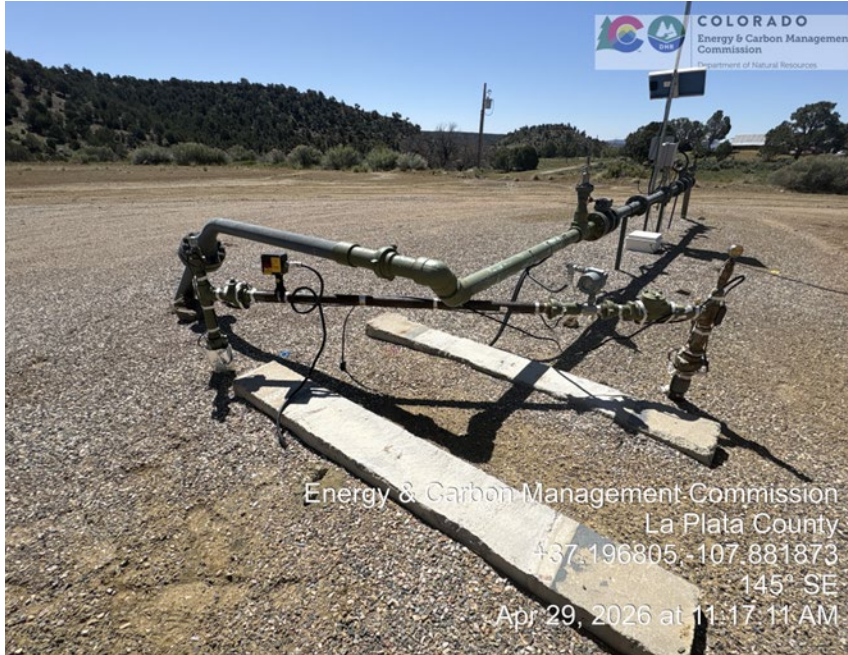
9. 2-inch flow line riser, possibly from when tank and separator were still on location.

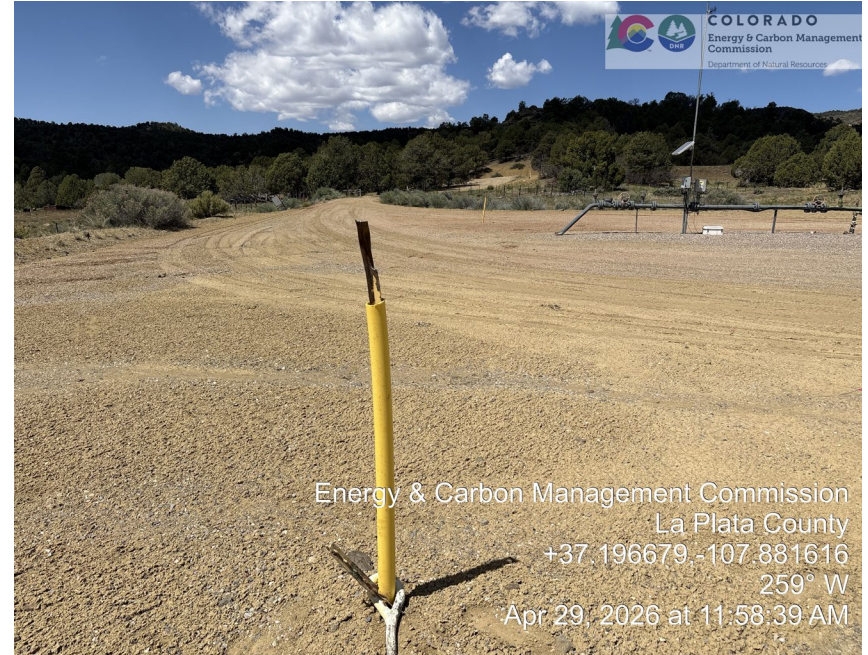
10. Rig marker anchors on south end.

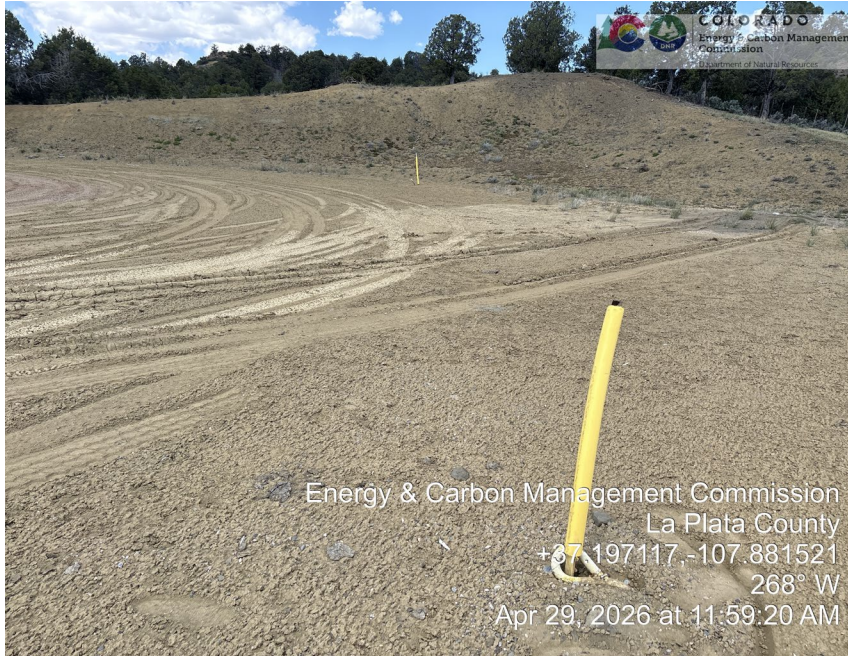
11. Rig anchor markers on north end.

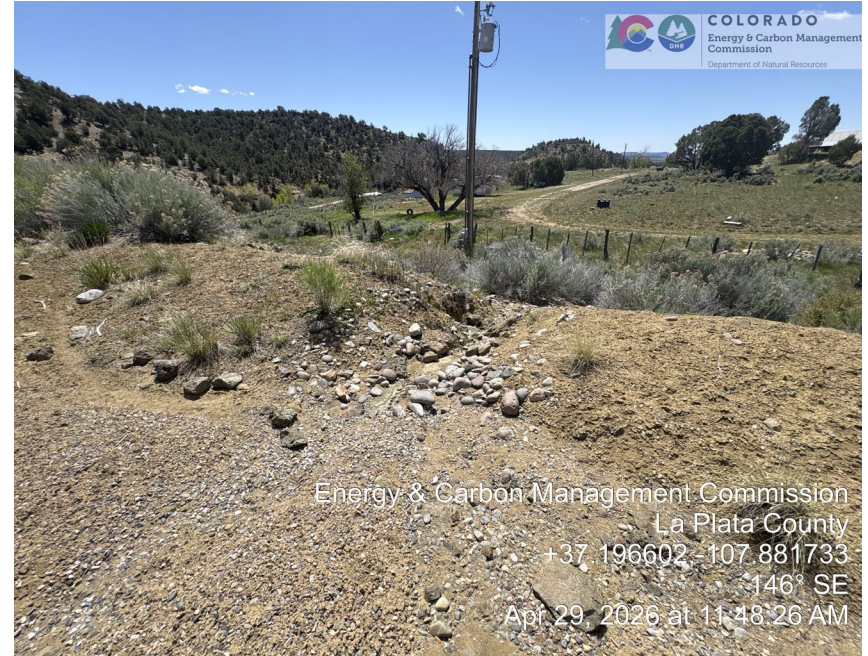
12. Gravel and riprap armored drain through berm on south end of pad is beginning to erode.

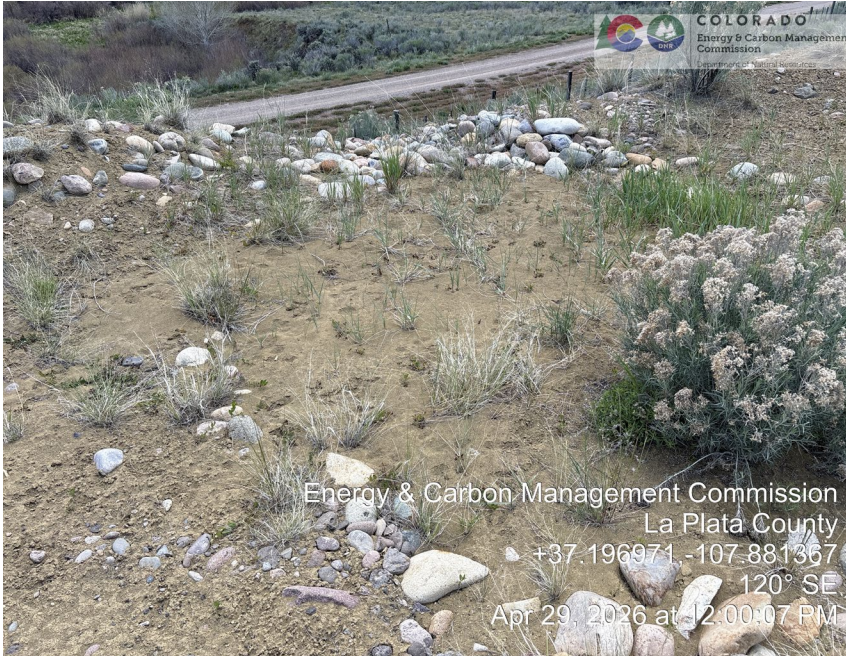
13. Riprap- armored drain and sediment retention feature is functional, but is filling with sediment.

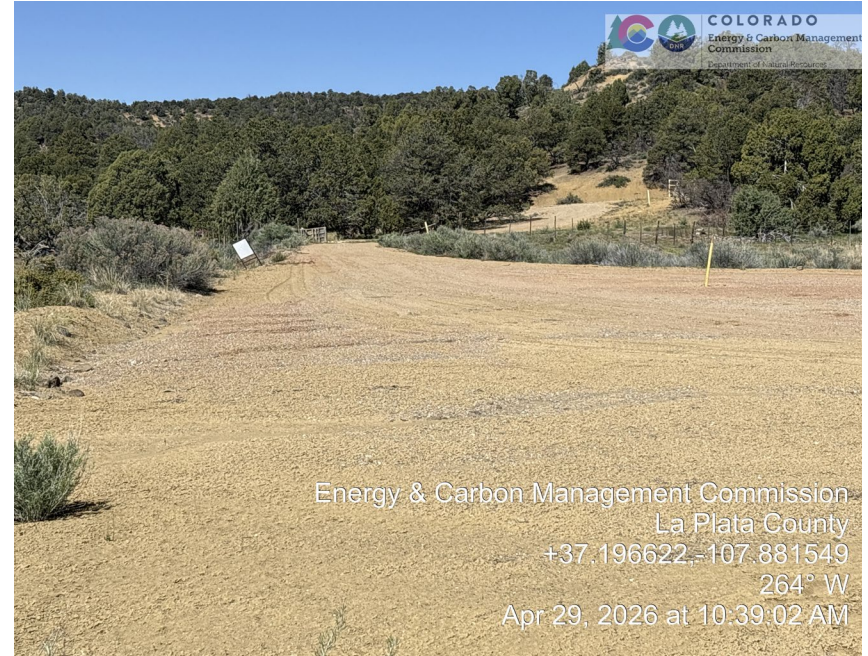
14. Location access road and south end of pad looking west.

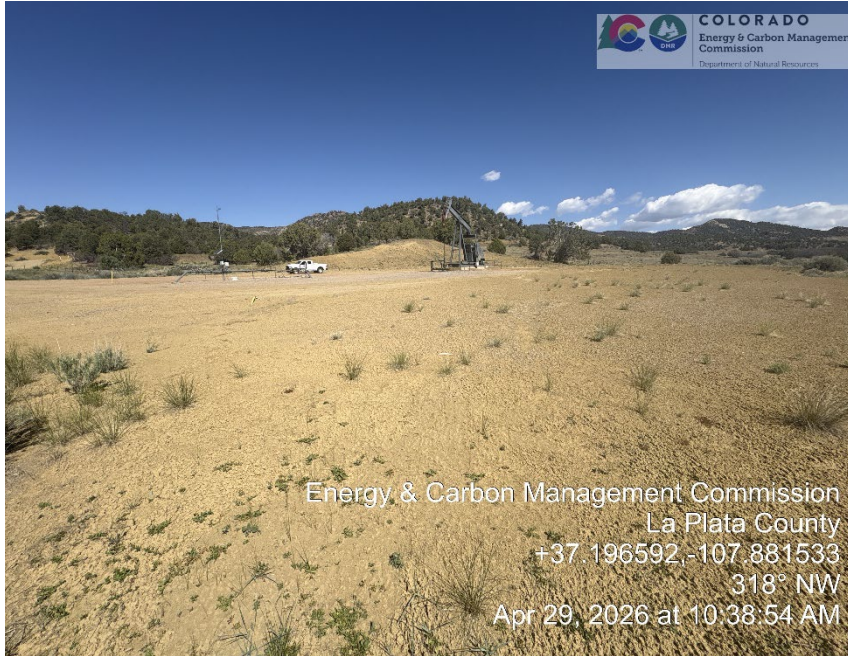
15. Location overview looking northwest from southeast corner.
