Inspection Photos

Location Name: Rainbow 23-20

API #: 05-043-06150

Location ID: 322234

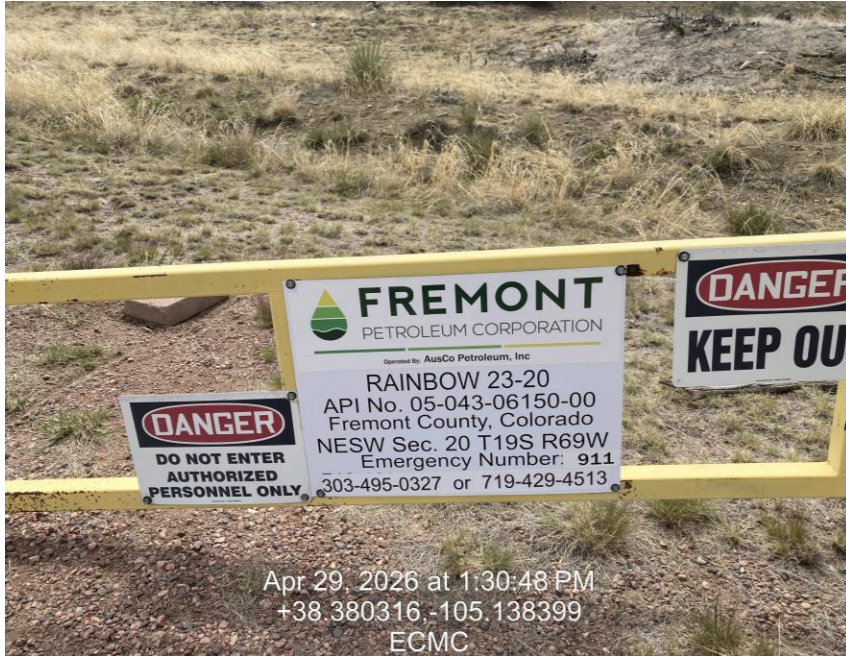
Photo 1: Well Placard at gate entrance

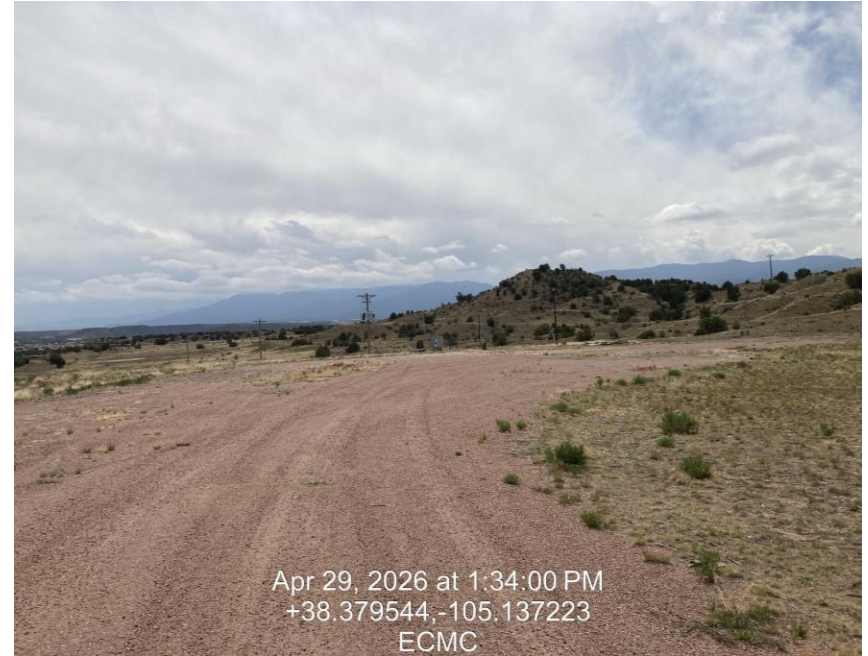
Photo 2: Location Overview from access road

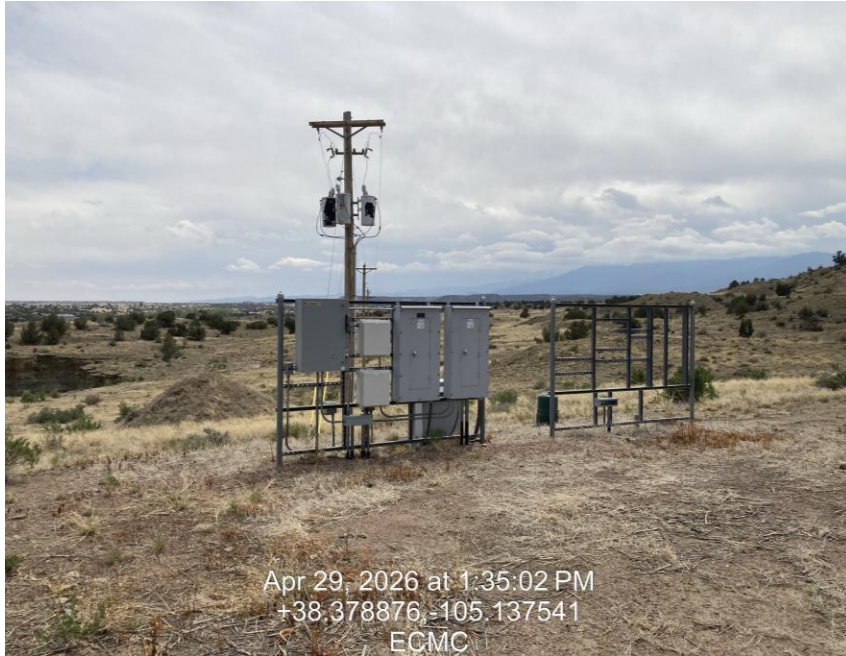
Photo 3: Electrical Panels

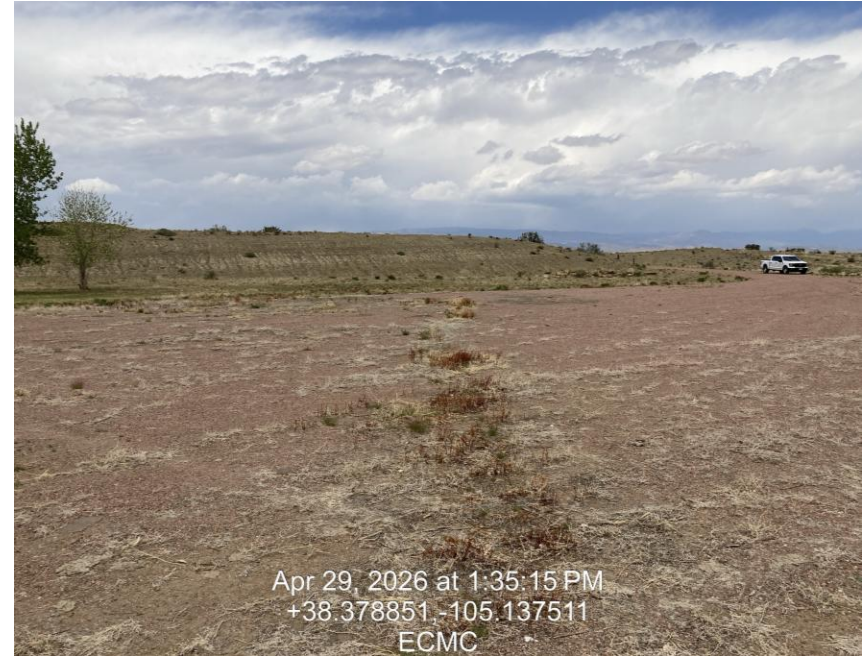
Photo 4: Electrical trench looking to north to wellhead

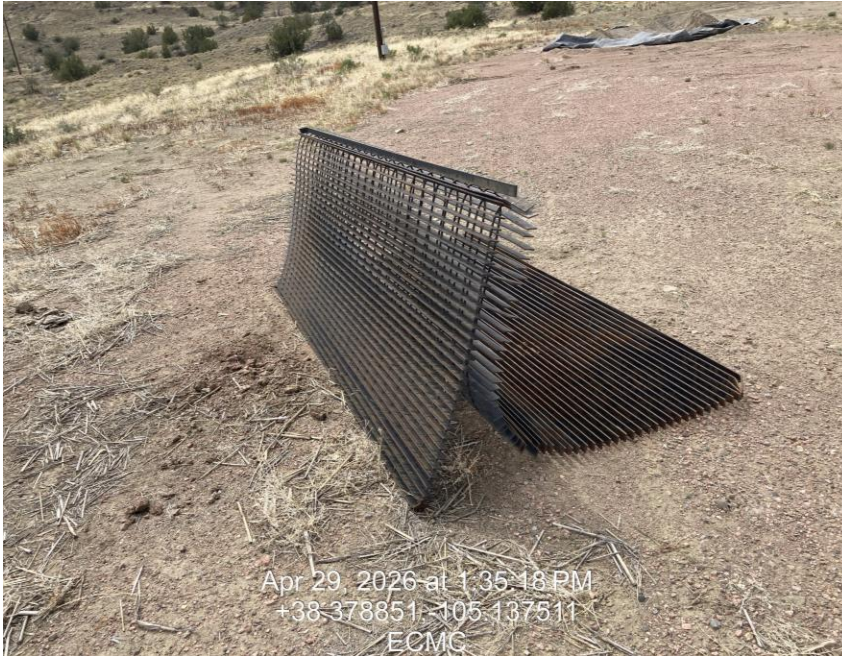
Photo 5: Guarding from excavations

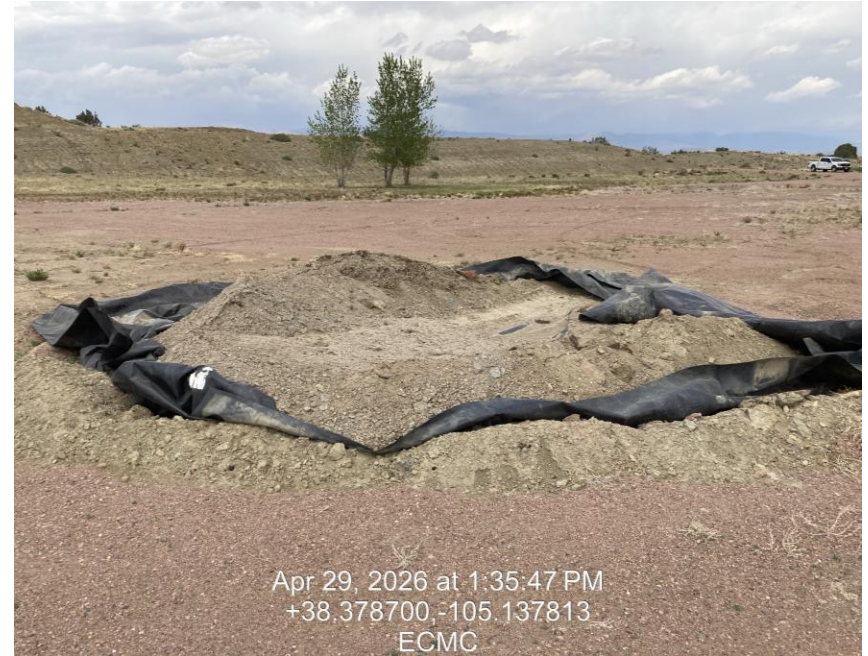
Photo 6: Spoil Pile

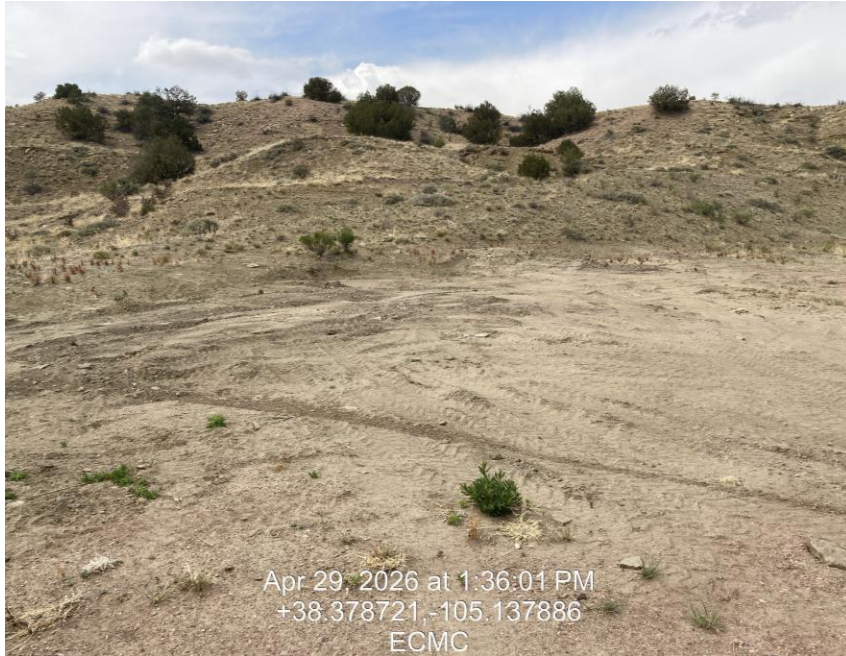
Photo 7: Excavation location backfilled

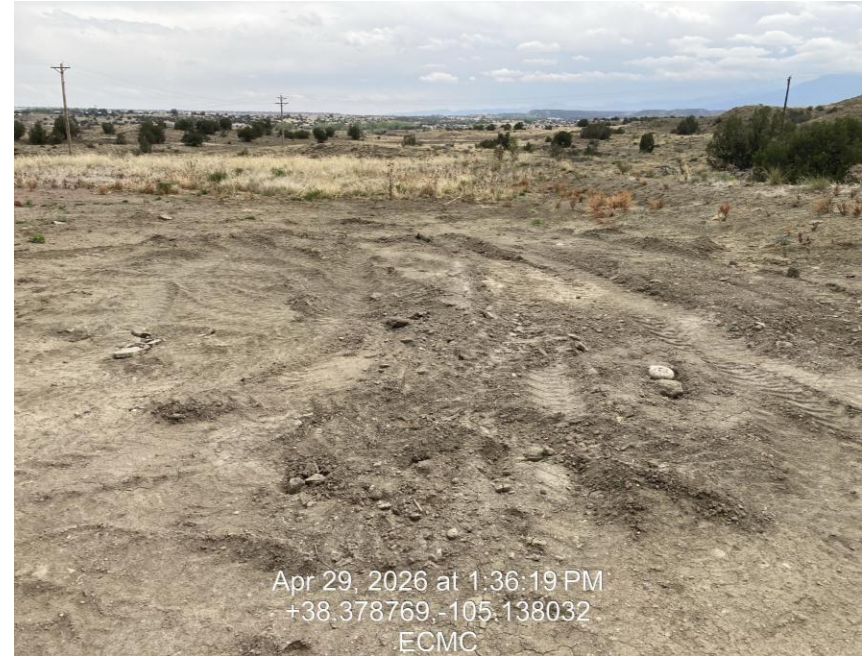
Photo 8: Excavation Location backfilled

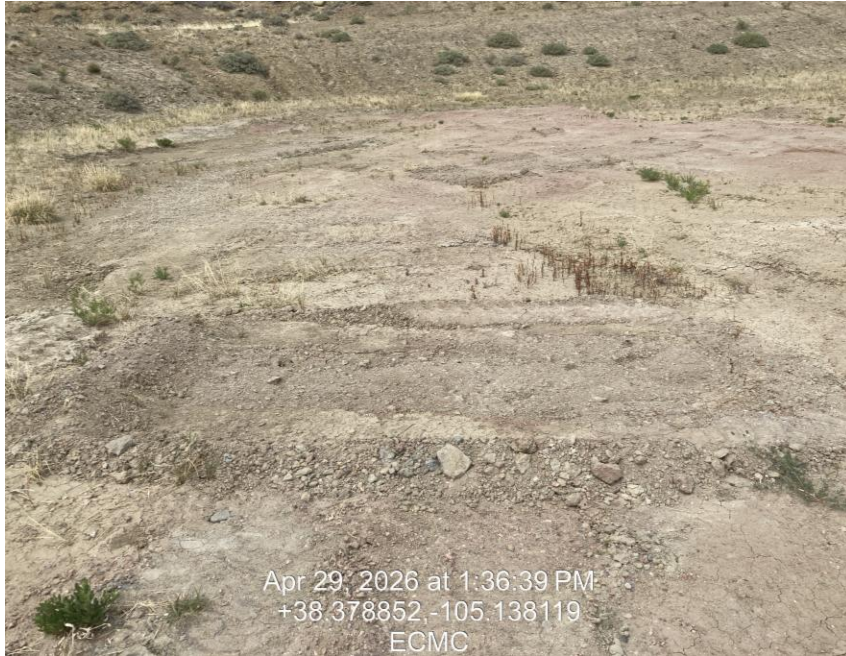
Photo 9: Excavation area backfilled

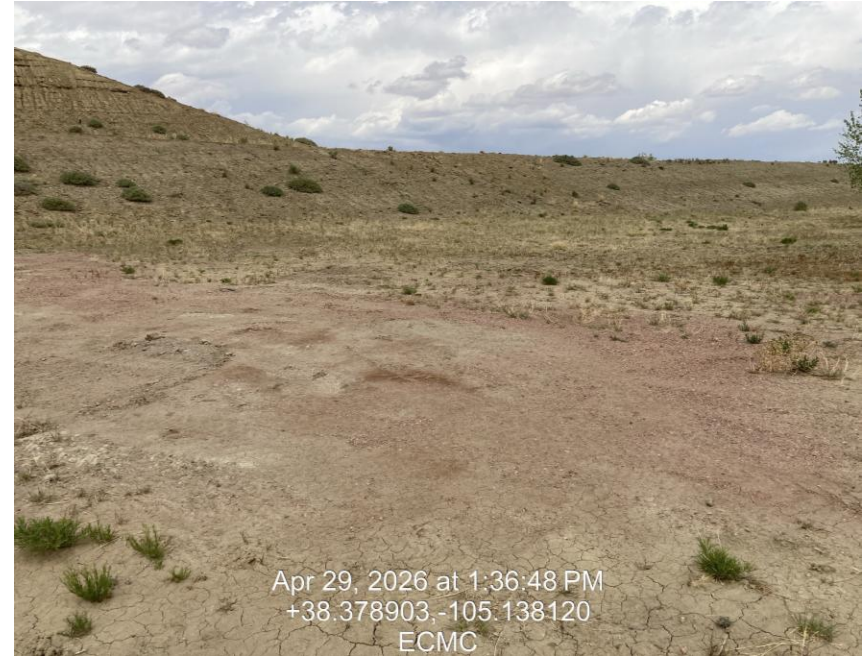
Photo 10: Excavation area backfilled

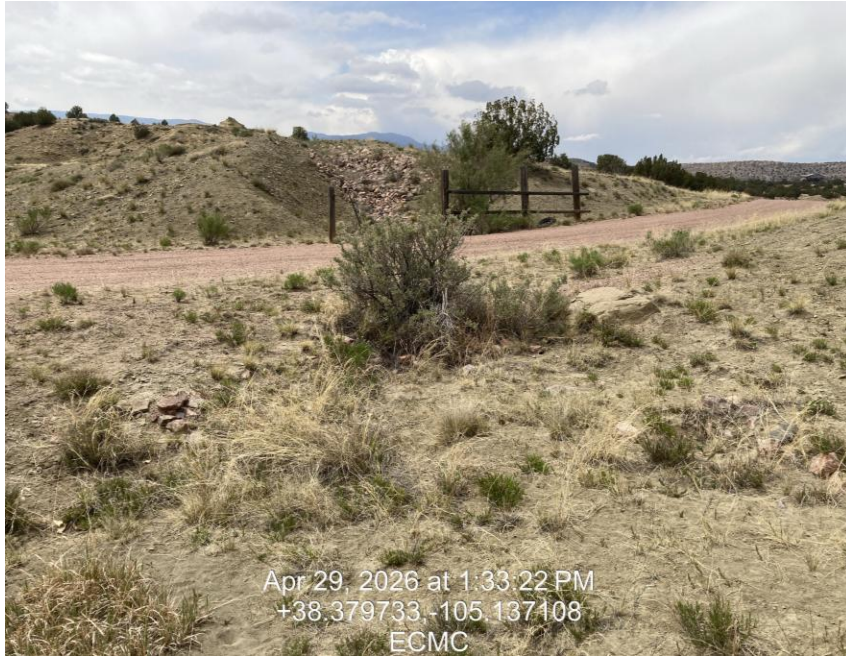
Photo 11: Plugged culvert access road and location.

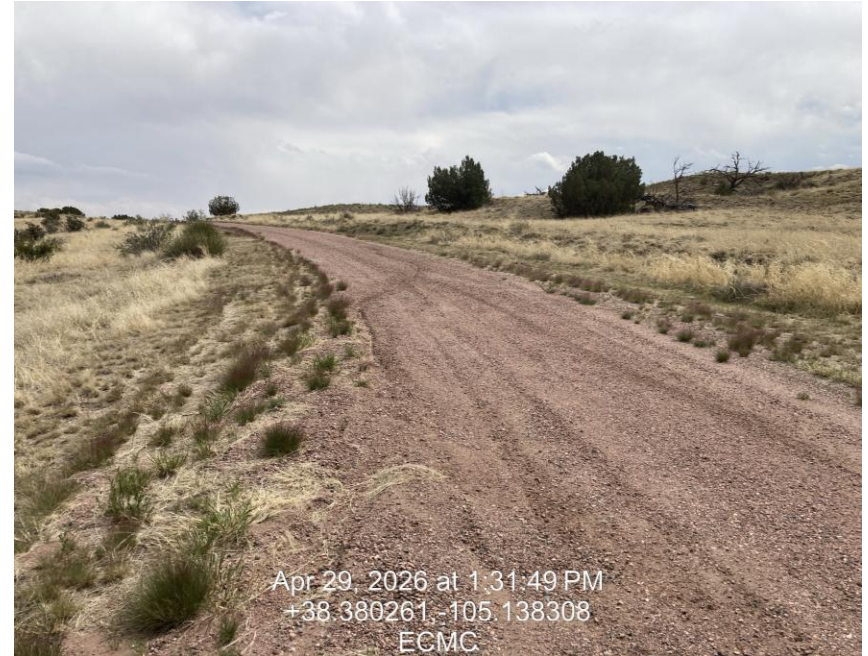
Photo 12: Erosion along access road.
