Inspection Photos
Location: Rainbow 23-20
Location ID: 322234
API # 05-043-06150

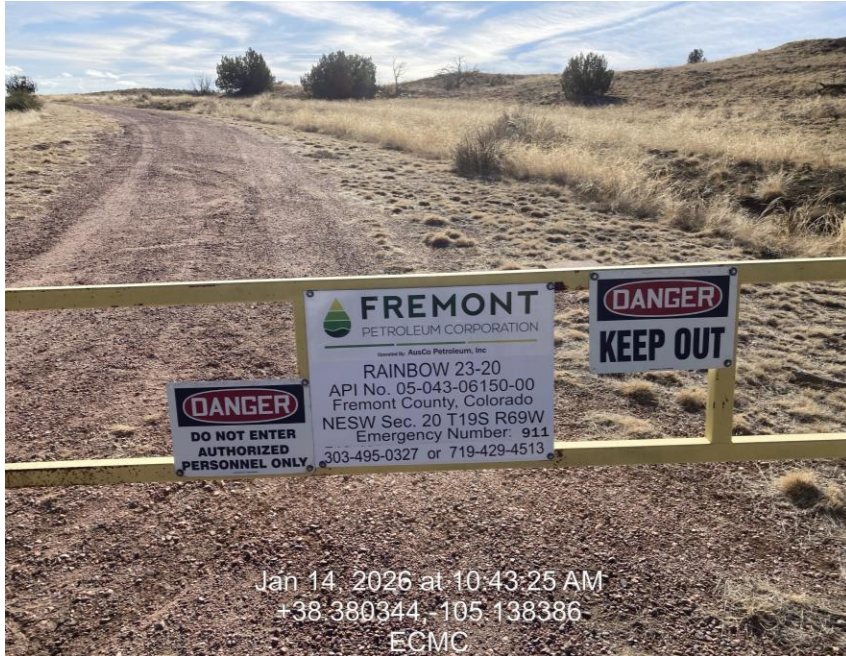
Photo 1 – Well Placard

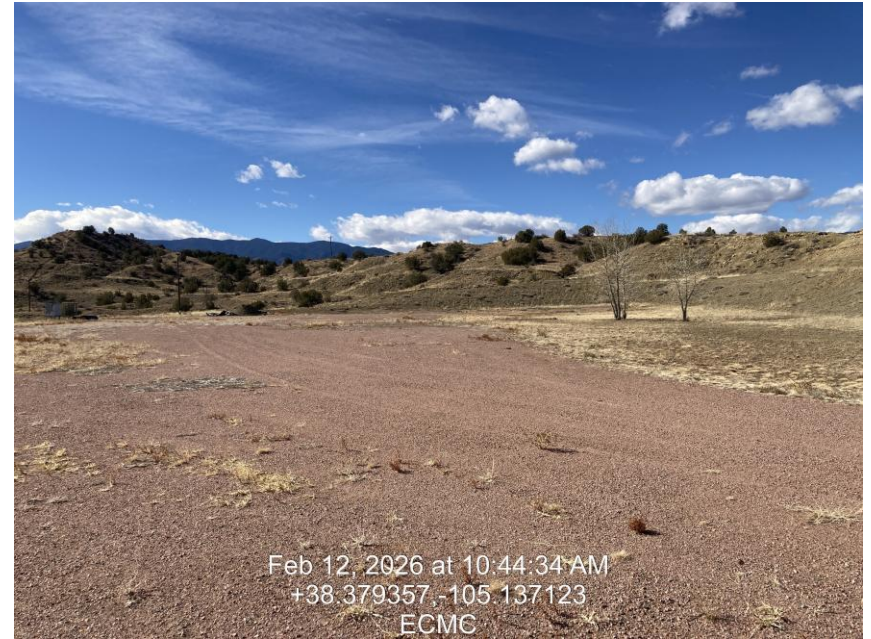
Photo 2 – Location Overview

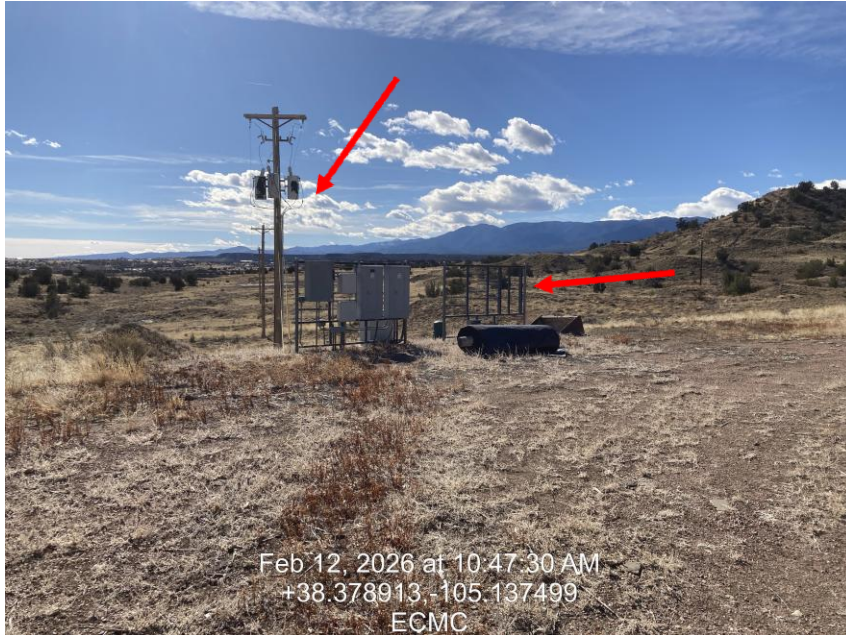
Photo 3 – Electrical Equipment

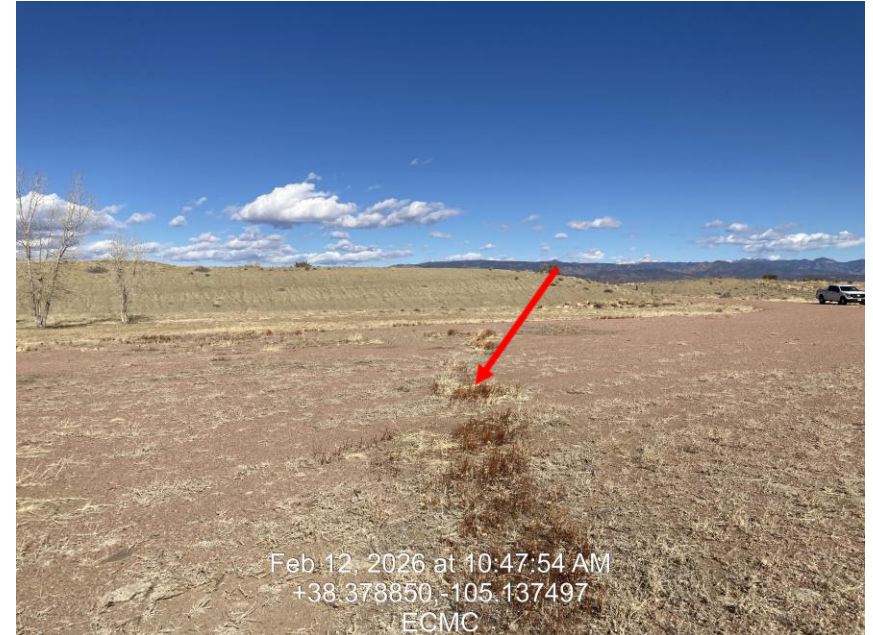
Photo 4 – Electrical Line corridor

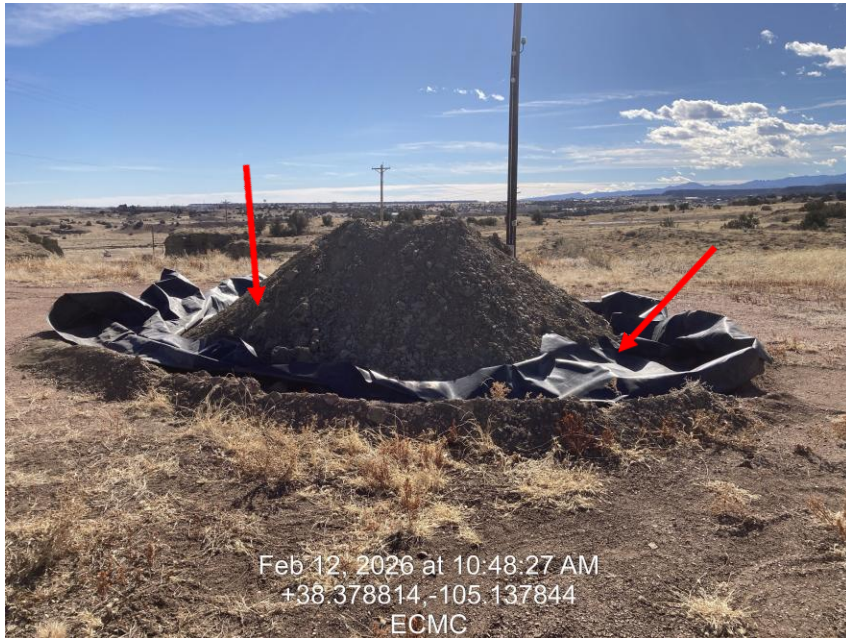
Photo 5 – Impacted spoil pile in containment

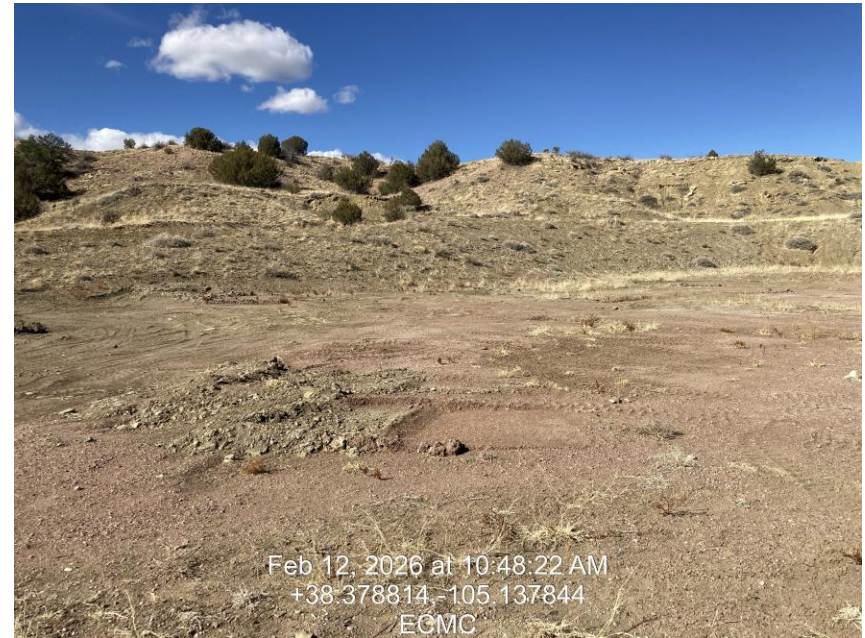
Photo 6 – Former Tank Battery/area with impacts to soils

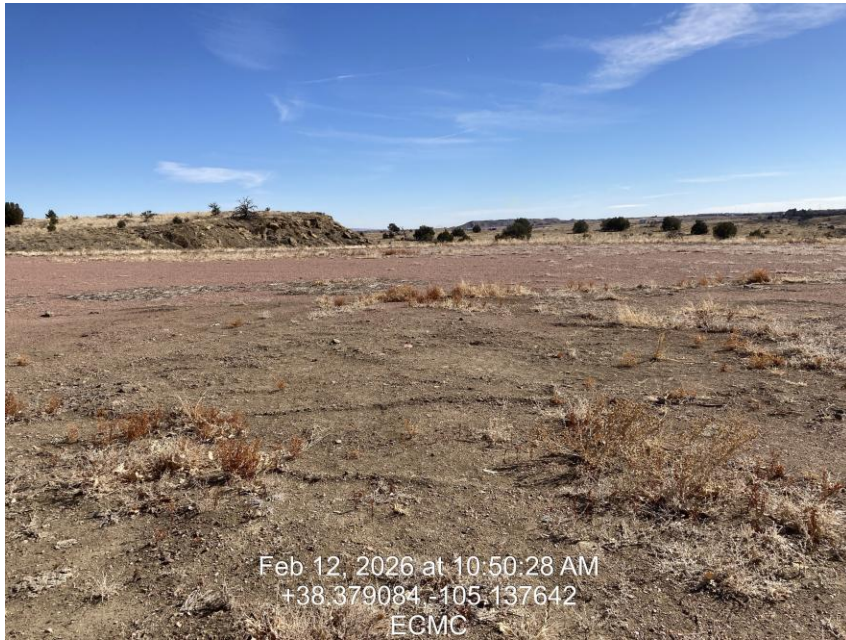
Photo 7 – Former Wellhead location

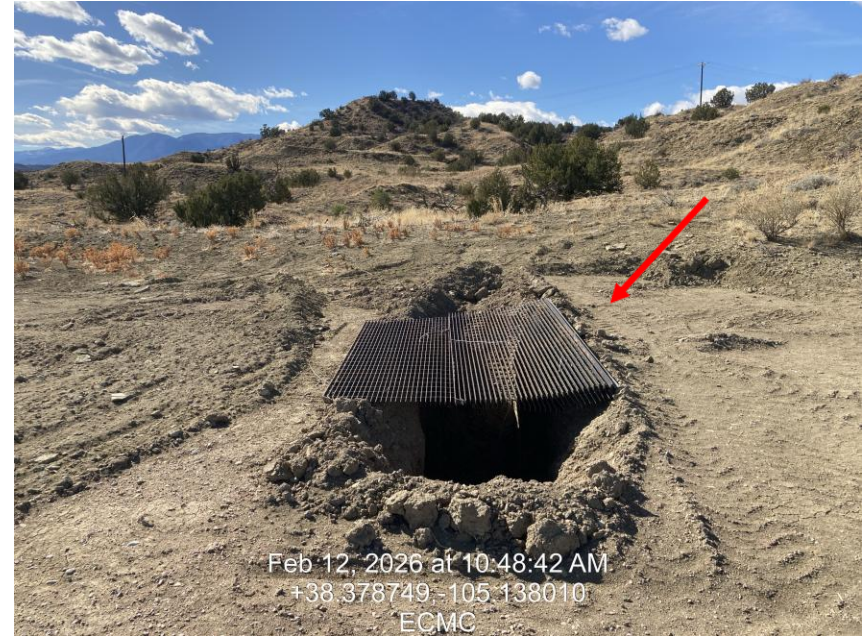
Photo 8 – Open Excavation

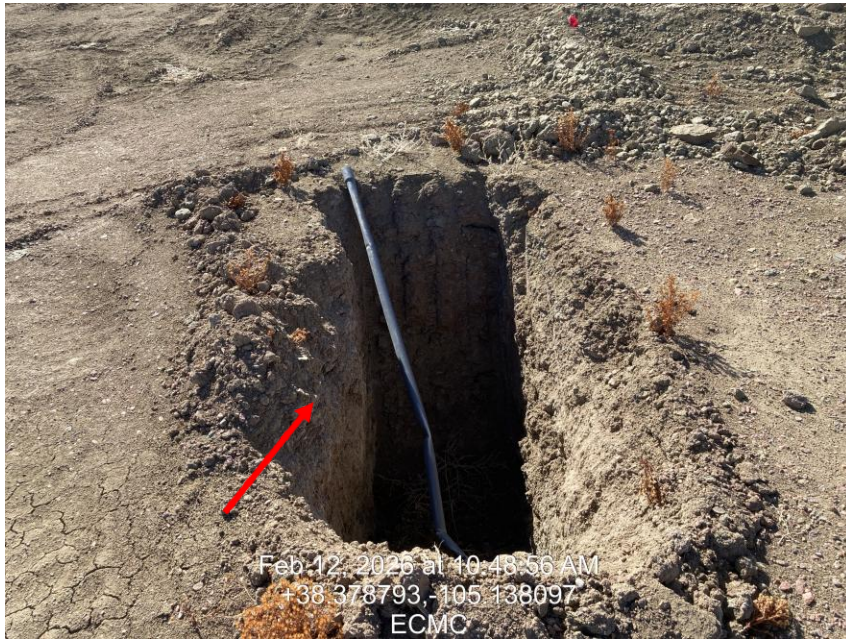
Photo 9 – Open Excavation

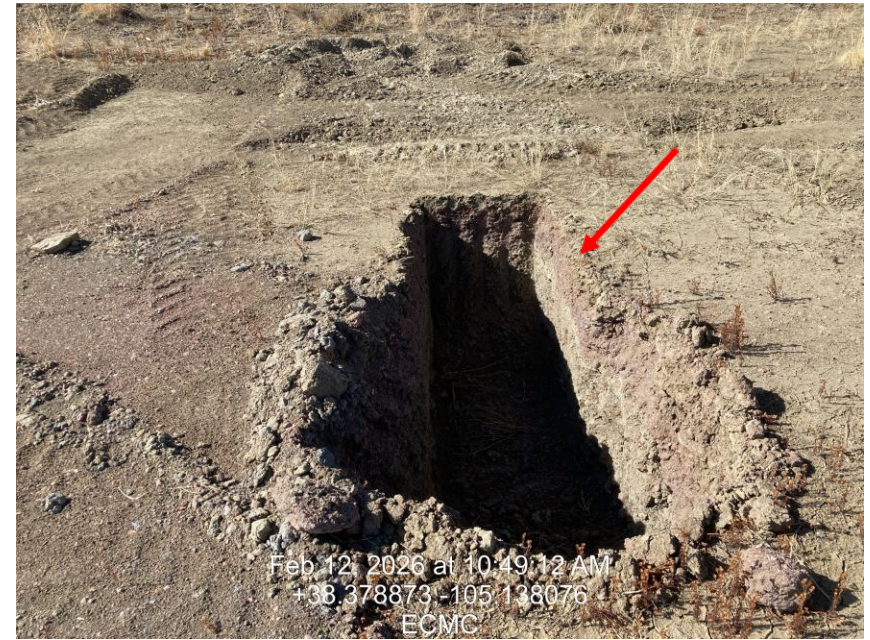
Photo 10 – Open Excavation

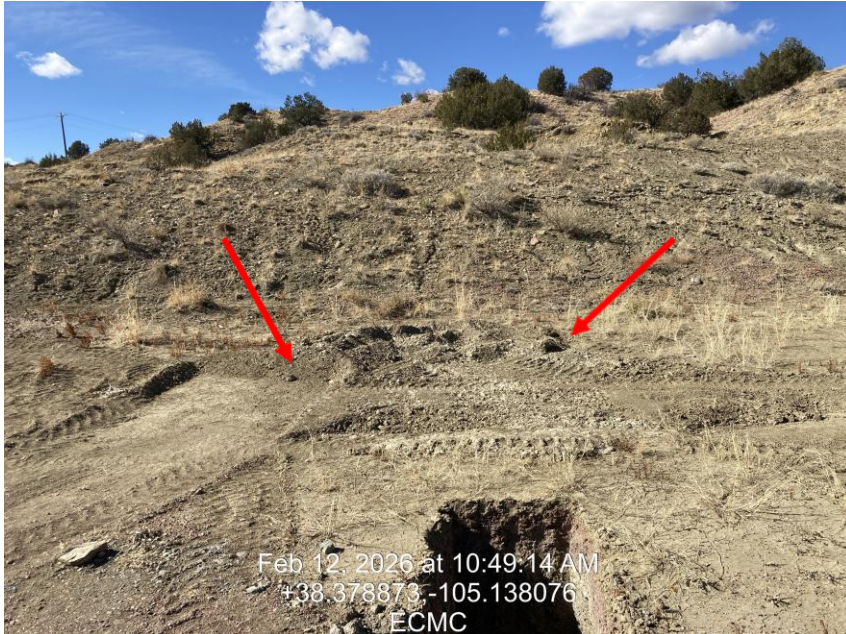
Photo 11 – Disturbance behind excavation

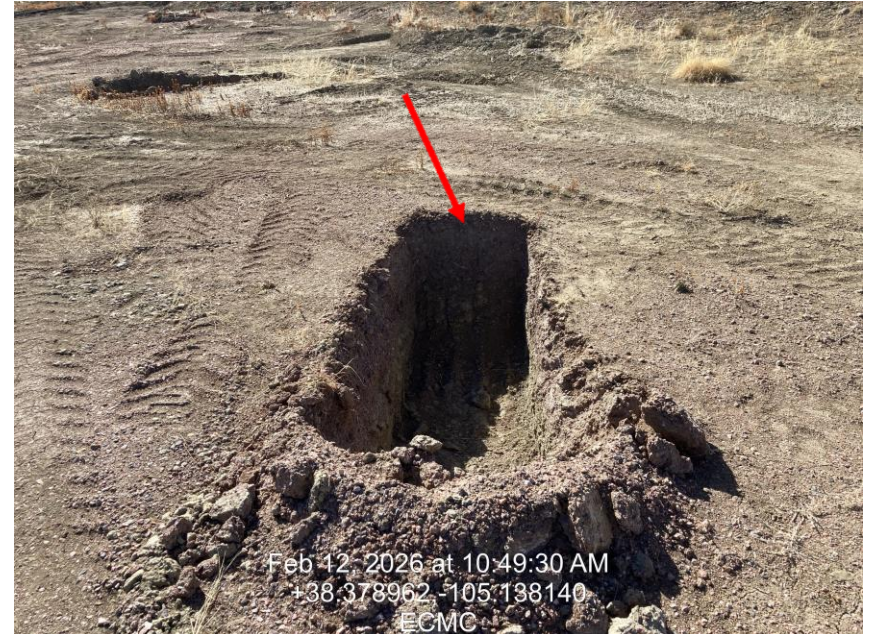
Photo 12 – Open Excavation

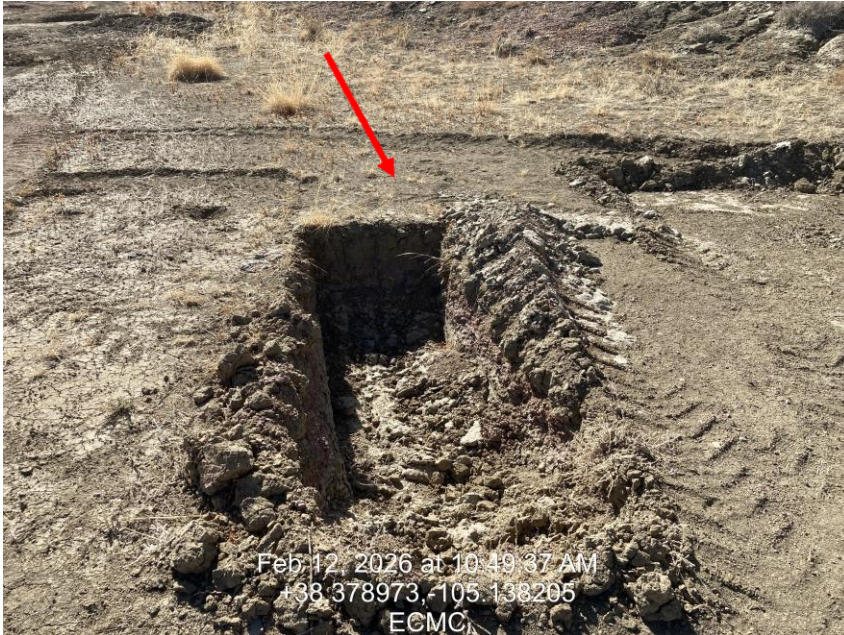
Photo 13 – Open Excavation

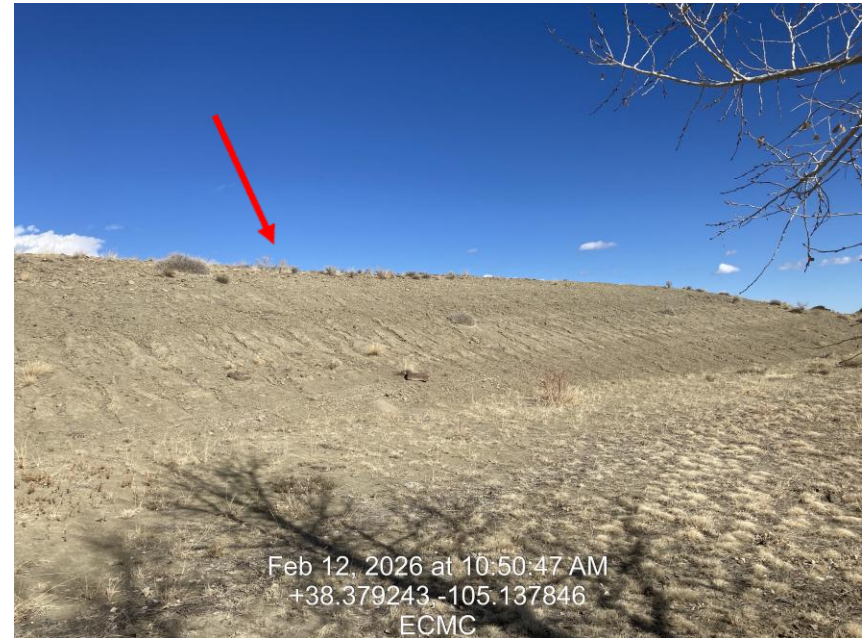
Photo 14 – Rilling along cut slope

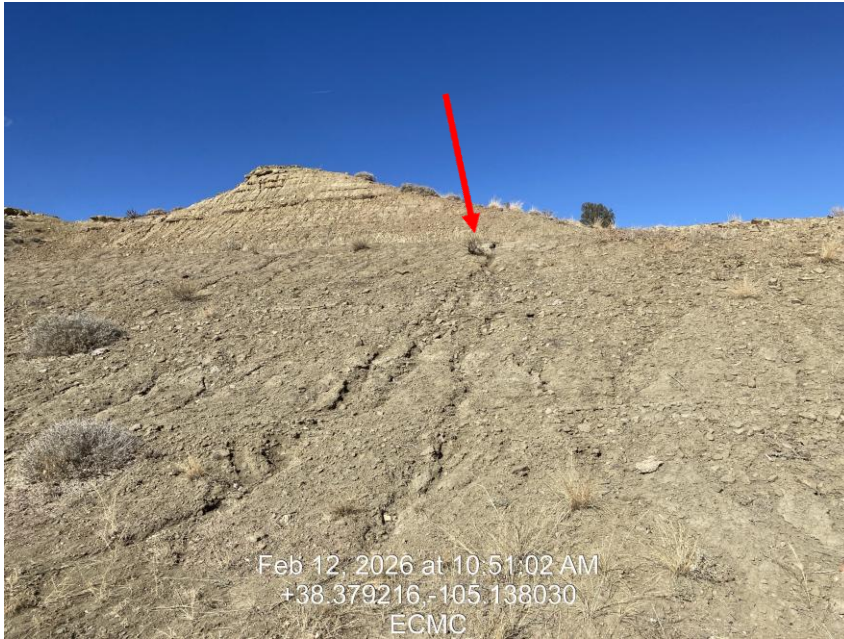
Photo 15 – Erosion on cut slope

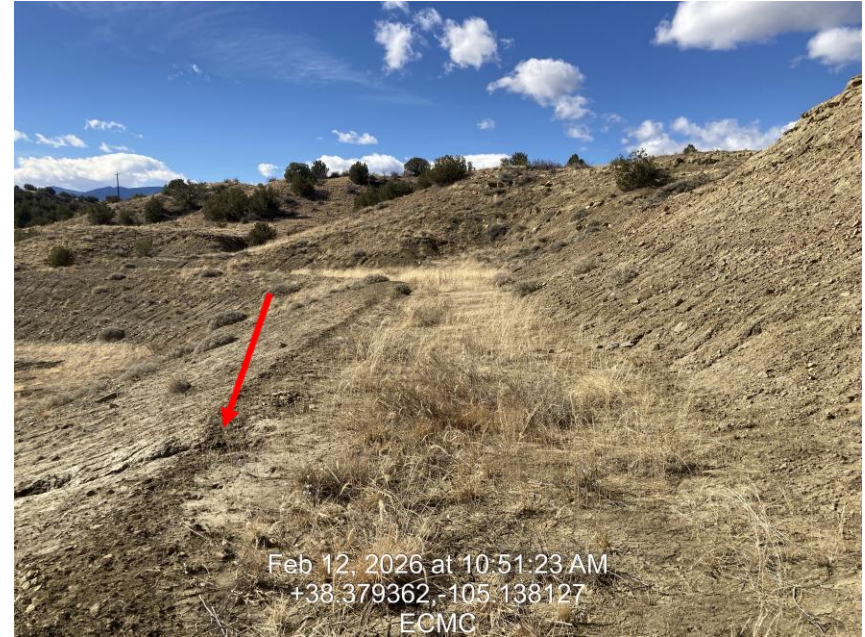
Photo 16 – Stormwater BMP at the top of cut slope is full, breach in dyke at red arrow

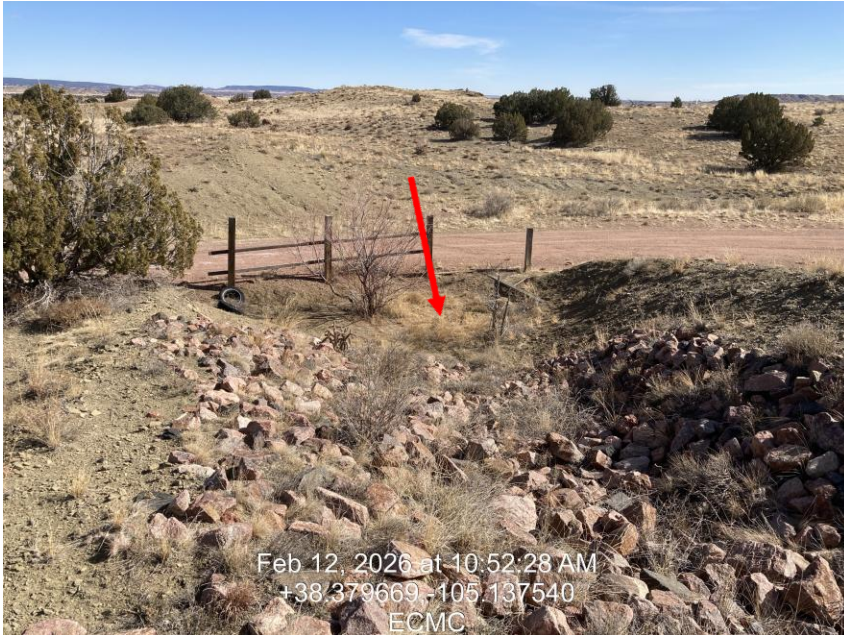
**Photo 17 – Stormwater BMP adjacent to access
Road is full**

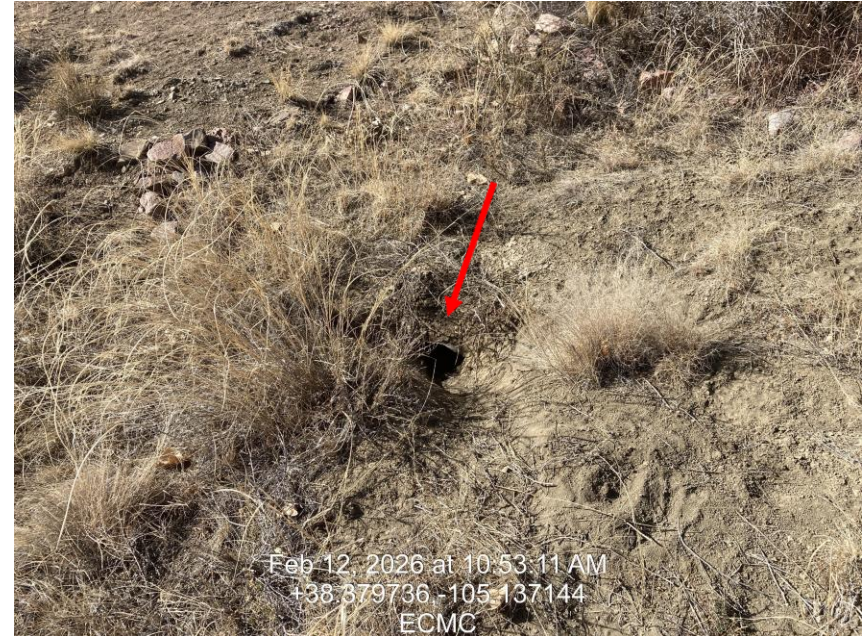
**Photo 18 – Plugged culvert at lower end of BMP in
photo # 17**
