Inspection Photos

API: 073-06189

Operator: MAGPIE OPERATING INC

Inspection Date: 4/29/2026

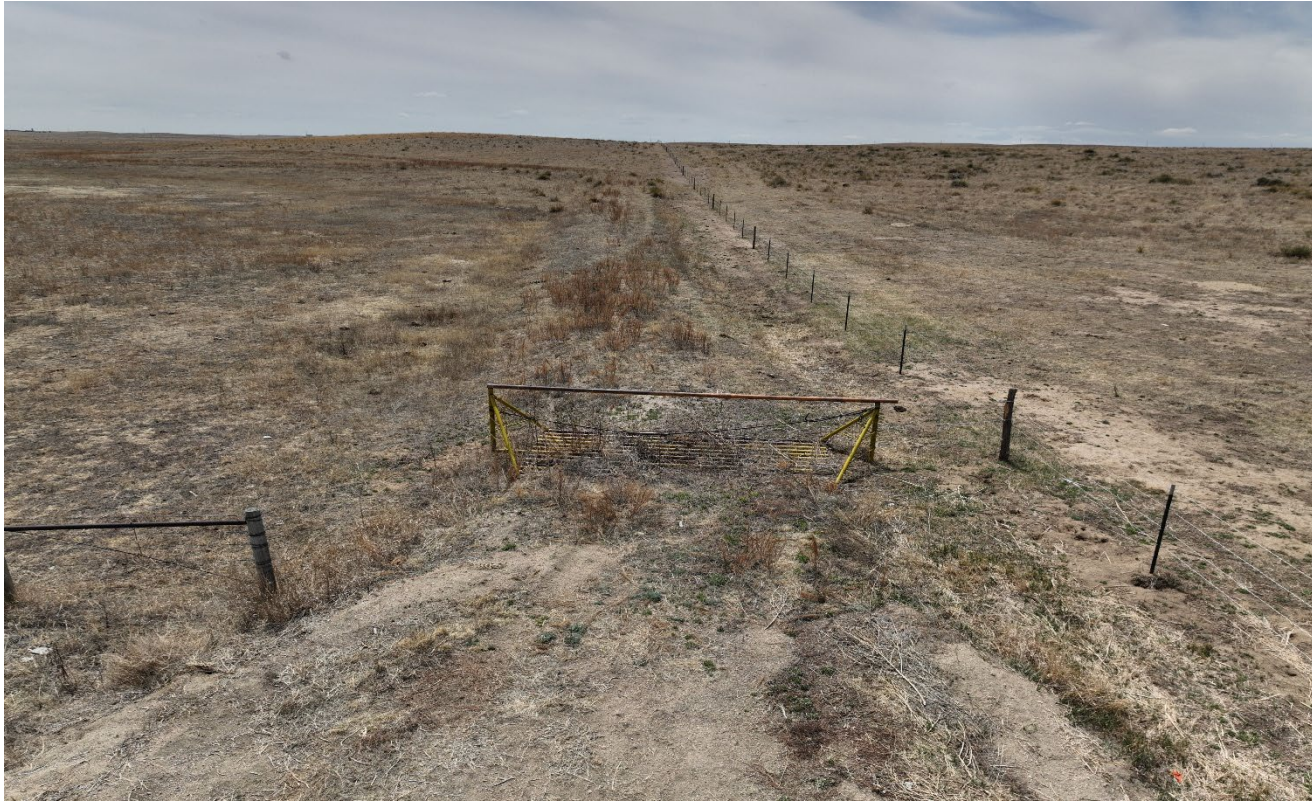
Photo 1. Drone aerial photo facing south at the beginning of the access road. The cattleguard and gate remains.

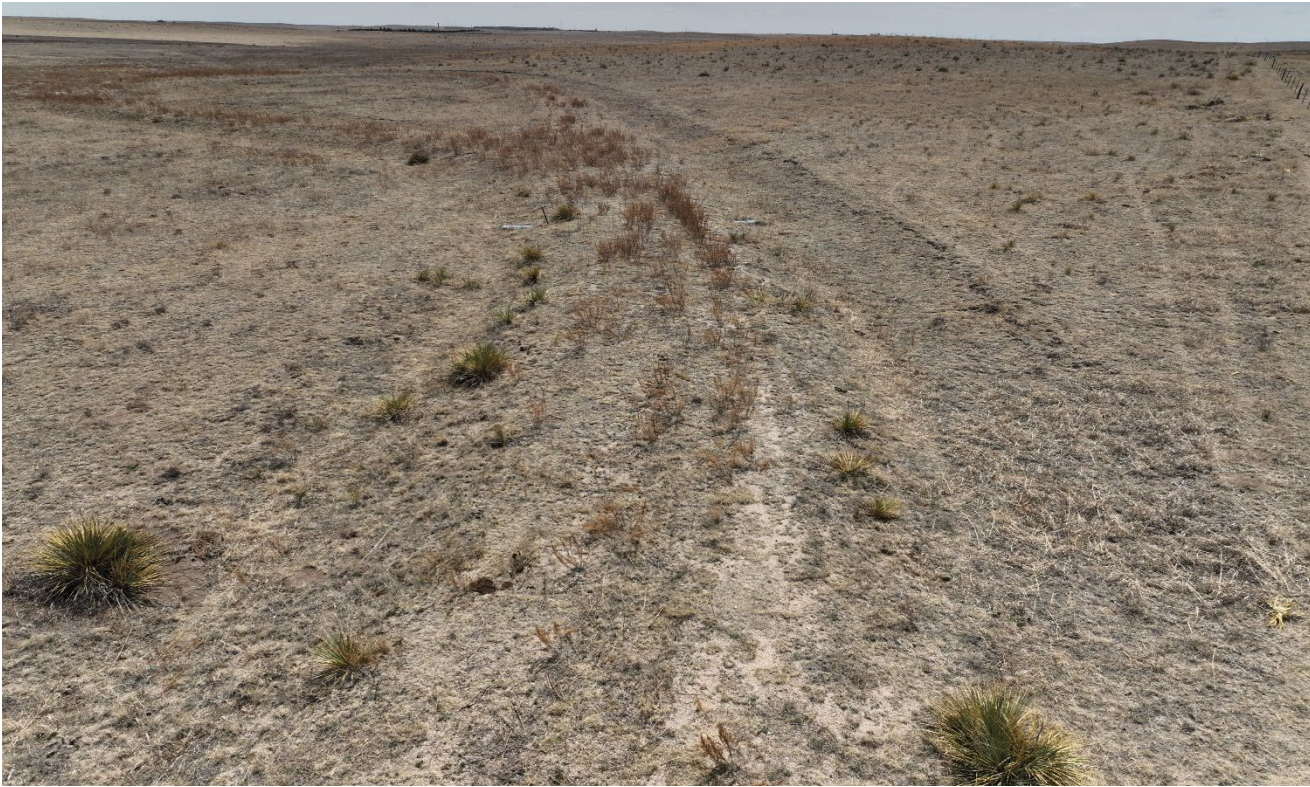
Photo 2. Drone aerial photo facing southeast along the access road.

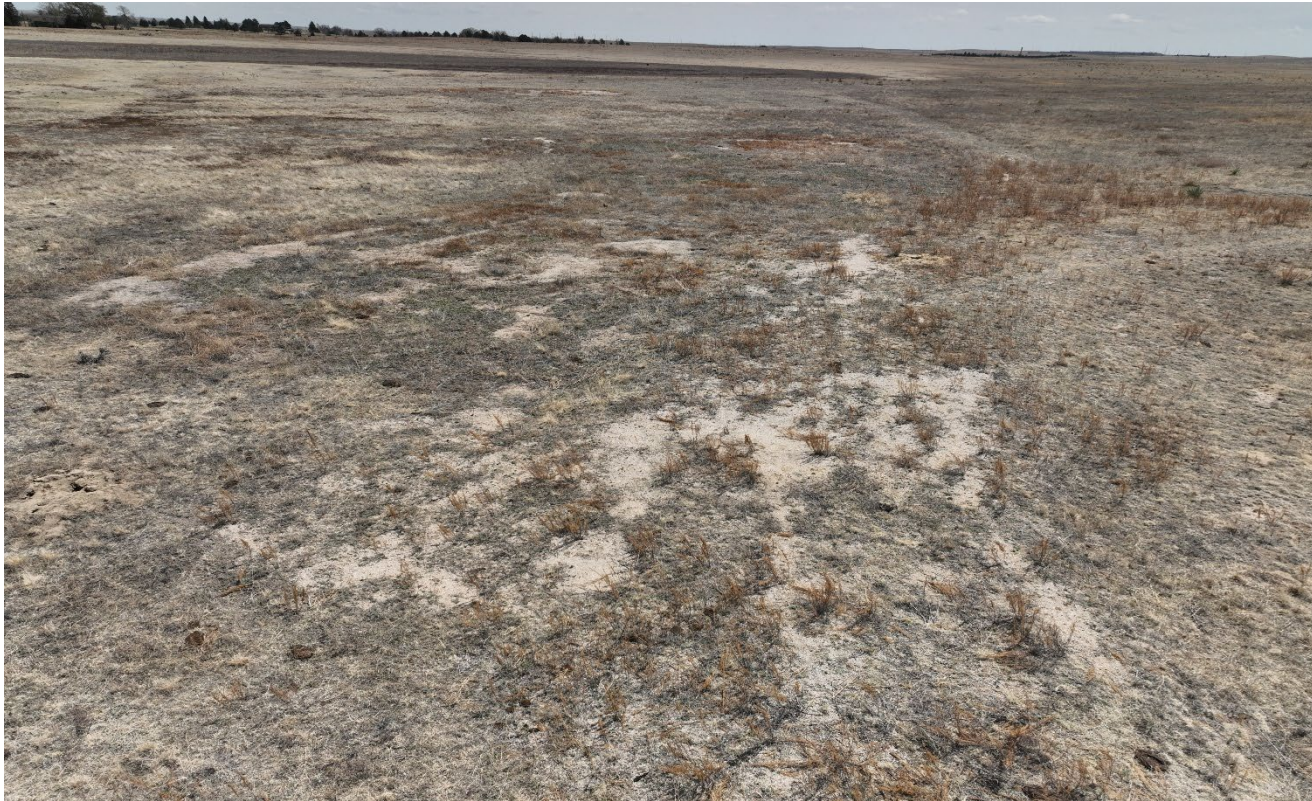
Photo 3. Drone aerial photo facing southeast toward the former tank battery site. This area has not revegetated and consists mostly of undesirable weeds.

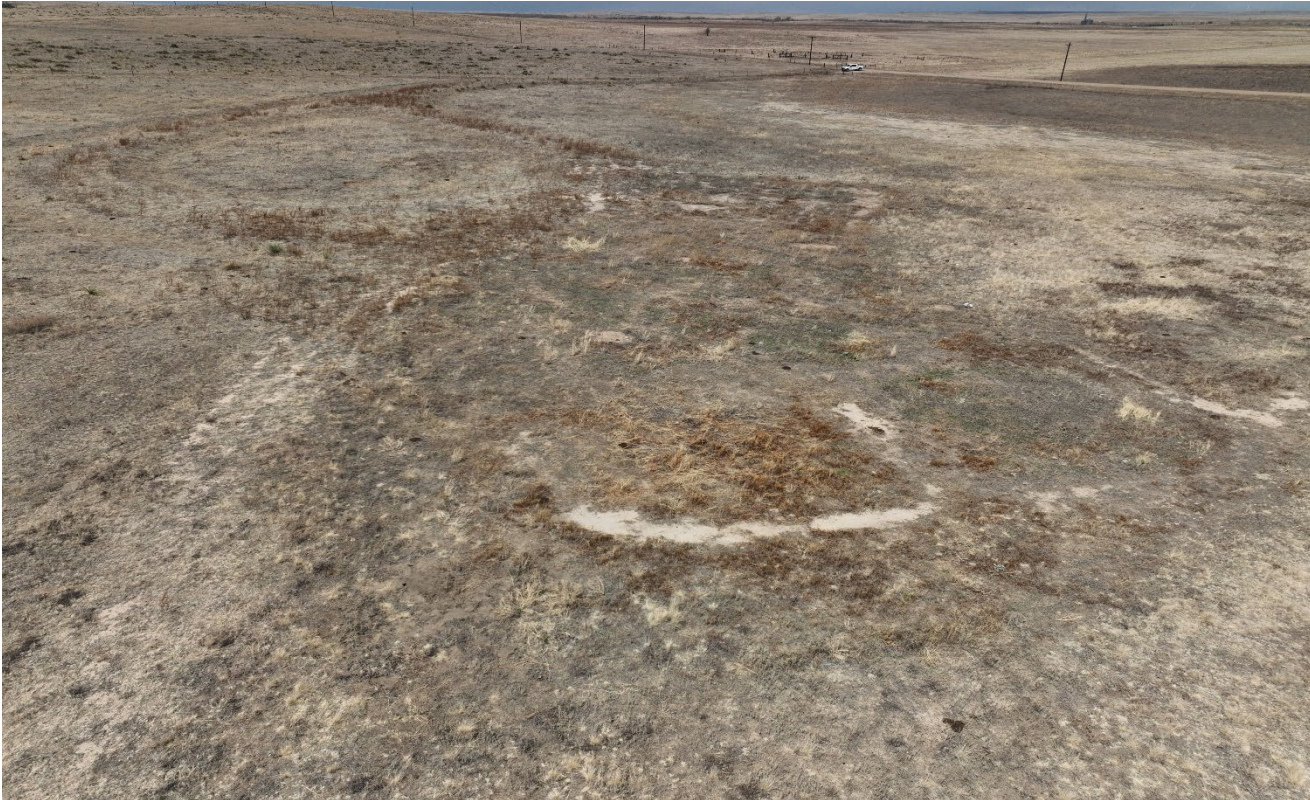
Photo 4. Drone aerial photo facing northwest toward the former tank battery site. This area has not revegetated and consists mostly of undesirable weeds..

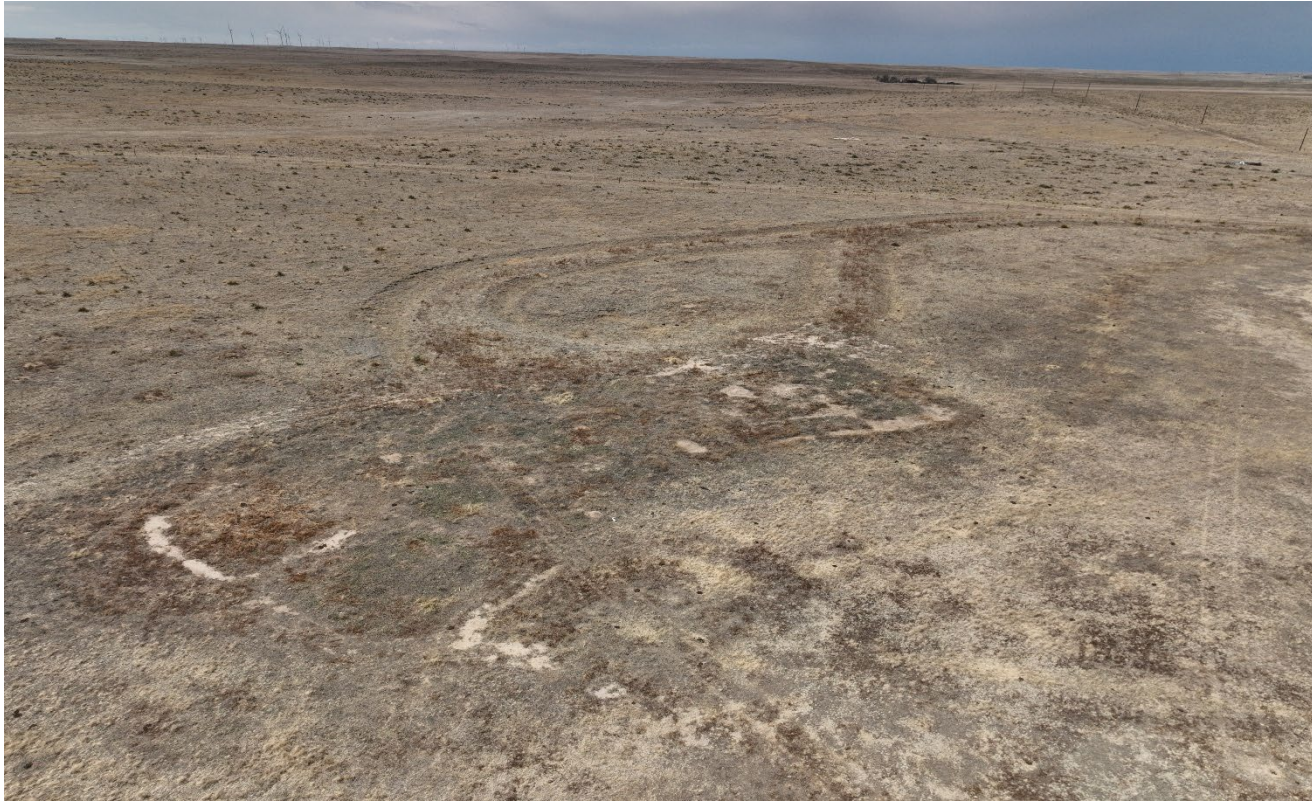
Photo 5. Drone aerial photo facing southeast overlooking the former tank battery site and access road.

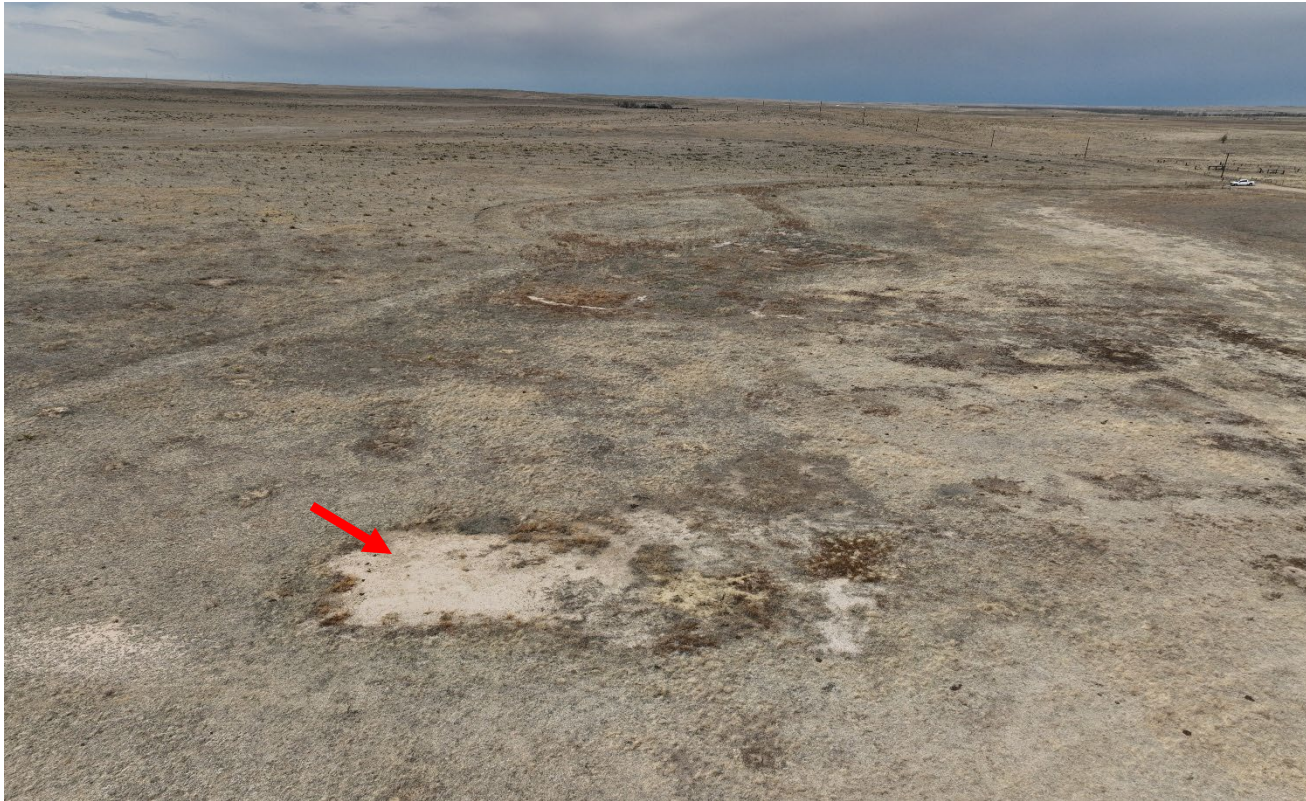
Photo 6. Drone aerial photo facing northwest toward the location. The red arrow points to the abandoned wellsite. This area is bare of vegetation and appears to be a suspected spill causing soil impacts.

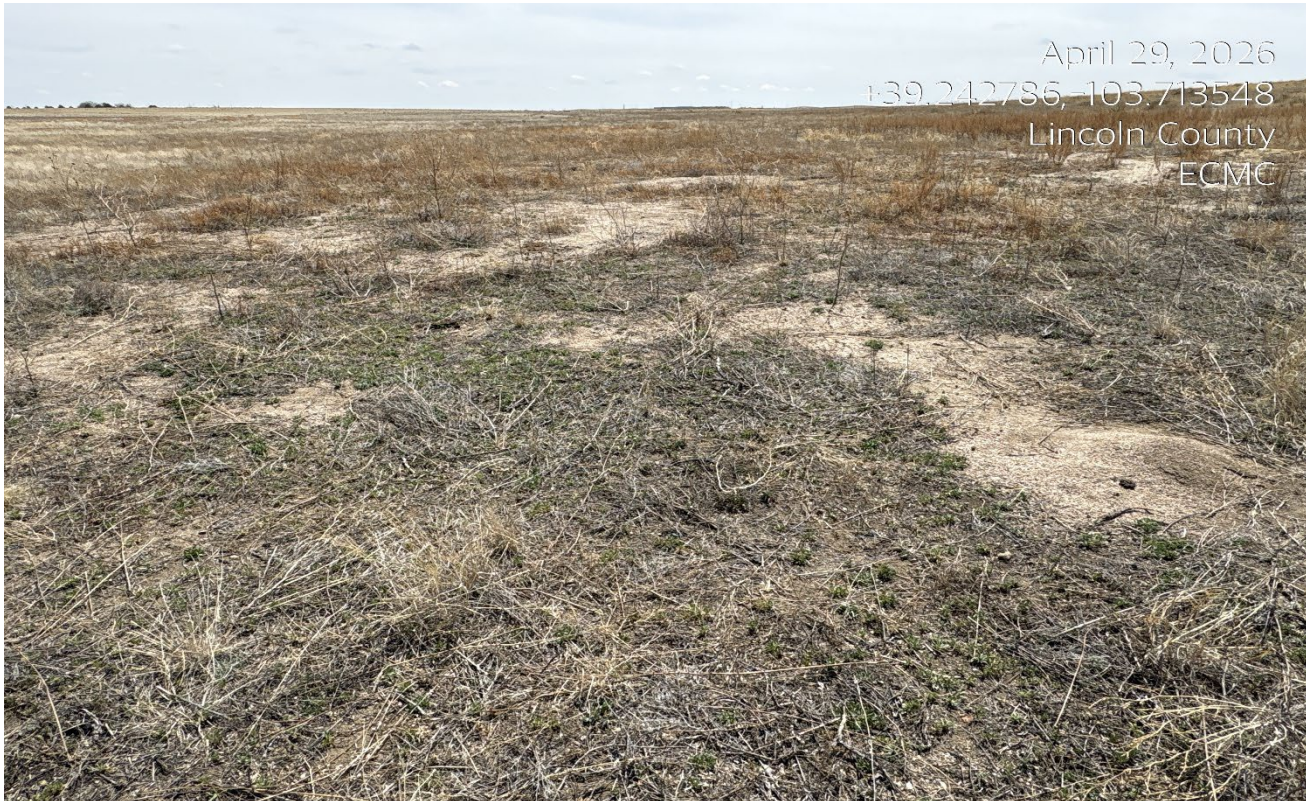
Photo 7. Facing southeast at the former tank battery location. This area consists mostly of undesirable weeds.

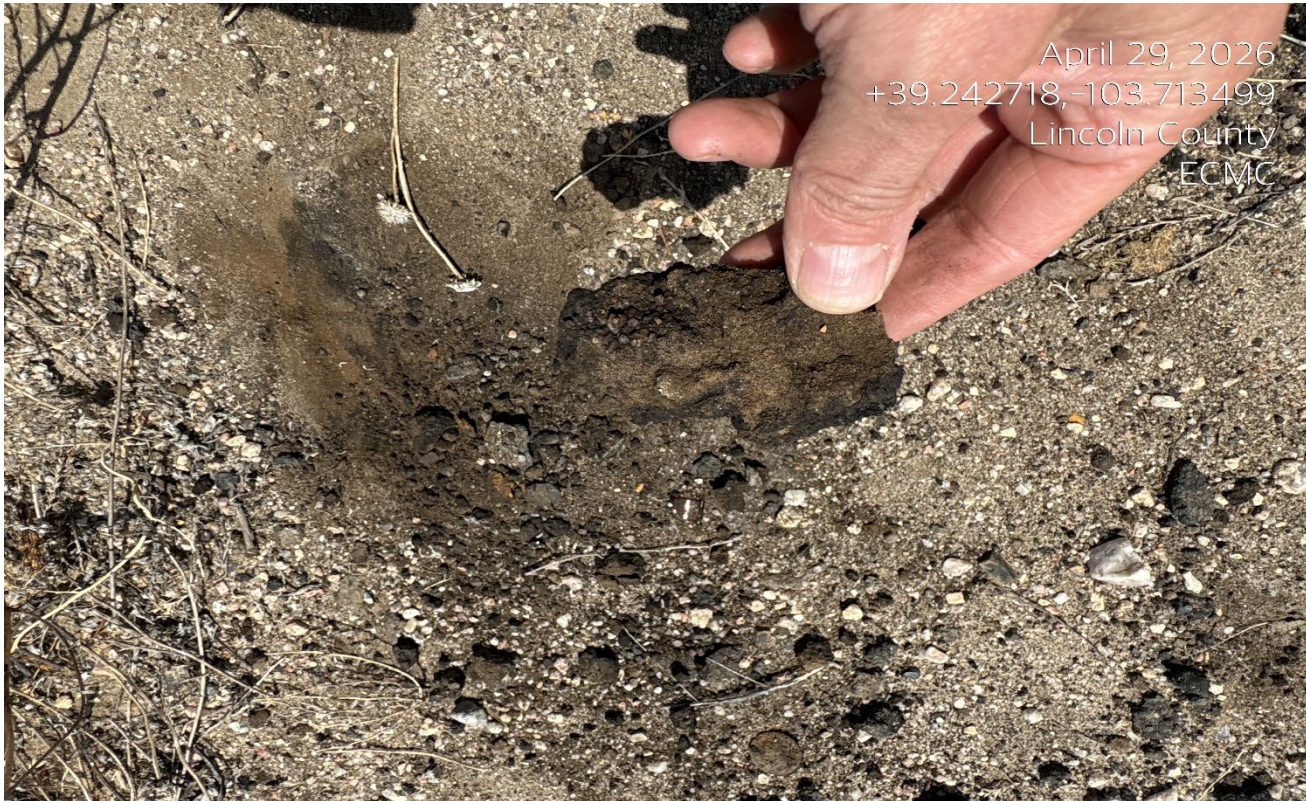
Photo 8. There is hydrocarbon impacts at the former tank battery that have become exposed at the surface..

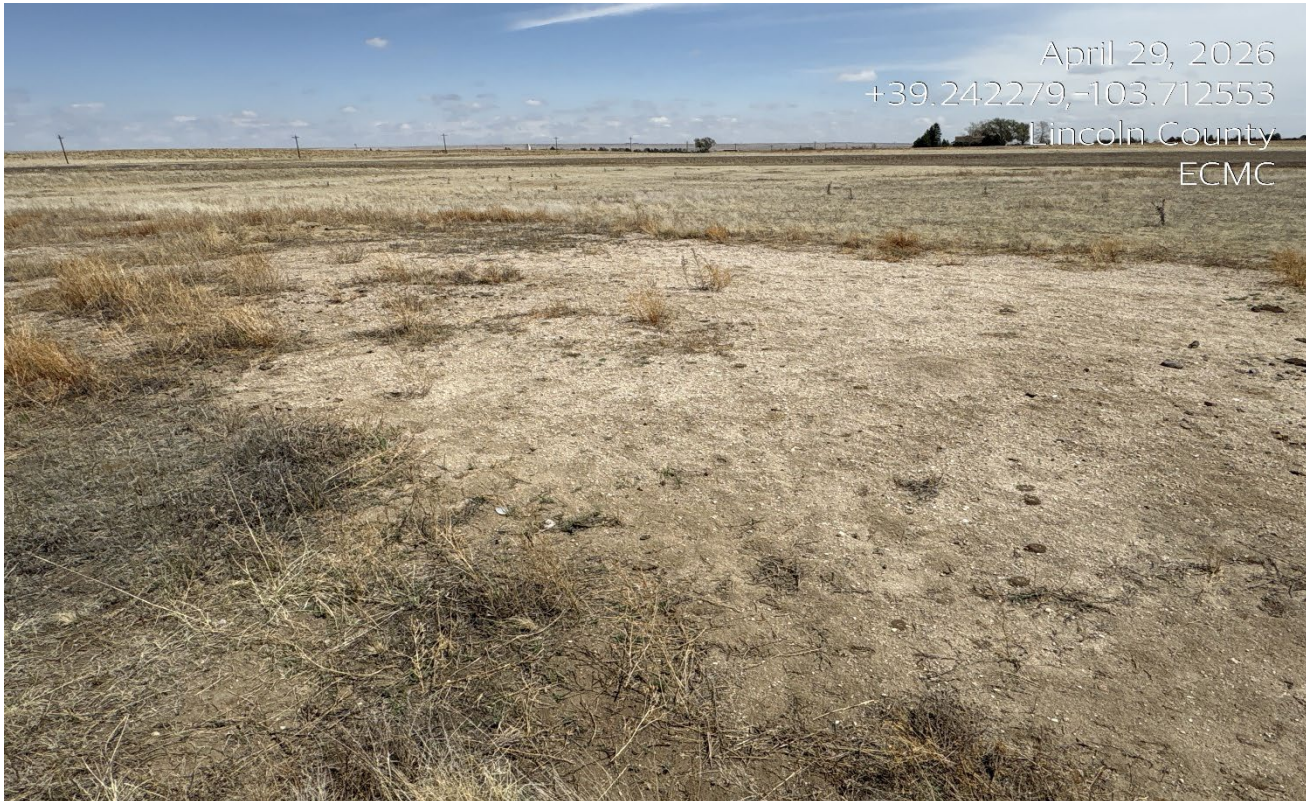
Photo 9. Facing northeast toward the former wellsite. This area has no vegetation and appears to have impacted soils from a historic spill..

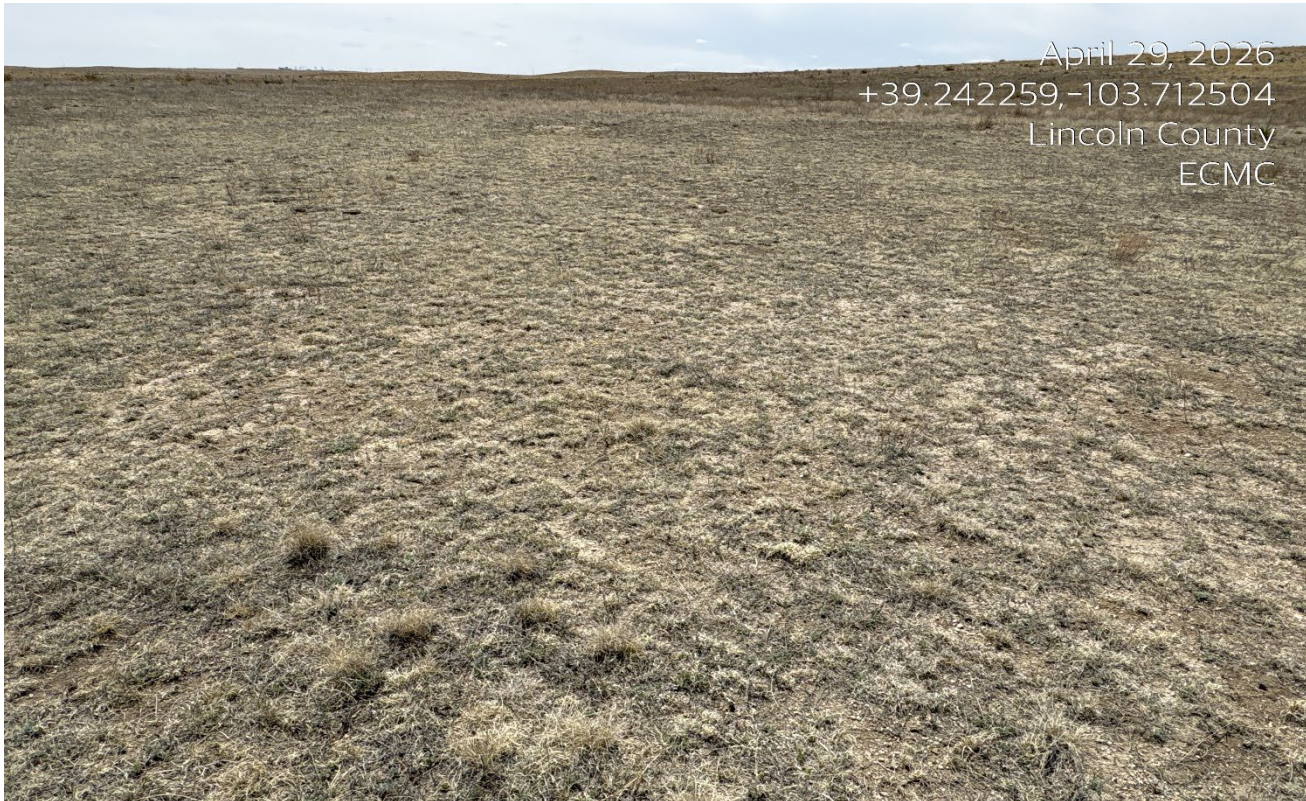
Photo 10. Facing south toward the surrounding reference area which consists of Blugrama dominated grassland.
