**TEP ROCKY MOUNTAIN LLC
FORCE-66S94W 33NWSE
Location # 324048**

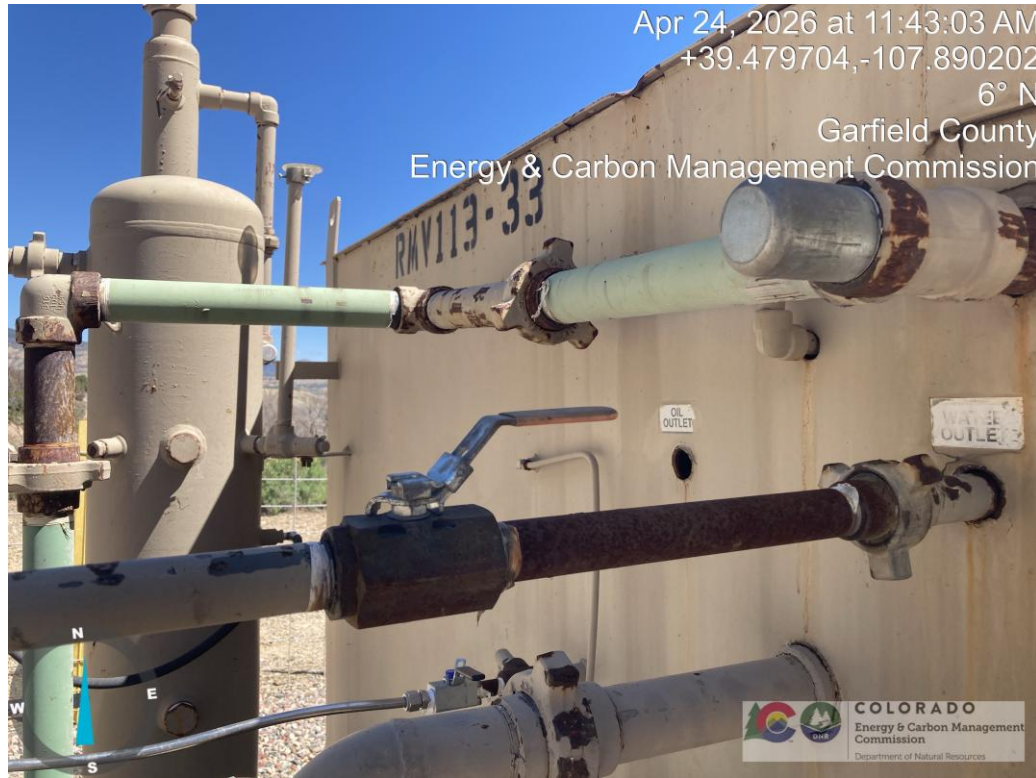
**Unpainted and/or Paint deterioration
and areas of rust.**

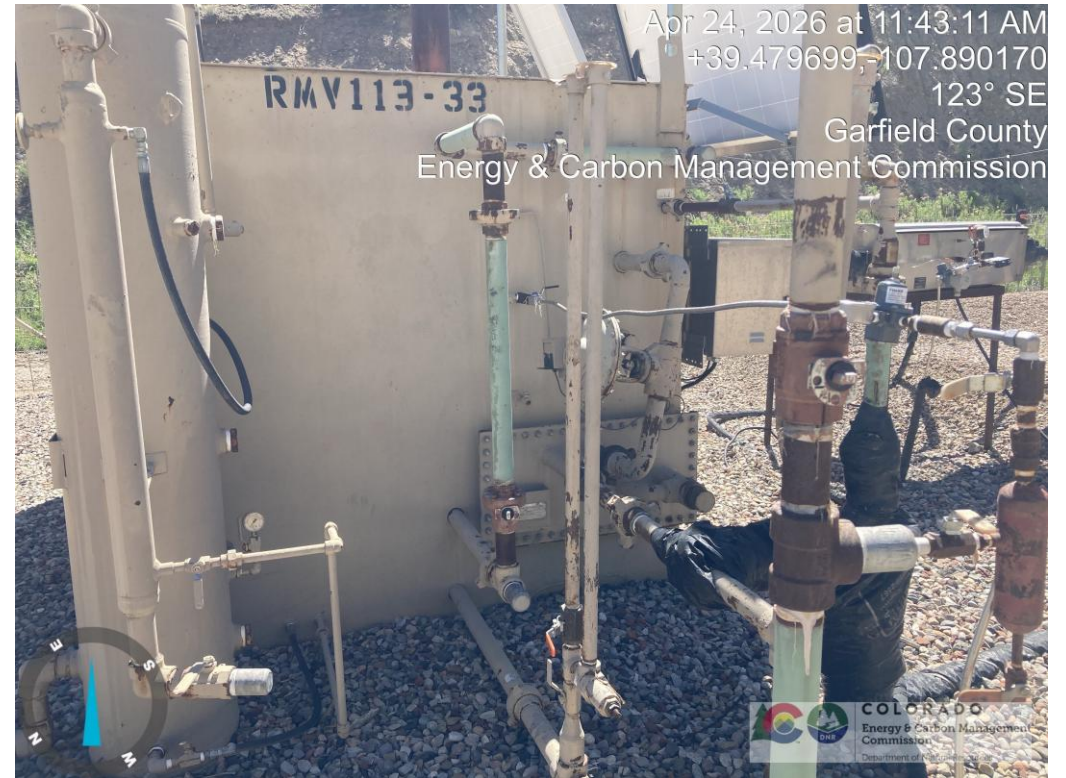
**Unpainted and/or Paint deterioration
and areas of rust.**

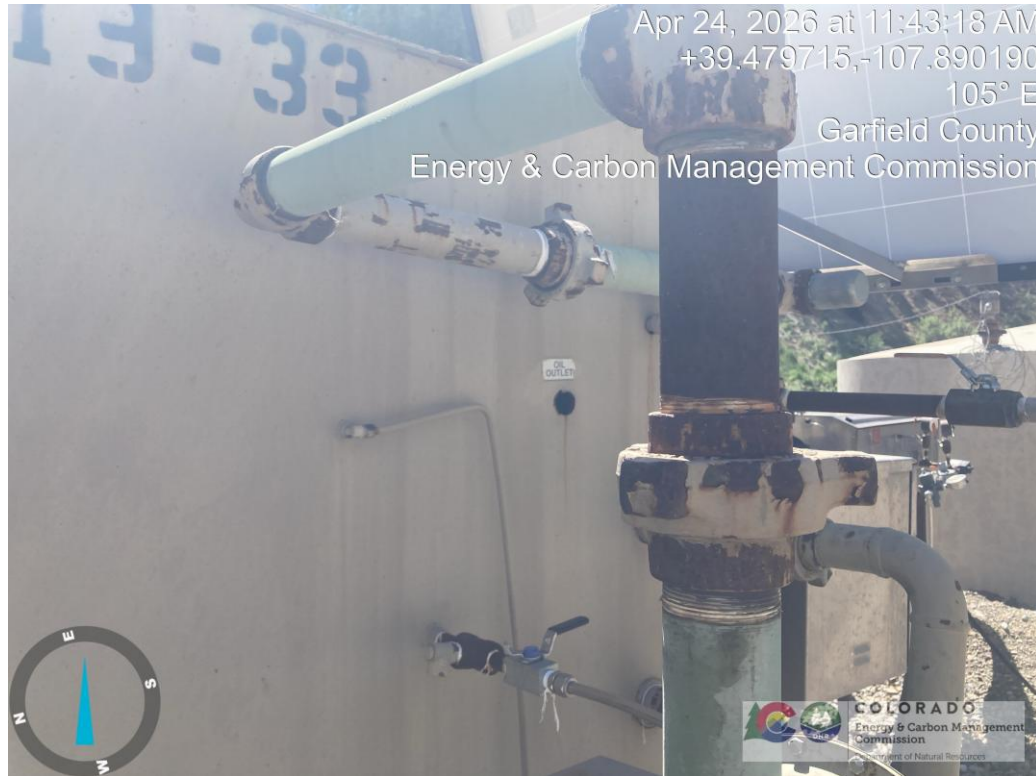
**Unpainted and/or Paint deterioration
and areas of rust.**

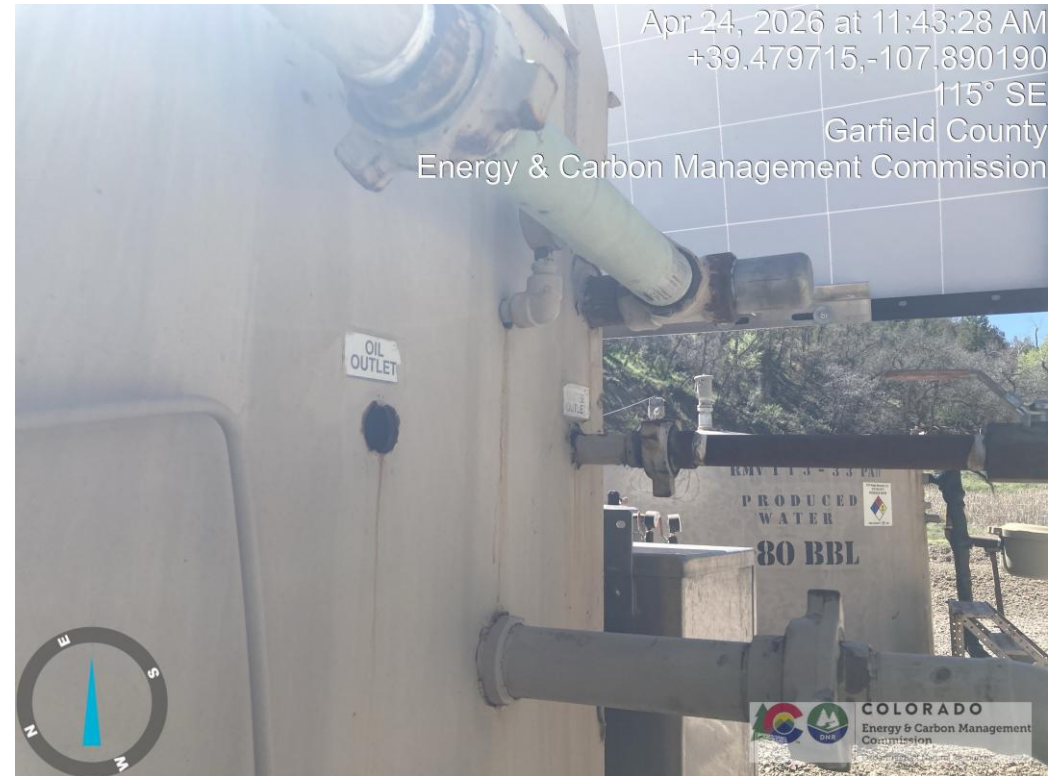
**Unpainted and/or Paint deterioration
and areas of rust.**

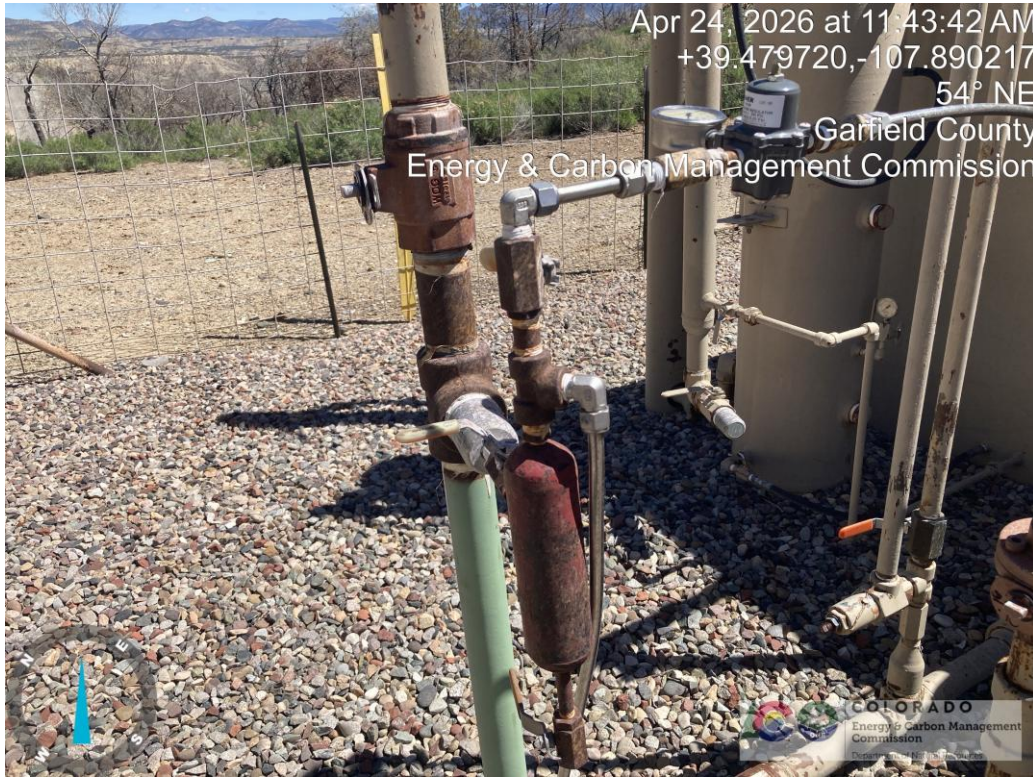
**Unpainted and/or Paint deterioration
and areas of rust.**

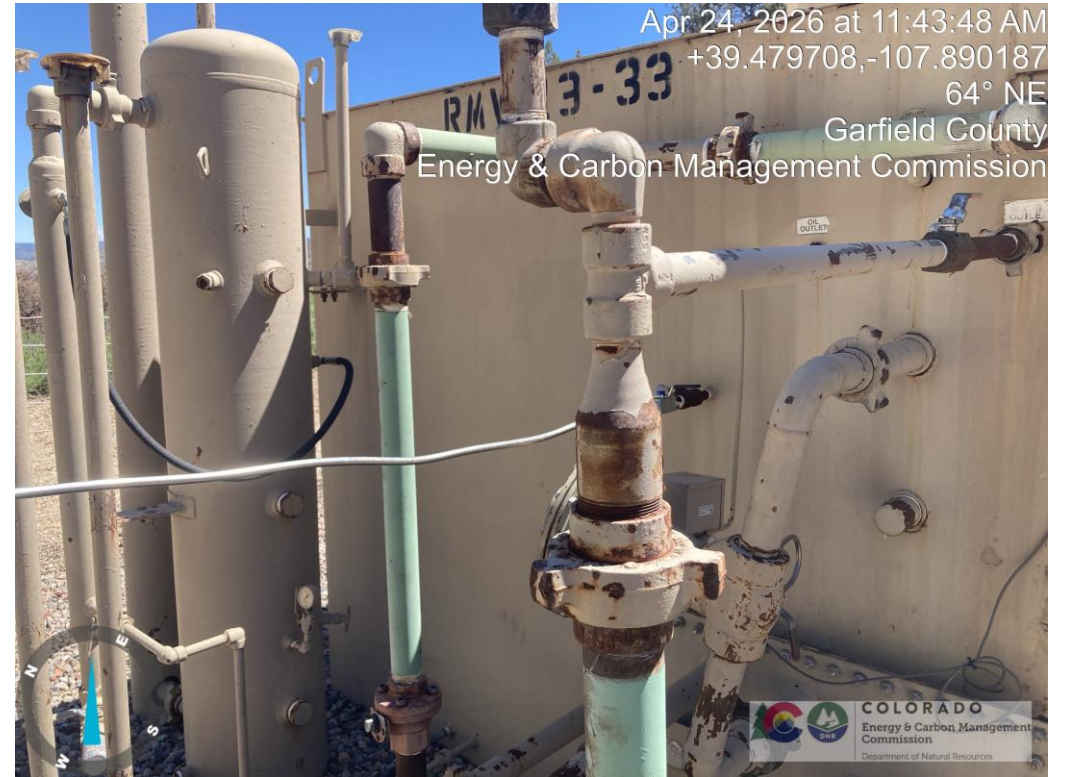
**Unpainted and/or Paint deterioration
and areas of rust.**

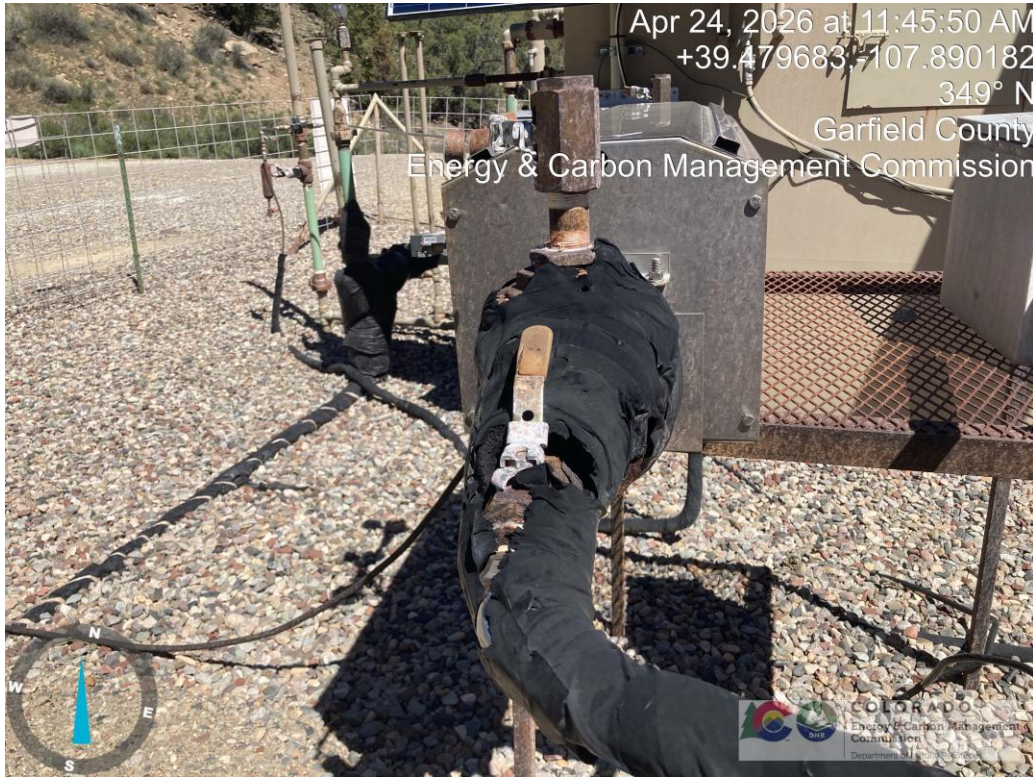
Rusted valves and fittings on catalytic heater.

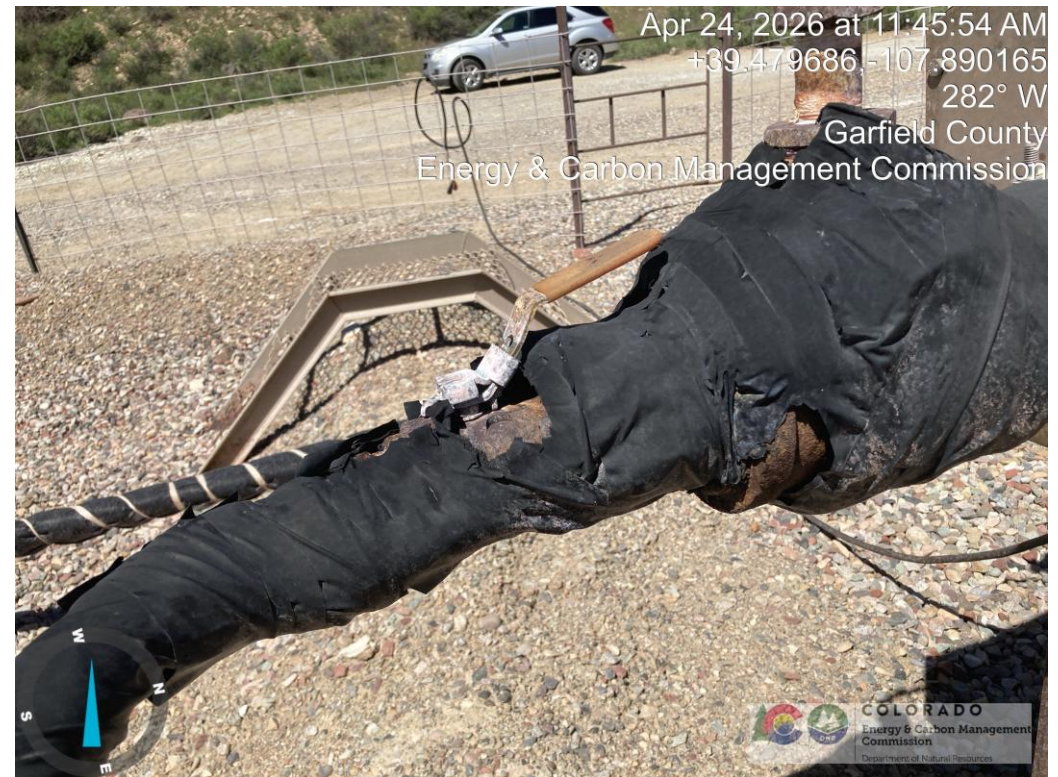
Rusted valves and fittings on catalytic heater.

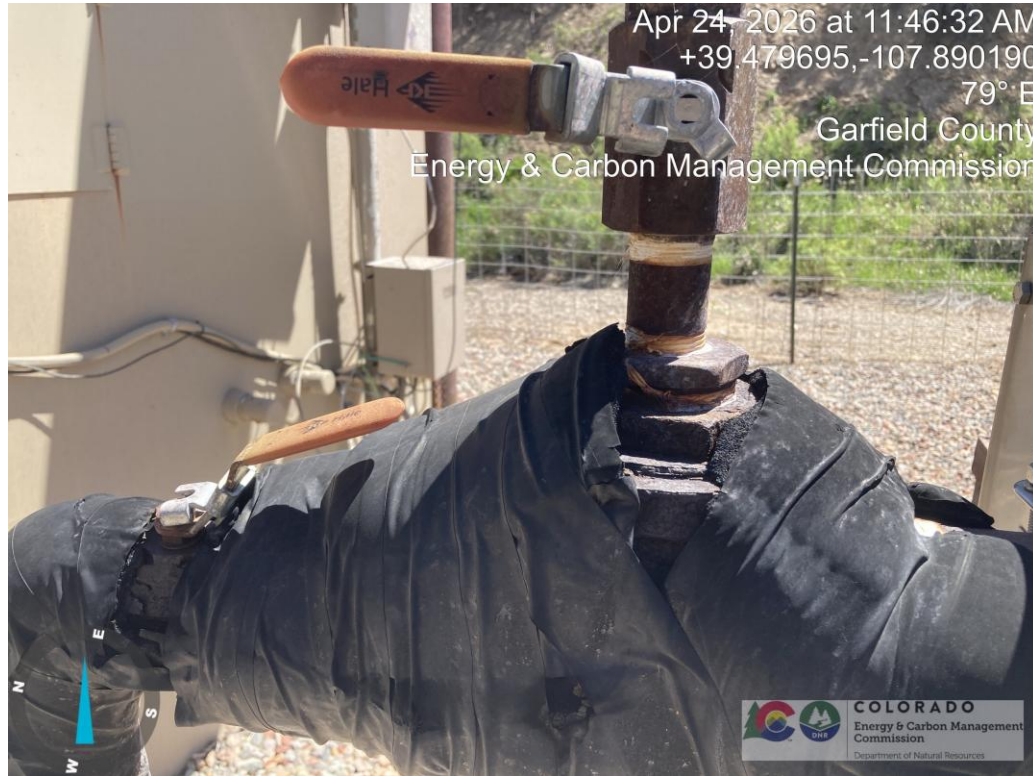
Rusted valves and fittings on catalytic heater.

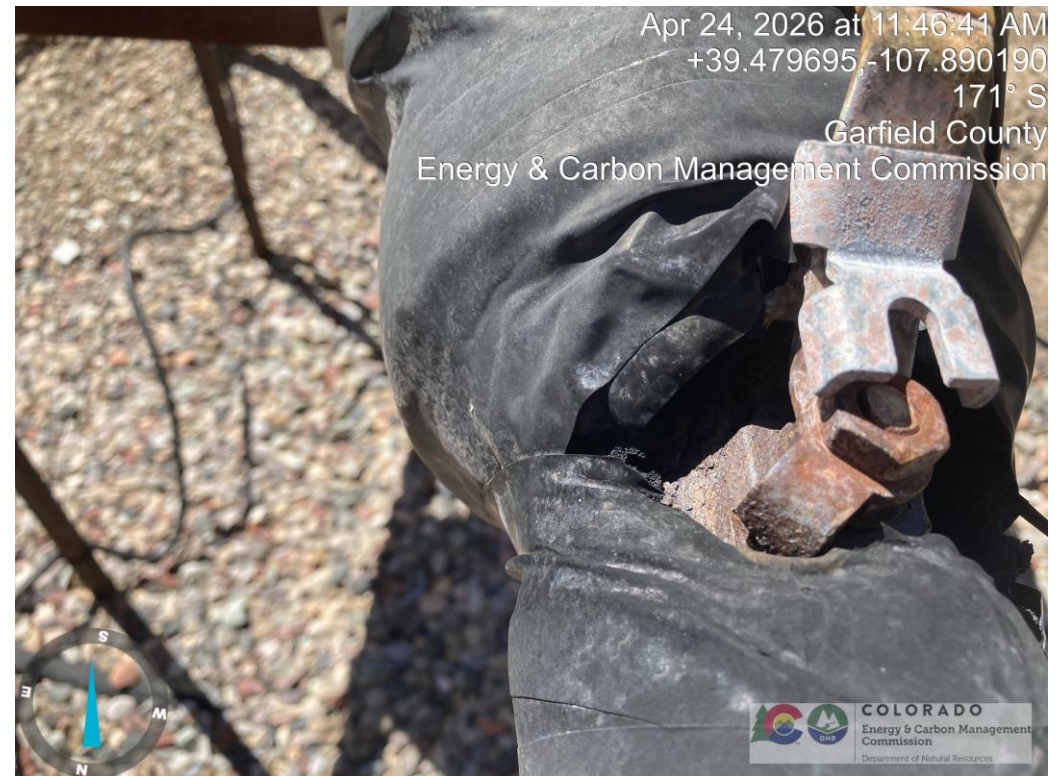
Rusted valves and fittings on catalytic heater.

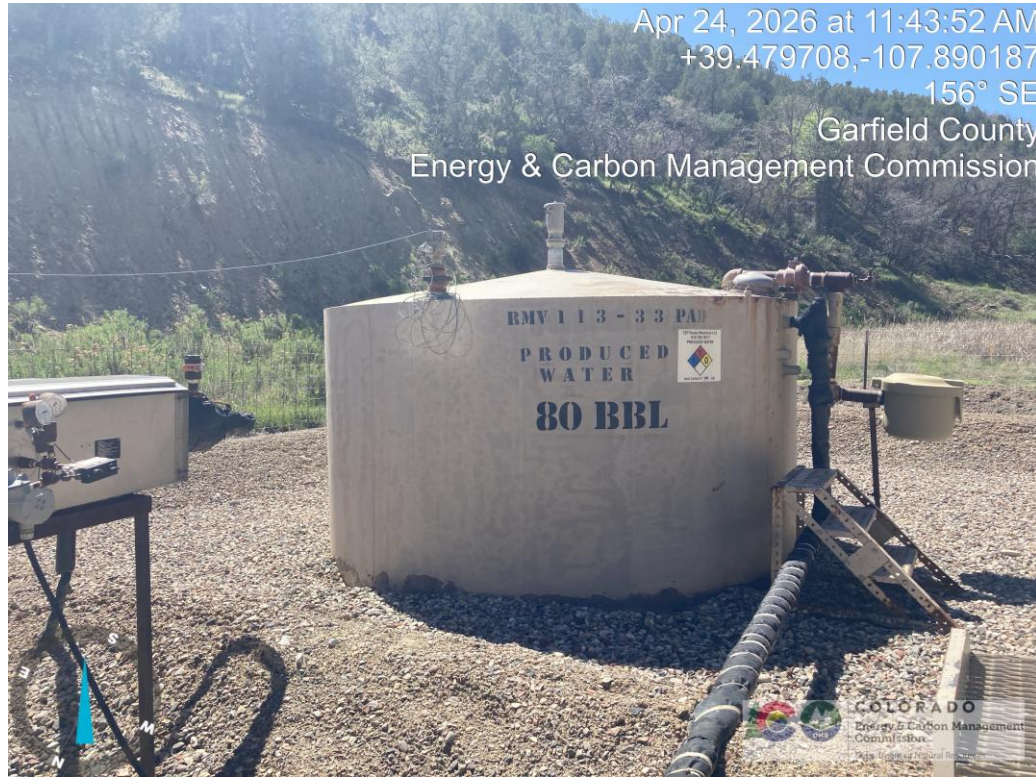
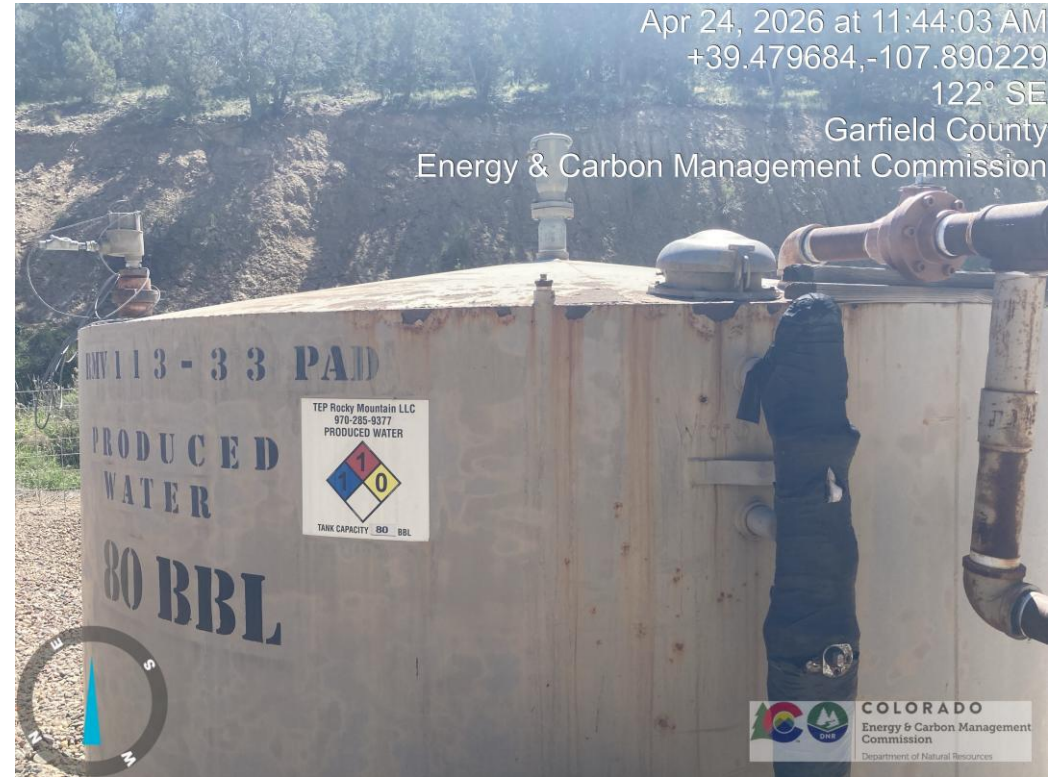
Paint deterioration and areas of rust.

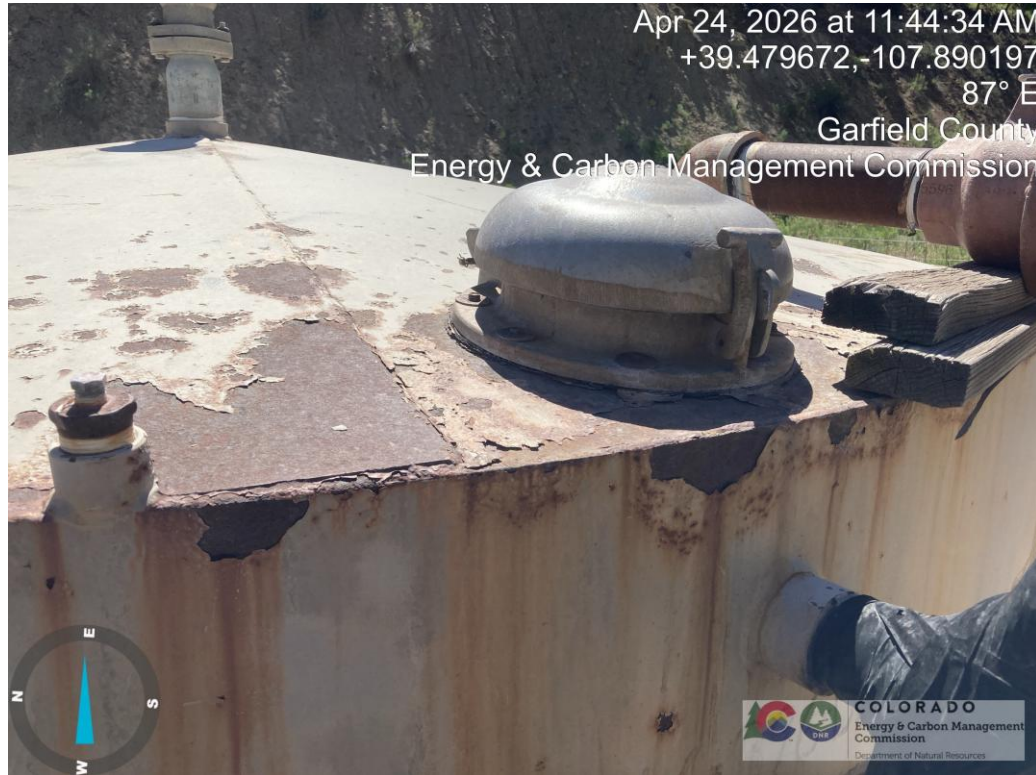
Paint deterioration and areas of rust.

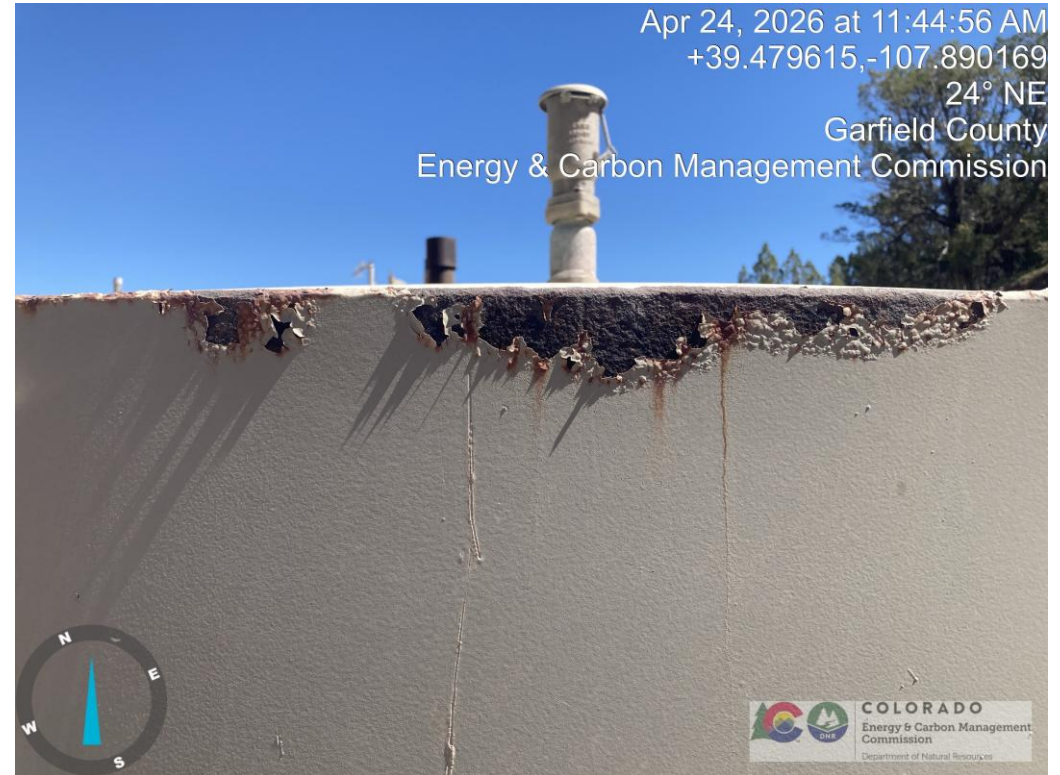
Paint deterioration and areas of rust.

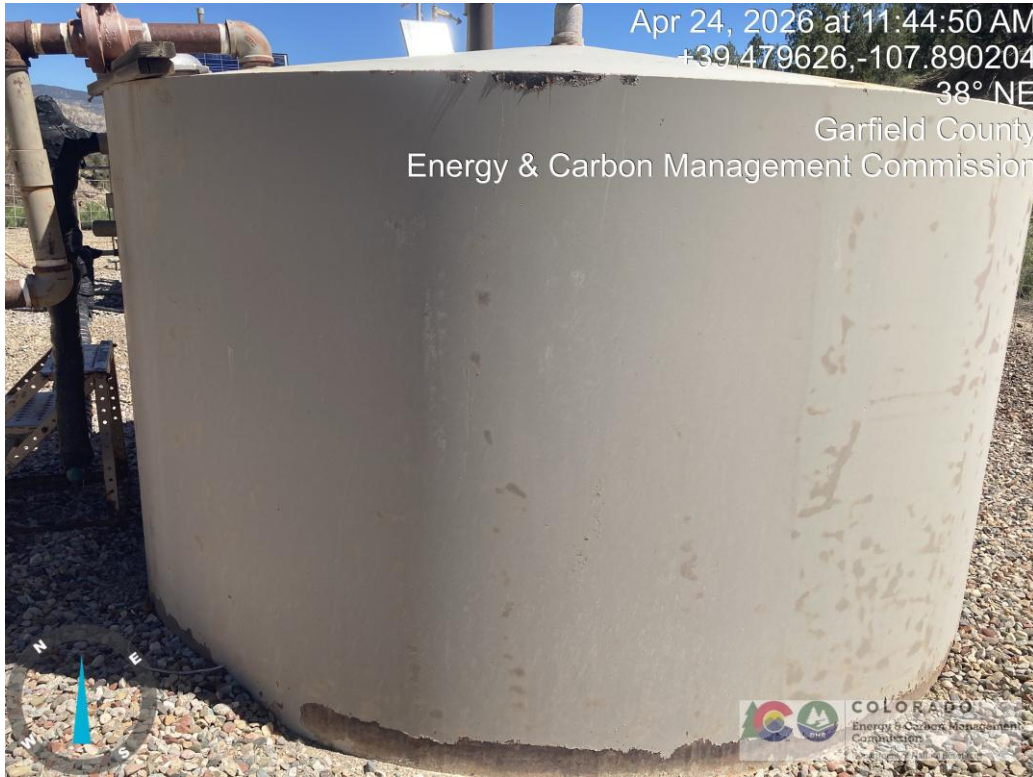
Paint deterioration and areas of rust.

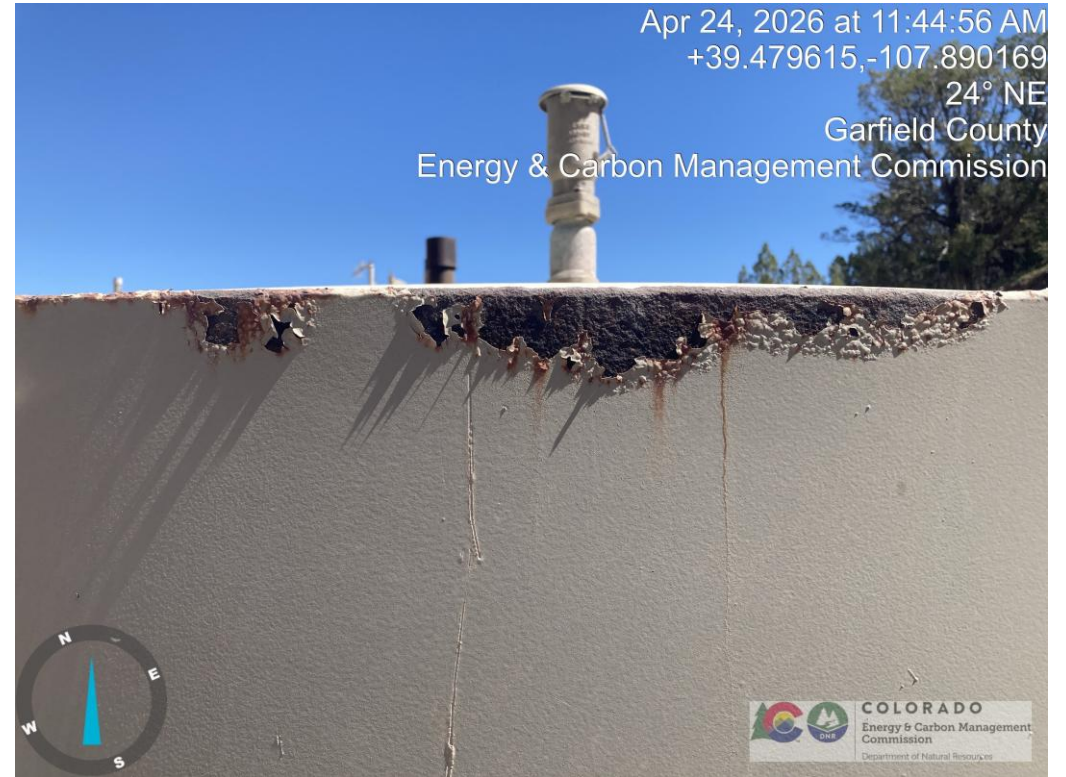
Paint deterioration and areas of rust.

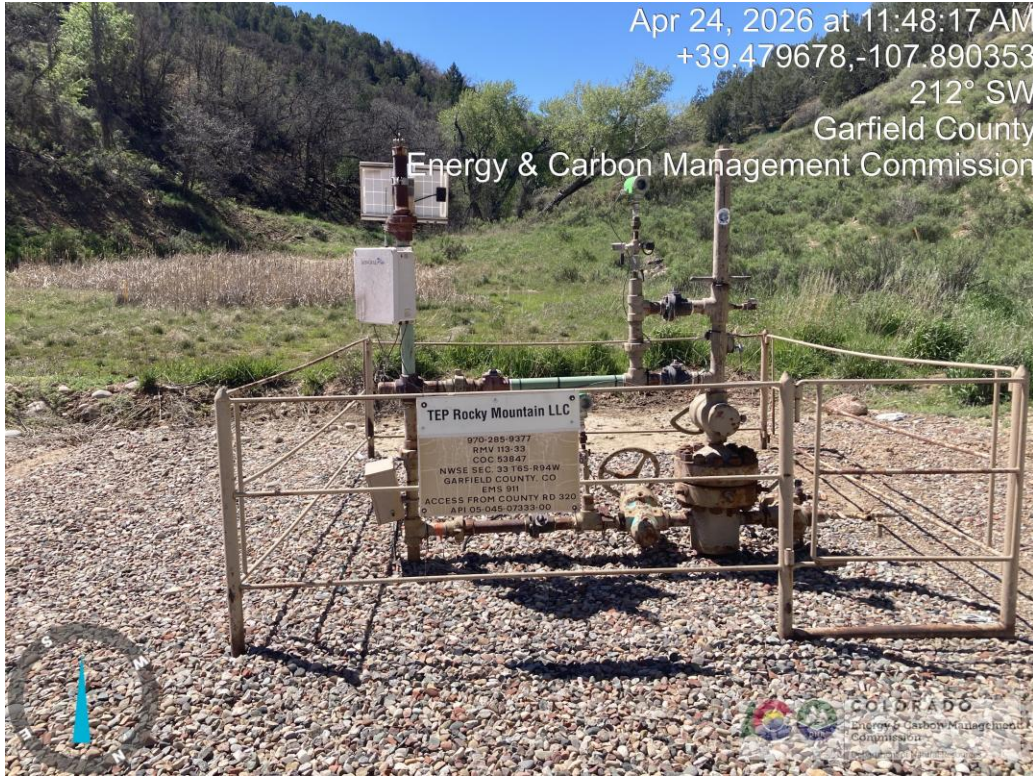
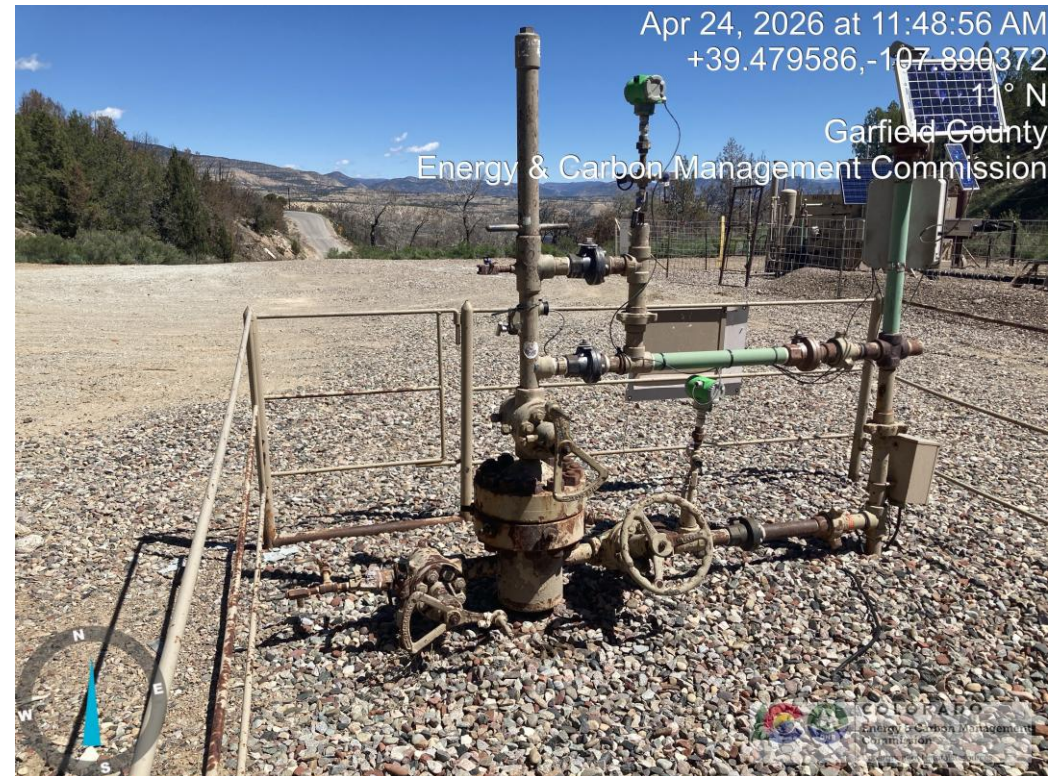
Paint deterioration and areas of rust.

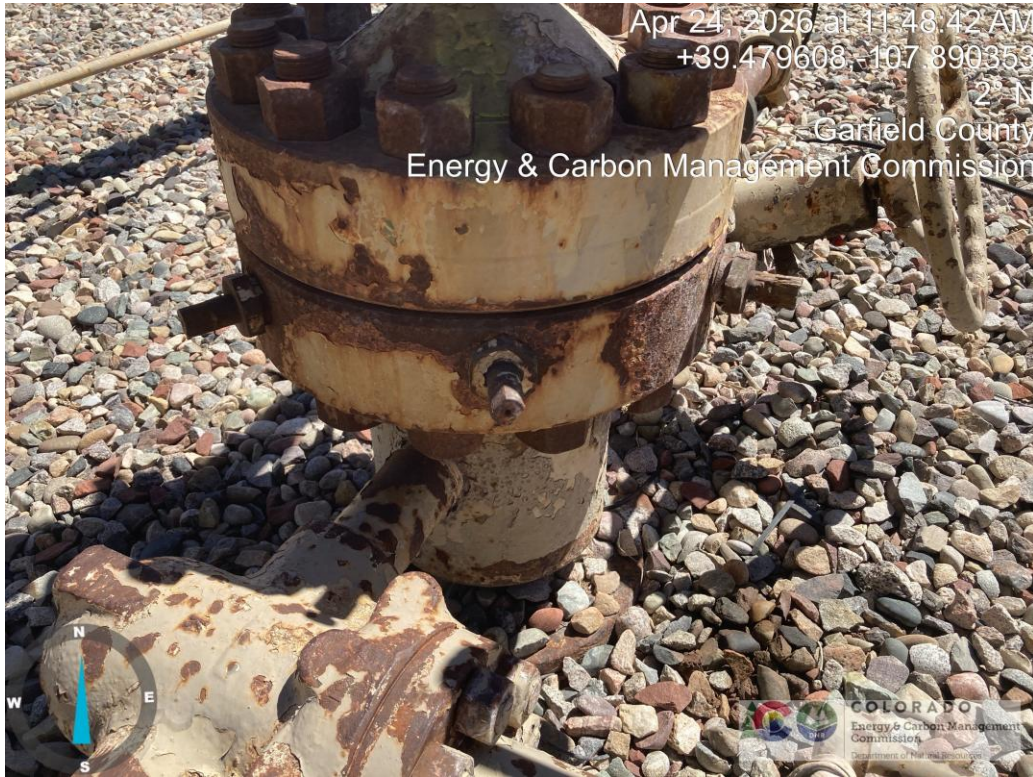
Paint deterioration and areas of rust.

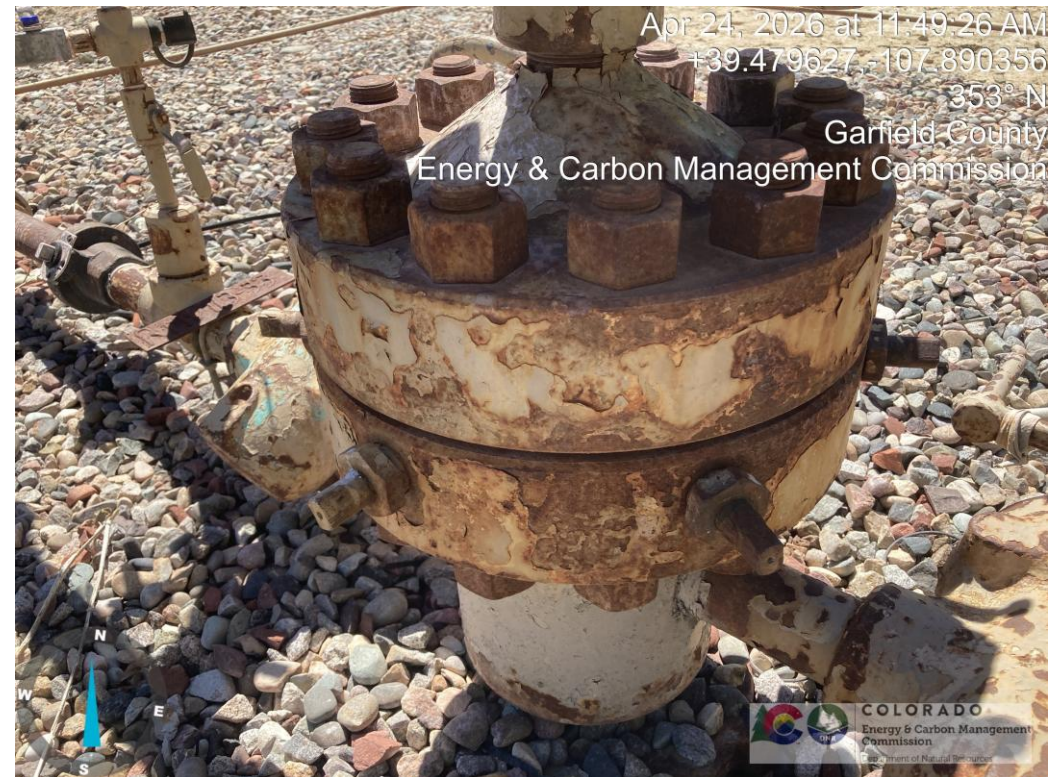
Paint deterioration and areas of rust.
