Inspection Photos
Hwy52 & CR19 (G)
SPILL ID 493177

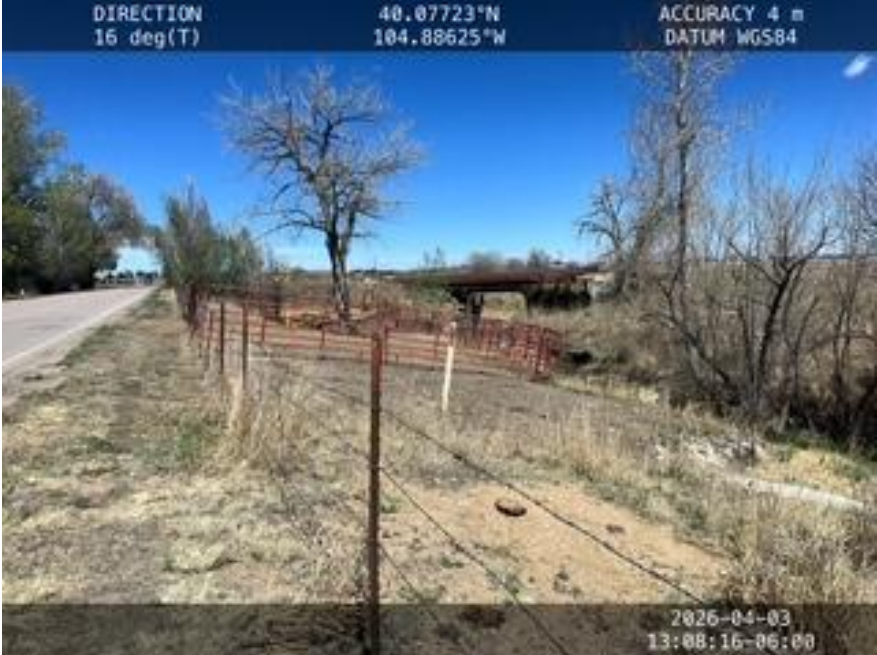
Fencing around former work area

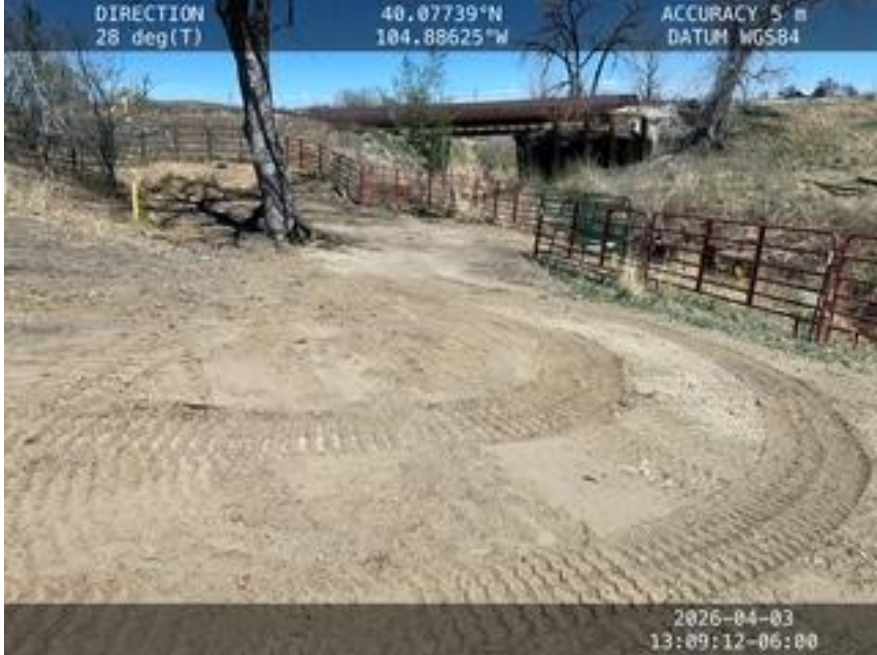
Former excavation area

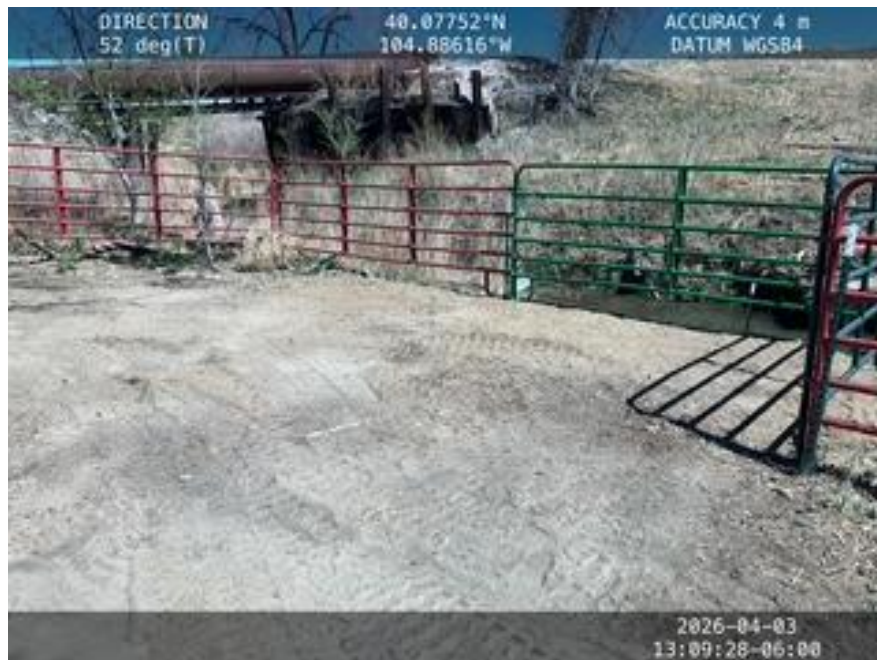
Fencing around former work area

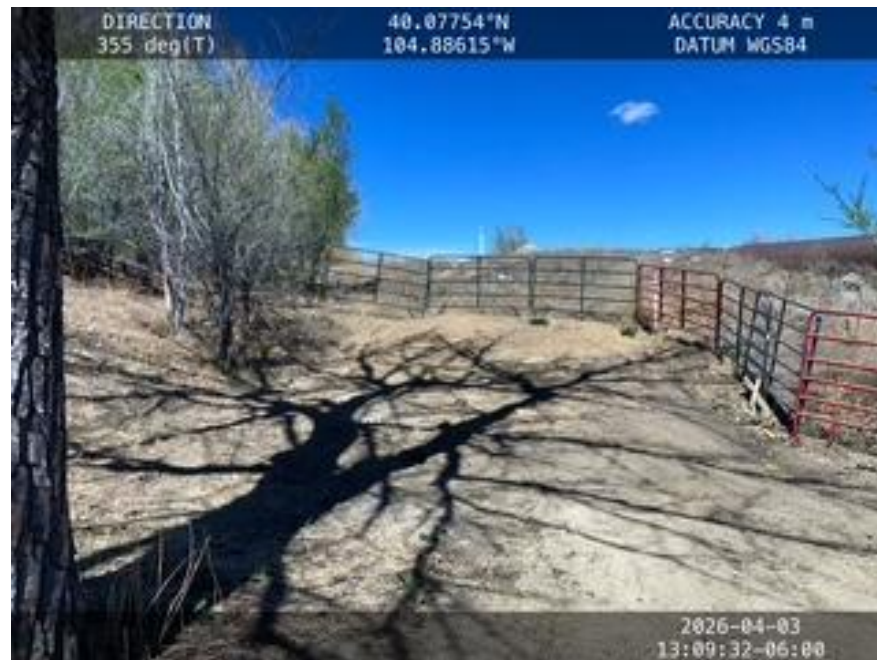
Fencing around former work area

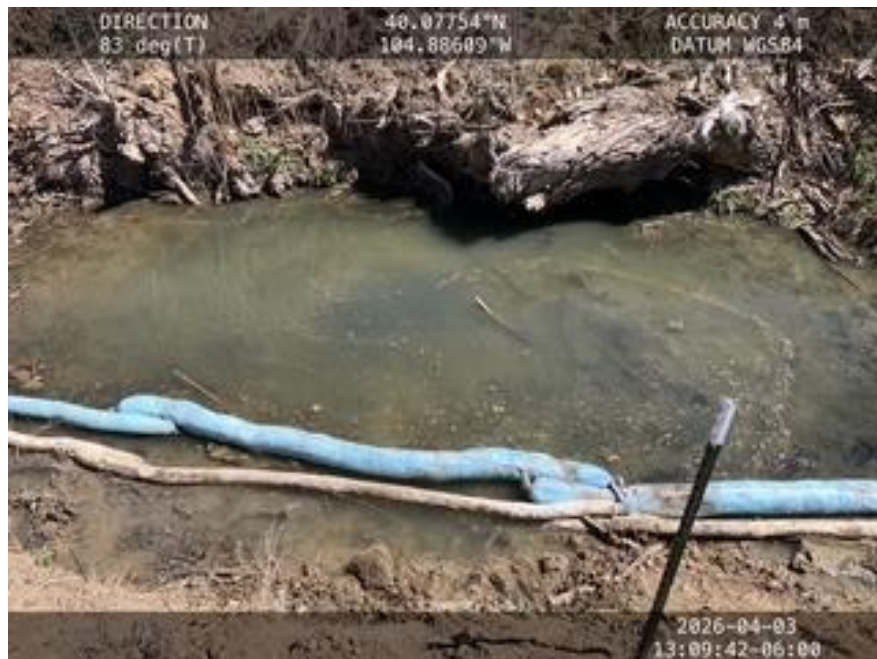
Hydrophobic oil-absorbent booms installed within Little Dry Creek adjacent to former excavation.

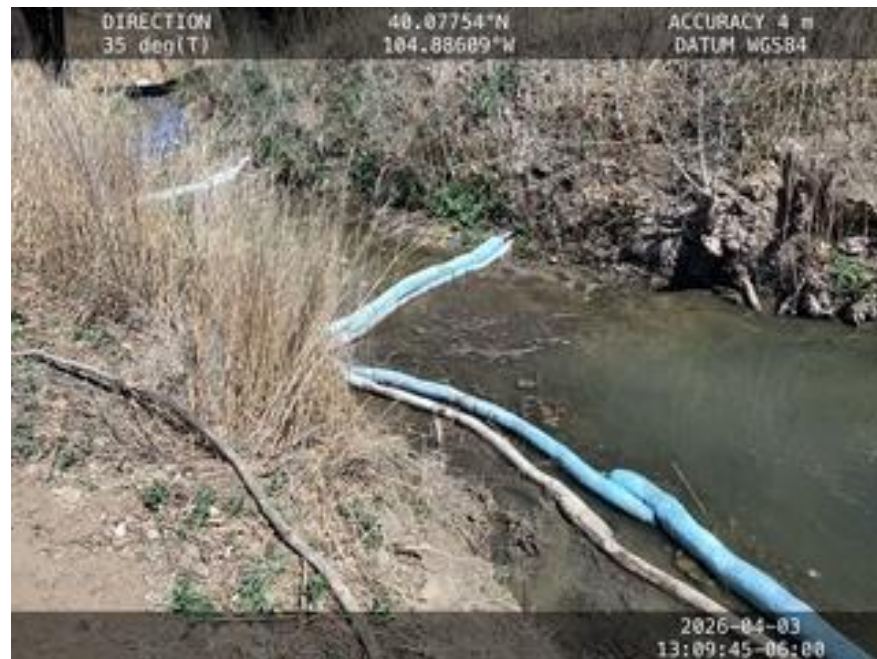
Hydrophobic oil-absorbent booms installed within Little Dry Creek adjacent to former excavation.

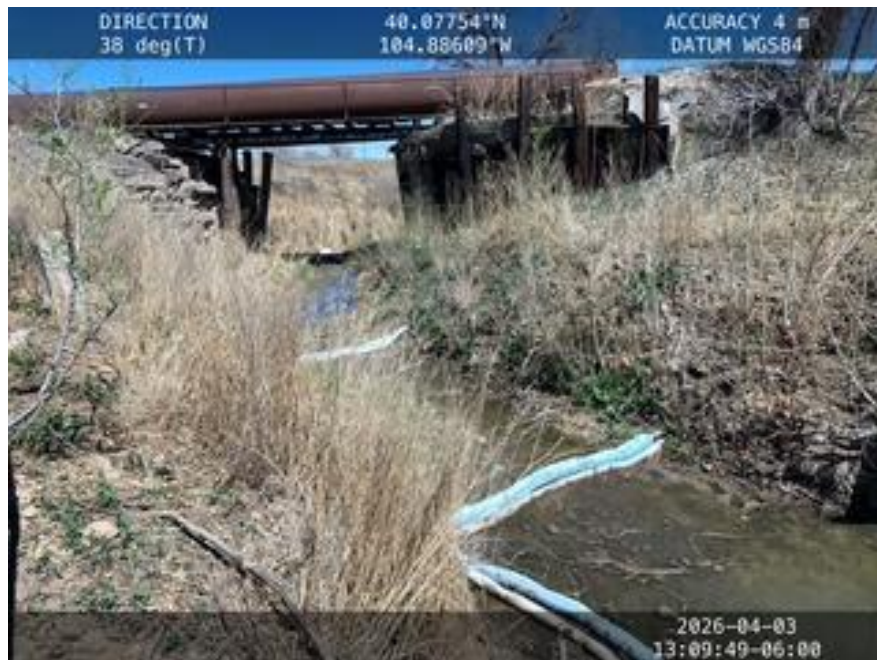
Hydrophobic oil-absorbent booms installed within Little Dry Creek downstream of former excavation.

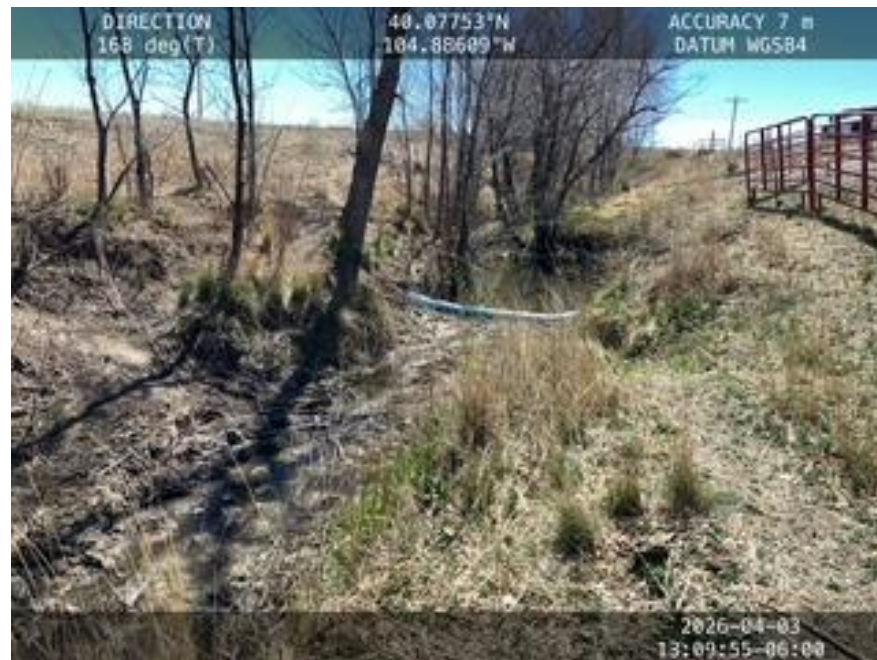
Hydrophobic oil-absorbent booms installed within Little Dry Creek adjacent to former excavation.
