Inspection Photos
Wandell 2N67W/7NENE
Spill ID 491145/Remediation No 40433

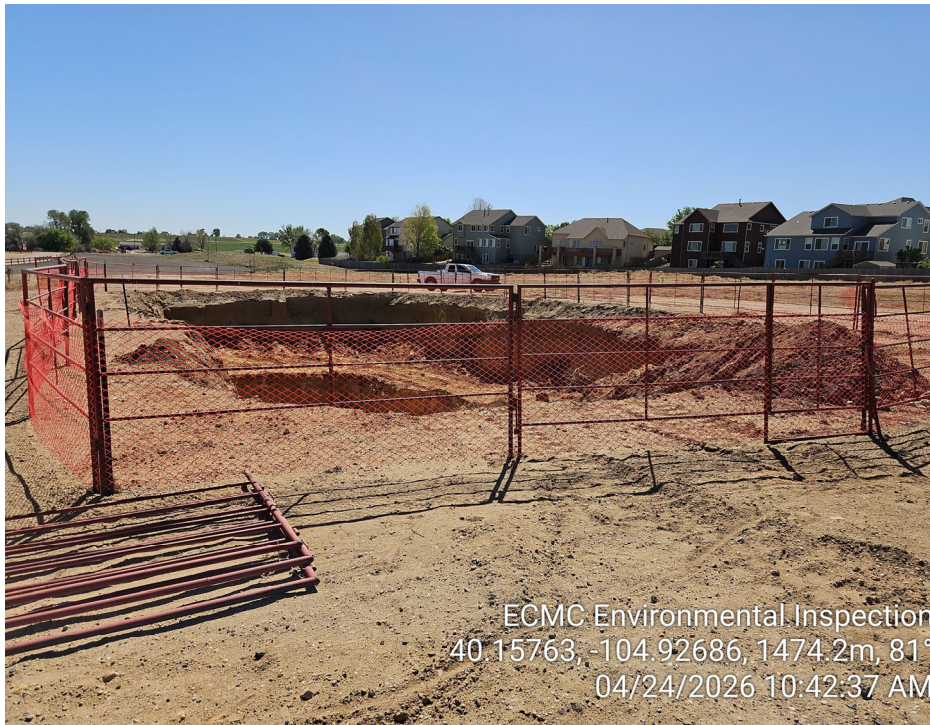
Photo 1 – Open excavation. Fencing adequate.

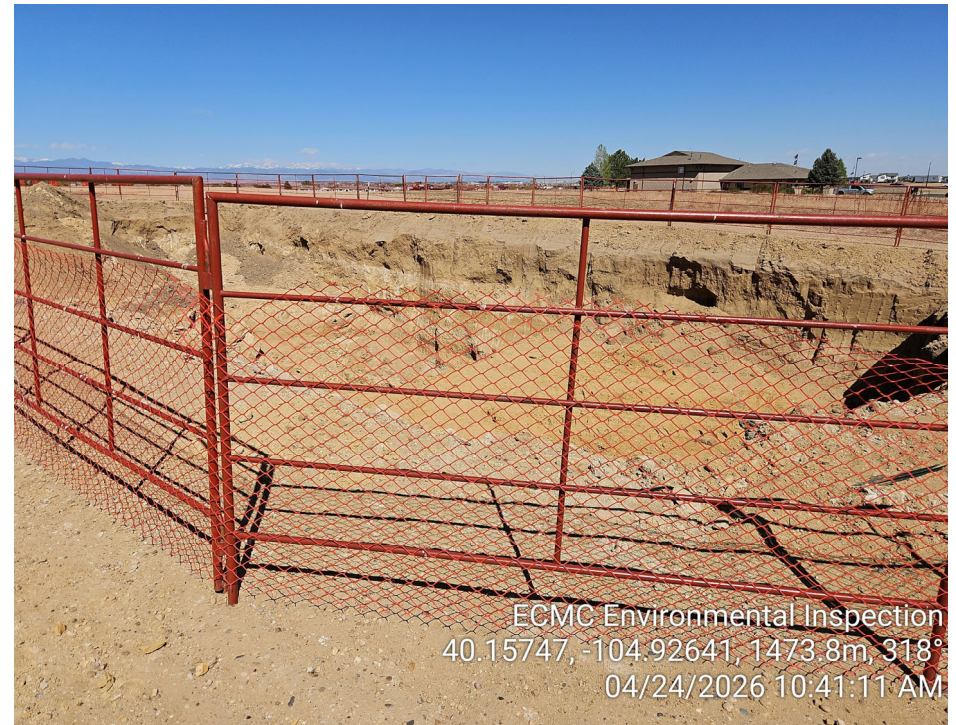
Photo 2 – Open excavation. Fencing adequate.

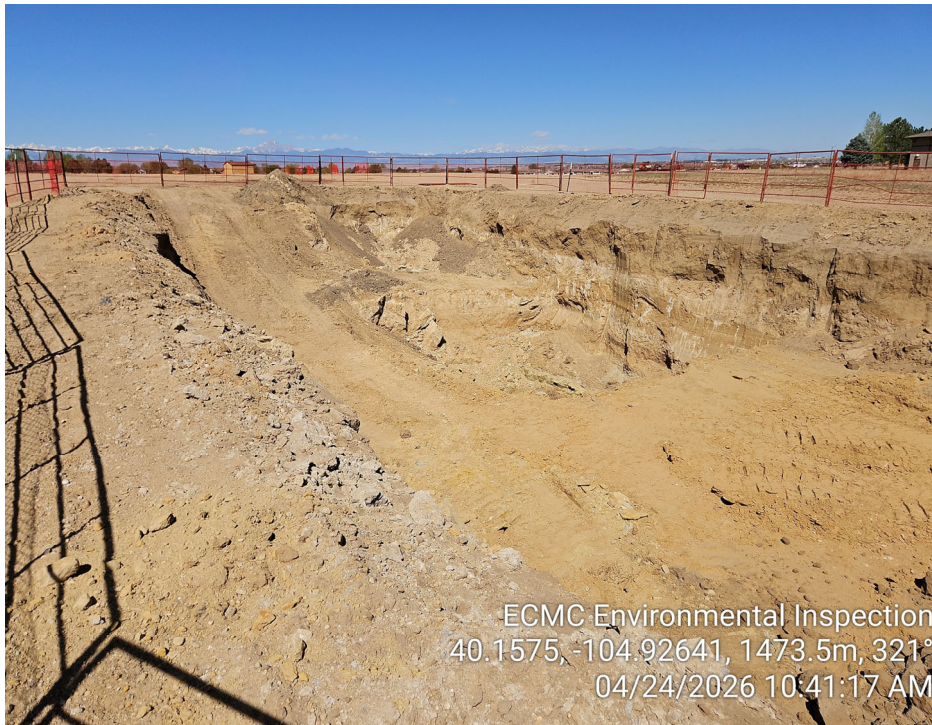
Photo 3 – Open excavation.

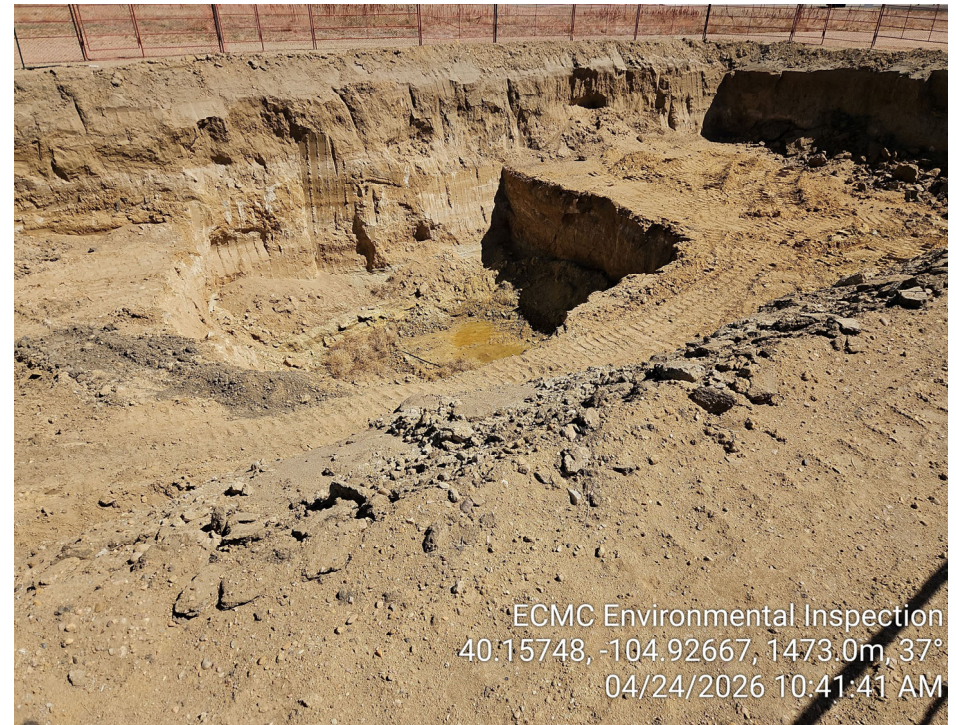
Photo 4 – Open excavation. Groundwater beginning to seep in.

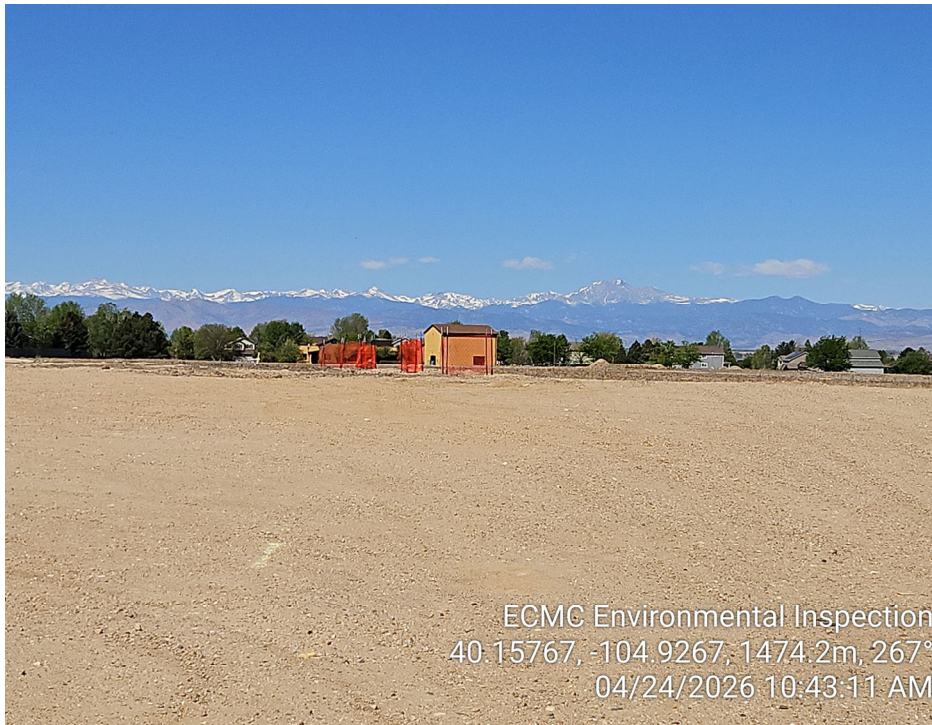
Photo 1 – Former wellhead location.

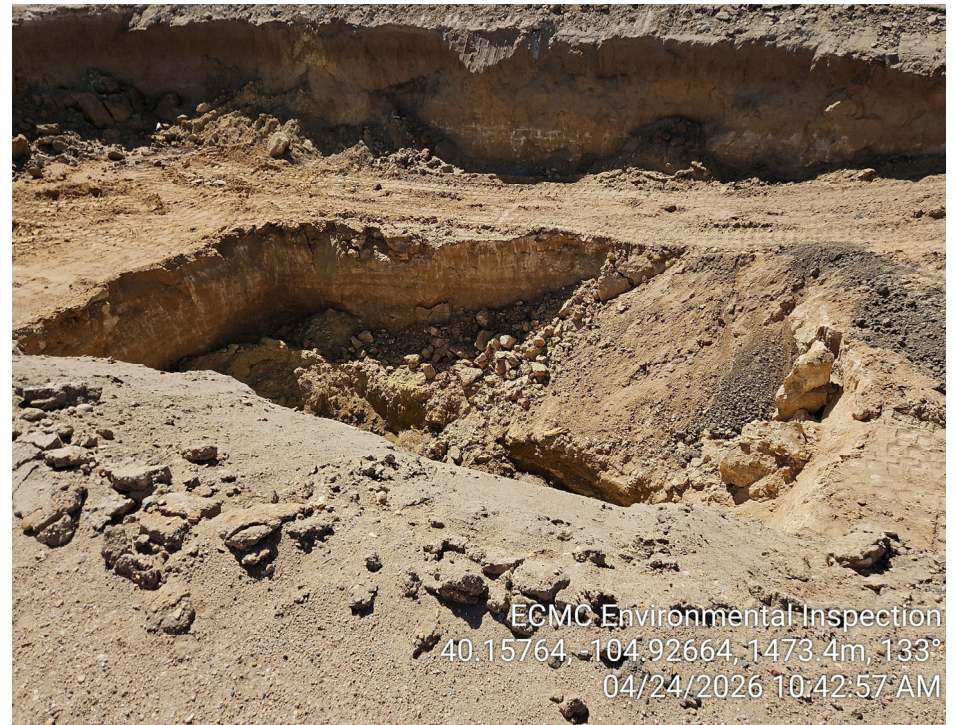
Photo 6 – Open excavation.
